# Inspection Report

**Brian & Jennifer Eddy**  
**3530 Lakeside Village**  
**Paso Robles, CA 93446**

Report Date: 5/21/2025

Customer File # **20813**

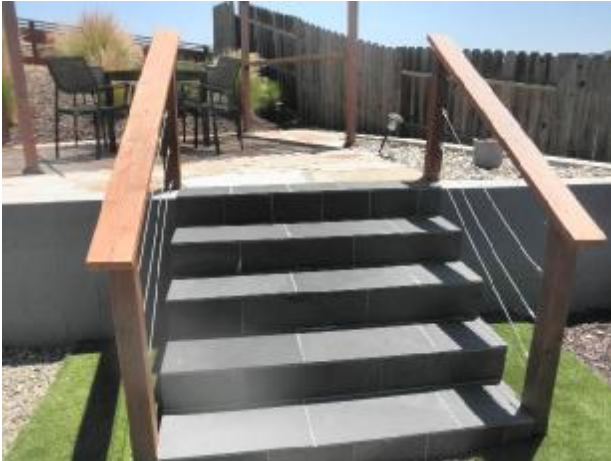
# GD

**Safety Hazard Note:** The railings at backyard upper patio do not meet current standards for height or grasp ability. It was very typical to use a 2X4 or 2X6 rail cap for many years however, this type of rail cap can be difficult to grab in the event of slipping on the stairs. New requirements are for a 1 1/4" to 2" maximum width rail cap that should be installed from 34" to 38" in height as measured from the nose of the stair tread.

Nongraspable handrails at the backyard upper patio steps.

Safety Hazard Note: The railings at backyard upper patio do not meet current standards for height or grasp ability. It was very typical to use a 2X4 or 2X6 rail cap for many years however, this type of rail cap can be difficult to grab in the event of slipping on the stairs. New requirements are for a 1 1/4" to 2" maximum width rail cap that should be installed from 34" to 38" in height as measured from the nose of the stair tread.

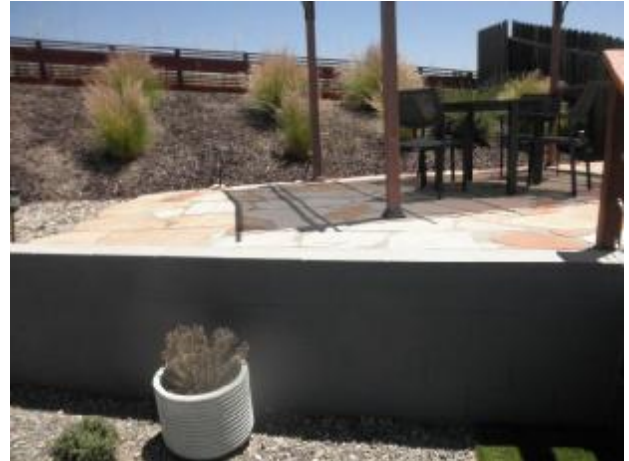
# GD

**Safety Hazard Note:** There is no railing installed at the upper backyard patio.

No railing installed at the backyard upper patio.

Safety Hazard Note: There is no railing installed at the upper backyard patio.

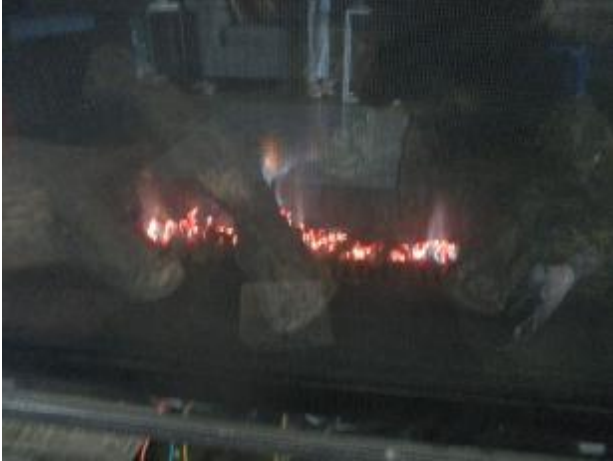
# IR

The gas fireplace was operable during the time of inspection.
