Pacific Coast Home Inspections

Steve Spisak

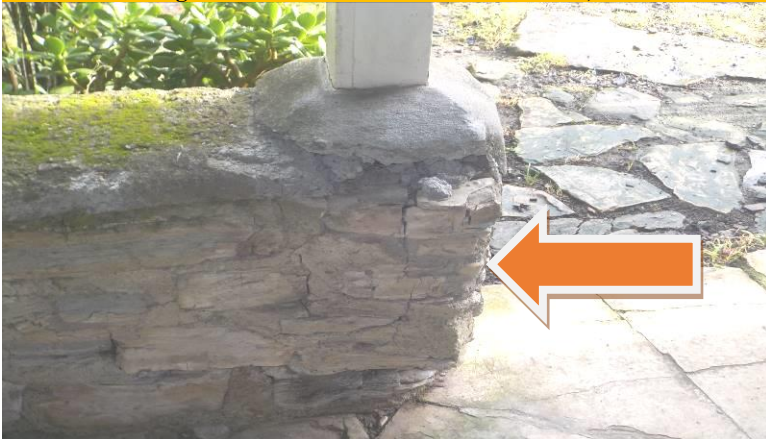
Item #6-Steps-At the rear deck, I recommend adding a maximum 2" diameter 'grab rail' to the top or side of the 2x6 rail cap

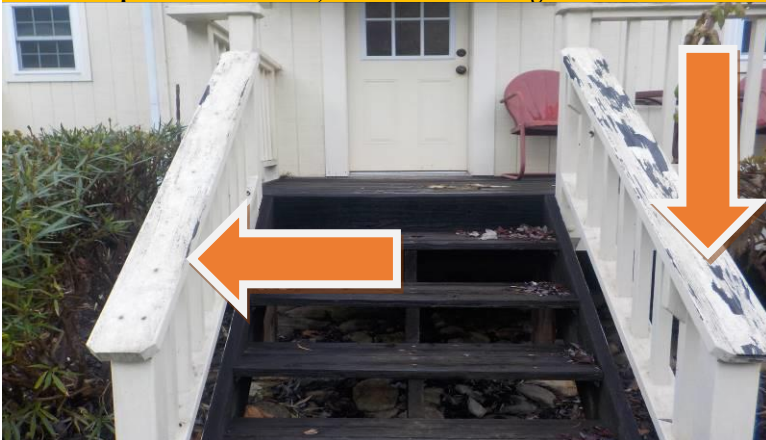
Item #12-Chimney-At the chimney for the Great room fireplace, there is surface corrosion on the chimney cap flashing

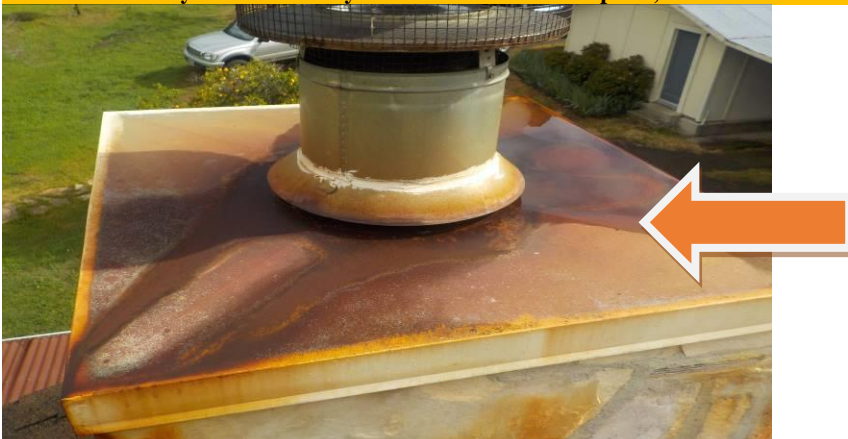
Item #13-Deck-At the rear deck, wood damage to the 2x6 rail cap corner join

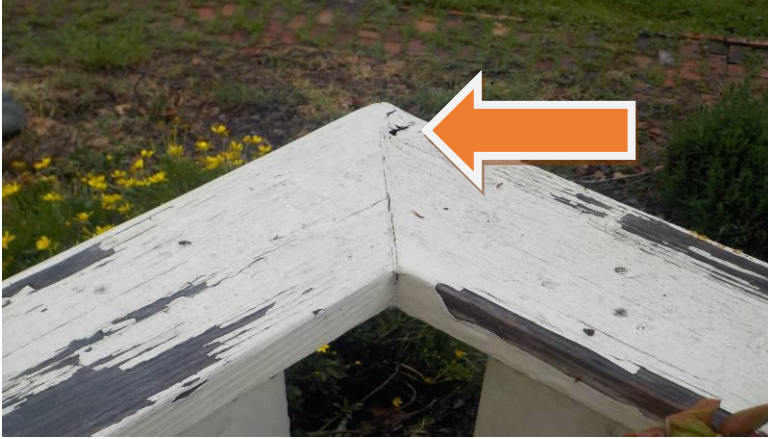
Item #13-Deck-At the rear deck, wood damage to the bottom rail framing

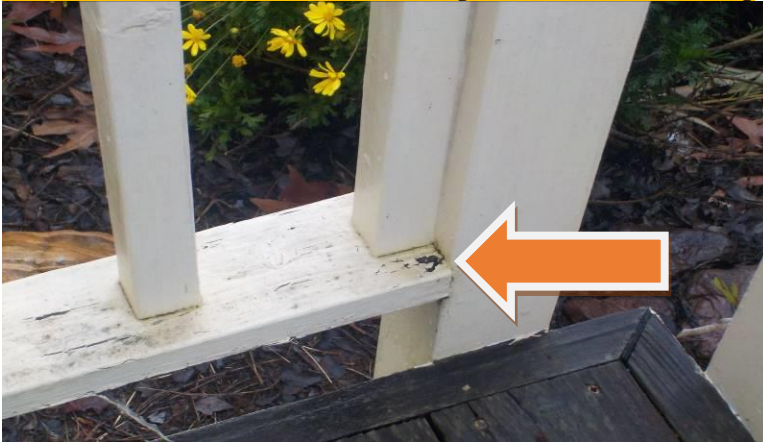
Item #15-Exterior doors-At the rear entry to the primary bedroom, the deadbolt strike plate on the door frame is missing/damaging the frame

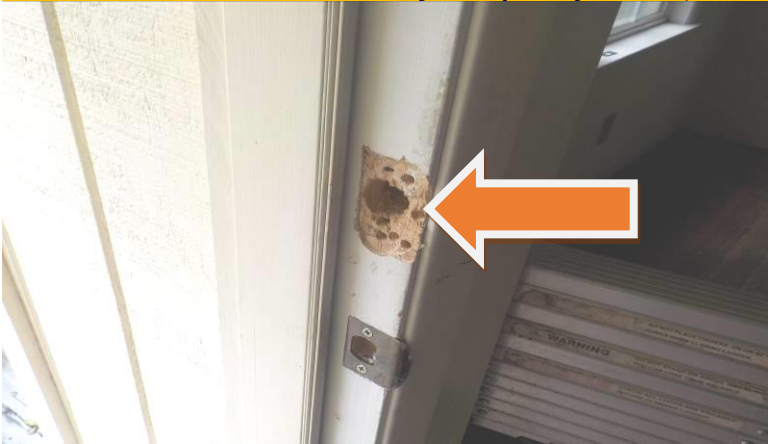
Item #18-Fascia-At the west end of the home, wood damage to the fascia board behind the rain gutter

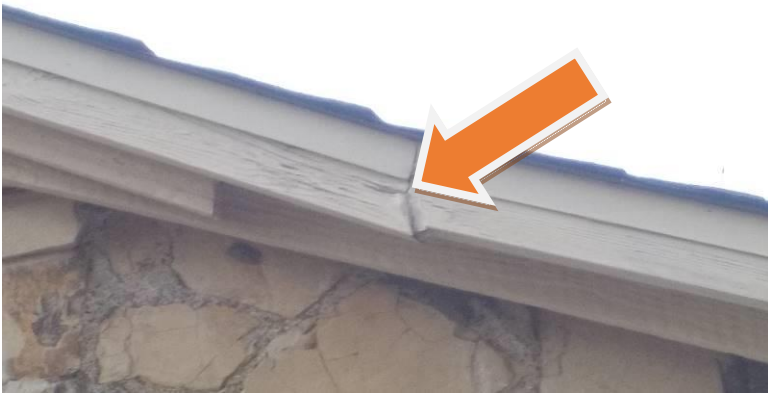
Item #19-Rain gutters-At the rear of the home, the gutters are blocked with debris, mainly at the gutter to downspout connection

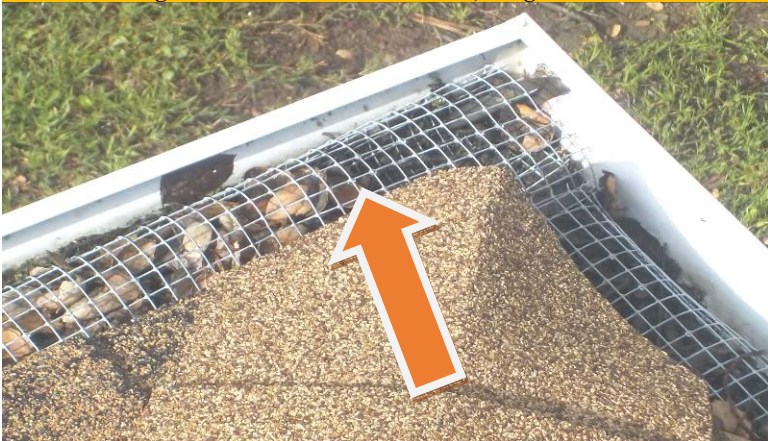
Item #22-Porch/veranda-At the west end of the home, a few of the flagstones are missing/trip hazard

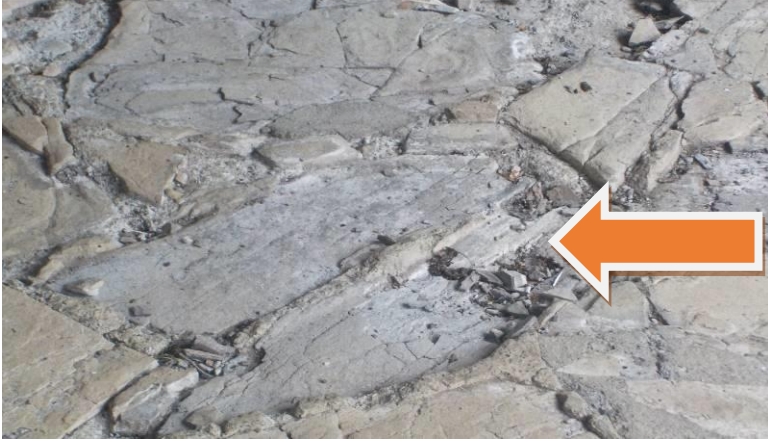
Item #22-Porch/veranda-At the west end of the home, some of the grout between the stones is missing/trip hazard

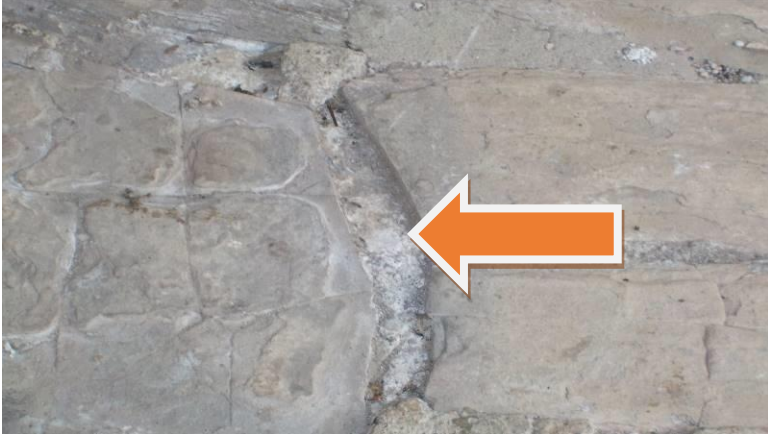
Item #24-Soffit/rafter tails-At the west end of the home and over the porch/veranda, wood damage to the 2x4 rafter

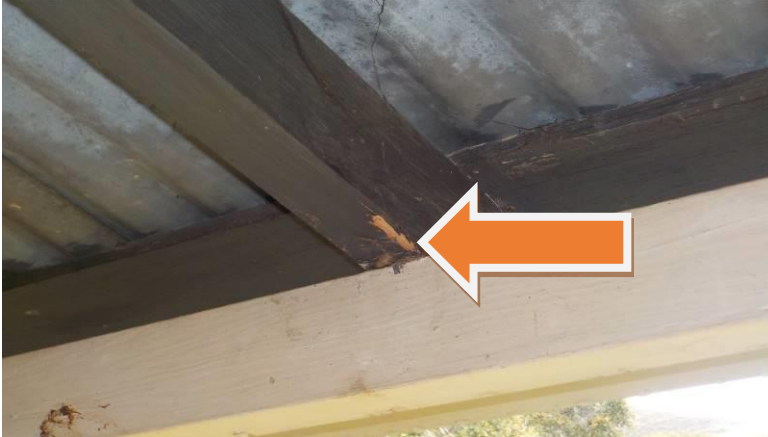
Item #25-Supports-Mainly at the west end of the porch/veranda, there is some wood damage to the 4x4 support posts, various posts

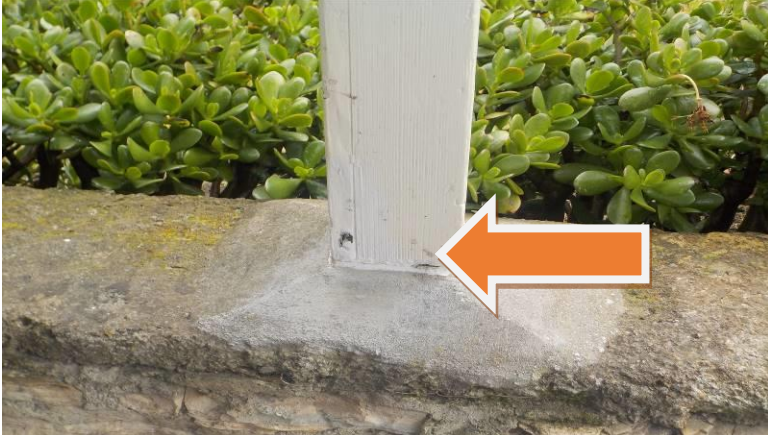
Item #25-Supports-Mainly at the west end of the porch/veranda, there is some wood damage to the 4x4 support posts, various posts

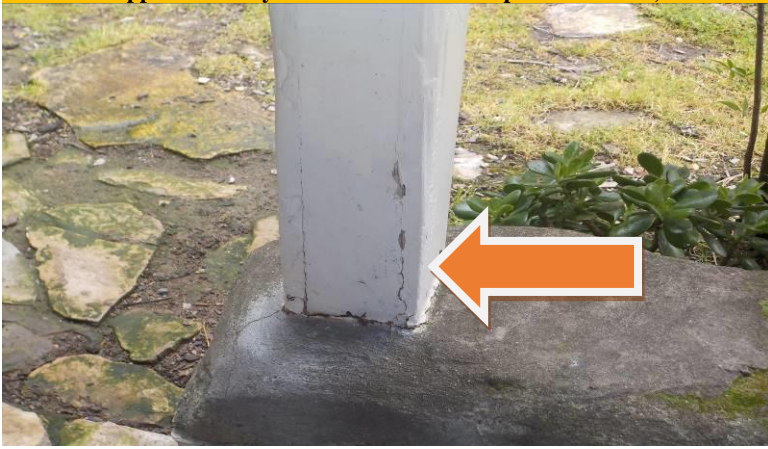
Item #25-Supports-Mainly at the west end of the porch/veranda, there is some wood damage to the 4x4 support posts, various posts

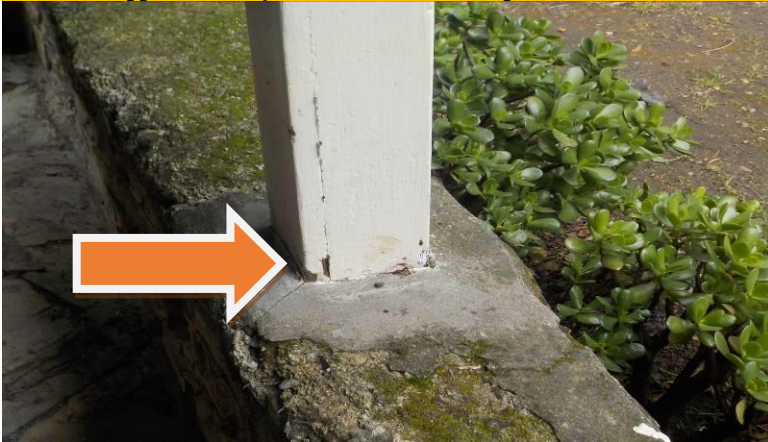
Item #25-Supports-Mainly at the west end of the porch/veranda, there is some wood damage to the 4x4 support posts, various posts

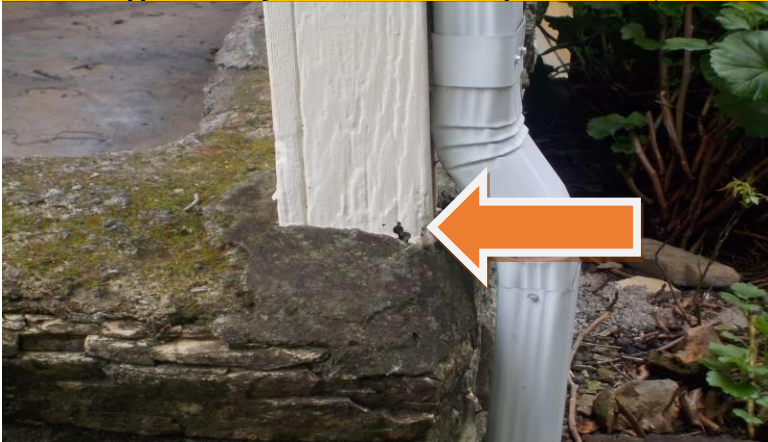
Item #25-Supports-Mainly at the west end of the porch/veranda, there is some wood damage to the 4x4 support posts, various posts

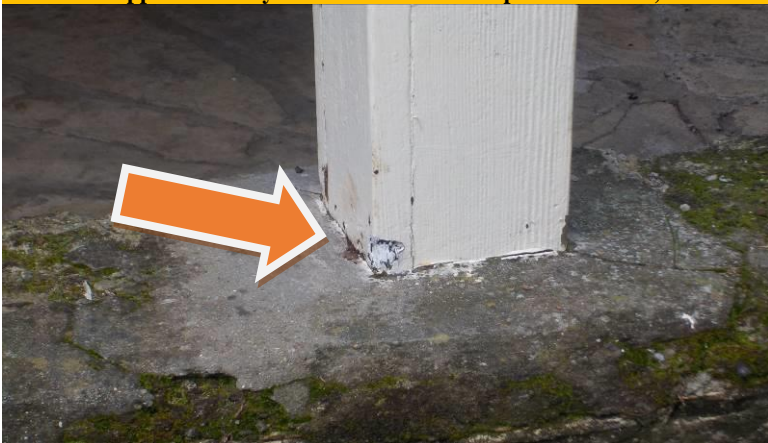
Item #26-Exterior trim-At the rear of the home, wood damage to the 1x4 window trim

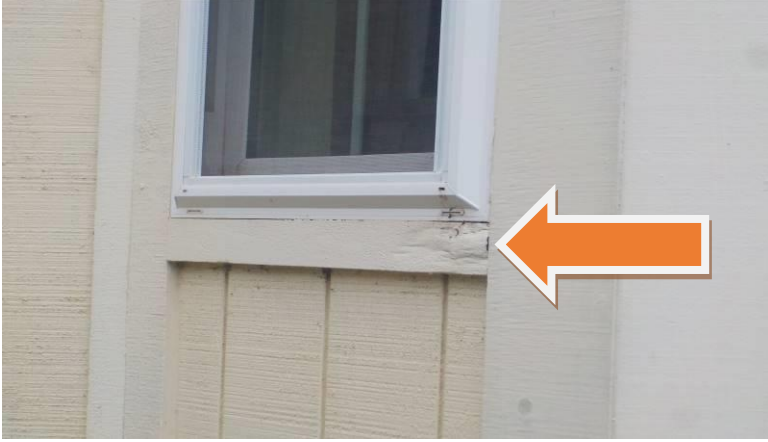
Item #26-Exterior trim-At the rear of the home, wood damage to the 1x4 window trim

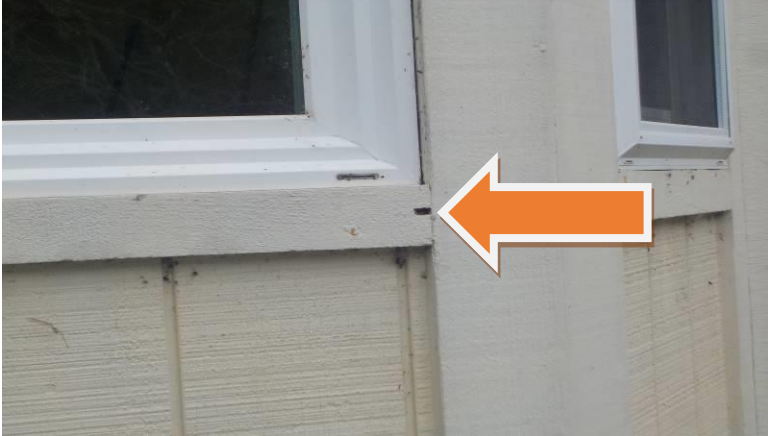
Item #26-Exterior trim-At the SE corner of the home, wood damage to the 1x4 vertical trim

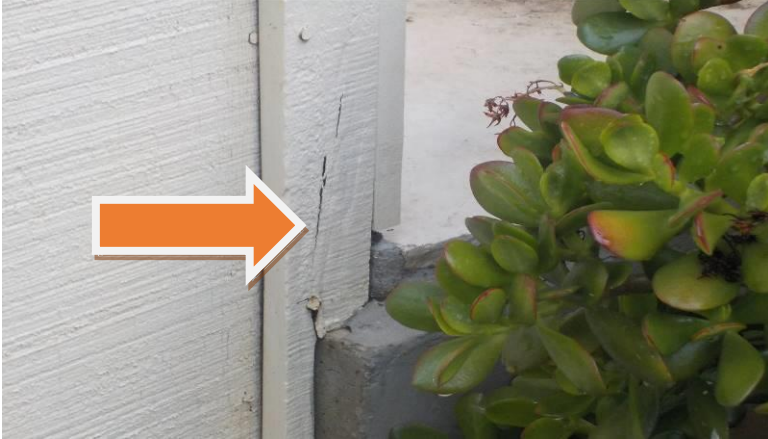
Item #26-Exterior trim-At the SE corner of the home, wood damage to the 1x4 vertical trim

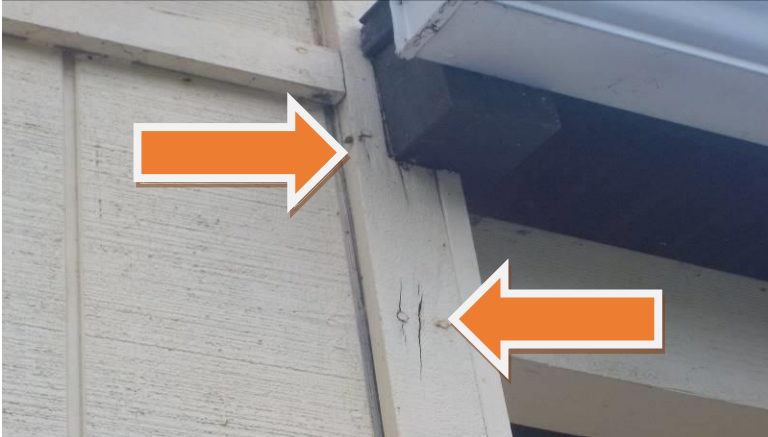
Item #59-Garage, exterior trim-On the north side of the garage, there is wood damage to the door frame and trim down near the threshold

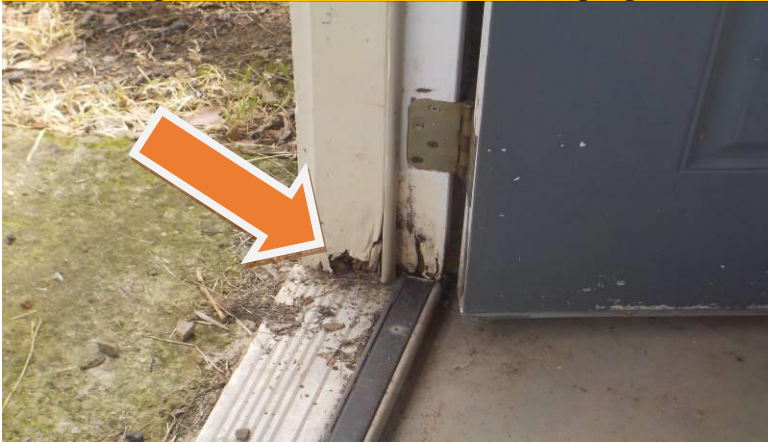
Item #59-Garage, exterior trim-On the north side of the garage, there is wood damage to the door frame and trim down near the threshold

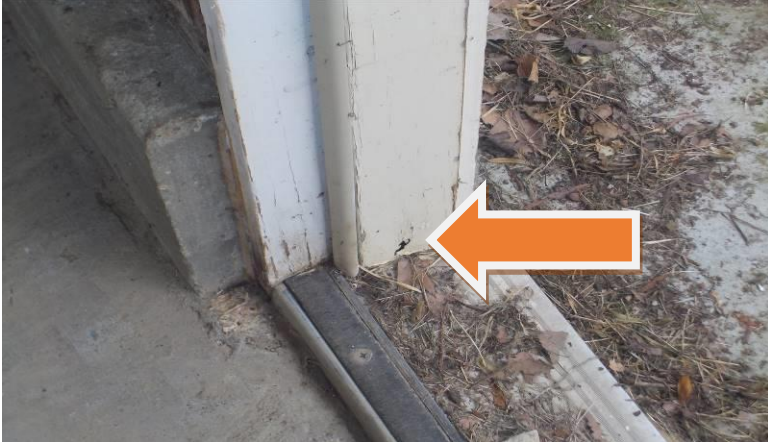
Item #67-Kitchen, drainage-This gray ribbed drain line should be re-routed to be higher than the bottom of the sink/see 3-photos below

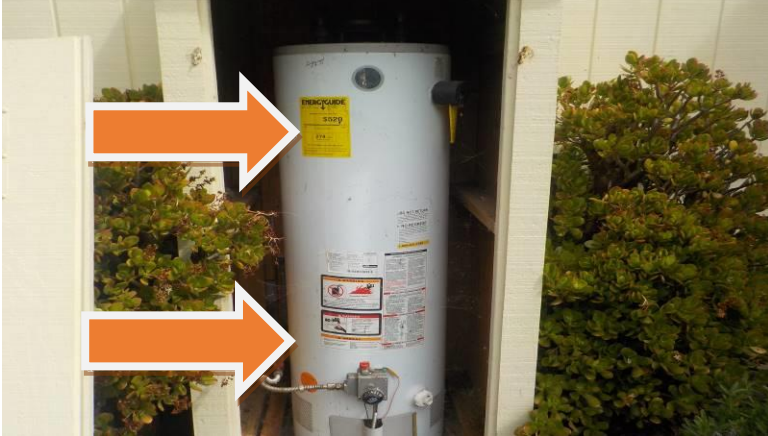
Item #88-Water heater-The water temperature in the home is at 136.9 degrees (too hot) / 115-120 degrees is recommended

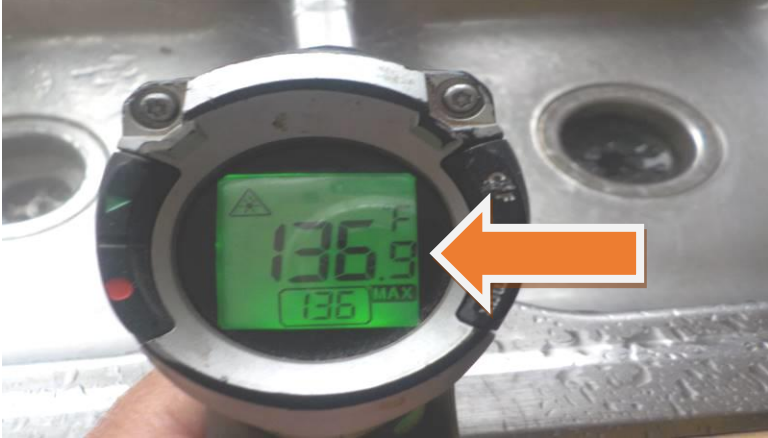
Item #88-Water heater-An extension is required from the pressure relief valve to within 6" of the ground

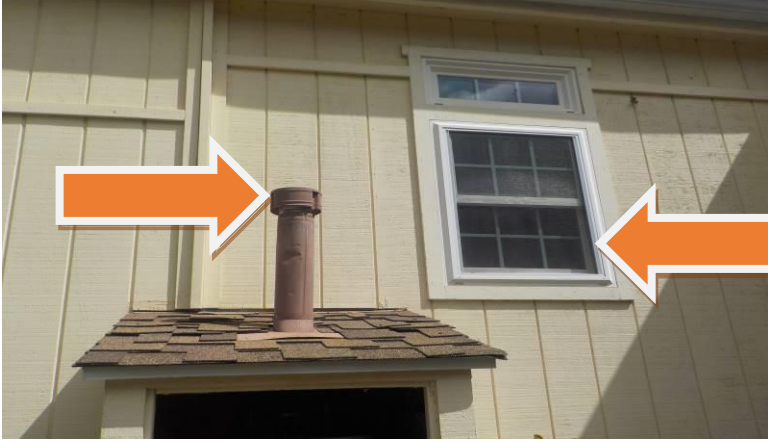
Item #'s 113/118-Crawl space, columns/girders-Many of the columns are not on piers, but buried in the soil and have wood damage

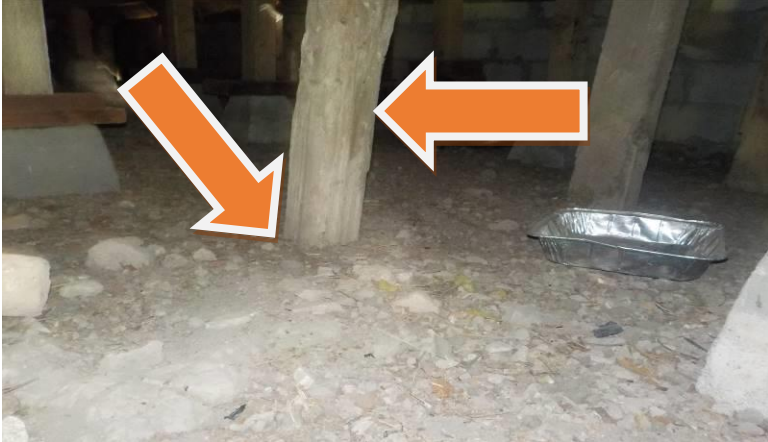
Item #'s 113/118-Crawl space, columns/girders-Many of the columns are not on piers, but buried in the soil and have wood damage

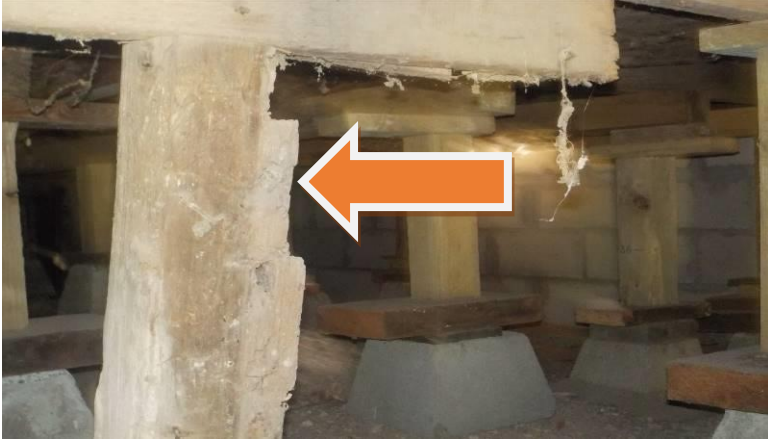
Item #'s 113/118-Crawl space, columns/girders-Many of the columns are not secured to the girders and have wood damage

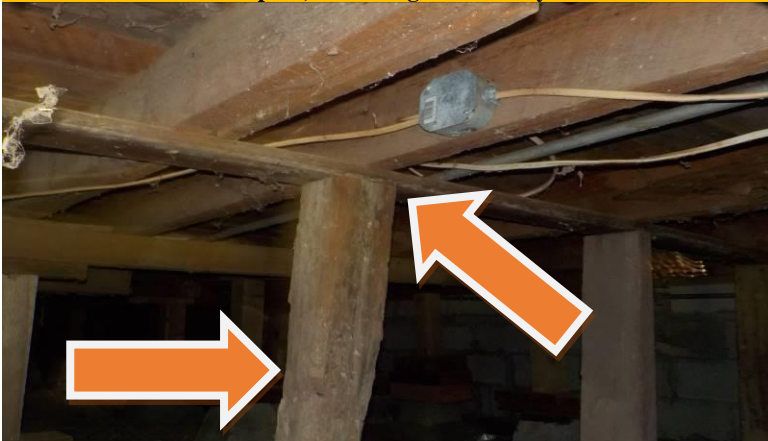
Item #'s 113/118-Crawl space, columns/girders-Many of the columns have spacers between the top of the columns and the girders/not secured

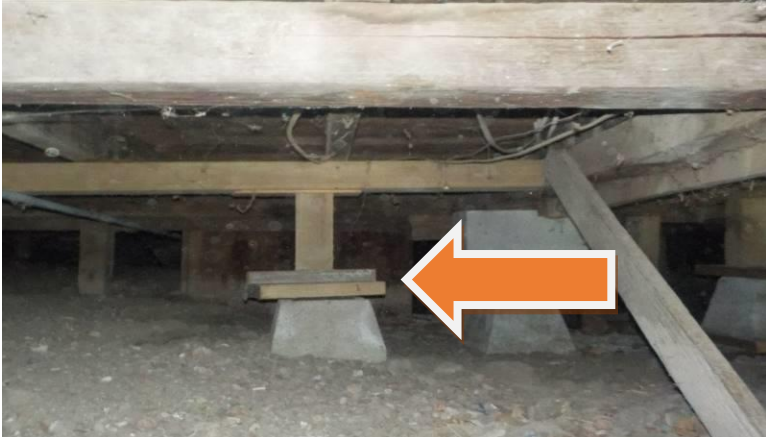
Item #117-Crawl space, foundation-Along the north side of the home (front), concrete rubble has been used as a foundation

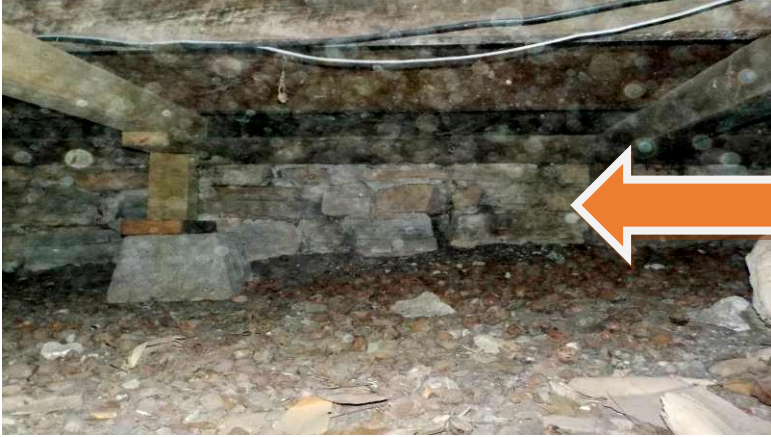
Item #117-Crawl space, foundation-Along the north side of the home (front), concrete rubble has been used as a foundation

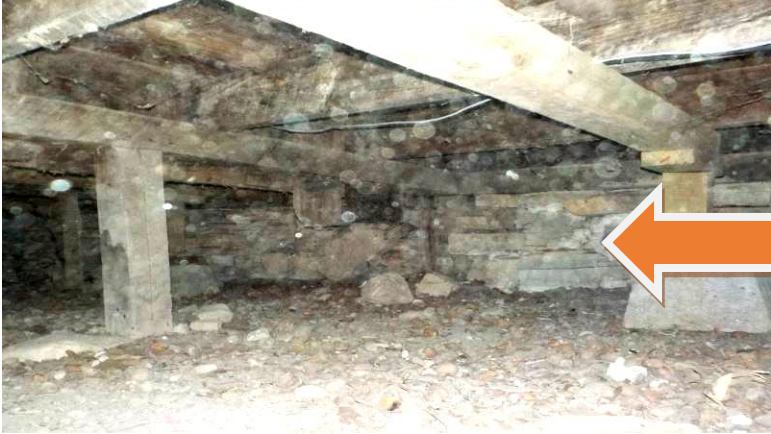
Item #117-Crawl space, foundation-Along the north side of the home (front), concrete rubble has been used as a foundation

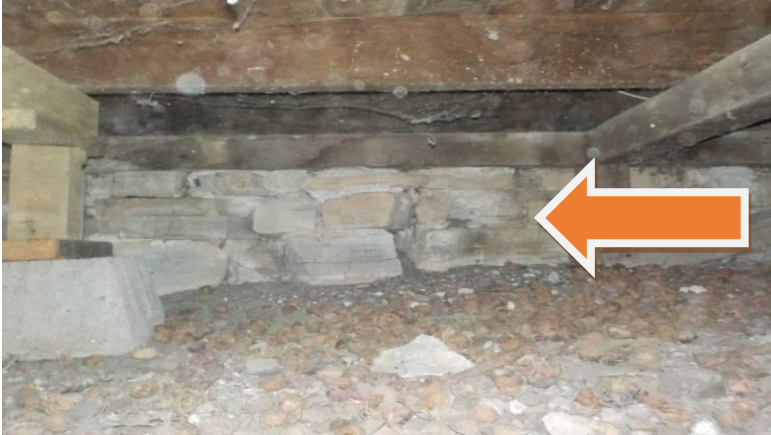
Item #117-Crawl space, foundation-Along the north side of the home (front), concrete rubble has been used as a foundation

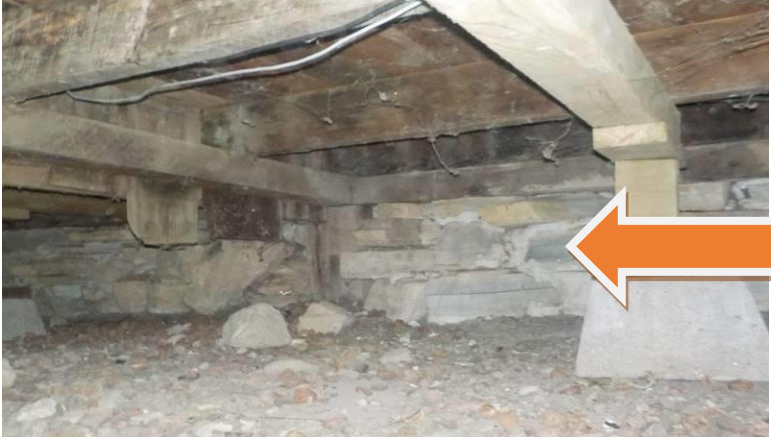
Item #191-Great room, ceiling-In the great room at the east end of the home, there is a crack in the ceiling at the peak of the room

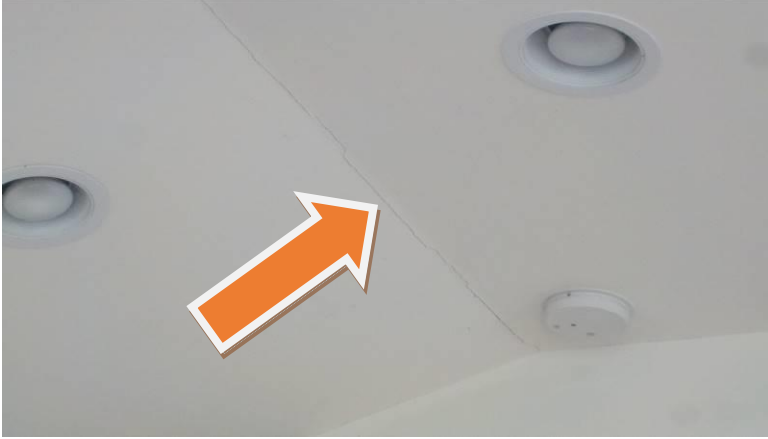
Item #219-Hallway, door-At the door to the closet, there is a hole in the hallway side of the door

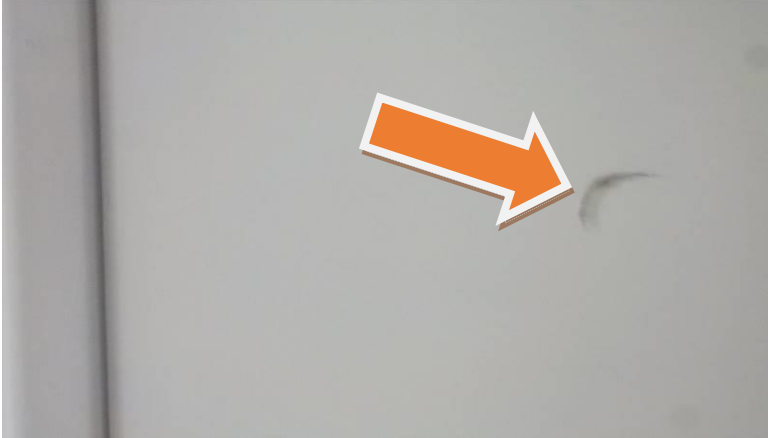
Note-Roof-The composite shingle roofing material all appears to be in good condition/below; over the great room

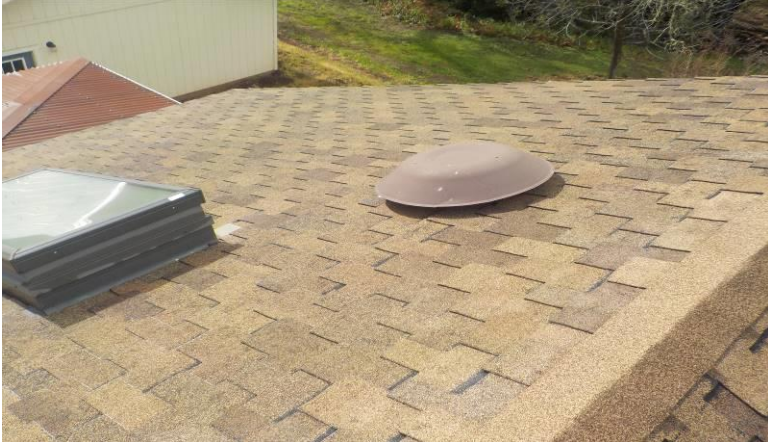
Note-Roof-The composite shingle roofing material all appears to be in good condition/below; over the great room

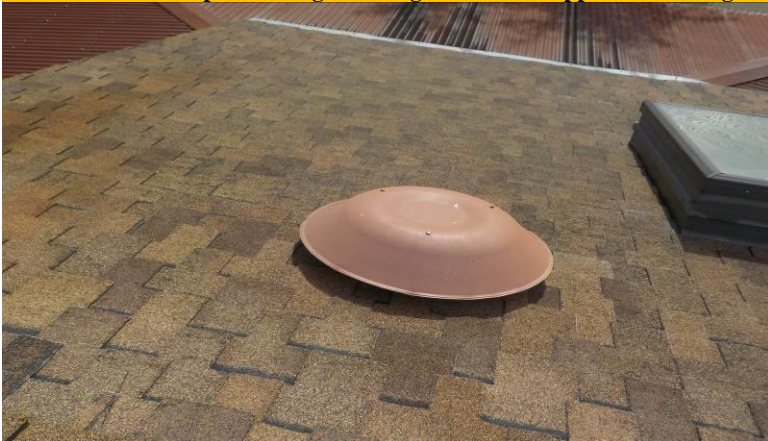
Note-Roof-The composite shingle roofing material all appears to be in good condition/below; over the great room

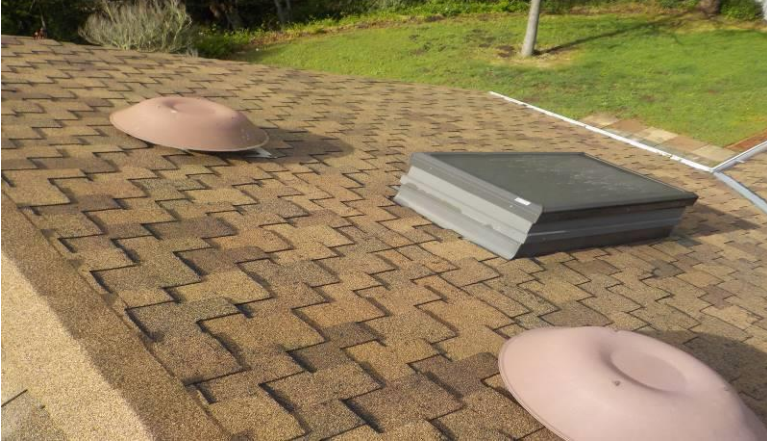
Note-Roof-The composite shingle roofing material all appears to be in good condition/below; over the great room

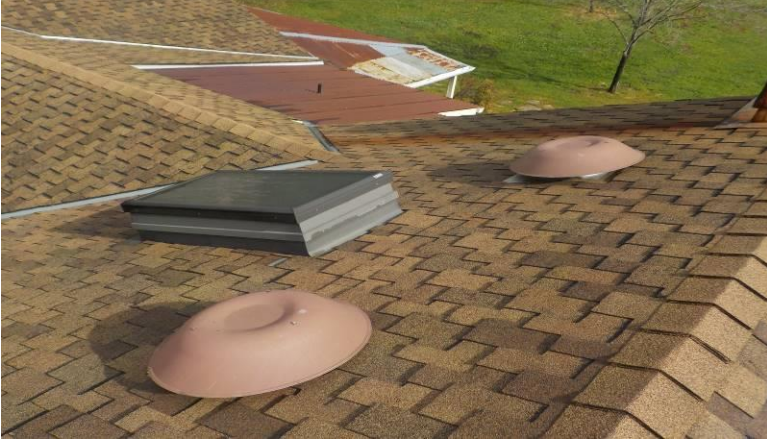
Note-Roof-The composite shingle roofing material all appears to be in good condition/below; over the great room

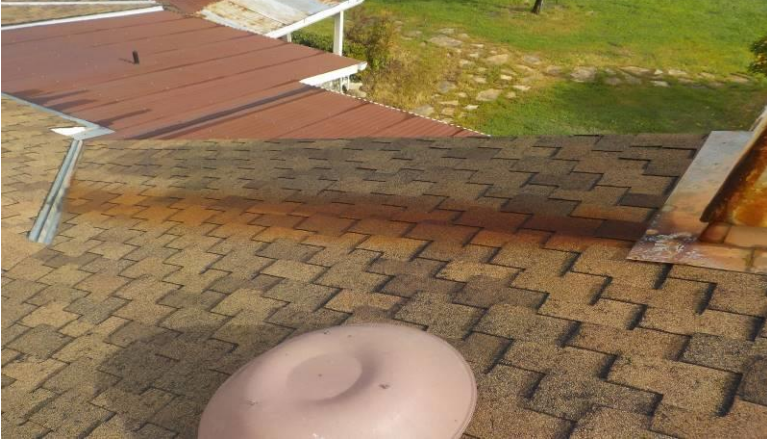
Note-Roof-The composite shingle roofing material all appears to be in good condition/below; over the west end of the great room

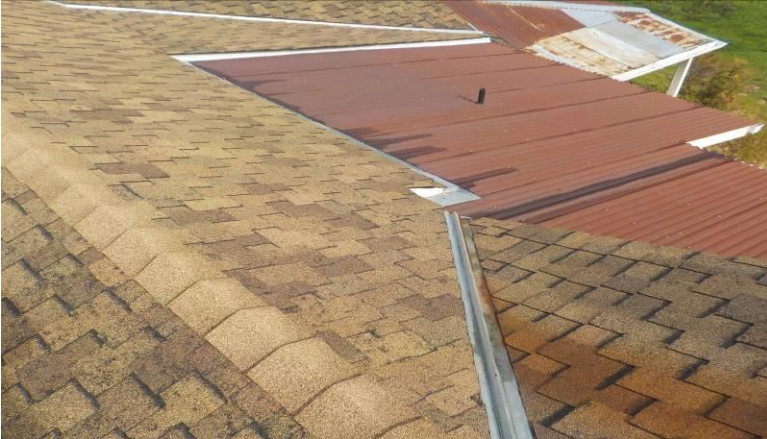
Note-Roof-The composite shingle roofing material all appears to be in good condition/below; over the great room and laundry room

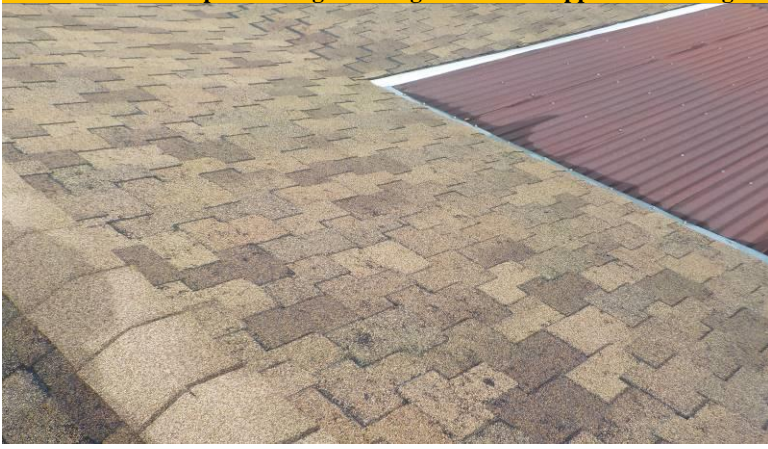
Note-Roof-The composite shingle roofing material all appears to be in good condition/below; over the laundry room

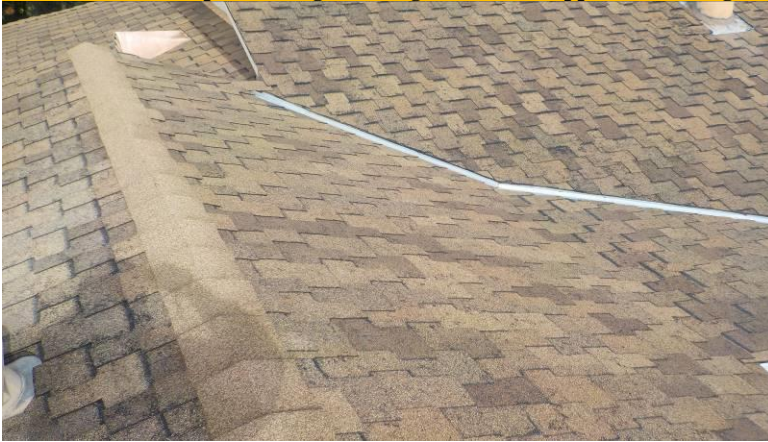
Note-Roof-The composite shingle roofing material all appears to be in good condition/below; over the laundry room and living room

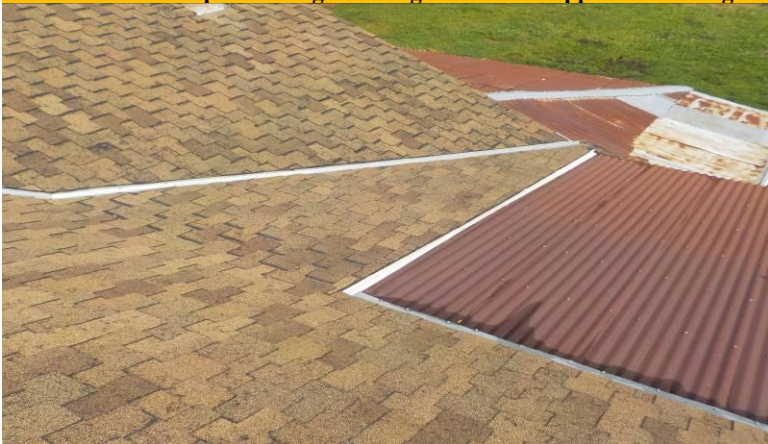
Note-Roof-The composite shingle roofing material all appears to be in good condition/below; over the guest bedroom

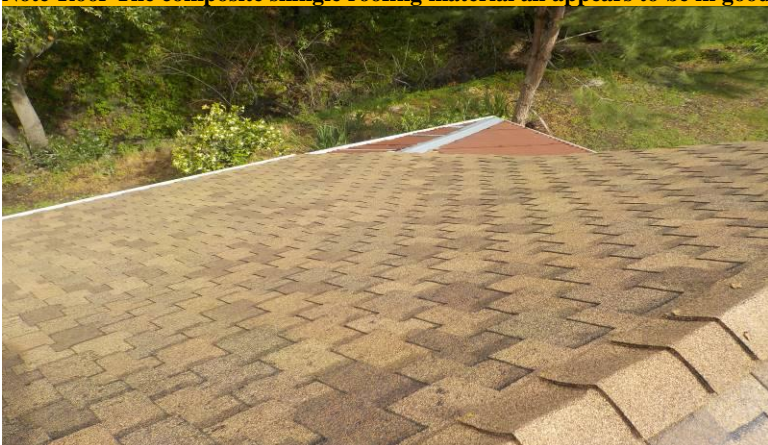
Note-Roof-The composite shingle roofing material all appears to be in good condition/below; over the bathroom

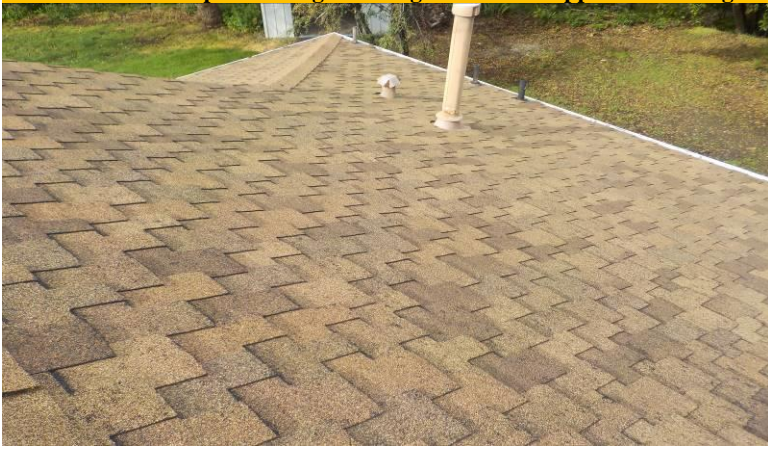
Note-Roof-The composite shingle roofing material all appears to be in good condition/below; over the primary bedroom

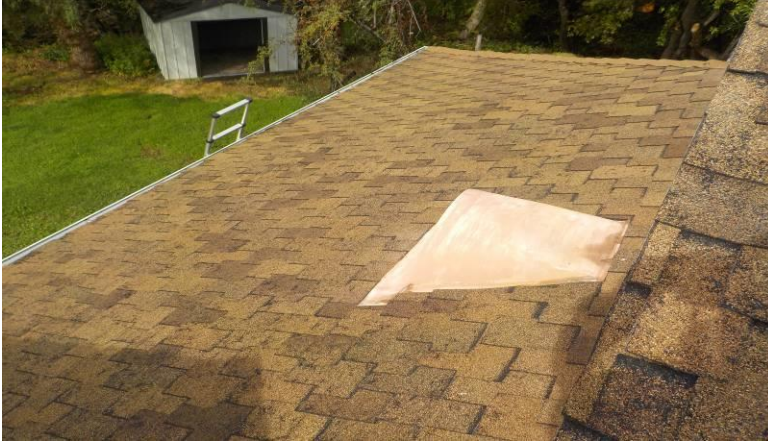
Note-Roof-The composite shingle roofing material all appears to be in good condition/below; over the primary bedroom and kitchen area

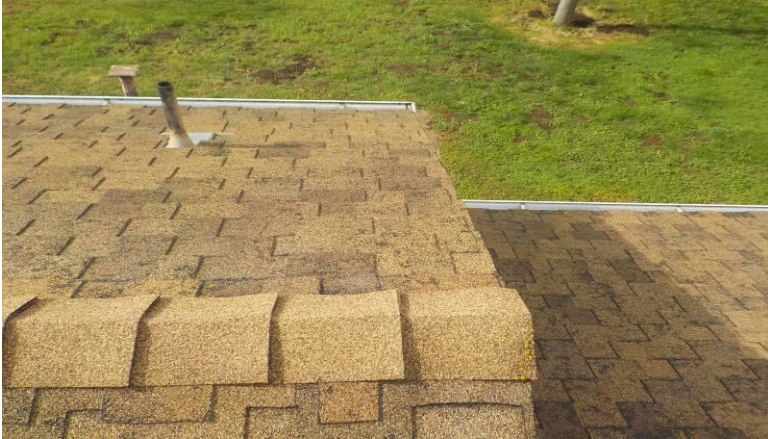
Note-Roof-The composite shingle roofing material all appears to be in good condition/below; over the kitchen area

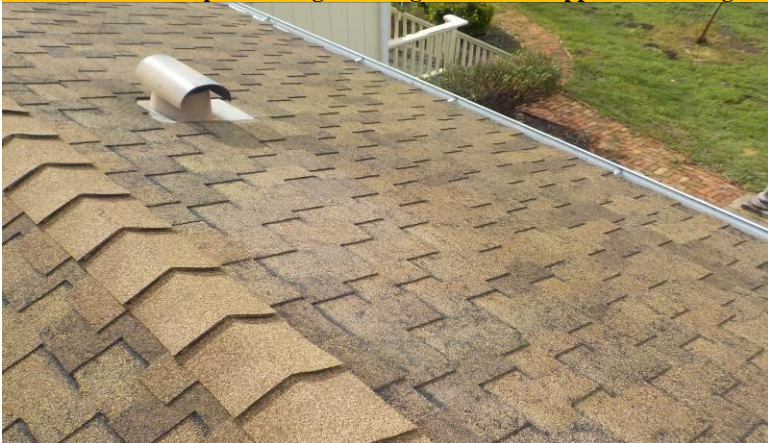
Note-Roof-The composite shingle roofing material all appears to be in good condition/below; over the kitchen and rear side of the great room

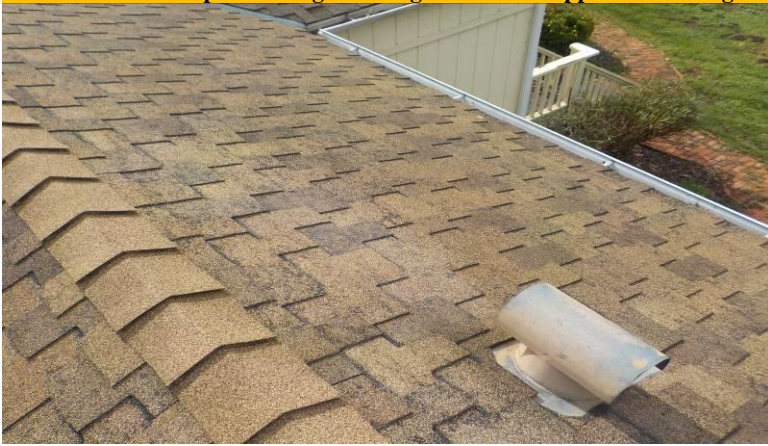
Note-Roof-The composite shingle roofing material all appears to be in good condition/below; over the rear side of the great room
