Inspection Report

Address: 333 York Ave Oceano, CA 93445

03/10/2026

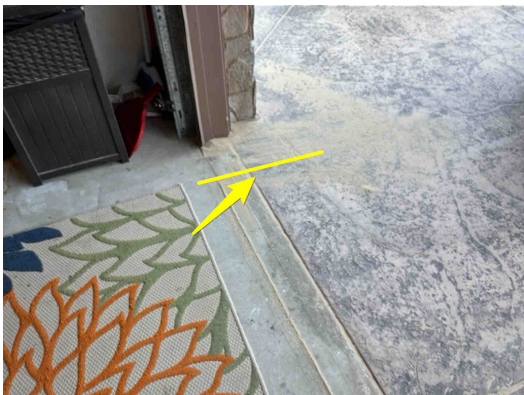
DS 15: **Disclosure**: Due to the slope and height of the driveway at the garage connection, some water intrusion into the garage may occur during certain weather.

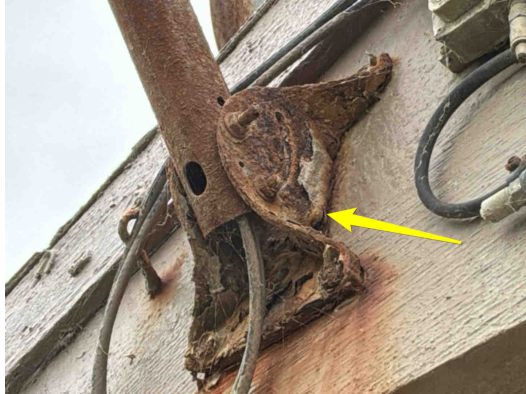
SU 26: Some heavy rust deterioration and damage found at the exterior mounted satellite TV dishes. Removal or replacement may be warranted for safety.

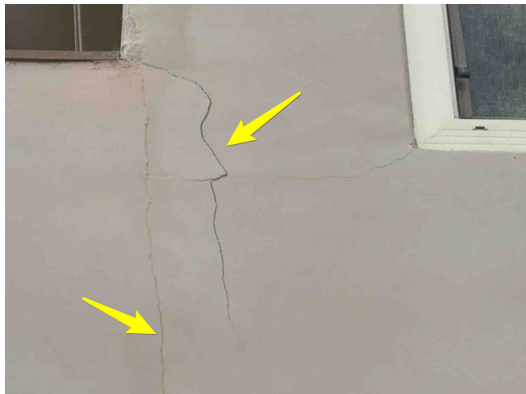
FI 28: Some unusual and large cracks found in the exterior stucco siding. This may be indicative of some uncommon settling of the cantilevered deck off the UPSTAIRS FAMILY ROOM. Client should contact an engineer to evaluate and make an opinion as to the cause, the current condition, potential for future issues and if upgrades and or repairs are warranted.

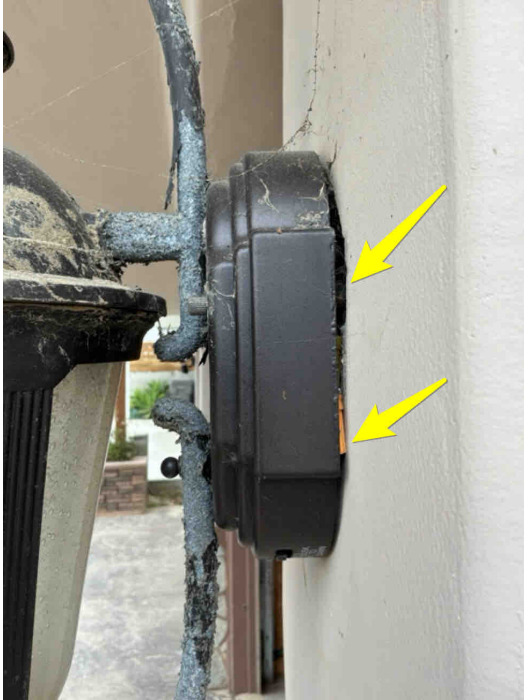
MR 30: Recommend sealing around the exterior light fixtures making sure they are sealed tight to the wall to help prevent water and/or critter intrusion per installation requirements.

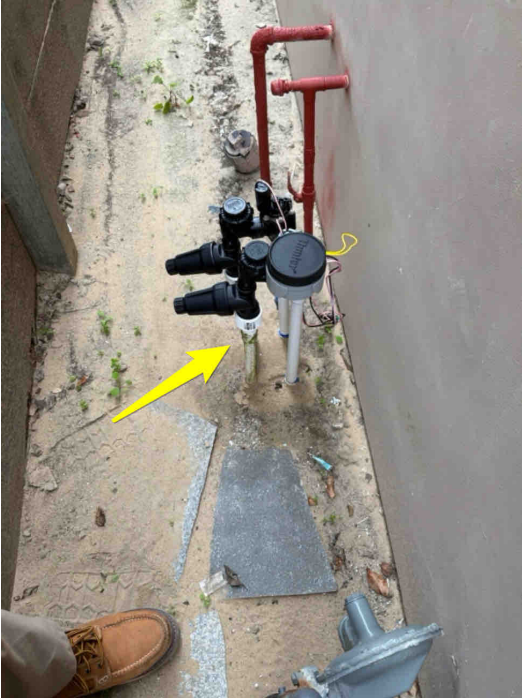
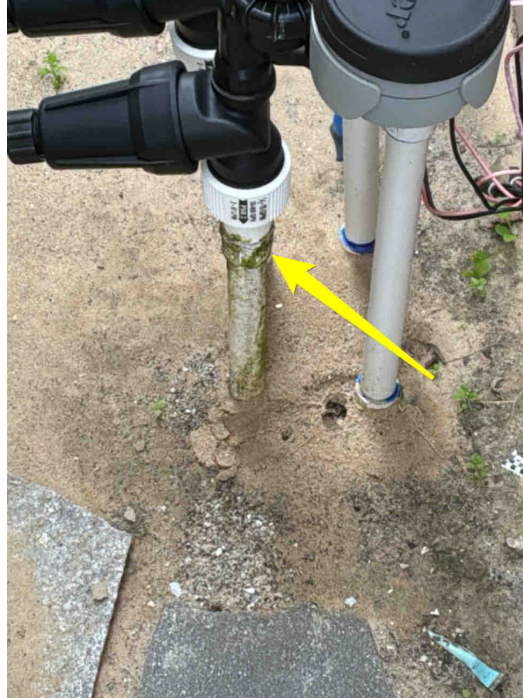
E&C 36: Active water leak found at sprinkler valve and/or piping: WEST SIDE YARD

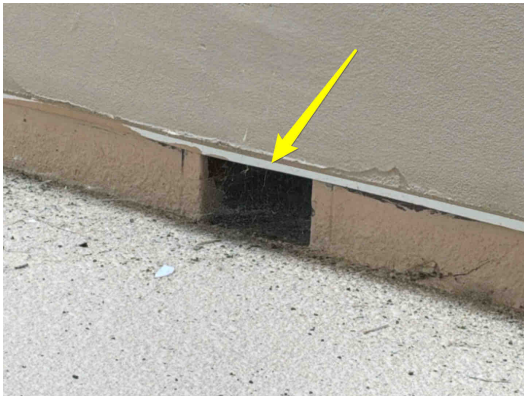
E&C 39: The deck drain scuppers / wall drain at the UPSTAIRS FRONT DECK OFF THE FAMILY ROOM found to be improperly partially blocked by the installation of the stucco railing / scuppers are undersized. At a minimum, the deck drain scupper is required to be 4" above the decking surface. Contact a qualified waterproof deck contractor to evaluate and make recommendations for proper upgrades or repairs.

R903.4.1 Secondary (emergency overflow) drains or scuppers. A minimum of one overflow scupper for each 20 ft.² of decking, shall be installed and is required to have an opening height of no less than 4 inches (102 mm) and a minimum width of 4 inches (opening = 4" x 4") and shall be installed in the adjacent parapet walls with the inlet flow (bottom of the scupper) located 2 inches (51 mm) above the low point of the deck drain inlet.

Scupper is undersized

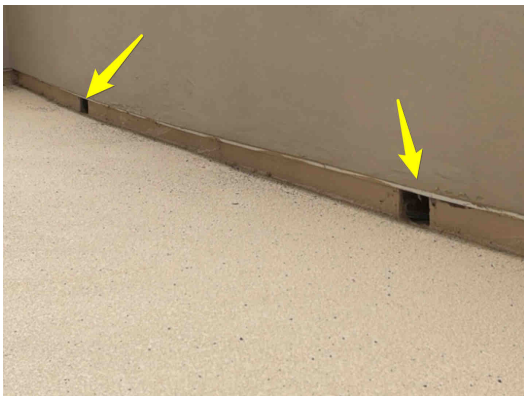
Scupper is undersized

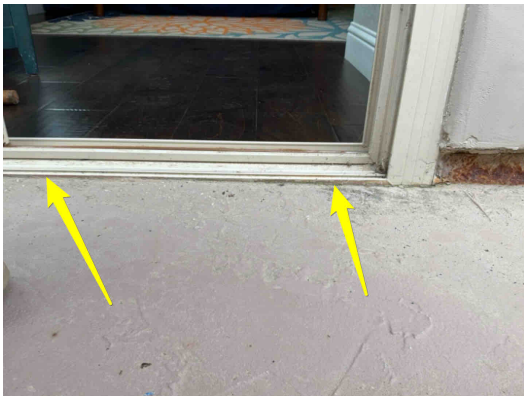
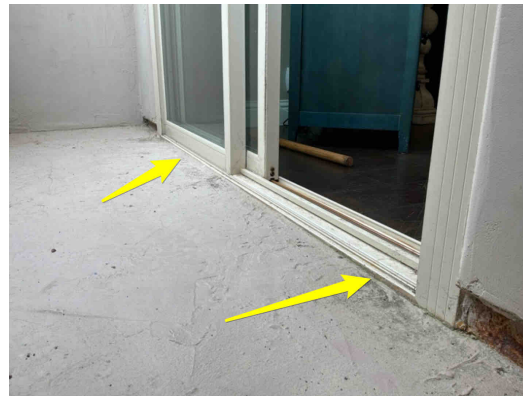
UPG DS 45: Areas of the UPSTAIRS BACKYARD DECK waterproof coating are improperly installed at or above exterior door threshold. This can allow water to potentially intrude under the deck exterior door threshold into the wall cavities. Building codes dictate, 2 inches from the bottom of the stucco to the top of the deck surfacing. Refer to the Termite Report for additional comments and recommendations.

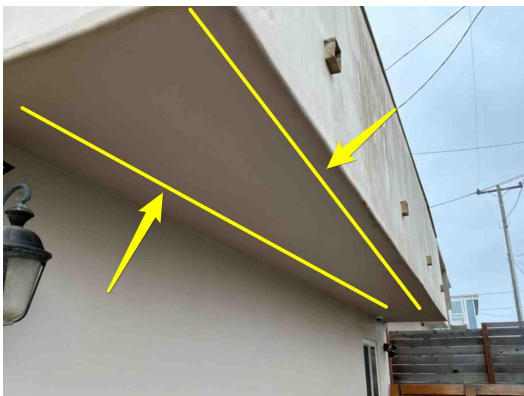
Example locations

46: No visible ventilation installed on the underside of the enclosed exterior portions of the waterproof deck off the UPSTAIRS BACKYARD DECK. Current Standards dictate that enclosed waterproof decks should be ventilation along the underside to help reduce condensation build up and to help prevent an excessive moisture condition such as fungus growth which could lead to a structural compromise of the wood framing. [CBC 2304.12.2.6 Ventilation beneath enclosed balcony, elevated walking surfaces and stairways]

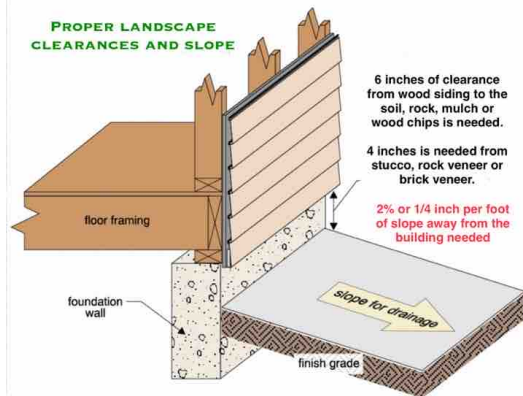
Example location

E&C MR 52: Soil level found high at areas of the foundation. (Recommend 4 inches from the bottom of the exterior stucco siding to dirt, rock, mulch or wood chips).

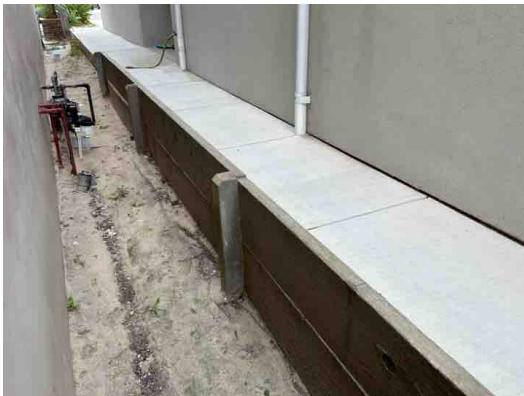
UPG 54: Areas of the wood retaining wall is bowing on the west side yard.

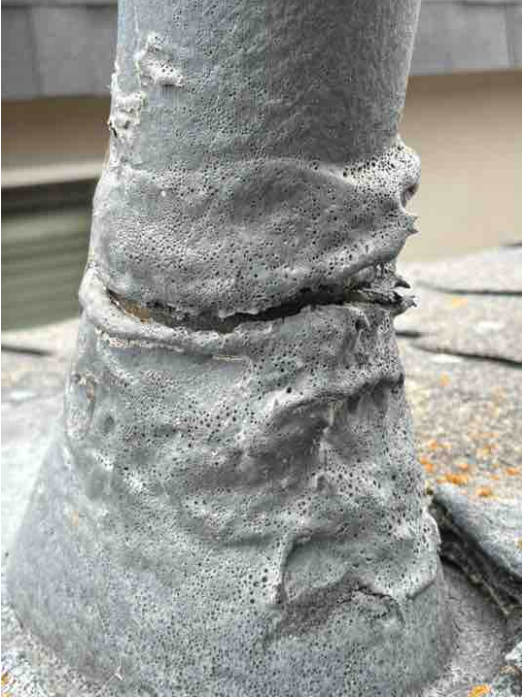
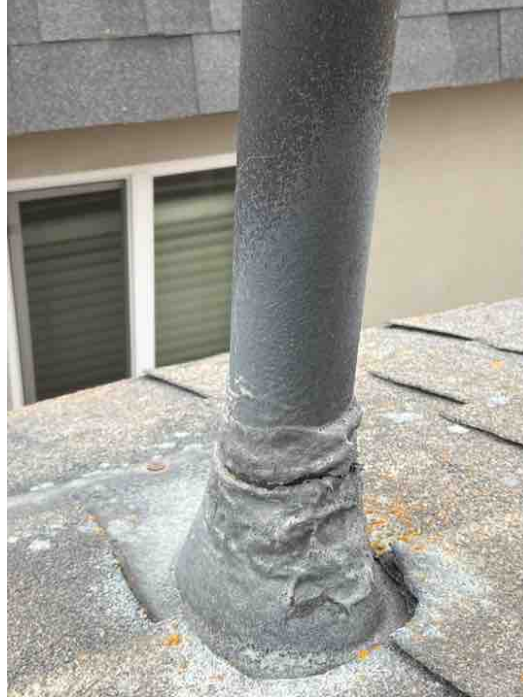
MR 61: Deteriorated sealant at some roof flashings, around the roof penetrations. Maintenance recommended to help prevent water intrusion into areas of the attic. Have roofer evaluate the roof flashings and correct as needed.

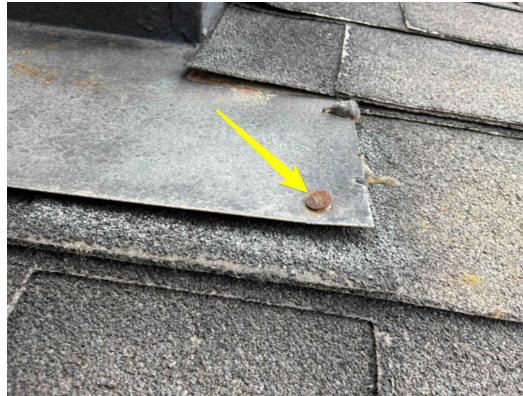
MR UPG 62: Recommend sealing all exposed nails at areas of roof/ roof flashing.

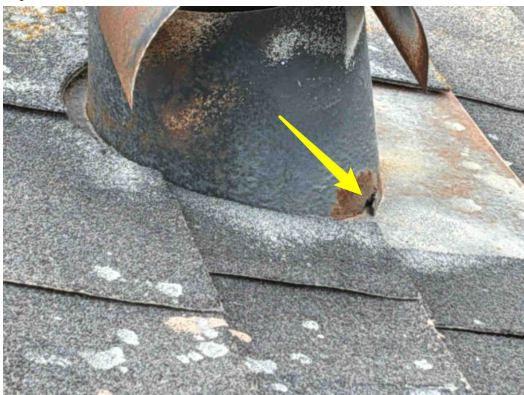
E&C MR 66: Some roof flashings found rusted and deteriorated. Further evaluation and potential upgrades needed by a licensed roofer.

A visible hole in the roof flashing

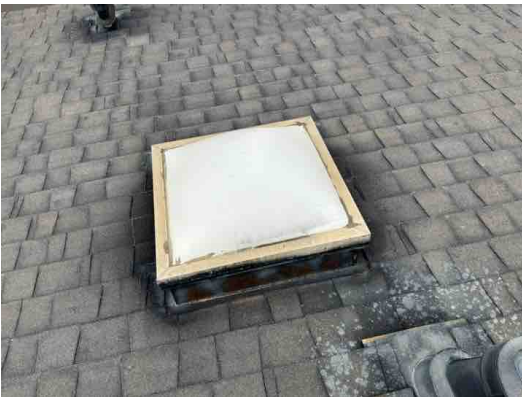
E&C 68: Some of the plastic roof skylights are cracked and damaged. Replacement is recommended. Contact a qualified roofer to evaluate and replace damaged skylights.

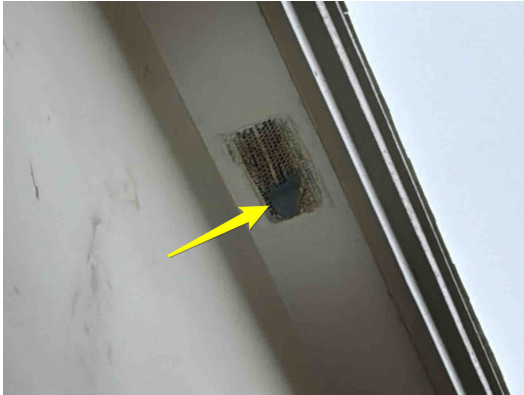
E&C MR 73: Some damaged or missing attic EAVE VENT screens on areas of the exterior at the roof overhangs. Repair or replacement recommended to help prevent critter intrusion into attic areas.

A visible hole found in the west side vent screen

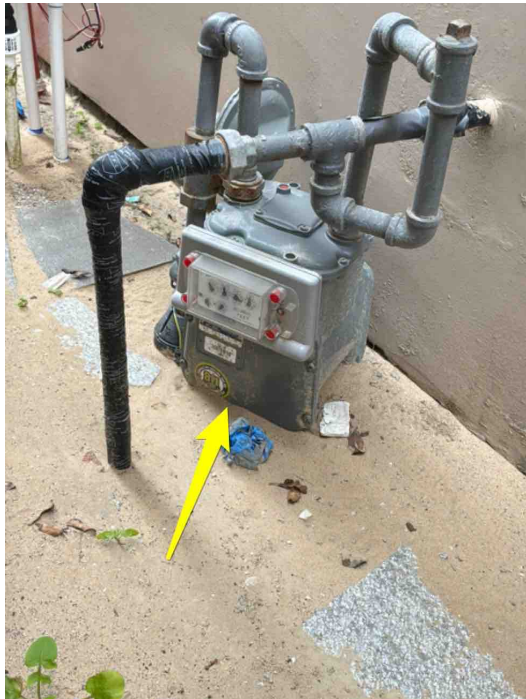
MR UPG 88: The Gas meter and/or shutoff valve found to be improperly in contact with ground or soil. Deterioration has or may occur. Maintenance or upgrades are needed to help prevent deterioration or damage.

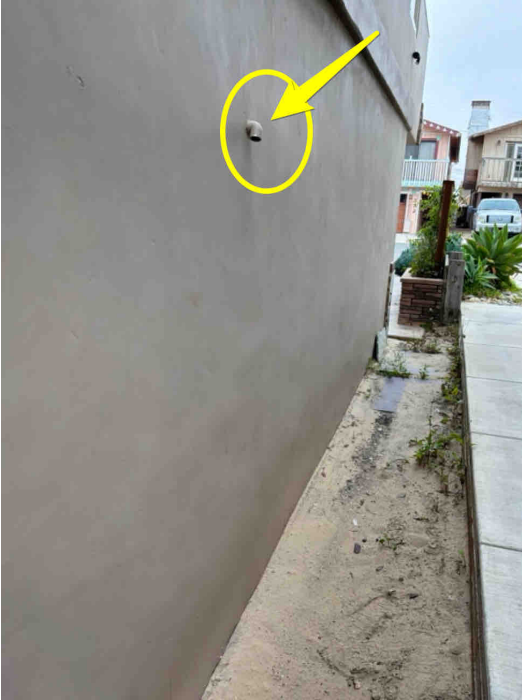
SC 93: The Water heater TPR (temperature pressure relief) pipe improperly terminates. Must terminate downward at the exterior at 6 to 24 inches from the ground.

Must terminate within 6 to 24 inches of the ground

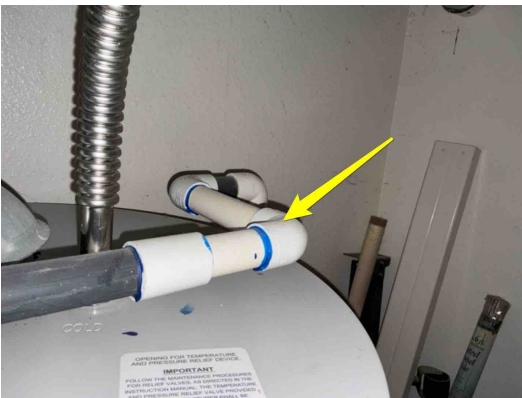
SC 94: An improper and unsafe use of plastic PVC piping for the water heater TPR (temperature pressure relief) pipe. This type of pipe can melt at high temperatures.

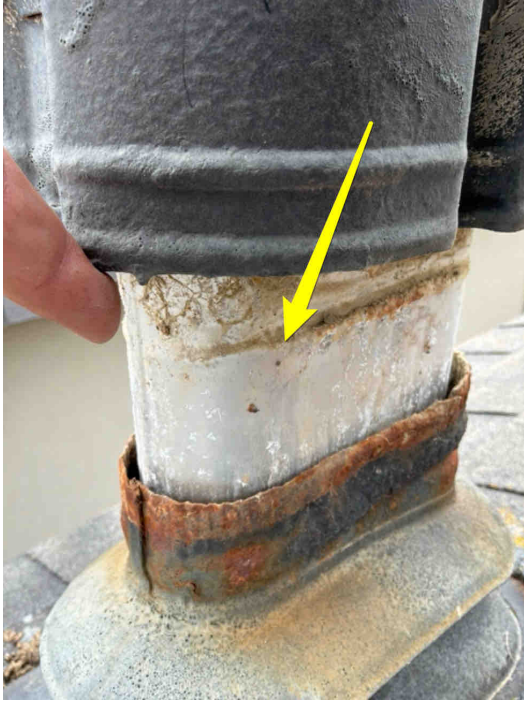
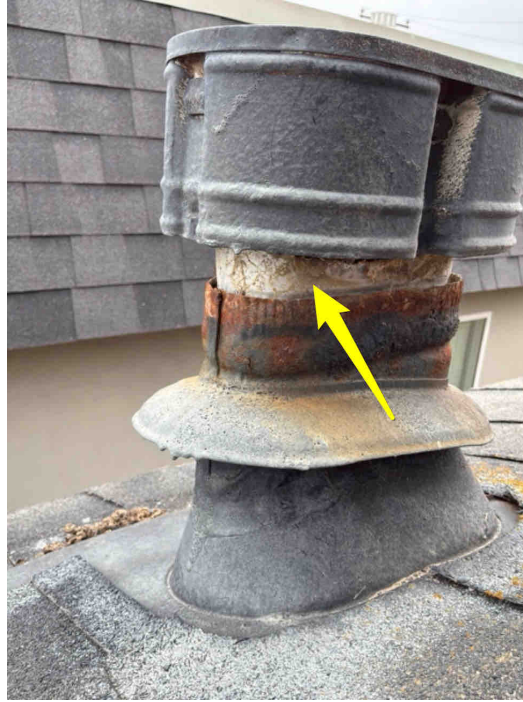
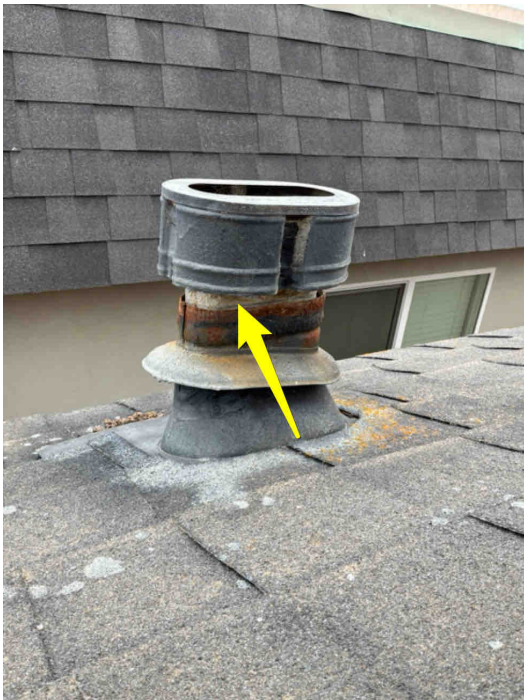
E&C 95: The water heater "B" vent double-wall type pipe found to have a damaged and disconnected interior sleeve. Contact a qualified plumbing professional to replace the damaged section of water heater and pipe for safety.

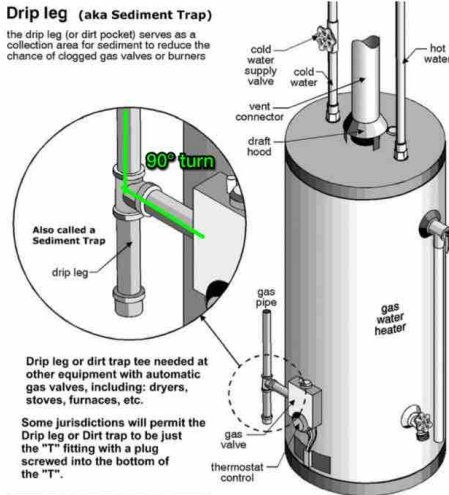
UPG 99: Recommend the installation of a sediment trap / drip leg at the WATER HEATER gas piping at flex connection by a certified or licensed plumbing professional familiar with minimum requirements.

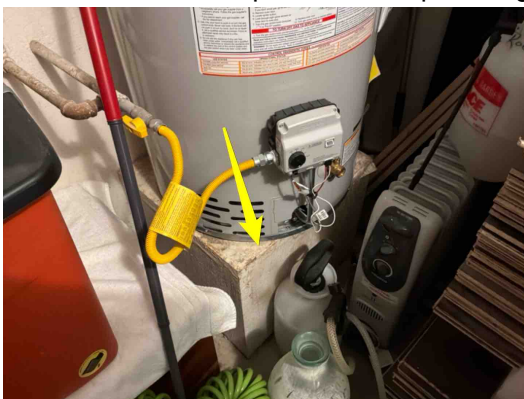
E&C 103: Missing / recommend a drip pan under the water heater. A drip pan is needed to help prevent damage if a leak were to occur per California plumbing codes and standards. [CPC 507.5]

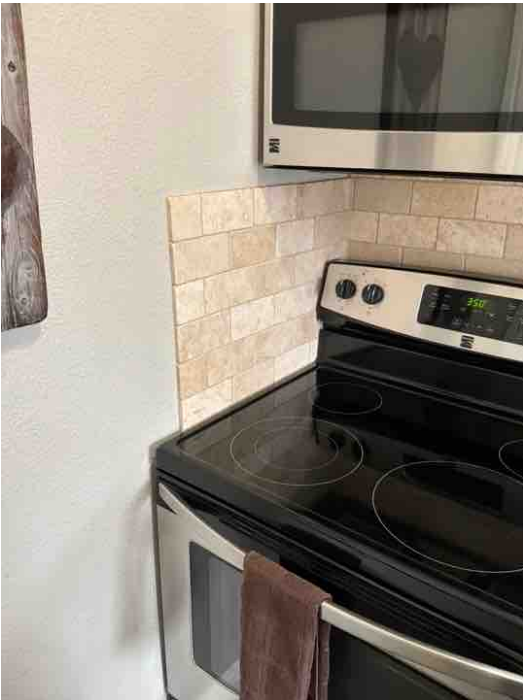
SC 135: Disclosure: The UPSTAIRS KITCHEN Cook top improperly installed too close to a vertical wall or cabinetry. A minimum of 6+ inches is recommended.

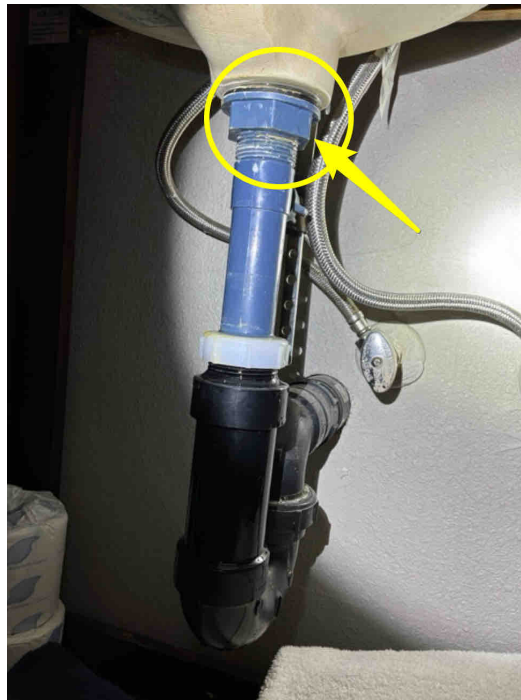
E&C 156: Active leaking from the bathroom sink drain line: DOWNSTAIRS PRIMARY BEDROOM BATHROOM

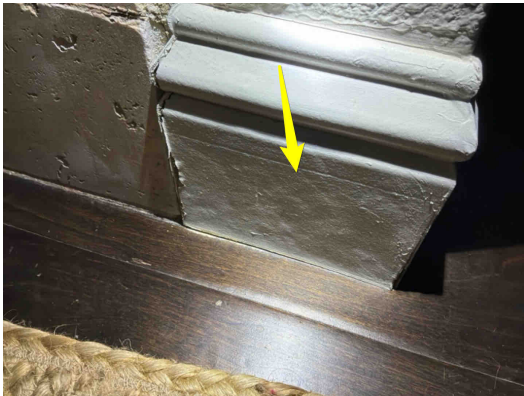
FI 163: Minor moisture stains & damage to baseboard outside shower: UPSTAIRS HALL NORTH END BATHROOM

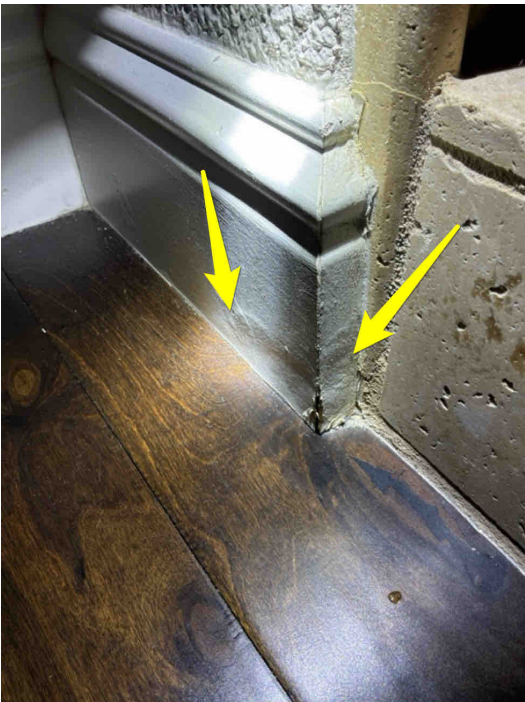
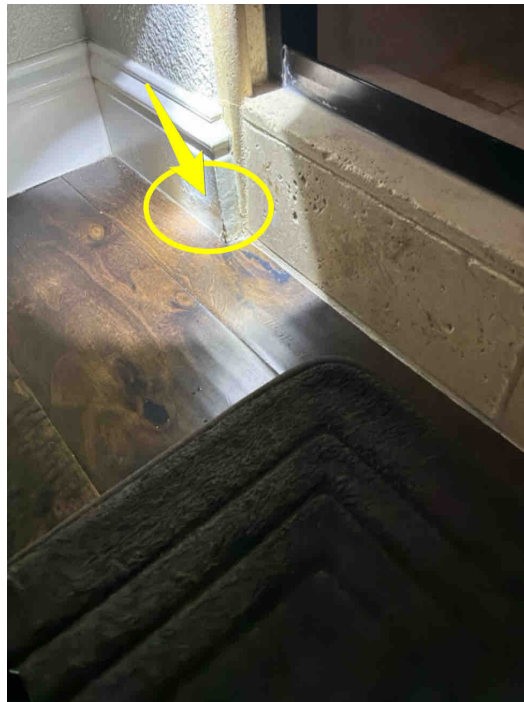
FI 164: Some minor moisture stains and swelling of the baseboards at the walls outside shower: DOWNSTAIRS PRIMARY BEDROOM BATHROOM

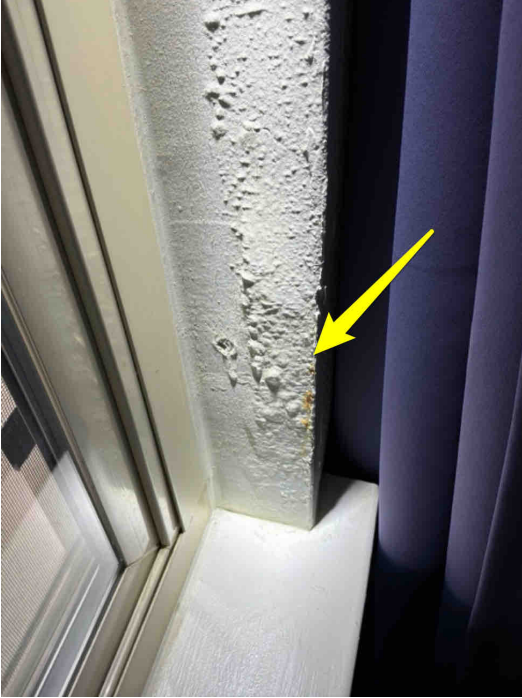
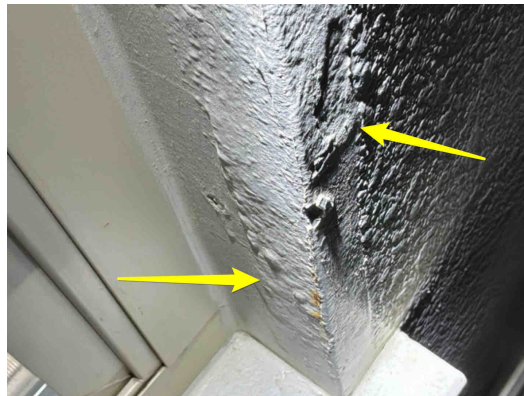
FI 180: Moisture stains and/or damage on the inside at some window sill: Example - UPSTAIRS DINING AREA.
Refer to the termite report for additional comments and recommendations.

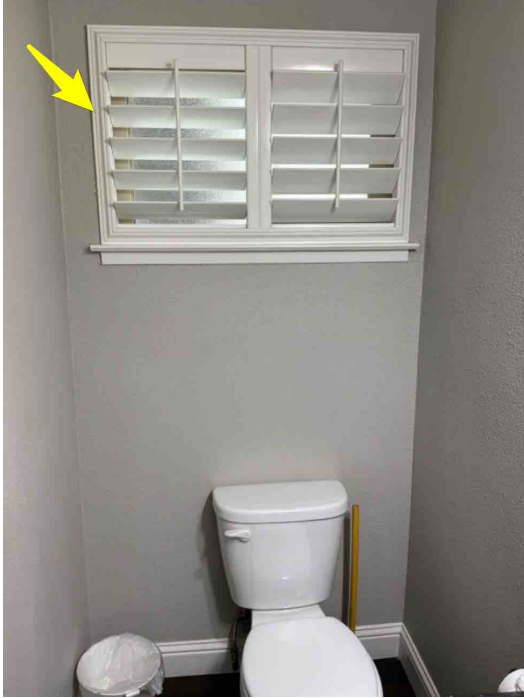
MR UPG 181: The wood blinds found loose in the window in the DOWNSTAIRS PRIMARY BEDROOM BATHROOM at the window ABOVE THE TOILET.

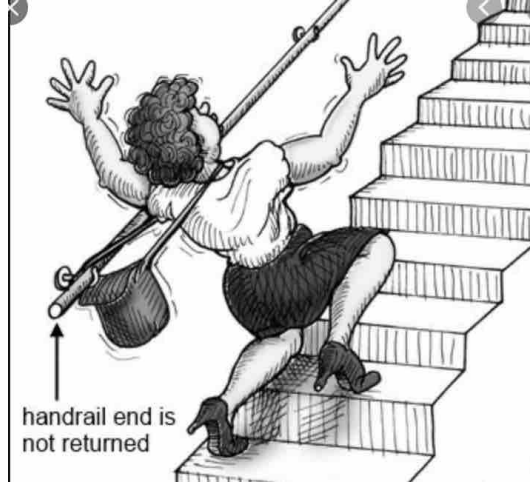
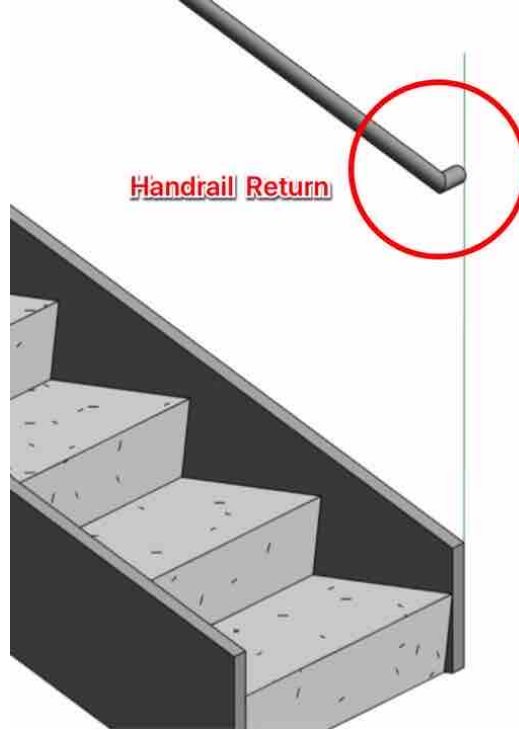
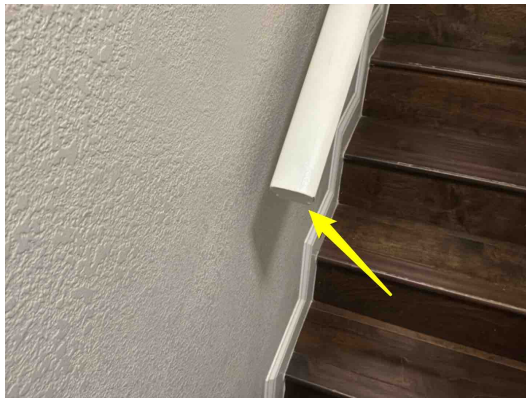
SU 195: Recommend returns at the interior stairway graspable handrails for safety per standards. A Return / turning the ends of the handrail into wall to help prevent catching coat or bag.

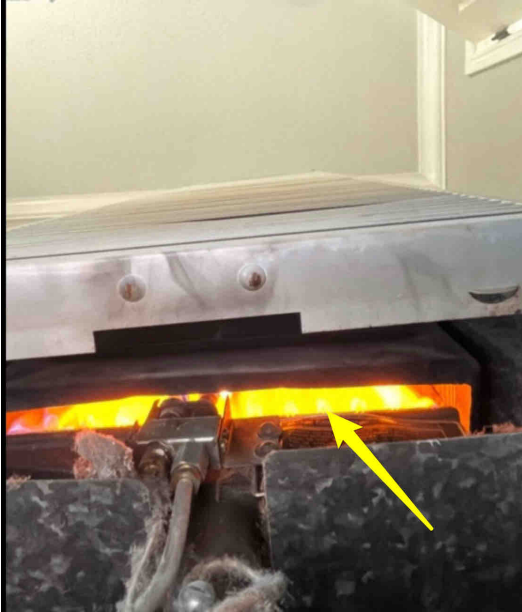
SC FI 201: An unusual Yellow flame color found at the DOWNSTAIRS PRIMARY BEDROOM gas wall heater. Defective flame. Recommend further review and opinion by a qualified and licensed HVAC professional familiar with this specific defect.

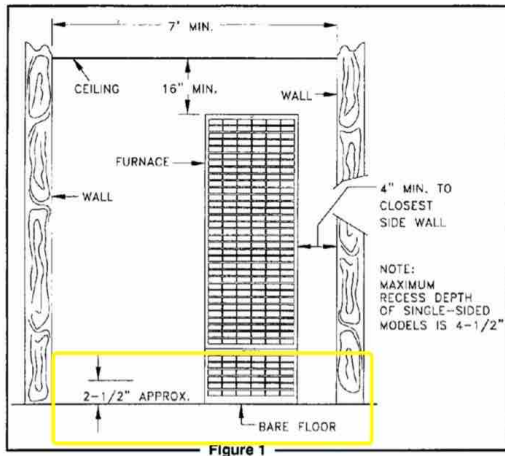
SU 203: The wall furnace in the DOWNSTAIRS PRIMARY BEDROOM found improperly installed too close to the floor.

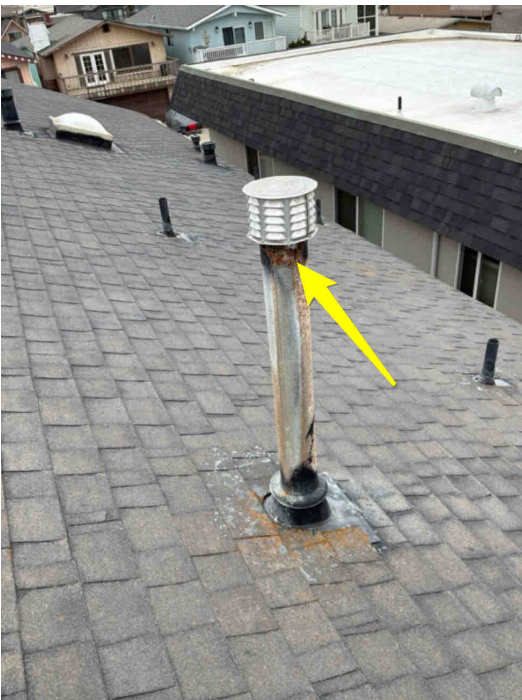
E&C 210: Rusted and damaged vent pipe found at the furnace vent termination at the roof. Recommend replacement of the damaged vent pipe by a qualified & licensed HVAC contractor.

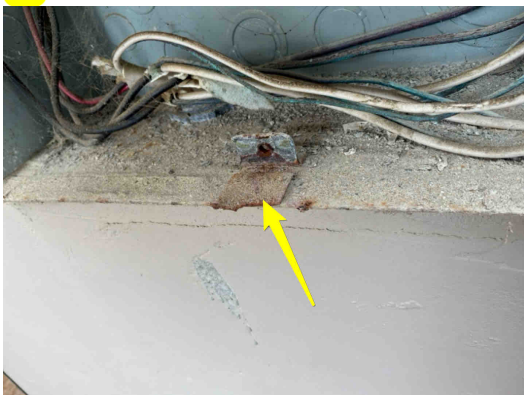
UPG 218: The MAIN ELECTRIC PANEL cover lock is broken, missing.

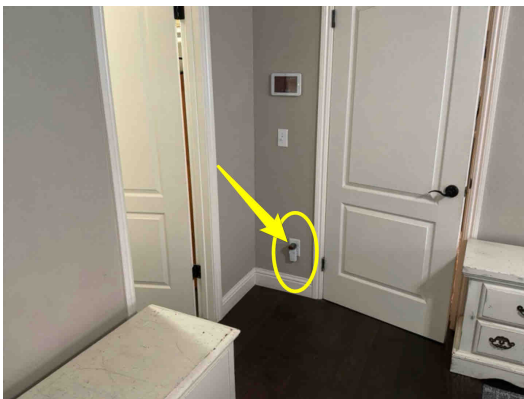
SC FI 224: Electrical outlet found non-operational: IN THE BEHIND THE OPENED ENTRY DOOR IN THE DOWNSTAIRS PRIMARY BEDROOM. Have outlet reviewed to determine the cause and have corrected by licensed electrical contractor.

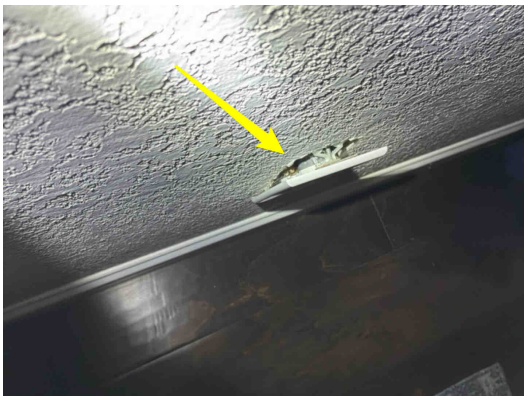
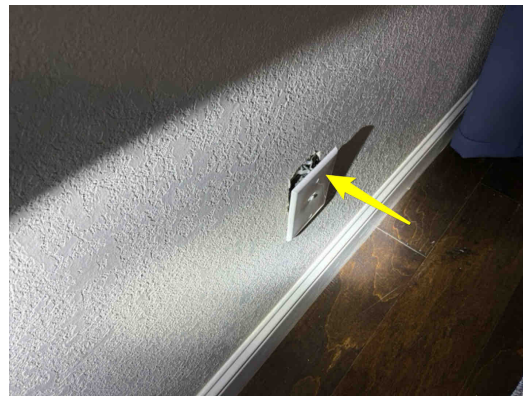
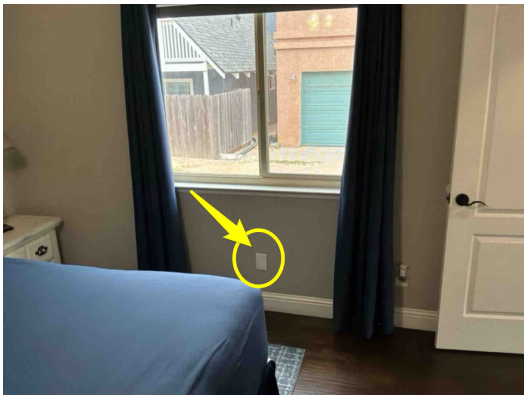
SC 231: Missing electrical cover plate at IN THE DOWNSTAIRS BEDROOM UNDER THE EAST SIDE WINDOW AT THE UNUSED ELECTRICAL OUTLET.

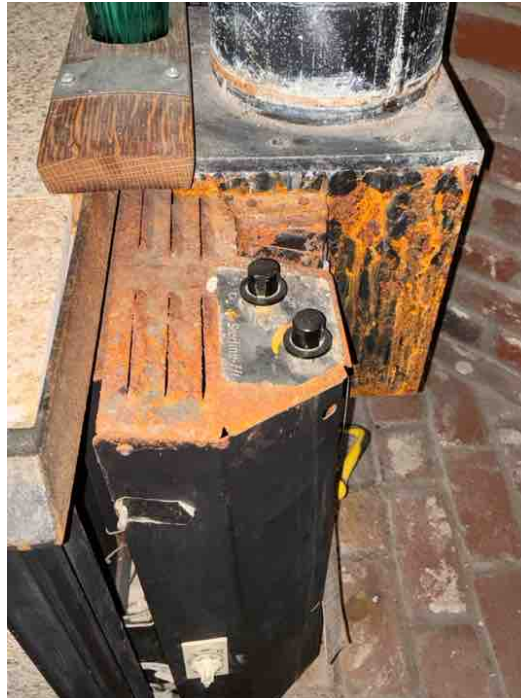
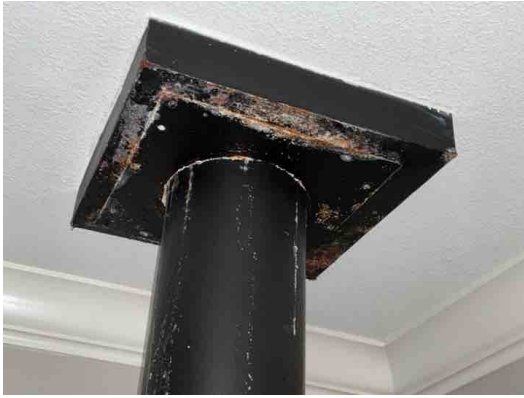
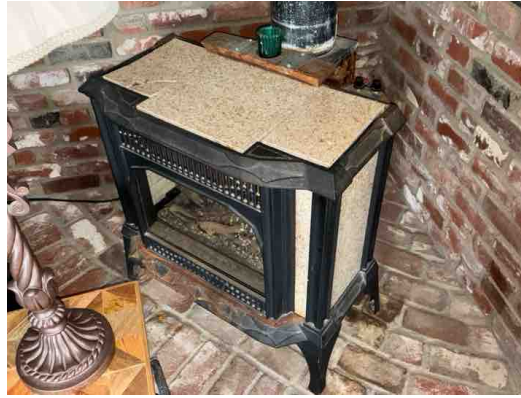
E&C 253: THE FIREPLACE CONDITION: The UPSTAIRS FAMILY ROOM FREESTANDING GAS Fireplace did not operate when tested, found rusted, deteriorated with some damaged stones at the top of the fireplace and an improper vent termination at the top of the fireplace chimney. Fireplace found to be in need of servicing, maintenance and repair. Contact the Gas Company for a free evaluation or a qualified gas fireplace service technician to evaluate and correct all issues as needed.

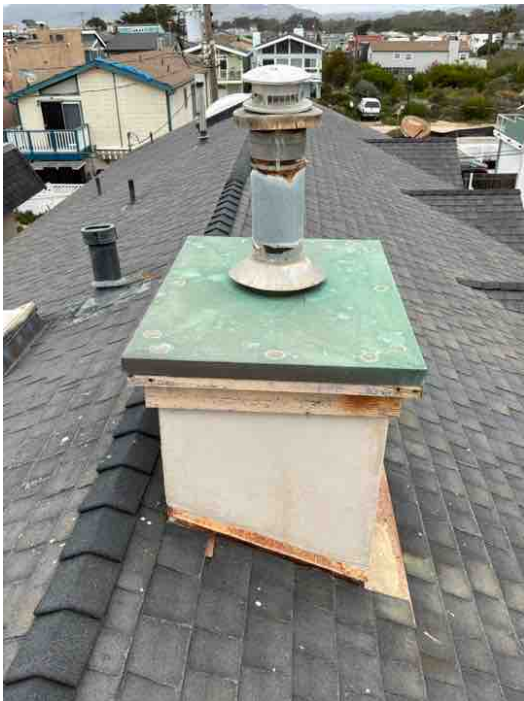
E&C 257: The metal chimney pipe found rusted and deteriorated but not significantly damaged atop the UPSTAIRS FAMILY ROOM fireplace chimney. Upgrades and or maintenance of recommended to preserve the overall life of the metal chimney pipe. This may consist of a rust inhibitor such as rust oleum type paint to help protect the metal pipe from additional deterioration and damage. Contact a qualified chimney sweep to perform needed maintenance.

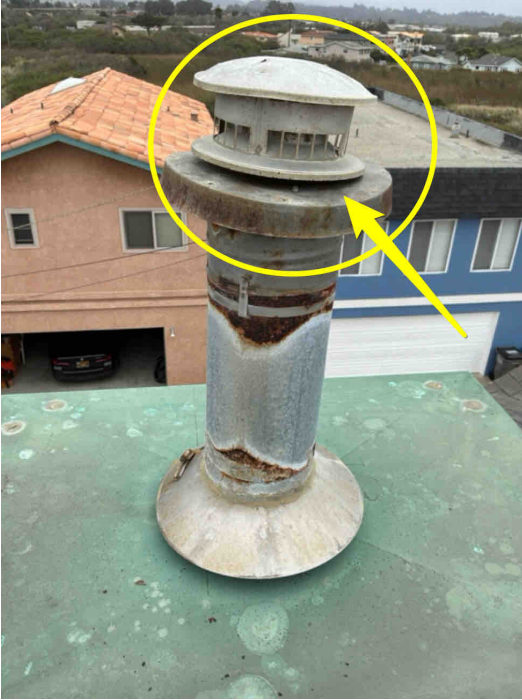
FI 258: The cap installed at the top of the UPSTAIRS FAMILY ROOM gas fireplace is not the original manufacturers cap. Termination has been modified. Contact to qualified gas fire technician to correct deficiencies and replaced rusted and deteriorated vent piping above the roof.
