### *Inspection Report*

Address: 904 Hartford St Cambria, CA 93428

03/20/2026

Inspector: Keith Vreeken, MCI, FCI  
P.O. Box 415 Templeton, CA 93465 O: 805.462.1978 C: 805.440.5050

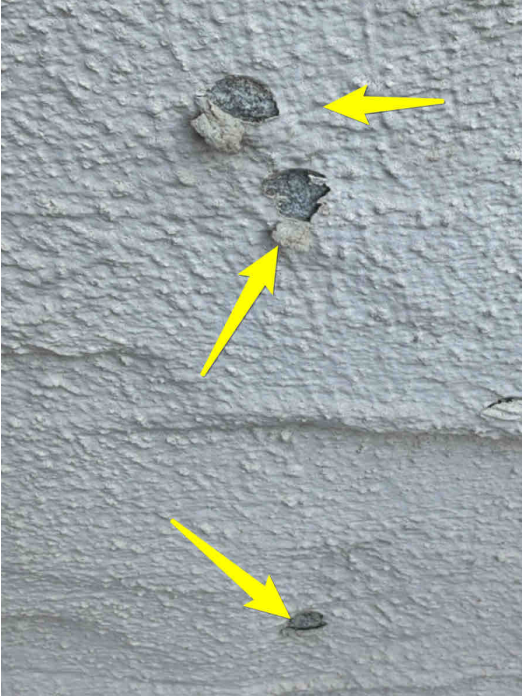
Example

**MR 32:** Some typical moisture damage, peeling of painted stucco color coat. (Ongoing maintenance recommended).

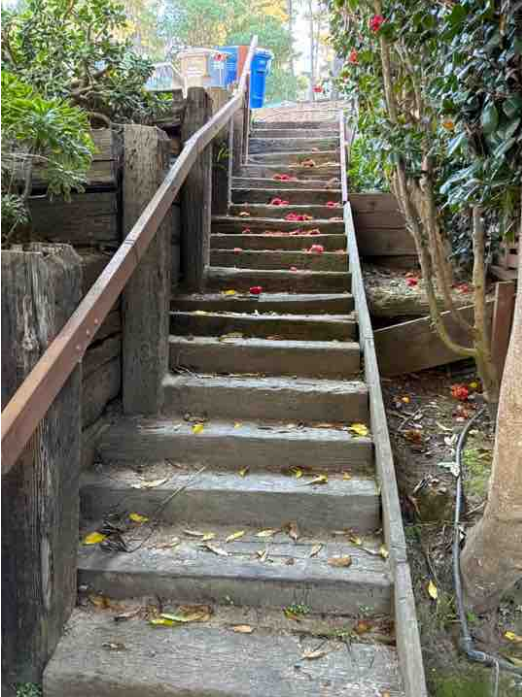
**39: Type:** Stack Railroad Tie exterior stairway - OFF THE WEST SIDE OF THE DRIVEWAY

**SC FI 40:** The Stack Railroad Tie exterior stairway - OFF THE WEST SIDE OF THE DRIVEWAY found unsafe due to the improper construction and/or physical damage.

**E&C 41:** The Stack Railroad Tie exterior stairway - OFF THE WEST SIDE OF THE DRIVEWAY does not meet minimum construction and safety standards, potential fall hazard.

**MR 42:** Earth-to-wood contact at the exterior wood framed Stack Railroad Tie exterior stairway - OFF THE WEST SIDE OF THE DRIVEWAY. Refer to a termite report for additional comments and recommendations.

**SC 43:** Uneven step tread rise, step heights are not all the same, at the Stack Railroad Tie exterior stairway - OFF THE WEST SIDE OF THE DRIVEWAY. Potential trip or fall hazard.

**E&C UPG 44:** Moisture and/or bug type damage & deterioration found at the Stack Railroad Tie exterior stairway - OFF THE WEST SIDE OF THE DRIVEWAY.

**SC 45:** Loose and unsecured treads found at areas of exterior stairway: OFF THE WEST SIDE OF THE DRIVEWAY.

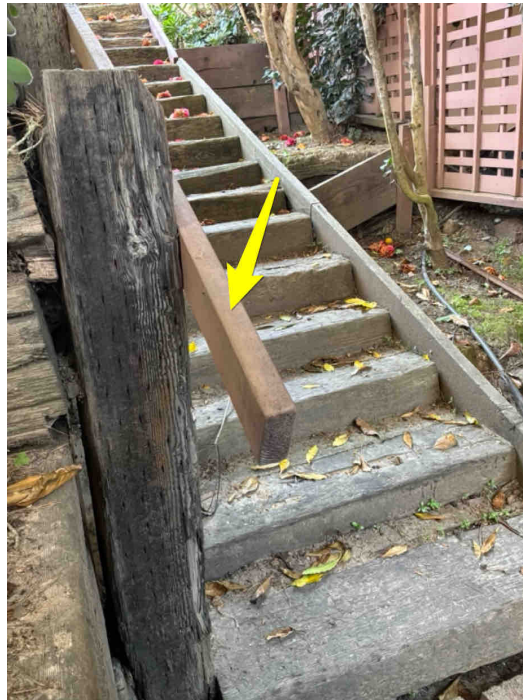
**SC SU 46:** Missing a required proper graspable handrail at the Stack Railroad Tie exterior stairway - OFF THE WEST SIDE OF THE DRIVEWAY. The current 2 x 4 handrail does not meet minimum requirements.

Meet minimum requirements

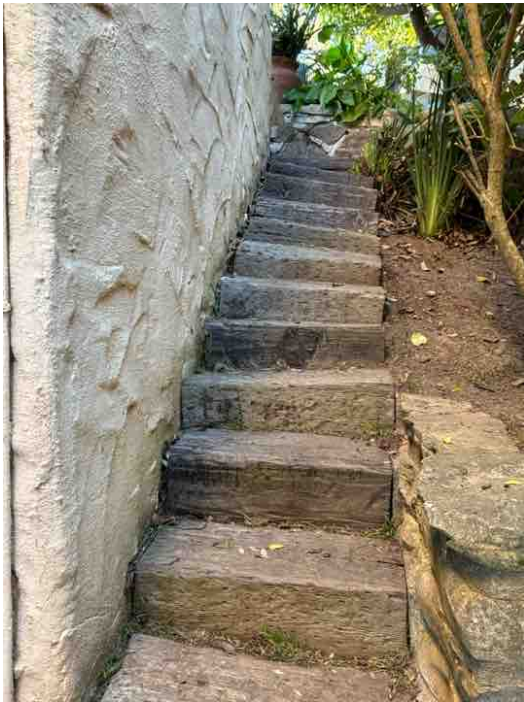
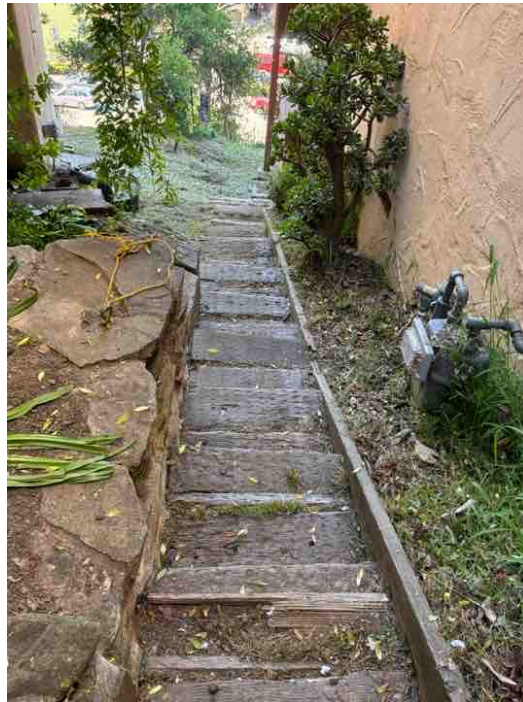
**47: Type:** Stack Railroad Tie exterior stairway - OFF THE EAST SIDE OF THE DRIVEWAY

**SC FI 48:** The Stack Railroad Tie exterior stairway - OFF THE EAST SIDE OF THE DRIVEWAY found unsafe due to the improper construction and/or physical damage.

**E&C 49:** The exterior stairway OFF THE EAST SIDE OF THE DRIVEWAY does not meet minimum construction and safety standards, potential fall hazard.

**MR 50:** Earth-to-wood contact at the Stack Railroad Tie exterior stairway - OFF THE EAST SIDE OF THE DRIVEWAY. Refer to a termite report for additional comments and recommendations.

**SC 51:** Uneven step tread rise, step heights are not all the same, at the Stack Railroad Tie exterior stairway - OFF THE EAST SIDE OF THE DRIVEWAY. Potential trip or fall hazard.

**E&C 52:** Moisture and/or bug type damage & deterioration found at the Stack Railroad Tie exterior stairway - OFF THE EAST SIDE OF THE DRIVEWAY. Refer to the Termite report for additional details and recommendations.

**SC 53:** Loose and unsecured treads found at areas of Stack Railroad Tie exterior stairway - OFF THE EAST SIDE OF THE DRIVEWAY.

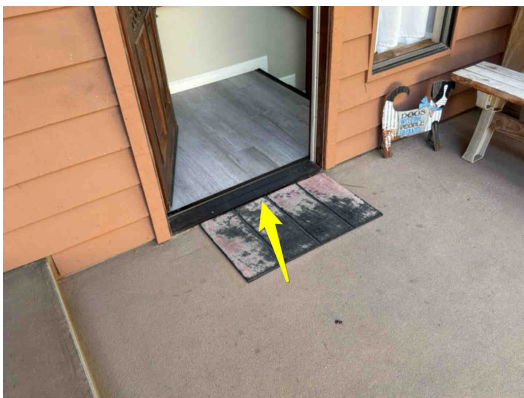
**DS 58:** Waterproof deck found to be installed a little too high at the door thresholds at the FRONT ENTRY DECK. There should be a minimum of 2 inches between the bottom of the siding and door threshold to the surface of the deck. This could potentially lead to deterioration and water intrusion. Contact a waterproof deck professional for additional comments and recommendations.

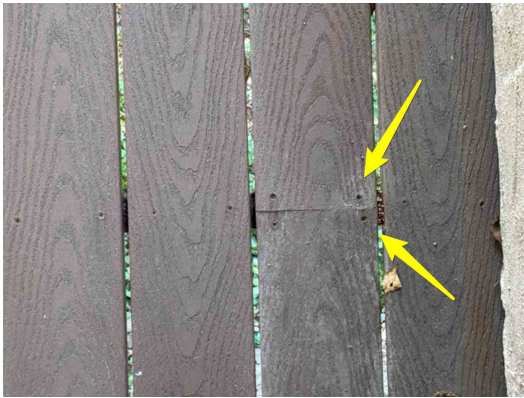
**E&C 77:** Installation of the UPSTAIRS DECK OFF THE FAMILY ROOM synthetic planks do not meet minimum installation standards. The end splices at the synthetic deck planks are required to have a minimum of 1-1/2 inch support under each side of the end splice. Currently the joints are only supported by splitting the single 1-1/2 inch joist and is supported by only 3/4 of an inch. Proper blocking at each splice per minimum standards is recommended per the installation requirements.

Joints at synthetic decking cannot split a single floor joist

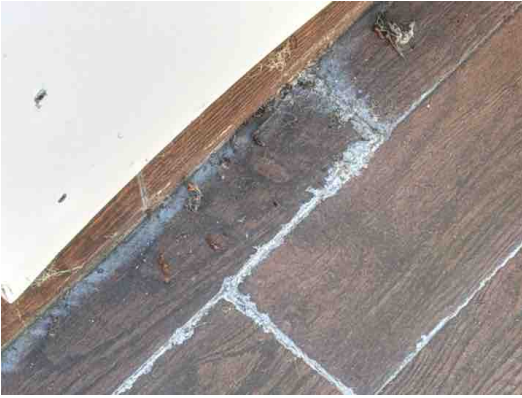
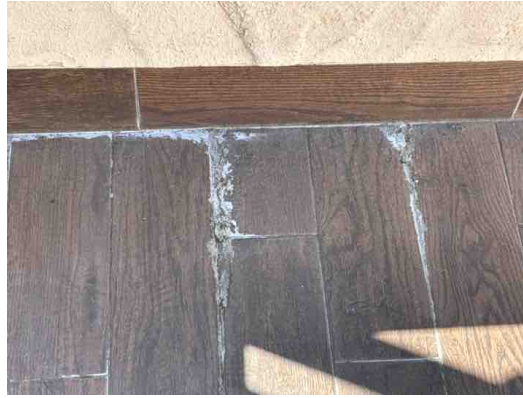
**84:** Inadequate quantity of deck drains provided for the tiled waterproof deck OFF THE UPSTAIRS PRIMARY BEDROOM.

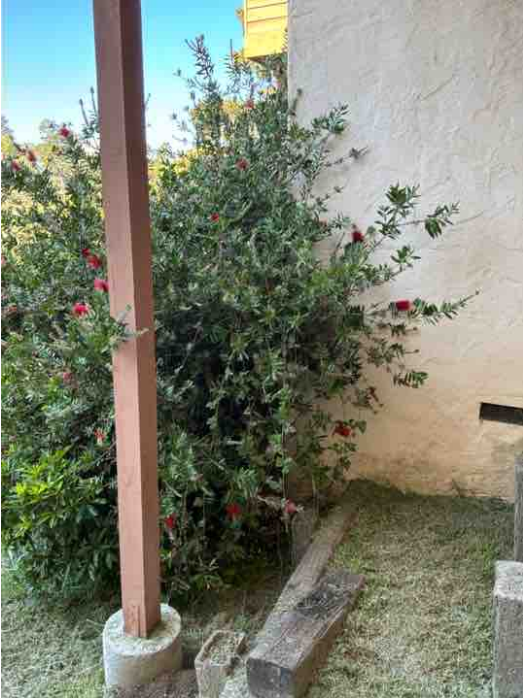
**MR 88:** Plants and/or trees touch the buildings exterior. Proper landscape maintenance needed.

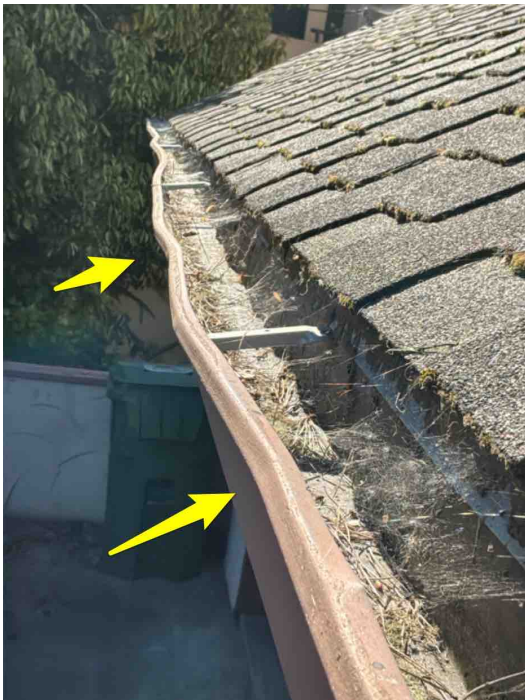
Example

**122:** Some damaged and dented rain gutters.

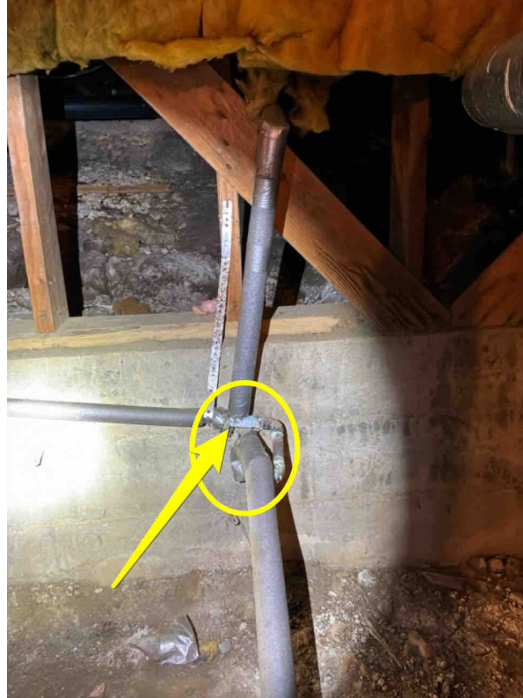
**E&C 129:** Some moderate corrosion noted at areas of the copper water supply piping in the crawlspace.

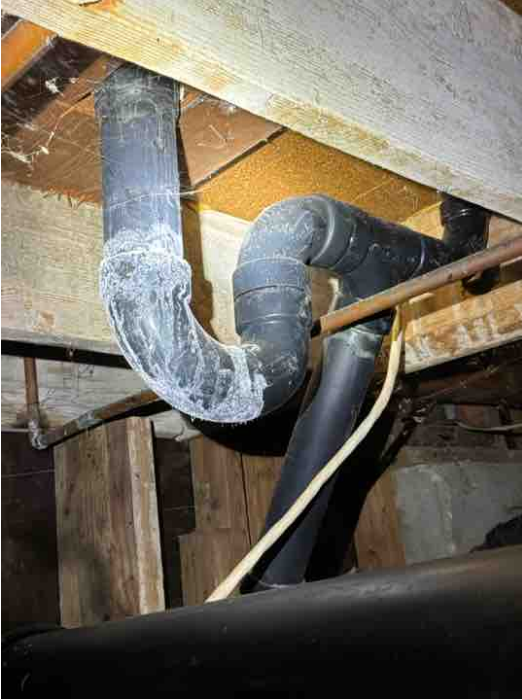
**FI 138:** Corrosion with evidence of past leaking noted on areas of the waste piping and fittings in areas of the crawlspace. Recommend further review of the waste piping throughout the crawlspace with cleanup and correction by qualified plumbing professional to help prevent additional future leakage.

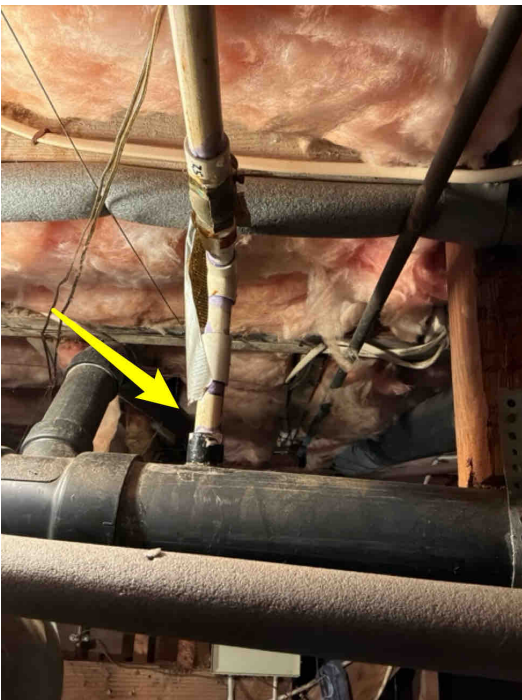
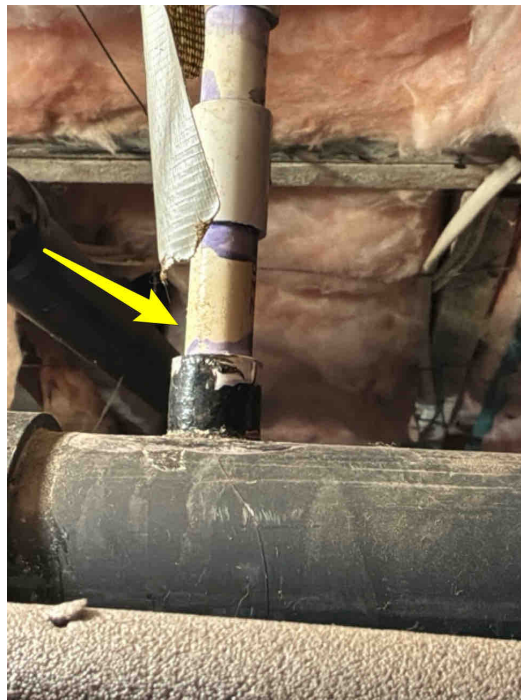
**SC 139:** Open waste or sewer line needing to be repaired or capped: WHERE THE OLD UNUSED WATER SOFTENER DRAIN PIPE WAS IMPROPERLY INSTALLED DIRECTLY INTO A SEWER PIPE IN THE CRAWLSPACE.

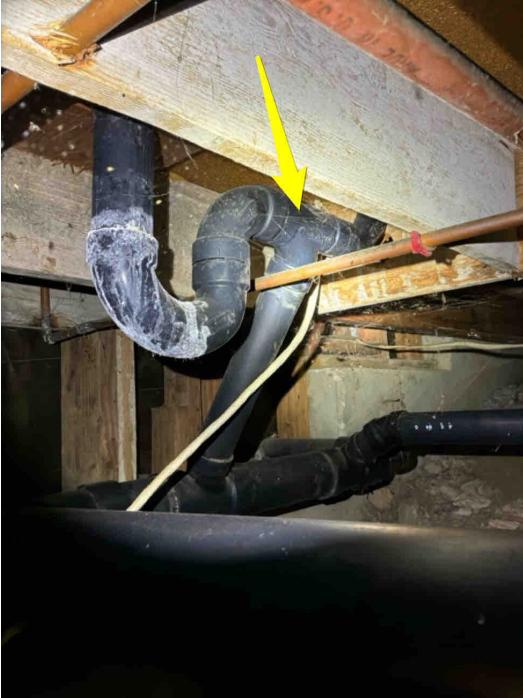
**E&C** 141: Improper waste piping found in the crawlspace at under a bathroom at a shower drain.

This will be considered an improper S Trap

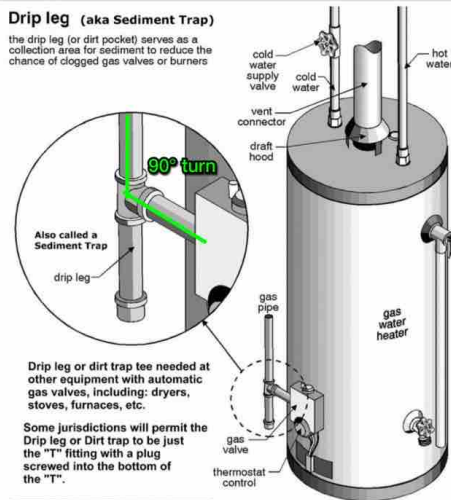
**SU 153:** Recommend the installation of the missing sediment trap / drip leg at the WATER HEATER gas piping at flex connection by a certified or licensed plumbing professional familiar with minimum requirements. [CPC 1212.8]

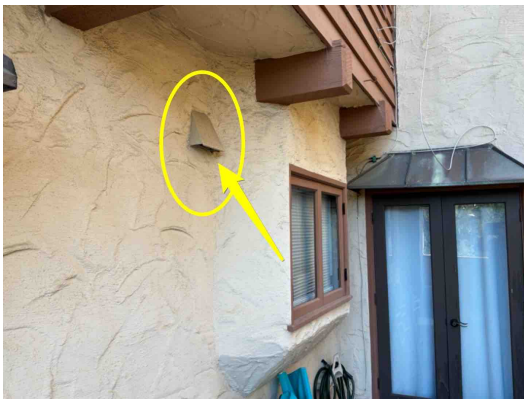
**MR UPG 168:** The screen in the exterior termination cap for the kitchen cooktop exhaust vent hood system found a little blocked or clogged. Upgrades recommended.

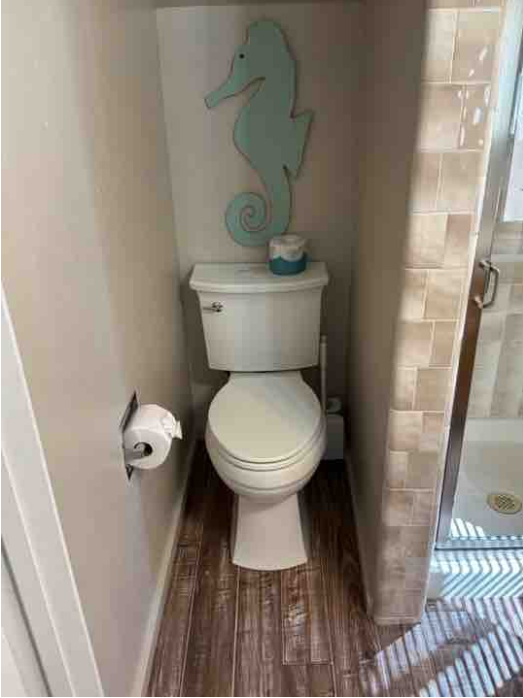
**DS 206:** Toilet alcove found a under sized and does not meet the minimum 30-inches wide: UPSTAIRS BONUS ROOM OVER THE GARAGE BATHROOM

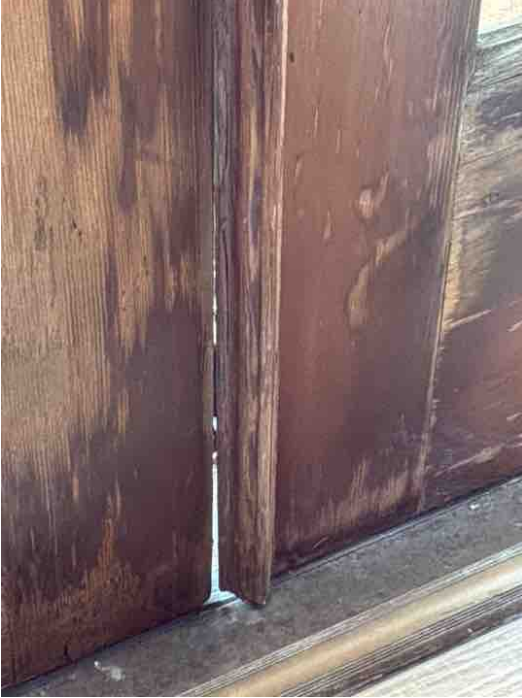
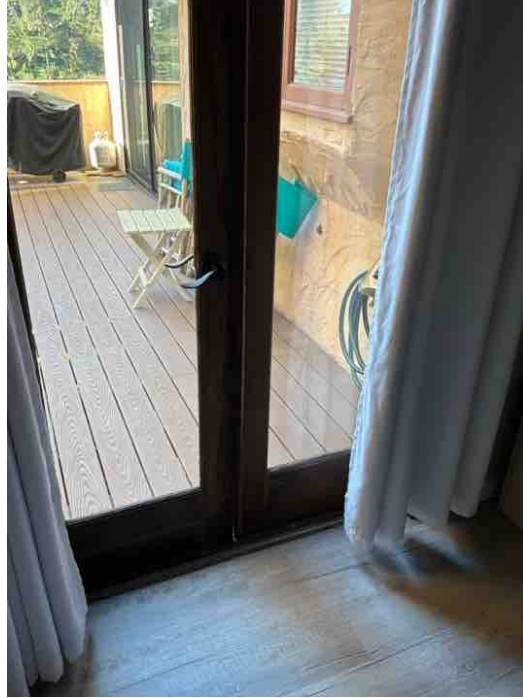
**MR** **UPG** **224:** Visible daylight noted around the DOWNSTAIRS BEDROOM exterior wood French doors. Installation of some weather stripping is recommended to help prevent water and critter intrusion.

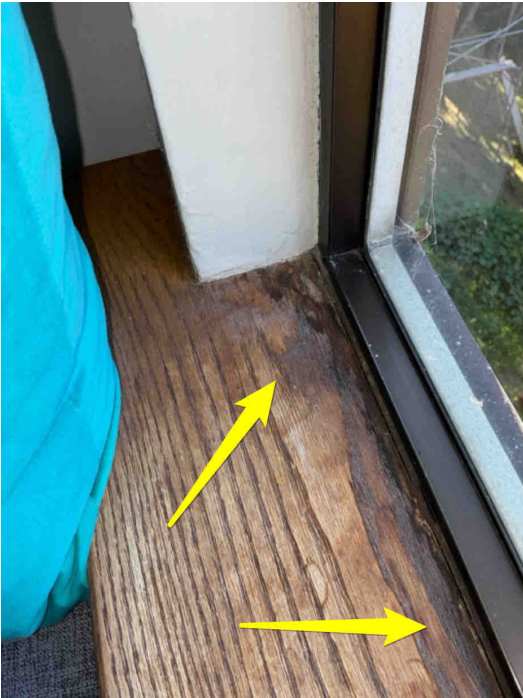
Example

**FI 230:** Moisture stains on the inside at some window sills. Refer to the termite report for additional comments and recommendations.

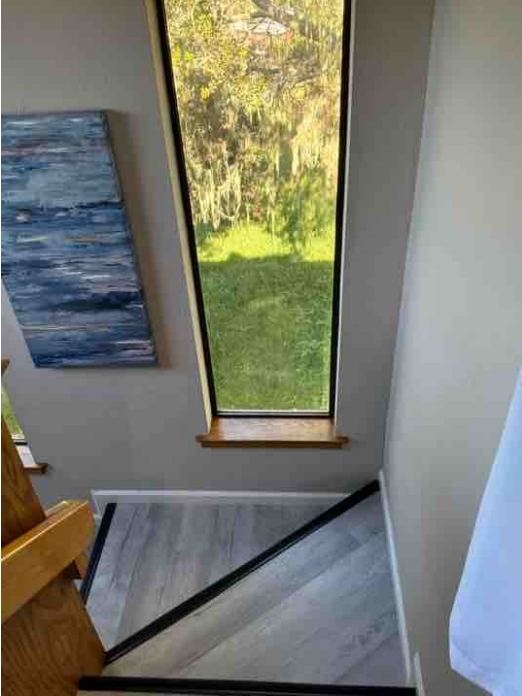
**SU 232:** Disclosure: the windows at the interior stairway do not appear to be tempered glass for safety. Upgrades recommended to help prevent damage to the window or accidentally crashing through if a fall were to occur

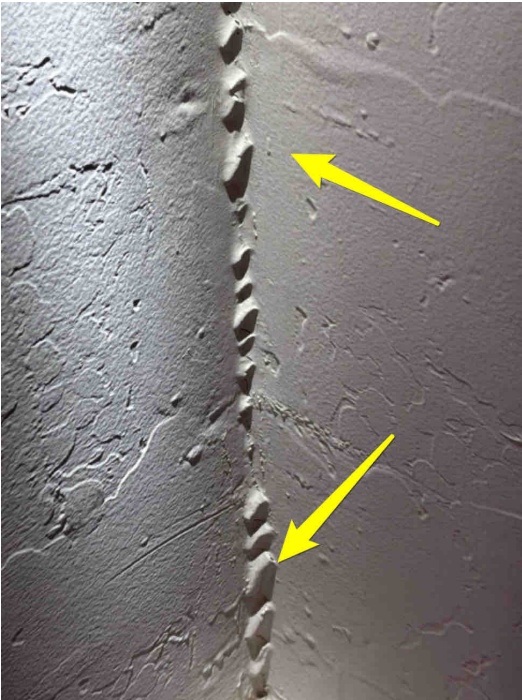
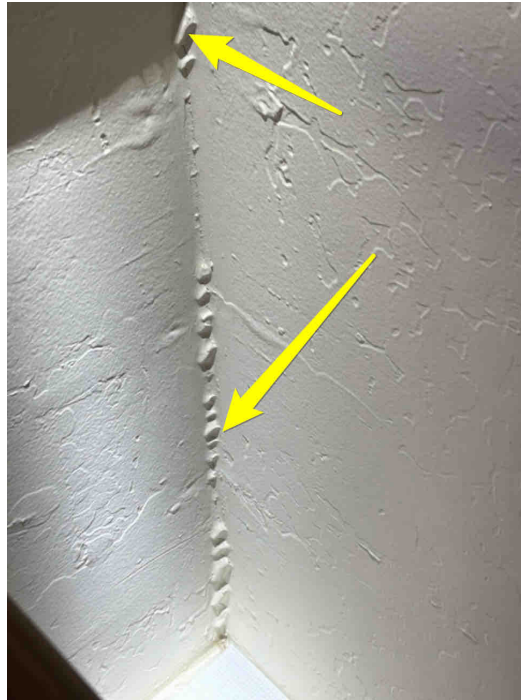
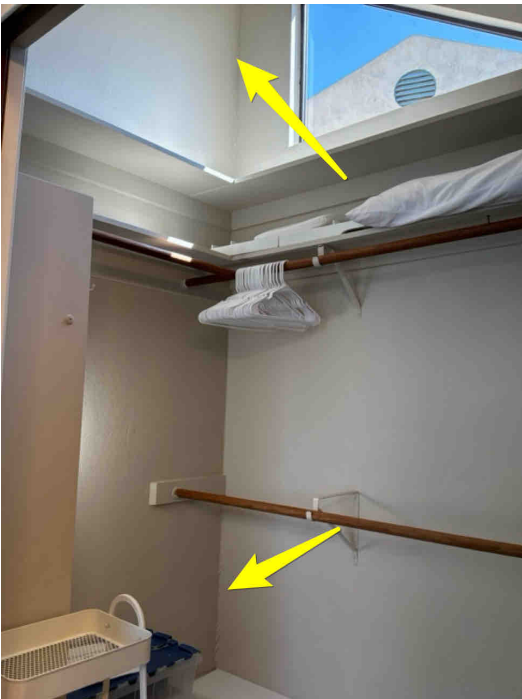
**FI 246:** Some unusual tearing of the drywall at areas of the interior inside the PRIMARY BEDROOM BATHROOM CLOSET. This appears to be from some type of movement or settlement of the framing and/or foundation system. It is advised to have a licensed engineer evaluate the cause, current condition and potential future issues.

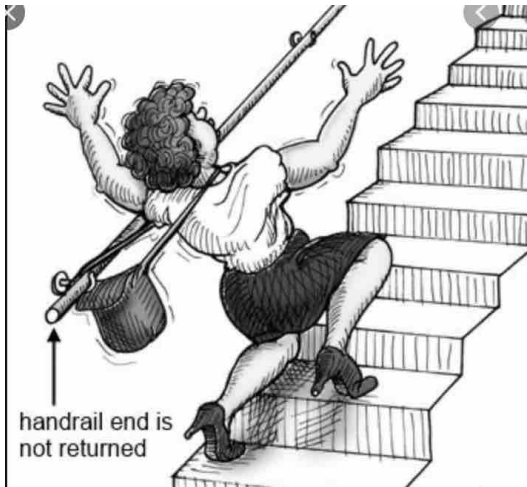
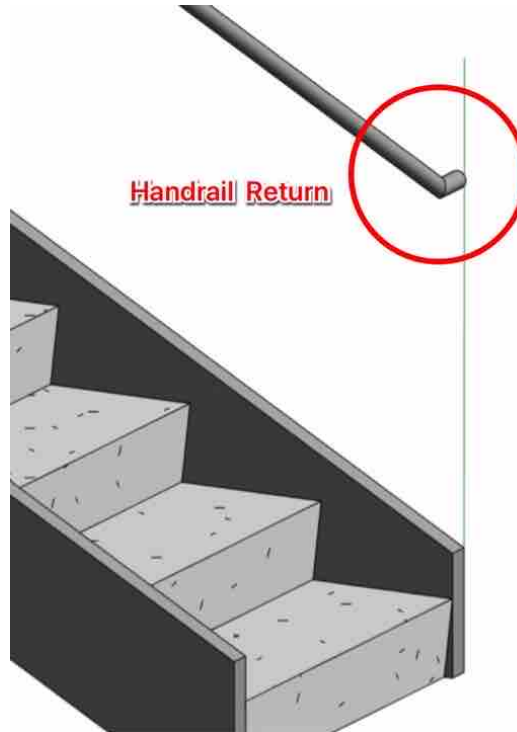
**SU 247:** Recommend returns at the interior stairway gripable handrails to the BONUS ROOM ABOVE THE GARAGE for safety per standards. A Return / turning the ends of the handrail into wall to help prevent catching coat or bag.

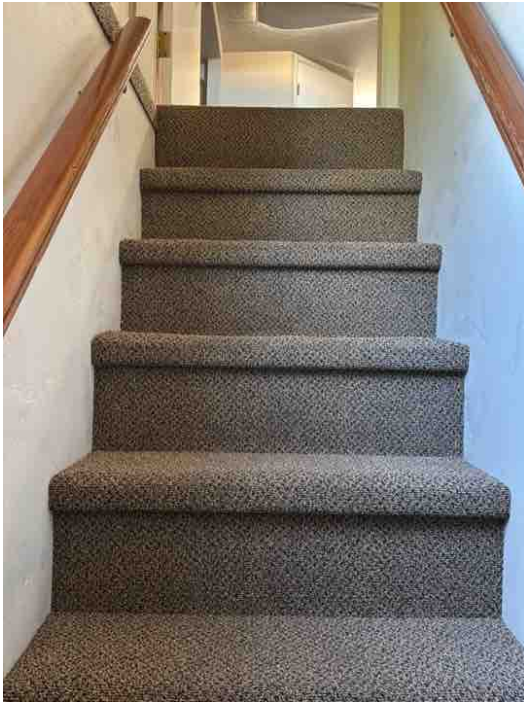
**SC 248:** The interior stairway to the UPSTAIRS BONUS ROOM OVER THE GARAGE does not meet minimum construction standards and may be a potential fall hazard. Stair treads are too tall and the step surface / tread is not deep enough per minimum standards. This can create a steep set of stairs.

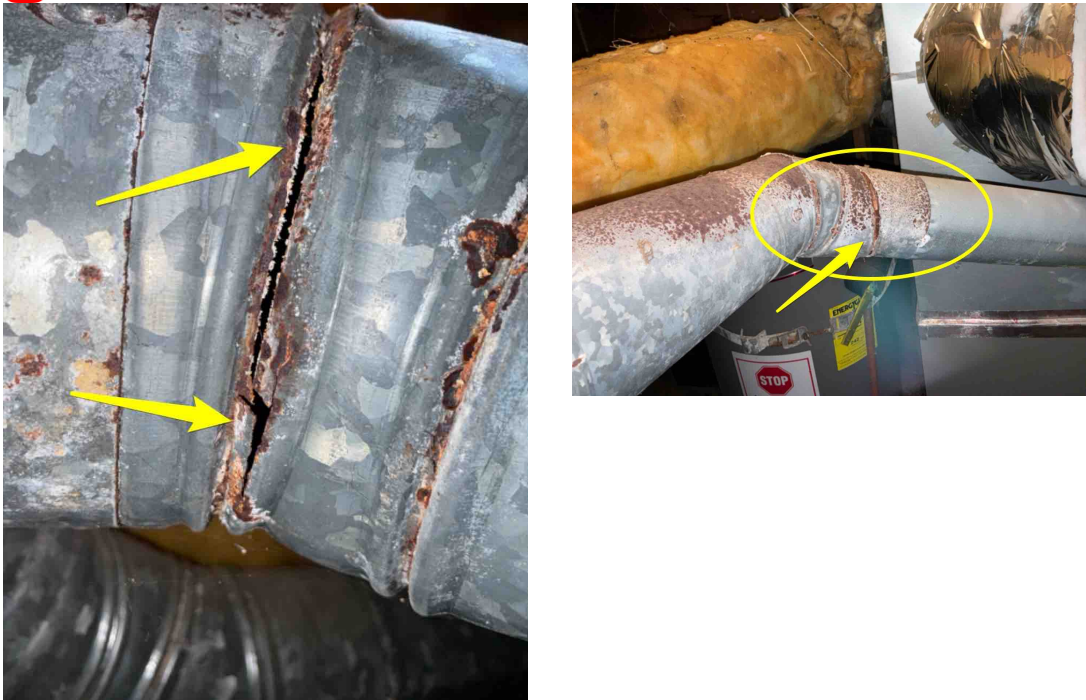
**SC 255:** Some rust deterioration and damage founded areas of the furnace vent piping in the crawlspace

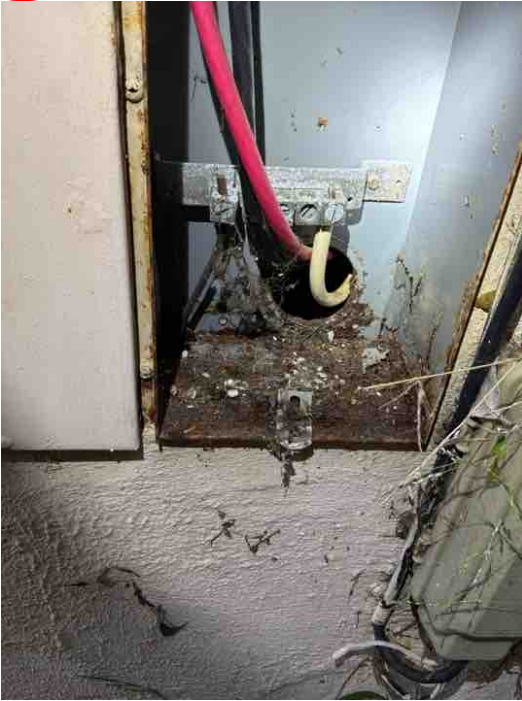
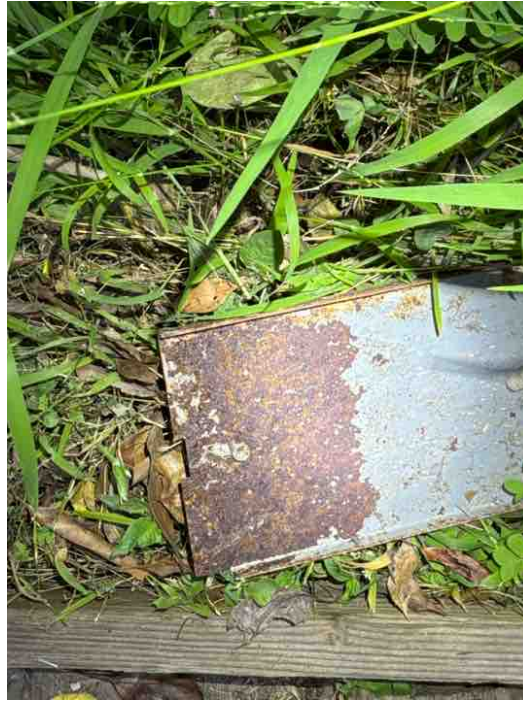
**SC 261:** Some water intrusion and rust deterioration found inside the MAIN ELECTRICAL PANEL.

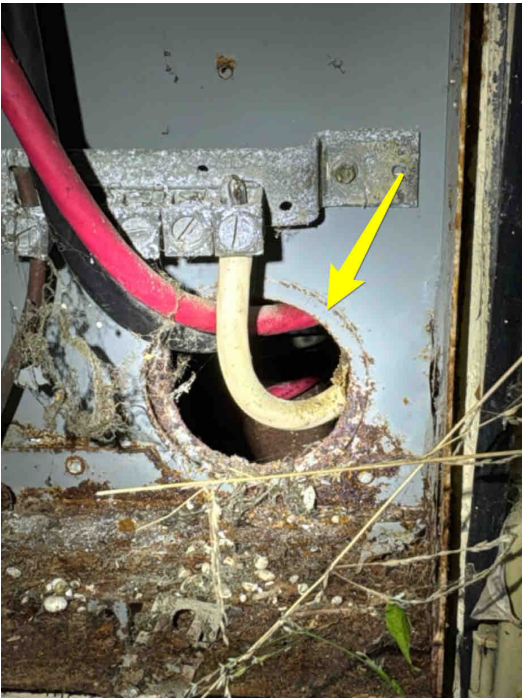
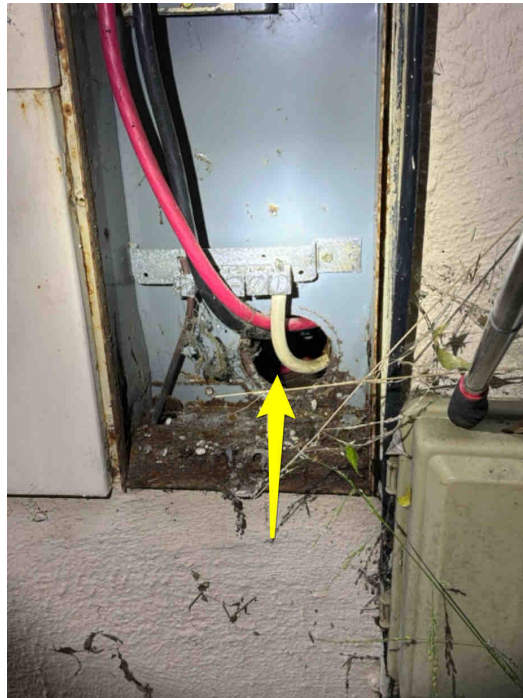
**SU 262:** Missing a bushing clamp as wires are passing into the metal MAIN ELECTRICAL PANEL. Wires are improperly rubbing on the sharp metal edge of the electrical panel as they pass through.

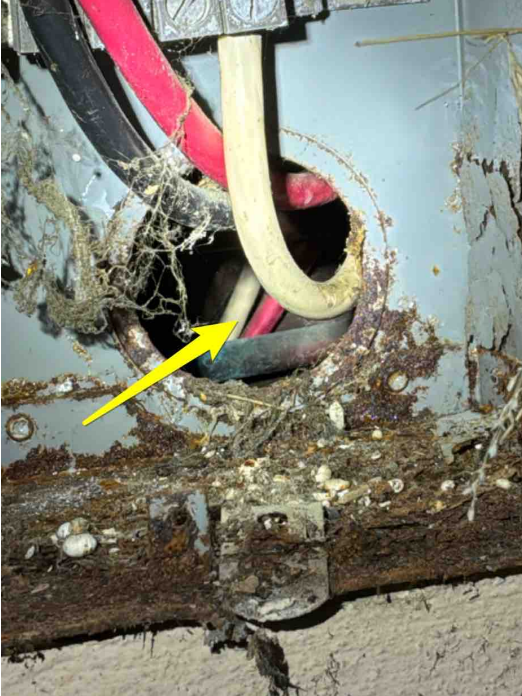
**SC 263:** Unprotected wires passing through the electrical panel not in a conduit leaving from the MAIN ELECTRICAL PANEL.

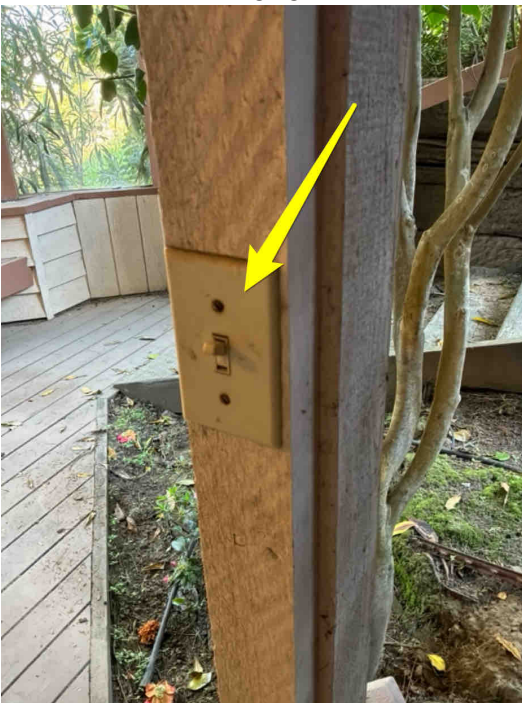
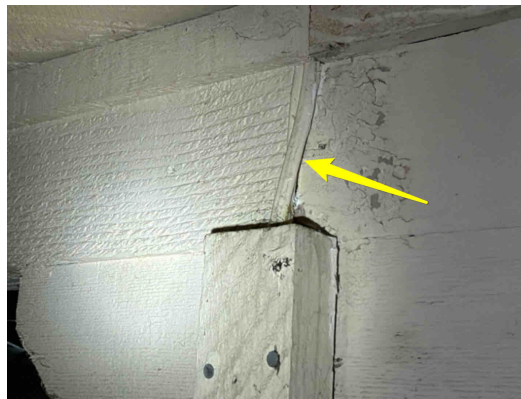
1. "Romex" improperly installed subject to physical damage, not in a conduit or raceway per standards
2. Improper use of a non-exterior rated box and cover at the added light switch, for the WEST SIDE YARD LOWER DECK ceiling light

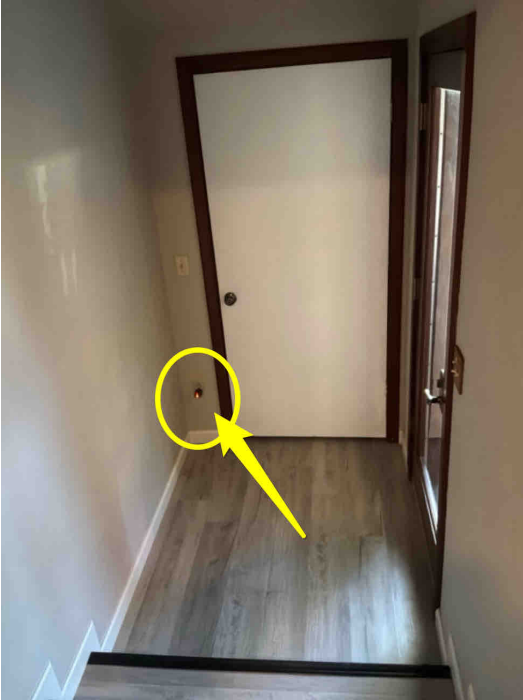
**SC 271:** Three-prong electrical outlets did not test properly grounded: DOWNSTAIRS HALLWAY. Contact a licensed electrical contractor for evaluation and repairs.

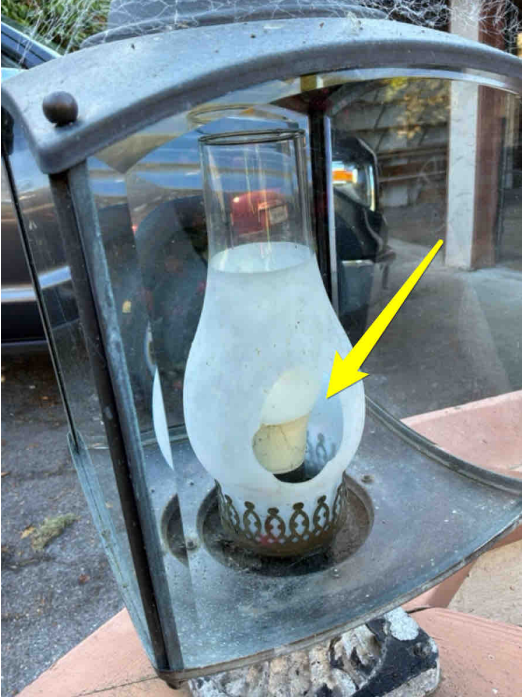
**E&C 275:** Lens at light fixture is cracked: exterior front entry light at the driveway area on the front entry deck handrail.

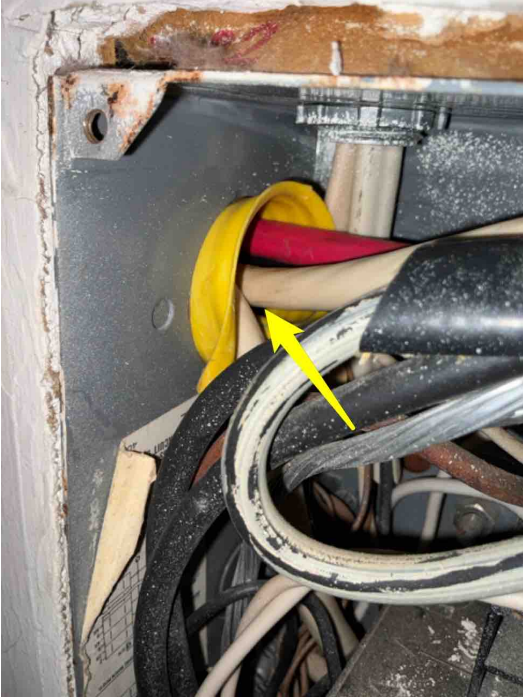
**SC 286:** Unprotected wires passing through the electrical panel not in a conduit leaving from the BEDROOM CLOSET MAIN ELECTRICAL PANEL

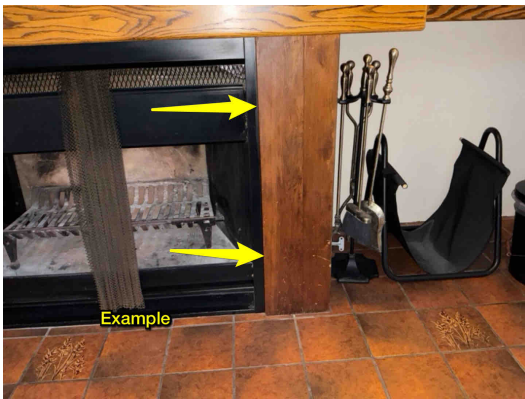
**E&C SU 331:** The added wood mantle is too close to the PRIMARY BEDROOM fireplace opening per minimum standards. Corrections recommended.

Too close to the Fireplace opening
