Your Inspection Report

1330 Stonewood Court
San Pedro, CA 90732

INSPECTION DATE:
Wednesday, March 11, 2026

RE: Report No. 1569
1330 Stonewood Court
San Pedro, CA
90732

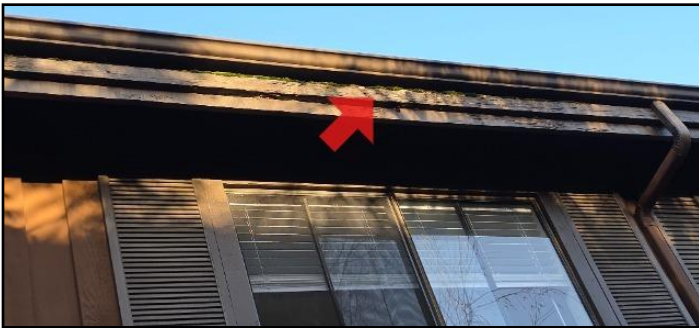
2. Condition: • [Rot or insect damage](#)

Implication(s): Chance of water damage to structure, finishes and contents | Material deterioration

2. Rot or insect damage

Task: Repair or replace Further evaluation

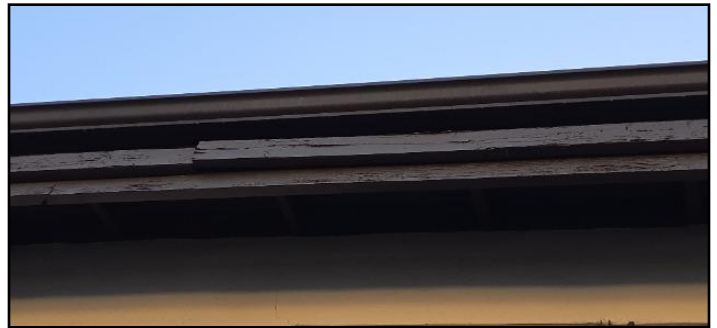
3. Rot or insect damage

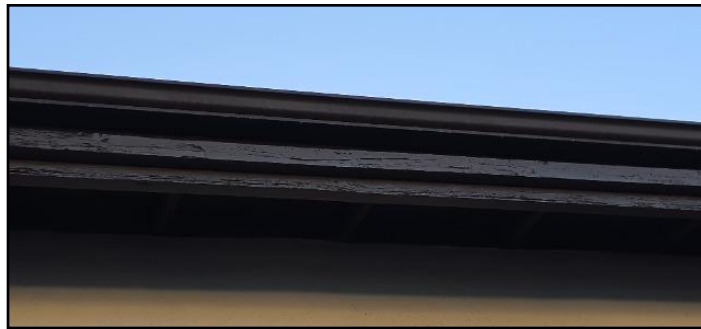
4. Rot or insect damage

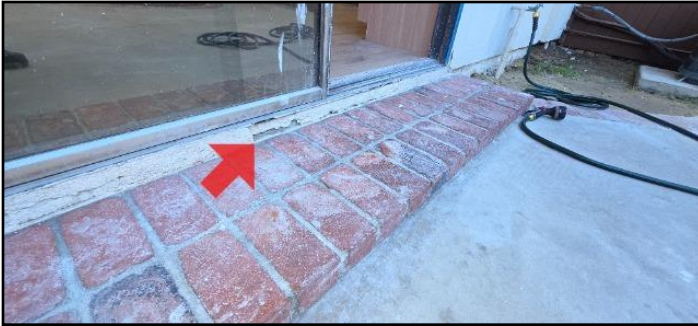
3. Condition: • [Crumbling](#)

Implication(s): Chance of water damage to structure, finishes and contents | Material deterioration

5. Crumbling

Task: Repair

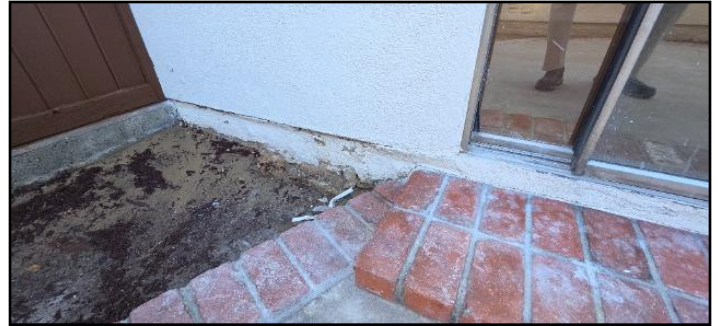
6. Crumbling

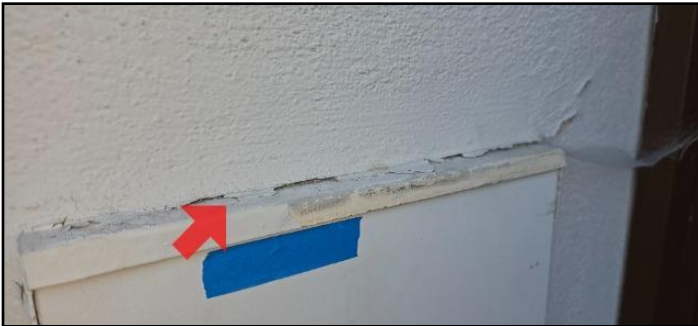
4. Condition: • [Minor cracks](#)

Implication(s): Shortened life expectancy of material

7. Minor cracks

Task: Repair Monitor

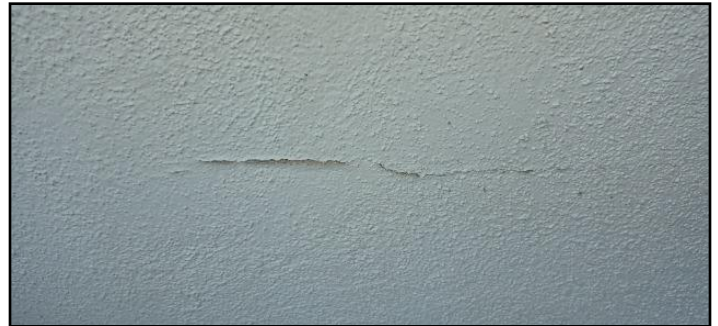
8. Minor cracks

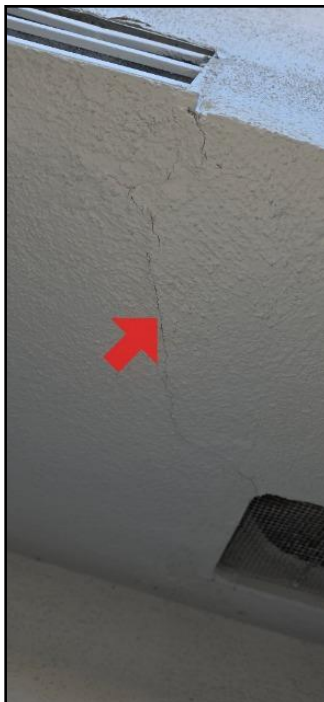
9. Minor cracks

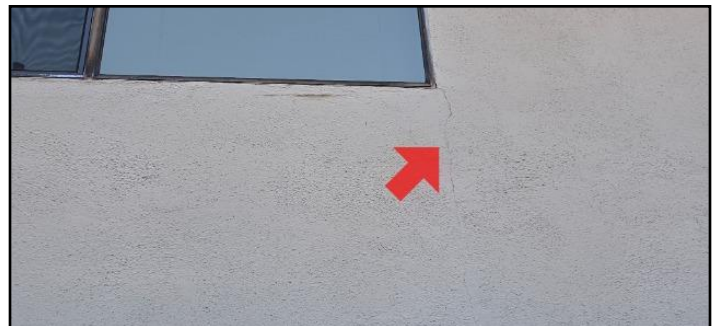
10. Minor cracks

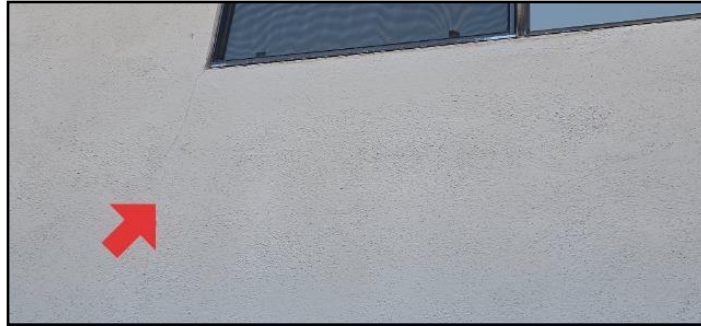
11. *Minor cracks*

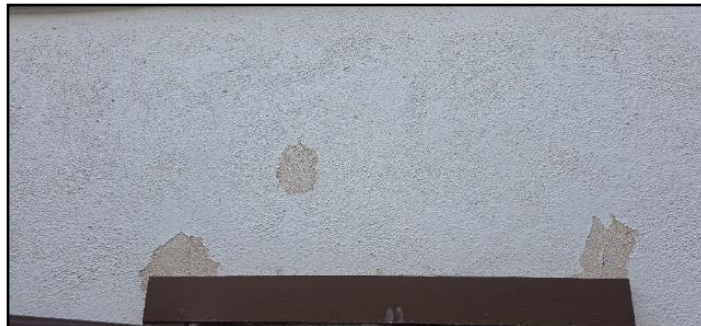
5. Condition: • Paint or stain - needed

Implication(s): Chance of water damage to structure, finishes and contents | Material deterioration

12. *Paint or stain - needed*

Task: Improve

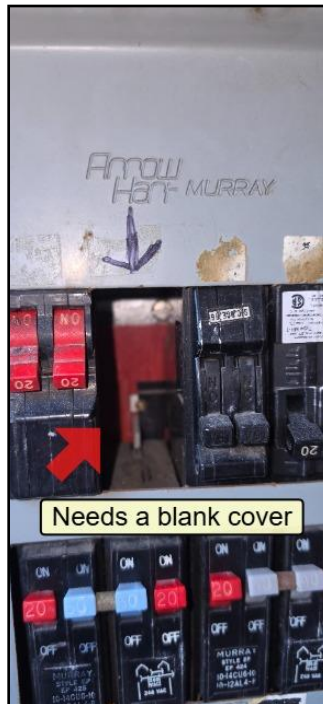
7. Condition: • [Openings in panel](#)

Implication(s): Electric shock | Fire hazard

15. Openings in panel

Task: Repair Improve

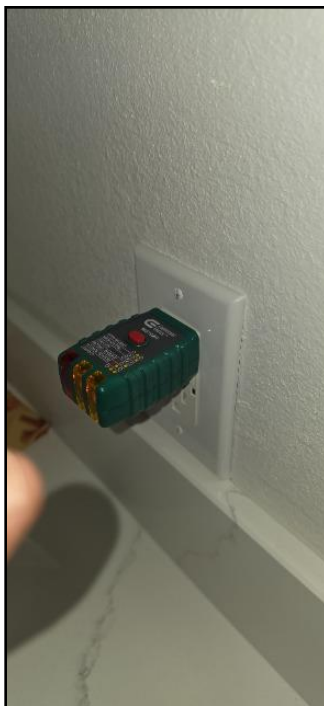
8. Condition: • [Arc Fault Circuit Interrupter \(AFCI\) test faulty](#)

Implication(s): Fire hazard

16. Arc Fault Circuit Interrupter (AFCI) test...

Task: Repair Further evaluation

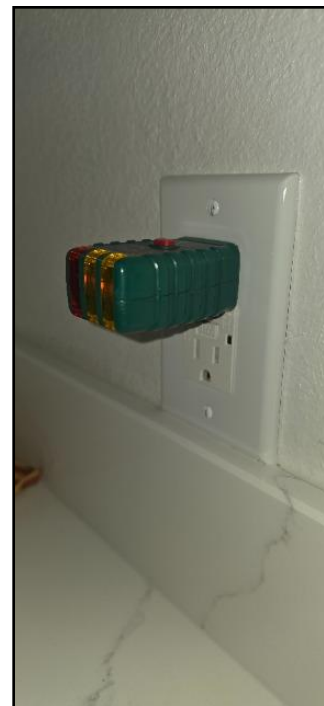
17. Arc Fault Circuit Interrupter (AFCI) test...

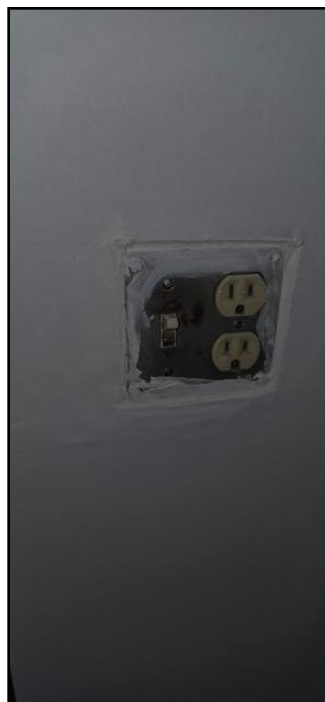
9. Condition: • [GFCI/GFI needed \(Ground Fault Circuit Interrupter\)](#)

18. GFCI/GFI needed (Ground Fault Circuit...)

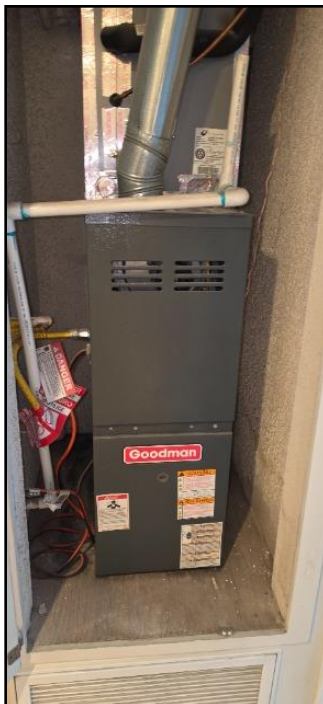
- Not tested as part of a building inspection
- Found off and tagged by The Gas Company

19. Not tested as part of a building inspection

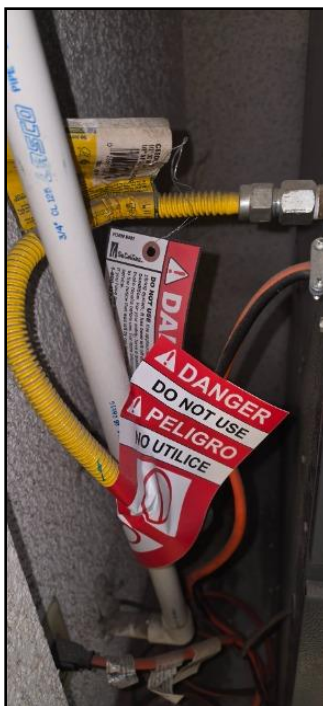
10. Condition: • [Inoperative](#)

Found off by The Gas Company

20. Inoperative

Task: Repair Further evaluation Service

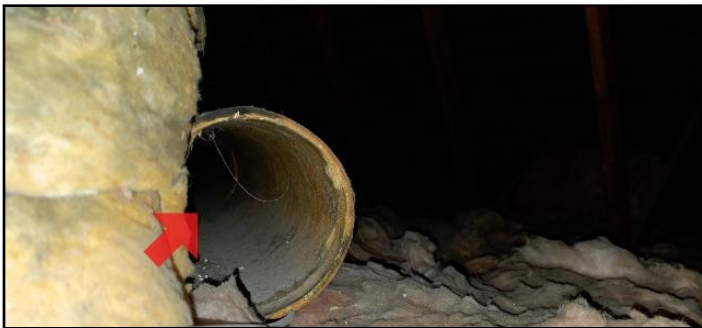
11. Condition: • [Disconnected ducts](#)

21. Disconnected ducts

Task: Repair Further evaluation

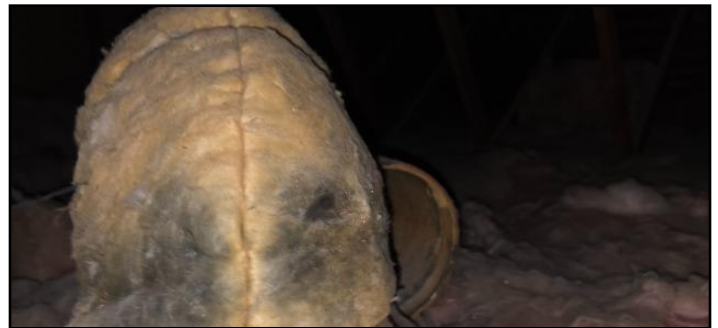
22. Disconnected ducts

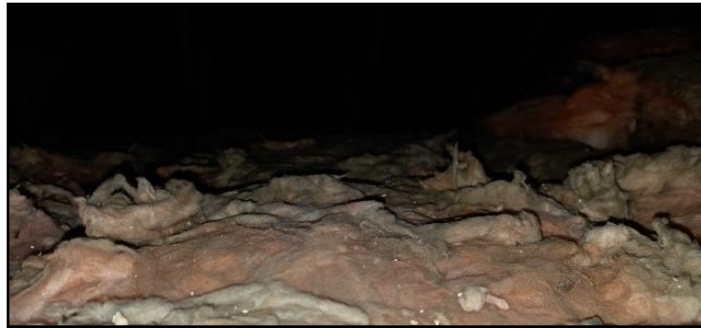
13. Condition: • [Amount less than current standards](#)

25. *Amount less than current standards*

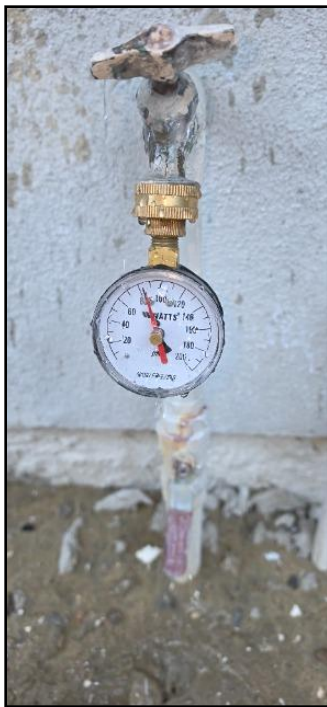
14. Condition: • [Missing](#)

Implication(s): Chance of water damage to structure, finishes and contents | Leakage | Damage to equipment

29. Missing

Task: Provide

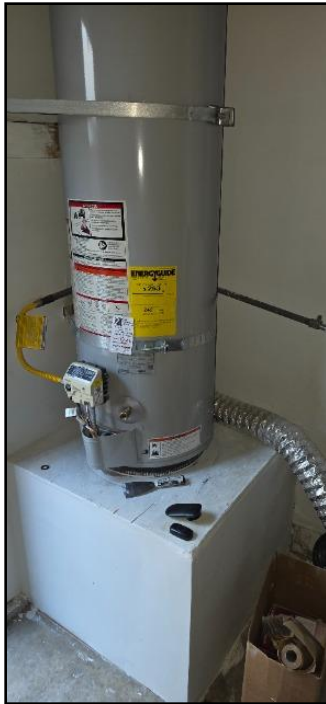
16. Condition: • Past life expectancy

Implication(s): Chance of water damage to structure, finishes and contents | No hot water

30. Past life expectancy

Task: Replace

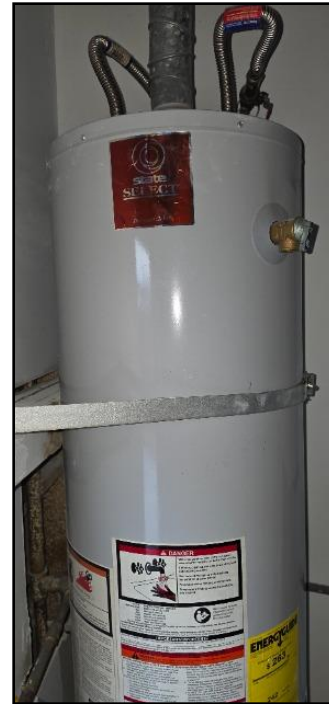
31. Past life expectancy

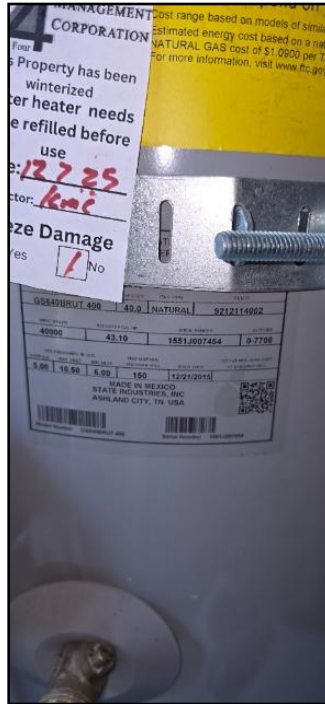
32. Past life expectancy

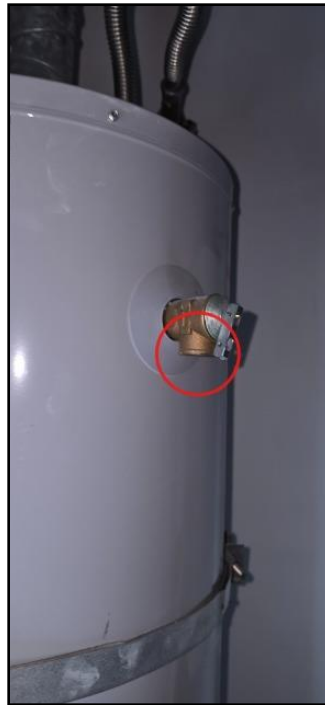
17. Condition: • [Discharge tube missing](#)

33. Discharge tube missing

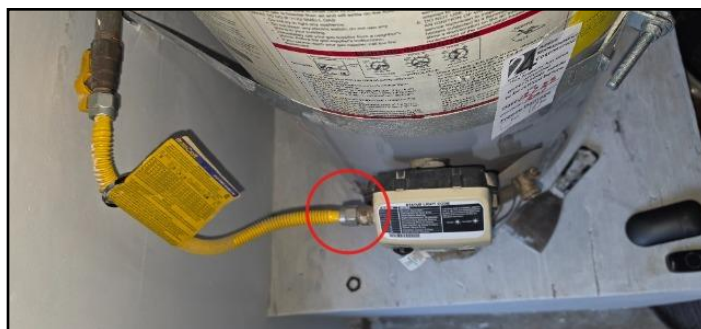
18. Condition: • [No drip leg \(sediment trap/dirt pocket\)](#)

Implication(s): Equipment failure

34. No drip leg (sediment trap/dirt pocket)

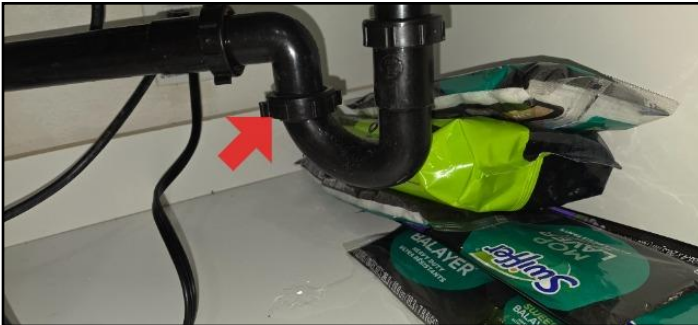
19. Condition: • [Leak](#)

35. Leak

Task: Repair or replace Further evaluation

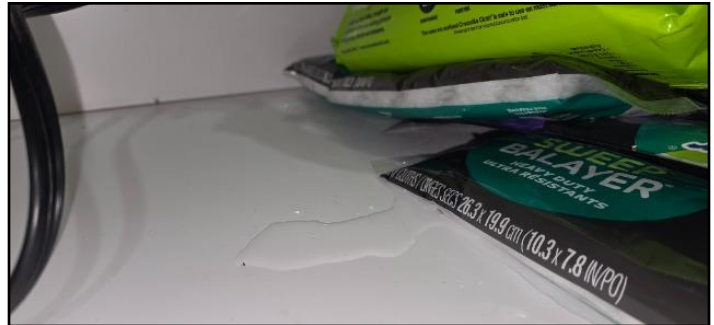
36. Leak

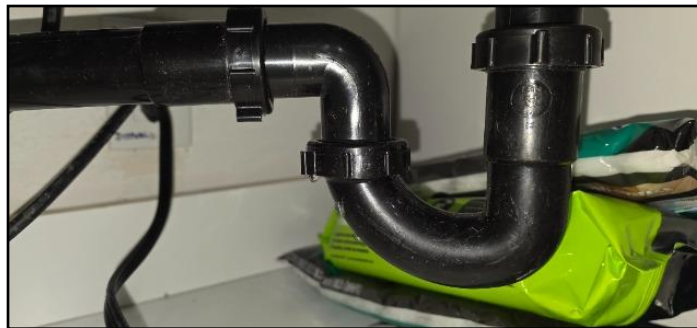
37. Leak

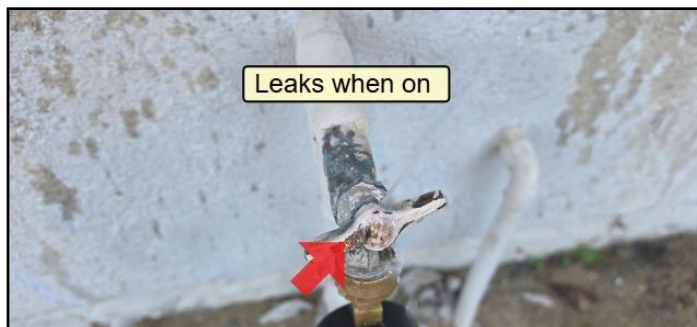
20. Condition: • [Leak or drip](#)

Implication(s): Chance of water damage to structure, finishes and contents

38. Leak or drip

Task: Replace

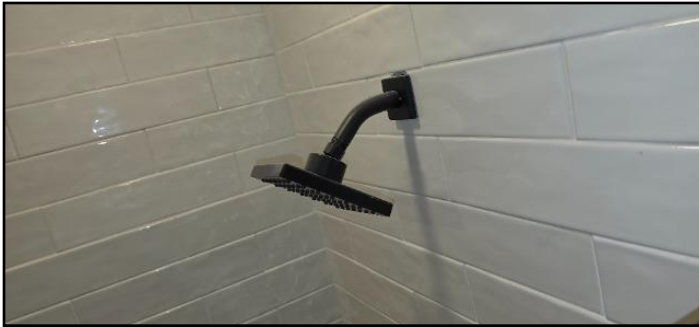
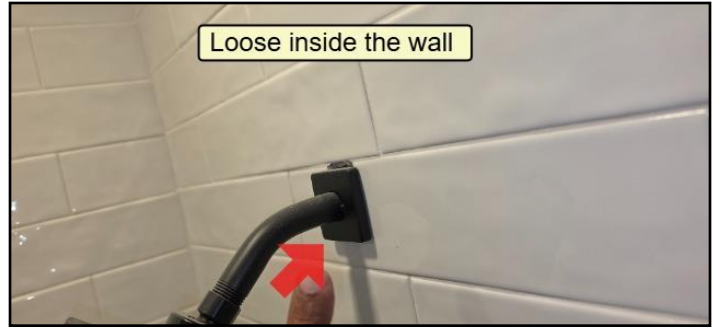
21. Condition: • The shower arm is loose in the wall

Task: Repair Further evaluation

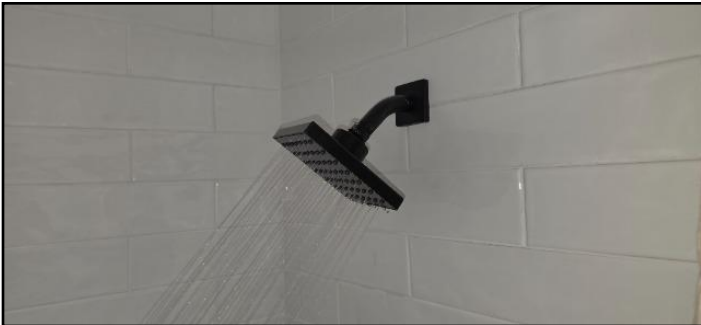
22. Condition: • [Leak](#)

The shower head is loose and leaks when on

41. Leak

Task: Repair or replace Further evaluation

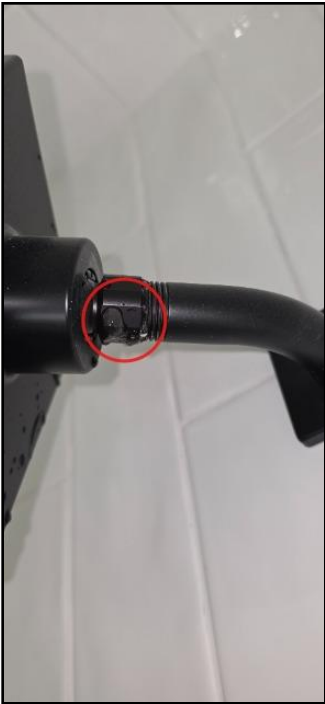
42. Leak

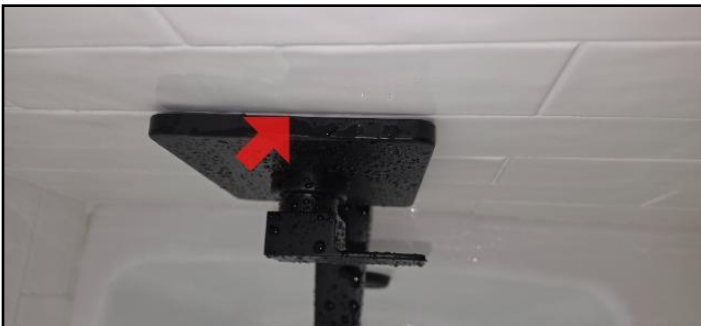
23. Condition: • [Caulking loose, missing or deteriorated](#)

Implication(s): Chance of water damage to structure, finishes and contents

43. Caulking loose, missing or deteriorated

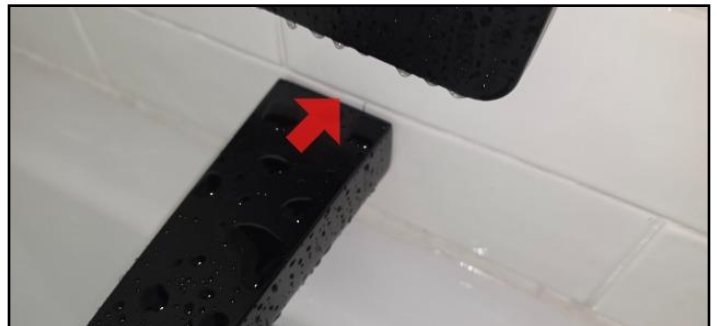
44. Caulking loose, missing or deteriorated

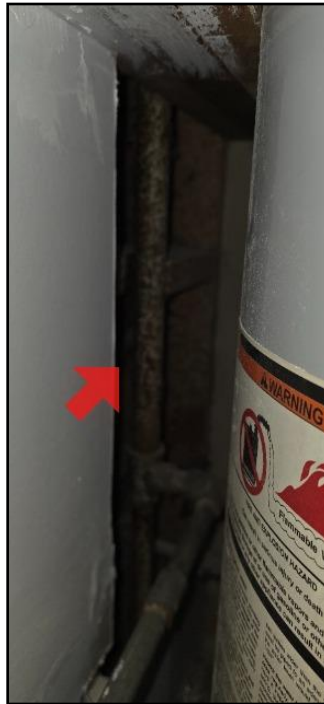
24. **Condition:** • [Loose or missing](#)

50. Loose or missing

Task: Repair

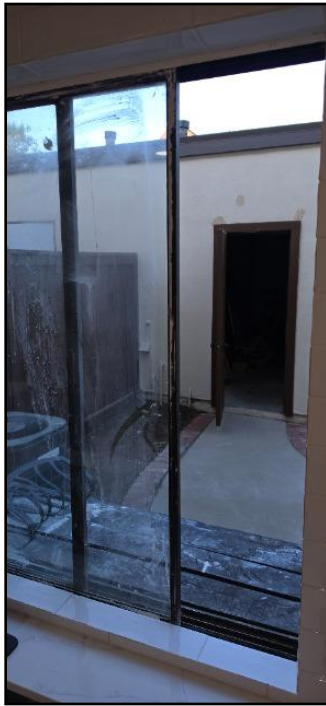
25. Condition: • [Missing](#)

51. Missing Screens

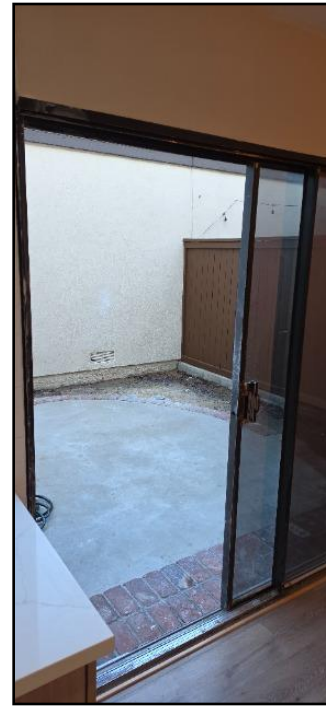
52. Missing Screens

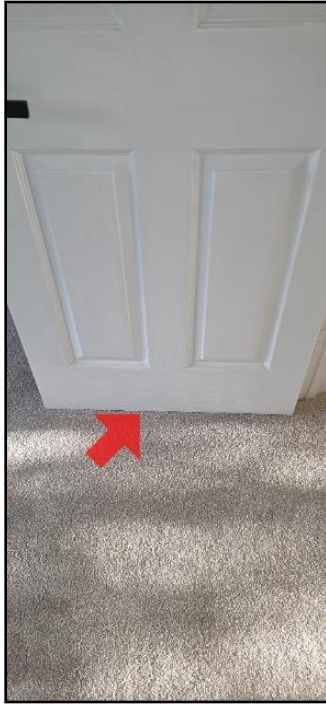
26. Condition: • Door rubs

53. Door rubs

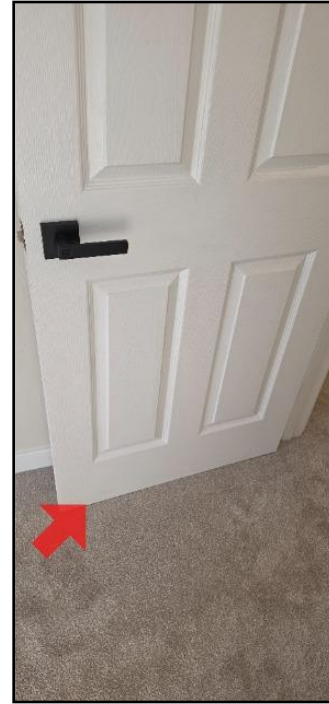
54. Door rubs

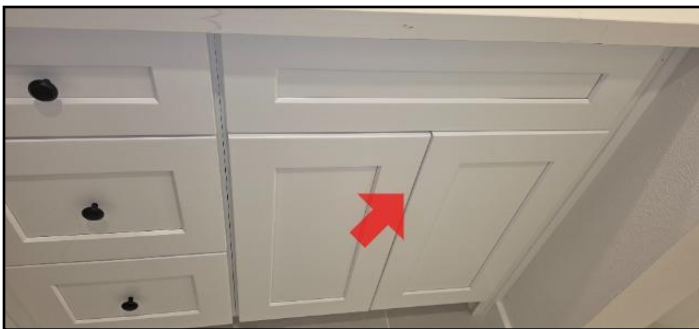
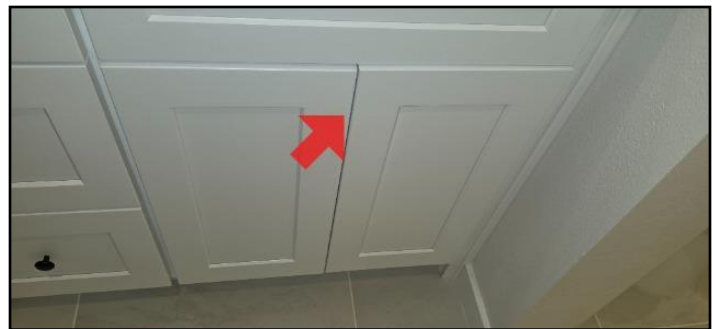
27. Condition: • Missing Vanity knobs

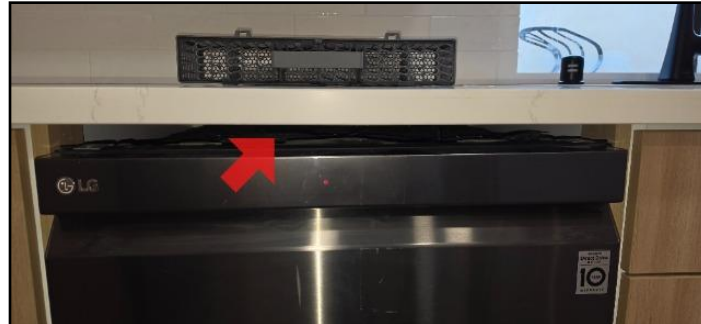
28. Condition: • Loose

57. Loose

Task: Repair
