Inspection Report

Claro Home Inspections LLC

6519 Denver Ave, Los Angeles, CA 90044

Three units inspection,
Duplex Front Units 1 - 2 rpts

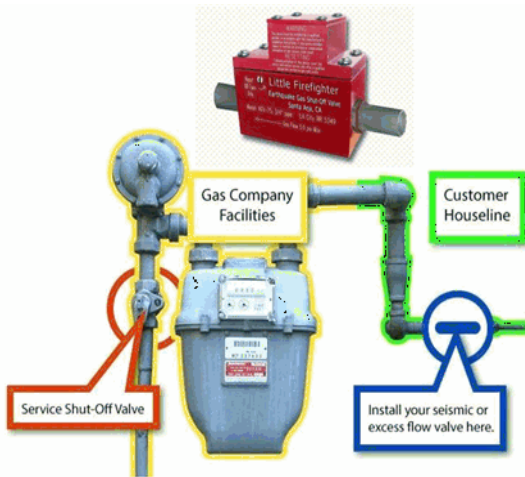
The meter was not equipped with an automatic seismic shutoff valve. We recommend client consult the local gas authority provider for requirements. Consult a licensed plumber for installation.

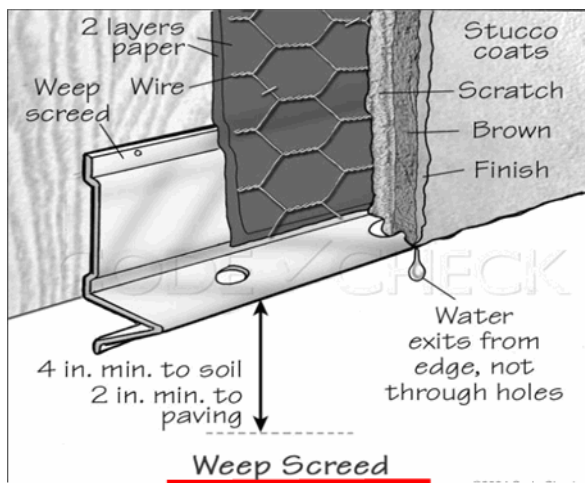
Weep screed not installed. It should be noted that the building stucco siding terminated below or at finished grade of the perimeter walls and foundation. This condition is no longer considered acceptable by modern construction standards and practices. Condition is conducive to moisture migration to the wood framing supporting members. Subject to moisture damage. It is suggested that a positive finish grade slope away from the buildings perimeter be maintained to prevent future moisture damage.

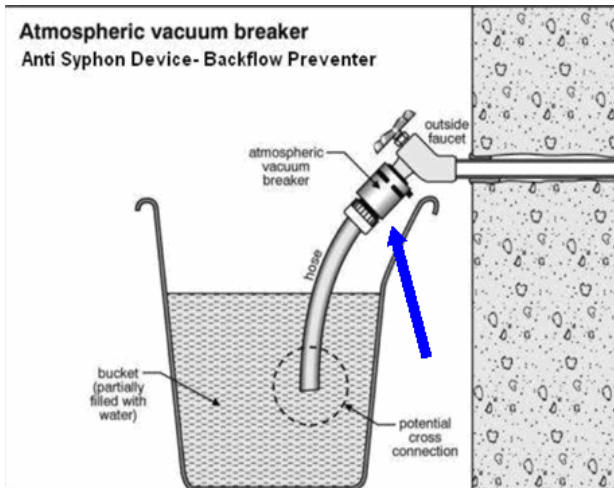
A representative number of hose bibs were tested and found to be in functional condition. **Back-flow preventers were not present.** Back-flow preventers should be installed at all hose bibs to prevent contamination to the homes drinking water. Maintenance, such as tightening of the packing nut, or replacements may be needed to prevent leaks while hoses are in use.

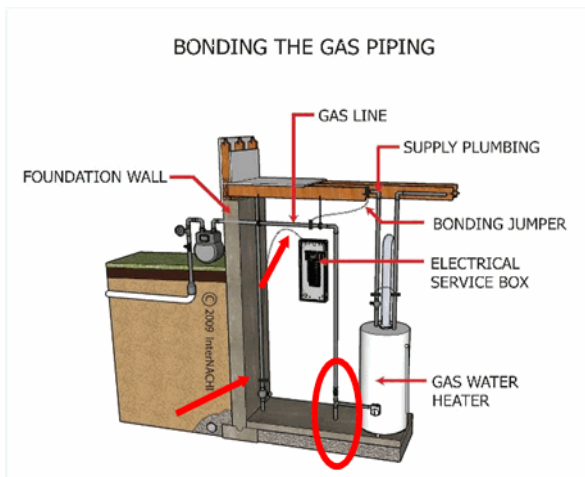
Pipe bonding between water supply line and gas line was not visible / installed. Therefore it could not be inspected. Ideally, current standards require a simple jumper wire across.

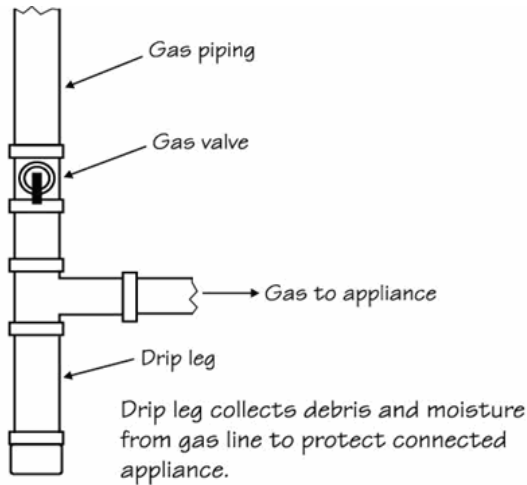
A drip leg (sediment trap) at the gas line connection was missing, it is recommended client consult their local utility provider / license plumber for local installation requirements.

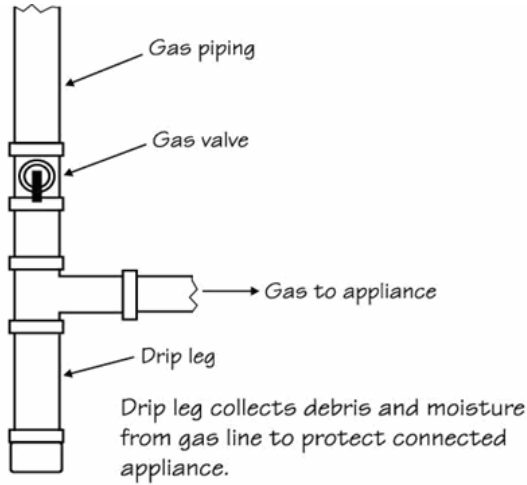
A drip leg (sediment trap) at the gas line connection was missing, it is recommended client consult their local utility provider / license plumber for local installation requirements.

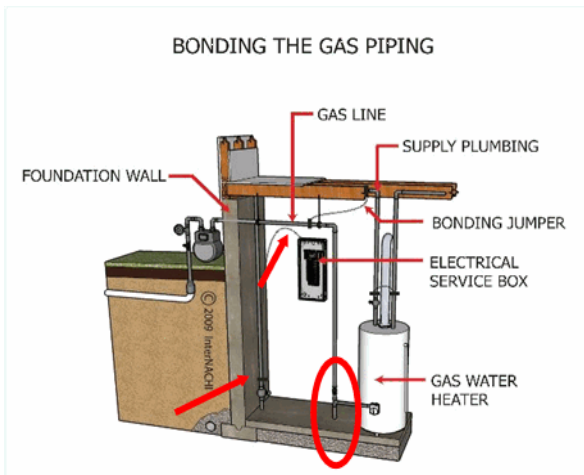
Pipe bonding between water supply line and gas line was not visible / installed. Therefore it could not be inspected. Ideally, current standards require a simple jumper wire across.

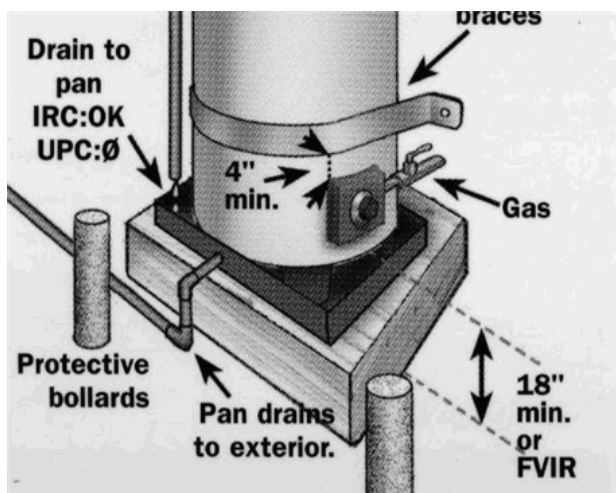
Drip pans are recommended below all hot water heaters. Drip pans should drain to the exterior. This will help contain leaks and prevent water damage.

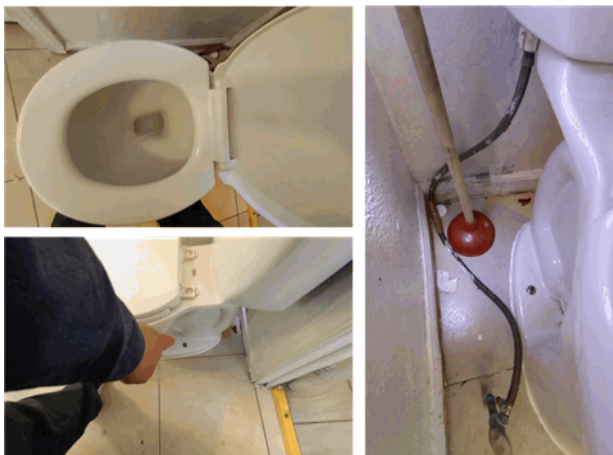
Rep Bathroom #1. Toilet was tested and found to be functional on the day of the inspection. **Toilet had a loose connection to the floor. Consult a licensed plumber to reattach flange bolts. Wax ring replacement may be needed.**
