Mitch Fredericks Home Inspections

13614 Dall Lane

Inspected on Wed, Mar 11 2026 at 2:19PM

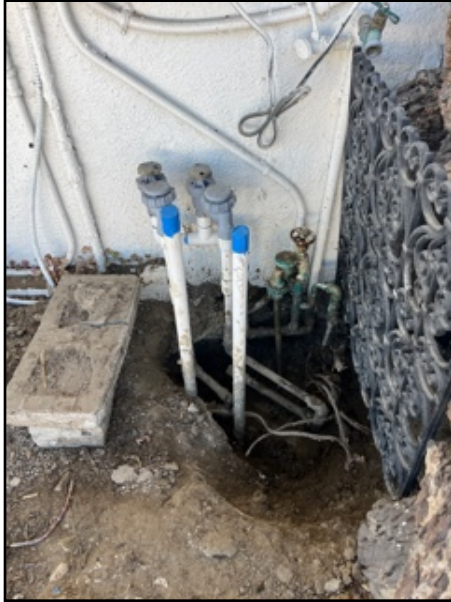
Figure 4-1

The backyard sprinkler valves appear to be free of leaks. The pool fill valve is presently leaking and is in need of repair.

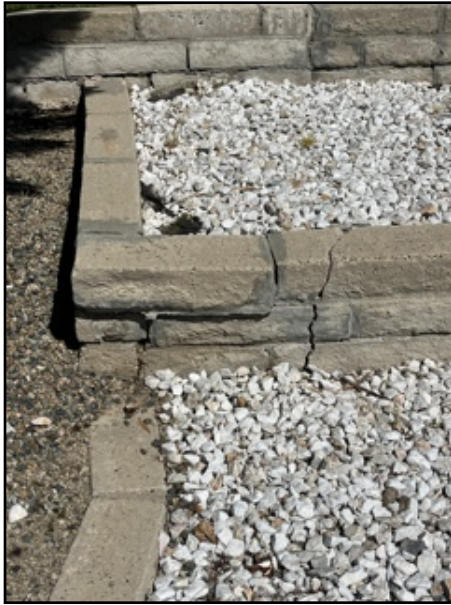
Figure 7-1

The front planter, retaining walls show cracks between the blocks, and the wall leans slightly.

Repairs can be made to the block wall.

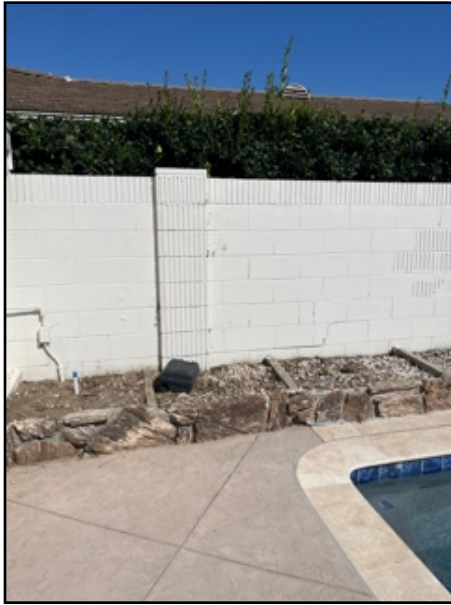
Figure 11-1

The rear block wall shows settling cracks.
The right side block wall shows outlines of settling between the blocks.

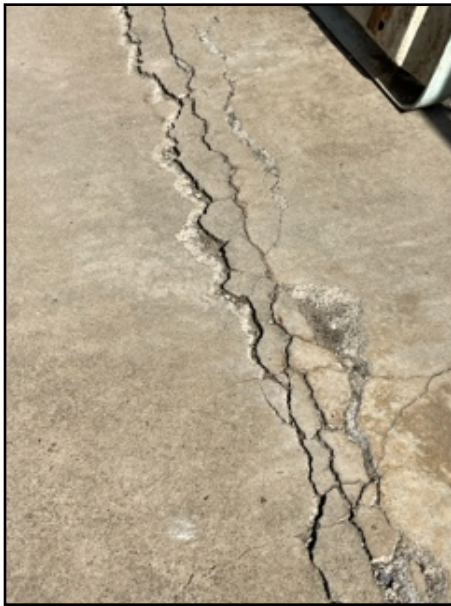
Figure 13-1

The backyard concrete patio shows settling cracks.

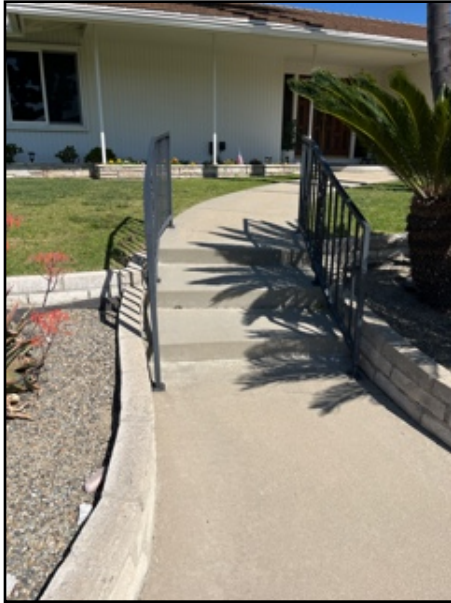
Figure 18-1

The front concrete steps show settling cracks.

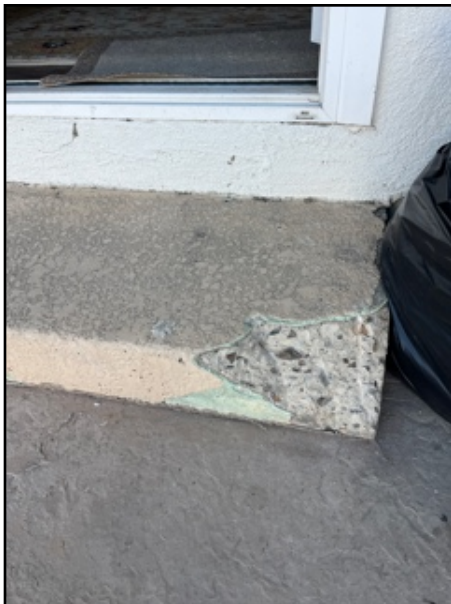
Figure 19-1

The backyard concrete step to the master bedroom shows a large piece of concrete missing.

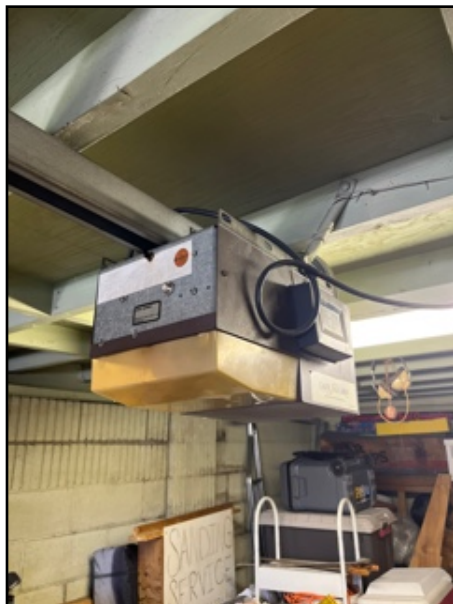
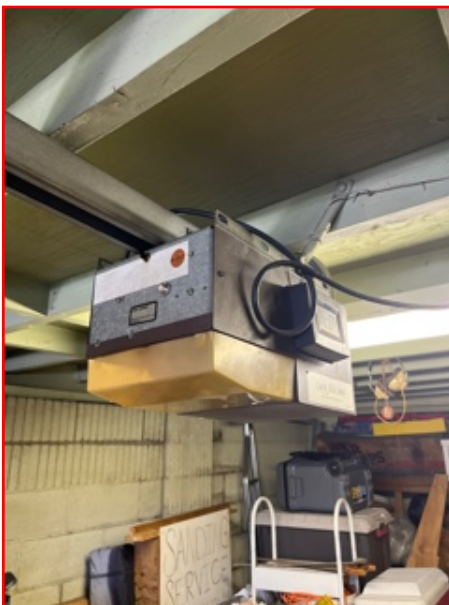
Figure 26-1

The tilt up garage door has safety rods down each of the springs. There is no auto reverse sensor for child safety. The opener is old and recommend upgrading.

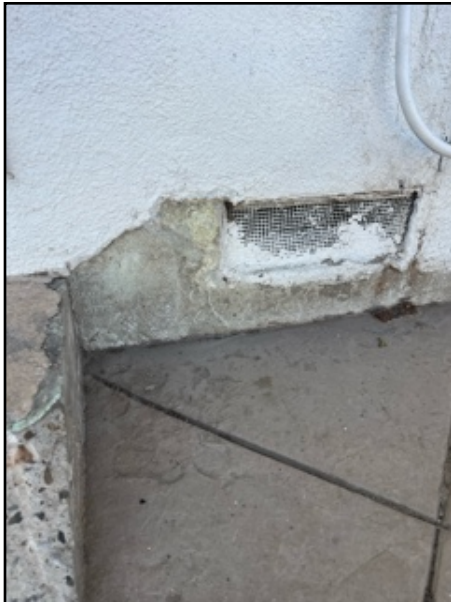
Figure 30-1

The stucco on the house at the rear shows flaking and crumbling. Repairs are needed at this time.

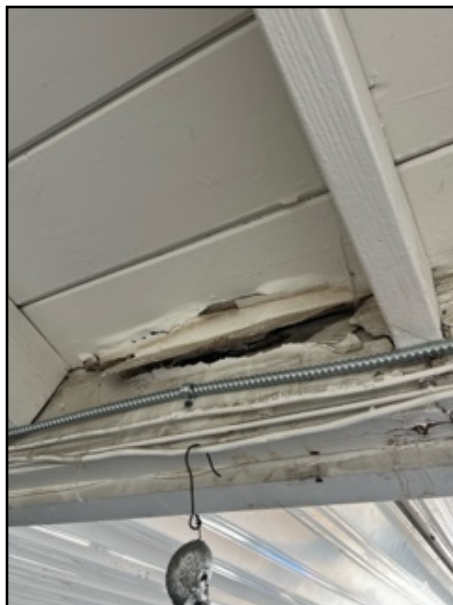
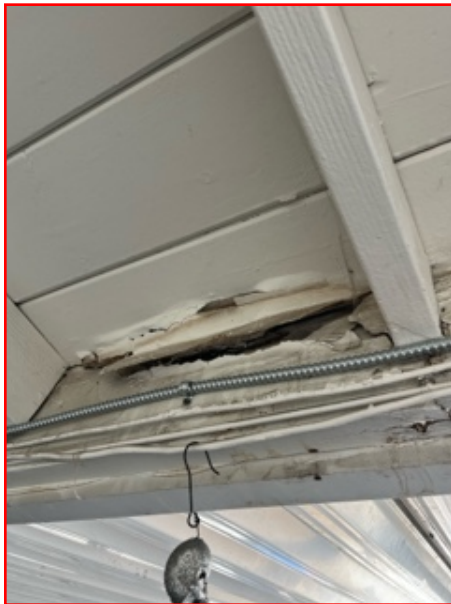
Figure 31-1

The ease at the rear of the house show wood damage and rocked because of the installation of the patio cover.

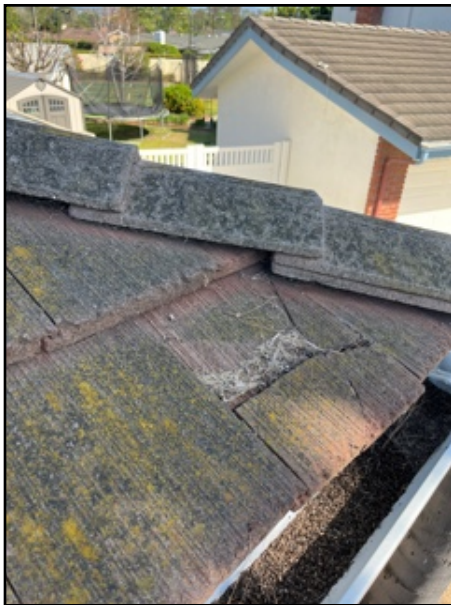
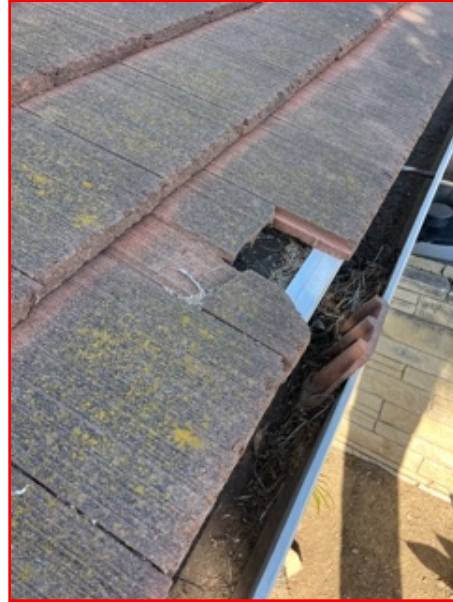
Figure 33-1

The front right corner tile is broken.

There is a second broken tile at the right side front corner.

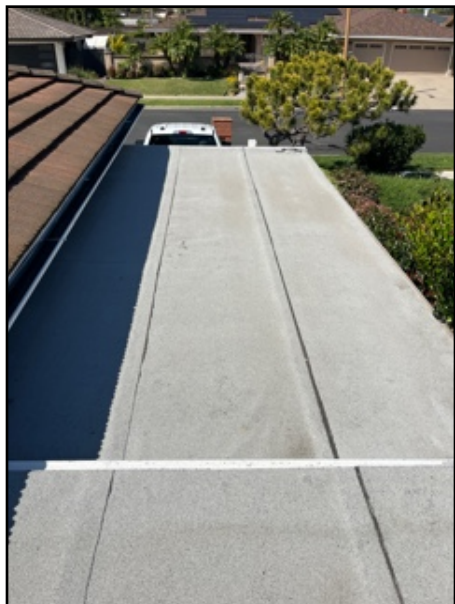
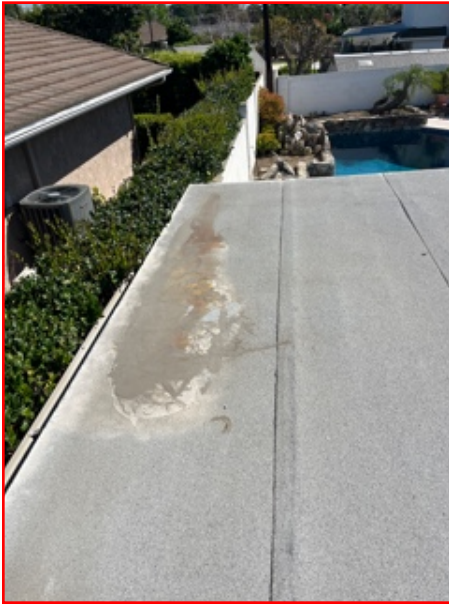
Figure 37-1

The flat roof over the garage/rear storage and room appears to be in overall good condition. There are water marks, indicating rainwater is pooling on this roof. Repairs are needed at this time.

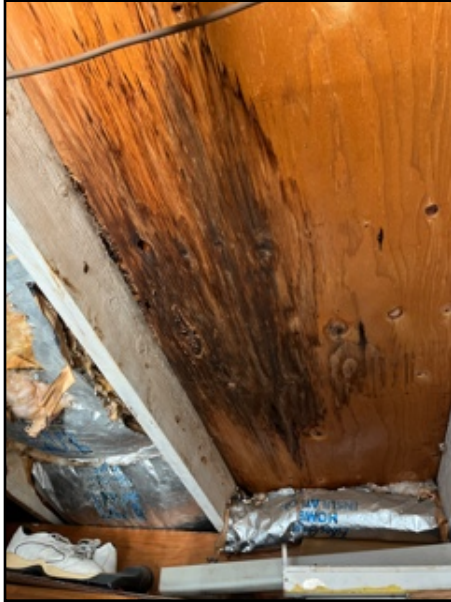
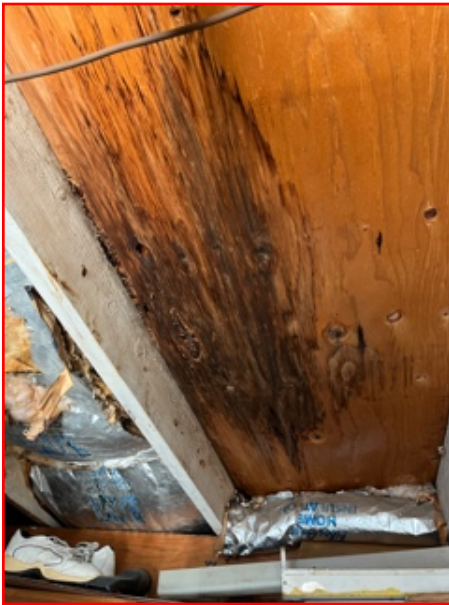
Figure 38-1

In the storage room behind the garage, the ceiling/plywood shows water stains from the flat roof.

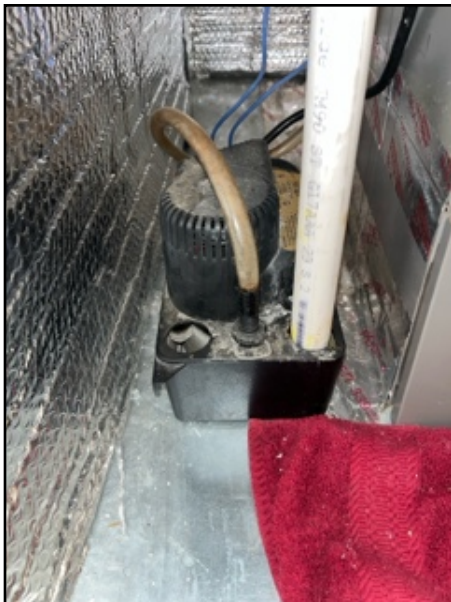
Figure 40-1

In the furnace closet in the hallway, there is a pump motor for the condensation to the air-conditioning.

The pump was not operating at the time of the inspection. When the box fills halfway, the pump turns on automatically pumping the water out.

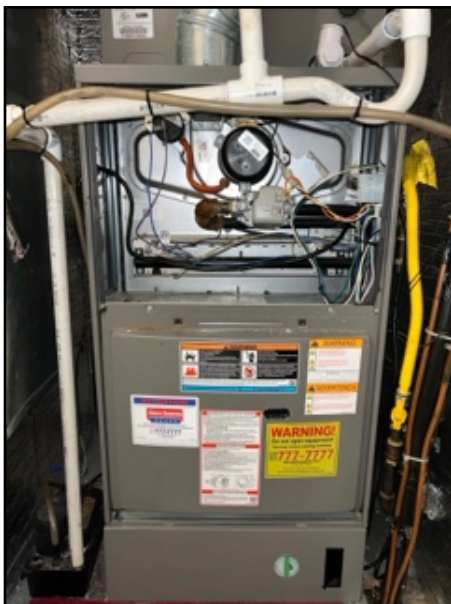
Figure 43-1

The furnace responds to the thermostat control. The burners ignite, and the blower motor is quiet at the time of the inspection.

The filter is dirty and should be replaced.

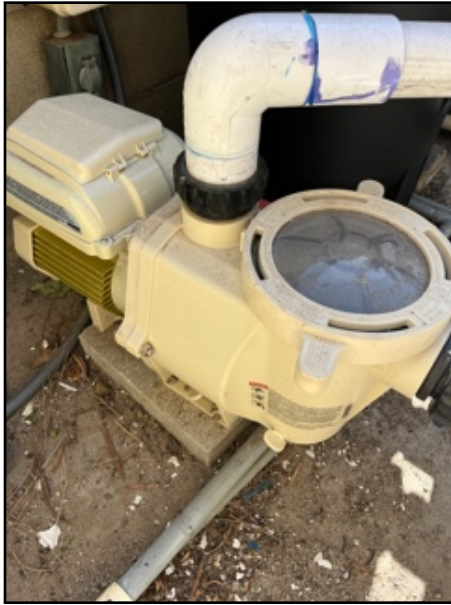
Figure 53-1

Comment 53:
The pump motor is quiet and free of leaks.
There is not a ground wire attached to the pump motor or the heater.

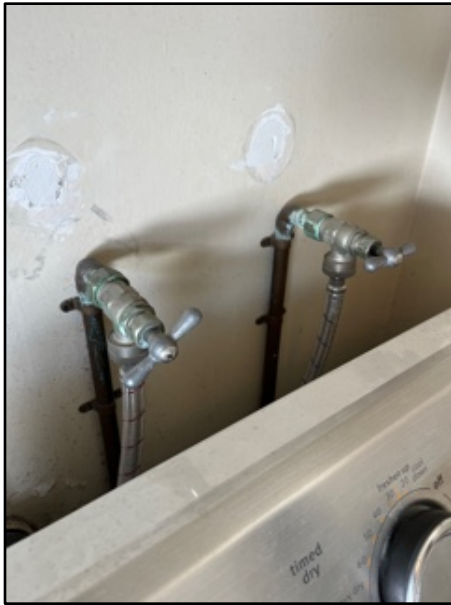
Figure 57-1

The washer hook up valves are free of leaks.

I recommend vacuuming, the dryer vent of lint and debris.

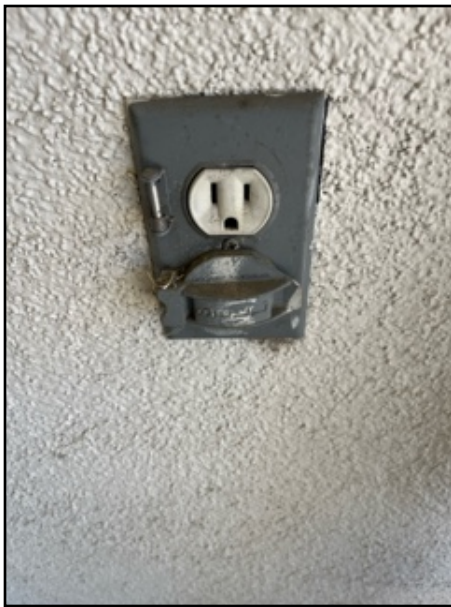
Figure 69-1

The front porch electrical outlet is missing its weather resistant cover plate.
The outlet is not GFCI protected.

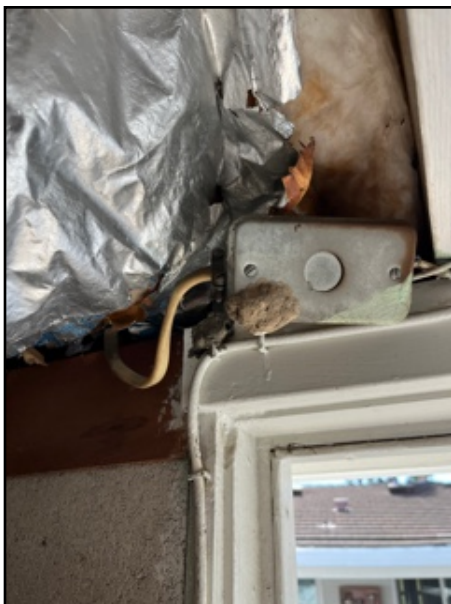
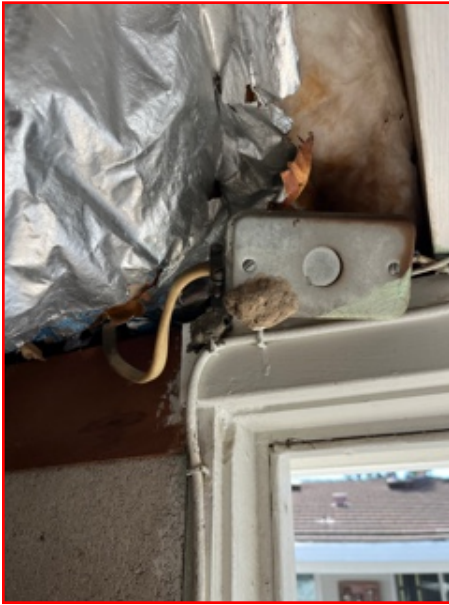
Figure 71-1

Comment 71:
At the rear of the garage, there is a storage shed that has electrical romex wiring exposed and not in conduit.
The old light fixture is in need of repair.

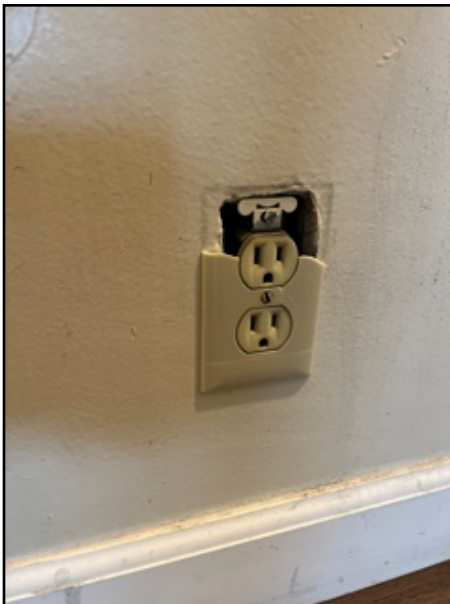
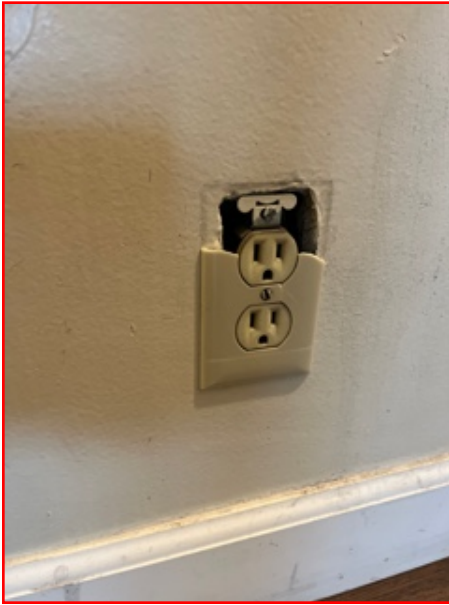
Figure 73-1

The bedroom hall outlet cover plate is broken.

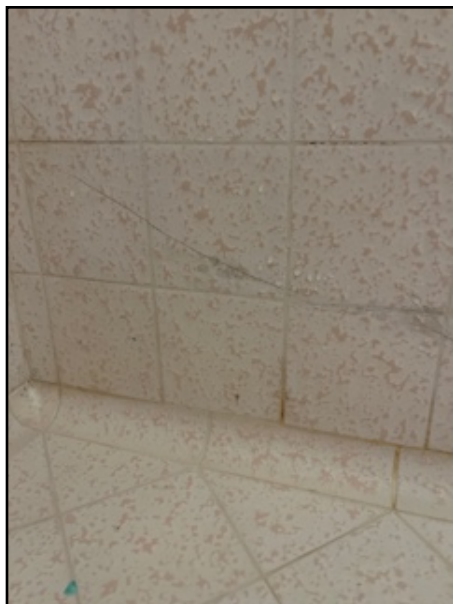
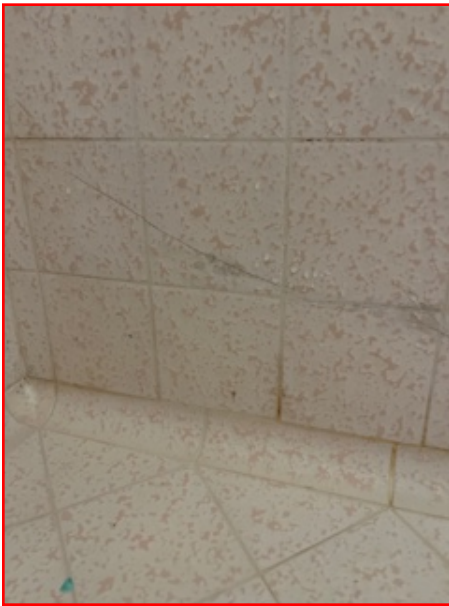
Figure 83-1

The master bathroom, shower tiles show cracks that have been sealed with caulking.

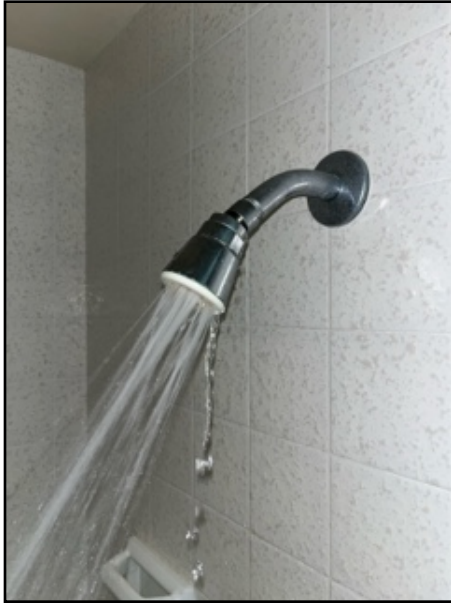
Figure 85-1

The hall bathroom showerhead is leaking at the gooseneck fitting.

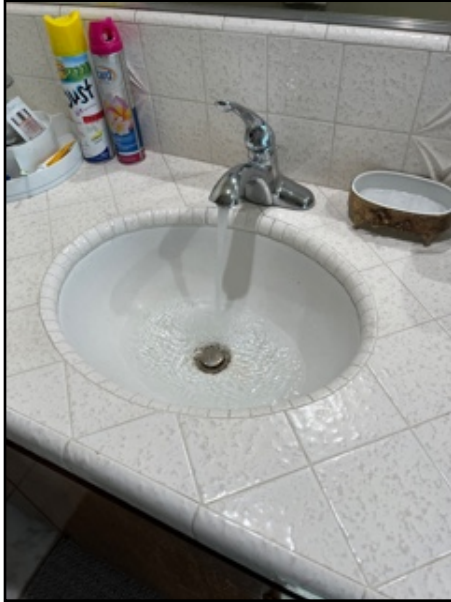
Figure 88-1

The hall bathroom left side sink drains slowly. Drano is present below the sink cabinet. The waste line pipe is heavily corroded and should be replaced.

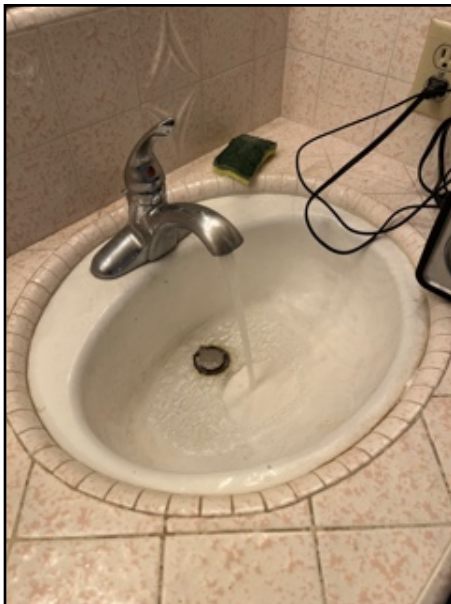
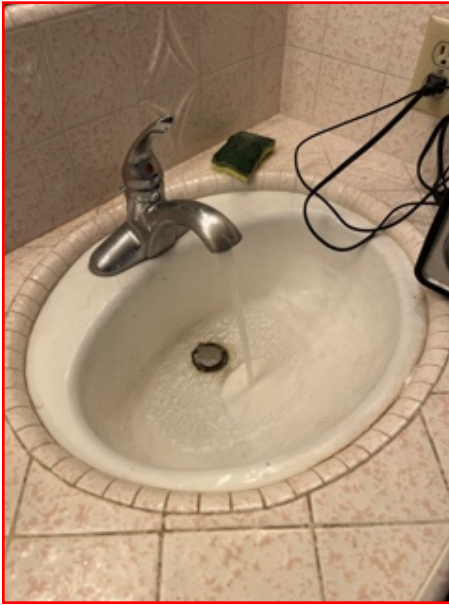
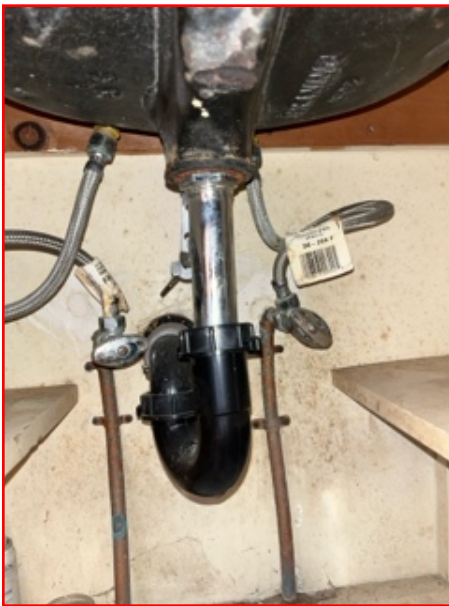
Figure 90-1

The master bathroom sink is draining slowly. The wasteline pipe appears free of leaks.

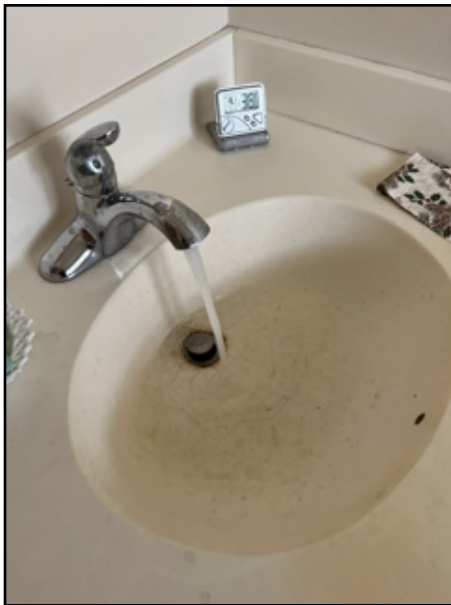
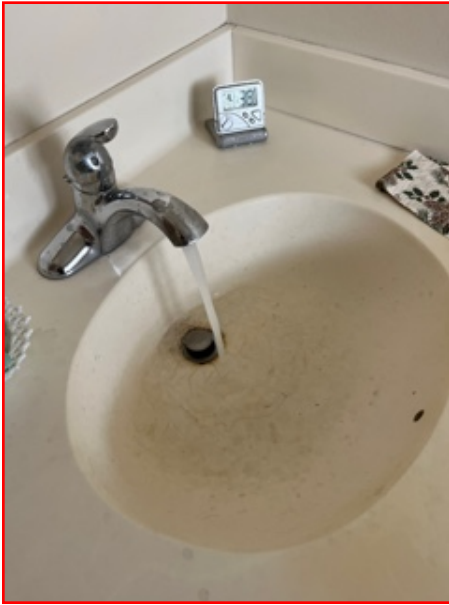
Figure 91-1

The half bathroom off of the laundry room shows cracks in the basin around the drain. Repairs are needed at this time.

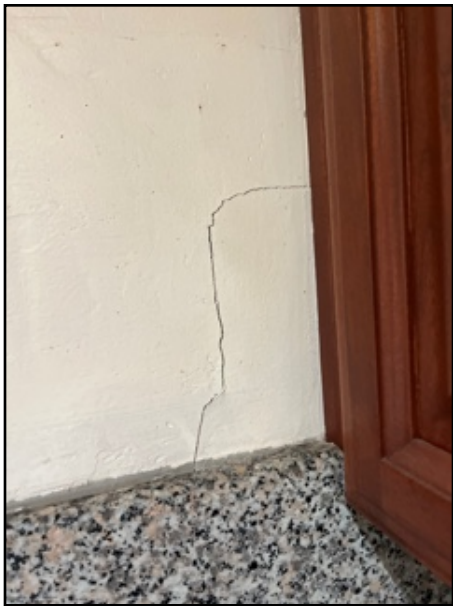
Figure 95-1

The kitchen walls show settling cracks.

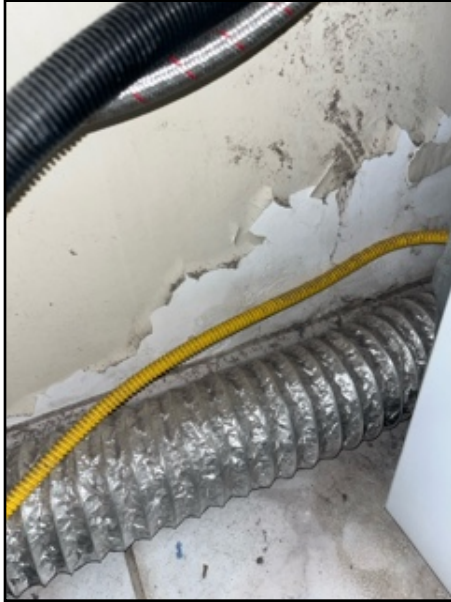
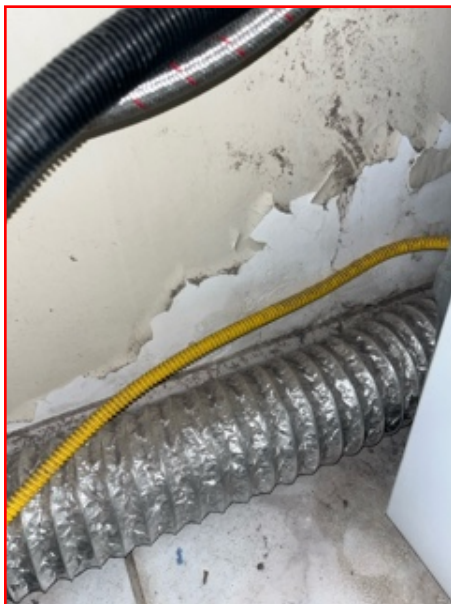
Figure 96-1

The laundry room wall shows paint peeling. This can be caused from humidity and heat from the dryer vent.

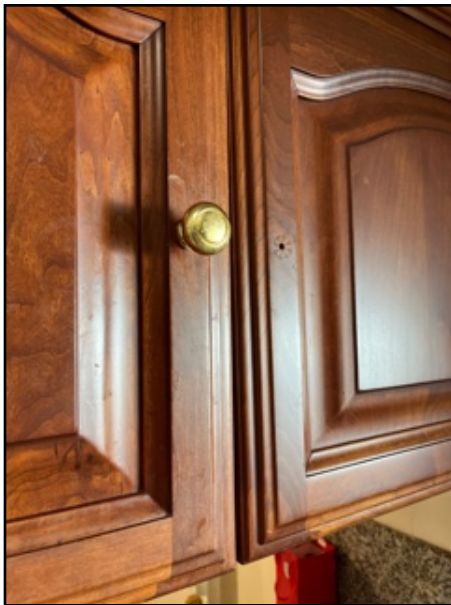
Figure 105-1

Cabinet pole knobs are missing. Adjustments are needed to the hinges.

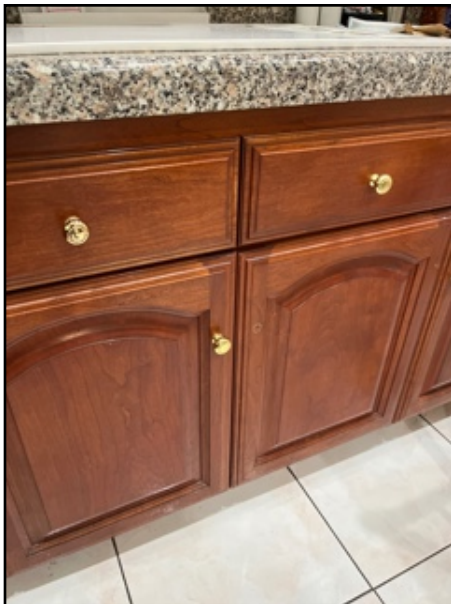
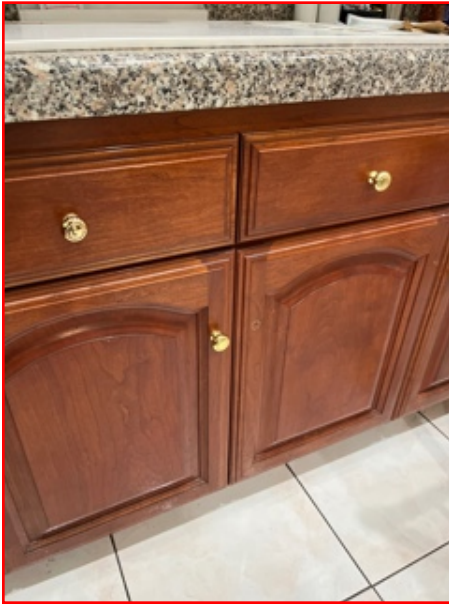
Figure 106-1

Comment 106:
Pull knobs are missing.

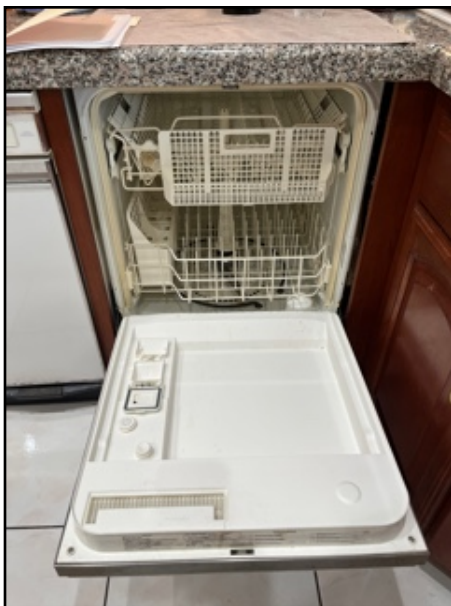
Figure 111-1

Comment 111:
The dishwasher does not operate.
I recommend replacing the dishwasher.

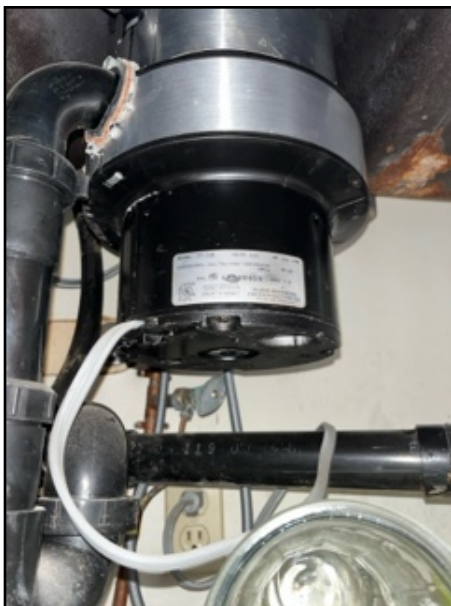
Figure 113-1

Comment 113:
The garbage disposal is noisy and should be replaced.

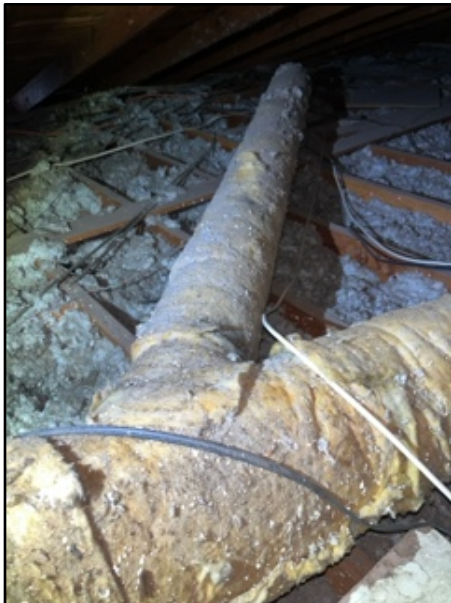
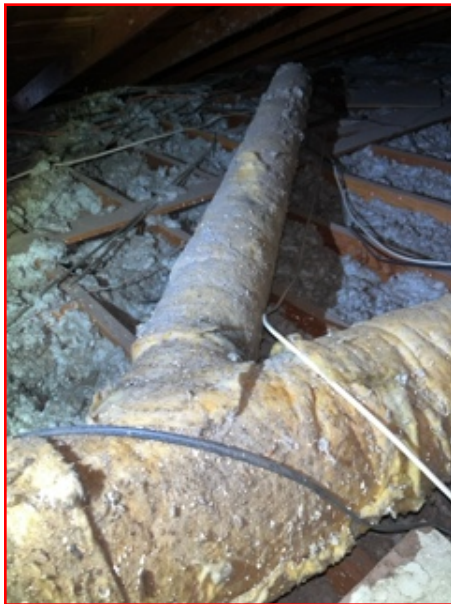
Figure 114-1

The heating ducts in the attic are sheet metal with insulation wrapped around them.

One or two of the heating ducts are missing its insulation.

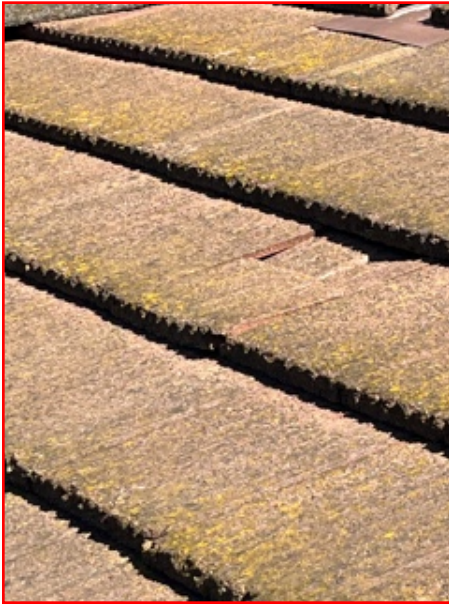
Figure 34-3

16) There are several broken tiles at the left side of the house near the valley area.

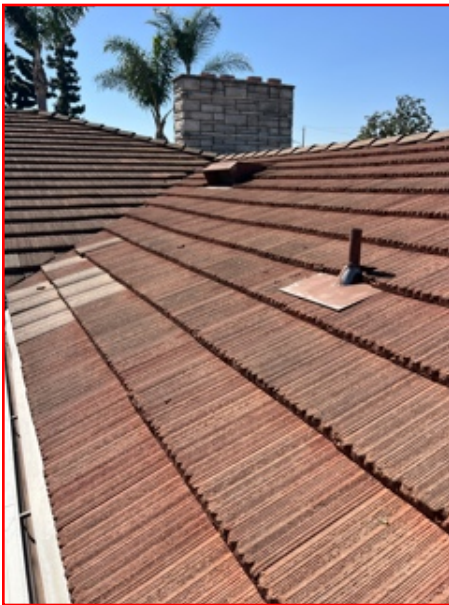
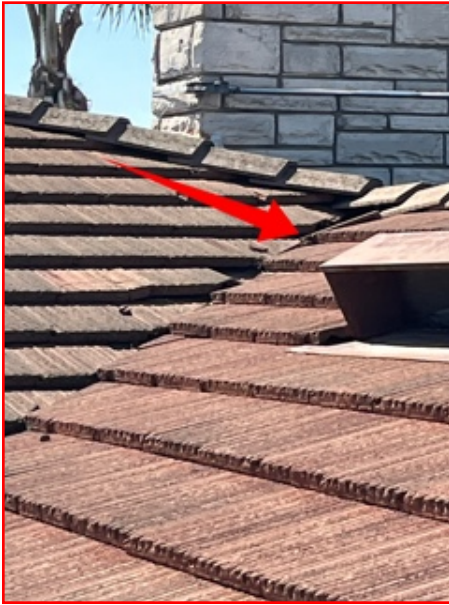
Figure 35-1

17) The rear roof shows broken roof tiles.

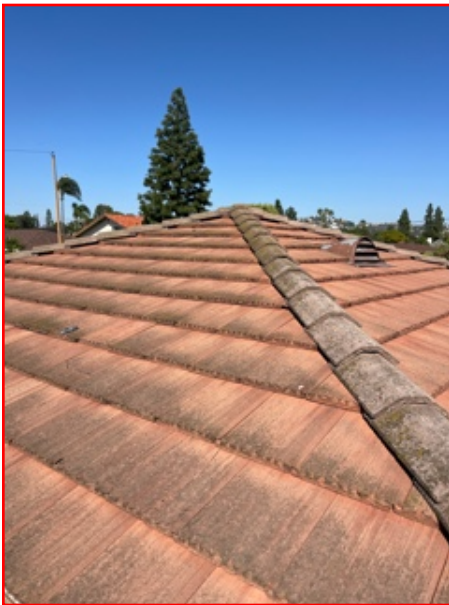
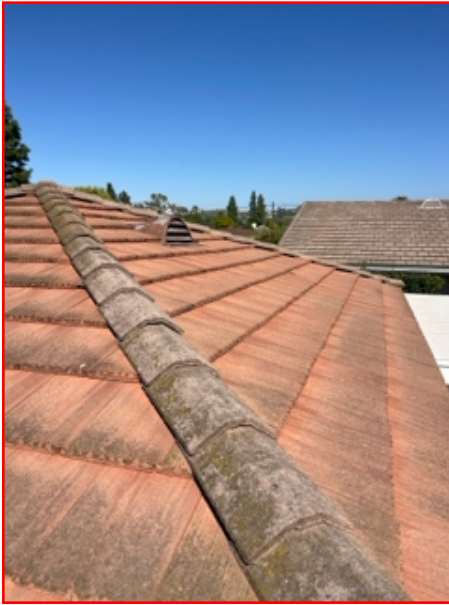
Figure 36-1

18) The garage roof also shows broken roof tiles.

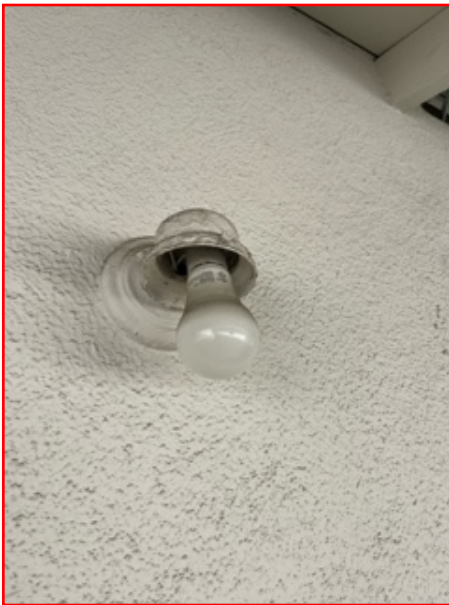
Figure 72-1

35) The laundry porch light does not have a glass globe.

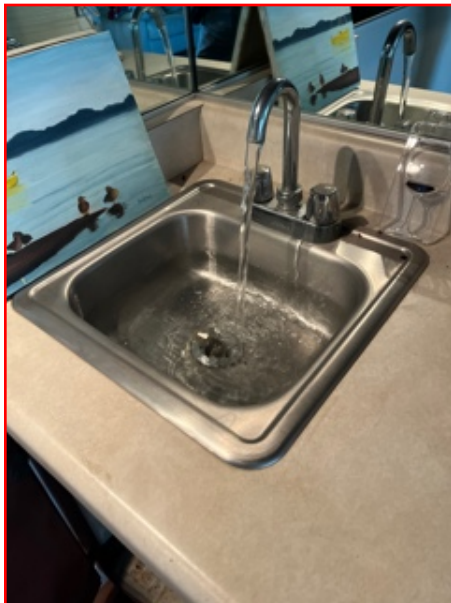
Figure 100-1

54) The family room wet bar is operating. Water is leaking at the control valve handles. No visible leaks under the sink at the wasteline pipes. Under the wet bar in the cabinet, there is rodent droppings. There are holes in the wall that should be sealed to keep rodents out.
