## Home Inspection Report

Prepared exclusively for  
**Jim Graser**

PROPERTY INSPECTED:  
**11821 Raspberry Lane**  
**Oak Glen, CA 92399**

**Date of Inspection: 01/12/2026**

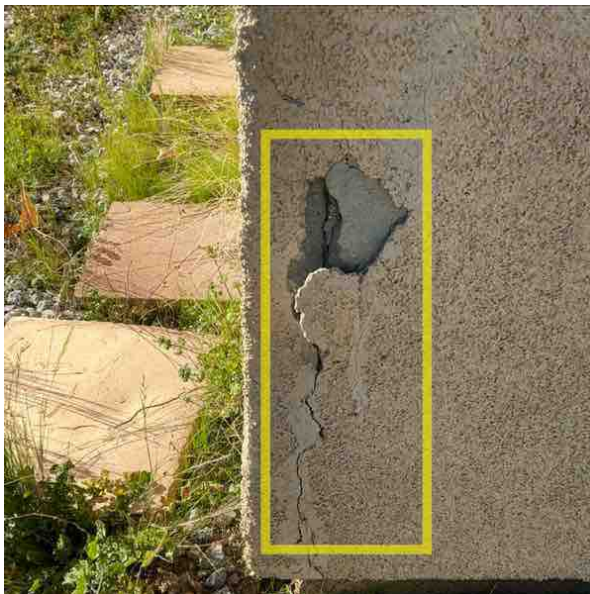
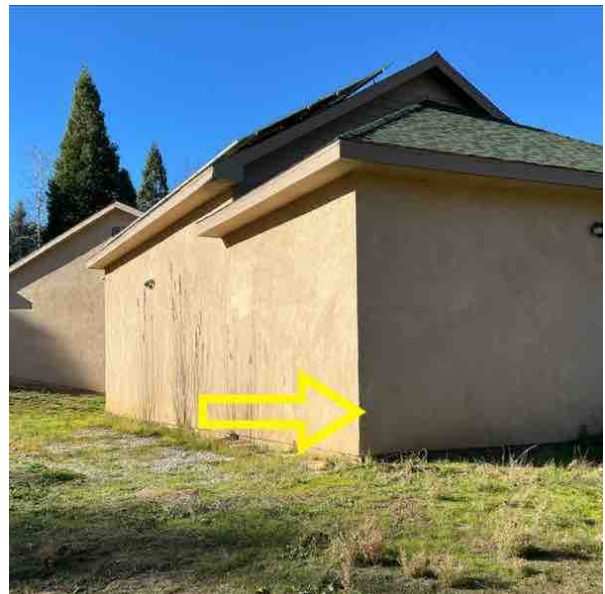
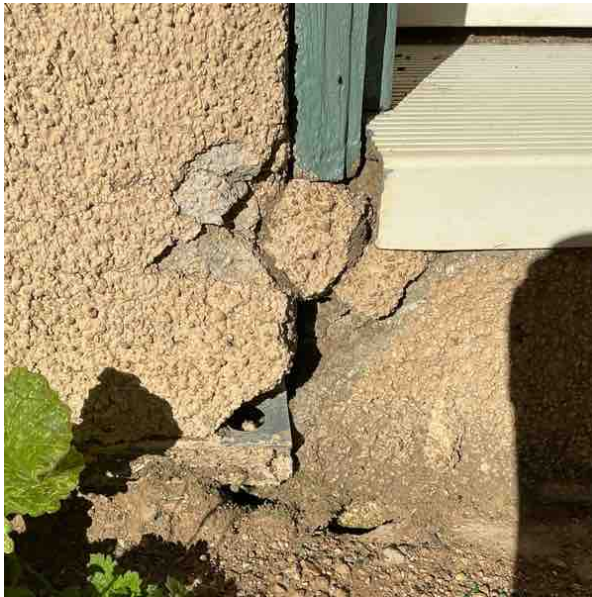
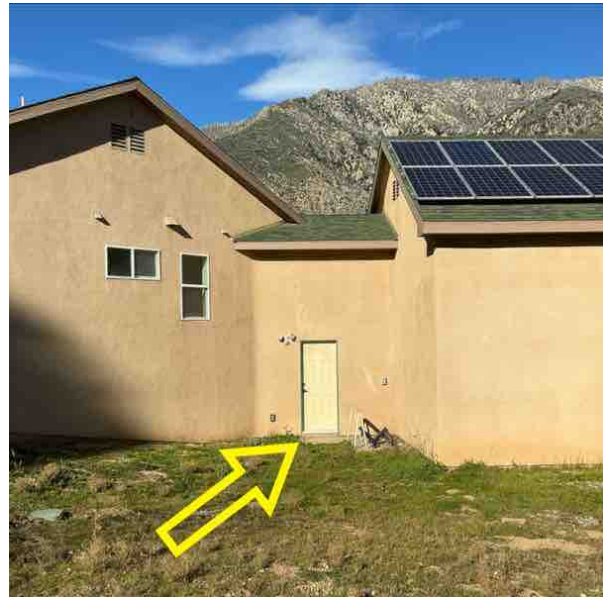
- Exterior Left
- Garage exterior left

##### 3.2.2 STUCCO – DAMAGE OBSERVED

Stucco damage was observed at exterior surfaces. Conditions may include cracking, chipping, or missing material, which can reduce durability, compromise appearance, and allow moisture intrusion if not corrected.

Have a qualified contractor evaluate the damaged areas and perform appropriate repairs to help restore the stucco's protective function and maintain exterior integrity.

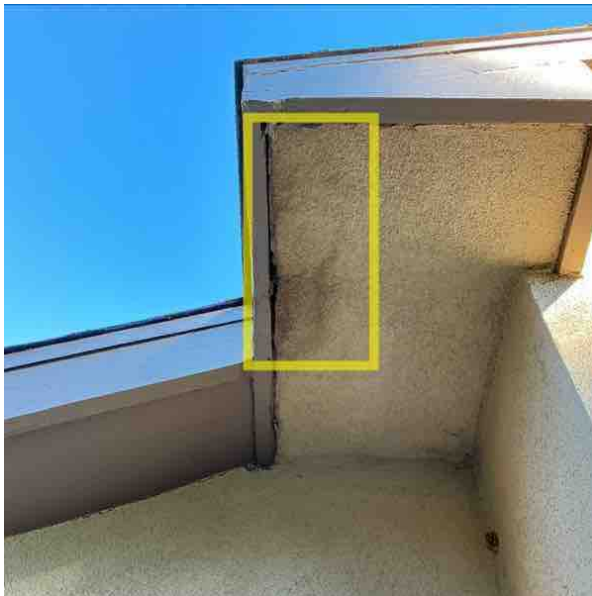
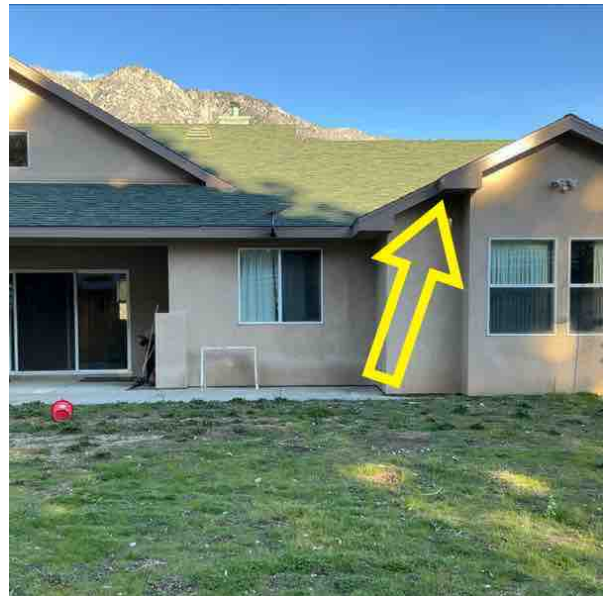
#### 3.3.1 STUCCO STAINING – EAVE AREA

Visible staining was noted on the stucco surface at the eave area. This may be related to roof runoff, moisture exposure, or typical weathering. The exact source was not confirmed during the inspection.

A qualified exterior or stucco contractor should evaluate the stained area and address any underlying moisture or drainage issues as needed. Cleaning or refinishing may be recommended to restore appearance and support a market-ready presentation. **(Exterior Back)**

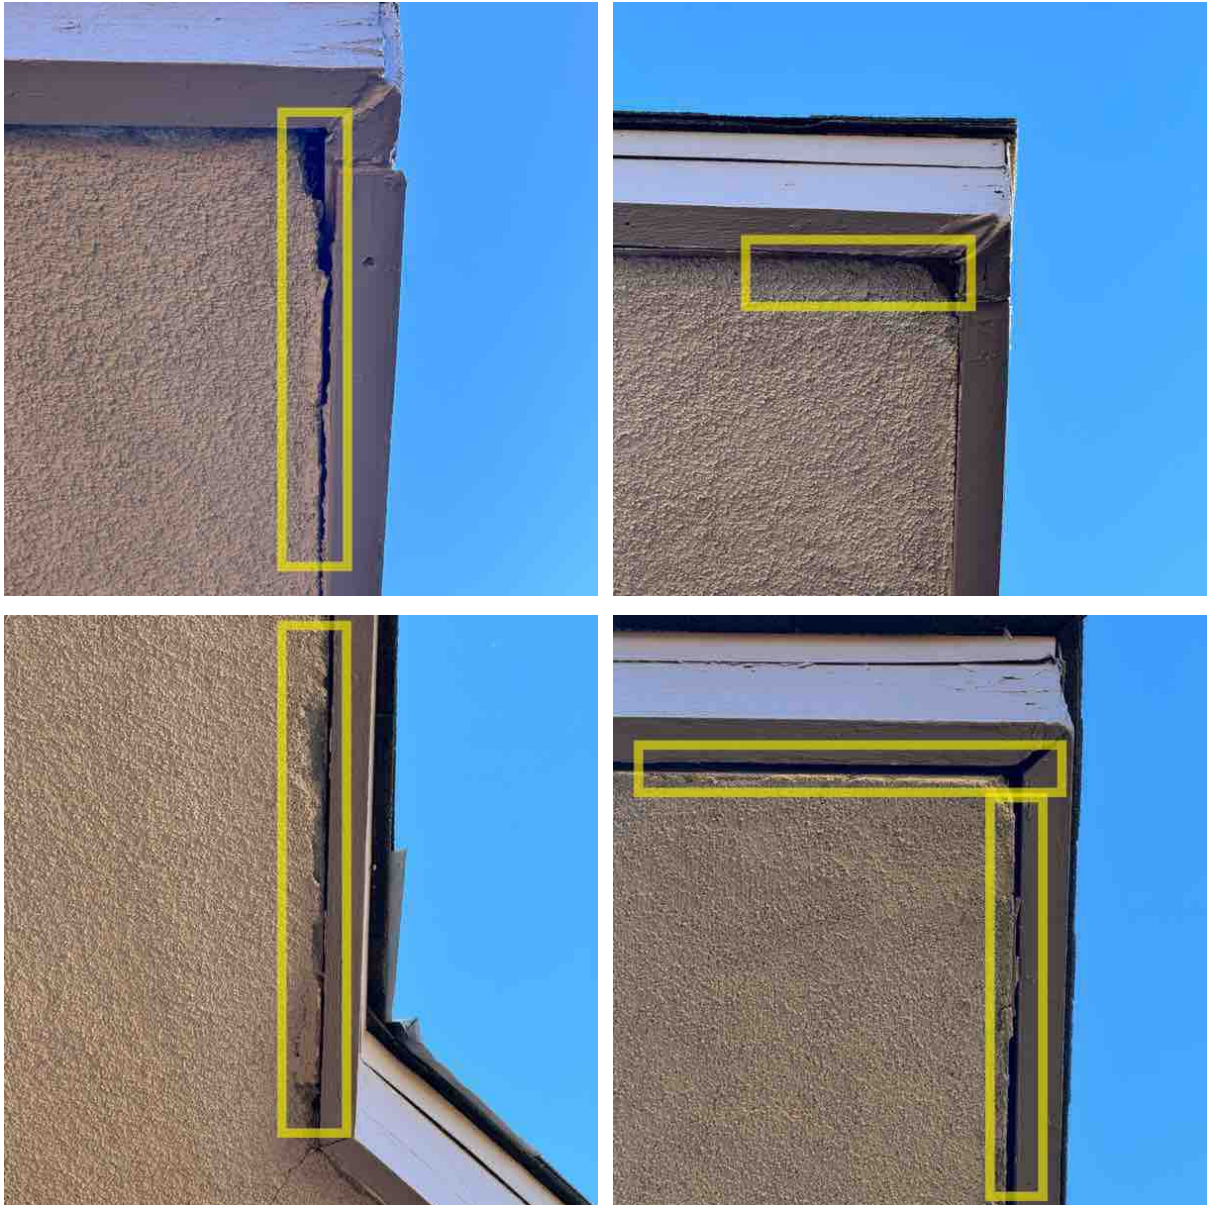
### 3.3.2 EAVES & FASCIA TRANSITIONS – SEPARATIONS AND MATERIAL LOSS

Separations and areas of material loss were observed at the eaves and fascia transitions throughout the exterior. These conditions may allow pest entry, contribute to further deterioration if not addressed, and can affect overall market-readiness.

A qualified contractor should evaluate the eaves and fascia transitions, repair or replace damaged materials, and address any contributing conditions to help prevent continued deterioration and support a market-ready presentation.

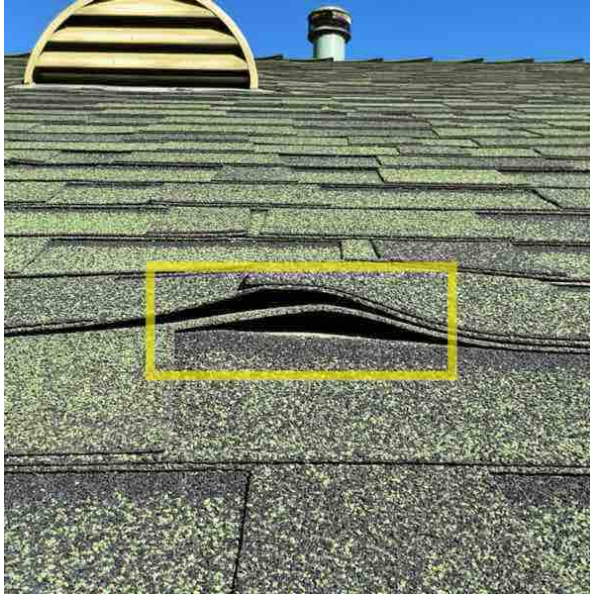
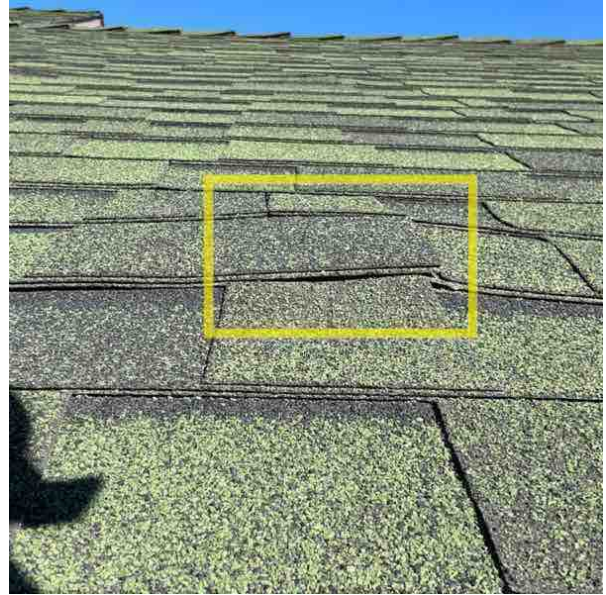
Several roofing fasteners are pushed up, creating raised points along the roof surface. This condition can compromise the shingle or tile seal, reduce wind resistance, and increase the potential for moisture intrusion.

A qualified roofing professional should secure or replace the affected fasteners and restore proper sealing of the roof covering. Further evaluation of the surrounding materials is advised to confirm no additional damage has occurred. **(Roof)**

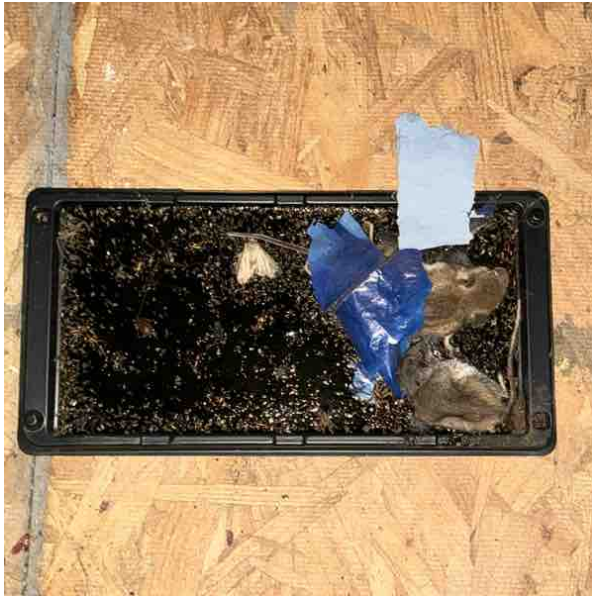
#### **(Garage Attic)**

### 5.3.2 DEAD RODENTS OBSERVED

Dead rodents were observed in the attic. This condition indicates past or possibly ongoing rodent activity and may contribute to sanitation concerns, insulation disturbance, or potential entry-point issues.

A qualified pest control contractor should evaluate the attic, remove the rodents, and determine whether active activity or entry points remain. Any affected insulation or materials should be repaired or replaced as needed.

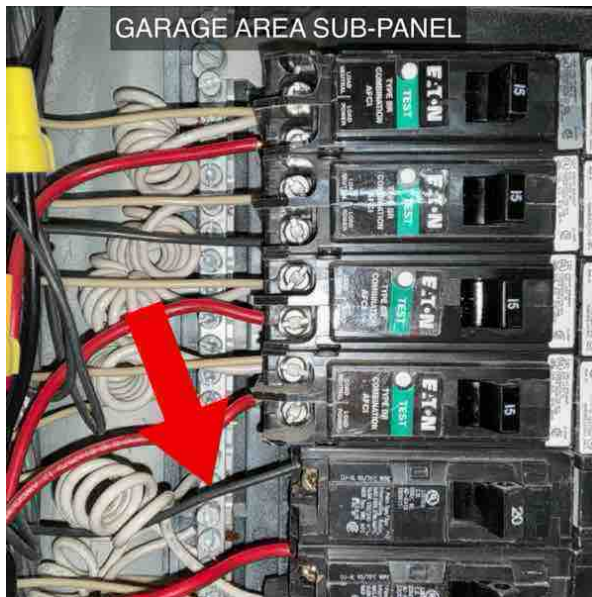
**(Garage)**

**7.6 Sub-Panel(s)****7.6.1 BREAKER / UNDERSIZED CONDUCTOR****Observation:**

A 20-amp breaker appears to be serving an undersized conductor. This mismatch occurs when the wire gauge is not appropriately rated for the breaker's overcurrent protection, which may create a safety concern and does not align with common installation standards. This condition can also affect overall market-readiness.

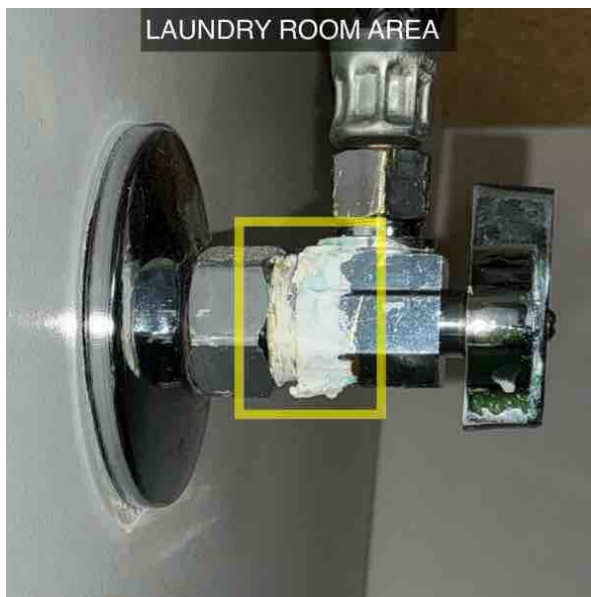
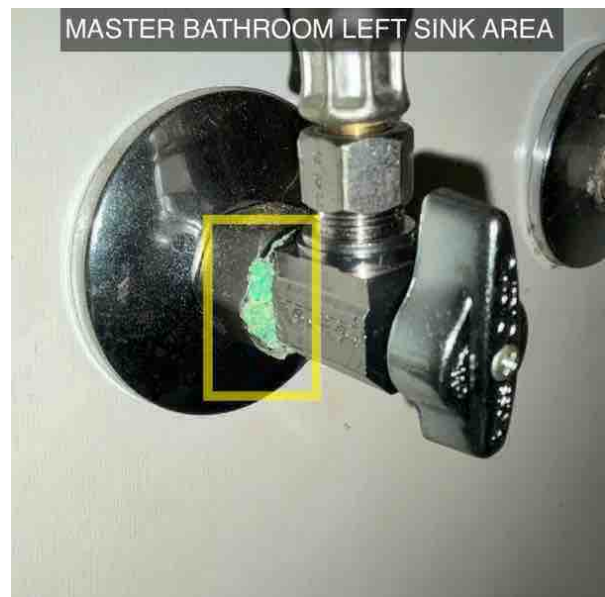
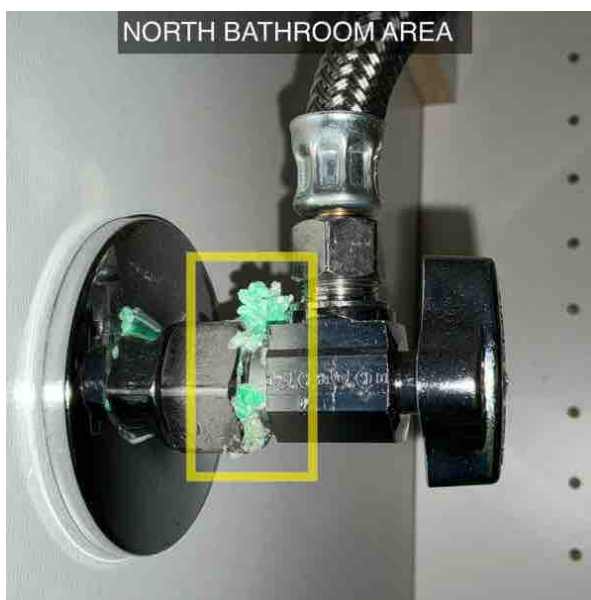
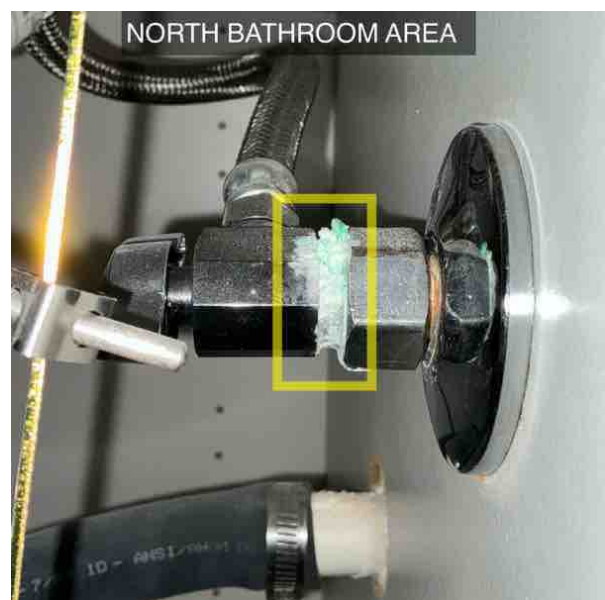
- Laundry Room
- North Bathroom
- Primary Bathroom

### 9.1.3 UNDER-SINK SHUT-OFF VALVE – EVIDENCE OF LEAKAGE

Mineral encrustation was noted on the water shut-off valve under the sink. This condition may indicate a slow past or present leak or mineral buildup from prolonged moisture exposure. The condition warrants further evaluation to confirm whether active leakage is occurring and may affect overall market-readiness.

A qualified plumber should evaluate the shut-off valve, clean the affected area, and repair or replace the valve if leakage or deterioration is confirmed. Correction will help ensure proper function and support a market-ready presentation.

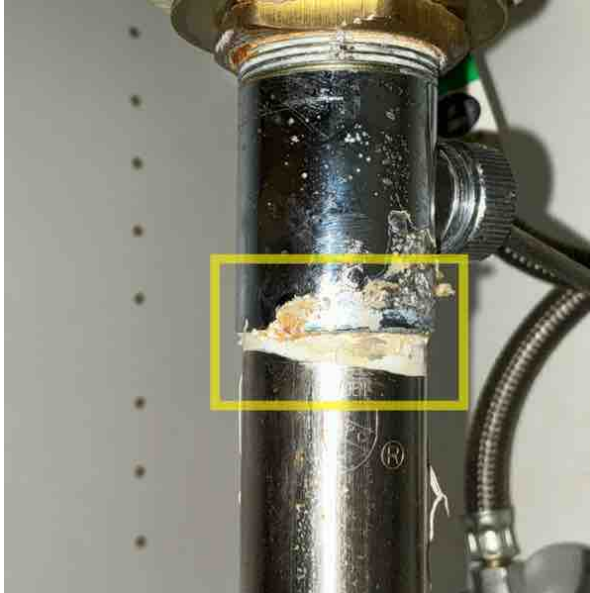
**9.2 Drain, Waste, and Vent Piping****9.2.2 DRAIN LINE PLUMBING LEAK****Observation:**

A leak was observed underneath the left sink area, which may indicate a faulty connection, deteriorated seal, or other plumbing-related issue.

Further evaluation by a qualified plumber is recommended to determine the source of the leak and assess necessary repairs. Prompt attention will help prevent potential water damage and maintain proper plumbing functionality. **(Primary Bathroom)**

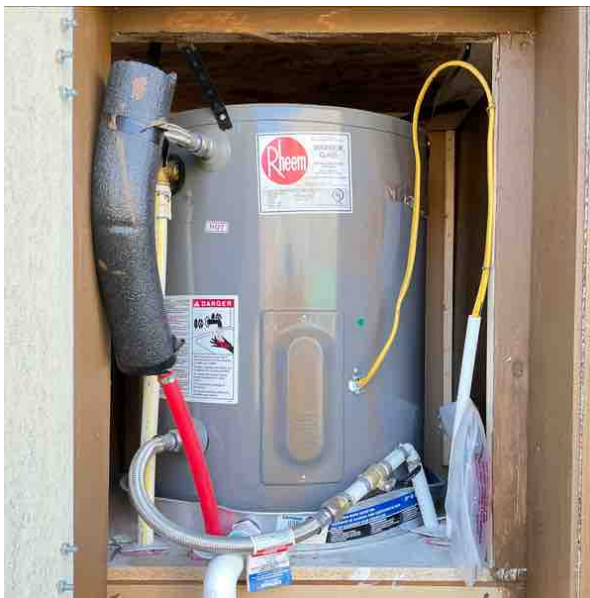
#### 9.3.1 ELECTRIC WATER HEATER – MULTIPLE INSTALLATION DEFICIENCIES

Multiple installation deficiencies were observed at the electric water heater.

- The temperature-and-pressure (T&P) relief valve termination was not visible, preventing confirmation that it discharges to an approved location.
- The drip pan drains directly into the crawlspace, which is not a standard or approved discharge method and may contribute to moisture-related issues.
- Seismic bracing was installed improperly and does not meet typical installation expectations.

A qualified plumbing contractor should evaluate the electric water heater installation, provide a visible and properly terminated T&P discharge line, reroute the drip pan drain to an approved location, and reinstall seismic bracing to meet typical standards. Corrections will help ensure safe operation and support a market-ready presentation. **(Guest house east exterior)**

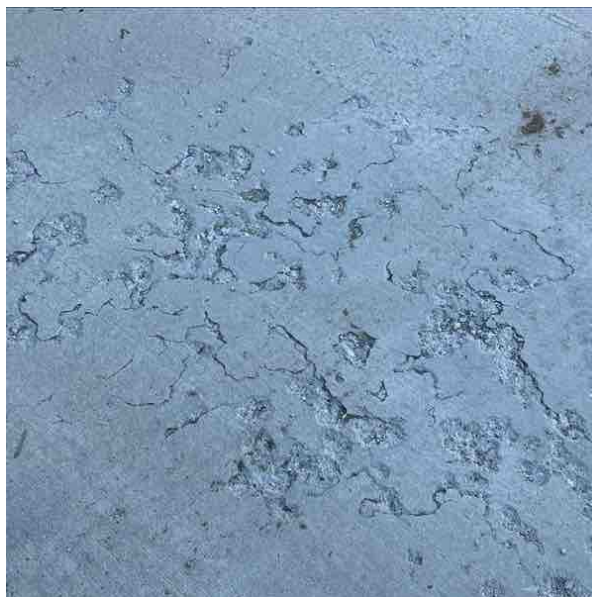
**2.1.1 CONCRETE SURFACE CONDITION****Observation:**

Minor cracks and surface wear were observed in the concrete. These conditions are typical and did not indicate immediate structural concerns at the time of inspection, though they may affect overall market-readiness if deterioration progresses.

Monitor for widening, deepening, or signs of moisture intrusion over time. If deterioration advances, targeted repairs may be needed to maintain surface integrity and support a market-ready presentation.

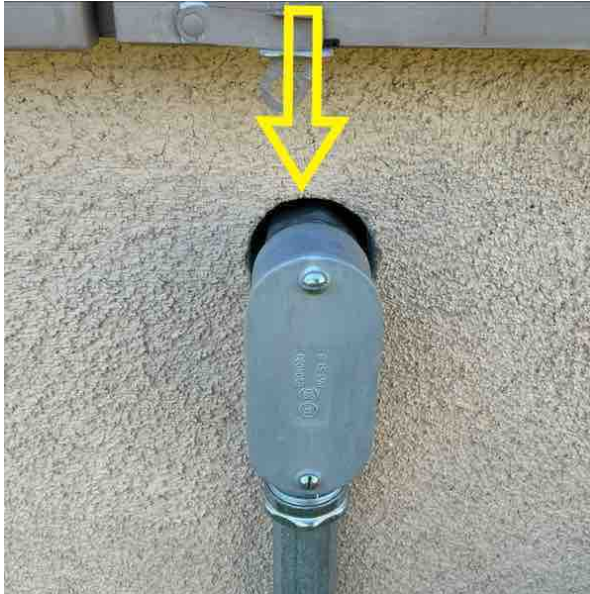
**3.1 Exterior General Comments****3.1.1 SEALING NEEDED AT CONDUIT AND EXTERIOR WALL TRANSITION****Observation:**

General sealing improvements are needed at transitions between an electrical conduit and the exterior wall surface. Gaps may allow moisture intrusion and reduce overall weather resistance.

Have a qualified contractor apply appropriate exterior-rated sealant at the affected transitions to help ensure proper weather protection and limit the potential for moisture-related damage. **(Garage exterior left)**

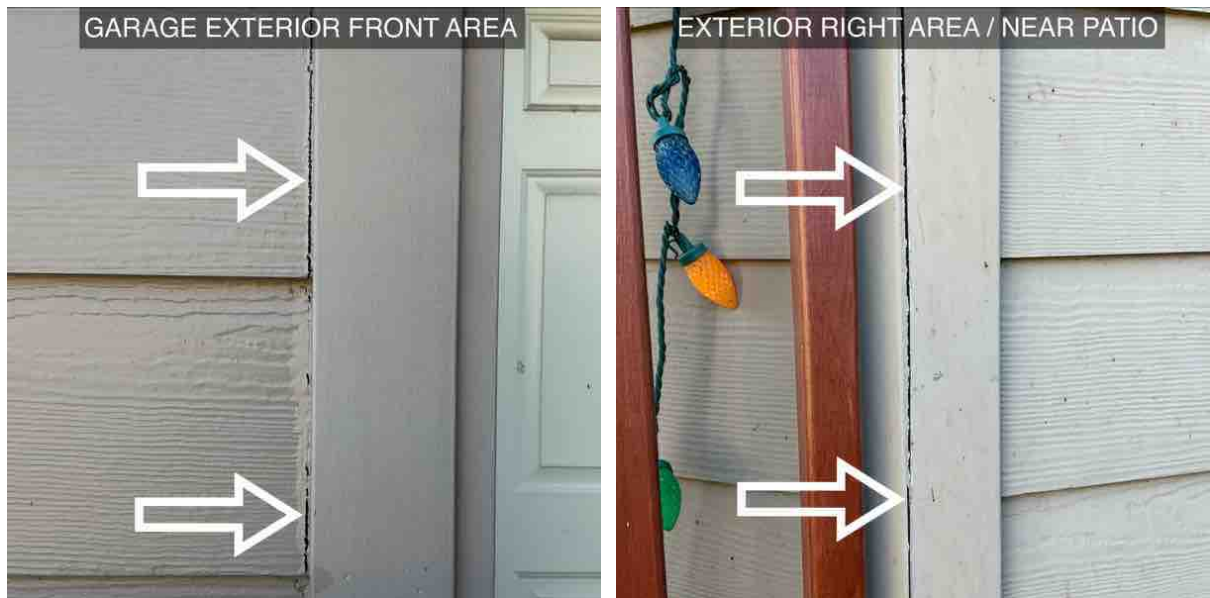
- Exterior Right
- Garage exterior front

### 3.1.2 SEALING NEEDED AT WINDOW, TRIM, AND SIDING TRANSITIONS

General sealing improvements are needed at transitions between the window assemblies, adjacent trim, and surrounding siding. Gaps or deteriorated sealant at these locations may allow moisture intrusion and reduce overall weather resistance, and can affect overall market-readiness.

A qualified contractor should apply appropriate exterior-rated sealant at the affected transitions to help ensure proper weather protection, limit the potential for moisture-related damage, and support a market-ready presentation.

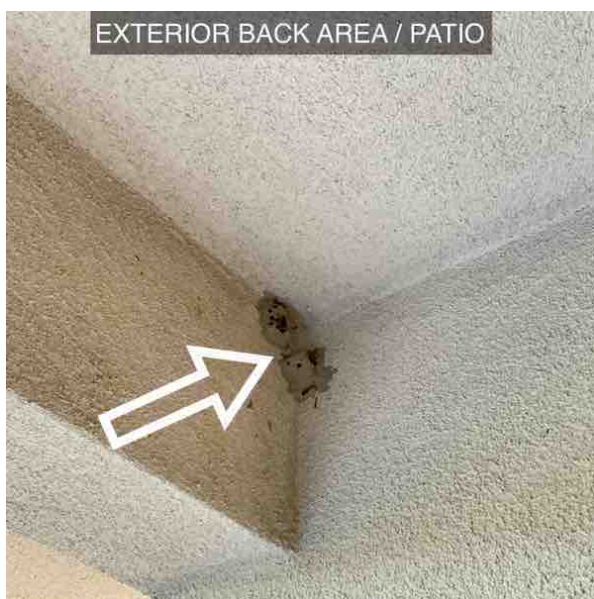
### 3.1.3 INSECT NEST

Insect nests resembling those of mud daubers were noted. Mud dauber wasps construct their nests from mud and are generally not aggressive. However, abandoned mud dauber nests are often repurposed by more aggressive wasp species.

Recommend removal by a licensed pest control professional to mitigate potential risks and prevent further insect activity.

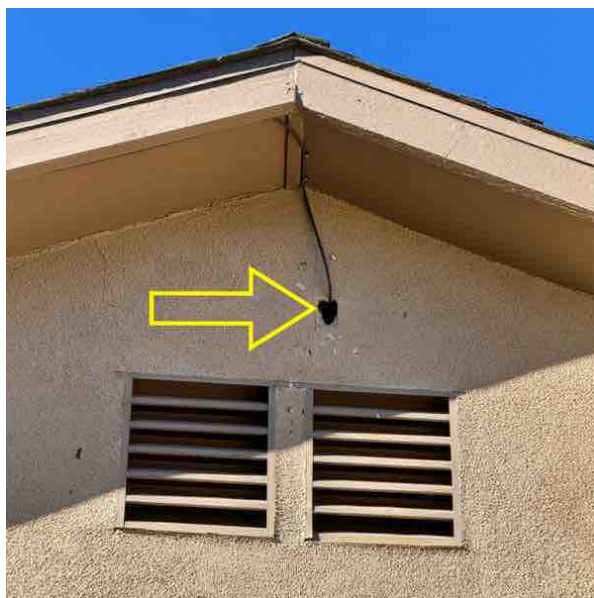
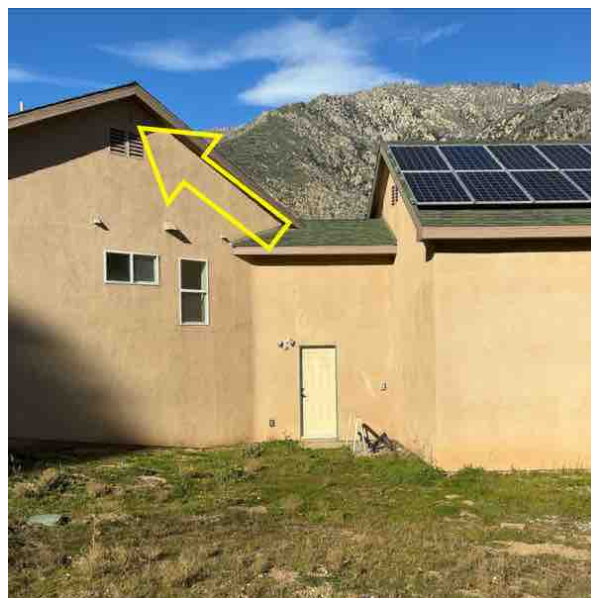
### 3.1.4 LOW-VOLTAGE COVER PLATE – MISSING

A low-voltage cover plate is missing, leaving an opening that could allow moisture and pest intrusion into the attic. This condition does not align with typical installation standards and may affect overall market-readiness.

A qualified contractor should install an appropriate cover plate to seal the opening and help prevent moisture and pest intrusion, supporting safe conditions and a market-ready presentation. **(Exterior Left)**

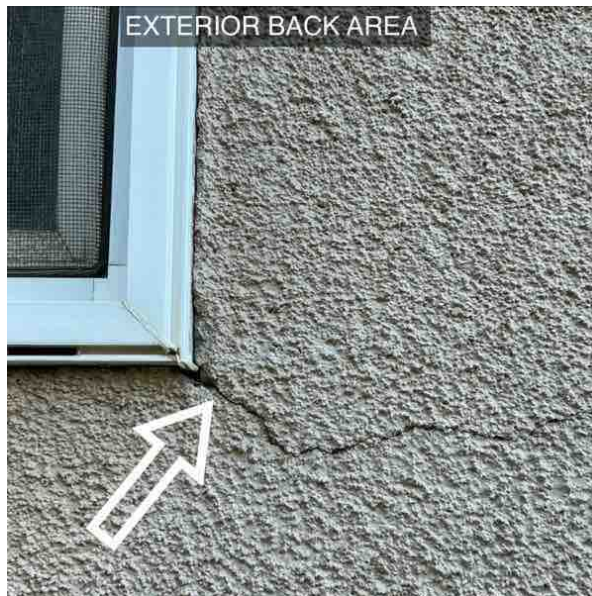
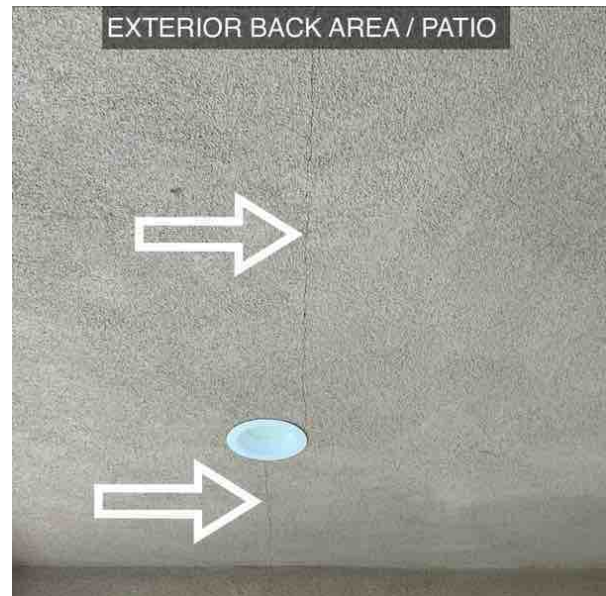
#### 3.2.1 STUCCO CEMENTITIOUS HAIRLINE TO MODERATE CRACKS

Hairline to moderate cracks were observed in the cementitious exterior finish. These conditions are commonly associated with thermal expansion, minor settling, or age-related wear. No signs of active moisture intrusion were noted at the time of inspection, and such surface cracking is typically not indicative of structural concerns. The condition may affect overall appearance and market-readiness.

A qualified exterior or stucco contractor should evaluate the cracked areas and perform sealing or cosmetic repairs as needed to maintain the finish, reduce the potential for future moisture intrusion, and support market-ready presentation.

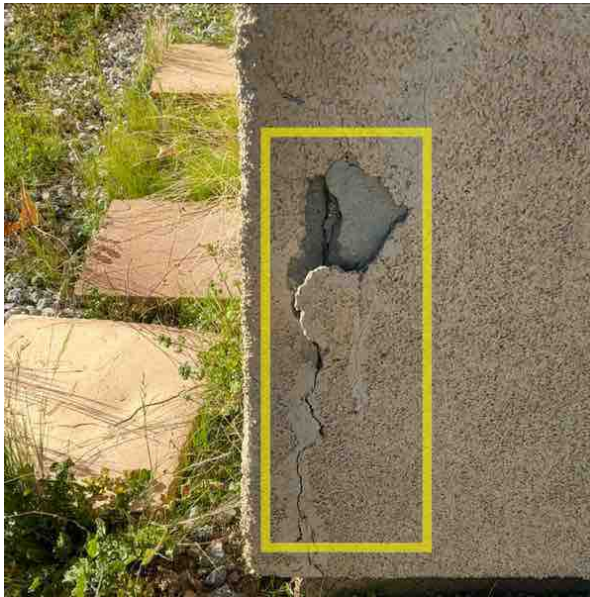
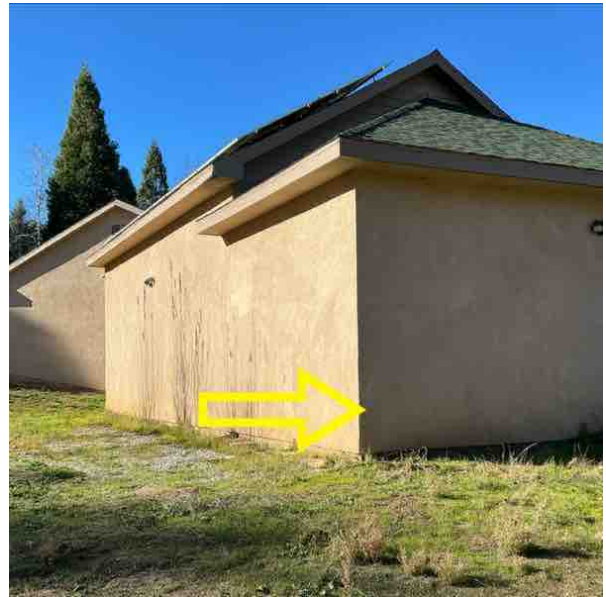
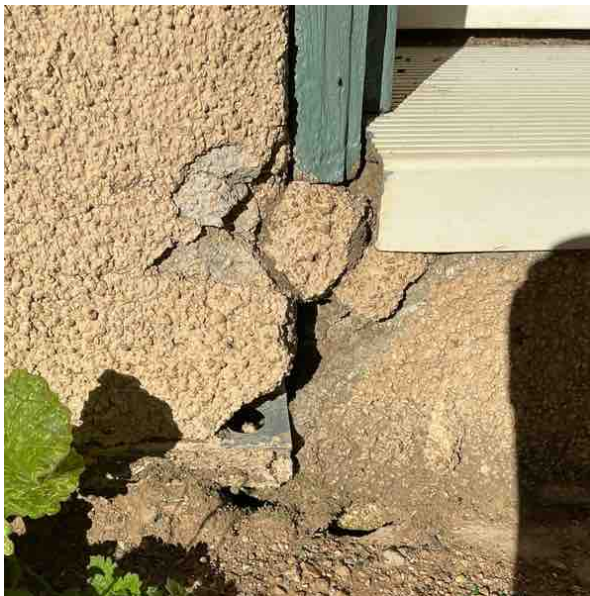
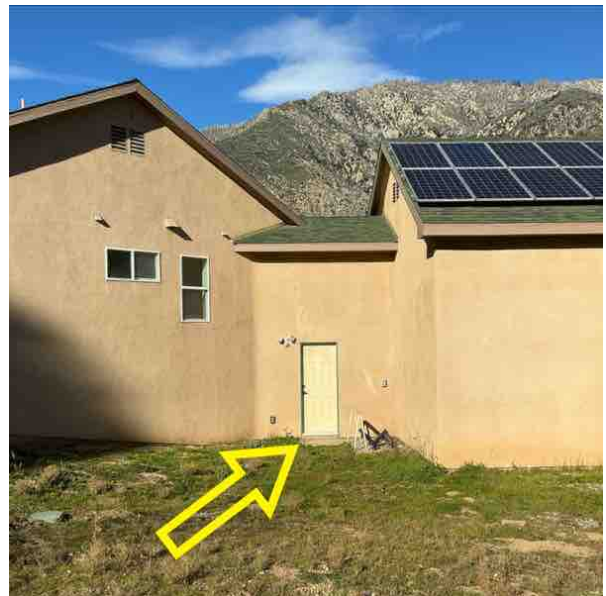
- Exterior Left
- Garage exterior left

### 3.2.2 STUCCO – DAMAGE OBSERVED

Stucco damage was observed at exterior surfaces. Conditions may include cracking, chipping, or missing material, which can reduce durability, compromise appearance, and allow moisture intrusion if not corrected.

Have a qualified contractor evaluate the damaged areas and perform appropriate repairs to help restore the stucco's protective function and maintain exterior integrity.

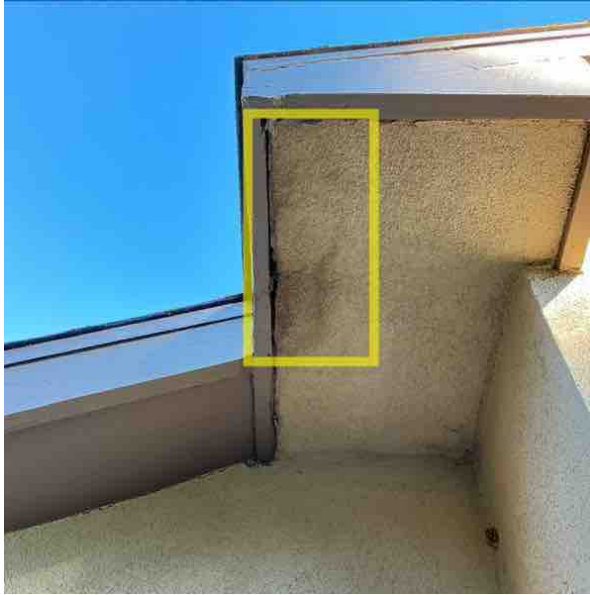
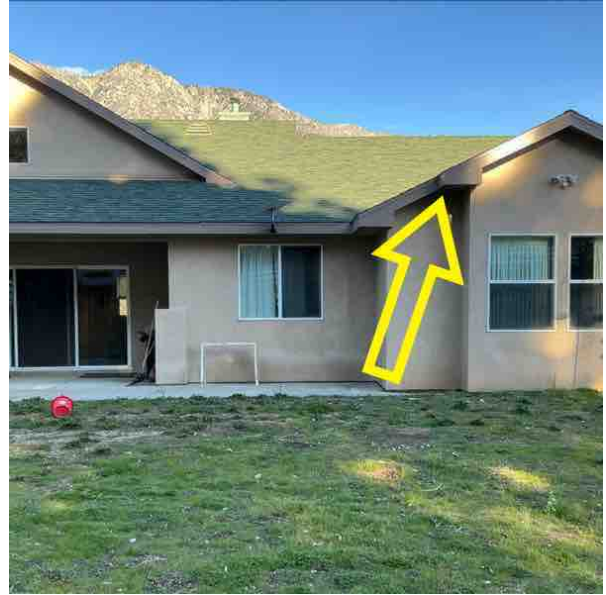
**3.3 Eaves / Fascia / Soffit****3.3.1 STUCCO STAINING – EAVE AREA****Observation:**

Visible staining was noted on the stucco surface at the eave area. This may be related to roof runoff, moisture exposure, or typical weathering. The exact source was not confirmed during the inspection.

A qualified exterior or stucco contractor should evaluate the stained area and address any underlying moisture or drainage issues as needed. Cleaning or refinishing may be recommended to restore appearance and support a market-ready presentation. (Exterior Back)

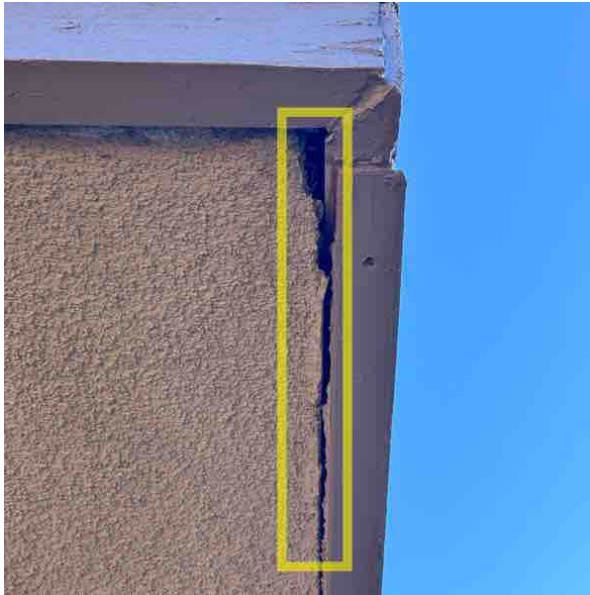
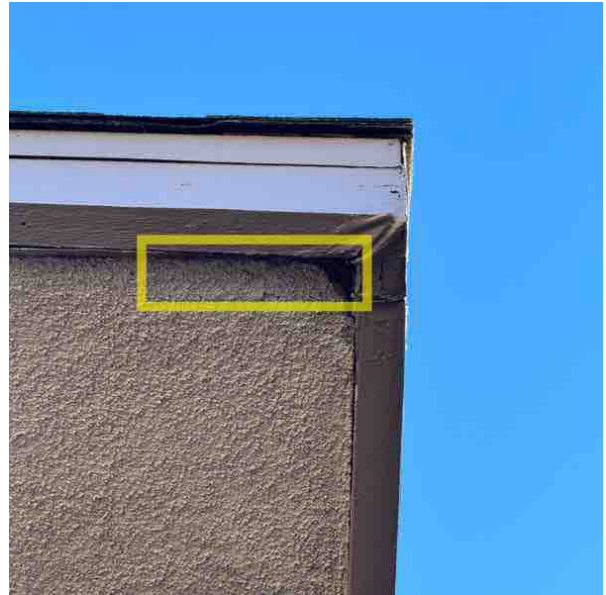
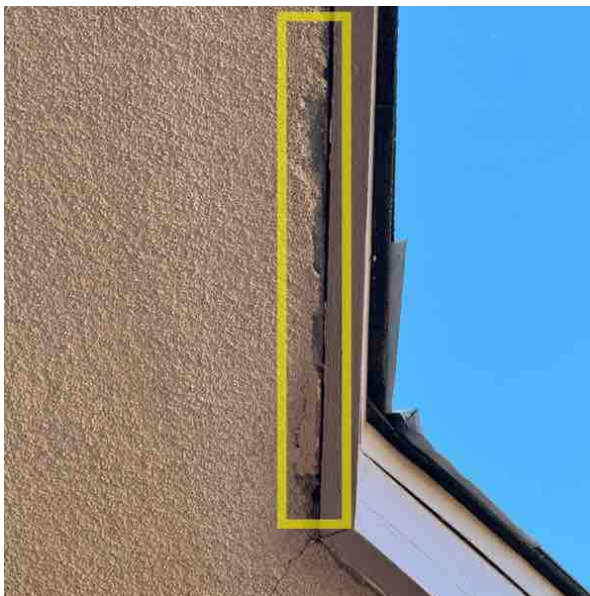
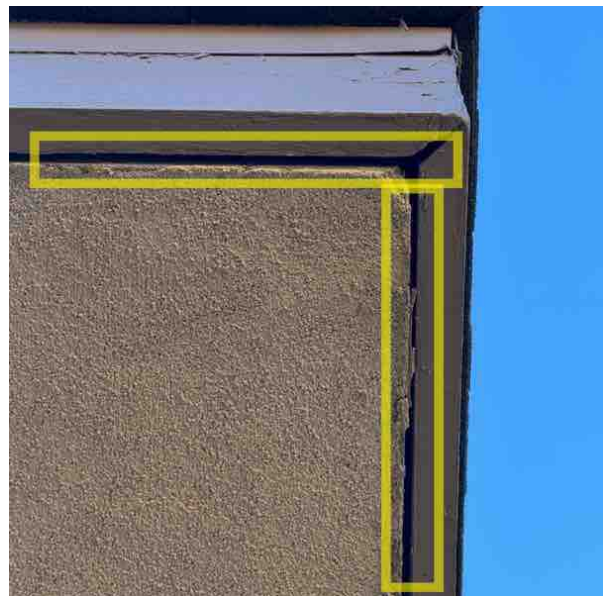
### 3.3.2 EAVES & FASCIA TRANSITIONS – SEPARATIONS AND MATERIAL LOSS

Separations and areas of material loss were observed at the eaves and fascia transitions throughout the exterior. These conditions may allow pest entry, contribute to further deterioration if not addressed, and can affect overall market-readiness.

A qualified contractor should evaluate the eaves and fascia transitions, repair or replace damaged materials, and address any contributing conditions to help prevent continued deterioration and support a market-ready presentation.

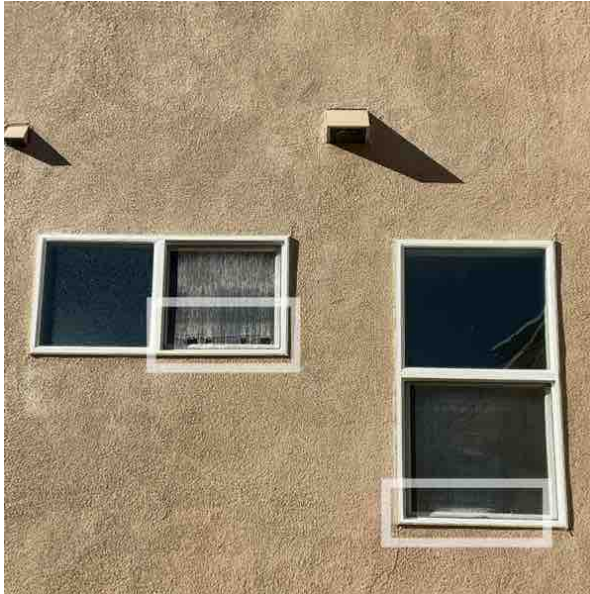
**(Exterior Left)**

#### 3.4.1 DAMAGED WINDOW SCREEN

One or more window screens were observed to be damaged, which may reduce ventilation efficiency and allow insect intrusion.

Repair or replacement of affected window screens is advised to restore functionality and maintain indoor comfort.

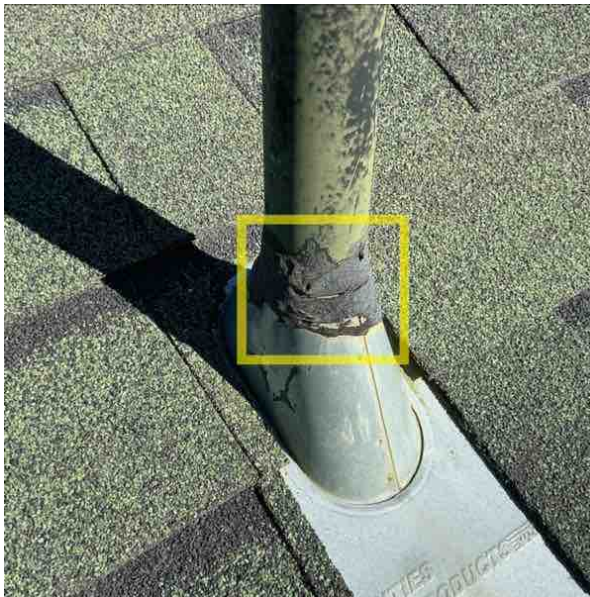
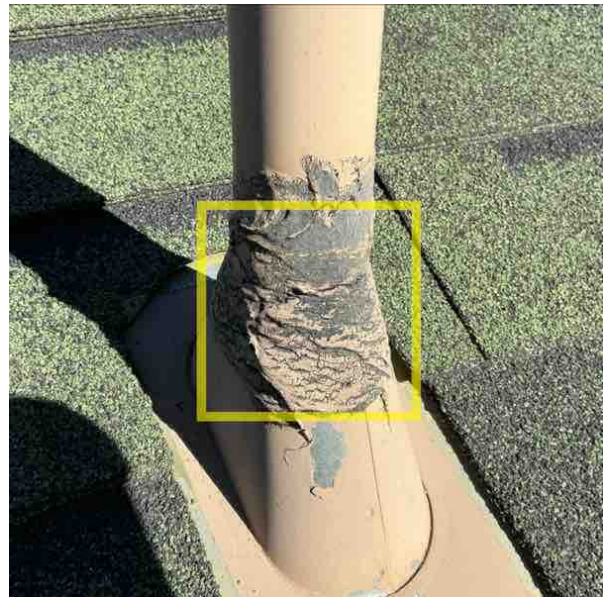
**(Roof)**

##### 4.4.1 SEALANT SEPARATION

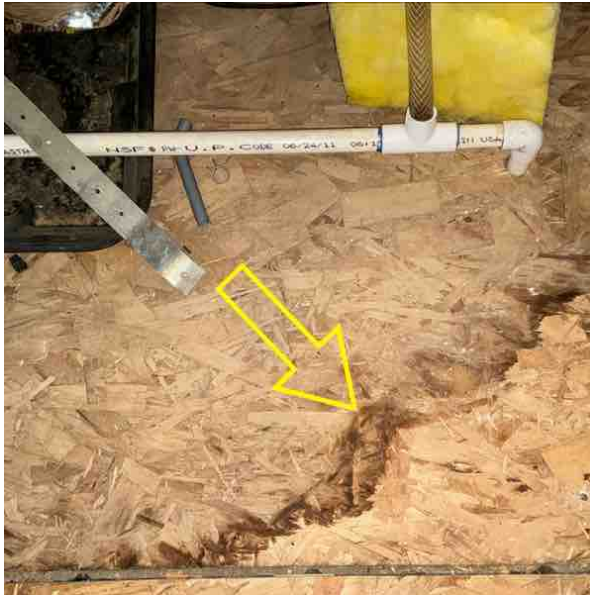
#### 5.3.1 HVAC SERVICE PLATFORM – MOISTURE STAINING

A qualified HVAC technician should evaluate the condensation drain system, confirm proper drainage, and correct any leaks or blockages. Repairs will help prevent further moisture intrusion and support a market-ready presentation. **(Attic)**

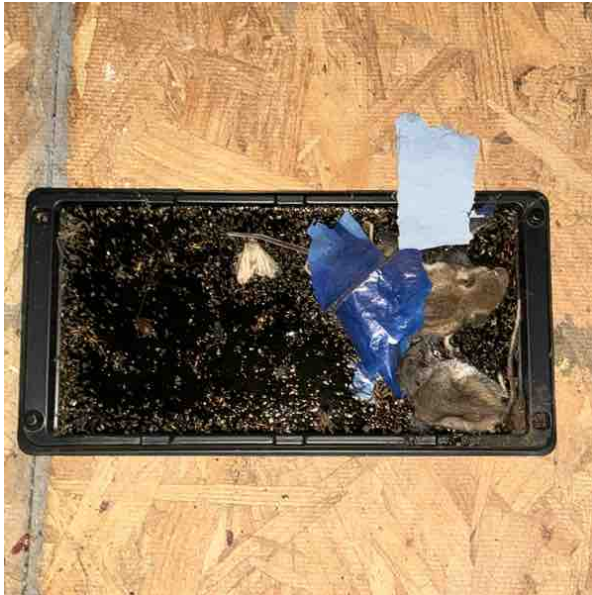
### 5.3.2 DEAD RODENTS OBSERVED

A qualified pest control contractor should evaluate the attic, remove the rodents, and determine whether active activity or entry points remain. Any affected insulation or materials should be repaired or replaced as needed. (Garage Attic)

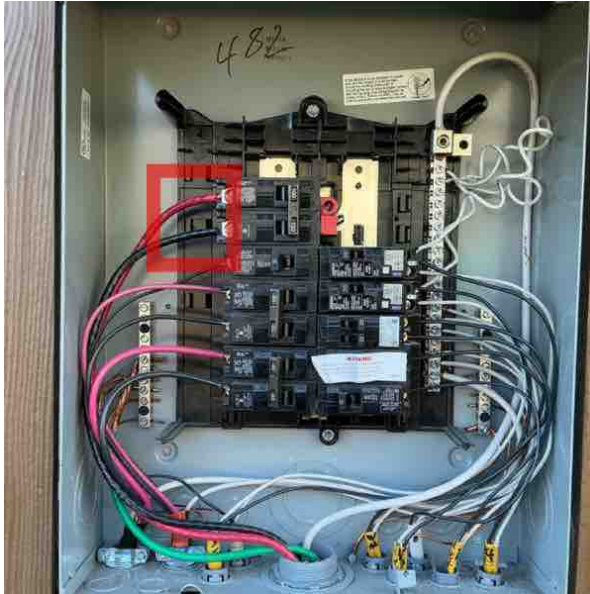
**7.6.2 SUB-PANEL FEEDER – UNDERSIZED CONDUCTORS OBSERVED****Observation:**

The sub-panel feeder was found to have 6-gauge conductors connected to a 100-amp breaker. This wire size is typically not rated for a 100-amp overcurrent device, creating an undersized-conductor condition that may pose a safety concern and does not align with common installation standards. Proper feeder sizing, conductor type, and breaker compatibility are critical for safe operation and reliable panel performance.

A qualified electrician should evaluate the sub-panel feeder, correct the conductor-to-breaker mismatch, and verify proper sizing and installation to help ensure safe operation and support a market-ready presentation. (Guest house east exterior)

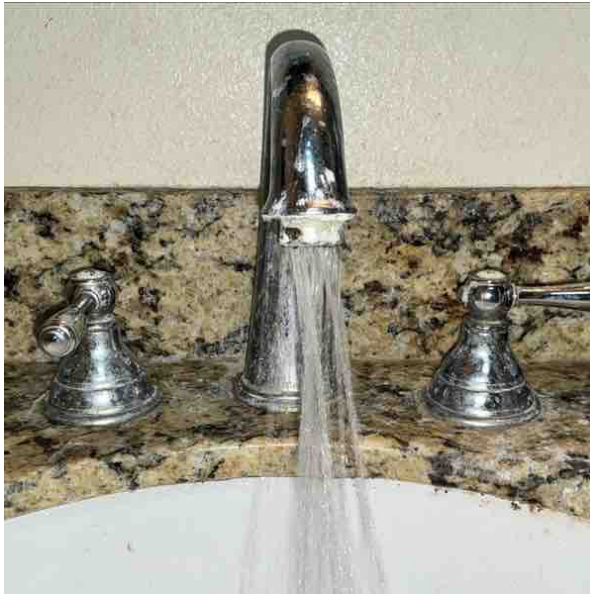
**(Primary Bathroom)**

#### 9.6.2 SINK FAUCET CONDITION – SPRAY PATTERN IRREGULARITY

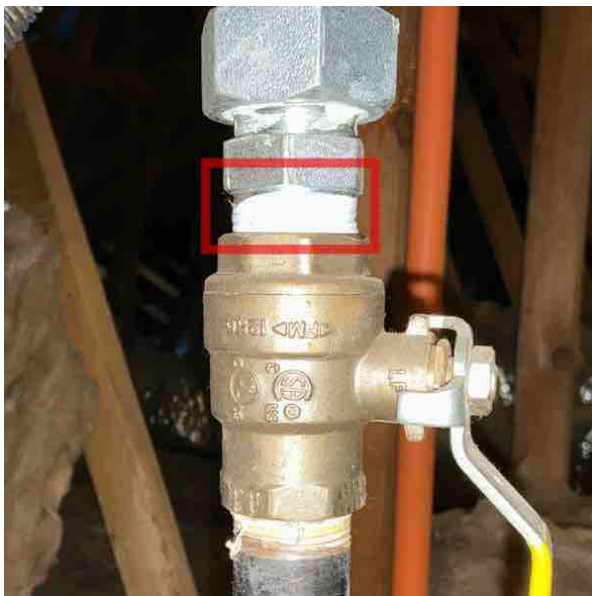
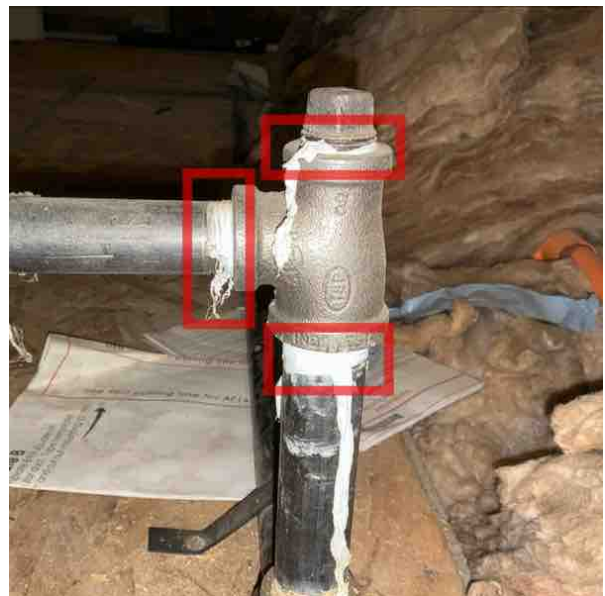
**9.11.2 GAS FITTINGS – TEFLON TAPE COLOR AND THICKNESS SHOULD BE VERIFIED****Observation:**

Teflon tape was observed on one or more gas fittings at the water heater and furnace. While the tape may appear white due to fading or wear, proper gas-rated tape is typically yellow and of specific thickness. Use of incorrect tape may compromise seal integrity and safety.

Verification of tape type, color, and thickness by a licensed plumber or gas technician is advised. If not confirmed as gas-rated, removal and reapplication with approved material is advised to ensure safe and compliant sealing. **(Attic)**
