### *Inspection Report*

Address: 4837 Tumbleweed Way Paso Robles, CA 93446

03/25/2026

Inspector: Taylor Vreeken, CCI

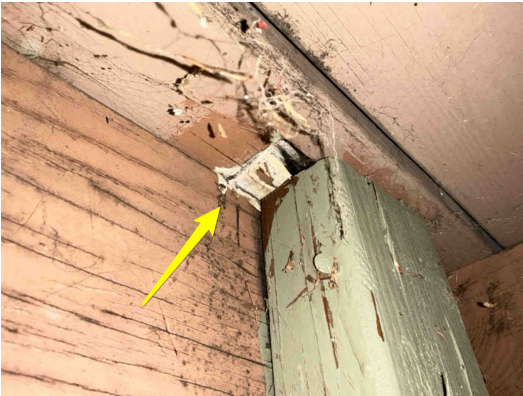
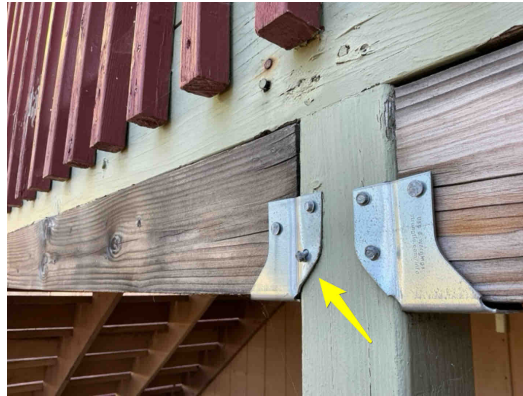
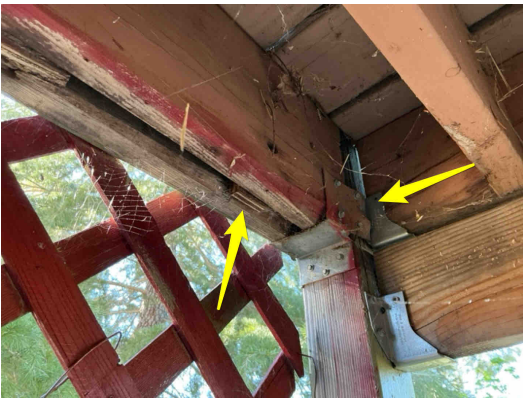
**E&C s-41:** The FRONT ENTRY DECK does not meet minimum construction standards, has moderate moisture damage, and appears to be at the end of serviceable life. Contact a qualified contractor for evaluation and repairs or replacement.

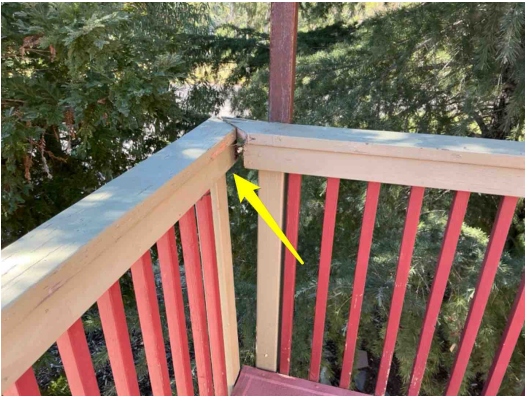
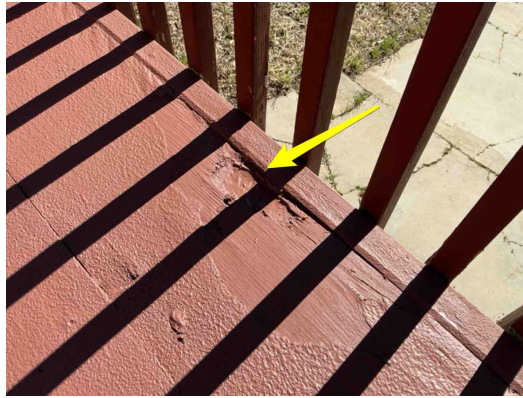
**E&C SC s-43:** The UPSTAIRS DECK OFF THE LIVING ROOM is improperly constructed and not a proper waterproof assembly. Too many individual defects to list. Areas of the decking found unsafe. Contact a qualified decking contractor for further evaluation and reconstruction/ repairs.

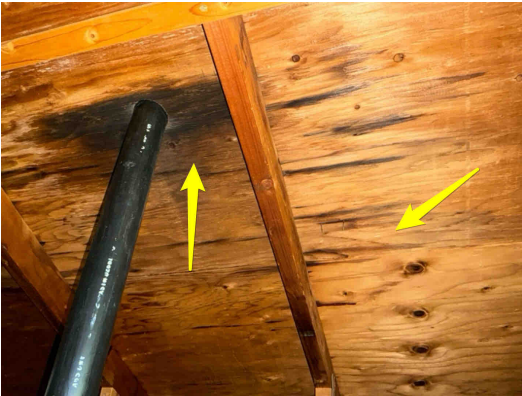
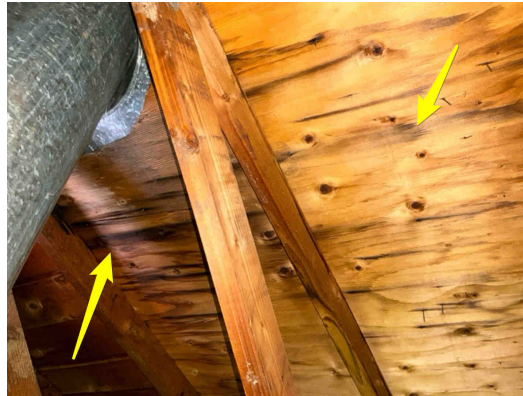
**FI DS s-79:** Some moderate and heavy moisture stains noted in areas throughout the attic. All water stains should be investigated by a licensed roofer. Refer to termite report for additional comments and/or recommendations.

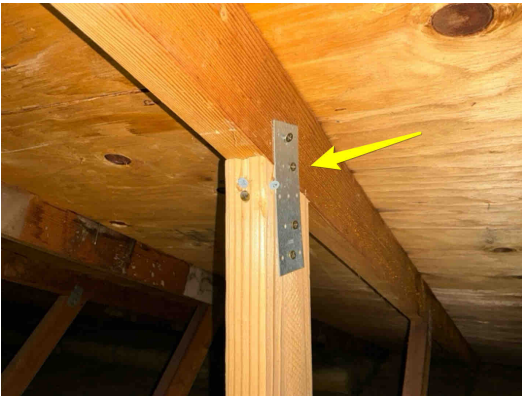
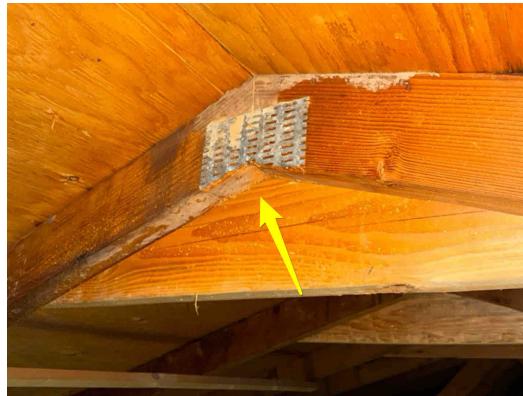
**E&C SC s-80:** Roughly 2/3 of the attic truss system found heavily altered and removed. This substandard alteration to attic framing is a significant structural concern and warrants further evaluation by qualified engineer.

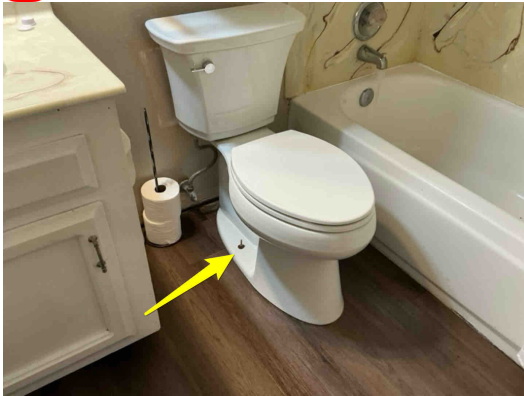
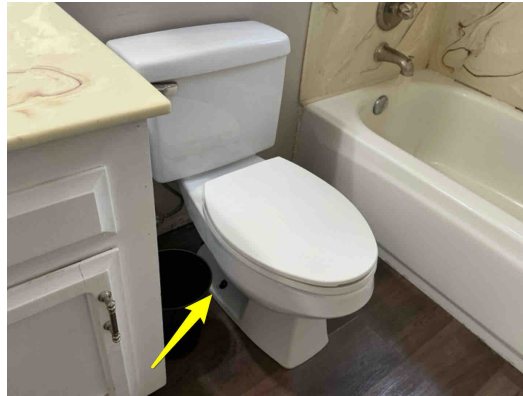
**E&C** s-131: Toilet loose at floor: HALLWAY BATHROOM and PRIMARY BEDROOM BATHROOM

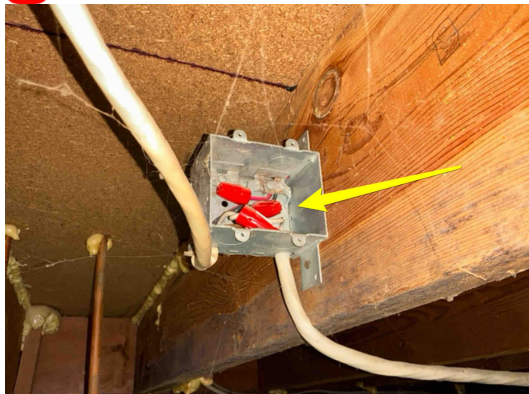
**SC** s-182: Missing electrical cover plate: MULTIPLE IN THE CRAWLSPACE

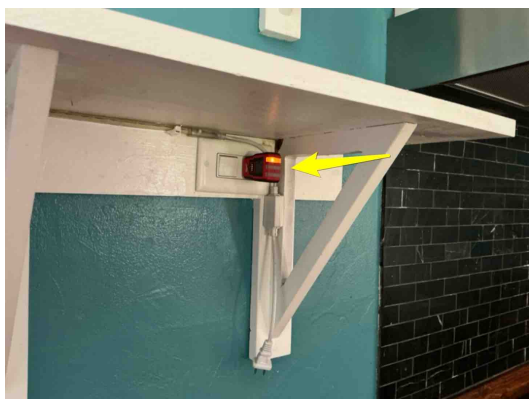
**SC** s-183: Miswired electrical outlet (open neutral). Have electrician check all outlets and correct as needed: KITCHEN

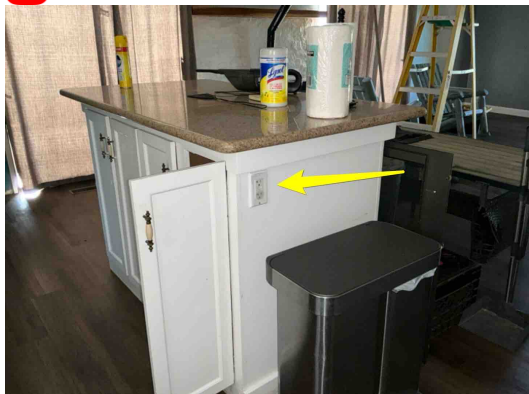
**E&C** s-186: The kitchen island GFCI found non-operational/ abandoned.

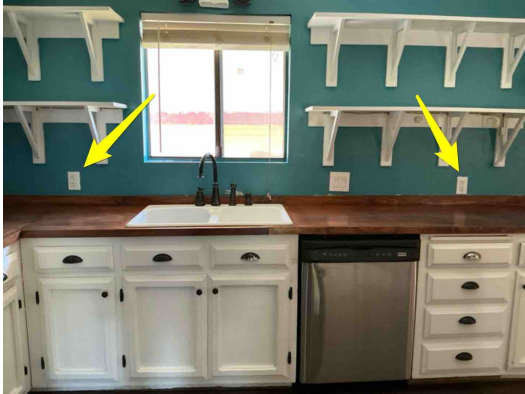
**E&C s-192:** The KITCHEN LEFT SIDE GFCI outlet found to be improperly wired in series with the KITCHEN RIGHT SIDE GFCI outlet (improper line / load reversal). When the GFCI trips off it improperly trips off a second GFCI in a different location and will not reset unless the other outlet when found is reset first. This is considered an improper installation.

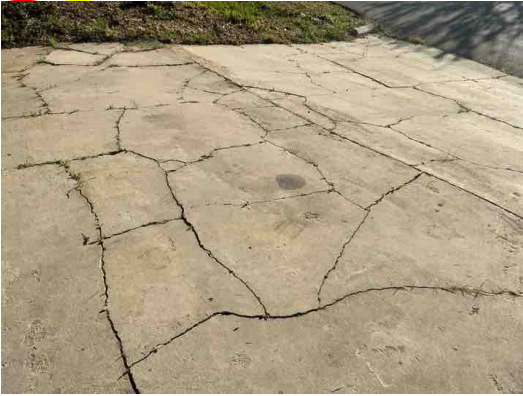
**FI** **UPG** **17:** Some moderate and heavy cracks found in areas of the driveway.

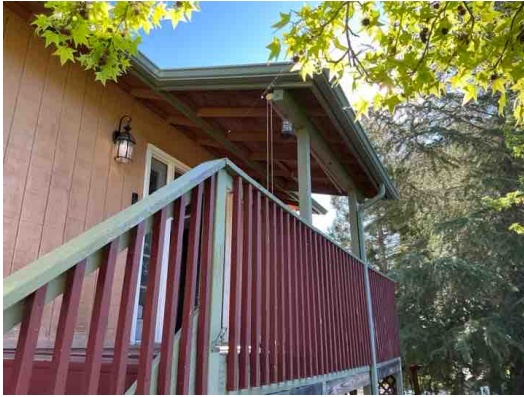
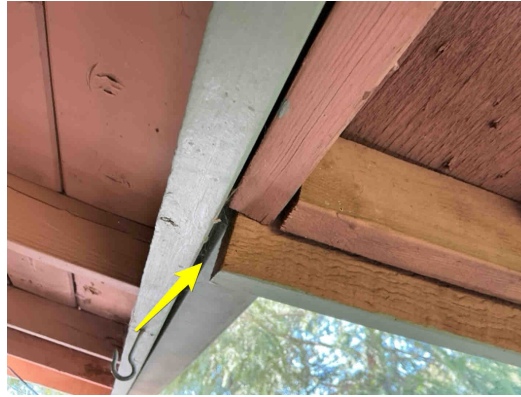
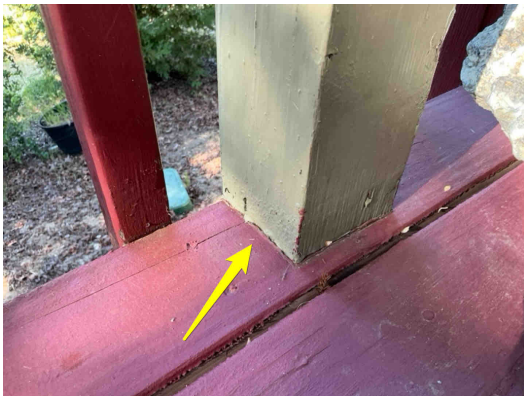
**E&C SU 22:** Areas of the wood framed FRONT PORCH COVER do not meet minimum construction or engineering standards. Certain issues can negatively affect the overall integrity of the structure. Further evaluation with upgrades or repairs by a licensed contractor familiar with minimum construction and engineering standards is recommended.

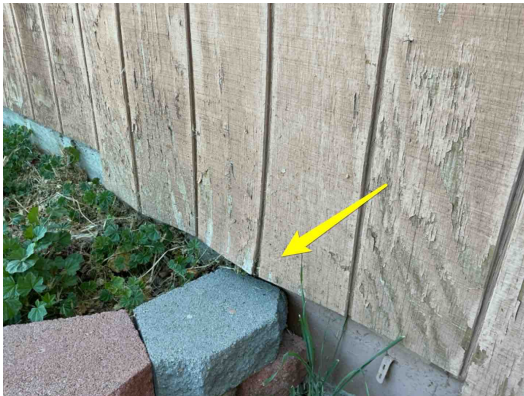
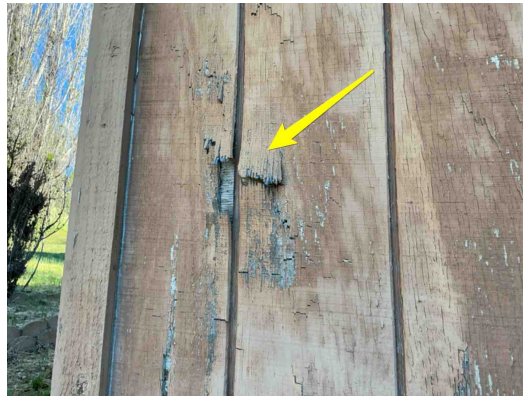
**27:** The exterior wood siding found heavily deteriorated and damaged at multiple locations throughout. Too many individual defects and locations to list. Recommend further evaluation in corrections/repair by a licensed contractor familiar with minimum codes and standards.

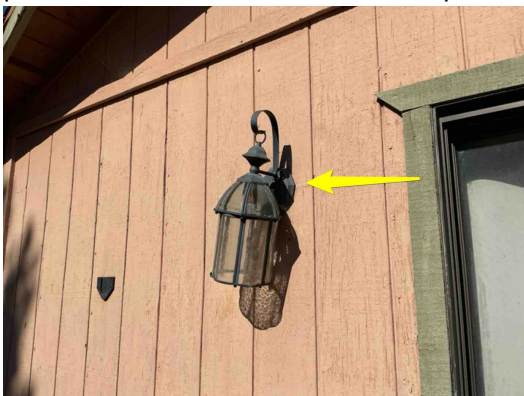
**MR 28:** Recommend sealing around the exterior light fixtures making sure they are sealed tight to the wall to help prevent water and/or critter intrusion per installation requirements.

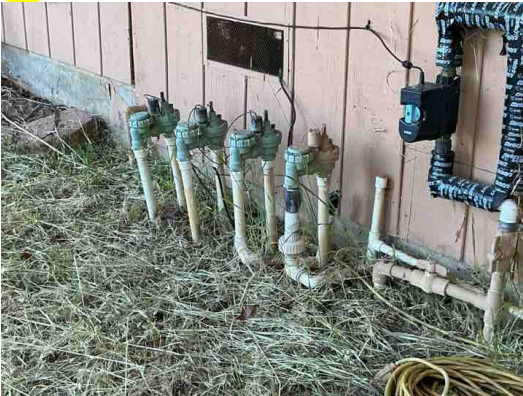
**MR 33:** Recommend freeze protection at exposed sprinkler valves and/or pipes.

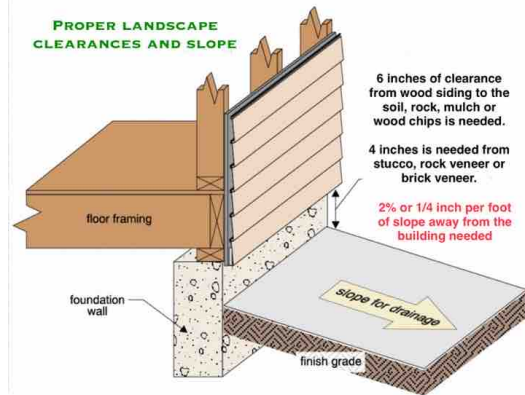
**MR 46:** Soil level found high along areas of the perimeter of the foundation and exterior siding (recommend 6 inches from the bottom of the exterior siding to dirt, rock, mulch or wood chips).

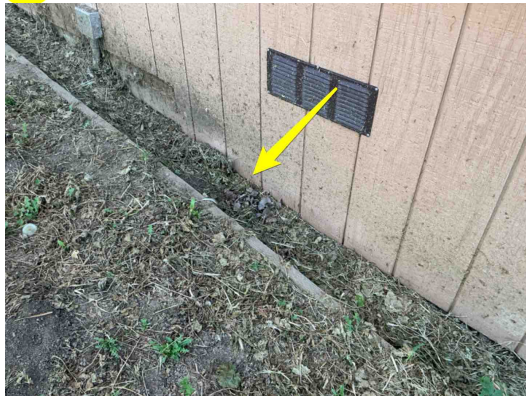
**MR 47:** Earth-to-wood contact noted at areas of the exterior siding or trim. Proper landscape grading warranted.

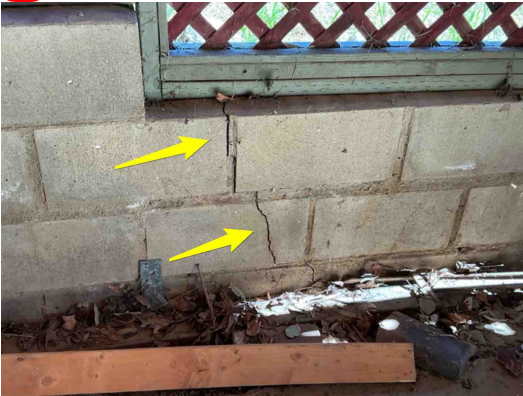
**FI 49:** Moderate, Major cracks with some displacement visible in the retaining walls.

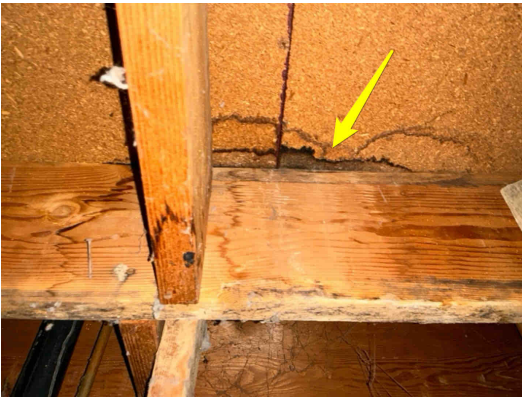
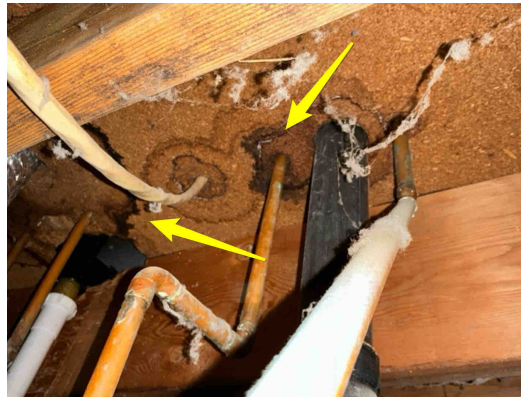
**FI 52:** Some water stains noted on the underside of the wood framing in areas of the crawlspace under some exterior doors, bathrooms and/or kitchen. Refer to the Termite report for additional comments and recommendations as to the exact location, extent, and if repairs are needed.

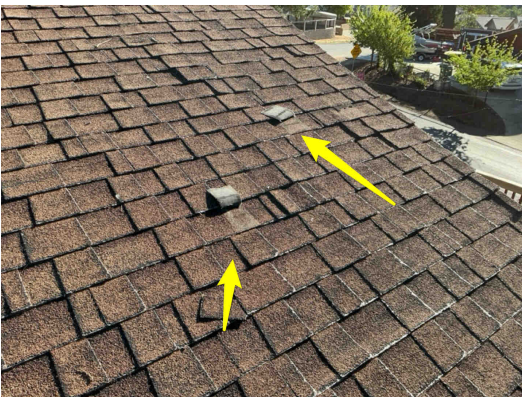
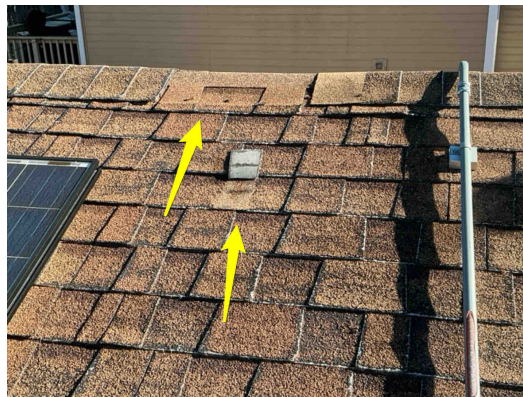
**E&C DS 72: ROOF CONDITION:** Roof is at or past the end of its life expectancy. Recommend contacting a licensed roofing contractor for a price / proposal for replacement.

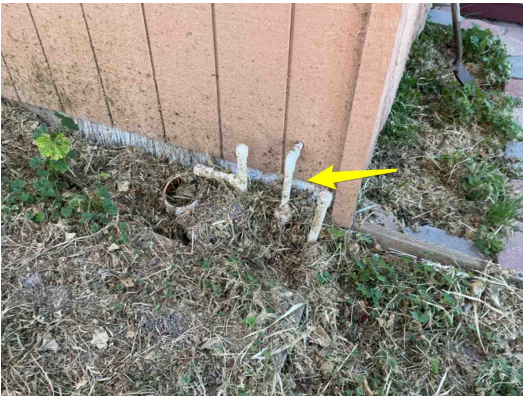
**MR UPG 89:** Exposed exterior water supply pipes subject to freezing are not insulated, not insulated well or have damaged or deteriorated insulation installed. Upgrades are recommended.

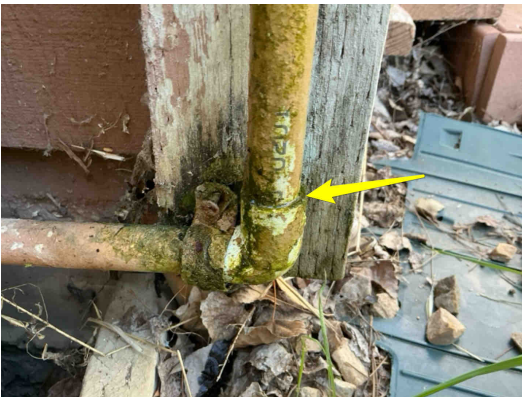
**E&C 90:** Active water leak found at NORTHWEST ADDED HOSE BIB SUPPLY LINE. Recommend further evaluation and repairs by qualified plumbing professional.

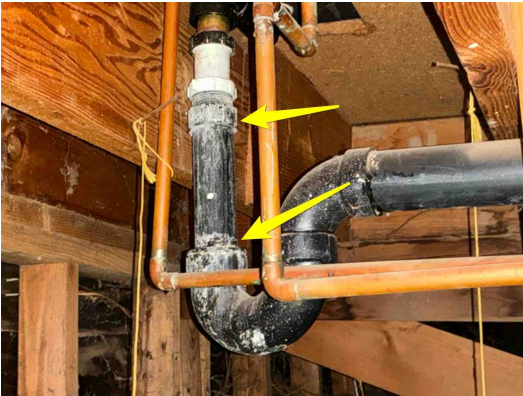
**FI 94:** Corrosion with evidence of past leaking noted on areas of the waste piping and fittings in areas of the crawlspace. Recommend further review of the waste piping throughout the crawlspace with cleanup and correction by qualified plumbing professional to help prevent additional future leakage.

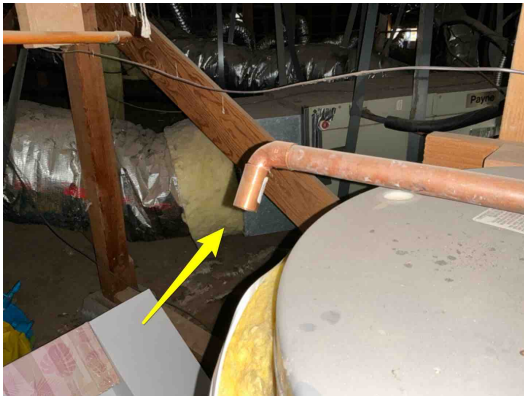
**SC 98:** The Water heater TPR (temperature pressure relief) pipe improperly terminates. Must terminate downward at the exterior at 6 to 24 inches from the ground.

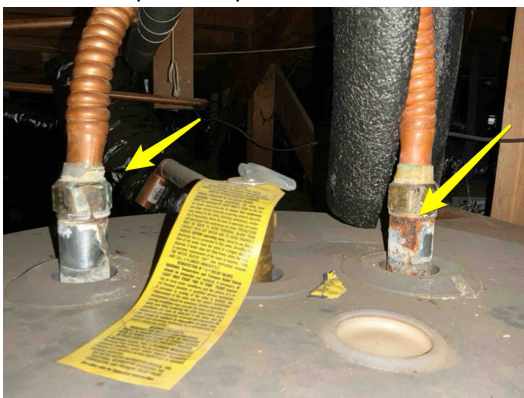
**FI 100:** Evidence of past leaking with corrosion at the HOT and COLD water supply piping at the water heater. Contact a qualified plumber to evaluate and correct.

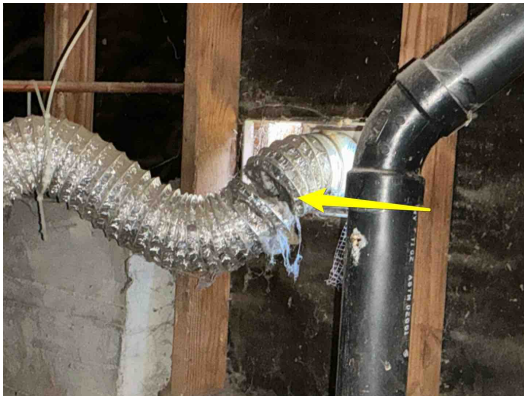
**E&C 128:** The laundry dryer vent pipe found damaged, leaking and/or disconnected in the crawlspace. Correction needed for safety.

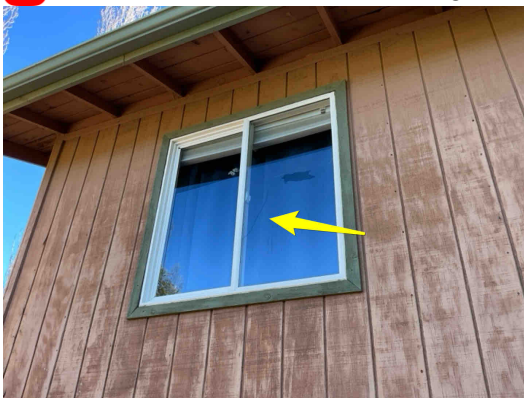
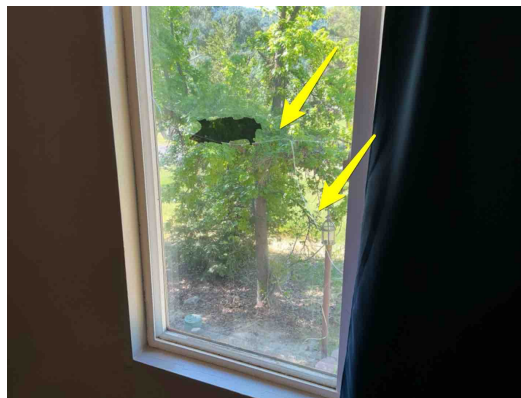
**SC 151:** Cracked or broken window glass found: BEDROOM-2

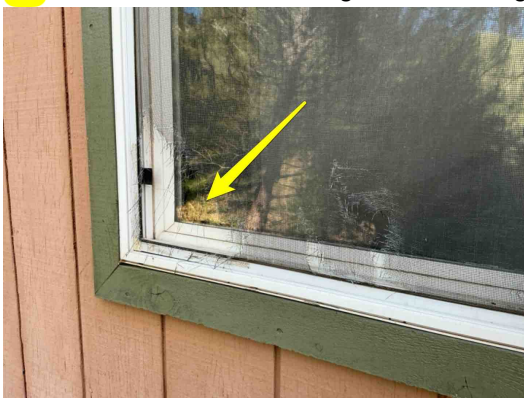
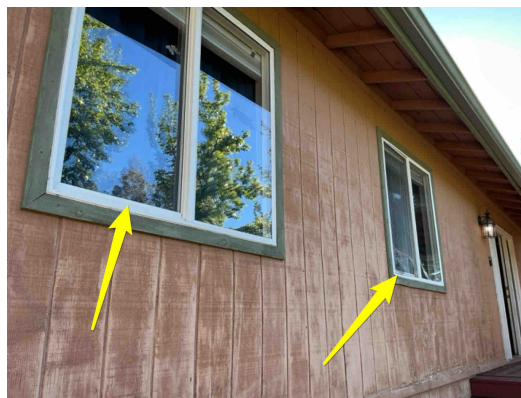
**MR 152:** Disclosure: Missing and/or damaged screens found at some windows.

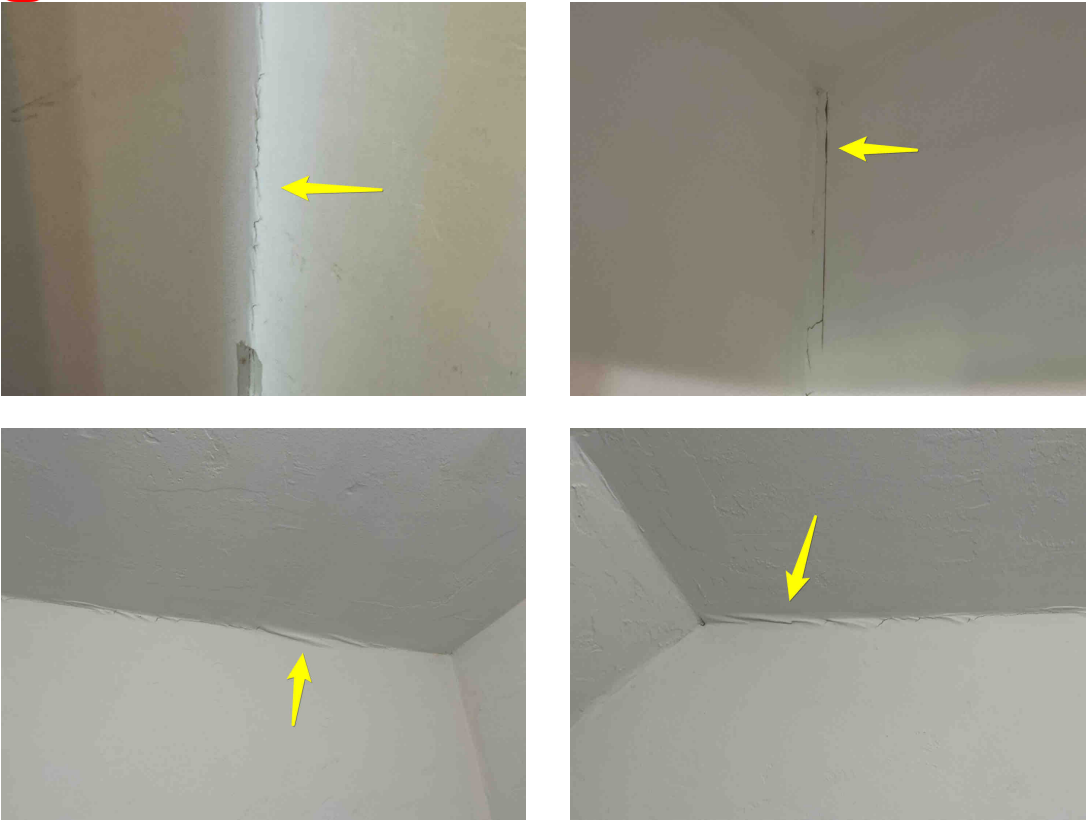
**E&C 166:** Several cracks noted throughout interior drywall indicative of minor structural movement.

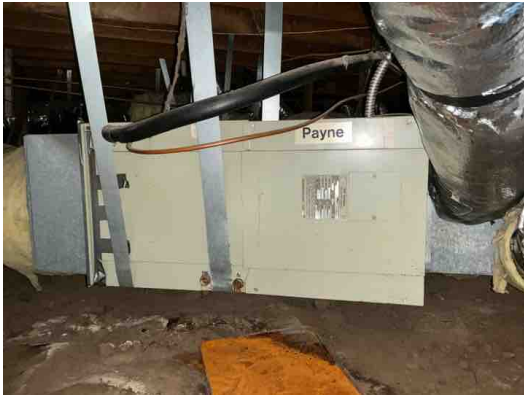
**E&C** **SU** **169:** This type of heating and cooling system has an anticipated 20+/- year life span and is currently 48 years old. **The heating and cooling did not operate today and may warrant full replacement.** Contact a licensed HVAC professional for evaluation and repair/replacement.

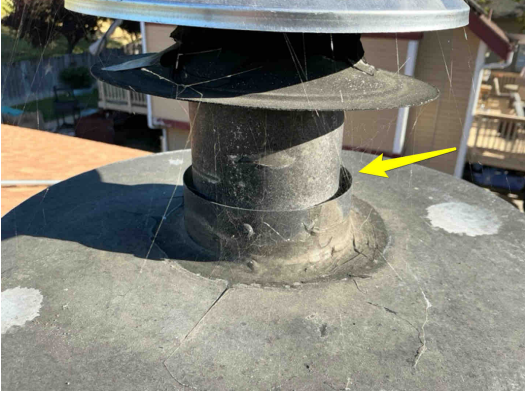
**E&C** **MR** **203:** Missing the proper storm collar at the top of the fireplace chimney pipe around the chase collar to help prevent water intrusion down the metal chimney pipe and into the wood chase.
