# PROPERTY INSPECTION REPORT

**FOUR POINT**  
HOME INSPECTION INC.

**65380 San Lucas Rd**  
**Inspection Prepared For: Hector Macias**  
**Agent: -**

**Date of Inspection: 7/9/2025**

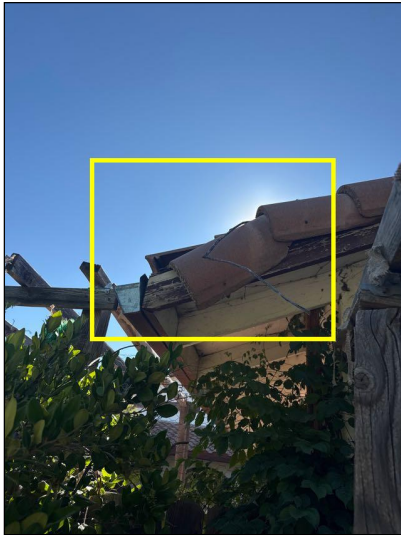
Tiles along the rakes (sloped roof edges) were loose and fasteners were visibly protruding. Falling tiles can cause serious or fatal injury. The inspector recommends correction by a qualified roofing contractor.

Tiles along the rakes (sloped roof edges) were loose and fasteners were visibly protruding.

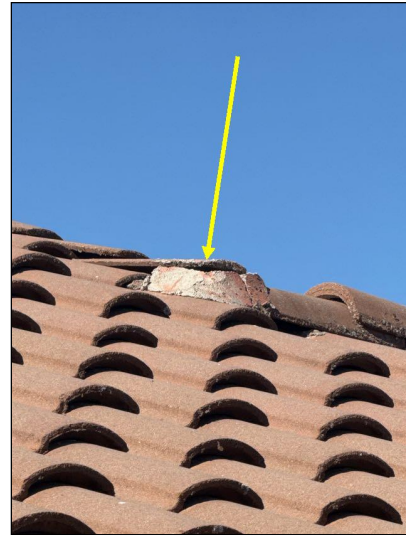
Roof ridge cap tiles are mastic sealed at intersections, the mastic is cracked

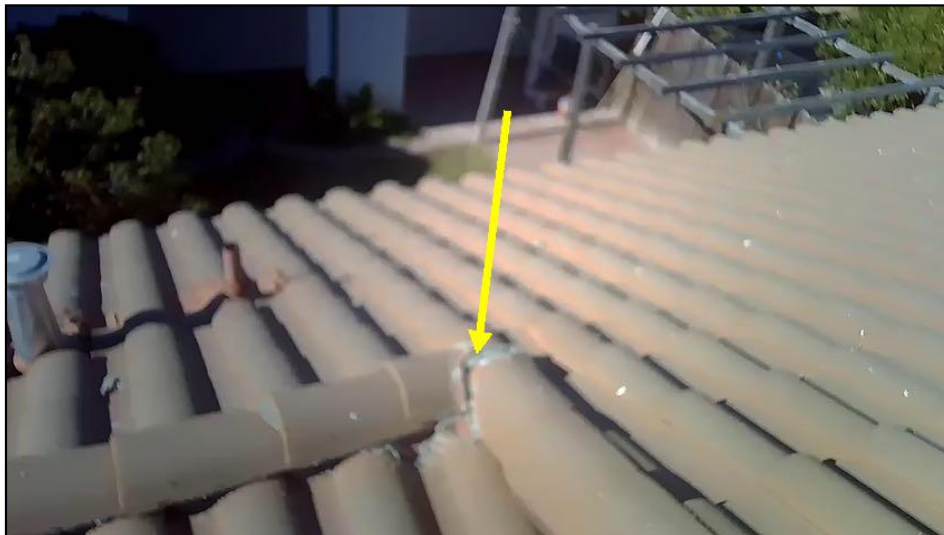
Roof ridge cap tiles are mortar sealed at intersections, the mortar is cracked which could allow moisture intrusion to the underlayment of the roof structure. Recommend having all mortar joint at ridge cap intersections sealed and maintained on a semiannual basis. The Inspector recommends any necessary work be performed by a qualified roofing contractor.

Roof ridge cap tiles are mortar sealed at intersections, the mortar is cracked

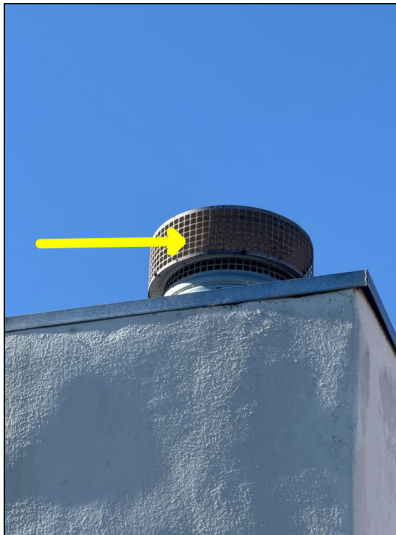
Wire mesh only is installed as a spark arrestor

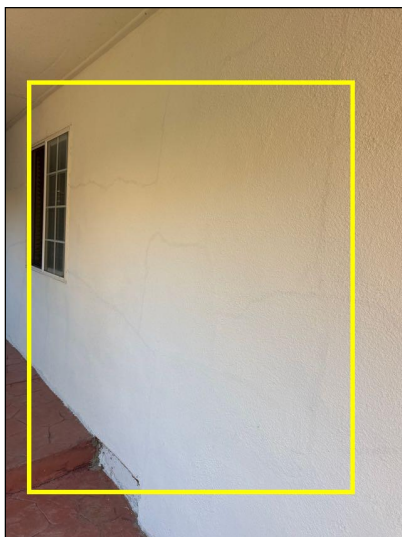
**Monitor:** Normal cracking was visible in stucco covering exterior walls of the home at the time of the inspection.

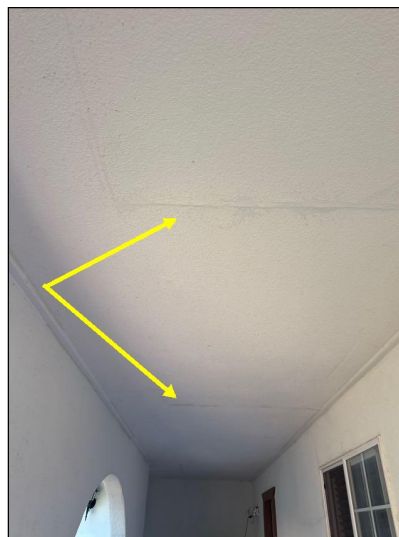
**Monitor:** Normal cracking was visible in stucco covering exterior walls of the home at the time of the inspection.

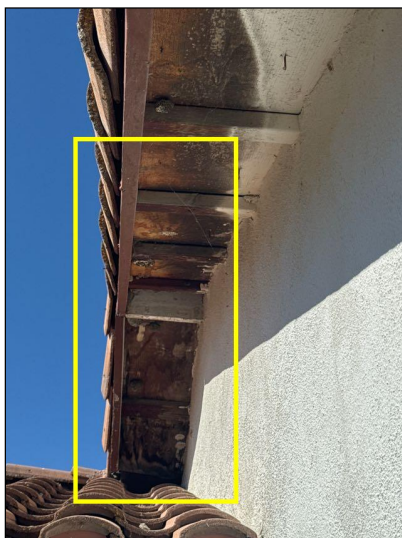
**Monitor:** Home soffits had stained areas visible at the time of the inspection indicating past roof leakage.

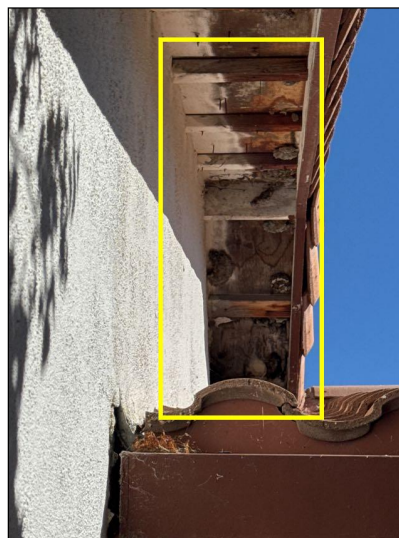
**Monitor:** Home soffits had stained areas visible at the time of the inspection indicating past roof leakage.

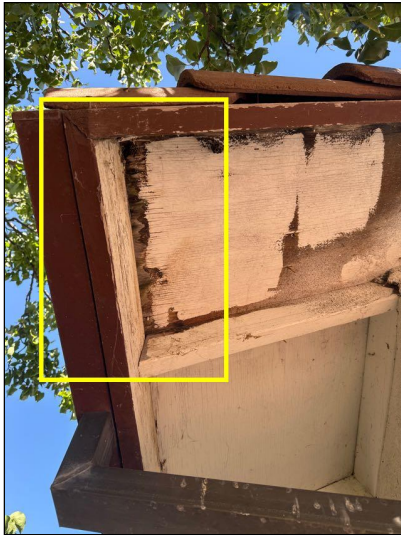
**Monitor:** Home soffits had stained areas visible at the time of the inspection indicating past roof leakage.

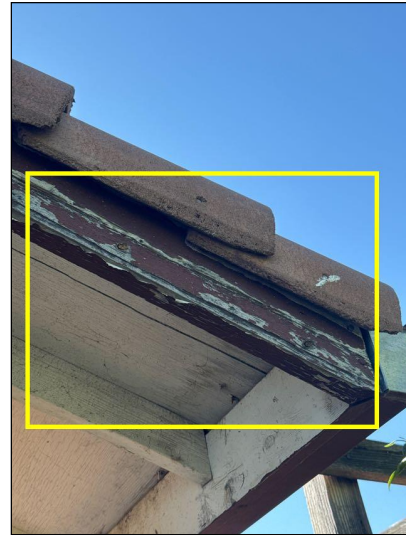
**Maintenance Needed:** Fascia had peeling paint and needed maintenance.

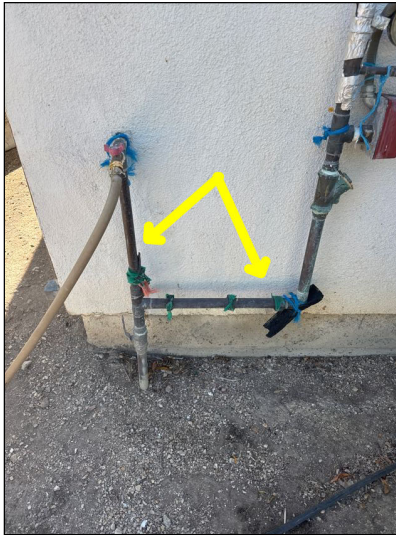
**Recommend Improvement:** The Inspector recommends that uninsulated main water supply pipe be insulated.

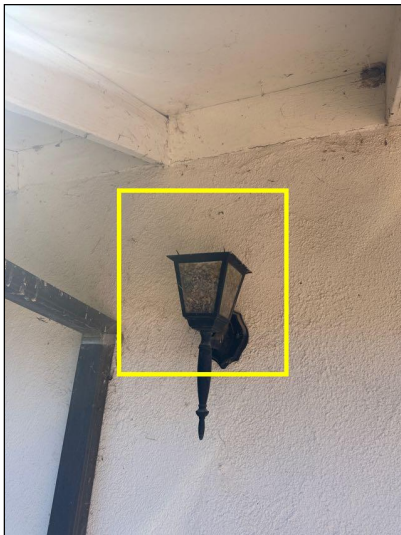
Several exterior light fixture were damaged and/or missing light bulbs at the time of the inspection. The Inspector recommends correction by a qualified electrical contractor.

Several exterior light fixture were damaged

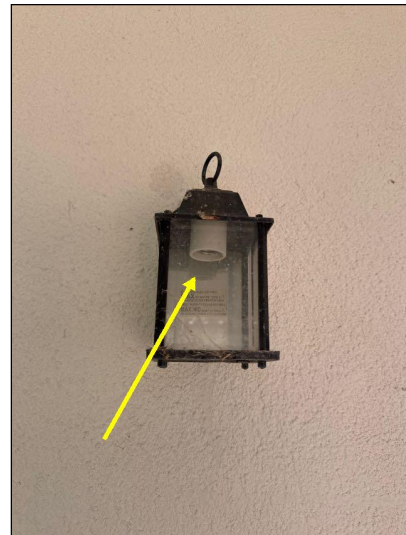
Several exterior light fixture were missing light bulbs at the time of the inspection.

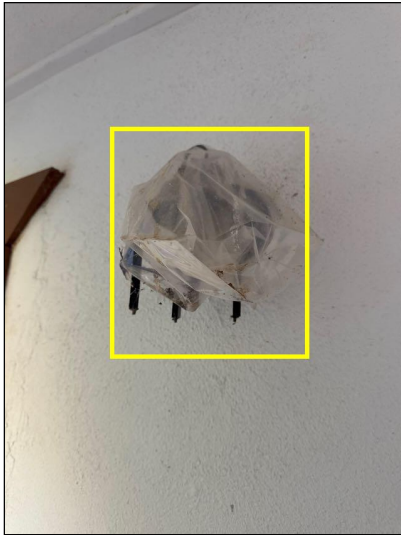
Several exterior light fixture were damaged

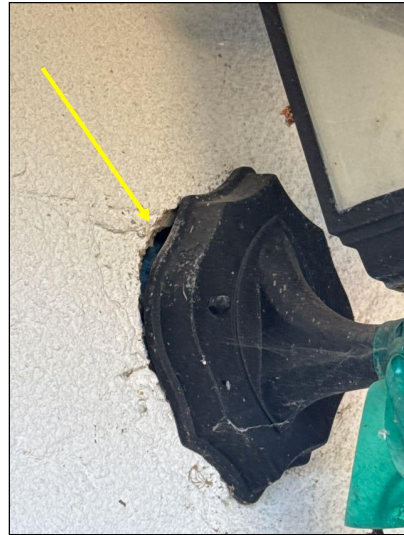
Exterior lighting was installed in a manner that left energized electrical components exposed to moisture intrusion.

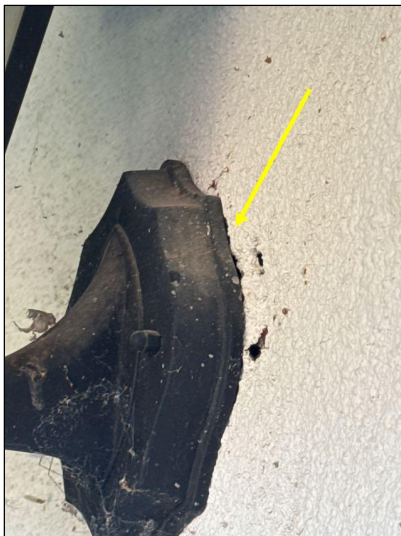
Exterior lighting was installed in a manner that left energized electrical components exposed to moisture intrusion.

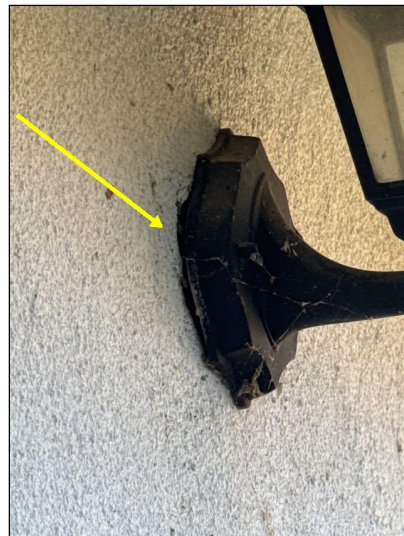
Exterior lighting was installed in a manner that left energized electrical components exposed to moisture intrusion.

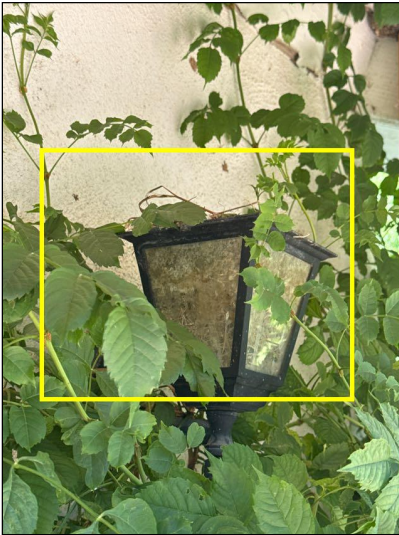
Several exterior light fixture were damaged

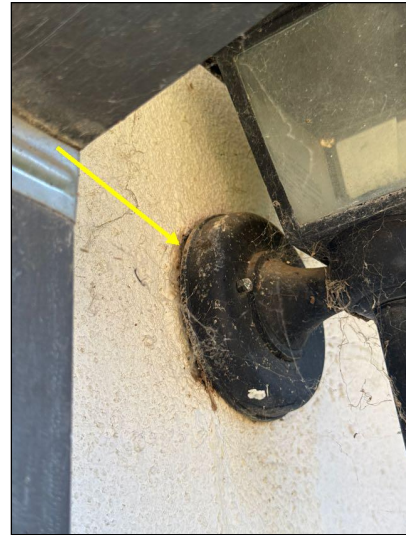
Exterior lighting was installed in a manner that left energized electrical components exposed to moisture intrusion.

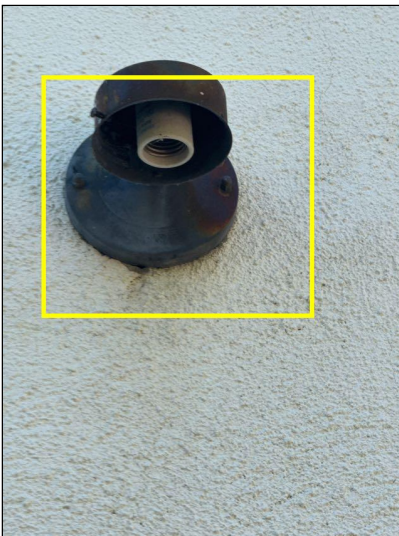
Several exterior light fixture were damaged

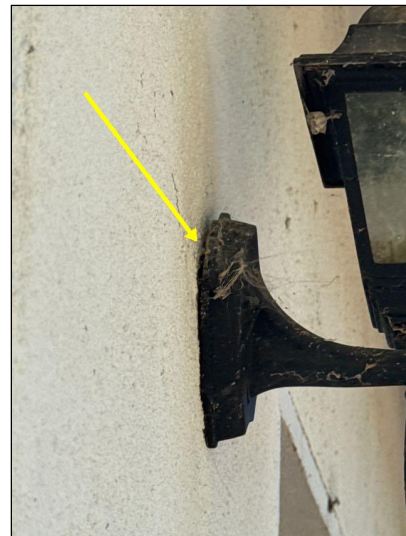
Exterior lighting was installed in a manner that left energized electrical components exposed to moisture intrusion.

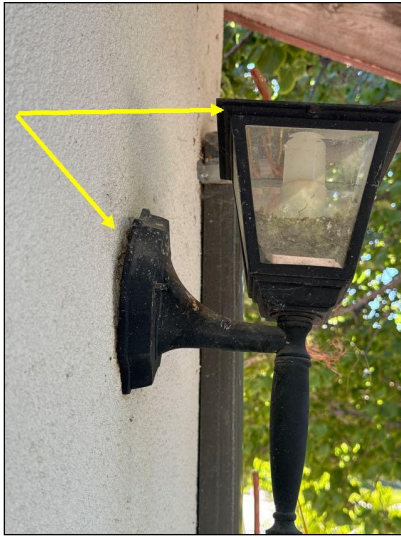
Exterior lighting was installed in a manner that left energized electrical components exposed to moisture intrusion.

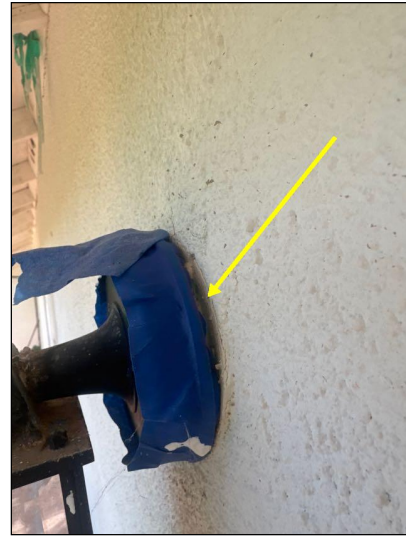
Exterior lighting was installed in a manner that left energized electrical components exposed to moisture intrusion.

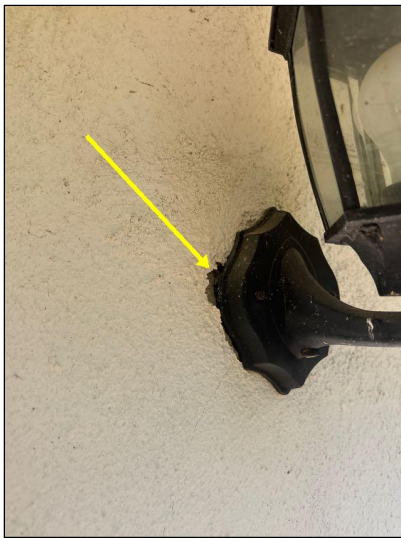
Exterior lighting was installed in a manner that left energized electrical components exposed to moisture intrusion.

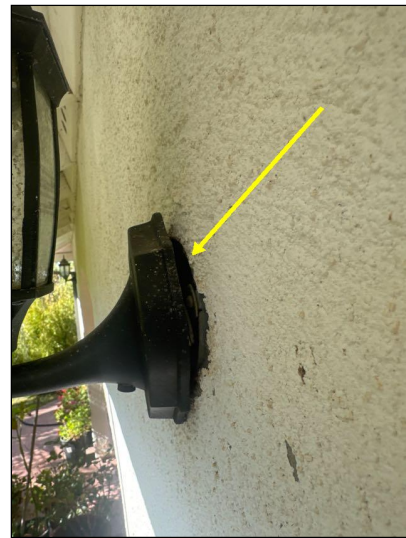
Exterior lighting was installed in a manner that left energized electrical components exposed to moisture intrusion.

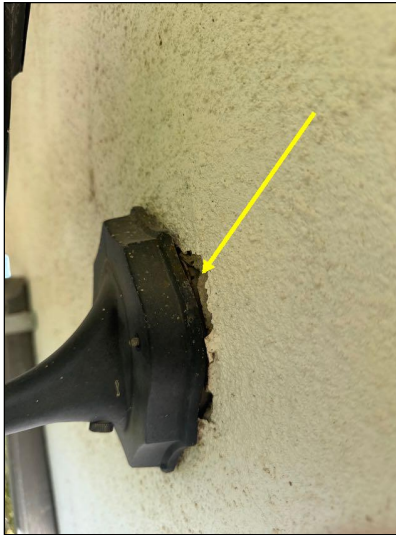
Exterior lighting was installed in a manner that left energized electrical components exposed to moisture intrusion.

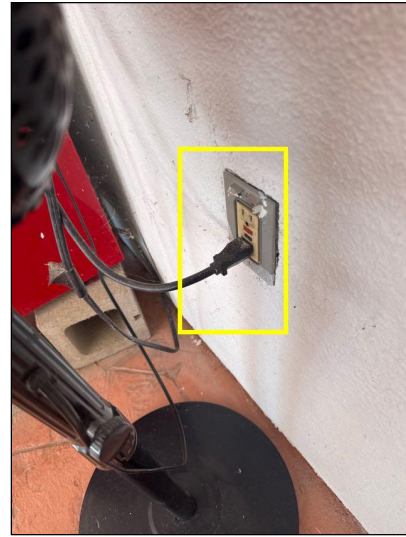
Exterior GFCI outlet at the home was not protected from weather.

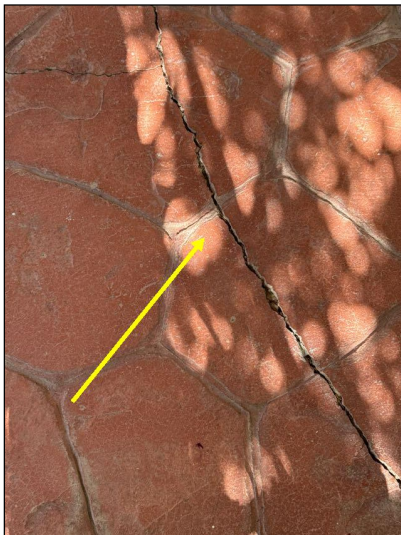
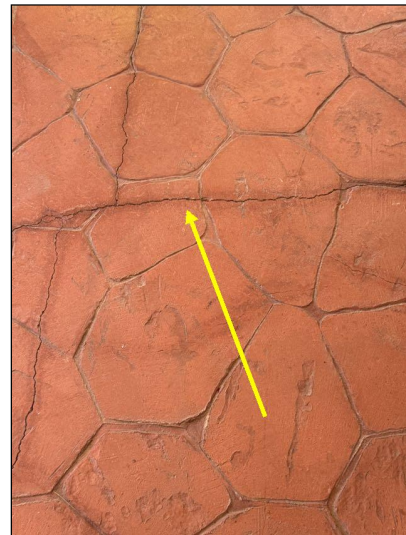
The porch concrete slab had shrinkage cracks. These are very common in poured concrete slabs and are a cosmetic concern, not a structural problem.

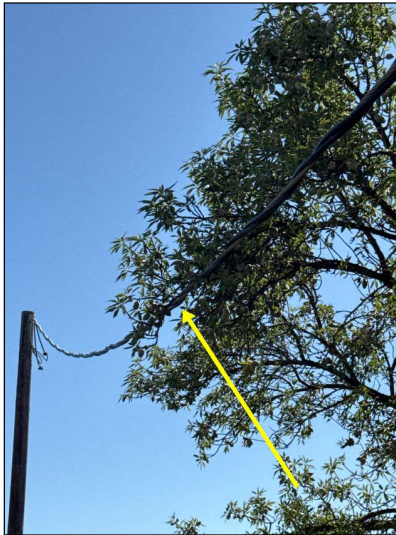
The overhead service-drop conductors had inadequate clearance from tree branches. This condition should be corrected by a qualified contractor or the utility service provider to avoid abrasion and damage to the conductors. Work around the service conductors should be performed by a qualified personnel only. Injury or death may result from attempts at correction by those without proper qualifications.

The overhead service-drop conductors had inadequate clearance from tree branches.

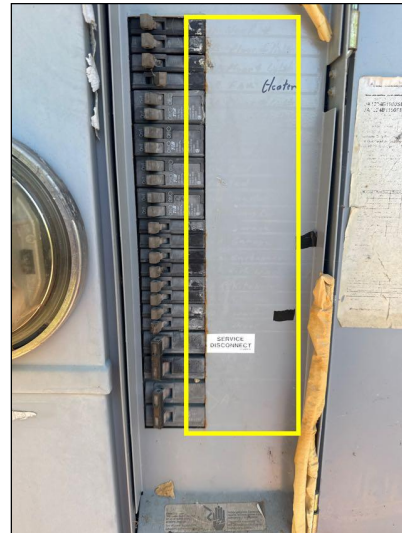
**Safety Improvement:** The Circuit Directory label identifying individual electrical circuits was missing from the service panel.

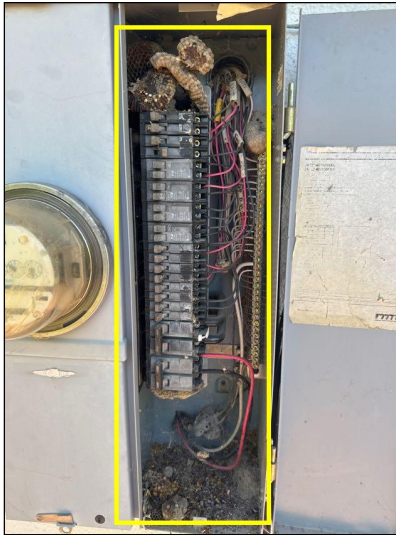
**Monitor:** The interior of the electrical service panel cabinet contained stinging insect nests. This condition may affect the ability of electrical components within the service panel to function as they were designed. The Inspector recommends nests be removed and action taken to close off any openings that may allow insect intrusion in the future. All work should be performed by a qualified electrical contractor.

**Monitor:** The interior of the electrical service panel cabinet contained stinging insect nests.

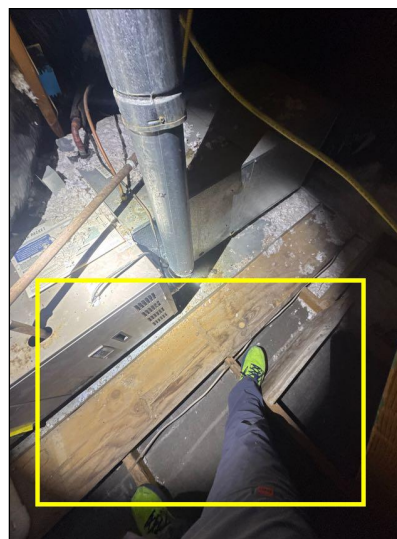
The furnace maintenance platform was of inadequate size for good service access.

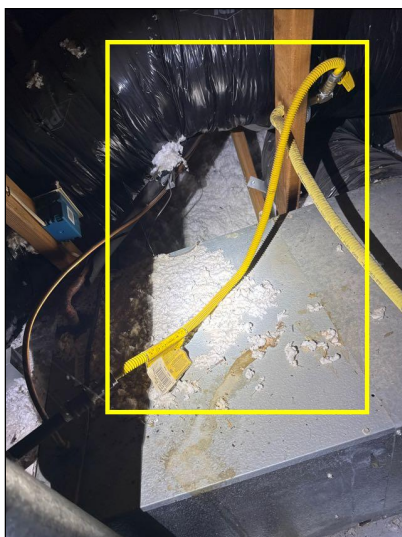
**Improvement:** The gas supply pipe contained no sediment trap.

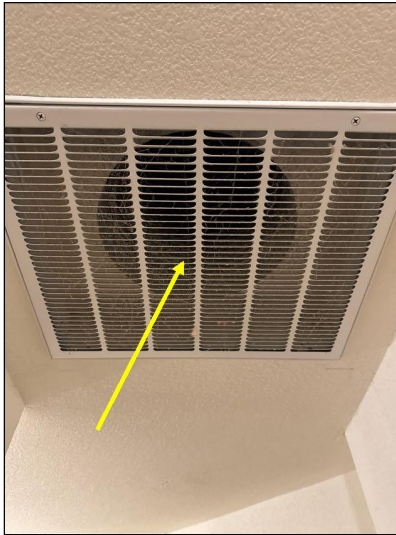
No air filter was installed in this furnace at the time of the inspection.

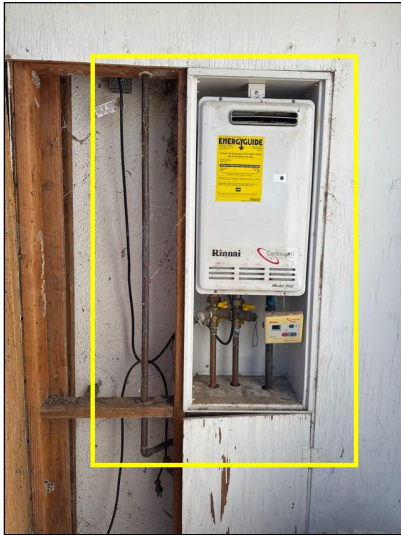
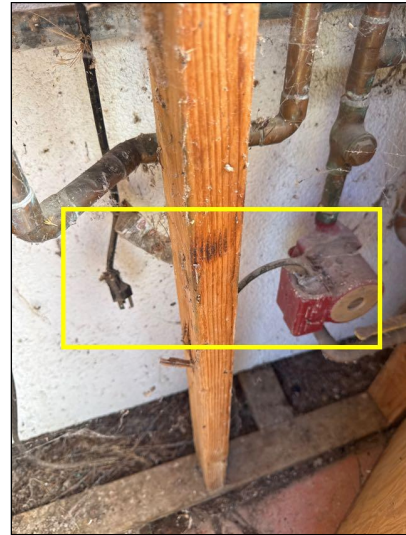
**Monitor:** The home had a hot water re-circulation system installed that was unplugged.

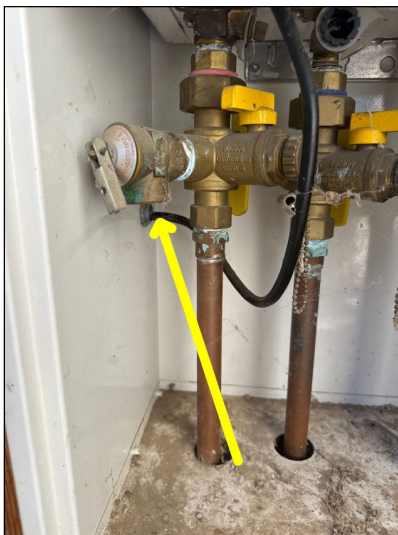
| | Page 43 Item: 5 | TPR Discharge Line Condition | The discharge line for the water heater relief valve (TPRV) is missing. This is a potential scalding concern as water can discharge improperly. Recommend installing the proper <b>TPR valve</b> discharge tube that must be made of copper, iron, or CPVC (NOT regular <b>PVC</b> ). It must terminate within 6" above the floor--the end cannot be threaded or have a fitting. We recommend that the discharge line extend to the exterior of the home if possible. |

The discharge line is missing for the water heater relief valve (TPRV).

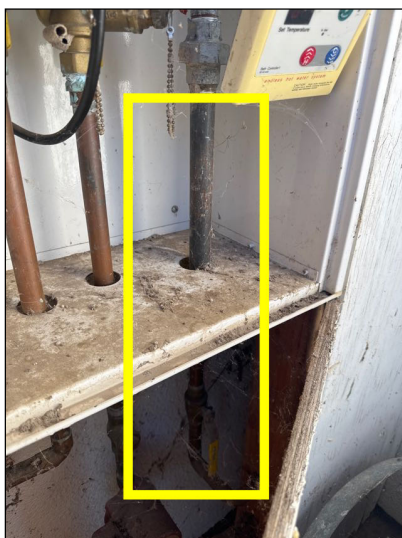
**Recommended Improvement:** The gas supply pipe contained no sediment trap. The purpose of a sediment trap is to prevent sediment or debris particulates from entering and clogging the water heater gas valve, which can cause the water heater to shut down. You may wish to consult with local contractor concerning the advisability of installing a sediment trap in the gas line.

**Improvement:** The gas supply pipe contained no sediment trap.

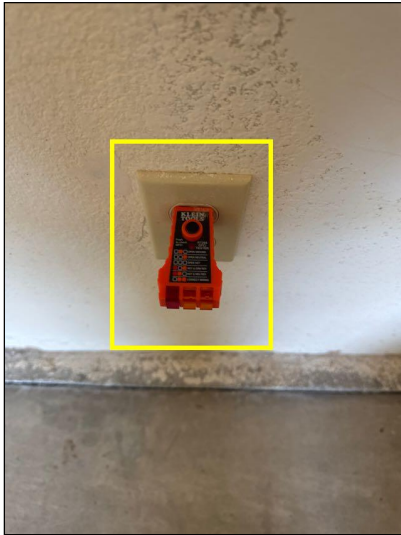
| | Page 48 Item: 5 | Garage Electrical | One or more electrical receptacles in the garage were inoperable at the time of the inspection. The Inspector recommends evaluation and correction by a qualified electrical contractor. |

One or more electrical receptacles in the garage were inoperable at the time of the inspection.

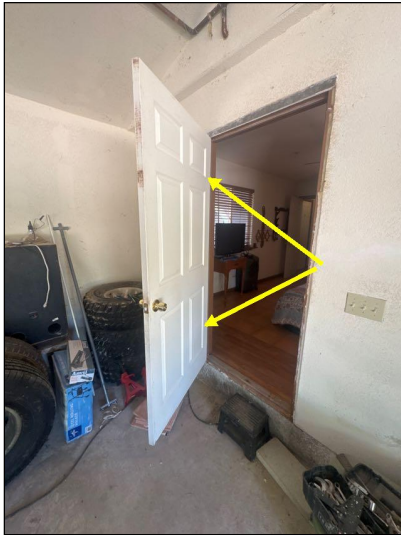
Door stops that prevent the door from self-closing are considered a breach in the firewall.

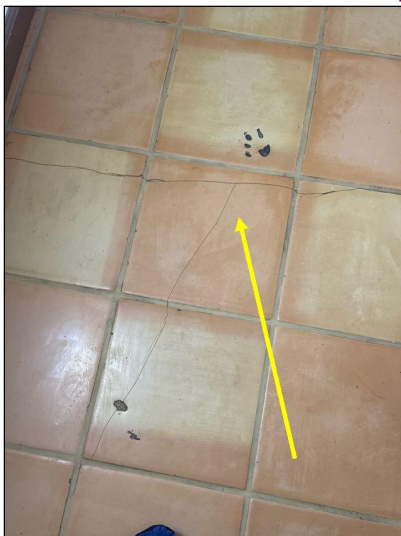
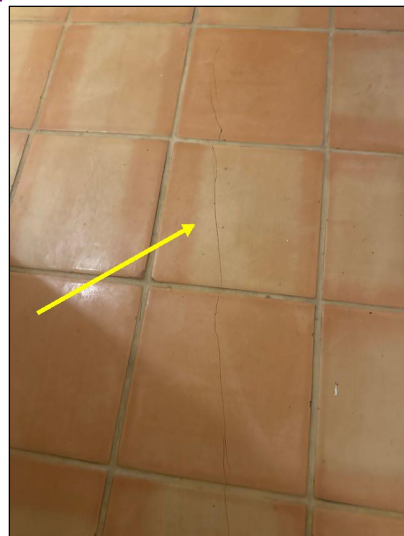
The Hallway, Dining Room had cracked floor tiles visible at the time of the inspection. You should ask the seller if spare tiles are available as matching replacements. The Inspector recommends that before the expiration of your Inspection Objection Deadline you consult with a qualified contractor to discuss options and costs for replacement.

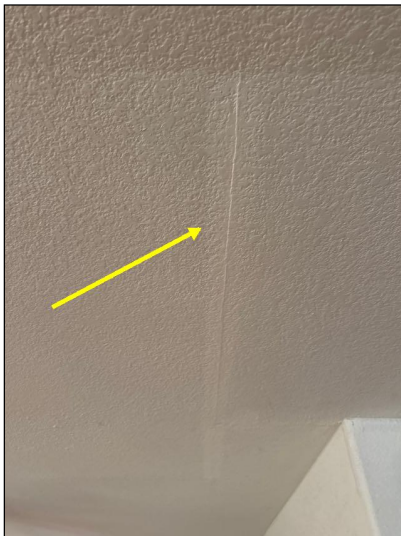
**Monitor:** Normal settlement cracking was visible in interior ceiling of the home at the time of the inspection.

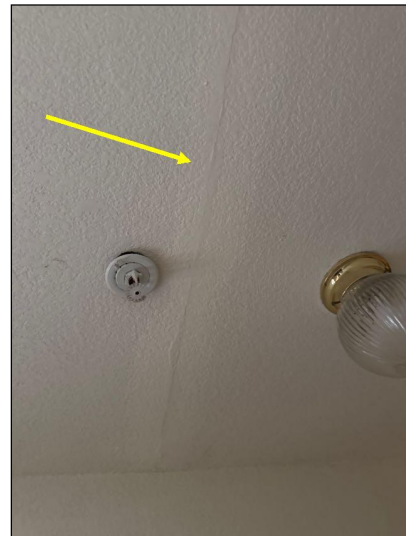
**Monitor:** Normal settlement cracking was visible in interior ceiling of the home at the time of the inspection.

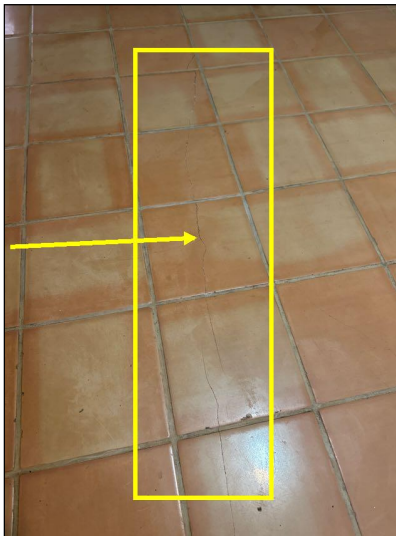
The kitchen floor had one or more broken tiles.

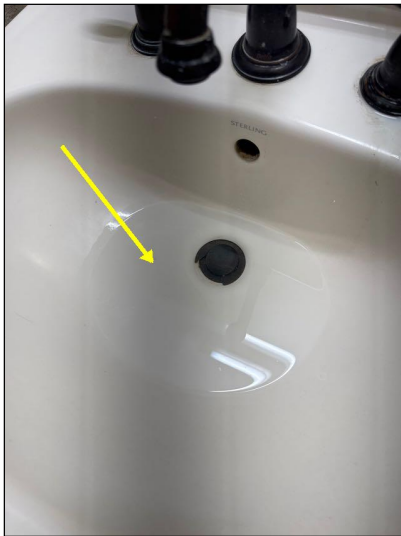
**Monitor:** The sink in this bathroom was slow to drain.

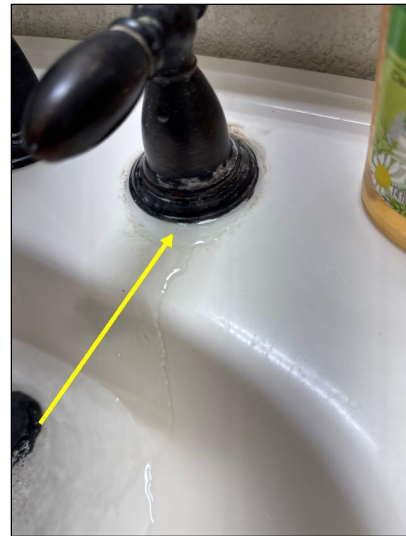
The faucet at this bathroom sink leaked when the water was turned on. This typically indicates that a valve seal needs replacement.

The faucet at this bathroom sink leaked when the water was turned on.
