## WOOD DESTROYING PESTS AND ORGANISMS INSPECTION REPORT

Building Address: <b>2301 S Center St. Units A, B, C, Santa Ana, CA 92704</b>		Date of Inspection <b>03/23/2026</b>	Number of Pages <b>6</b>

General Description: 2 story wood frame stucco composition roof attached garages slab tri-plex		Inspection Tag Posted:    Laundry Room	
		Other Tags Posted: None	
An inspection has been made of the structure(s) shown on the diagram in accordance with the Structural Pest Control Act. Detached porches, detached steps, detached decks and any other structures not on the diagram were not inspected.			
Subterranean Termites <input type="checkbox"/> Drywood Termites <input checked="" type="checkbox"/> Fungus / Dryrot <input checked="" type="checkbox"/> Other Findings <input type="checkbox"/> Further Inspection <input type="checkbox"/>			
If any of the above boxes are checked, it indicates that there were visible problems in accessible areas. Read the report for the details on checked items.

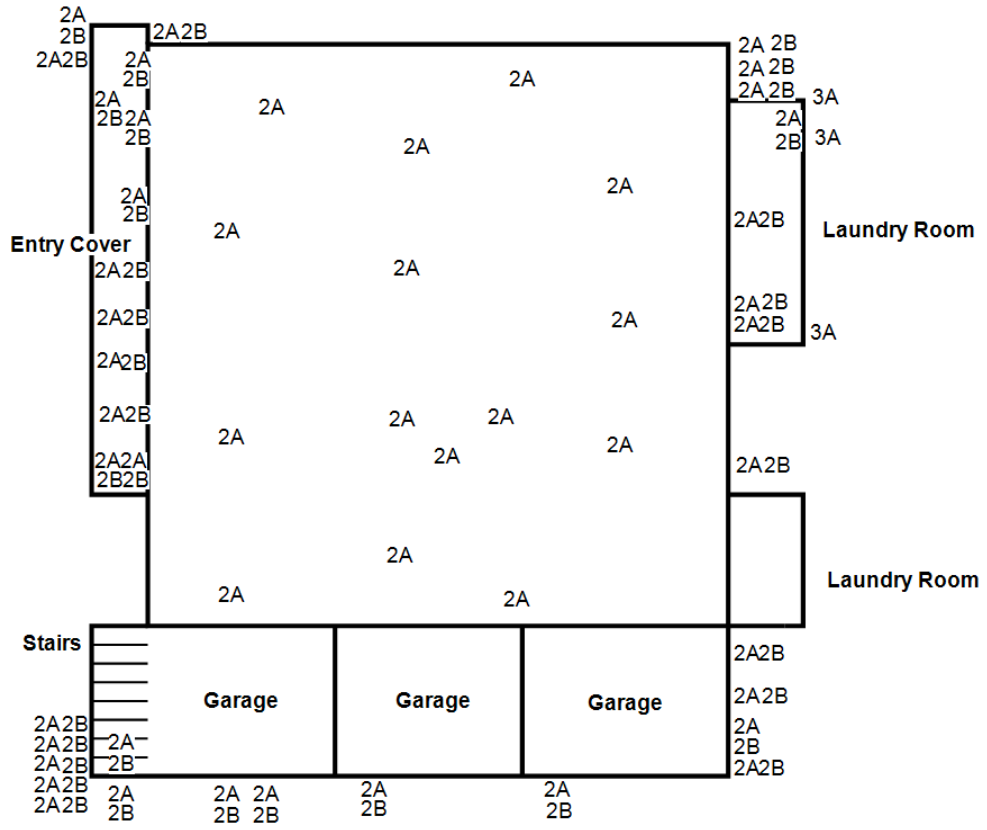
**This Diagram is not to scale**

- 2A PRICE: \$2,850.00 (Section I)  
FINDINGS: Evidence of dry-wood termite infestations at eaves, attic, entry cover and laundry rooms as indicated on the diagram.  
RECOMMENDATION: Vacate the premises and seal the structure for fumigation with Vikane Gas. Remove or cover accessible evidence of infestation. Fumigation warranted for two years. Fumigation awareness notice must be signed prior to fumigation. See fumigation notice for terms and liabilities.

- 2B PRICE: \$8,150.00 (Section I)  
FINDINGS: Evidence of termite damaged wood members noted at time of inspection at approximately 2x10x12ft fascia, approximately 2x6x60ft rafter tails, approximately 2x4x10ft rafter tails, approximately 4x4x6ft post, approximately 1x6x20ft shiplap, approximately 1inx3inx6ft starter board, approximately 4x8x1ft beam and approximately 4x12x2ft beam as indicated on the diagram.  
RECOMMENDATION: Replace or repair termite damaged wood members as necessary. No painting is included in this estimate.

- 3A PRICE: See 2B (Section I)  
FINDINGS: Dry-rot wood members found at sheathing, door jambs and door at time of inspection.  
RECOMMENDATION: Replace or repair dry-rot damaged wood members as necessary. No painting is included in this estimate. If additional adverse conditions are uncovered during repairs, further inspection will be recommended and a supplemental report will be issued indicating any infection, or additional repairs.
