# SUMMIT INSPECTIONS

150 S. Glenoaks Blvd. • PMB 1045  
Burbank, CA 91502  
(818) 426-9977

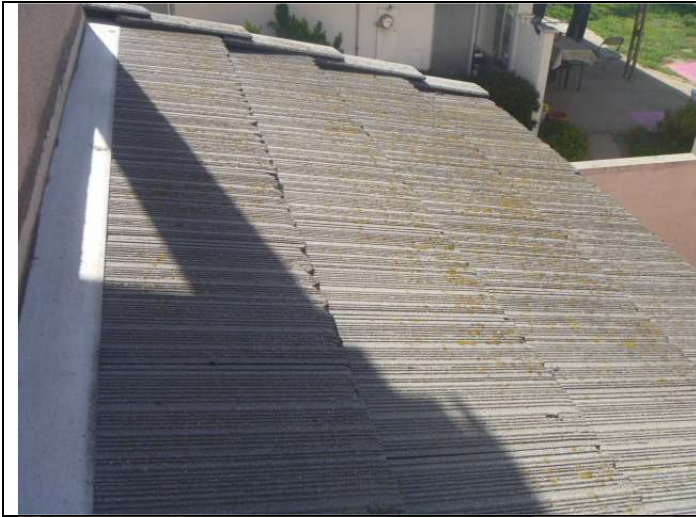
Recommend considering a termite/wood destroying organisms inspection.

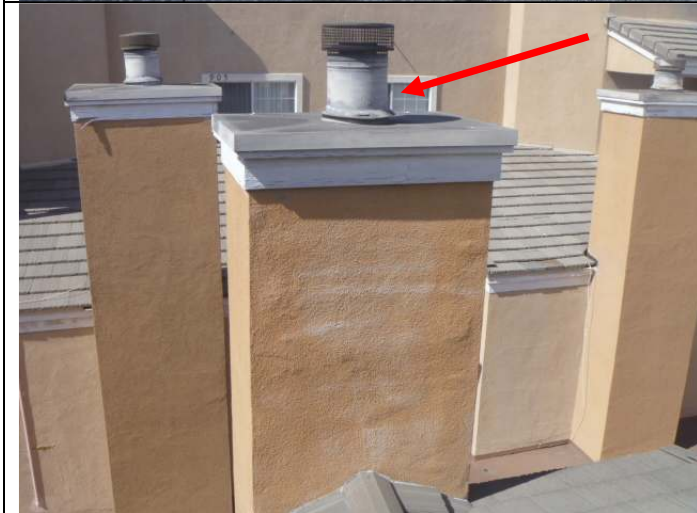
Chimney upper exterior.

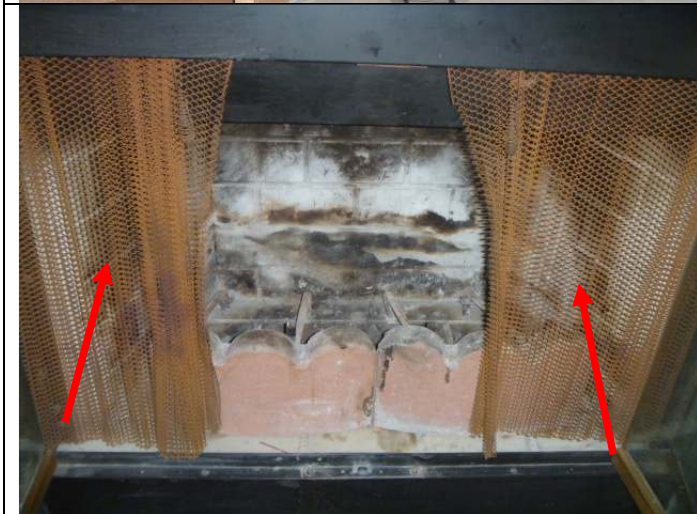
Fireplace. Note: The rusted screens.

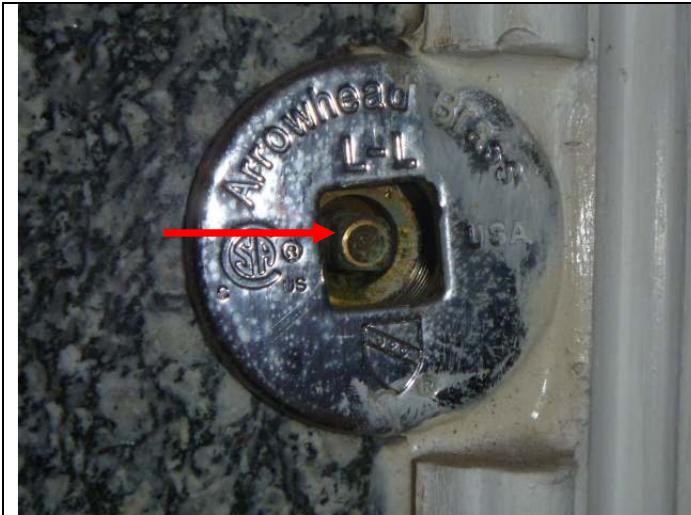
Fireplace gas valve.

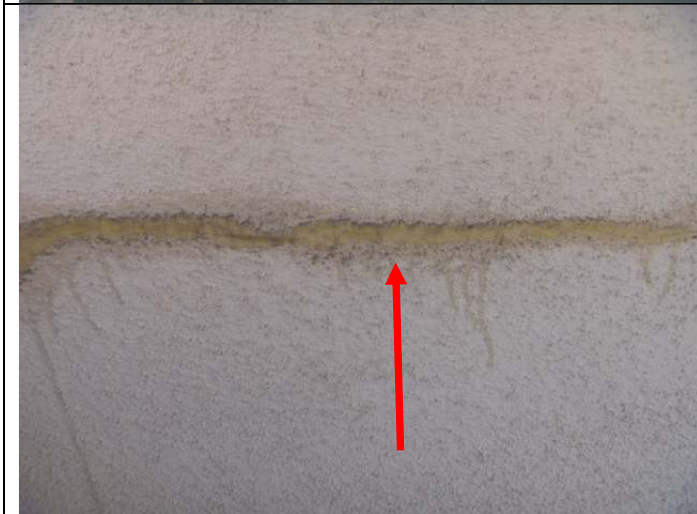
Fireplace damper in the closed position.

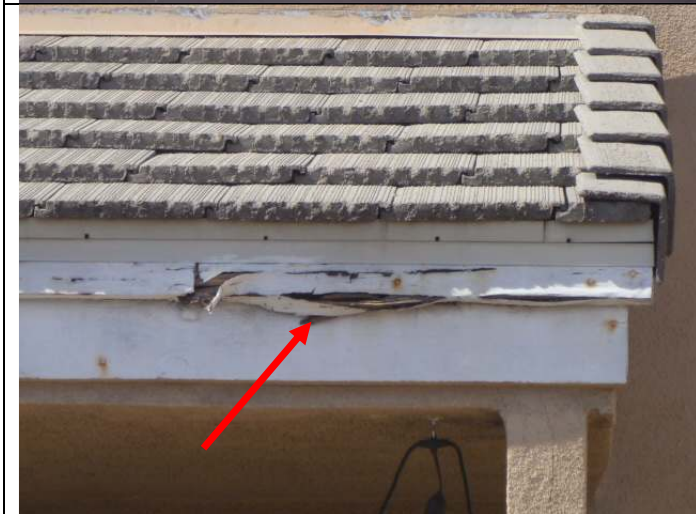
Example of damaged wood.

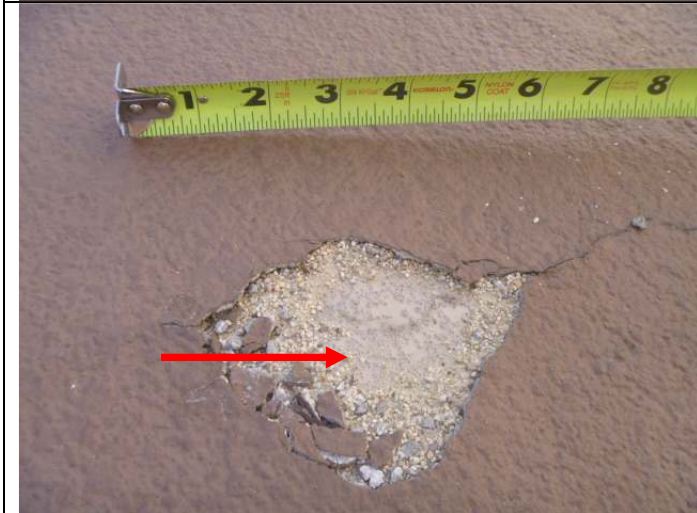
Courtyard surface damage.

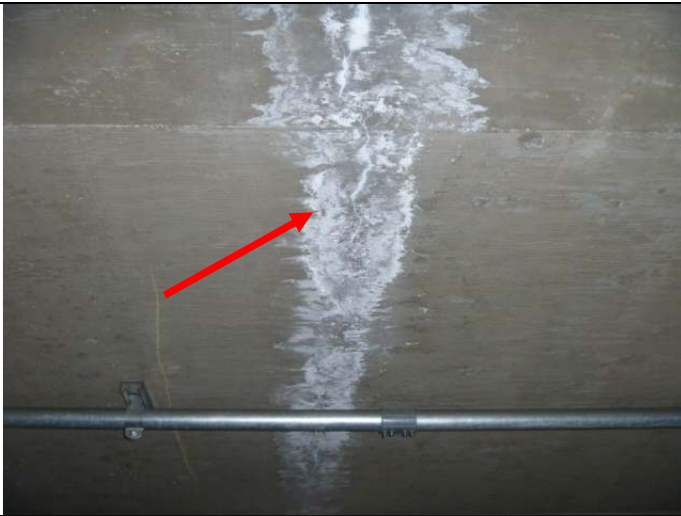
<p>Moisture related efflorescence of the garage ceiling (below the courtyard).</p>

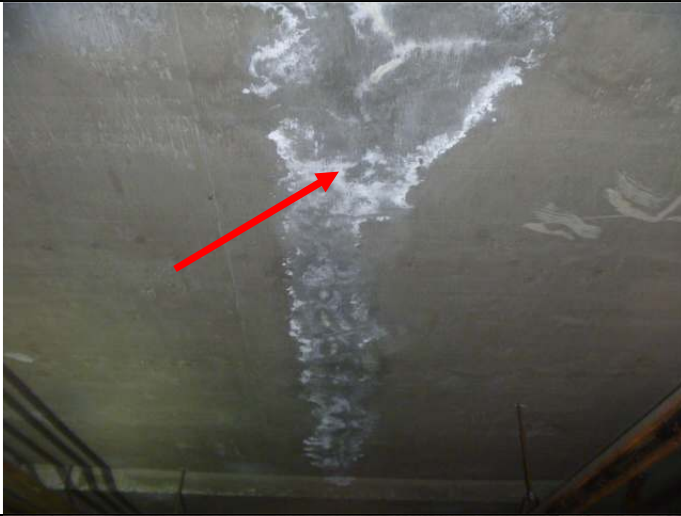
<p>Moisture related efflorescence of the garage ceiling (below the courtyard).</p>

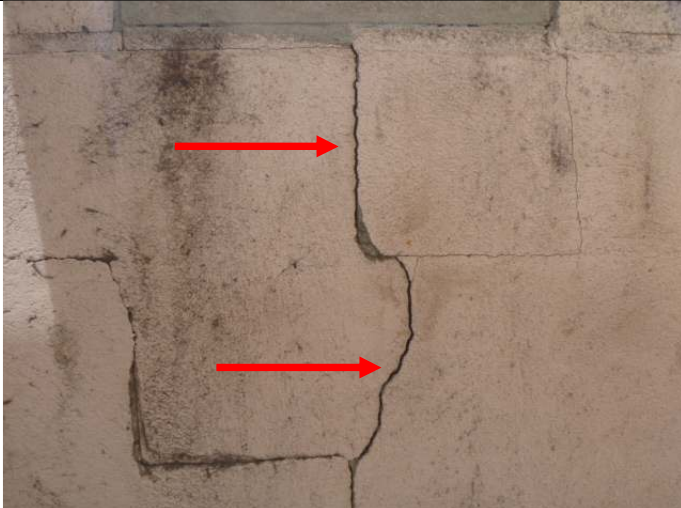
<p>Cracks in the west block wall.</p>

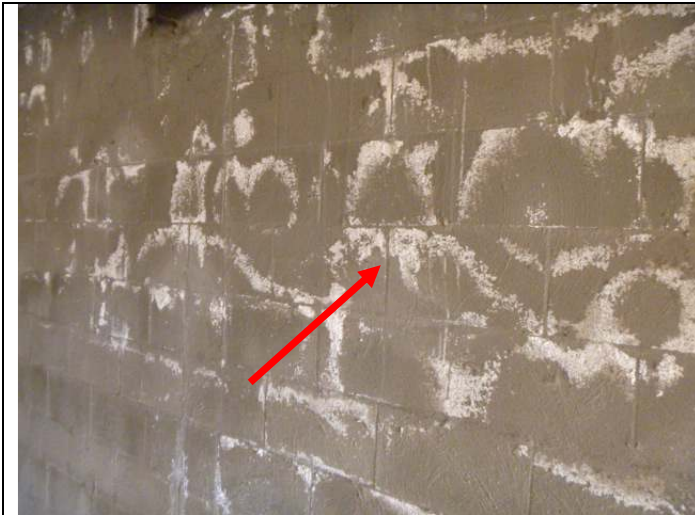
Moisture related efflorescence of the garage east wall.

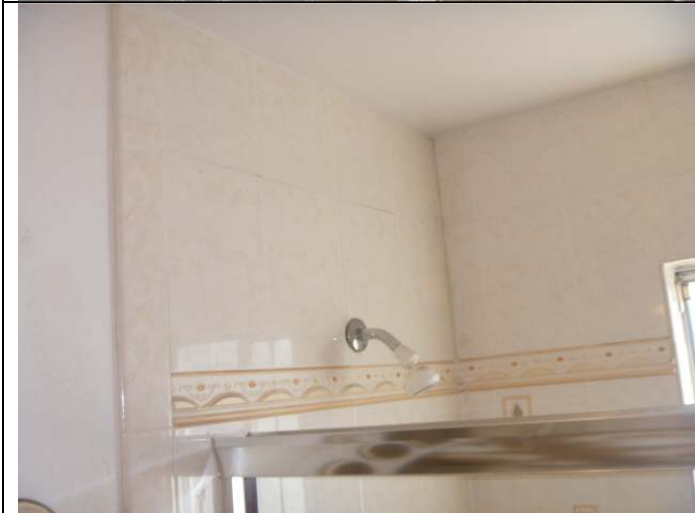
Full bathroom shower/tub. Note: The tiles backing type was not determined.

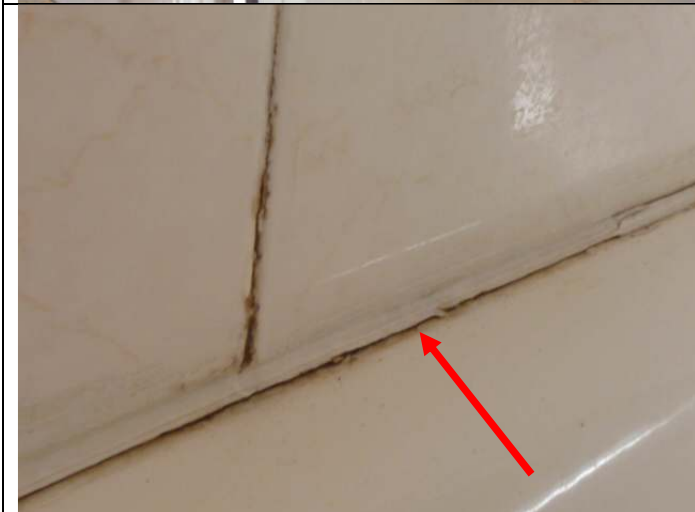
Cracked sealant along the perimeter of the tub.

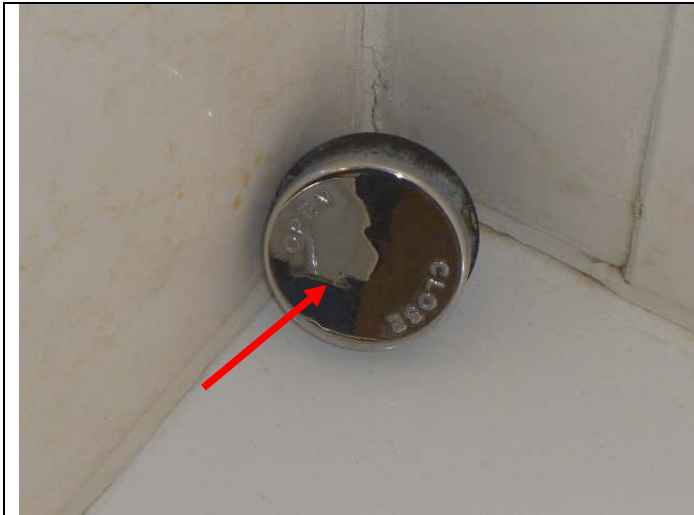
Tub stopper (screw-in type) not installed.

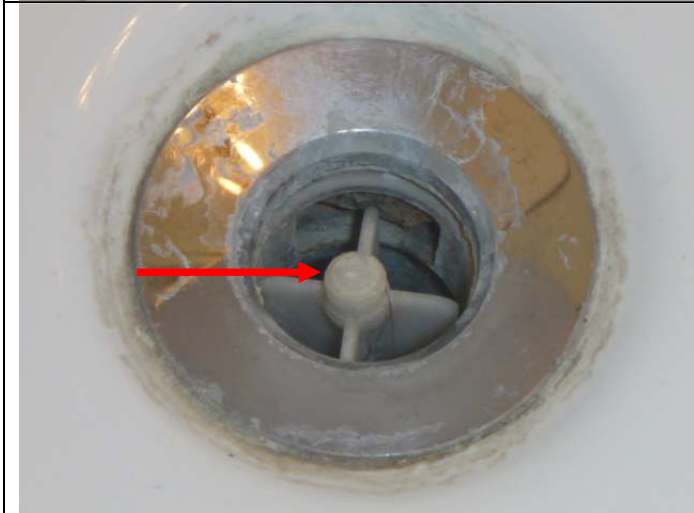
Full bathroom sink stopper with missing top piece.

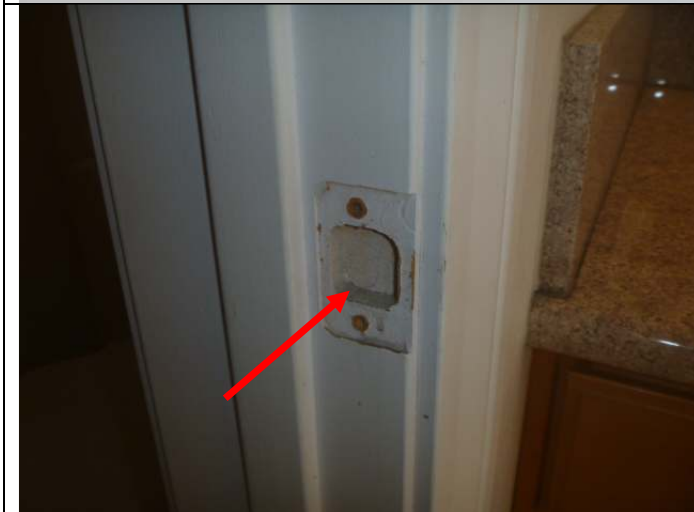
Missing strike plate for the door leading to the full bathroom toilet area.

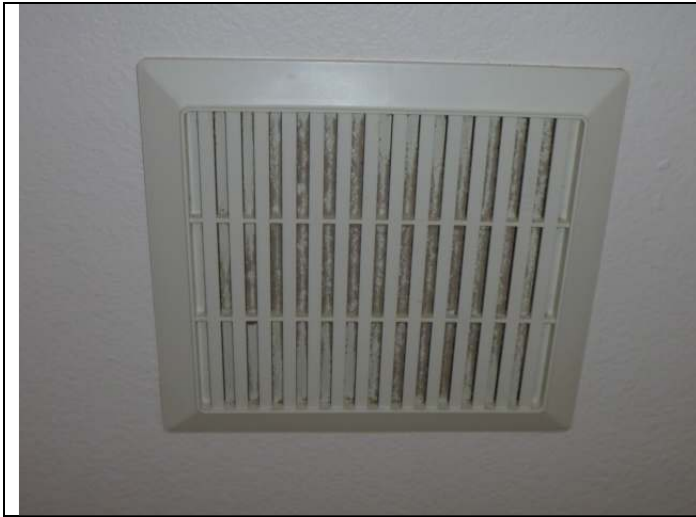
Full bathroom vent fan (which is relatively noisy).

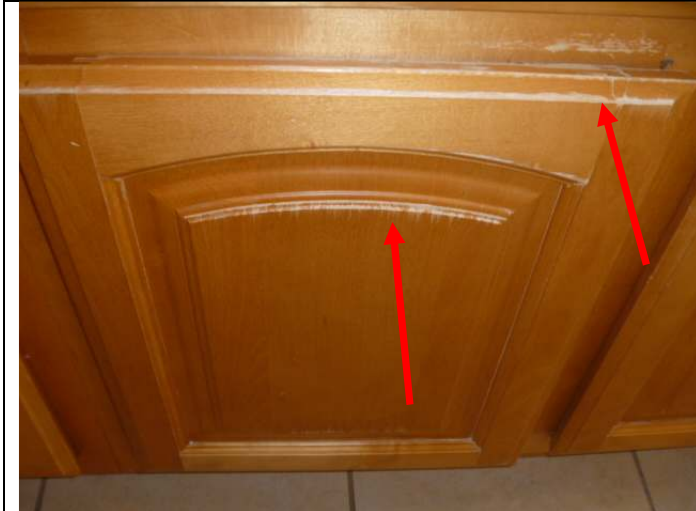
Full bathroom sink cabinet wear.

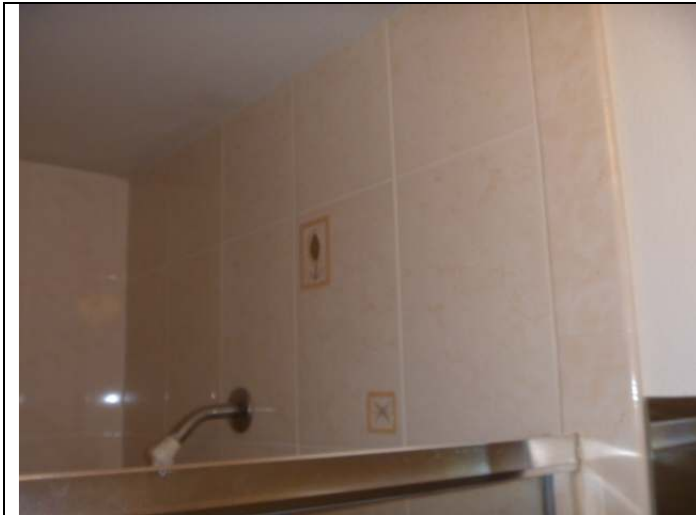
Upstairs 3/4 bathroom shower.  
Note: The tiles backing type was not determined.

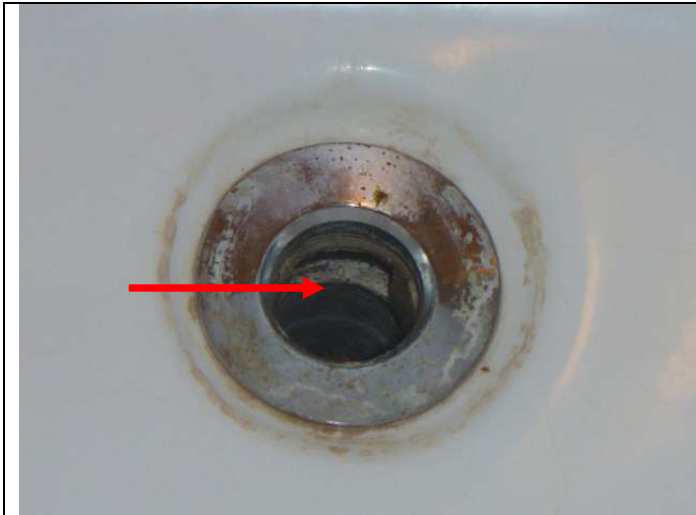
Upstairs 3/4 bathroom missing sink stopper.

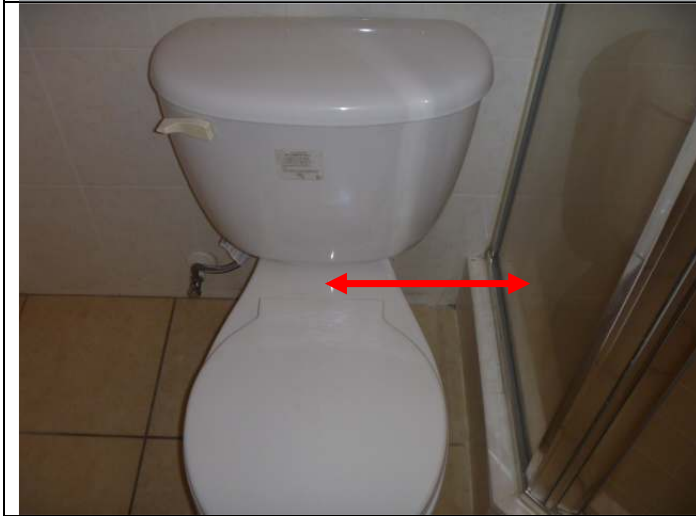
Upstairs 3/4 bathroom toilet relatively close to the shower enclosure.

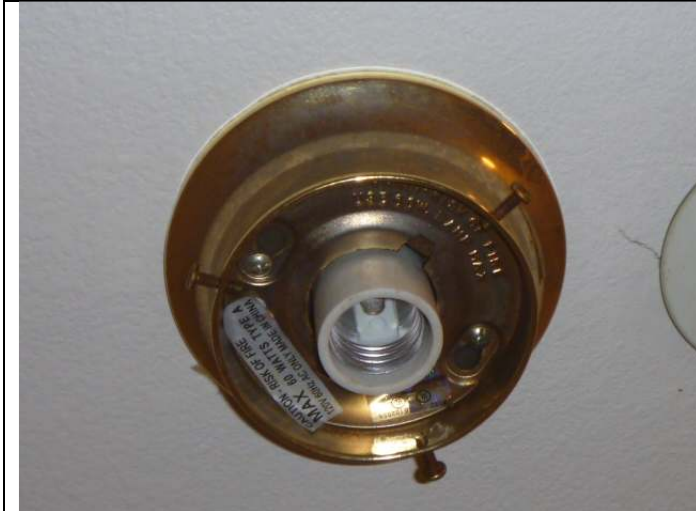
Upstairs 3/4 bathroom ceiling light fixture with missing cover.

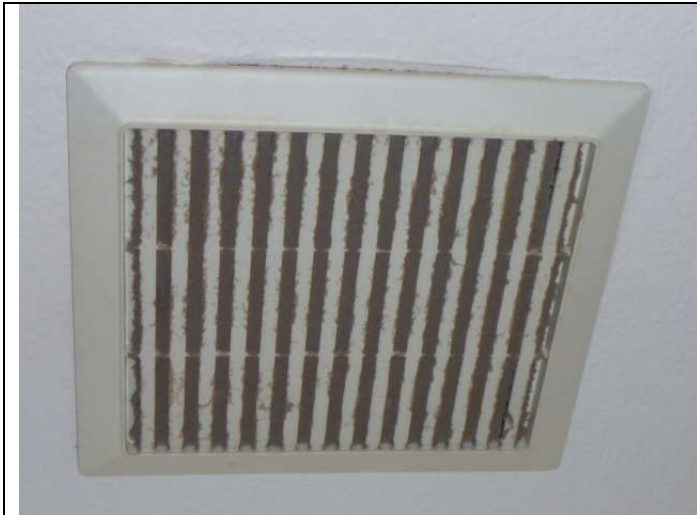
Upstairs 3/4 bathroom vent fan (which is relatively noisy).

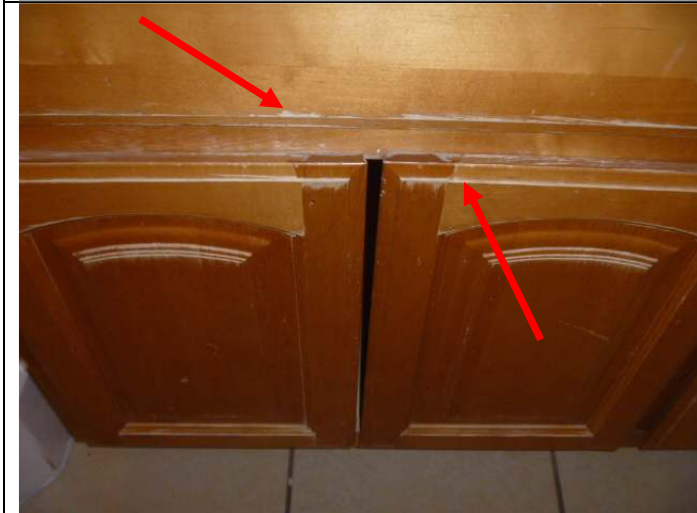
Upstairs 3/4 bathroom sink cabinet wear.

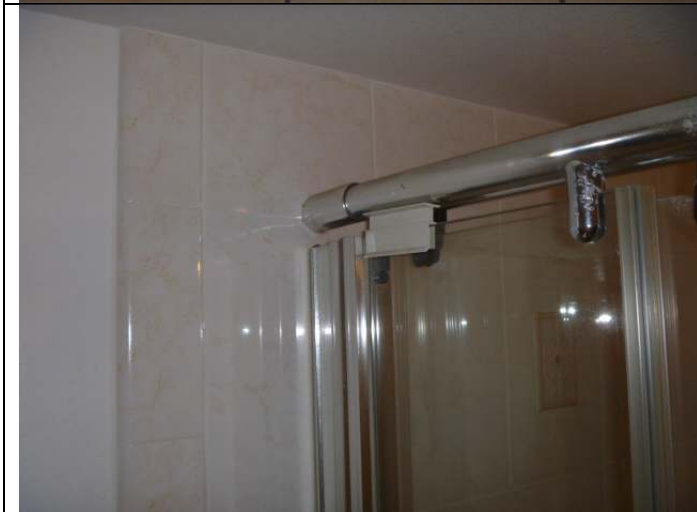
Downstairs bathroom shower. Note: The tiles backing type was not determined.

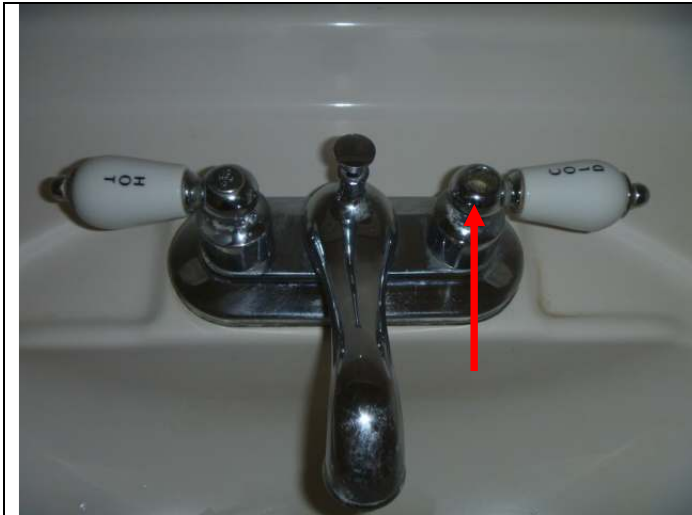
Downstairs 3/4 bathroom sink faucet. Note: The missing handle cap piece.

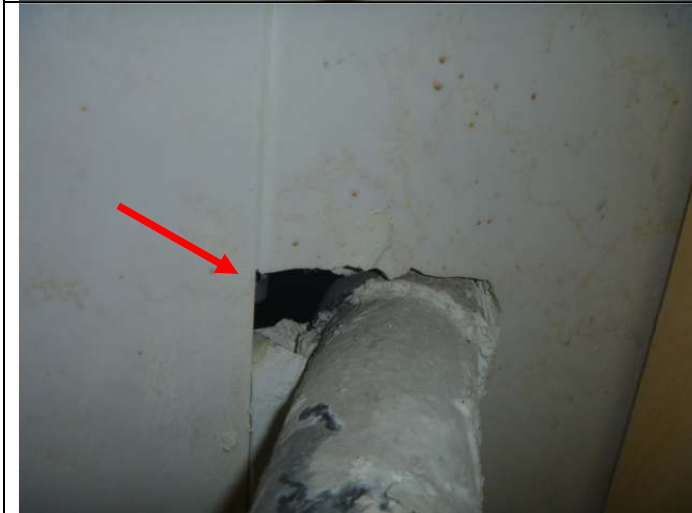
Gap in the wall at the drain pipe below the downstairs 3/4 bathroom sink.

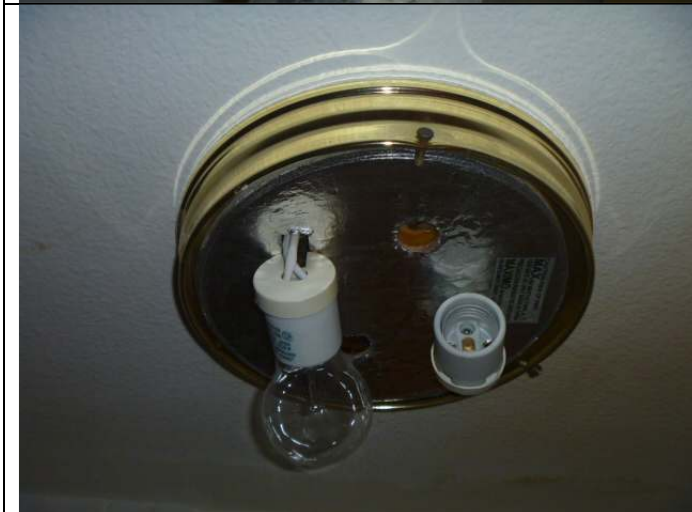
Downstairs bathroom light fixture with missing cover.

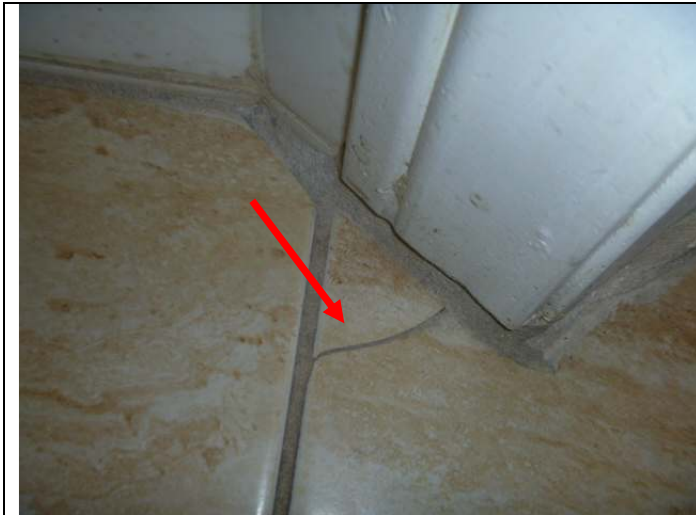
Cracked floor tile to the left of the downstairs 3/4 bathroom entry door.

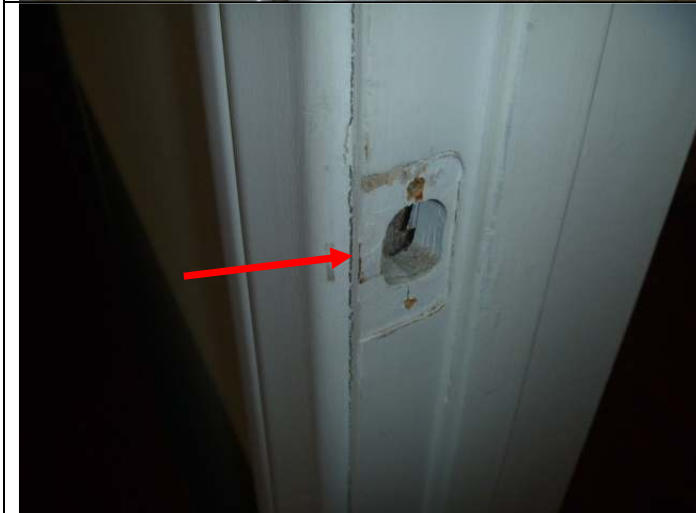
Missing strike plate for the west bedroom entry door.

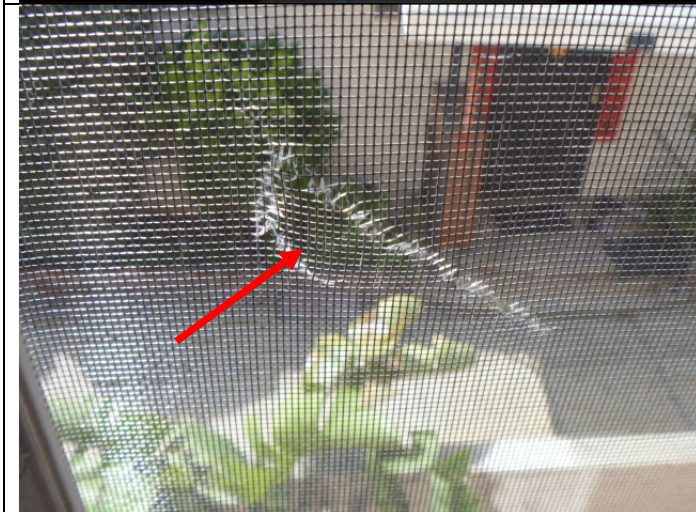
West bedroom torn window screen.

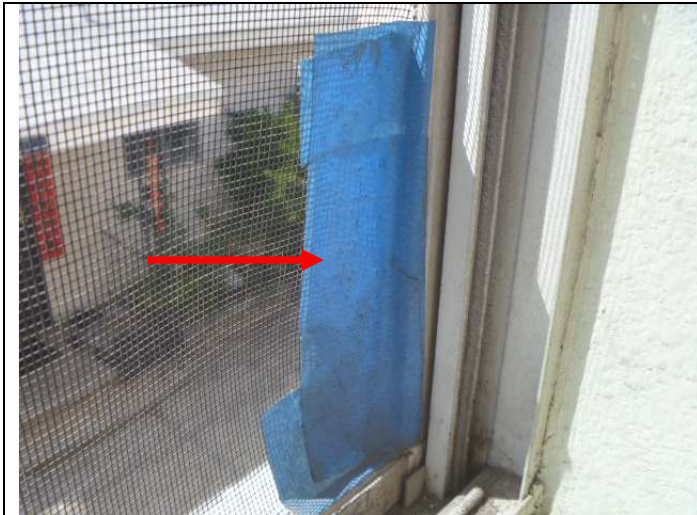
West bedroom window screen repair.

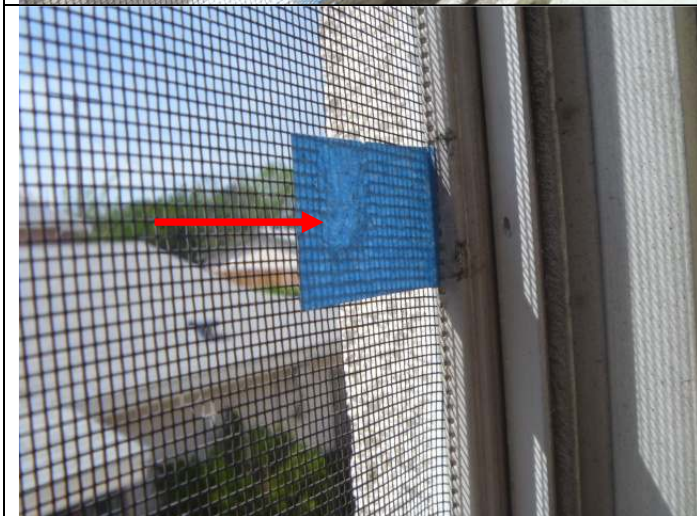
West bedroom window screen repair.

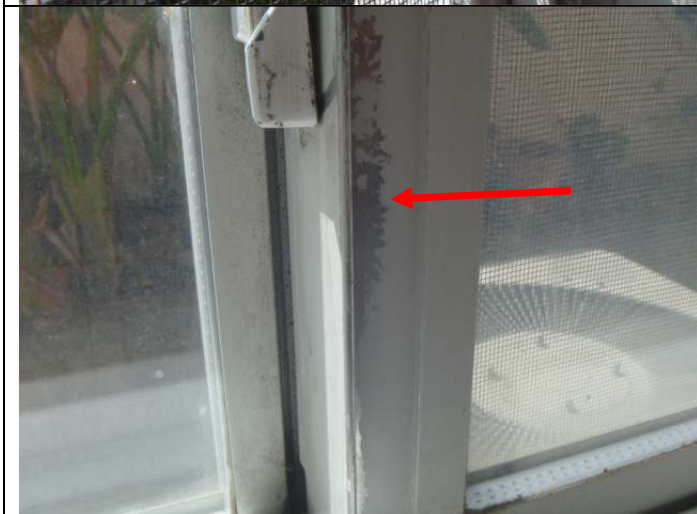
Downstairs bedroom window surface damage.

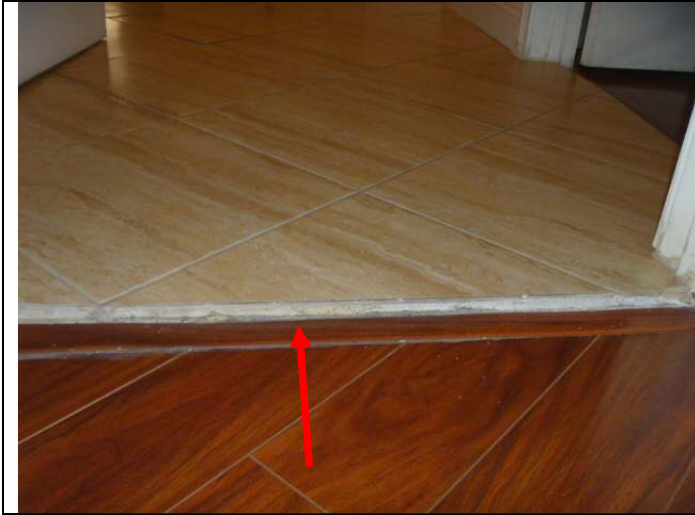
Step along the downstairs bedroom entry doorway.

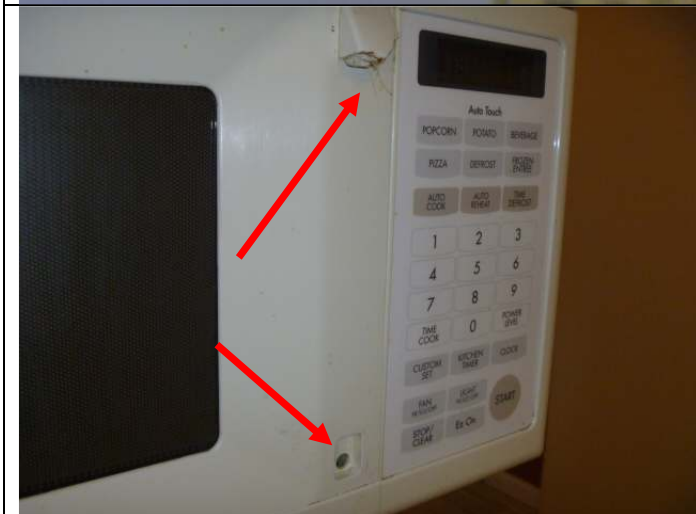
Microwave broken off handle.

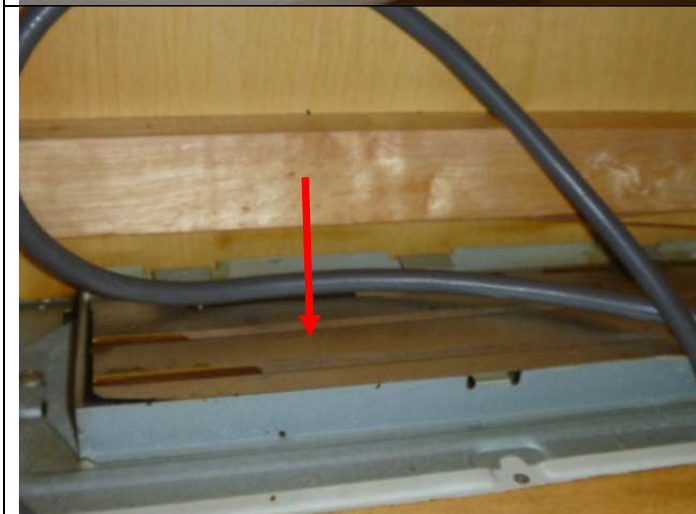
Microwave vent fan venting into the above cabinet.

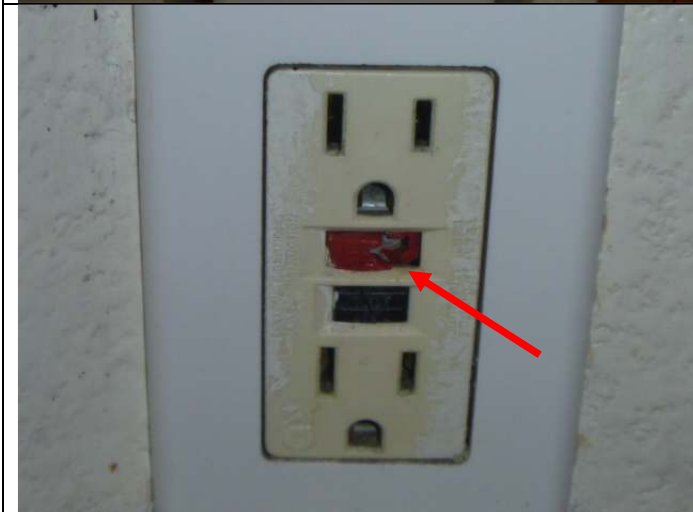
Damaged ground fault circuit interrupter (GFCI) receptacle to the right of the sink.

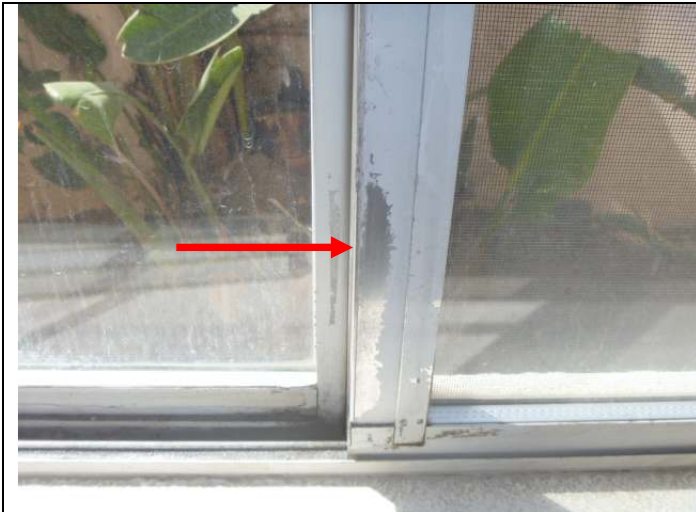
Kitchen window surface damage.

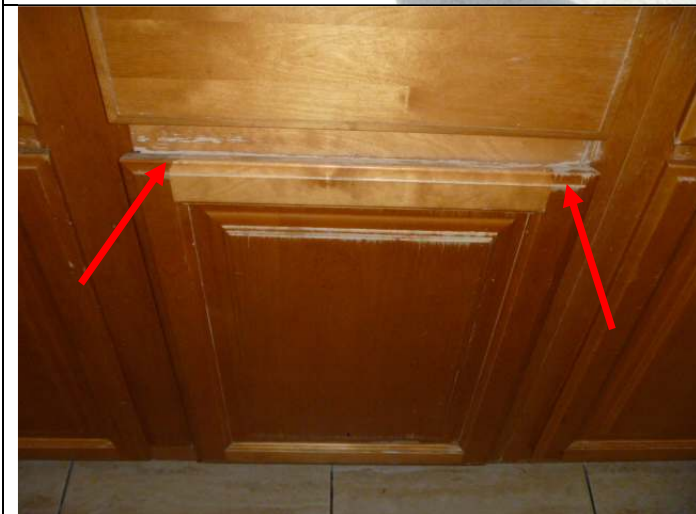
Kitchen cabinet door.

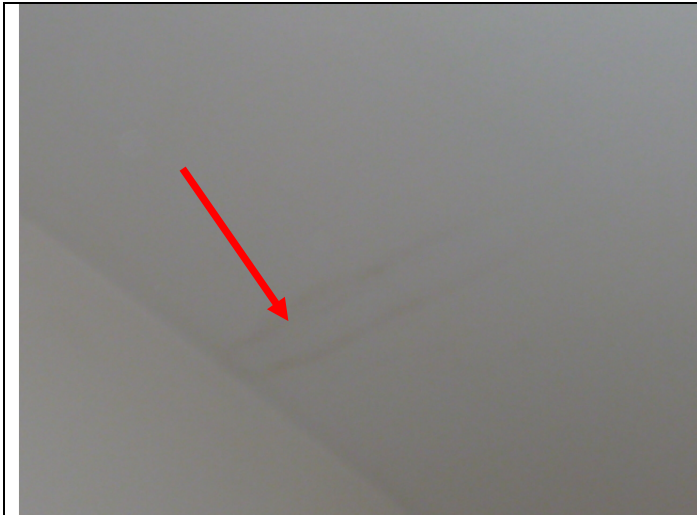
Moisture related discoloration in the living room ceiling at the west wall.

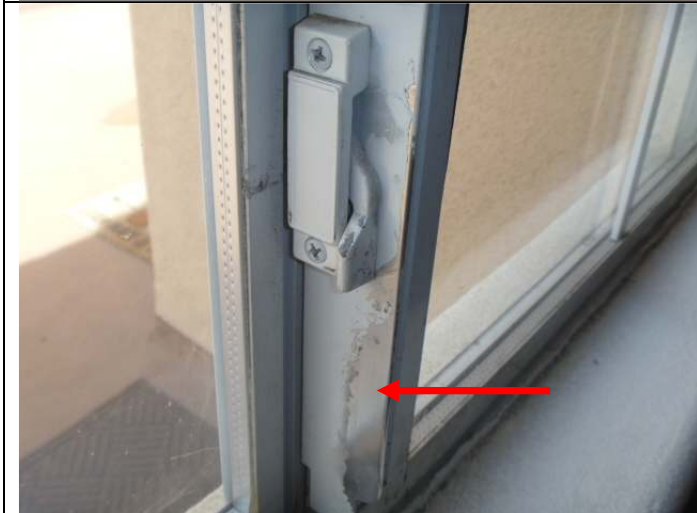
Dining room window surface wear.

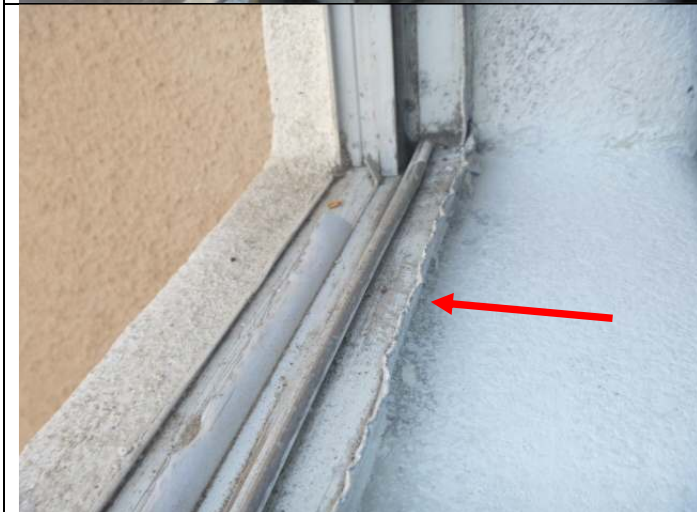
Dining room window bent lower track.

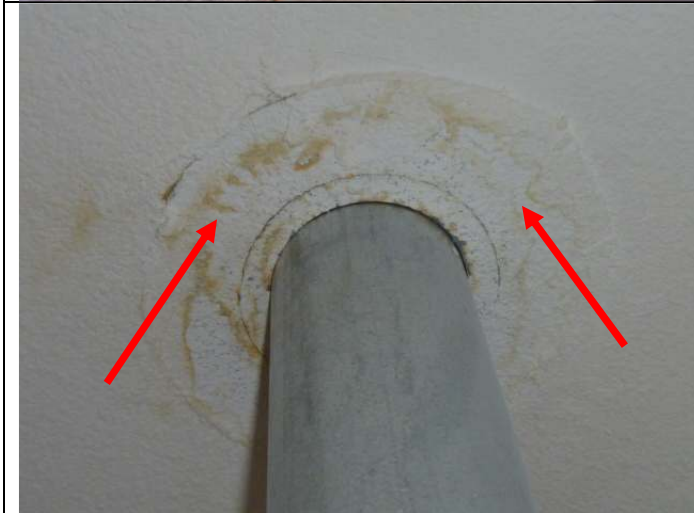
Moisture related discoloration in the laundry room ceiling at the water heater vent pipe.

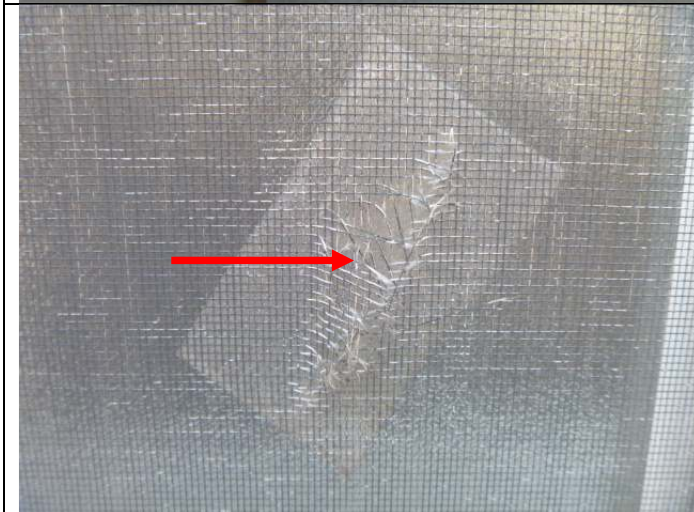
Kitchen torn window screen with transparent tape.

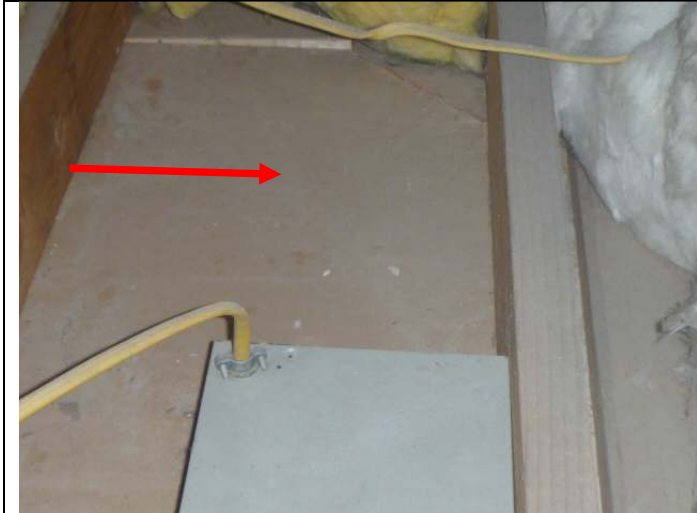
Area of missing attic insulation.

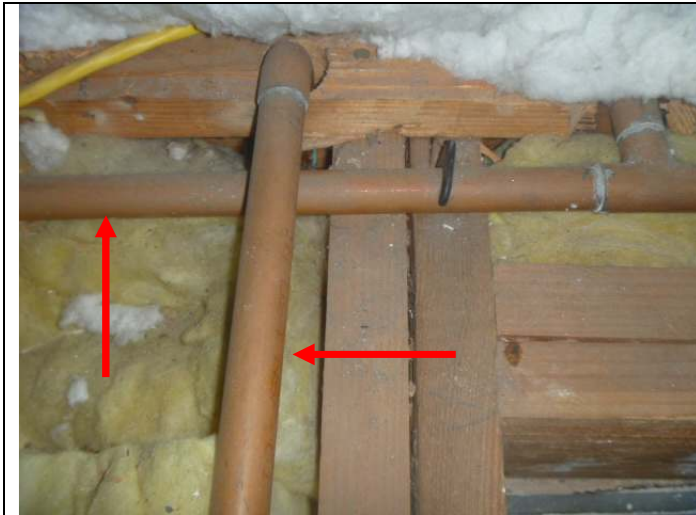
Copper water piping routed through the attic.

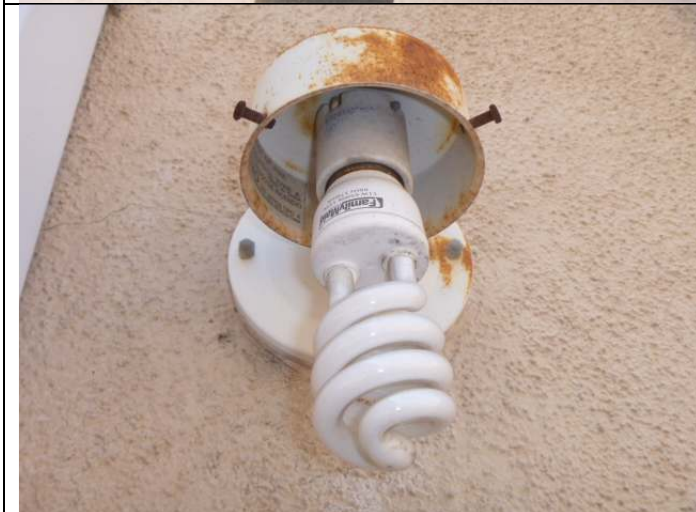
Missing light exterior light fixture to the right of the living room exterior door.

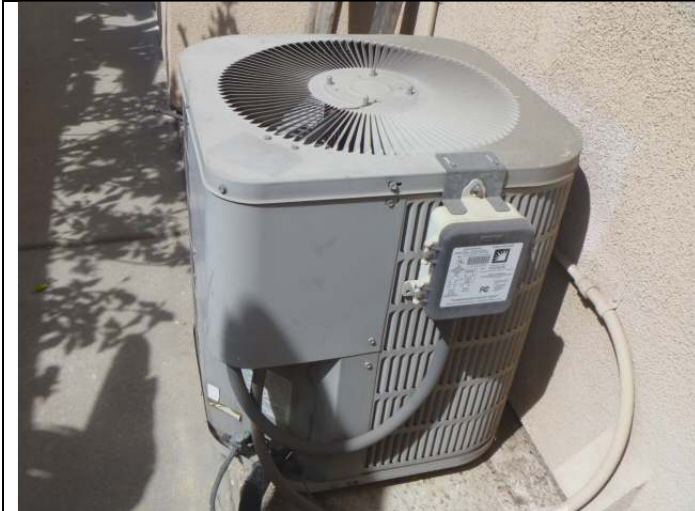
Air conditioner condensing unit.

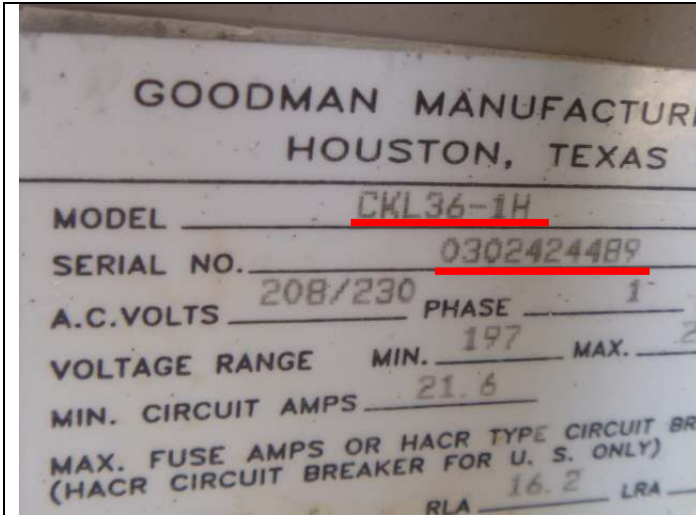
Air conditioner model and serial numbers (indicating a 2003 build date).

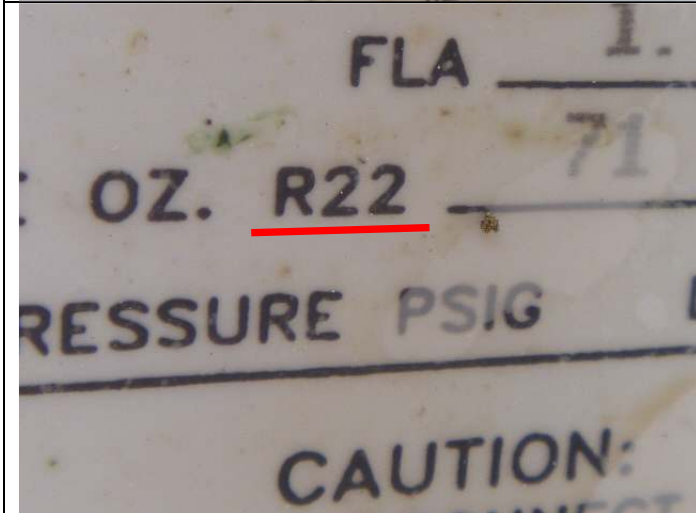
Air conditioning refrigerant type (obsolete R-22).

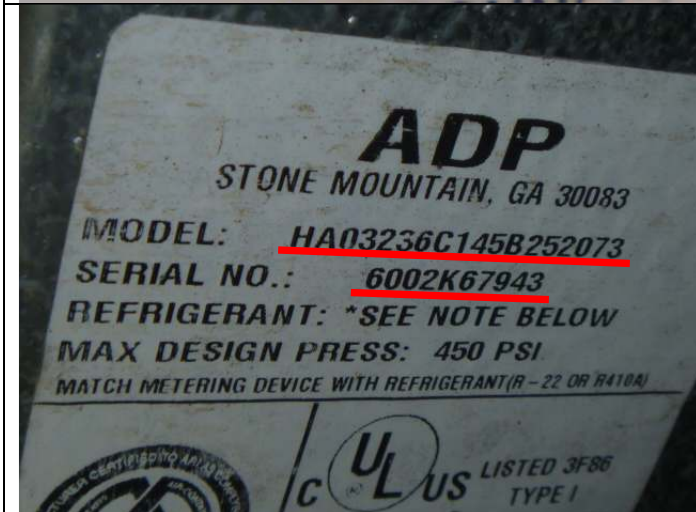
Air condition coil model and serial numbers (indicating a 2002 build date).

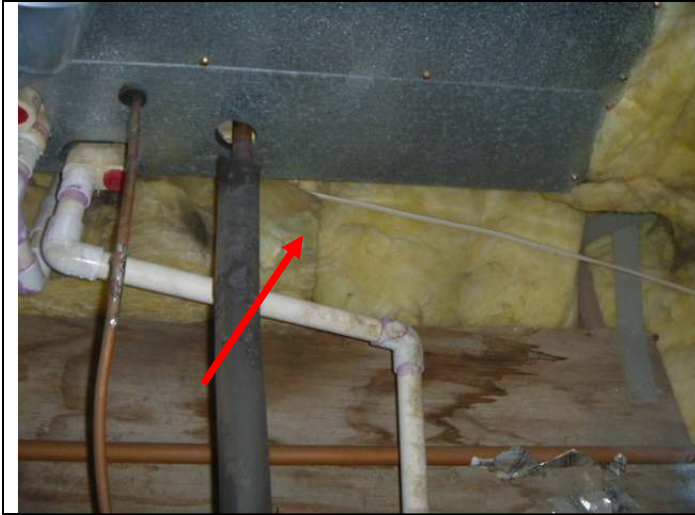
Air conditioner coil without a catch pan.

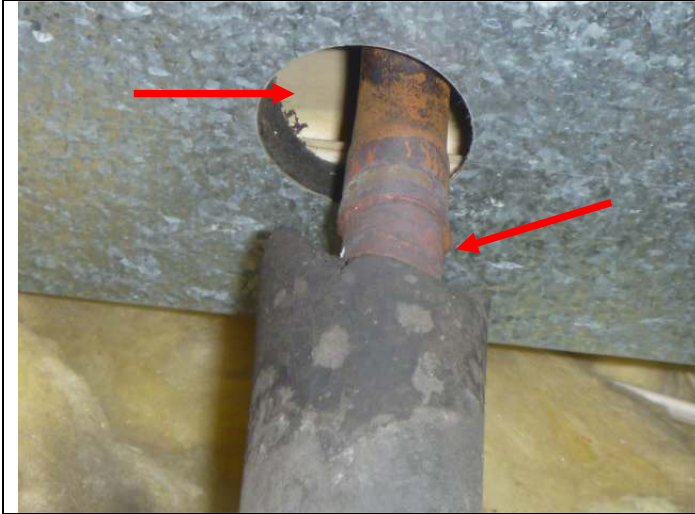
Gap in the air conditioner coil housing at the refrigerant suction line. Note: The missing section of refrigerant line insulation.
