WOOD DESTROYING PESTS AND ORGANISMS INSPECTION REPORT

Building No. 1534	Street HEIRLOOM AVE	City Perris	Zip 92571	Date of Inspection 02/04/26	Number of Pages 7
----------------------	------------------------	----------------	--------------	--------------------------------	----------------------

GENERAL DESCRIPTION: TWO STORY STUCCO RESIDENCE WITH 2CAR GARAGE ATTACHED TILE ROOF.	Inspection Tag Posted: GARAGE Other Tags Posted: NONE.
---	---

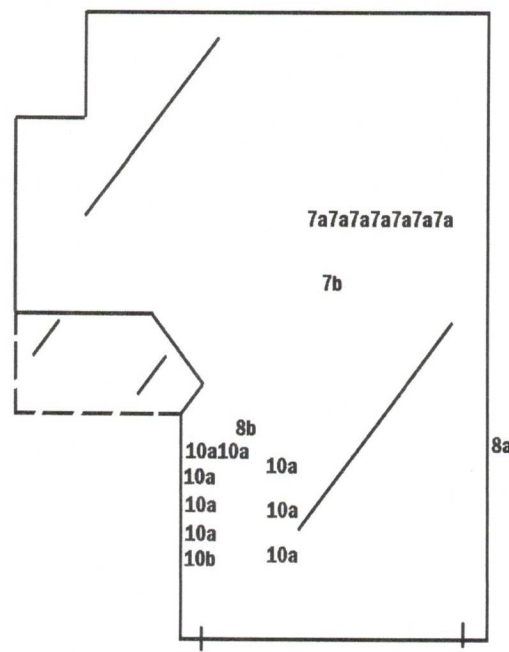
Diagram Not To Scale

7A FINDINGS: Evidence of dry-wood termite infestation.

7B FINDING - Dry-rot wood members visibly damage at time of inspection.

8A FINDING - Dry-rot wood members visibly damage at time of inspection noted on door.

8B FINDINGS: Water damage at time of inspection noted on water heater wall.

10A FINDINGS: Evidence of dry-wood termite infestation.

10B FINDING - TERMITE DAMAGE WOOD MEMBERS, NOTED AT TIME OF INSPECTION NOTED ON PLYWOOD FLOOR.

RECOMMENDATION: Vacate the premises and seal the structure. Fumigate the structure with a registered fumigant in accordance with the manufacturer's labels. Remove, mask or cover all visible and accessible pellets. Fumigation warranted for two years. Fumigation awareness notice must be signed prior to fumigation. See fumigation notice for terms and liabilities. Property must be accessible for fumigation process between three to four days. Bug Light Inc. is not liable for any costs to vacate or prepare property for any further work required or performed under warranty. We do not provide on-site security during fumigation procedure or after the tarps or seals are removed. We are not responsible for personal items and/or other items stolen or damaged due to burglary of the premises during fumigation.

RECOMMENDATION - Owner/Agent should engage the services of proper tradesman to replace dry-rot damaged wood member(s) noted in the above finding.

RECOMENDATION: Others to repair water damage as necessary.

RECOMMENDATION - Owner/Agent should engage the services of proper tradesman to replace/Repair Termite damaged wood member as noted.
