SB 326/721 3708 Baldwin Ave

Flagged Items:

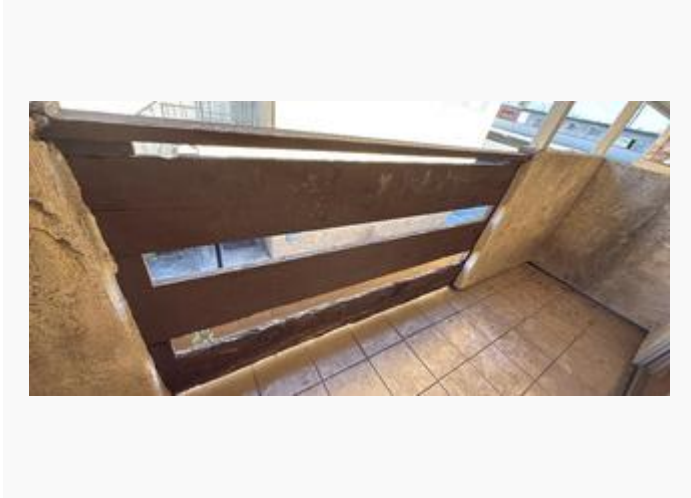
Railing/wall has got some wear and tear but still stable and secure

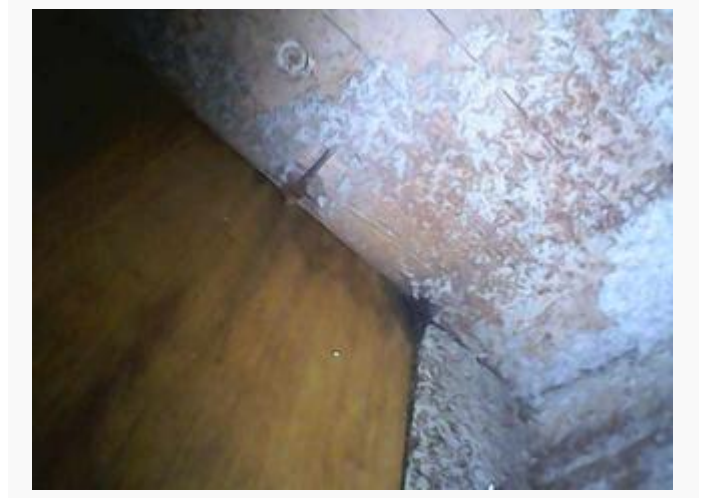
Structural integrity, good with no damage evident

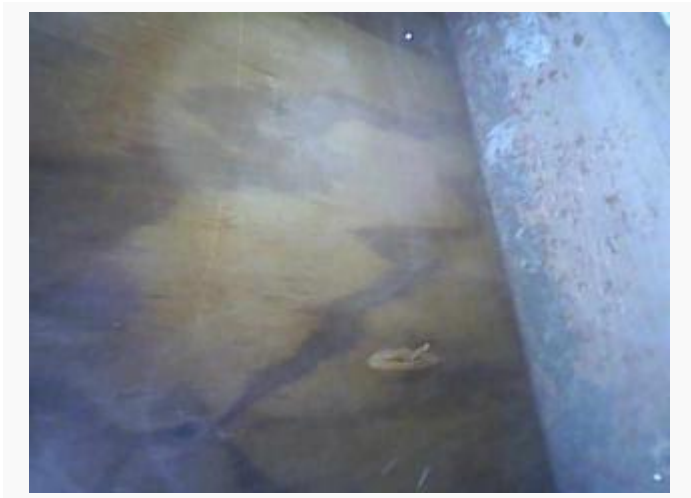
Interior dry with no signs of water intrusion and loadbearing elements are in good condition

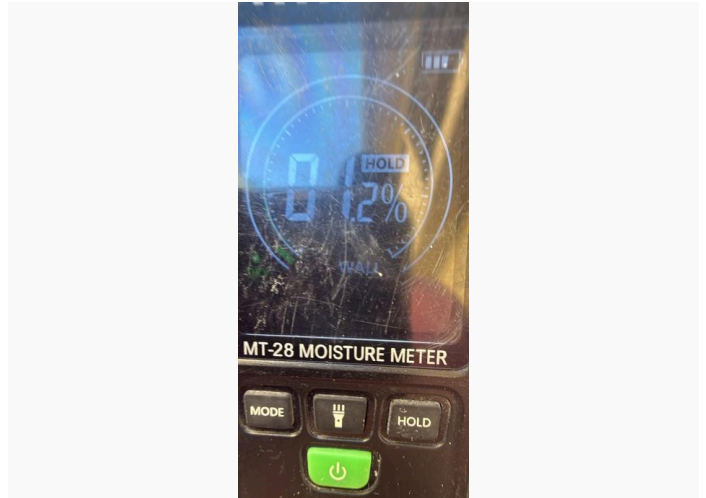
Capture_1769540545.jpg

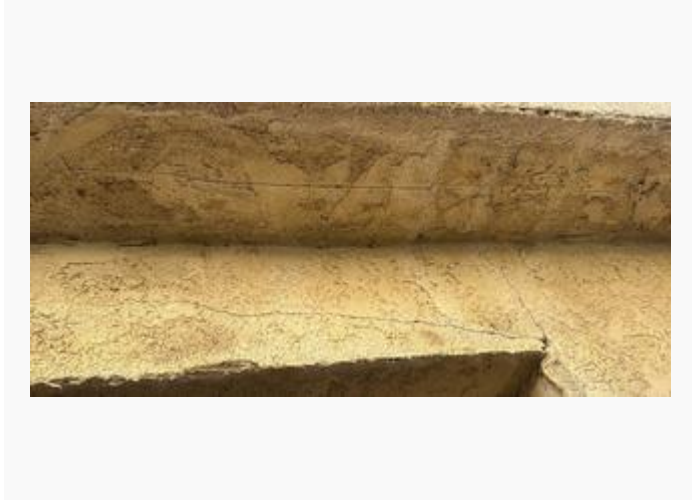
Minor cracking on under side of Balcony

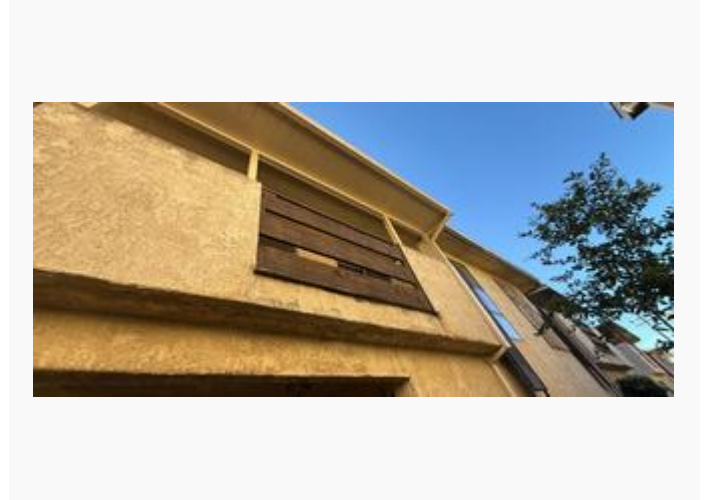
Exterior view shows minor, cracking, in Stucco

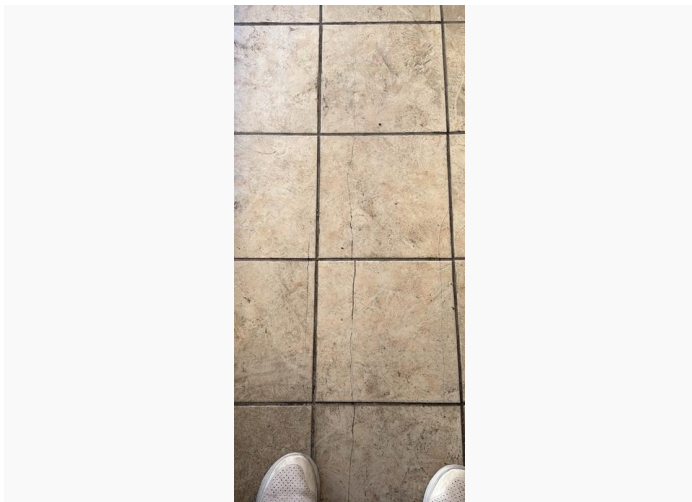
Close-up shows some minor cracking wood reseat with clearcoat or waterproofing recommended

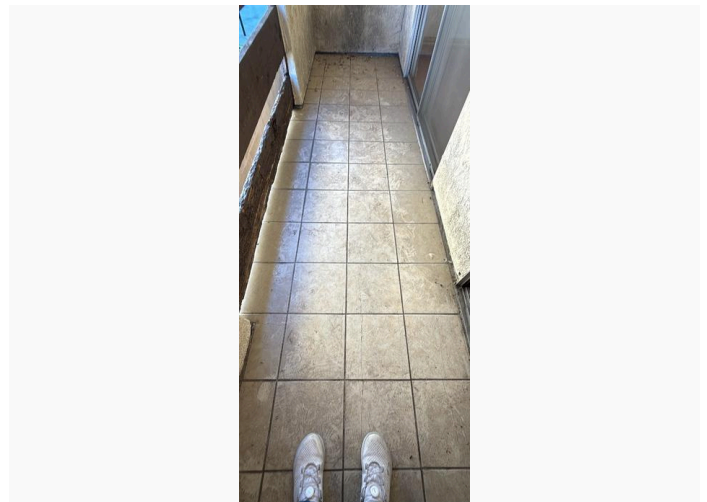
Tile in generally good condition, but some minor cracks

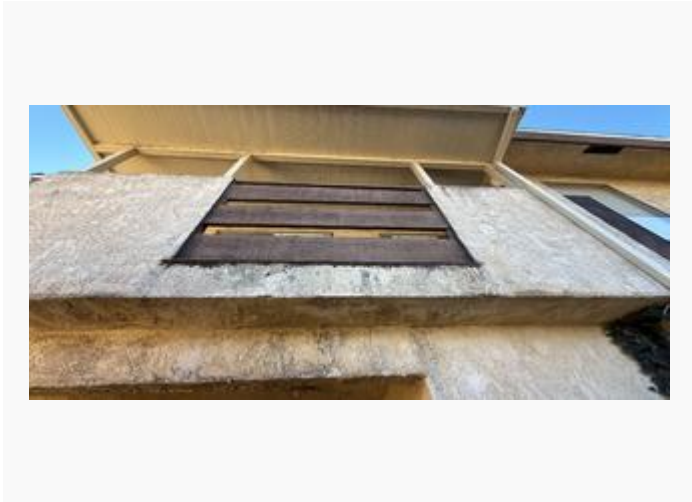
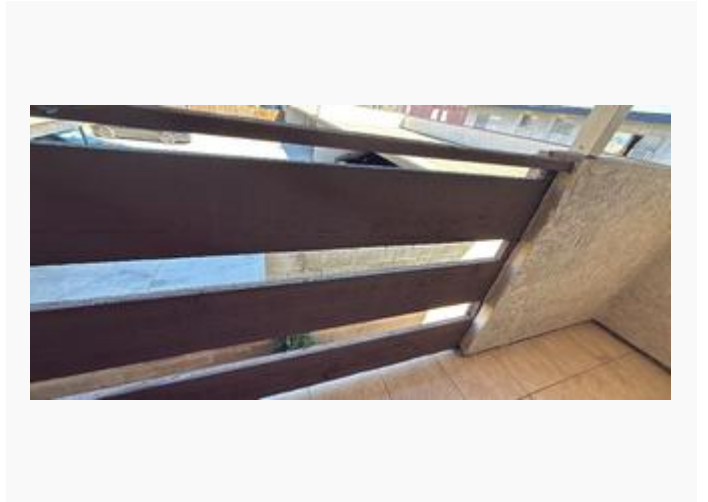
Exterior view shows no significant damage or problems

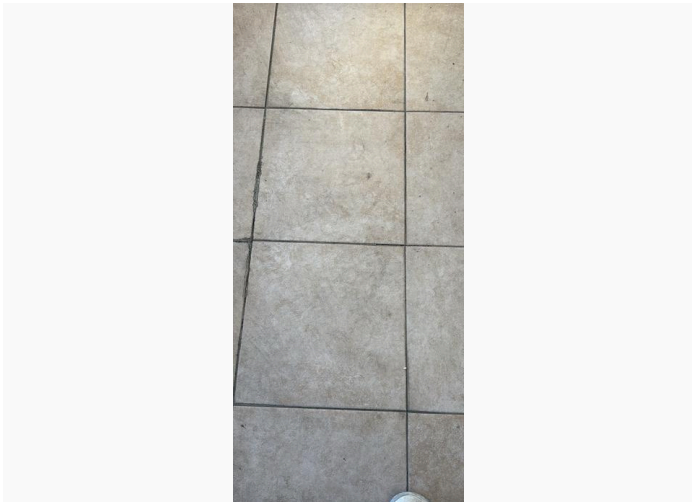
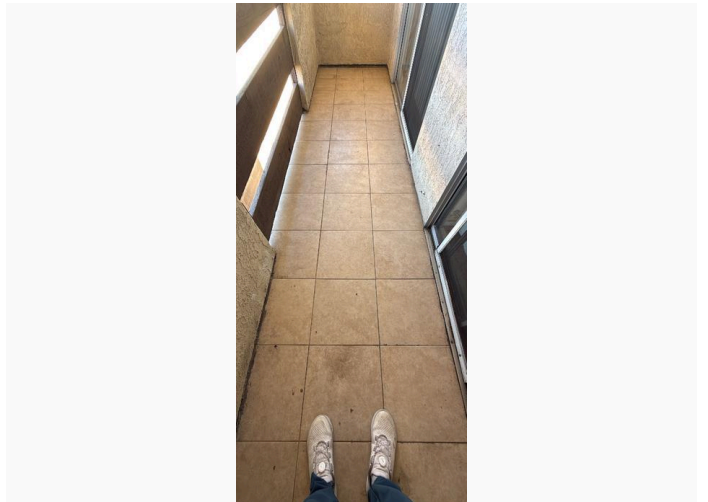
Tile floor in good condition

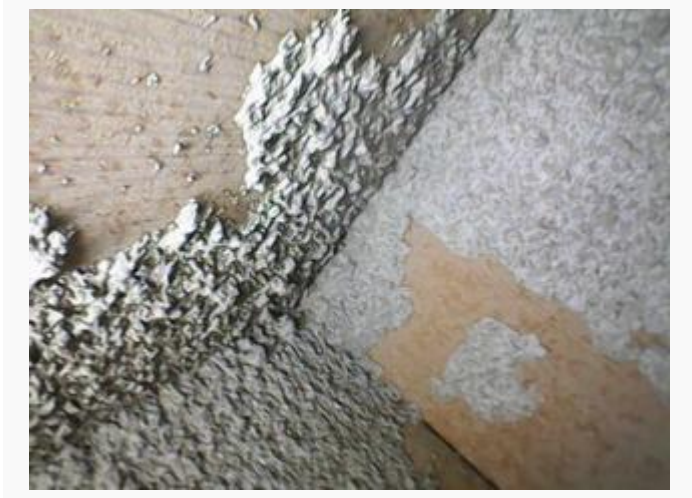
No signs of damage or excessive wear. Structural integrity is good.

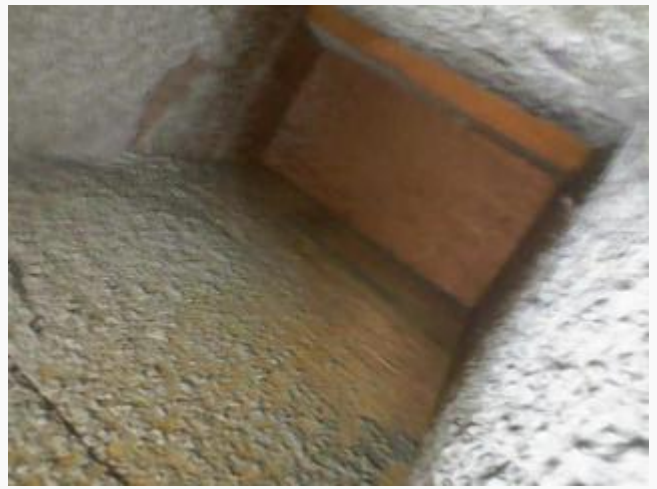
No signs of water intrusion, loadbearing elements, excellent

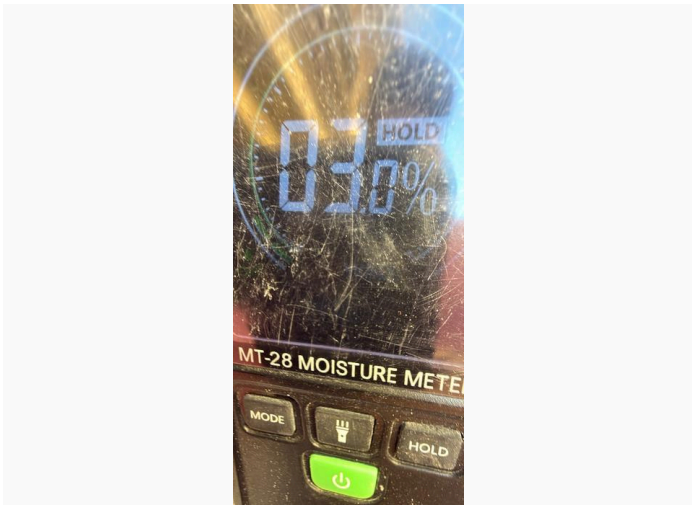
Capture_1769541803.jpg

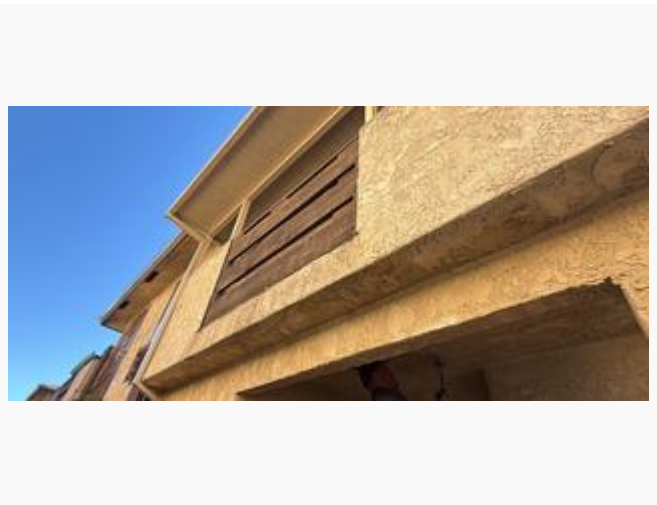
Exterior view shows no significant damage

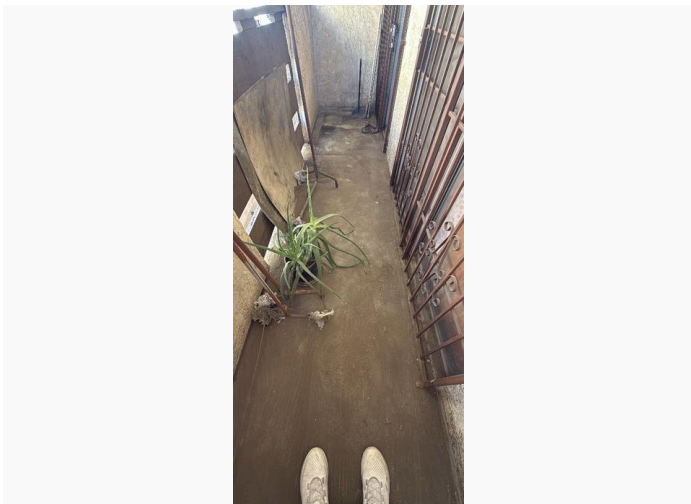
Deck floor has no significant damage or cracks

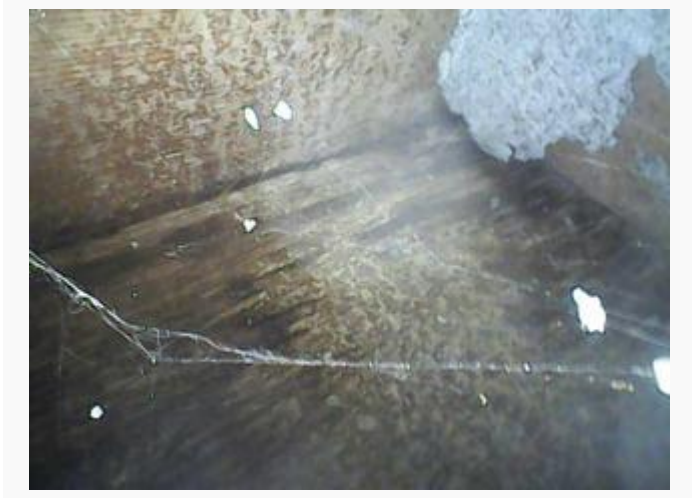
Minor signs of water intrusion, but no significant loadbearing damage

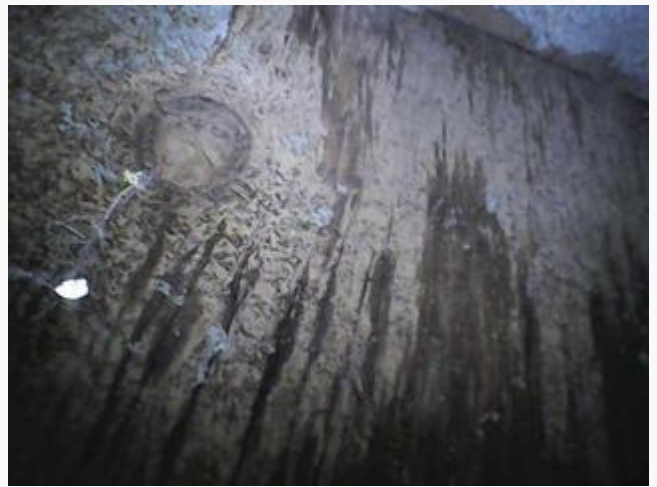
Some signs of water intrusion

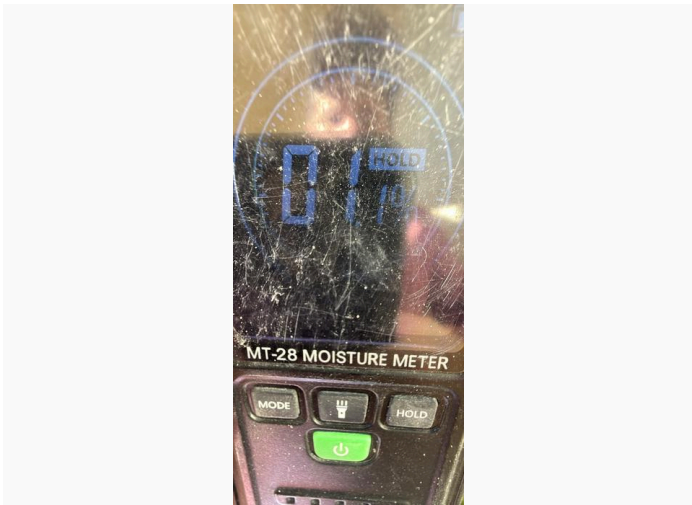
Capture_1769542620.jpg

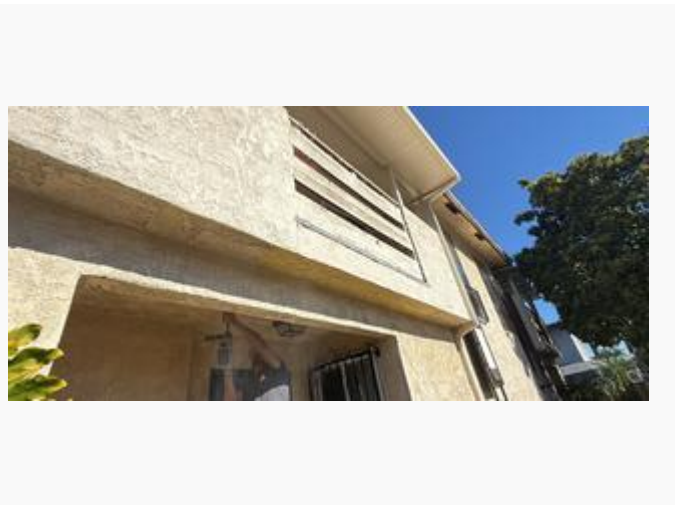
Exterior view shows no issues or damage

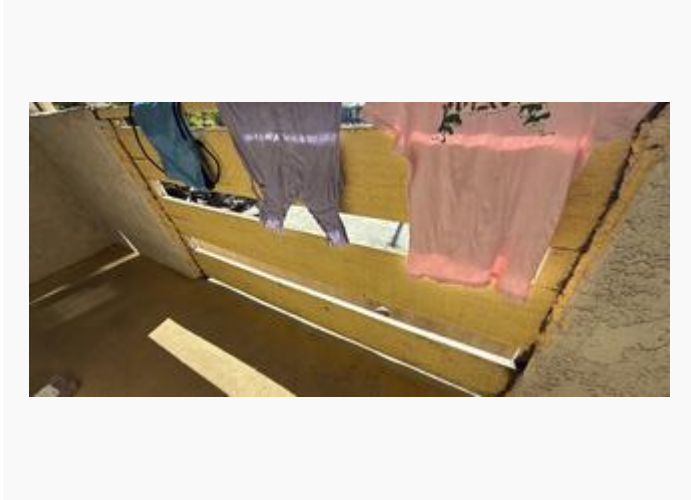
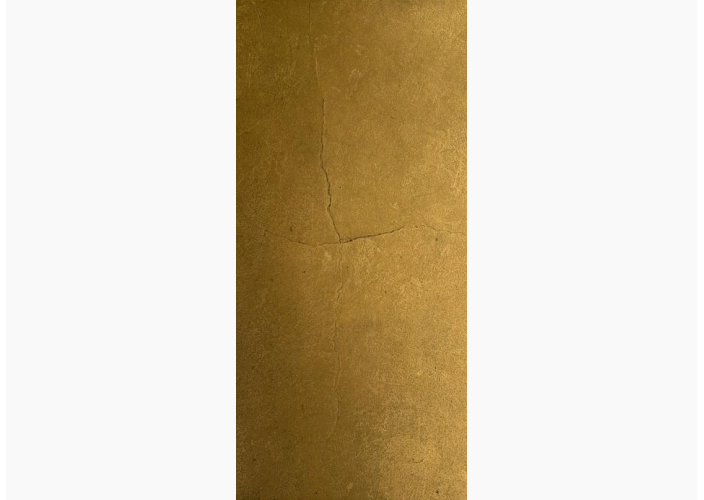
Wall/railing in good condition with no significant damage

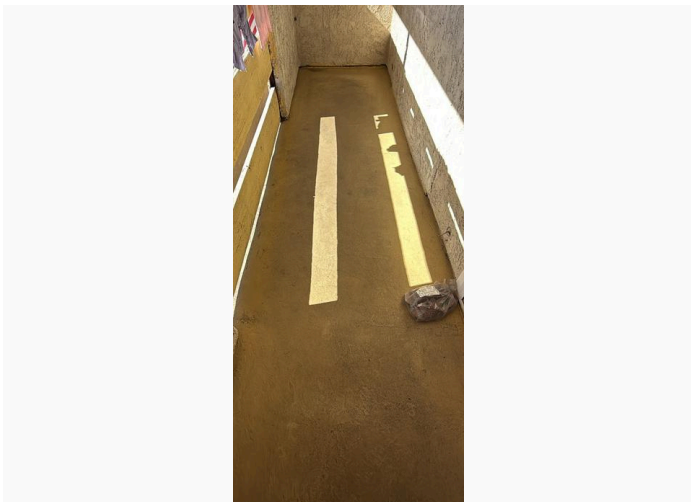
Deck surface in generally good condition with minor wear and tear

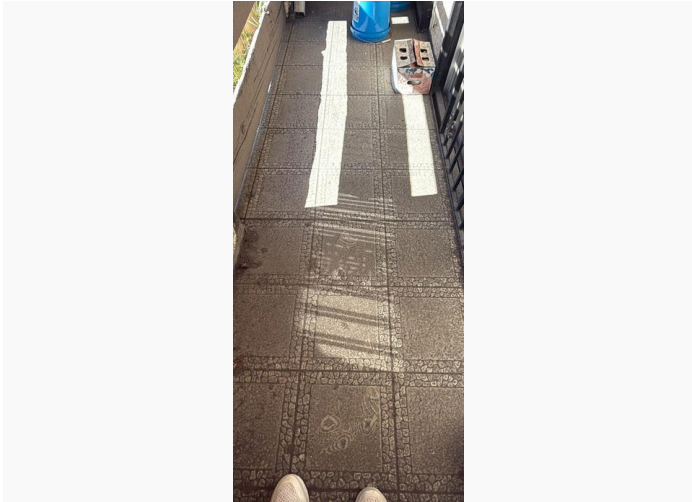
Deck needs some general maintenance, but structurally sound

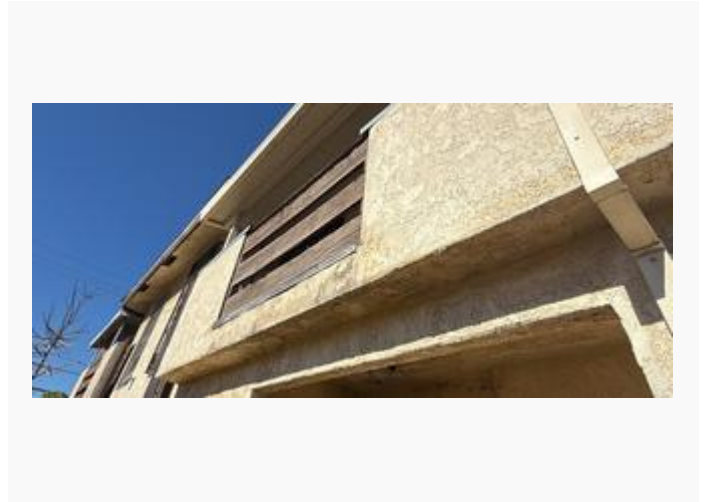
Exterior view shows no significant damage or problems

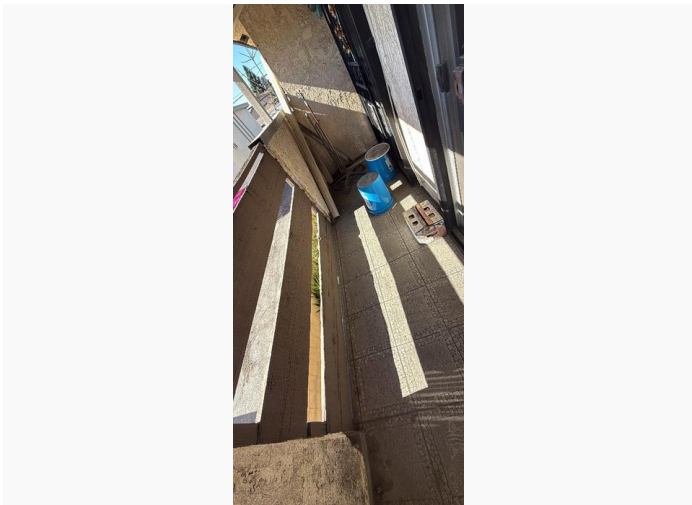
Structurally sound just in need of cleaning and waterproofing

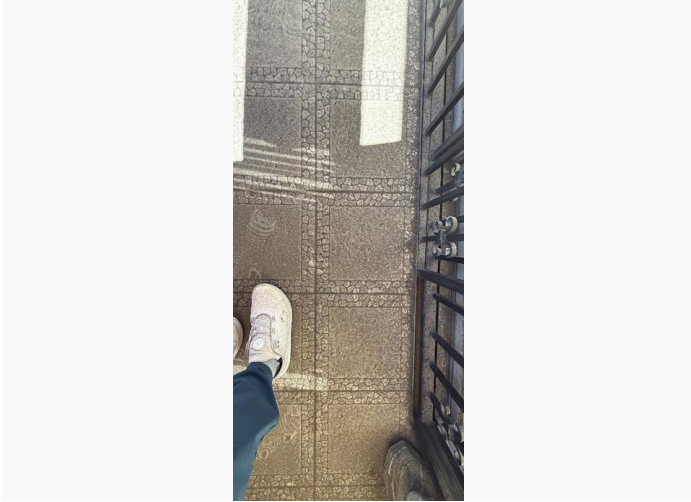
Tile floor in generally good condition, but could use a waterproofing, clearcoat and maintenance

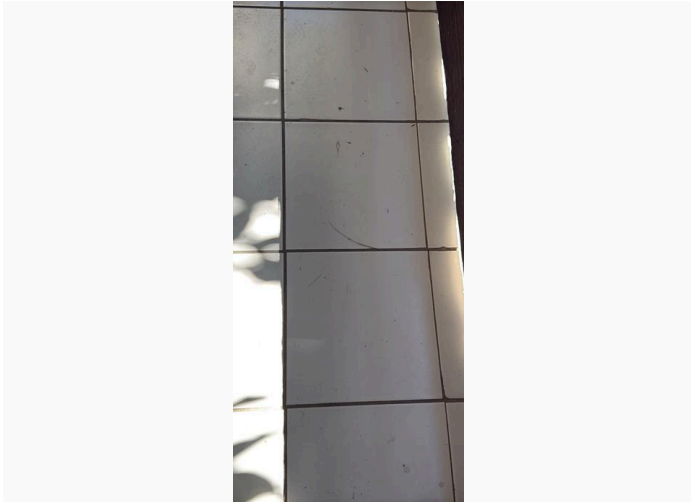
lacks waterproofing, but deck is in generally good condition

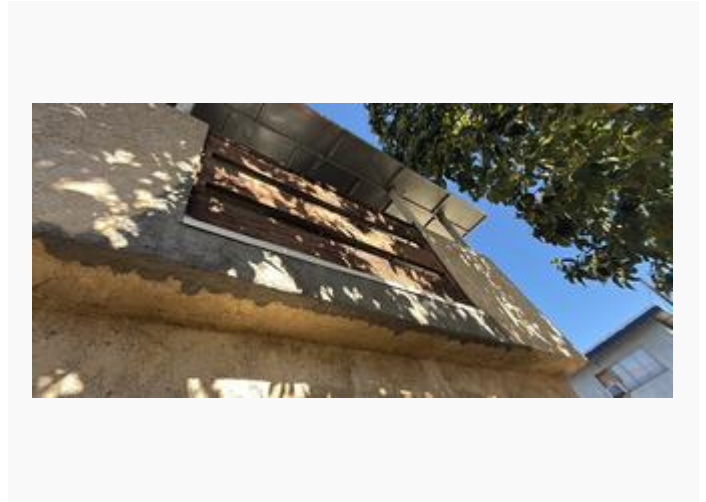
Stucco has been repaired recently

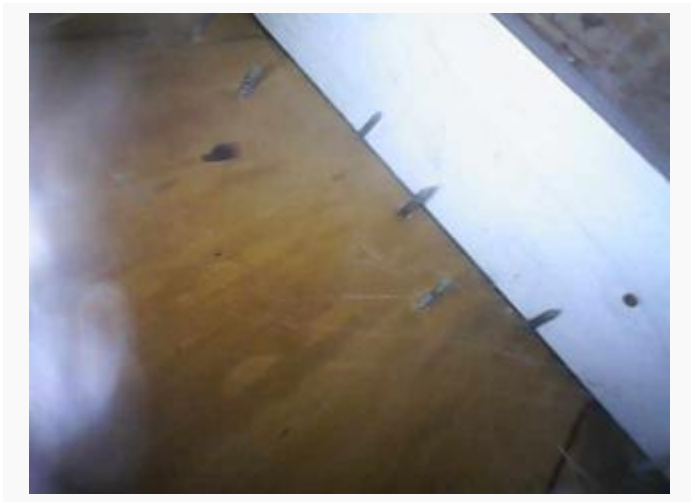
Structural integrity, good with no signs of water or damage

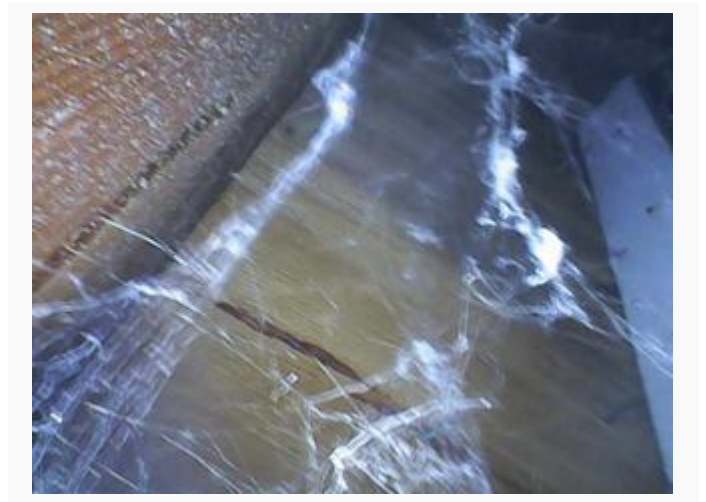
Interior shows no signs of water intrusion and loadbearing elements are good

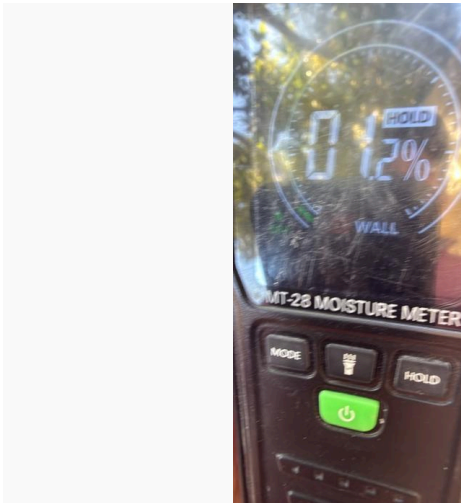
Capture_1769543092.jpg

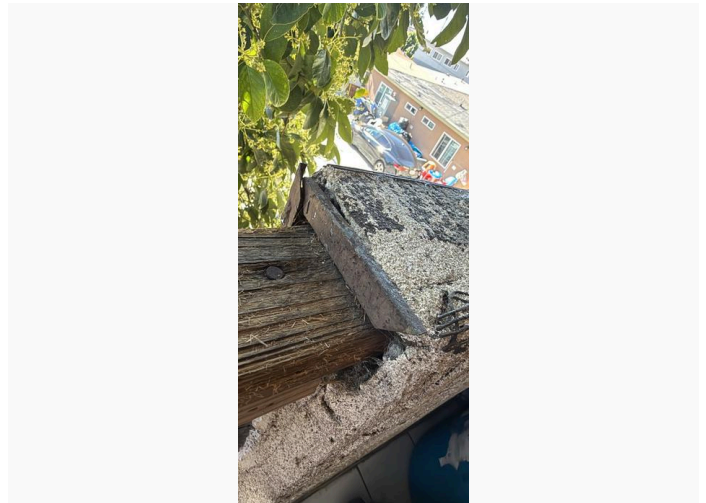
Sharp metal edges, potentially hazardous and needs to be fixed

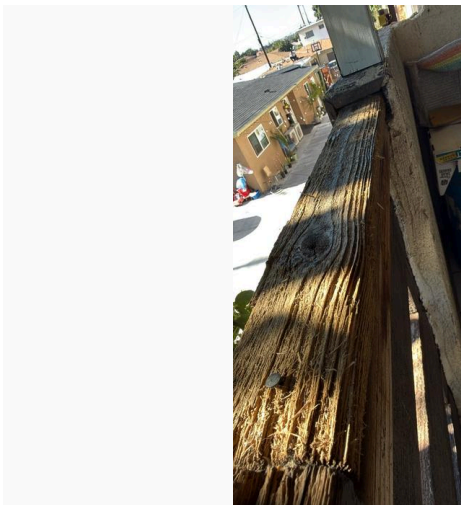
Exposed Rusty nails need to be addressed

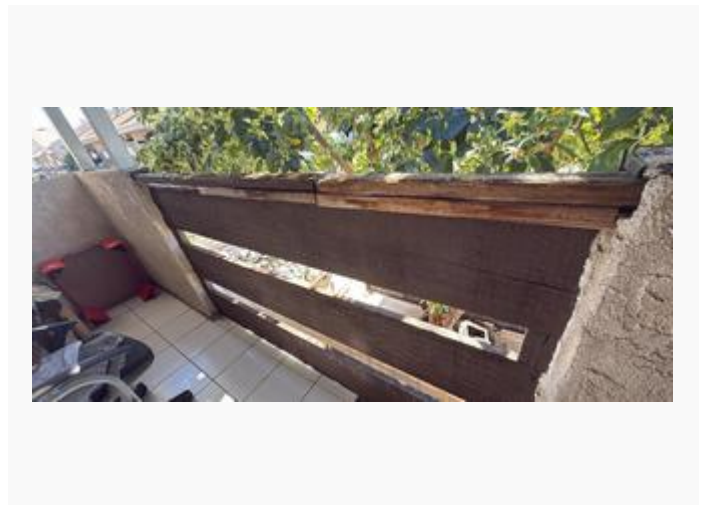
Wall stable and secure, but top railing needs to be replaced is worn and potentially hazardous

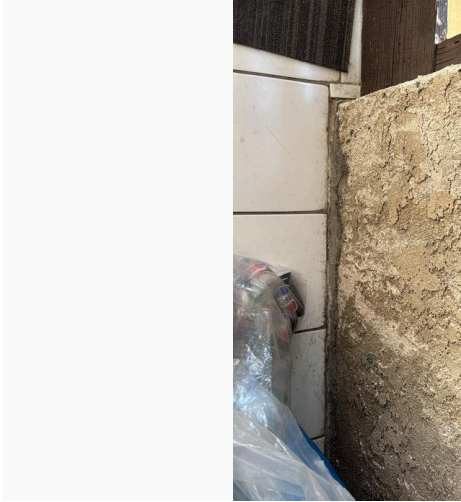
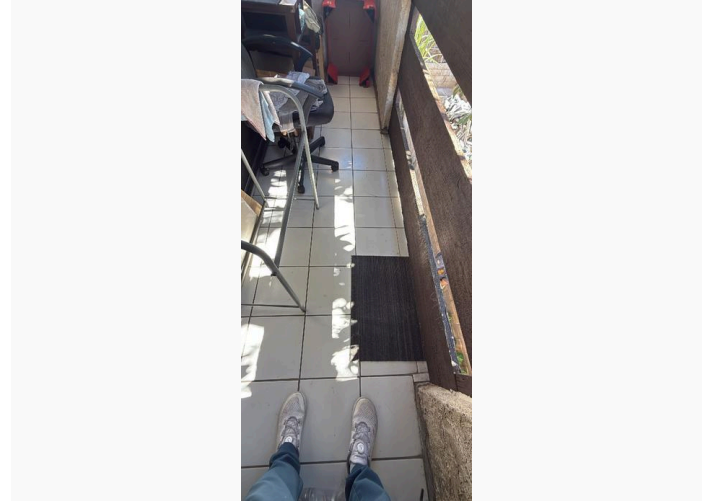
Signs of repair at base of wall
