# WOOD DESTROYING PESTS AND ORGANISMS INSPECTION REPORT

| Building No.<br>1198 | Street<br>BENJAMIN PL | City<br>EL CAJON | ZIP<br>92020 | Date of Inspection<br>11/17/2025 | Number of Pages<br>6 |
| GENERAL DESCRIPTION:<br>2 STORY STUCCO RESIDENCE, FURNISHED AND OCCUPIED WITH AN ATTACHED DOUBLE CAR GARAGE AND A COMPOSITION ROOF ON A CONCRETE SLAB FOUNDATION. | | | | Inspection Tag Posted:<br>CLOSET | |

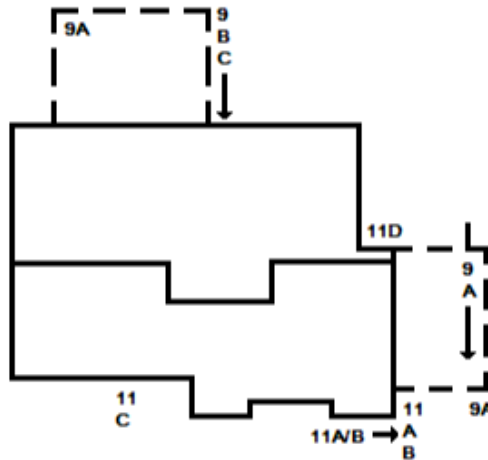
**Diagram Not To Scale**

FINDING-FUNGUS/DRY ROT DAMAGE NOTED AT THE PATIO AS INDICATED BY 9A ON THE DIAGRAM.

FINDING-EVIDENCE OF AN ACCESSIBLE DRYWOOD TERMITE INFESTATION NOTED AT THE PATIO AS INDICATED BY 9B ON THE DIAGRAM.

FINDING-DRYWOOD TERMITE DAMAGE NOTED AT THE PATIO AS INDICATED BY 9C ON THE DIAGRAM.

FINDING-EVIDENCE OF AN ACCESSIBLE DRYWOOD TERMITE INFESTATION NOTED AT THE FASCIA AS INDICATED BY 11A ON THE DIAGRAM.

FINDING-DRYWOOD TERMITE DAMAGE NOTED AT THE FASCIA AS INDICATED BY 11B ON THE DIAGRAM.

FINDING-FUNGUS/DRY ROT DAMAGE NOTED AT THE TRIM AS INDICATED BY 11C ON THE DIAGRAM.

FINDING-FUNGUS/DRY ROT DAMAGE NOTED AT THE DOOR JAMB AS INDICATED BY 11D ON THE DIAGRAM.

OWNER TO CONTACT A LICENSED CONTRACTOR TO MAKE NECESSARY REPAIRS OF THE DRY ROT IN ACCESSIBLE AREAS AND ANY INACCESSIBLE AREAS WHERE THE DRY ROT MAY EXTEND INTO. THIS INCLUDES CORRECTING OR REPAIRING ANY EXCESSIVE MOISTURE CONDITIONS WHICH HAS CAUSED THE EXISTENCE OF THE DRY ROT INFECTION. HI-TECH TERMITE CONTROL IS NOT RESPONSIBLE FOR THE WORKMANSHIP OF OTHERS.

RECOMMENDATION: VACATE PREMISES AND SEAL STRUCTURE. FUMIGATE WITH A LETHAL GAS VIKANE OR ZYTHOR (SULFURYL FLUORIDE) REMOVE THE SEALS AND AIR OUT BUILDING. MAKE READY FOR OCCUPANCY. COVER AND/OR REMOVE EVIDENCE. STRUCTURE MUST BE VACATED AT TIME OF TREATMENT.

OWNER TO CONTACT A LICENSED CONTRACTOR TO MAKE NECESSARY REPAIRS TO DRYWOOD TERMITE DAMAGE. HI-TECH TERMITE CONTROL IS NOT RESPONSIBLE FOR THE WORKMANSHIP OF OTHERS.
