The Original DOBRICH & SONS SEPTIC SERVICE

INVOICE

JOB SITE: 731 North Cloud

CITY Paradise	DATE ORDERED 12/19/2024	SCHEDULE DATE 12/23/2024	PUMP DATE
------------------	----------------------------	-----------------------------	-----------

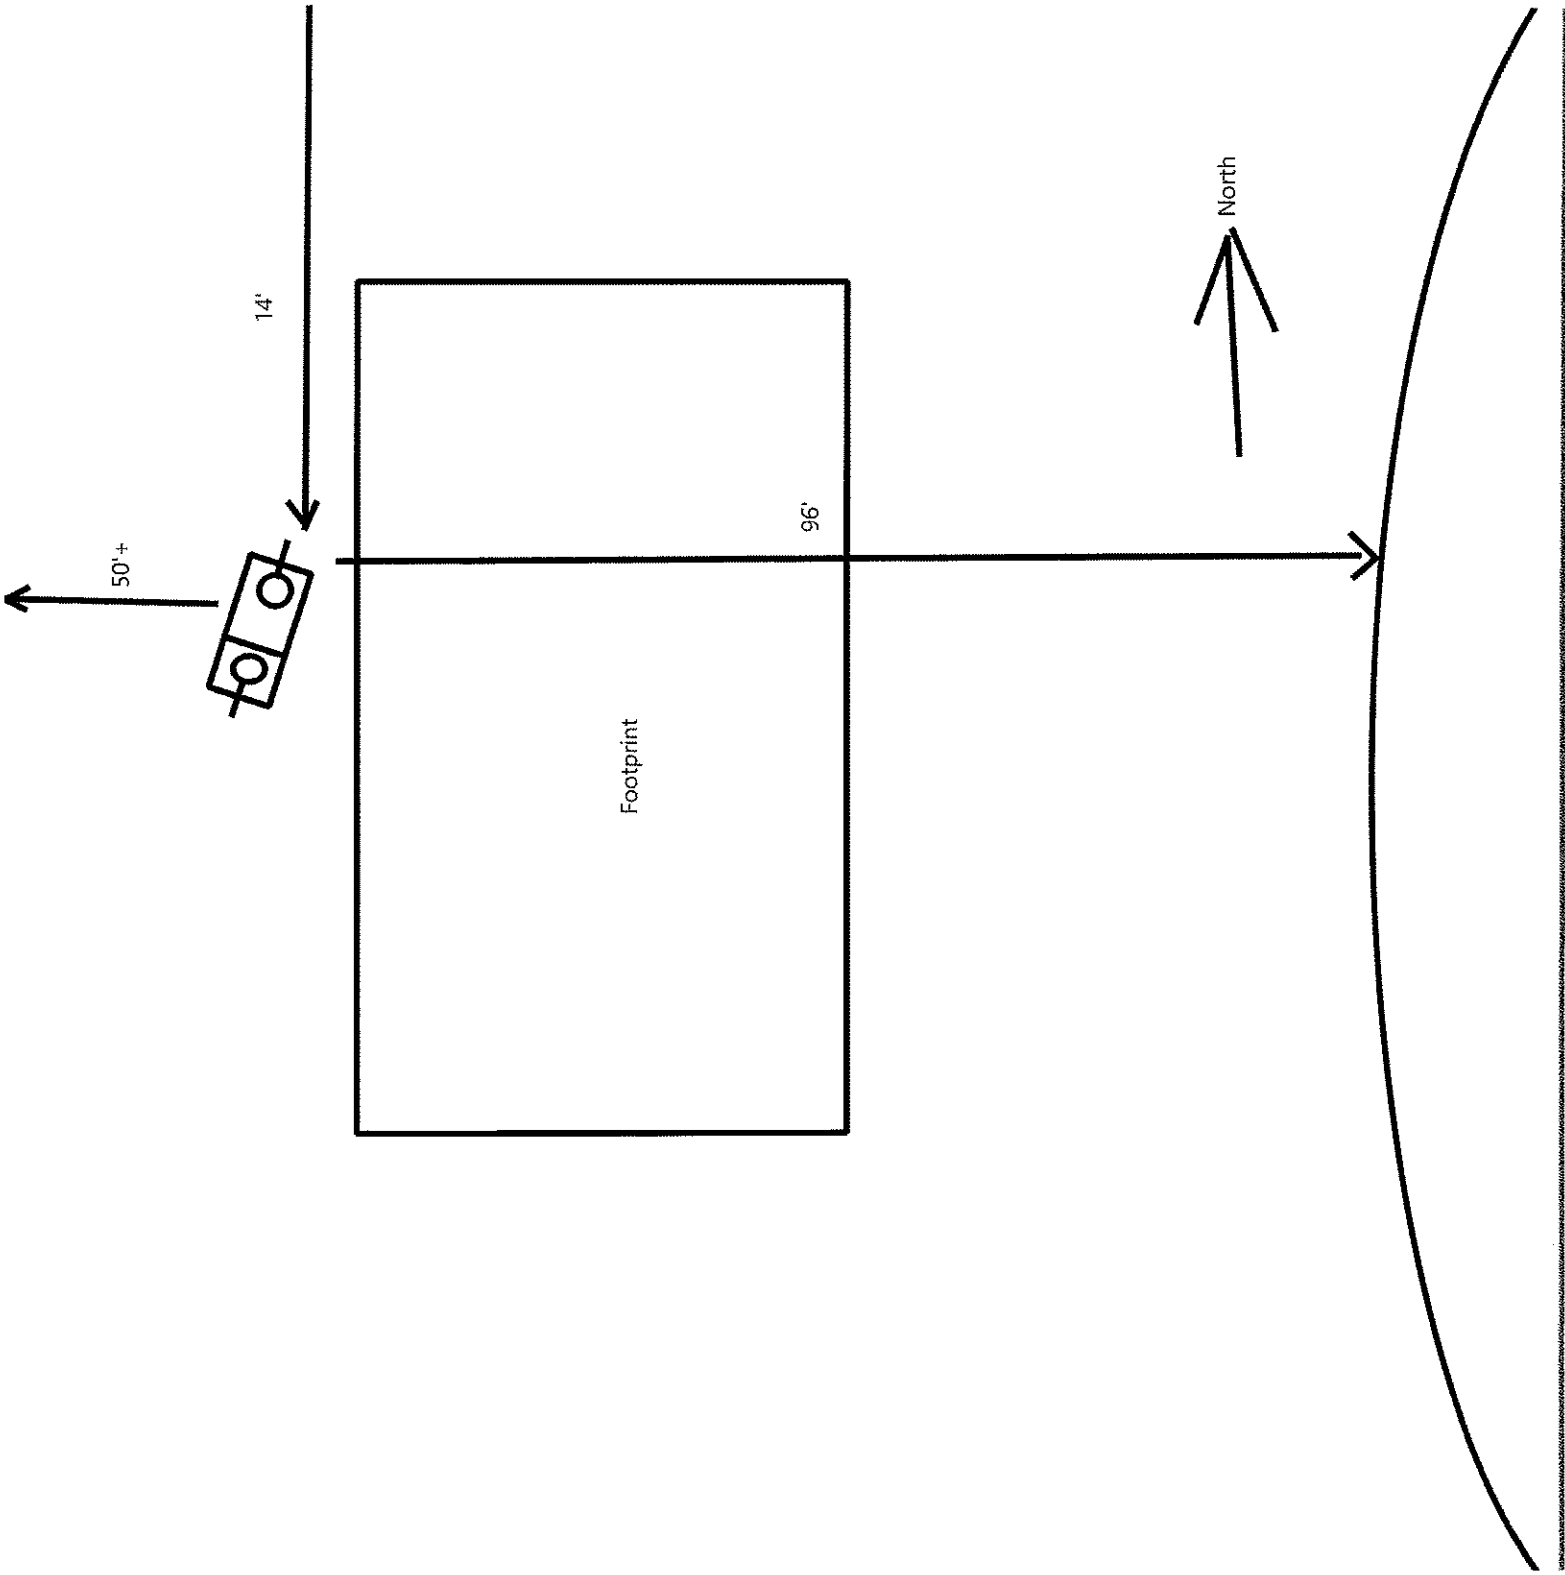
Septic inspection of a 1000 gallon concrete tank that's in poor condition, the tank top is broken. The tank was 4" deep. There was 0" of scum and 9" of sludge in the inlet side of the tank. The inlet and the outlet tees are intact. The effluent level in the tank is at normal operating level. The absorption field is operating as it should. **The tank top is in 2 pieces, it is pulled apart and broken.**
