# HOME INSPECTION REPORT

3267 Sueno Drive, San Jose

674732

April 11, 2026

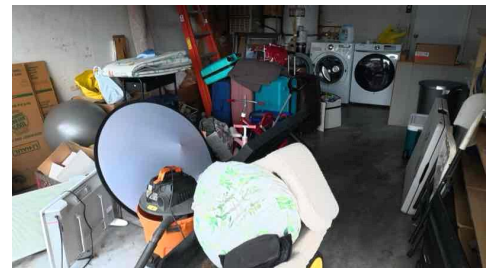
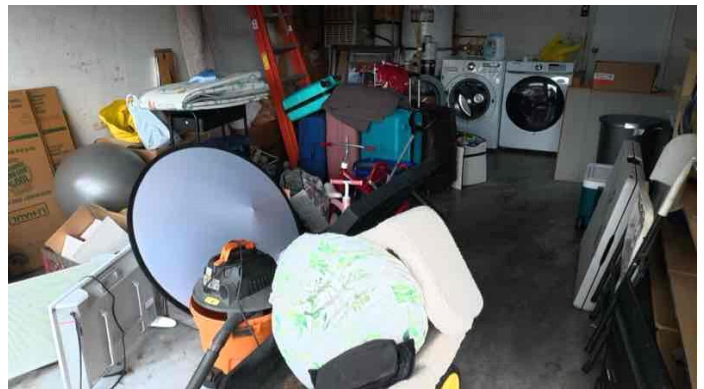
Photo 06

Storage of personal belongings within the interior of the garage prevented a full visual inspection of the area. Therefore, the area was not fully inspected. With removal of all personal items and a complete inspection, conditions in need of attention may be discovered. (See Photo 6)

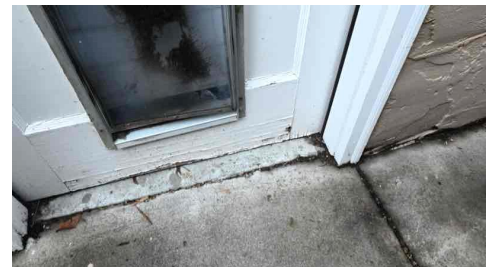
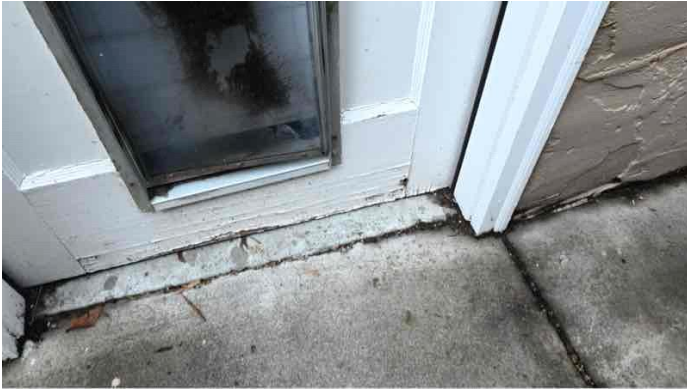
Photo 01

1. The door between the garage and the house did not have an automatic closing mechanism. The door between the garage and the interior of the house should be fitted with an automatic closing mechanism. This will reduce the potential of toxic automobile gases entering the house and serves as a fire break. (See Illustration 3G) (See Photo 10)
2. Storage of personal belongings within the interior of the garage prevented a full visual inspection of the area. Therefore, the area was not fully inspected. With removal of all personal items and a complete inspection, conditions in need of attention may be discovered. (See Photo 6)
3. Water damage was noted at the garage side entry door. We recommend the services of a licensed general contractor and/or structural pest control company regarding repairs. (See Photo 1)

- ! 2. Water damage was noted at the garage side entry door. We recommend the services of a licensed general contractor and/or structural pest control company regarding repairs. (See Photo 1)

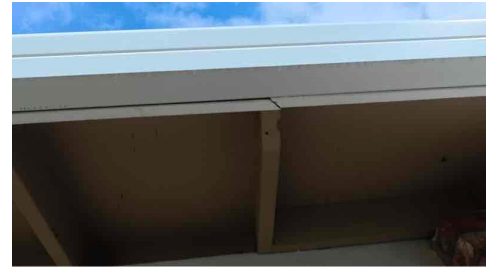
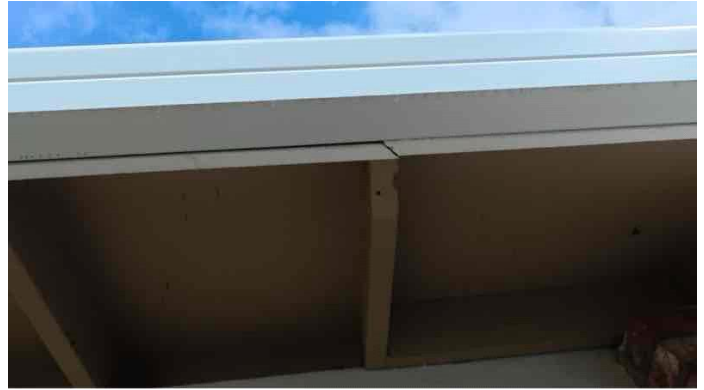
Photo 02

4. Water damage was observed to the rafters at the front. We recommend the services of a licensed general contractor and/or structural pest control company. (See Photo 2)

- ! 3. Water damage was observed to the rafters at the front. We recommend the services of a licensed general contractor and/or structural pest control company. (See Photo 2)

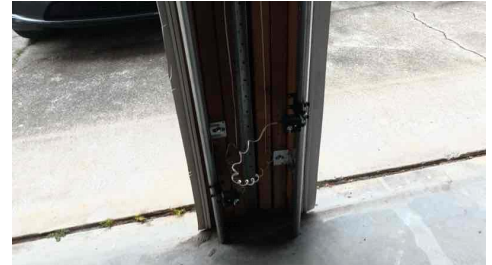
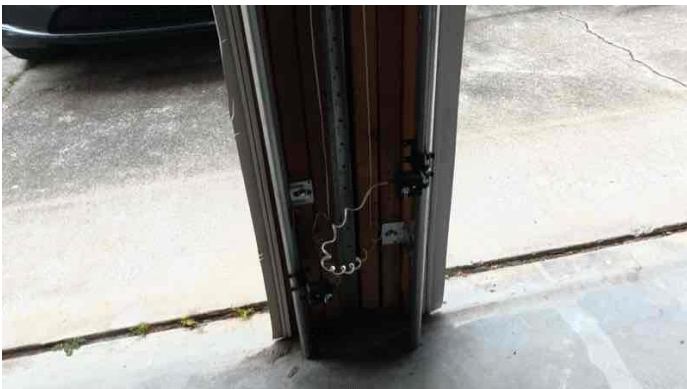
Photo 05

5. The garage door did reverse properly when the infrared detection system for the auto reverse was tested; however, we did note that the detection system for the auto reverse was installed too high or too low from the ground. We recommend proper mounting of the devices on the base of the garage jambs between 4" to 8" inches from the ground as per manufacturers recommendations. Information on the garage door openers is available from the consumer product safety commission at [www.cpsc.gov](http://www.cpsc.gov). (See Illustration 3B) (See Photo 5)

- ! 5. The garage door did reverse properly when the infrared detection system for the auto reverse was tested; however, we did note that the detection system for the auto reverse was installed too high or too low from the ground. We recommend proper mounting of the devices on the base of the garage jambs between 4" to 8" inches from the ground as per manufacturers recommendations. Information on the garage door openers is available from the consumer product safety commission at [www.cpsc.gov](http://www.cpsc.gov). (See Illustration 3B) (See Photo 5)

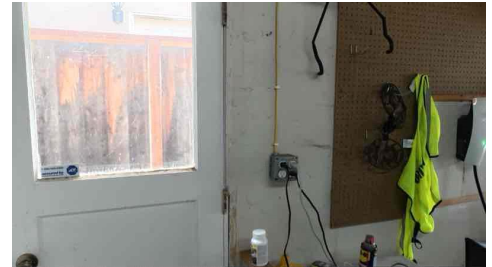
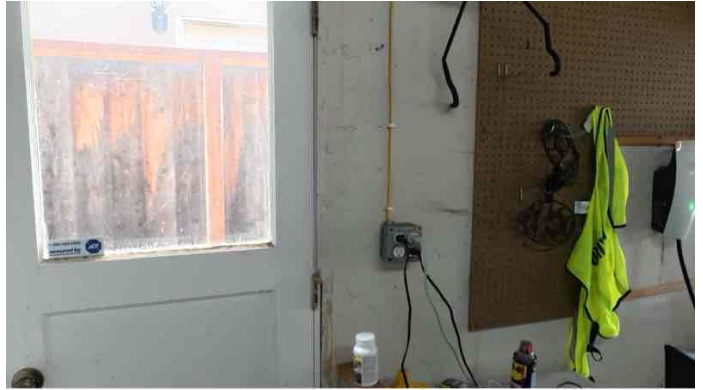
Photo 08

6. We found exposed wiring at the garage walls below 7' feet. Even if insulated, we recommend all wiring be encased in conduit or otherwise protected in accordance with present standards. (See Illustration 4E) (See Photo 8)

- ! 1. We found exposed wiring at the garage walls below 7' feet. Even if insulated, we recommend all wiring be encased in conduit or otherwise protected in accordance with present standards. (See Illustration 4E) (See Photo 8)

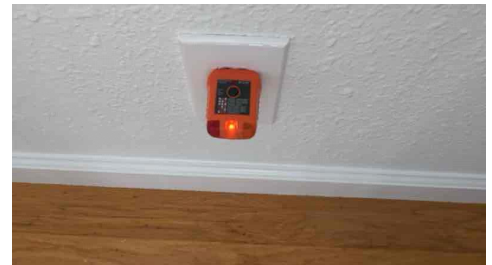
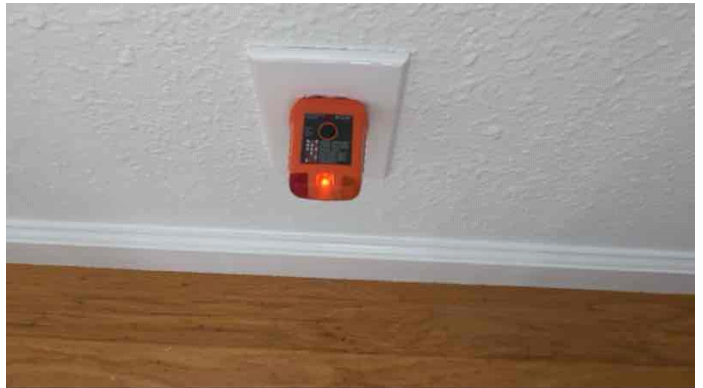
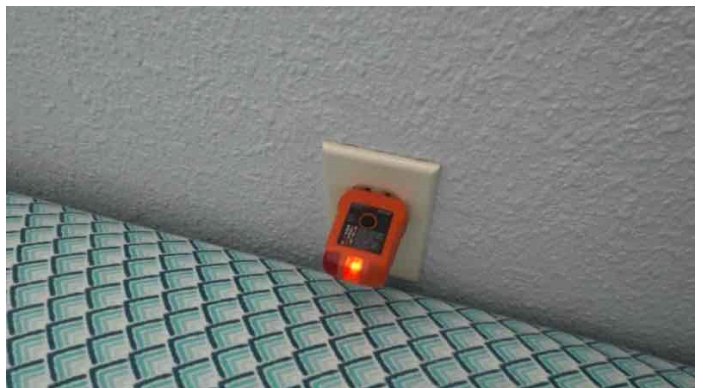
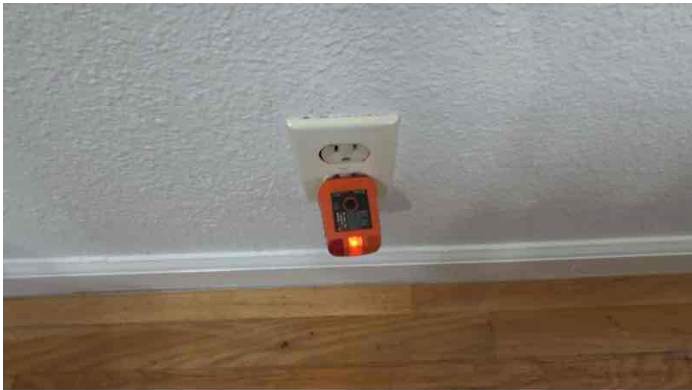
Photo 12

7. Ungrounded "3-prong" outlets at the dining room, upstairs bedrooms should be improved. A grounded cable or ground wire could be installed at these outlets, the outlet labeled as ungrounded or the original "2-prong" receptacle could be reinstalled. Based upon our inspection of a representative number of outlets, we recommend testing of every outlet. Repairs or rewiring are recommended at all deficient locations. For additional information we recommend a licensed electrician be consulted. (See Illustration 4O) (See Photo 12) (See Photo 14) (See Photo 15)

- ! 2. Ungrounded "3-prong" outlets at the dining room, upstairs bedrooms should be improved. A grounded cable or ground wire could be installed at these outlets, the outlet labeled as ungrounded or the original "2-prong" receptacle could be reinstalled. Based upon our inspection of a representative number of outlets, we recommend testing of every outlet. Repairs or rewiring are recommended at all deficient locations. For additional information we recommend a licensed electrician be consulted. (See Illustration 4O) (See Photo 12) (See Photo 14) (See Photo 15)

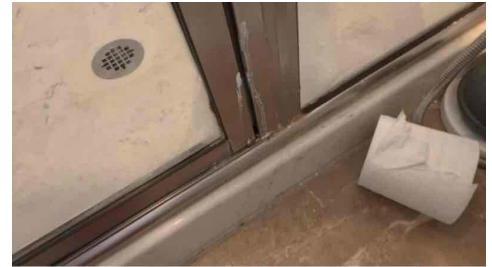
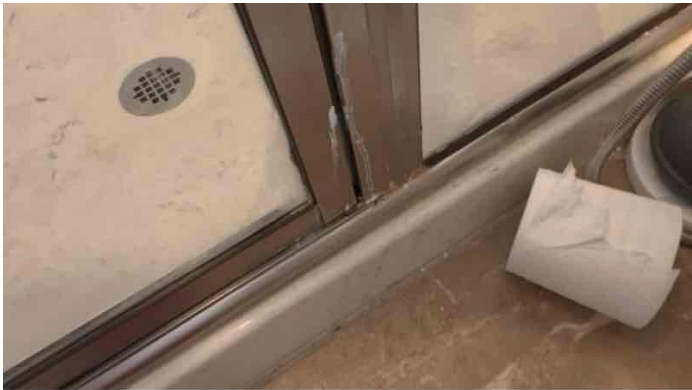
Photo 16

9. Cracked, deteriorated and/or missing tub/shower enclosure caulk in the master bathroom should be replaced. Water leaking through non-sealed areas can cause damage. Damage caused by water seepage cannot be determined by this visual observation. (See Photo 16)

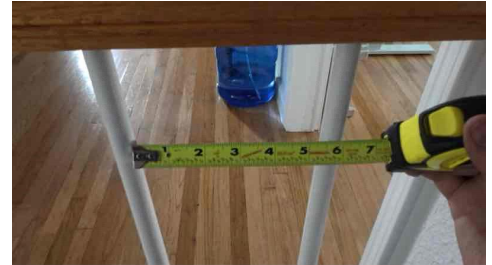
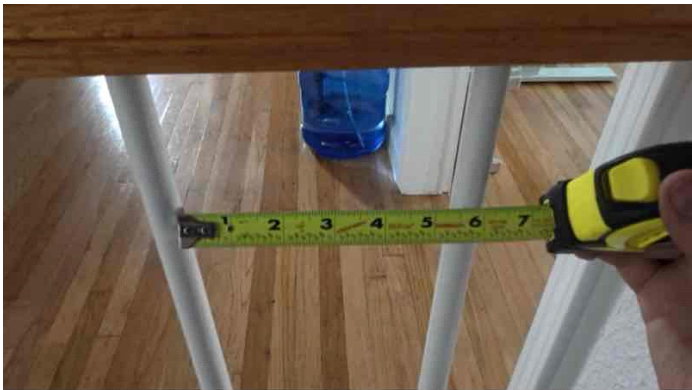
Photo 17

10. The openings in the staircase railing are larger than 4". For improved safety it is recommended that the railing be altered for an opening of less than 4". (See Illustration 9K) (See Photo 17)

- ! 1. The openings in the staircase railing are larger than 4". For improved safety it is recommended that the railing be altered for an opening of less than 4". (See Illustration 9K) (See Photo 17)

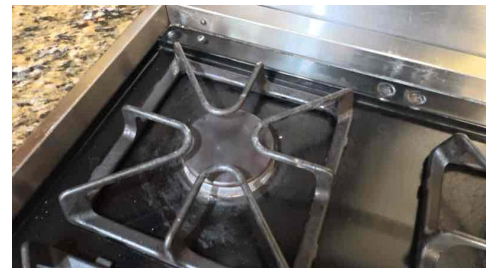
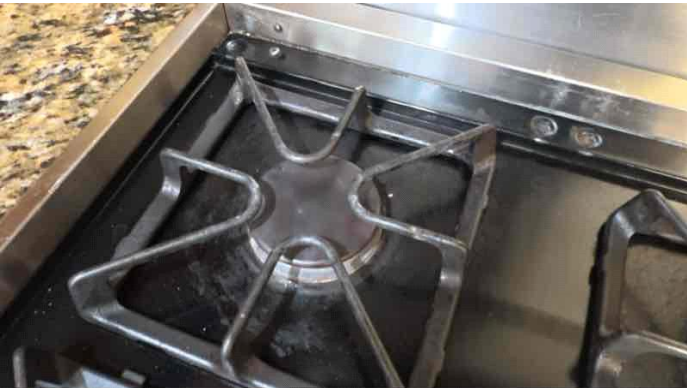
Photo 11

11. One or more of the burners on the cooktop/range top are inoperative or will not light. The pilot lights or electronic igniters are in suspect. For attention to the conditions noted and/or cost estimates, if necessary, we recommend the advice of a qualified appliance technician. (See Photo 11)

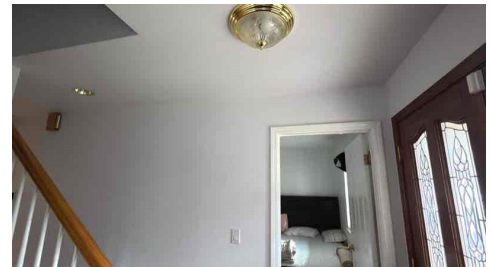
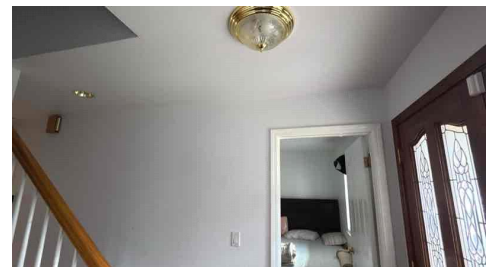
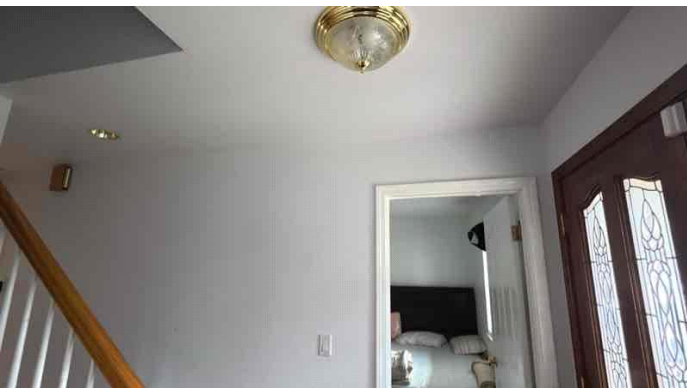
Photo 13

13. California law requires that all homes have a State Fire Marshall approved Carbon Monoxide Detector installed outside of the sleeping quarters and on each level of the home. At the time of this inspection a Carbon Monoxide Detector was located in the bedroom and upstairs hallway. As a carbon monoxide detector was not noted in all of the recommended locations additional detectors should be installed. (See Photo 13)

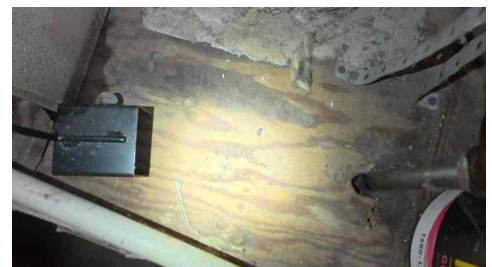
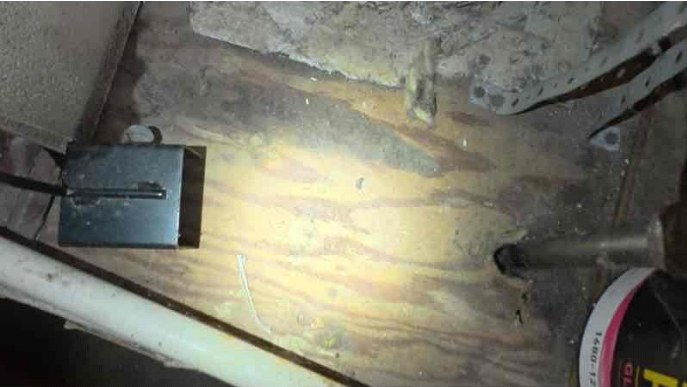
Photo 09

14. Evidence of vermin activity was observed within the structure. It is likely this evidence will extend into inaccessible areas. The owner is advised to contact the appropriate trade for further evaluation and remedial measures if necessary. (See Photo 9)

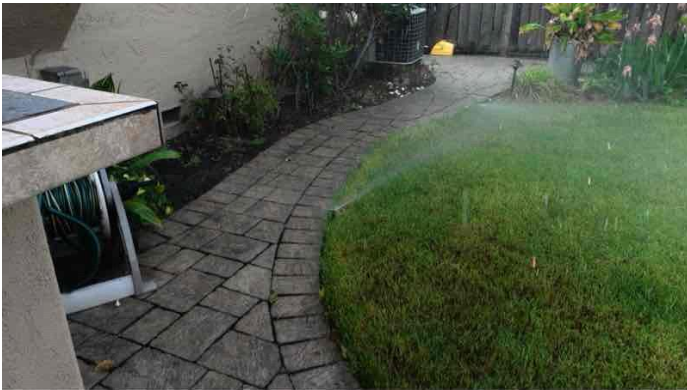
Photo 03

4. Sprinkler heads were observed tilted or misaligned. Improper alignment can reduce coverage efficiency and direct water away from intended landscaped areas. Adjustment or replacement by a qualified irrigation contractor is recommended. (See Photo 3)

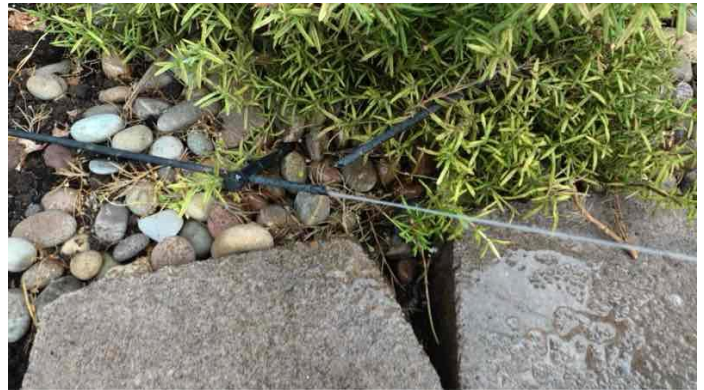
Photo 04

17. Drip irrigation tubing was observed leaking, damaged, or separated at one or more locations. Defects in drip tubing can waste water, reduce water delivery to landscaped areas, and contribute to localized saturation or erosion. A qualified irrigation contractor should further evaluate and repair or replace damaged tubing and fittings as necessary. (See Photo 4)

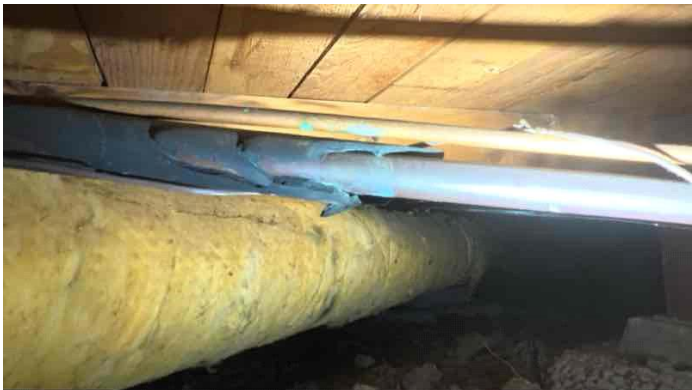
Photo 18

1. Damaged insulation on air conditioner refrigerant lines should be repaired. This will help to increase the efficiency of the unit. (See Photo 18)
2. The air conditioning condenser unit is not mounted or secured to the platform properly. We recommend it be secured or mounted as necessary.
3. The fins that are part of the coil at the exterior condenser unit show deterioration. This may be a cosmetic condition, but it could be a sign of other problems beyond the scope of our inspection. We recommend consulting a licensed HVAC contractor for further evaluation.

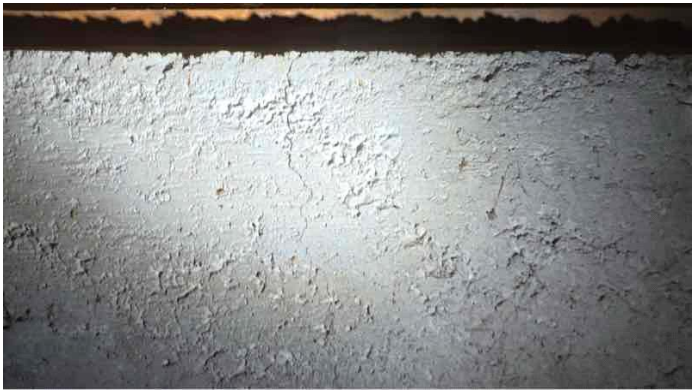
Photo 19

1. Minor cracks were observed in the foundation walls of the structure. Smaller foundation cracks are not uncommon and often indicate some settlement and/or movement may have occurred. The rate of movement cannot be predicted during a one-time inspection. A thorough evaluation of this condition is beyond our qualifications. For additional information we recommend contacting a licensed foundation contractor for further evaluation. (See Photo 19)
