OC Home Inspect

General Home Inspection

715 East McFadden Avenue

Inspected On Wed, Feb 4, 2026 at 12:15 PM

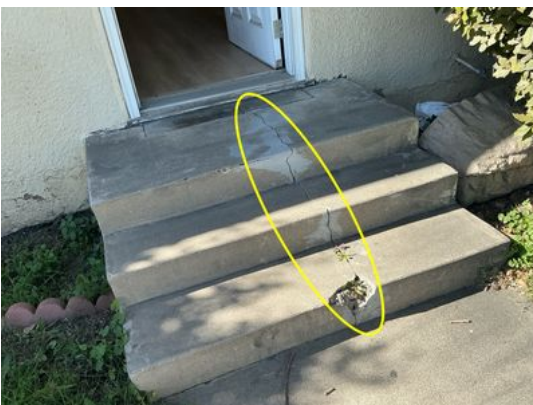
Comment 4

Concrete is cracked and broken at porch.

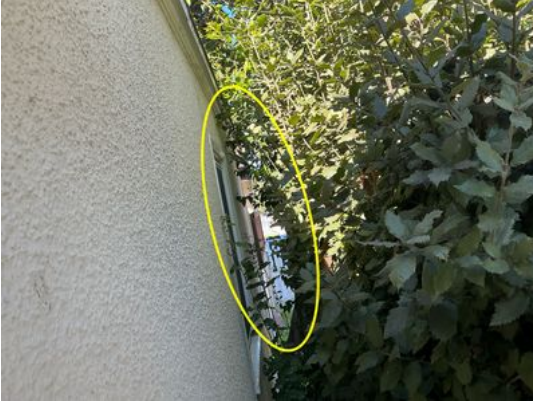
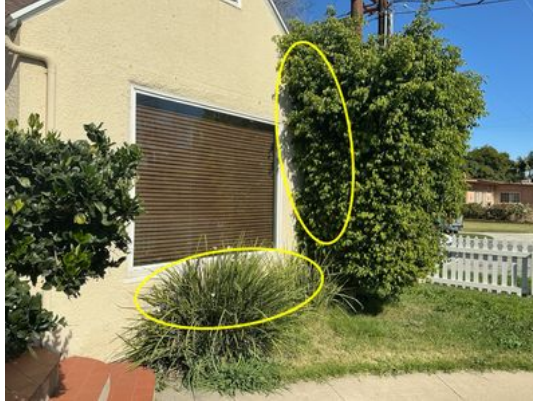
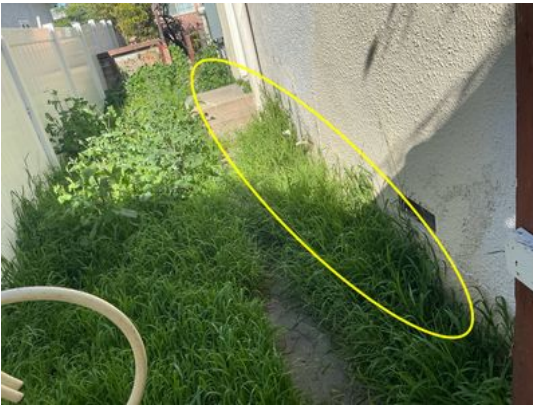
Comment 5

Vegetation growing against structure.

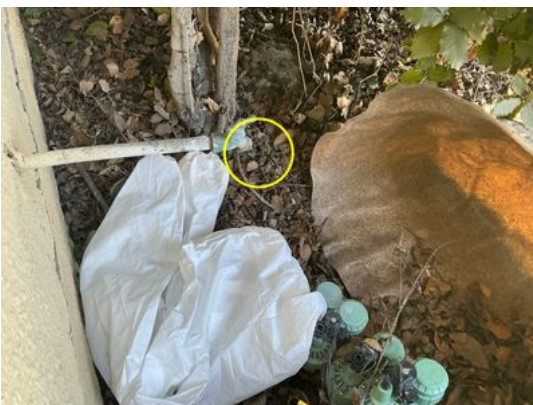
Comment 6

Vacuum breakers are not installed at hose spigots.

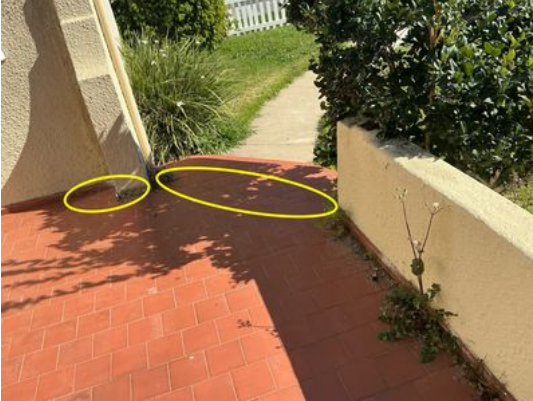
Comment 7

Concrete and tiles cracked at porch.

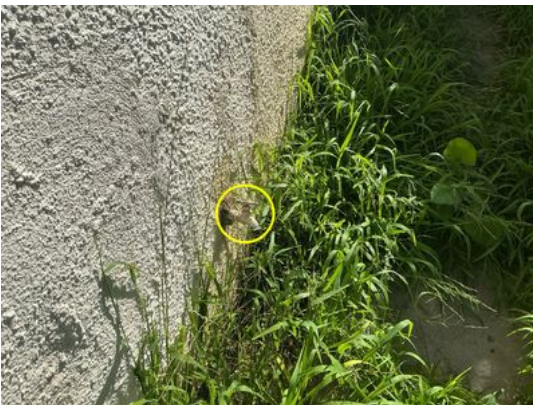
Comment 8

Hose spigot handle leaks when open.

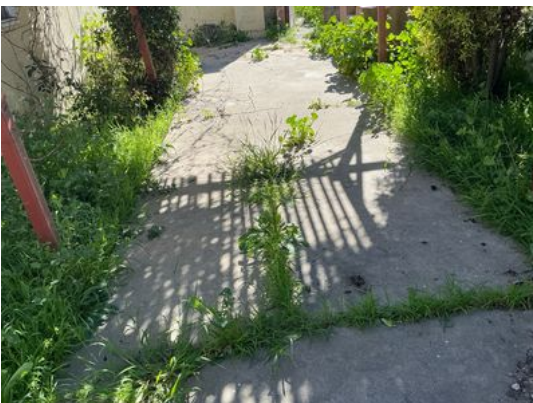
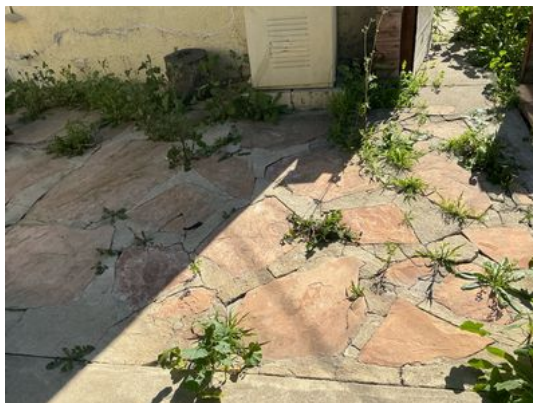
Comment 9

Stone and concrete patios are cracked. Vegetation growing through patios.

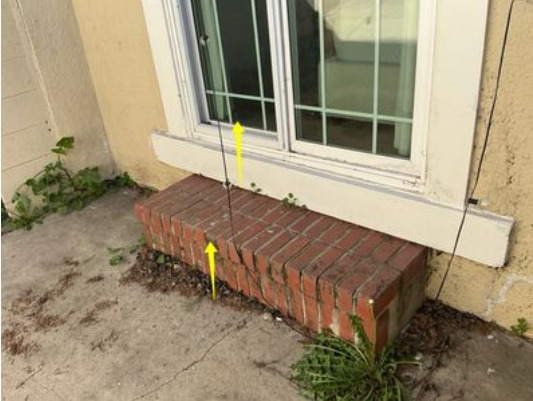
Comment 10

Step out of door is too tall.

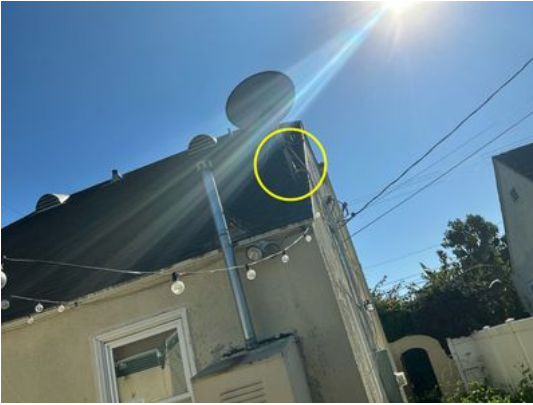
Comment 11

Satellite dish is mounted through roof.

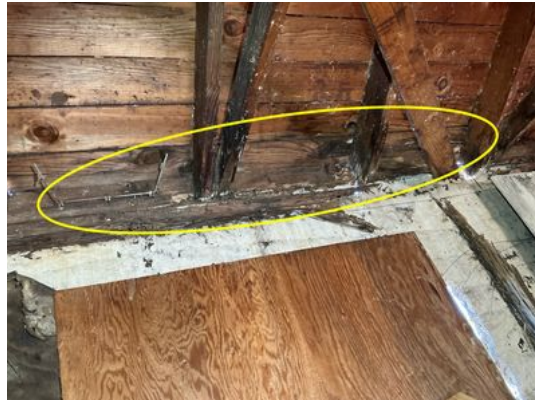
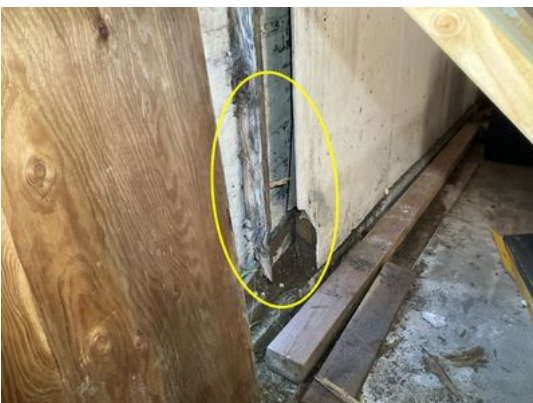
Comment 12

Water damage and visible apparent mold at roof and wall. Wall and roof are open to the elements.

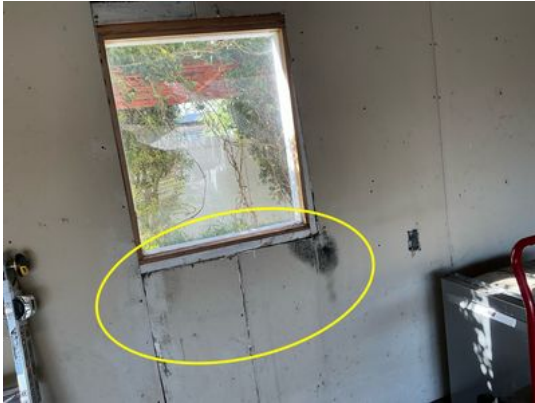
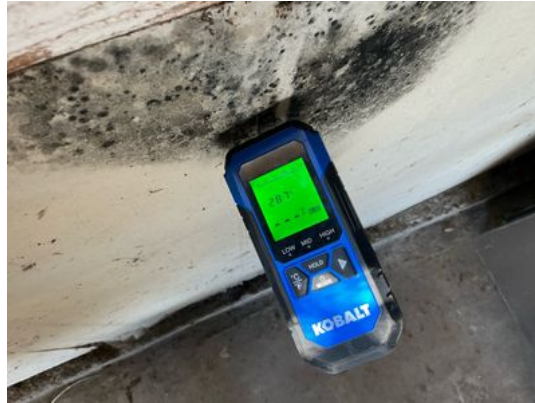
Comment 13

Water damage and visible apparent mold at wall around window. Window leaks. High levels of moisture detected.

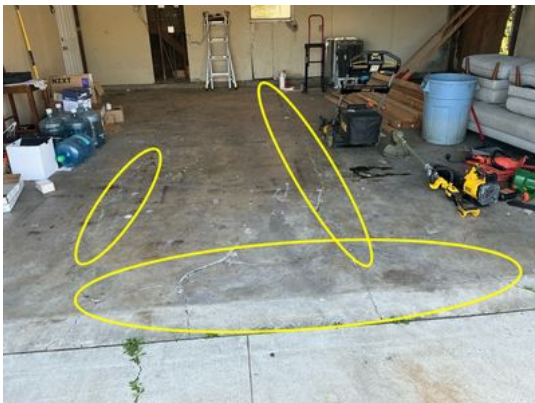
Comment 14

Slab is cracked. Differential detected at cracks. Cracks are more than 1” wide in some areas. Recommend further evaluation by a qualified and licensed geotechnical engineer.

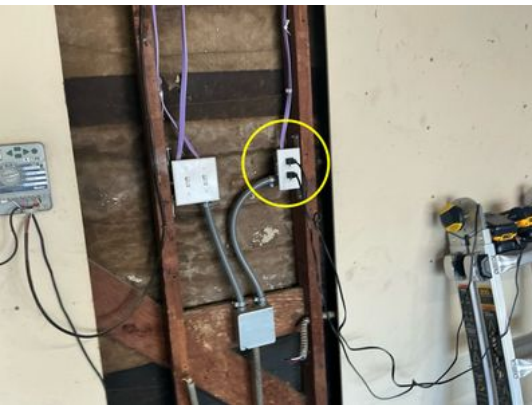
Comment 16

Electrical outlet(s) not protected by a ground fault circuit interruptor (GFCI).

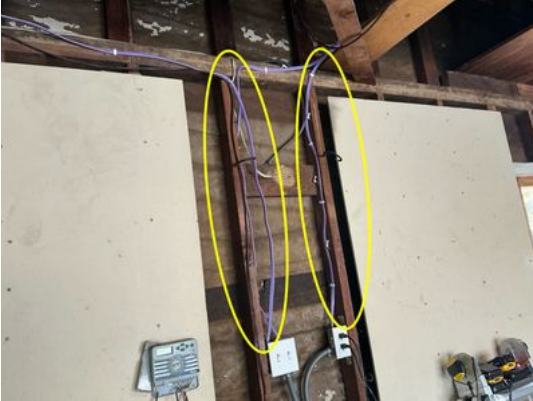
Comment 18

Electrical wiring installed without protective metal conduit.

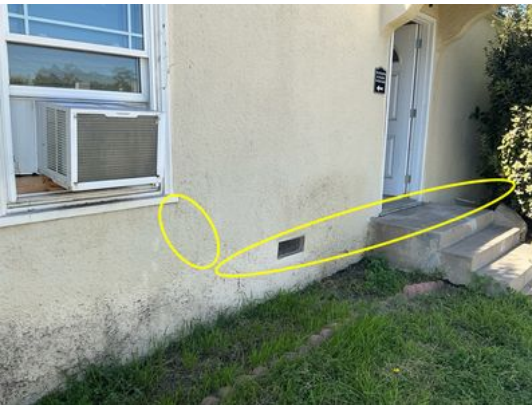
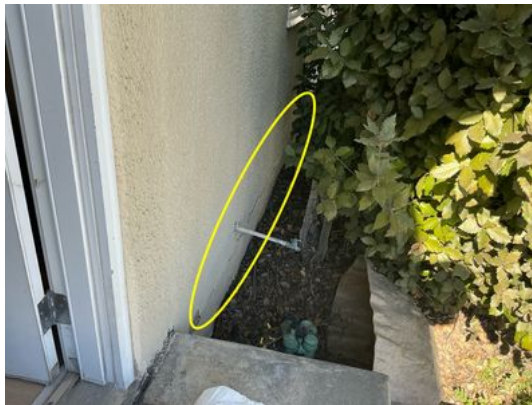
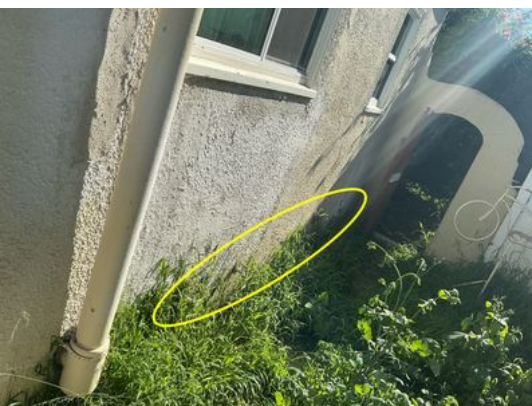
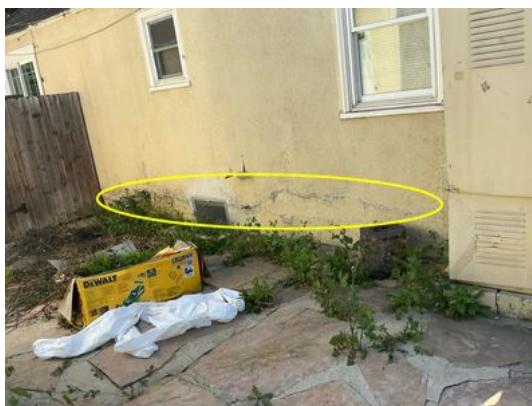
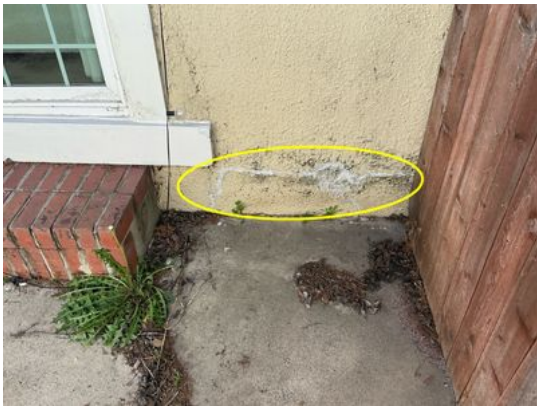
Comment 19

Cracks at the walls where they meet foundation. These cracks are running length of the house on all four sides. Differential at cracks indicates structural movement. Recommend further evaluation by a qualified and licensed structural engineer.

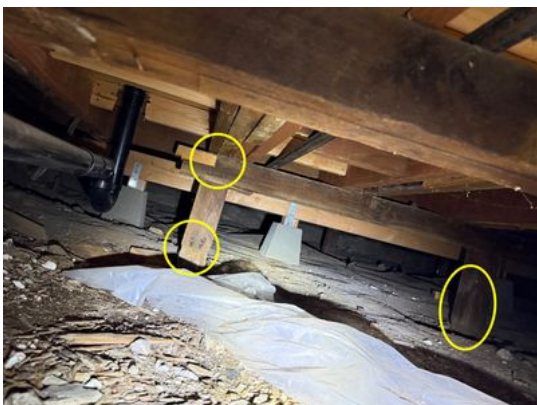
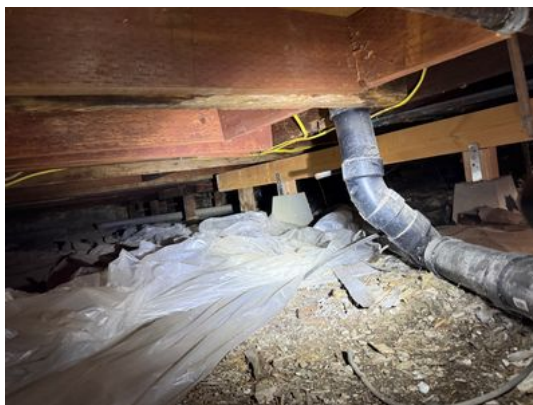
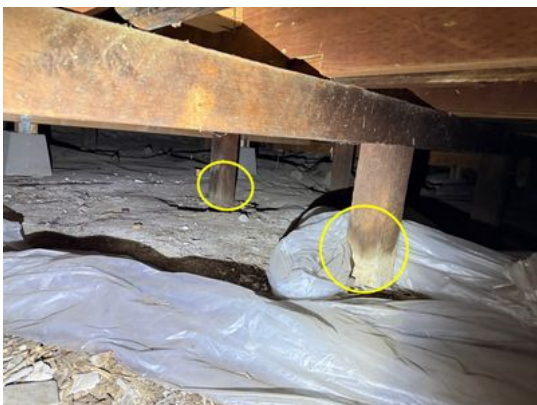
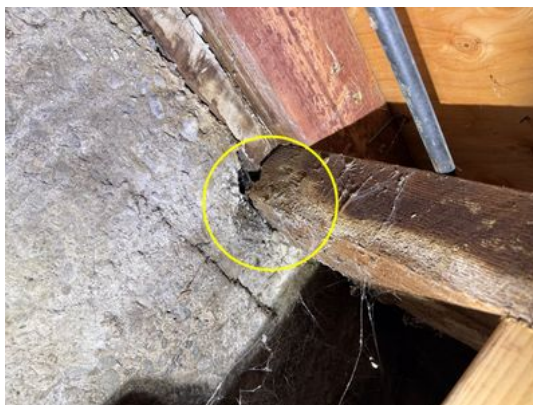
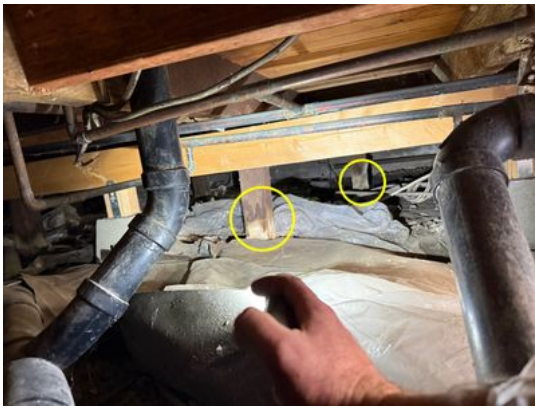
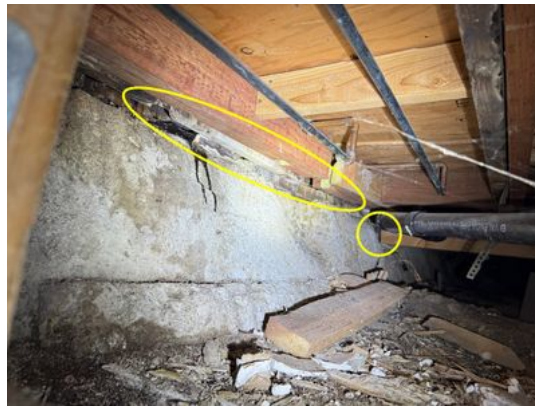
Comment 20
Further Evaluation

Pier and post foundation construction does not meet the standards set forth by modern building construction requirements. Subfloor is not bolted to foundation. Girder beams are not resting on foundation in some areas. Wood posts in direct contact with earth. Water stains on posts. Some addition beams and posts have been added. Floors are not level inside the house. Recommend further evaluation by a qualified and licensed structural engineer.

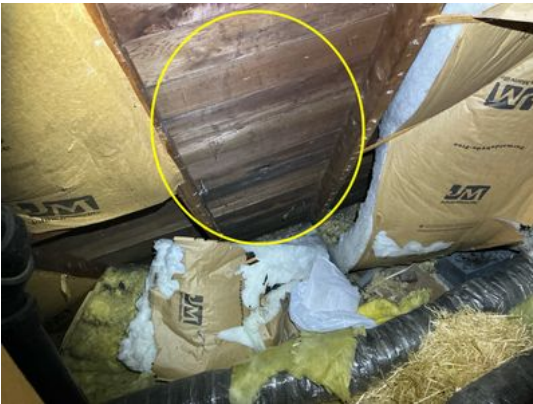
Comment 21

Insulation has fallen down at roof line.

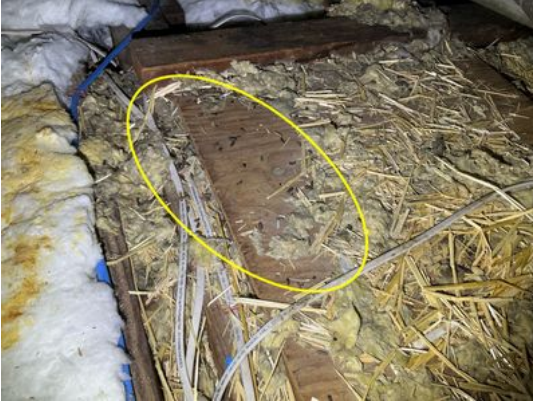
Comment 22

Evidence of rodent infestation. Recommend further evaluation by a qualified and licensed pest inspector.

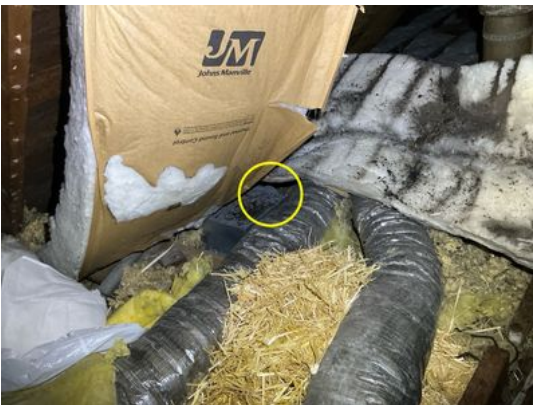
Comment 23

Bathroom exhaust fan duct is not installed. Fan discharges into attic.

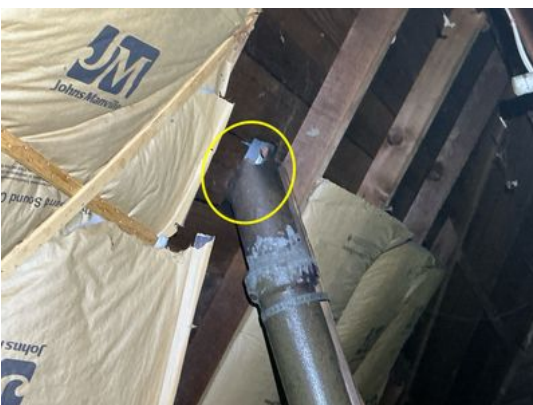
Comment 24

Sewer vent is broken and does not extend out through roof.

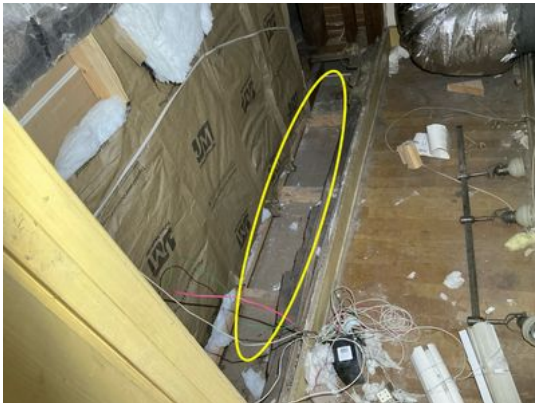
Comment 25

Insulation is partially installed. One or more sections of the unconditioned space are not insulated.

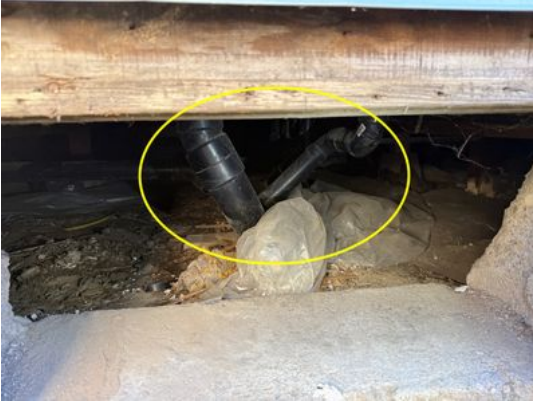
Comment 27

Portions of the crawlspace were not inspected due to access being restricted. Access point is smaller than required by modern standards and plumbing is installed in front of access point.

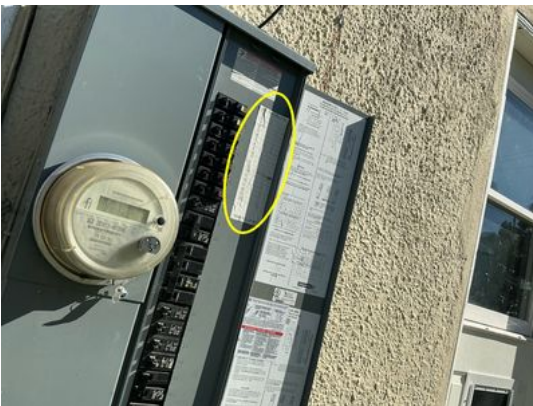
**Comment 29
Safety**

Service panel legend is incomplete.

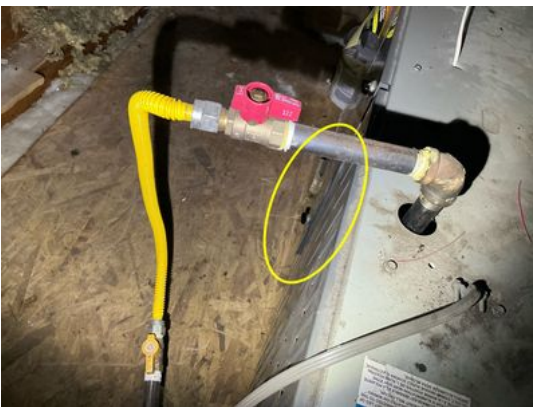
Comment 31
Defect

Sediment trap is not installed at gas line.

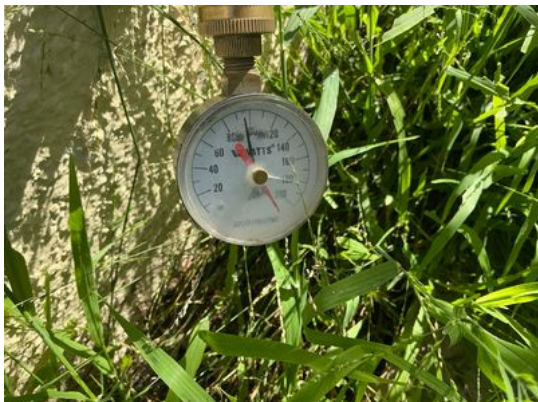
Water pressure is higher than recommended. This may cause leaks or damage to plumbing fixtures. A pressure regulator is not installed so the water pressure cannot be adjusted.

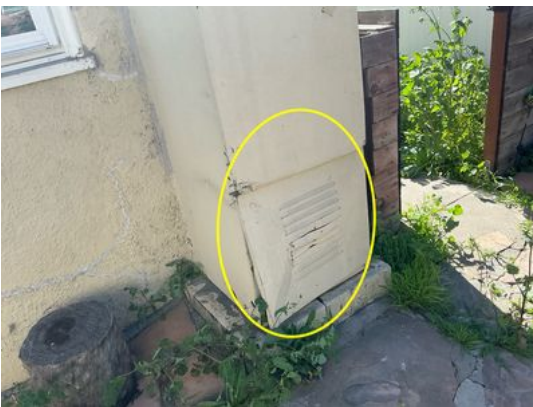
Comment 35
Defect

Cabinet is damaged.

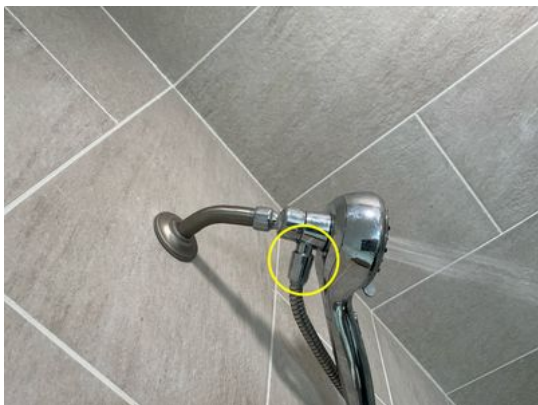
Shower head leaks at thread.

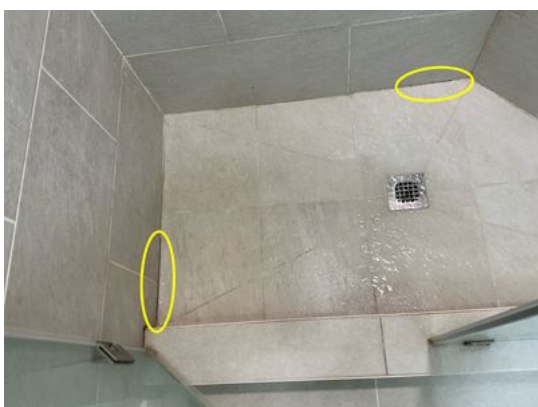
Comment 37

Grout is cracked at shower floor.

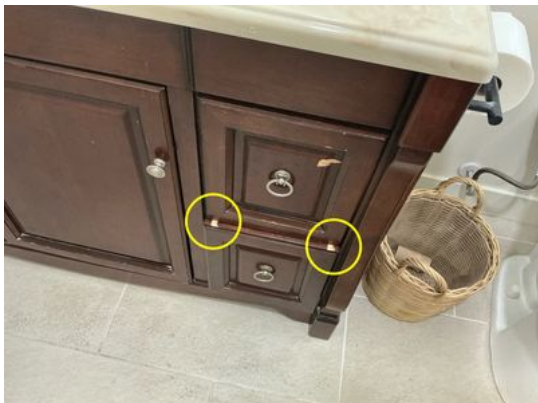
Comment 38

Cabinet drawer catches and is damaged.

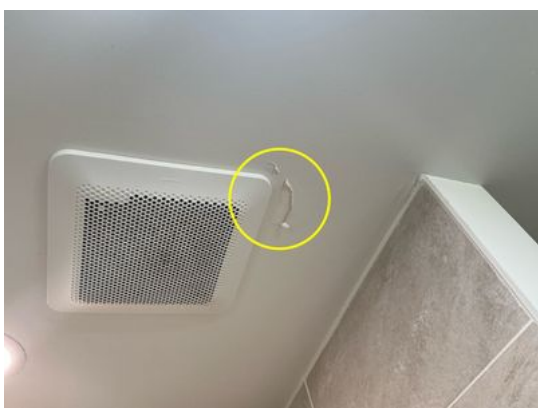
Comment 39

Paint is peeling at ceiling around exhaust fan.

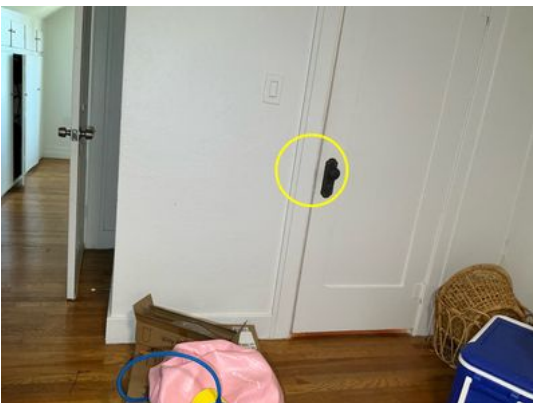
Bedroom closet door does not latch.

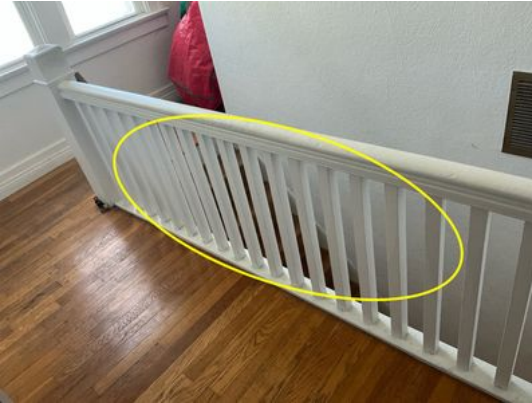
Comment 41

Guardrail is less than 36" tall.

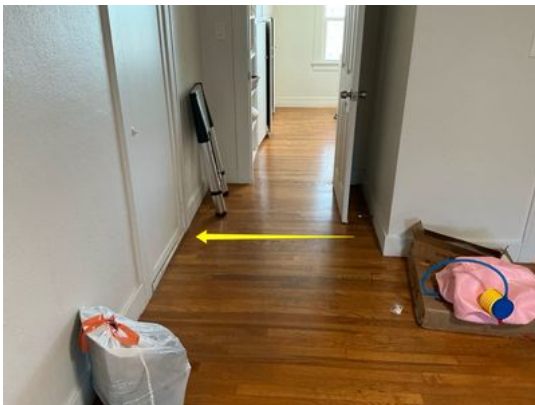
Comment 42

Floor is sloped towards north side of house.

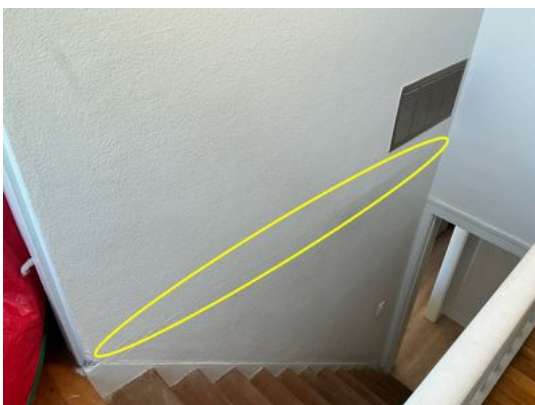
Comment 43

Drywall bowing at wall in stairwell.

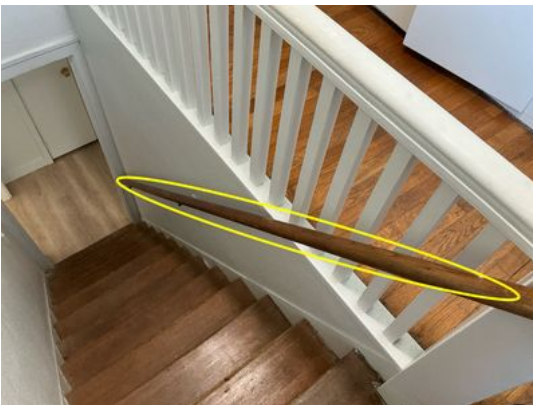
Handrail is loose.

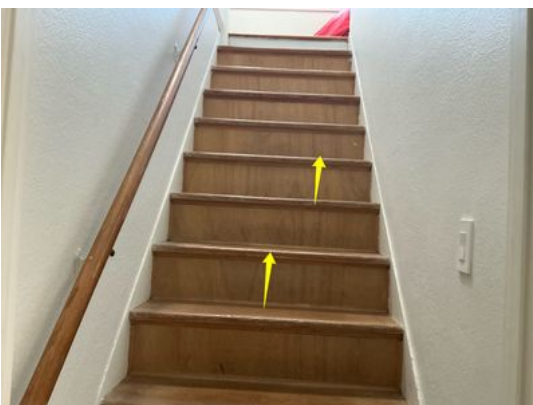
Comment 46

Stairs are constructed with a steep rise. Risers are over 8" tall.

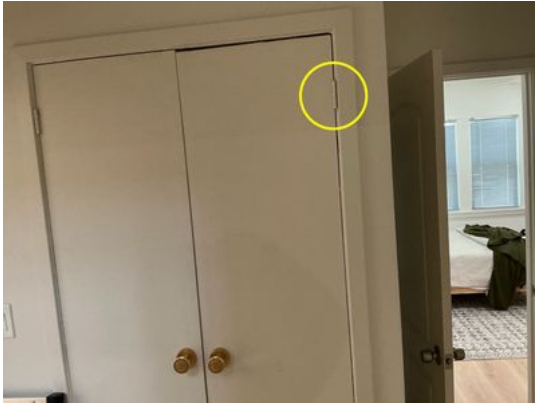
Comment 47

Closet door hinge is loose in hallway.

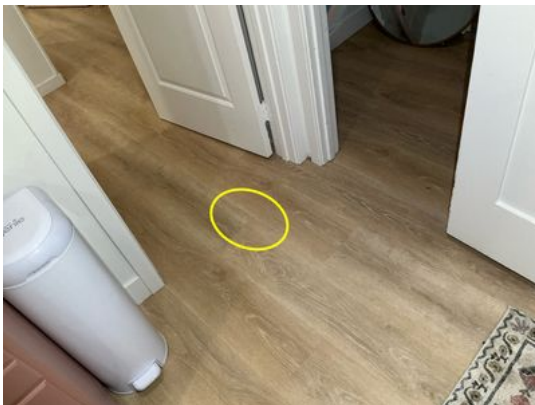
Comment 48

Flooring is lifted in bedroom.

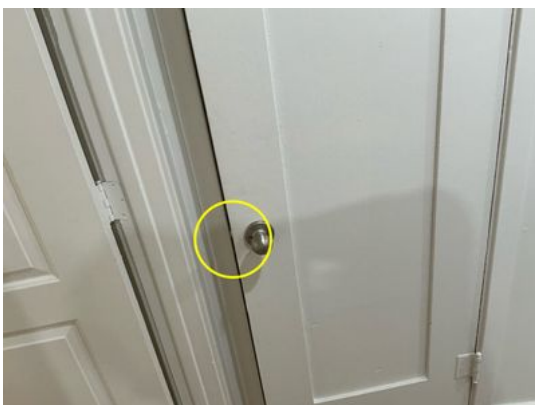
Comment 49

Bedroom closet door does not latch.

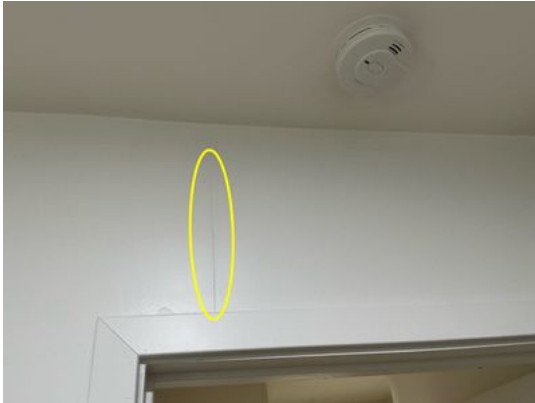
Comment 50

Drywall crack above door in bedroom.

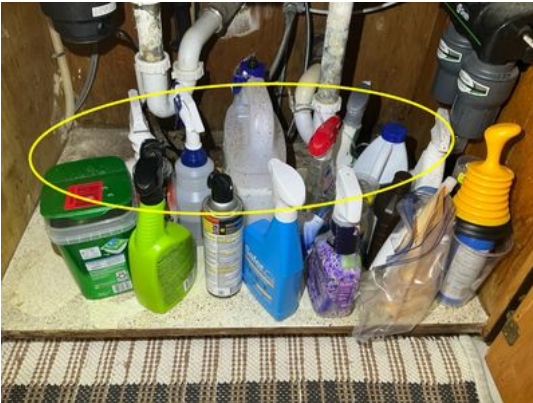
Water damage at cabinet under sink.

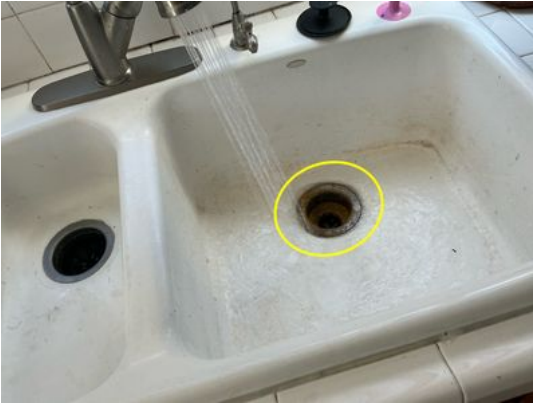
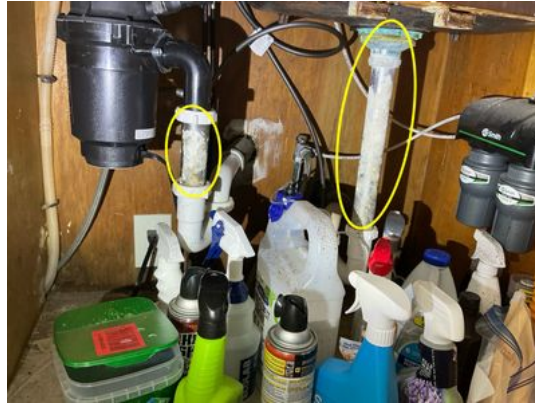
Comment 52

Sink drain and pipes are corroded.

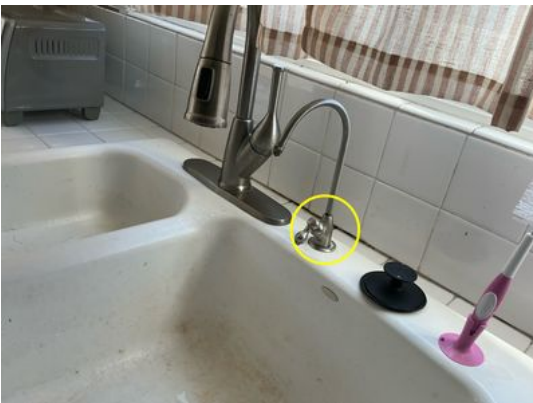
Comment 53

Spigot is loose at sink.

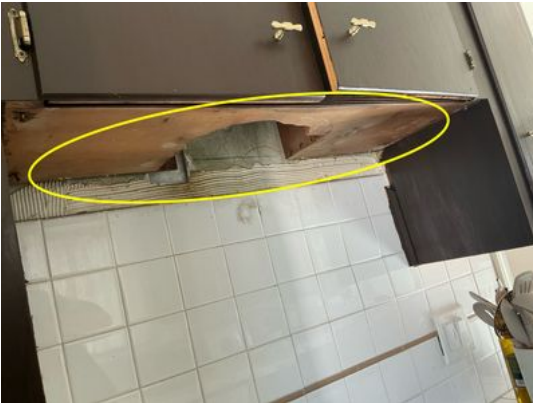
Range hood is not installed. Duct is abandoned in attic and does not extend outside.

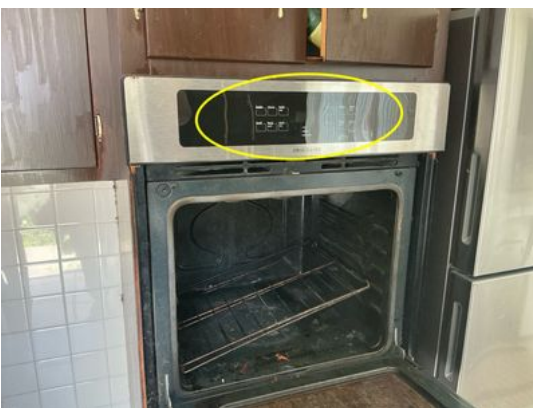
Comment 55

Oven is inoperable.

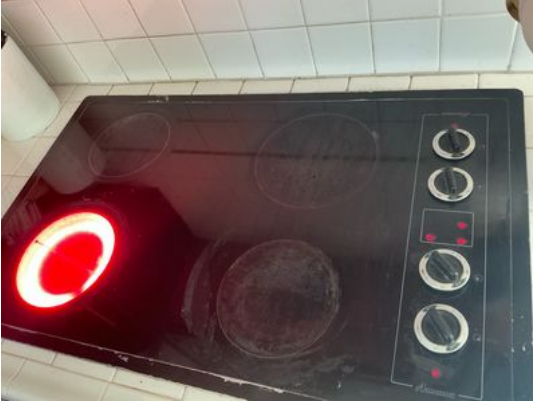
Comment 56

Burners are not heating at cooktop.

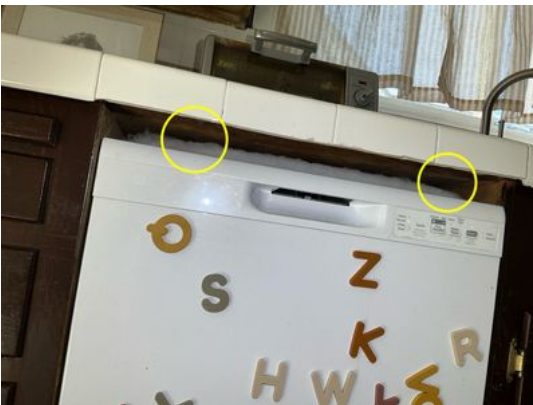
Comment 57

Dishwasher is not fastened to cabinet.

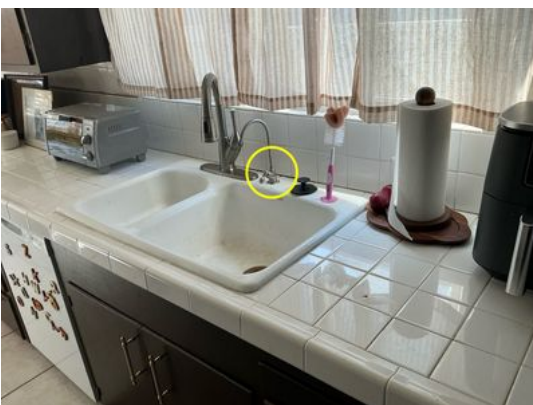
Comment 58

Dishwasher is not equipped with an air gap fitting.

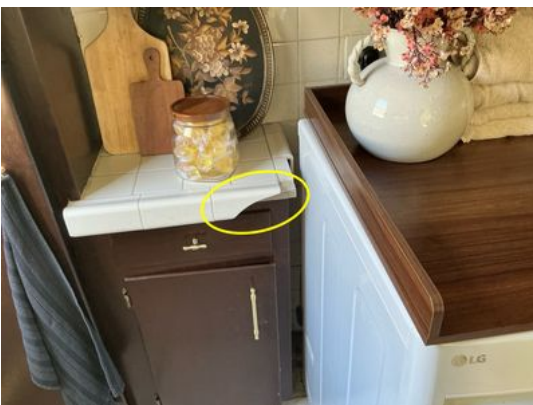
Tile is broken at countertop.

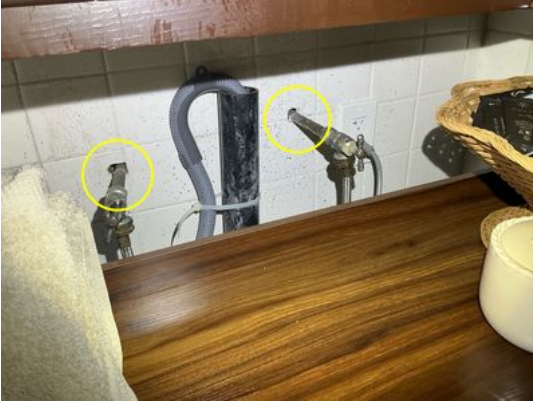
Comment 60

Escutcheons are not installed.
