### *Inspection Report*

Address: 482 Yerba Buena St Morro Bay, CA 93442

04/07/2026

Inspector: Keith Vreeken, MCI, FCI  
P.O. Box 415 Templeton, CA 93465 O: 805.462.1978 C: 805.440.5050

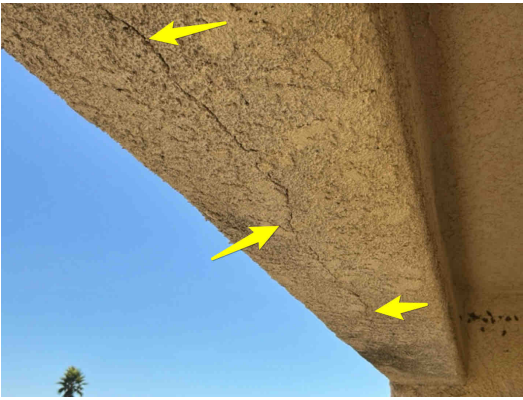
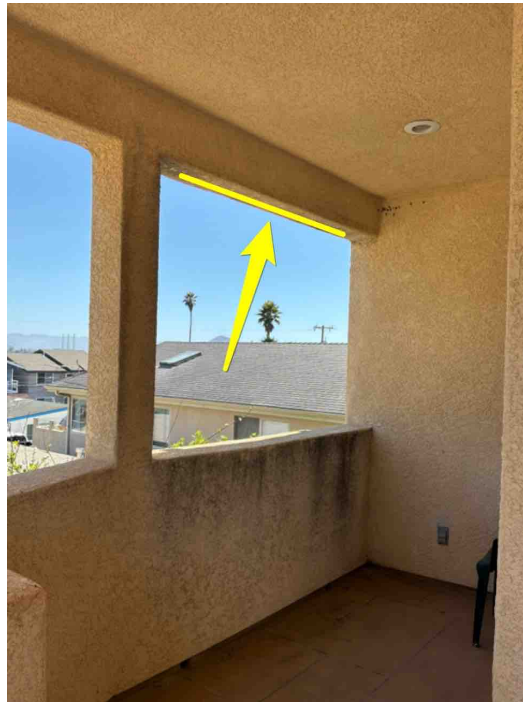
**FI** 21: Some unusual and moderate cracking at areas of the exterior stucco AT A BEAM ON THE SOUTH SIDE OVER THE UPSTAIRS BACKYARD WATERPROOF DECK. Referred to photo for specific location. This type of cracking is indicative of a failure of the waterproofing under the stucco which is causing swelling, deterioration and/or damage to the structural wood framing. Client should investigate further by removing the stucco until satisfied as to the cause, condition, potential future issues and correct as needed. Refer to termite report for additional comments and recommendations.

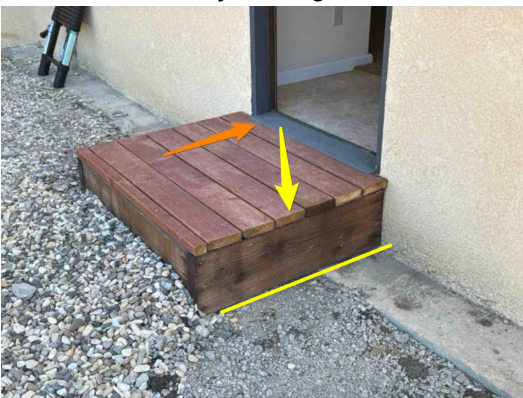
1. An unusually tall step that exceeds the maximum height found at the FRONT ENTRY EXTERIOR WOOD LANDING. Potential fall or trip hazard. Upgrades or repairs are recommended for safety. The maximum step off the front landing should not exceed 8 inches.
2. The FRONT ENTRY EXTERIOR WOOD LANDING found to be improperly installed unusually high at the exterior door threshold. This could lead to water intrusion under the door threshold. Upgrade and monitor as future moisture conditions could manifest. A minimum of 2 inches should have been installed between the top of the exterior wood entry landing and the bottom of the front entry door threshold.

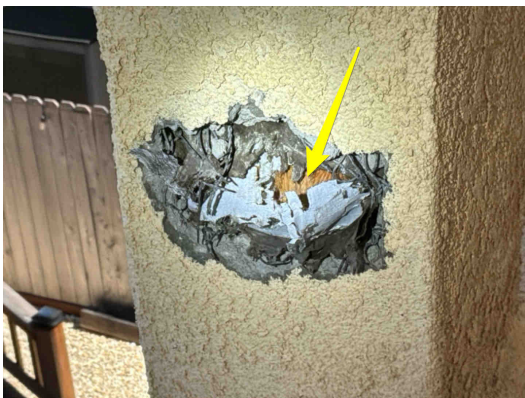
- FI 24:** Some damaged exterior stucco found at the
1. stucco ceiling area above the backyard upper waterproof deck, and
  2. at one of the support posts at the the backyard upper waterproof deck

Support post Stucco damage

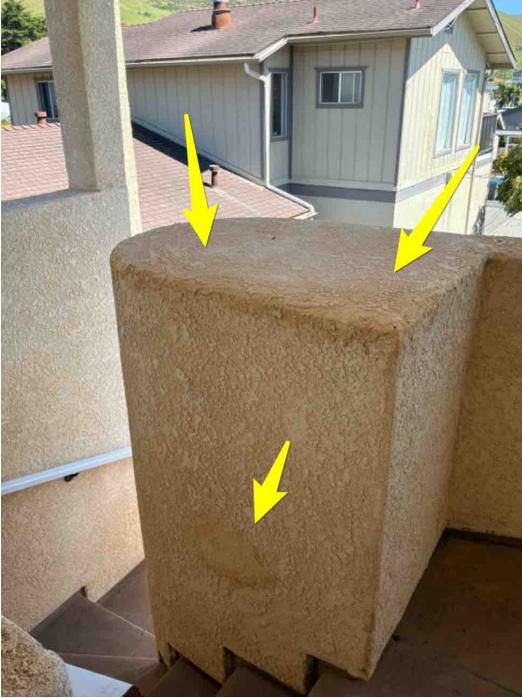
**FI 25:** Some recent stucco repairs found at areas of the exterior stairway stucco wall walls off the upstairs backyard waterproof deck

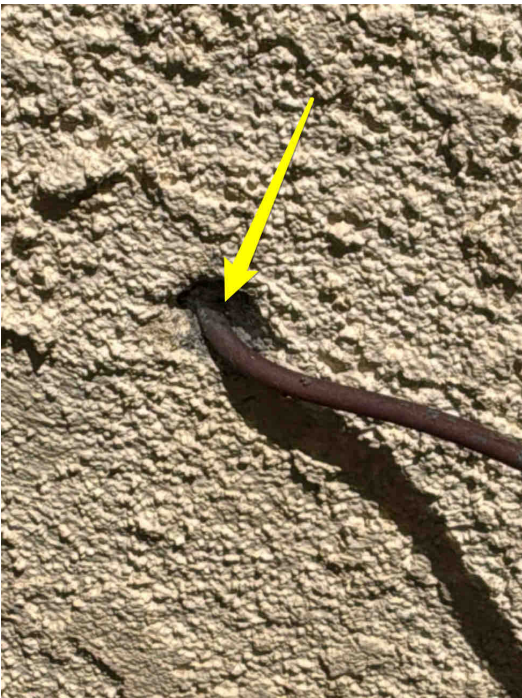
Example

**MR 26:** Recommend sealing holes in exterior walls to prevent water intrusion around areas such as unused open holes in the exterior siding and trim, exterior light fixtures, around exterior electrical boxes and covers, and where utility pipes and/or wires pass through the exterior walls. Have a qualified painter or licensed professional evaluate the entire exterior and seal where needed.

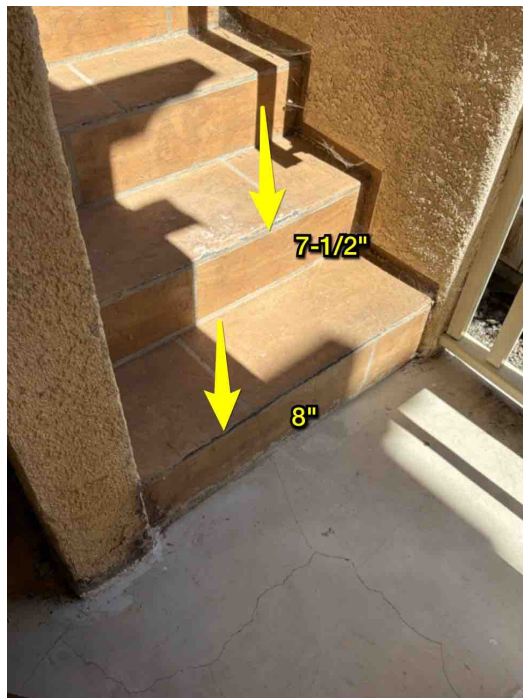
**SC 29:** Uneven step tread rise, step heights are not all the same, at the exterior stairway off the BACKYARD UPPER DECK. Potential trip or fall hazard.

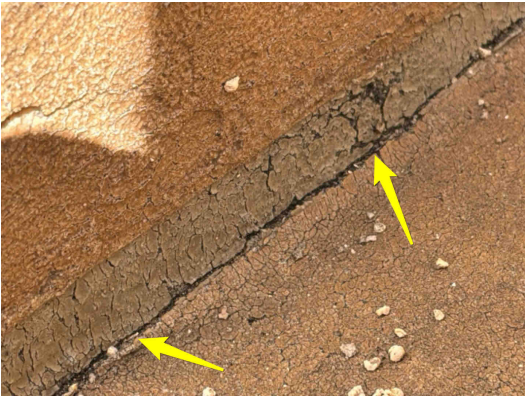
**E&C 30:** Some visible deterioration and or damage noted at areas of the exterior stairway waterproof coating at the exterior stairs OFF THE BACK OF THE HOUSE TO THE UPSTAIRS DECK.

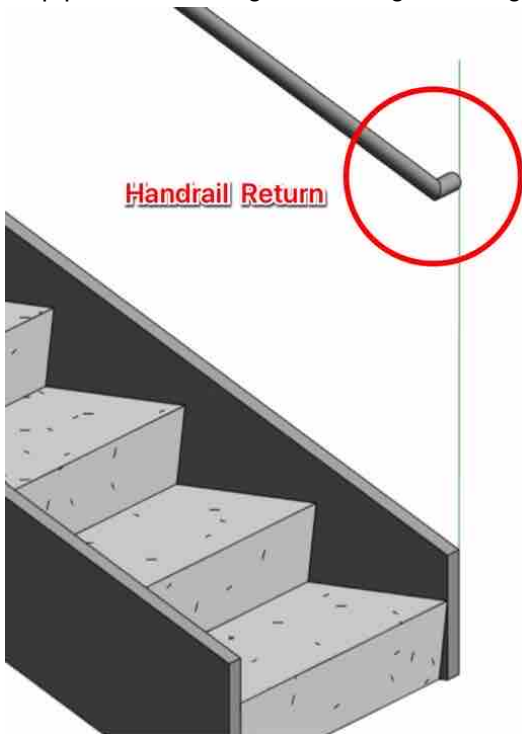
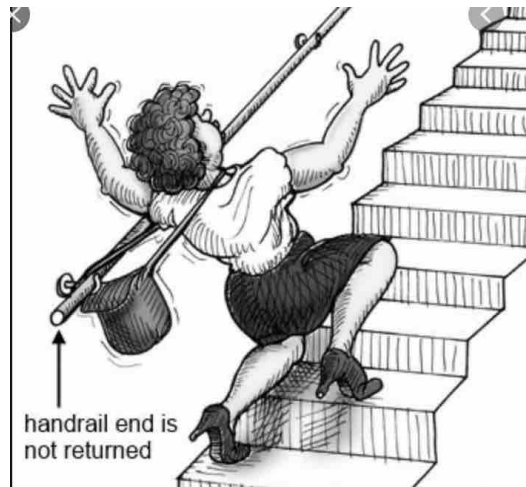
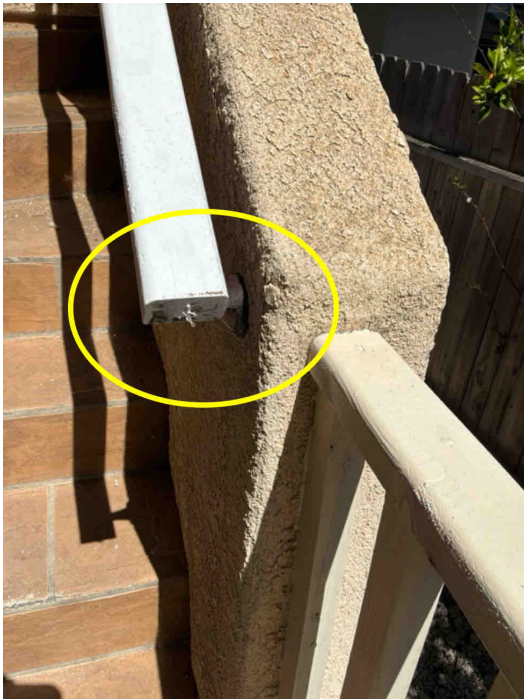
**SC 31:** Recommend returns at the exterior stairway graspable handrails for safety per standards at the exterior stairway OFF THE BACK OF THE HOUSE TO THE UPSTAIRS DECK. (Turning ends of the handrail into wall to help prevent catching coat or bag on railing).

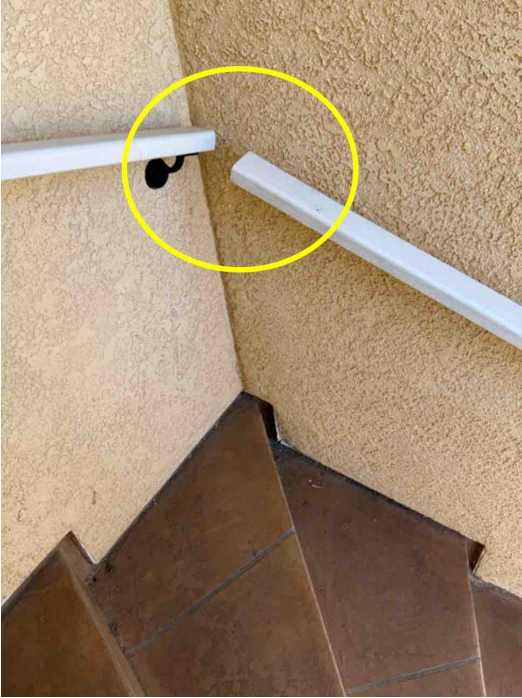
**SC 32:** Handrail off the backyard upper deck is required to be one single railing and should not be broken or disconnected creating one single railing all the way from the top to the bottom.

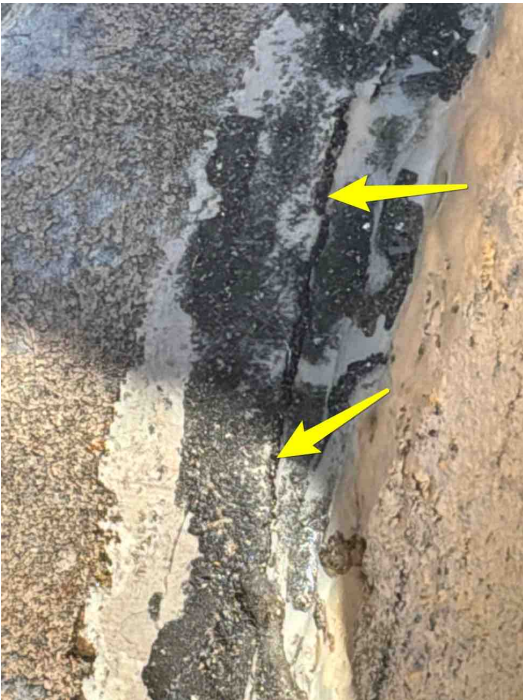
**FI 42:** Professional patch, improper use of caulking, heavily deteriorated and damaged at areas of the waterproofing around the UPSTAIRS ROOF DECK. Recommend additional review and repairs by licensed waterproof Deck professional

Current sealant heavily deteriorated

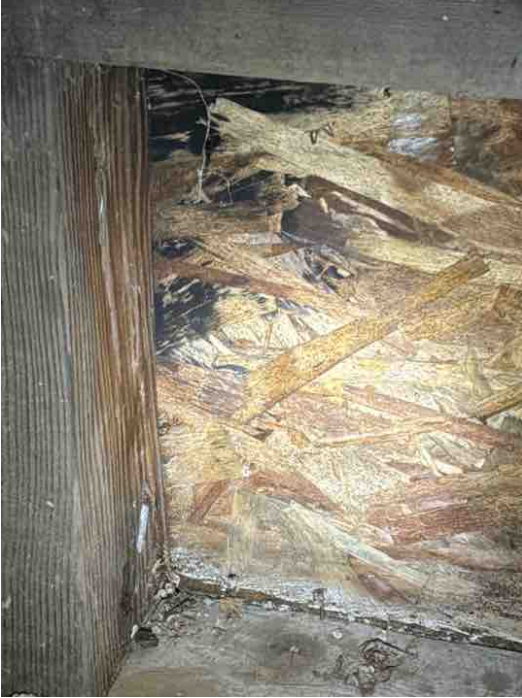
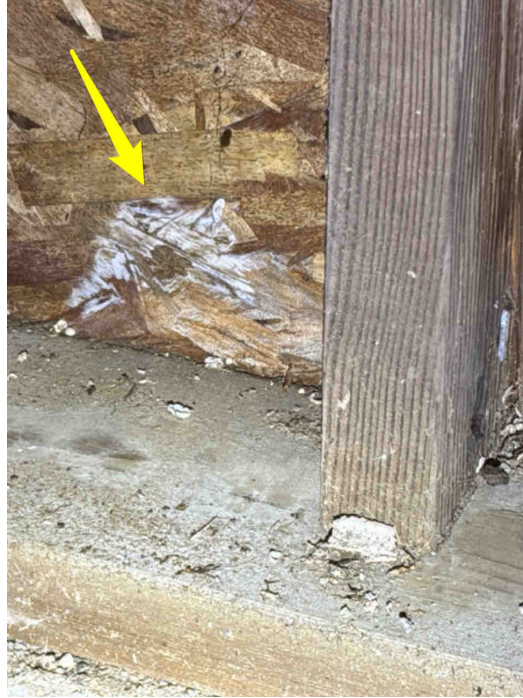
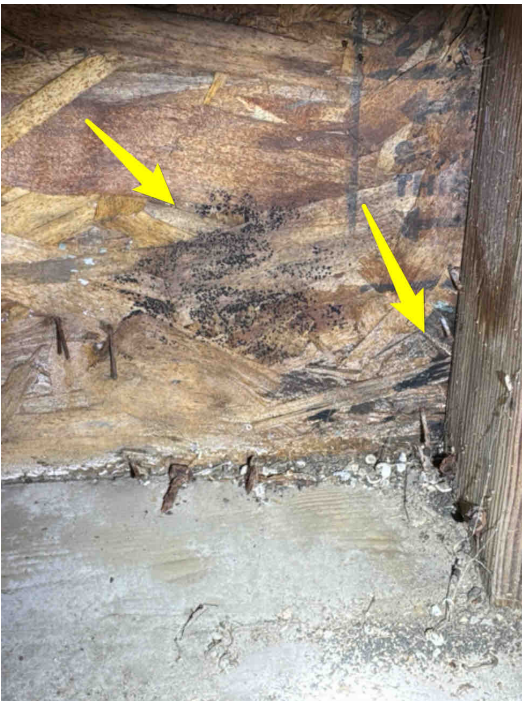
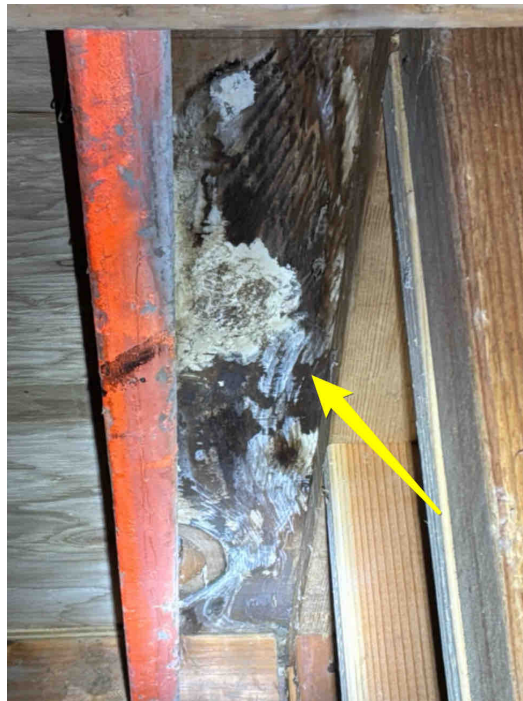
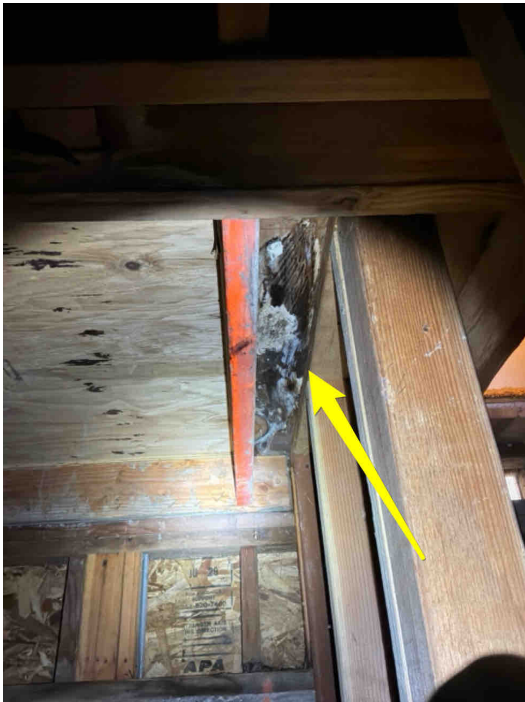
**FI 49:** Moisture and/or bug type deterioration and/or damage found in areas of the crawlspace at wood framing and/or sub-floor. Refer to the current Termite / pest inspection report for additional comments.

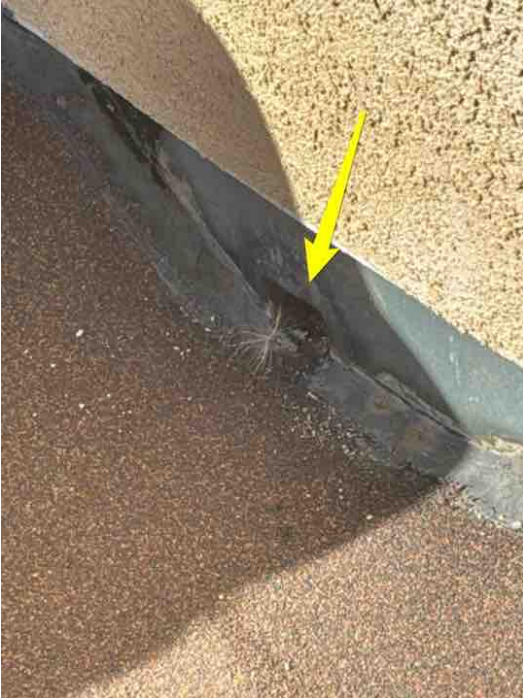
**E&C 62:** Missing the required secondary roof drain(s) at the low slope roof system. Overflow roof drains or scuppers are required to be installed at 2 inches (51 mm) above the primary roof drain inlet. [Section 1506.3 of the CA building code]. This can be accomplished by adding additional roof drainage through the roof system or adding appropriate roof scuppers, at 4" x 4" - two inches above the primary roof drain pipe.

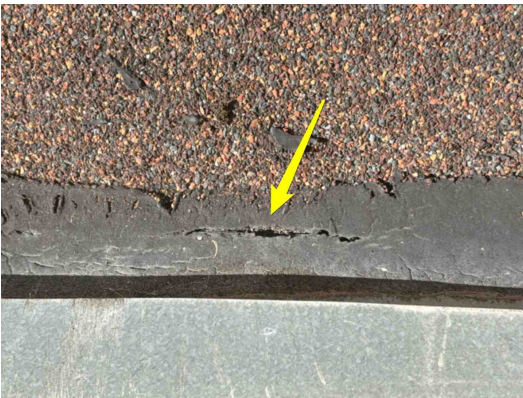
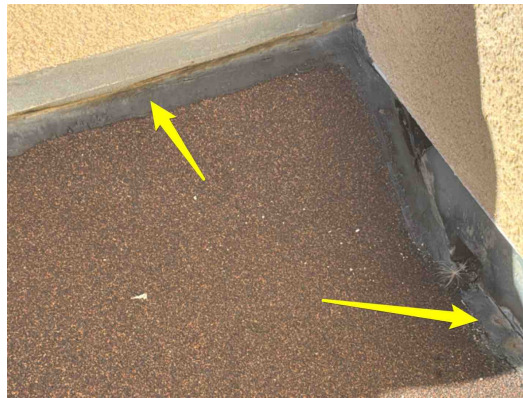
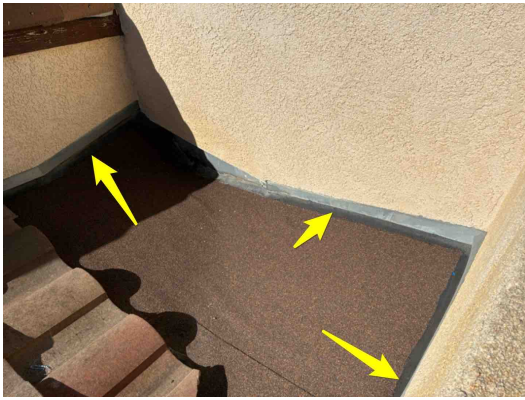
**FI 63:** Some moderate heavy deterioration of the sealant around the head wall connections. Suspected improper installation or past non-professional leak repairs.

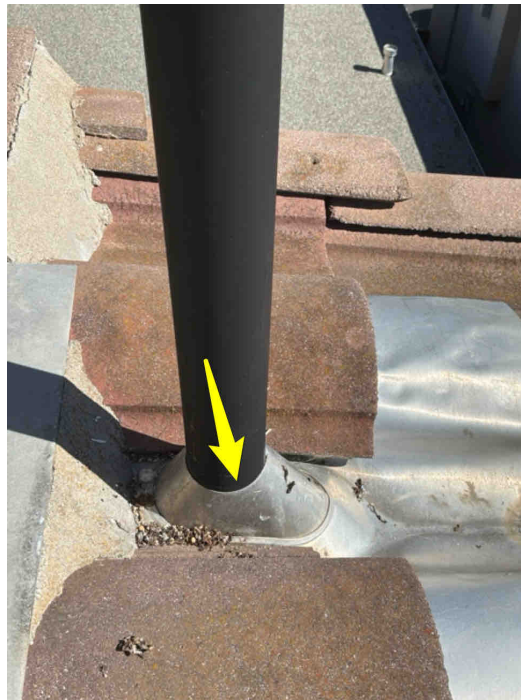
Example location

**MR 66:** Missing and/or deteriorated sealant at roof jack flashings.

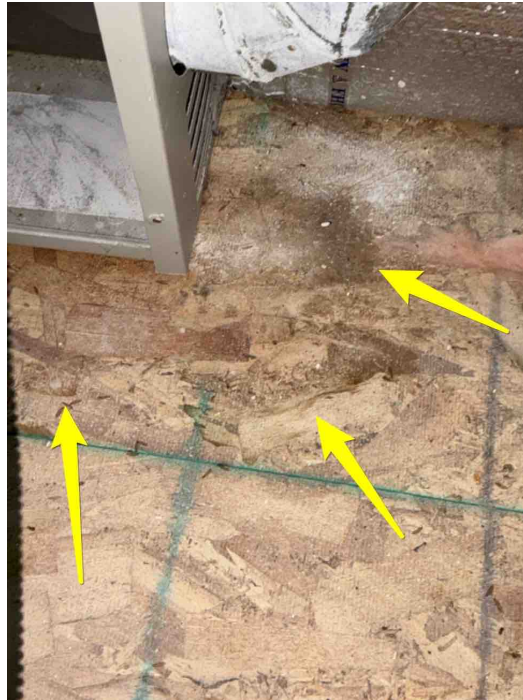
**FI DS 72:** Some moisture stains noted in the attic AROUND THE FURNACE AREA. All water stains should be investigated by a licensed roofer. Refer to termite report for additional comments and/or recommendations.

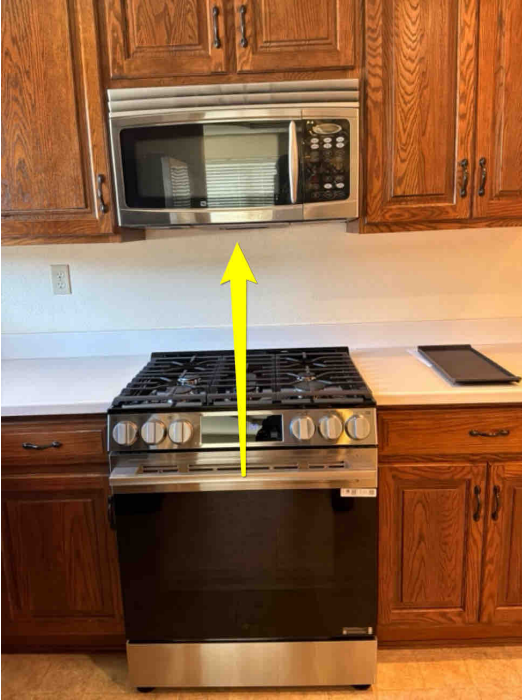
**E&C 99:** Kitchen cook top exhaust hood FAN and light at the microwave installed over the cooktop found non-operational or not operating properly.

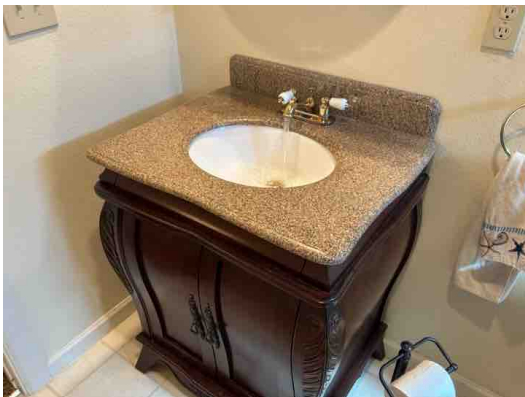
**MR** 129: Missing Grout and/or Caulking at the bathroom sink counter to the wall connection in the: DOWNSTAIRS HALL BATHROOM

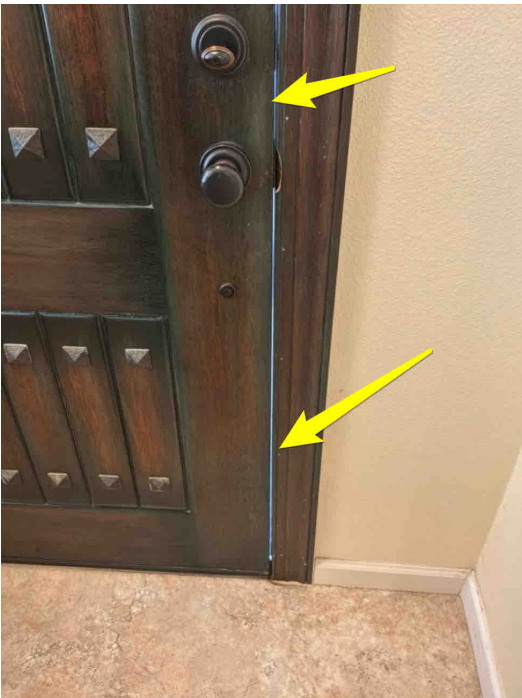
**MR 137:** Some visible daylight noted around the exterior front entry door. Adjustment and/or repair of the weather stripping is recommended to help prevent water and critter intrusion.

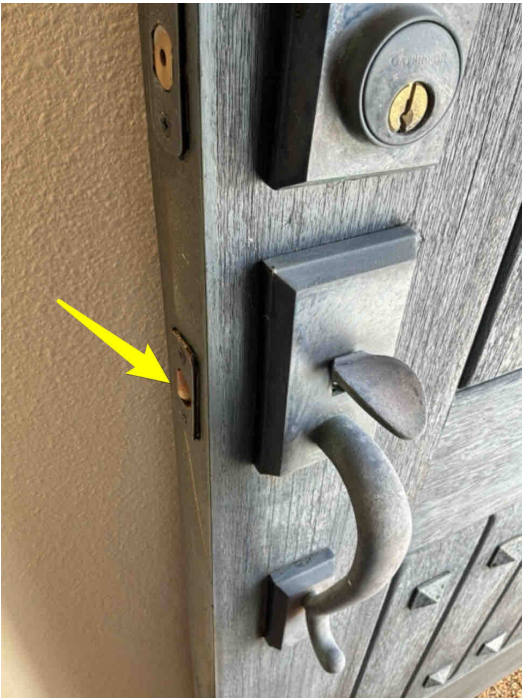
**SC 143:** Exterior door latching hardware is not operating properly: UPSTAIRS BEDROOM HALLWAY exterior door.

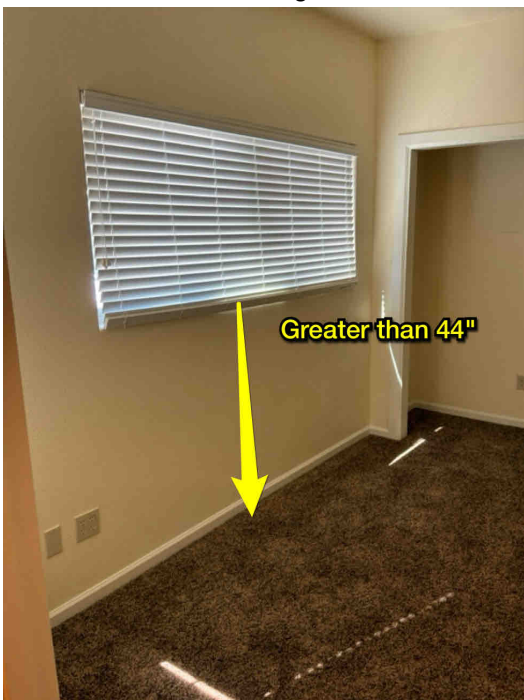
**SC 152:** The window in the UPSTAIRS BEDROOM-3 is too high off the floor (greater than 44 inches) and does not meet minimum fire egress standards.

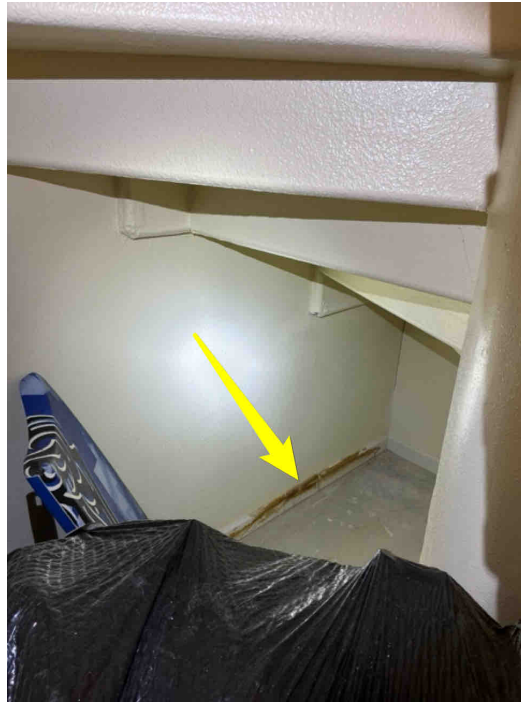
**FI 163:** Evidence of moisture stains and/or damage at the walls in the AREAS THROUGHOUT THE EXTERIOR STAIRCASE INSIDE THE UNDER STAIRWAY ENCLOSURE OFF THE BACK OF THE GARAGE. Recommend further review of the water stains to determine the cause, the current condition and if repairs are needed.

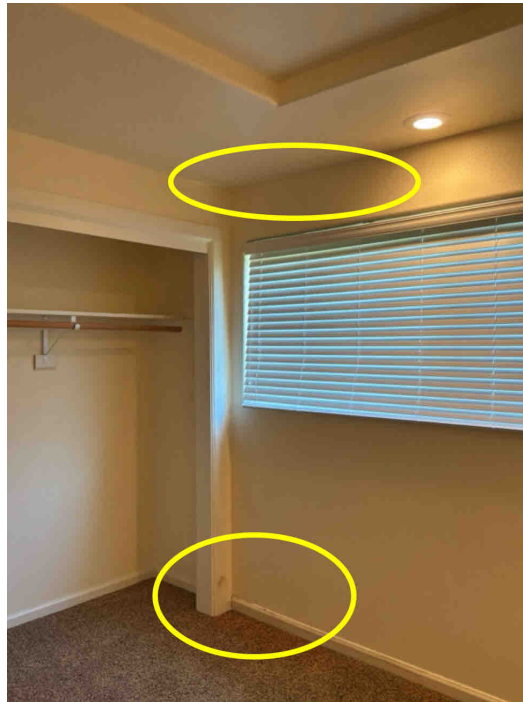
Example. Inside the closet

**FI 164:** Evidence of moisture stains and/or heavy water damage with visible mold growth at the walls, baseboard and closet door trim in BEDROOM-2 NEXT TO THE CLOSET UNDER THE WINDOW. Water intrusion appears to be coming from above the window. Recommend further review of the water stains to determine the cause, the current condition and repair as needed.

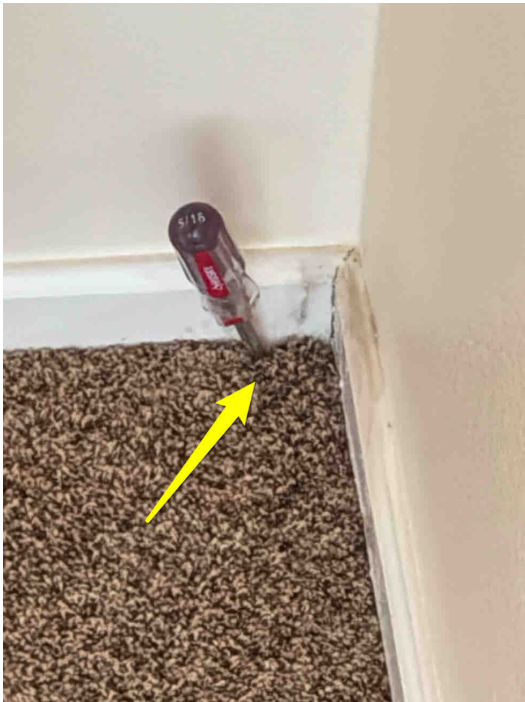
**FI 165:** Evidence of some displaced puffy drywall at wall area in the BEDROOM-1 EXTERIOR SOUTH WALL. Recommend further review determine the cause, the current condition and if repairs are needed.

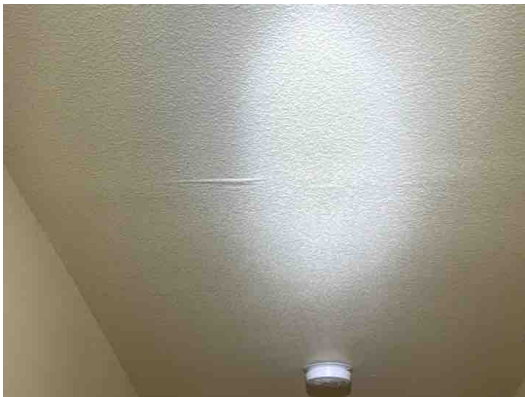
**FI 167:** Evidence of past moisture stains & damage at ceiling area in the UPSTAIRS BEDROOM HALLWAY BELOW THE FURNACE. Recommend further review of the water stains to determine the cause, the current condition and if repairs are needed.

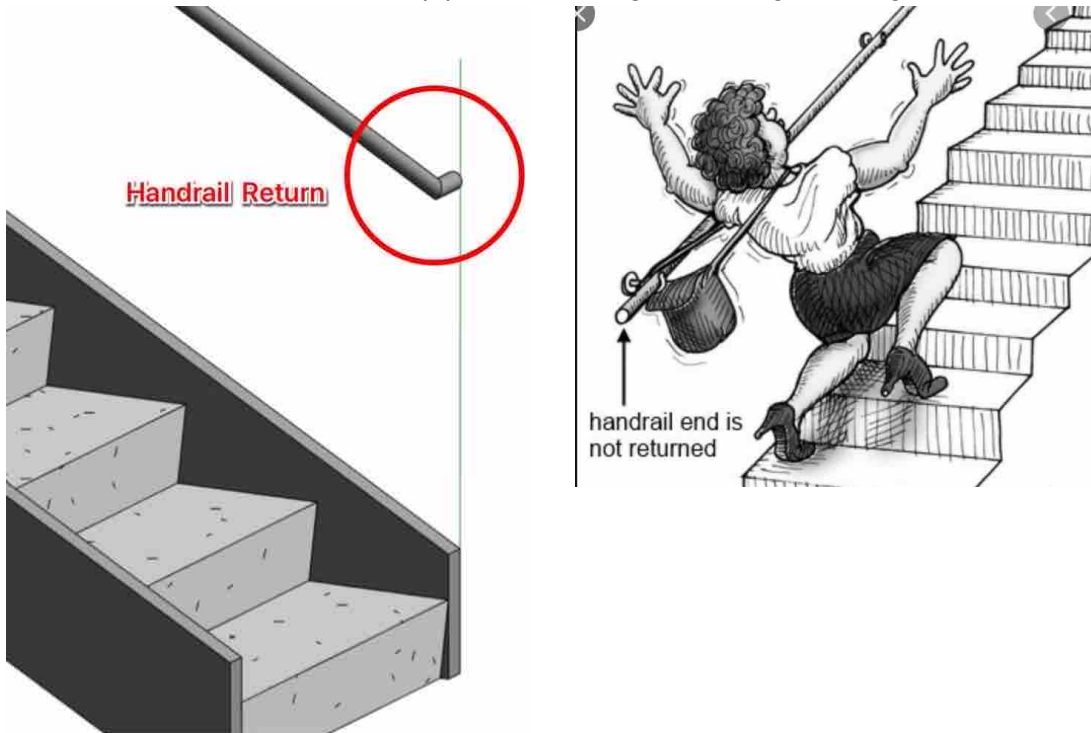
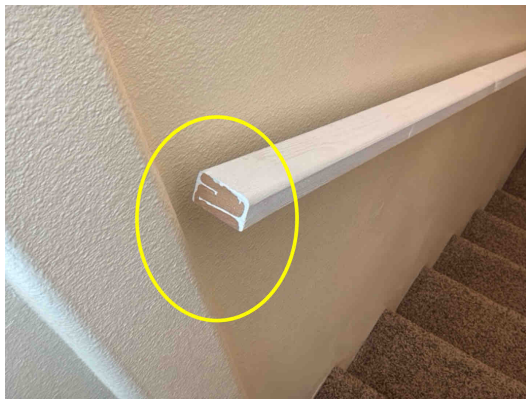
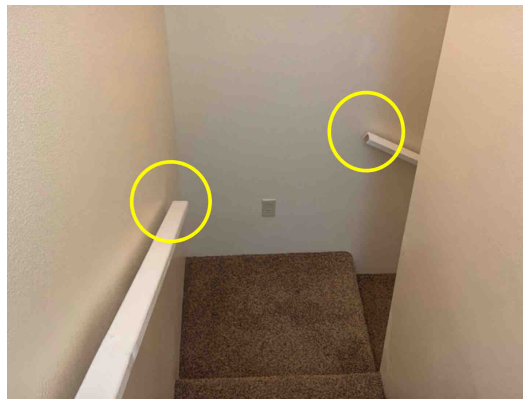
**UPG 171:** Missing returns at the interior stairway gripable handrails for safety per standards. Return are turning the ends of the handrail into wall to help prevent catching coat or bag on railing.

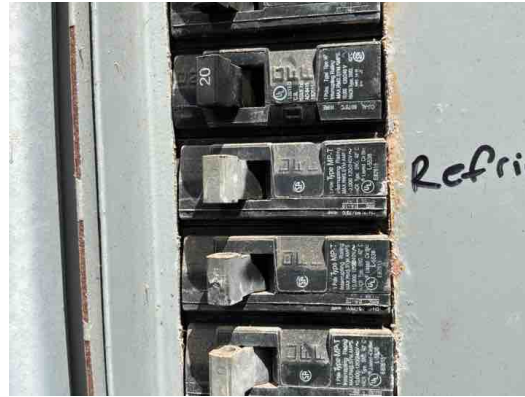
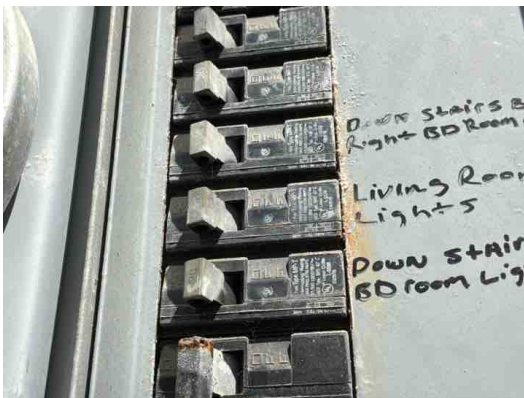
**SC FI 184:** Areas of excessive deterioration and damage were observed at multiple circuit breakers in the MAIN ELECTRICAL PANEL, This is likely due to prolonged exposure from the panel cover being left open or not properly secured. The affected breakers show signs of significant wear and degradation. Replacement of all deteriorated and damaged breakers is recommended by a qualified electrician.

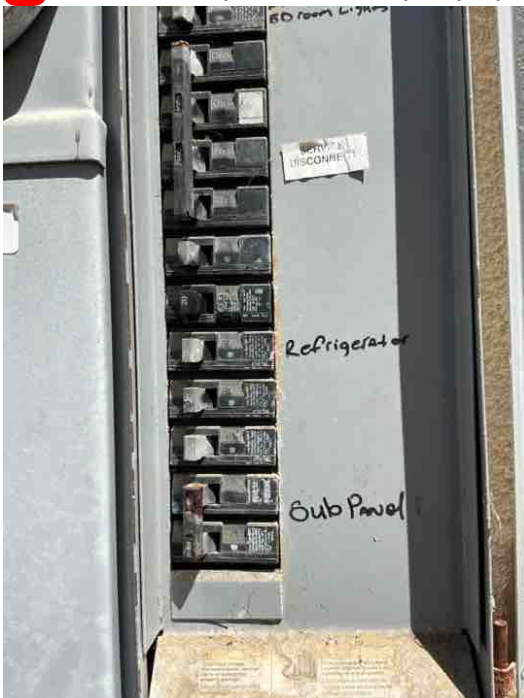
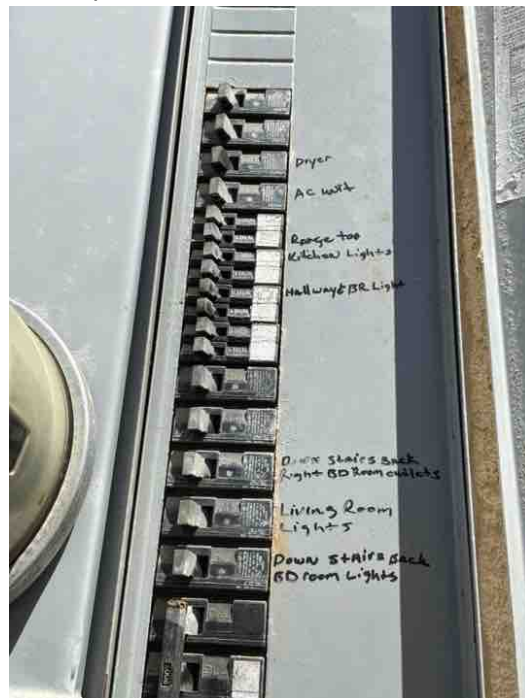
**SC 185:** Breaker panel is not fully or properly labeled per standards: MAIN ELECTRICAL PANEL.

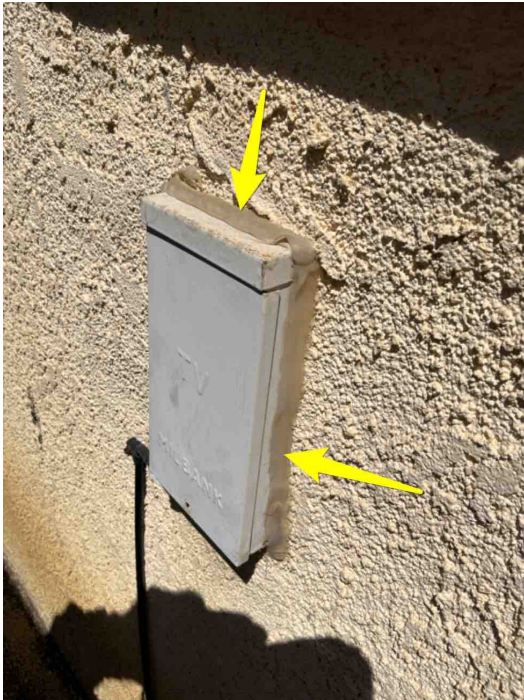
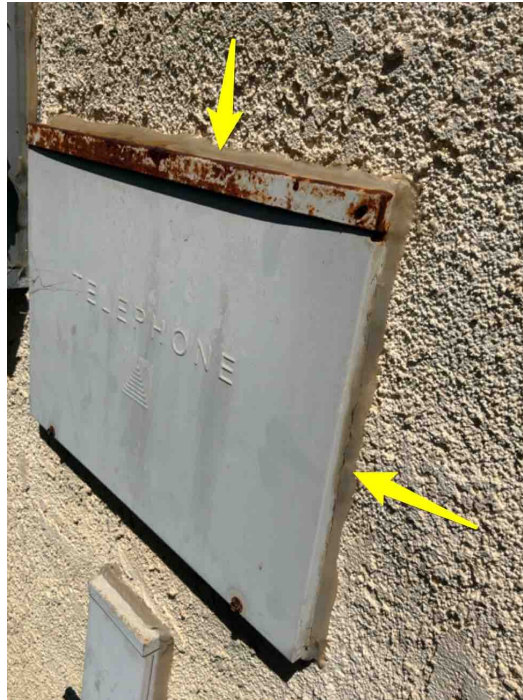
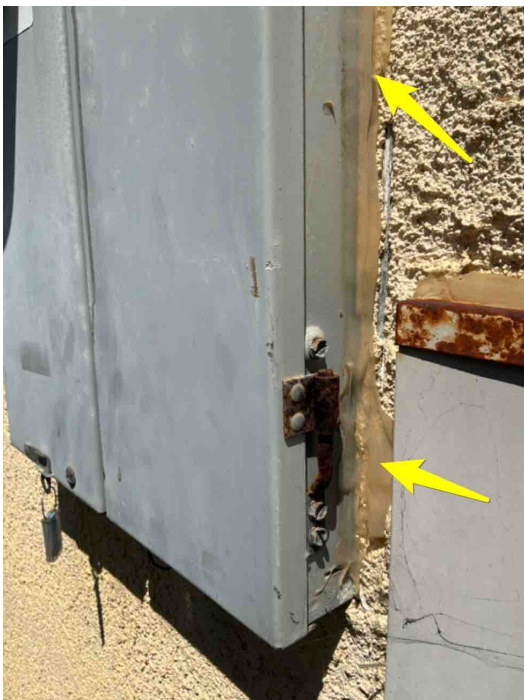
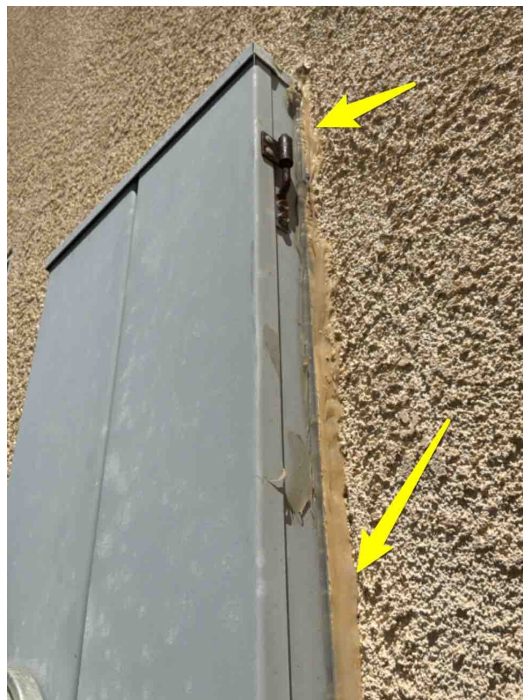
**FI 189:** Unusual and non-standard caulking was observed at the wall-to-panel interfaces at the main electrical panel, telephone service panel, and TV service panel. This condition is not typical of proper installation practices and is commonly associated with prior water intrusion or moisture-related deficiencies. The presence of sealant in these locations suggests a possible concealed condition. Further evaluation is warranted to determine reasons for the unusual and added caulking around the panels by an appropriate contractor to determine if there is or was a concealed moisture condition such as past water intrusion and if proper upgrades or repairs are needed.

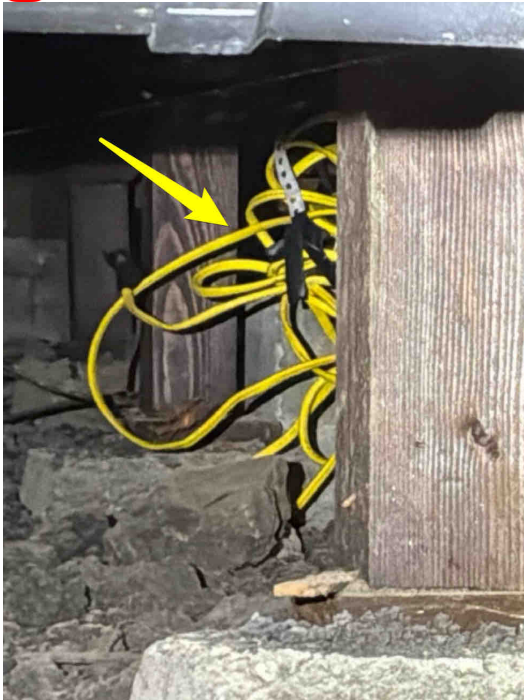
**SC 193:** Improper and unsafe electrical wiring IN THE CRAWLSPACE

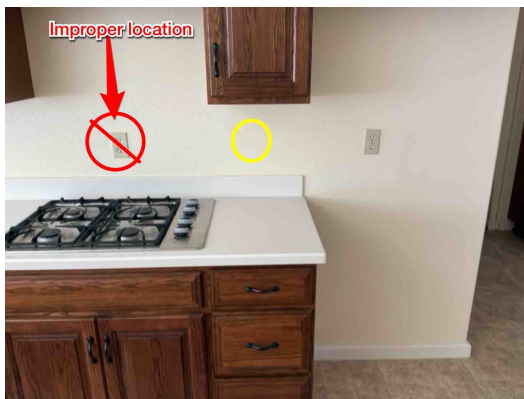
**SC 194:** Required electrical receptacles are missing at some required location in the UPSTAIRS ADU KITCHEN for countertop appliances. This condition does not comply with CEC 210.52(C), which mandates receptacle placement at countertop spaces 12 inches or greater in width and requires spacing such that no point along the wall line exceeds 24 inches from an outlet. Missing outlets at these locations are considered improper and may lead to unsafe use of extension cords and overloading conditions.

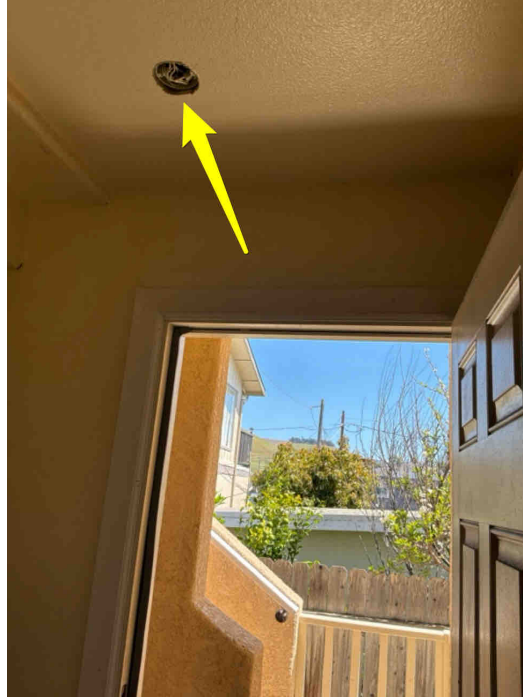
**SC 200:** Light fixture is missing with exposed wires: ON THE INTERIOR CEILING LIGHT FIXTURE ABOVE THE GARAGE PEDESTRIAN DOOR

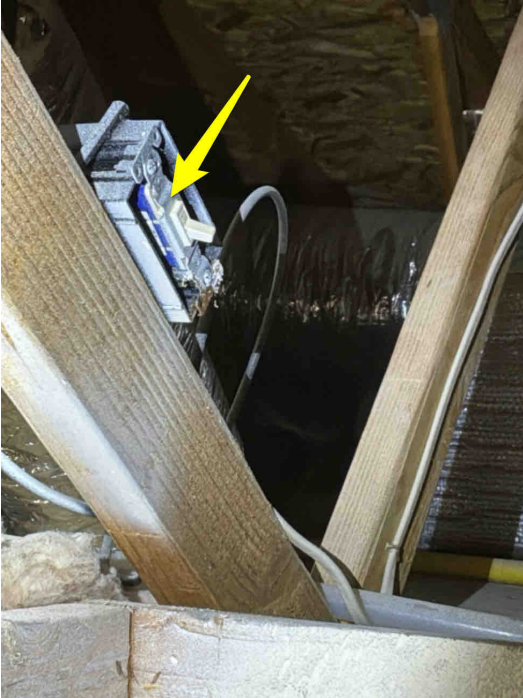
**SC 202:** Missing electrical cover plate at the attic light switch.

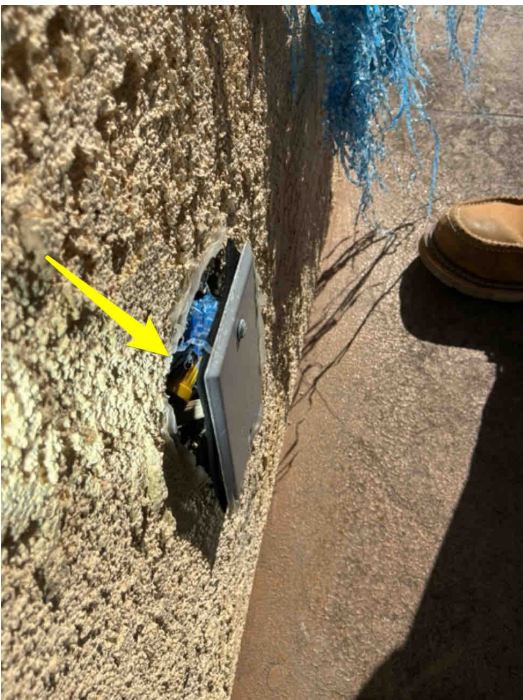
**SC 203:** Loose, improper installation of TWO separate weather tight junction box cover at the AT THE UPSTAIRS ROOF DECK ISLANDS ELECTRICAL JUNCTION BOX. Exposed electrical wiring, potential water intrusion into the wall cavities.
