### *Inspection Report*

**Address: 7955 Las Lomas Ave Atascadero, CA 93422**

**04/11/2026**

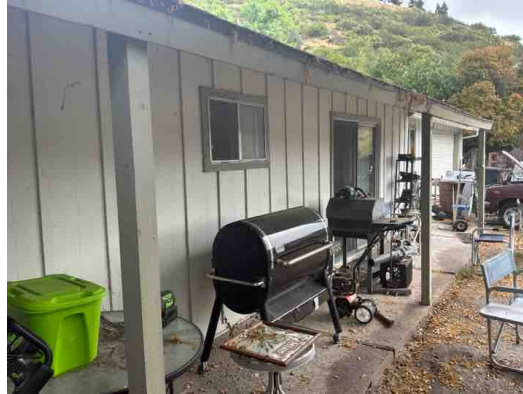
**E&C 17:** Some moisture and/or bug-type damage found at the wood framed SOUTH SIDE PATIO COVER. Refer to the Termite Report for additional comments and recommendations.

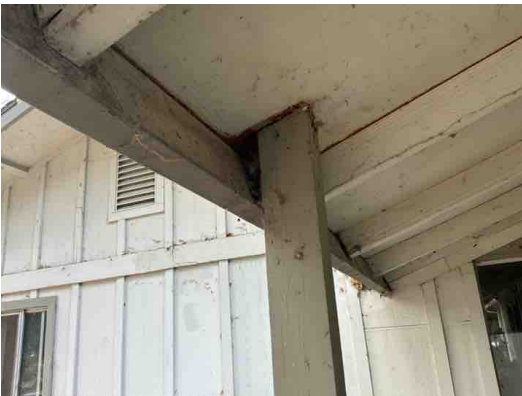
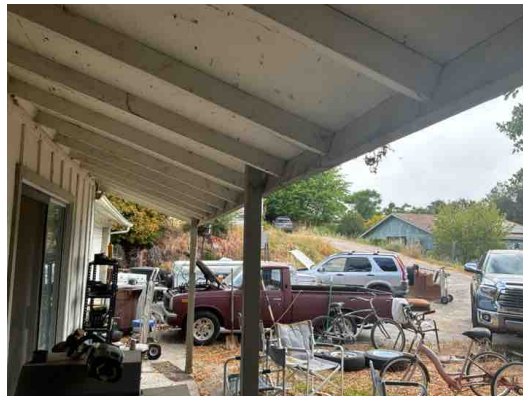
**E&C SU 18:** Areas of the wood framed SOUTH SIDE PATIO COVER do not meet minimum construction or engineering standards. Certain issues can negatively affect the overall integrity of the structure. Further evaluation with repairs are warranted by a licensed contractor familiar with minimum construction and engineering standards is recommended.

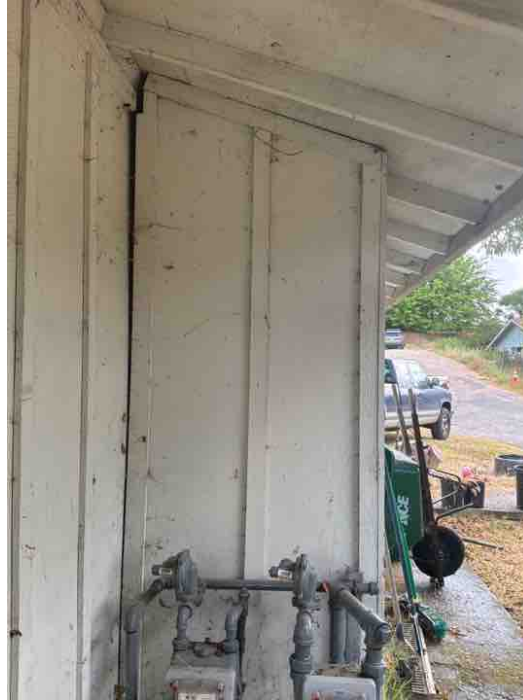
**FI 22:** The added Shed on the south side of the house found to be pulling off the building and separating. Evidence of a compromised structural integrity. Upgrades are warranted.

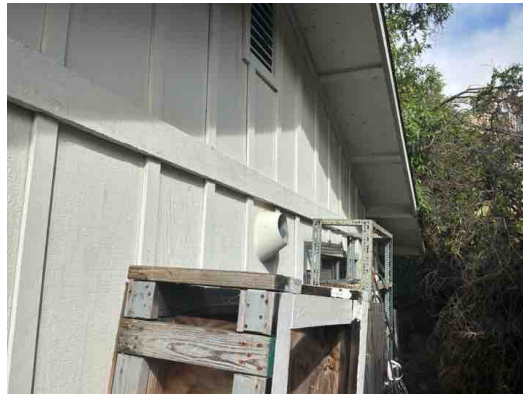
**E&C 23:** Open hole through the exterior Garage wall found on the North side of the home. The open hole needs to be sealed to prevent critter and water intrusion.

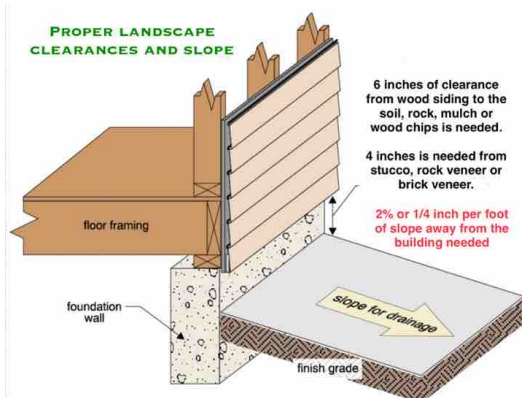
**MR 32:** Soil level found high along areas of the perimeter of the foundation and exterior siding (recommend 6 inches from the bottom of the exterior siding to dirt, rock, mulch or wood chips).

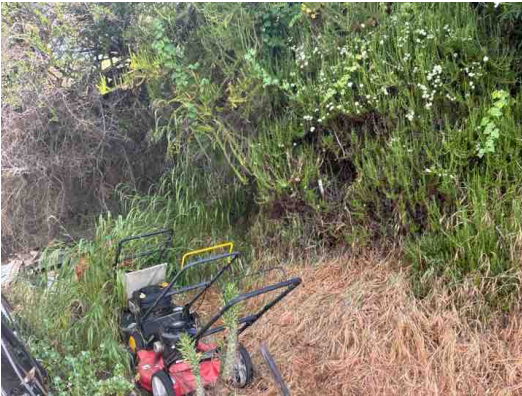
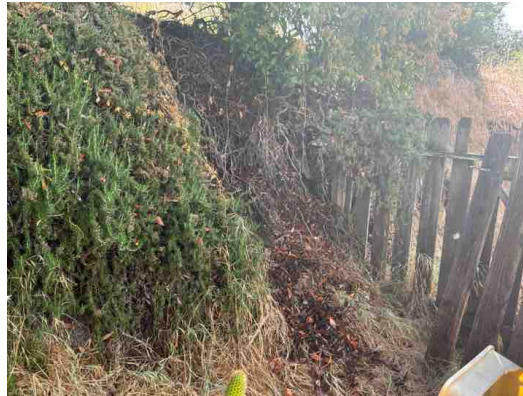
**FI 36:** Some soil instability on the property at the North side of the home. Evidence of movement or setting of the house foundation sidewalks, driveways, etc. Have a licensed Civil engineer evaluate the movement of the foundation systems and the suspected site settlement to determine the cause, the current conditions, potential future issues.

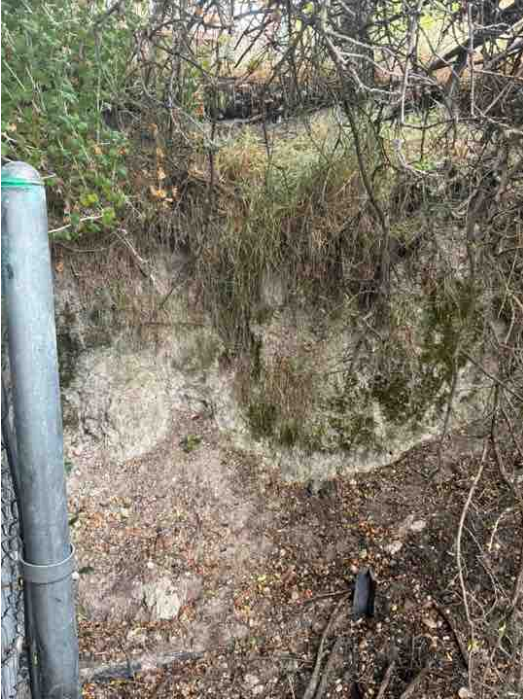
**FI 39:** Some unsecured steep cuts in the hillside found not supported by retaining walls with some visible erosion falling of the topsoil. Recommend further review and upgrades by a qualified and licensed professional familiar with the minimum retaining wall installation requirements.

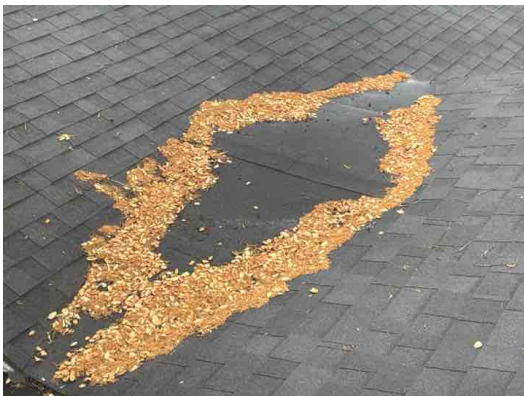
**MR 49:** Debris covers portions of the roof and/or roof flashings. This may cause deterioration and/or a roof leak. Areas of the roof are not fully visible. Clean and inspect regularly.

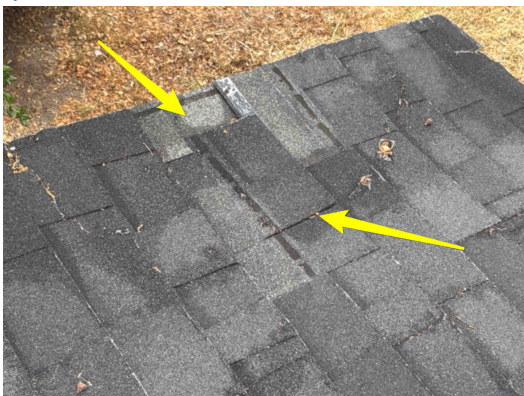
**E&C 50:** Some damaged and missing roof shingles noted at areas of the roof. Corrections are needed. Contact a qualified roofer to evaluate the roof and make the appropriate recommendations and repairs as needed.

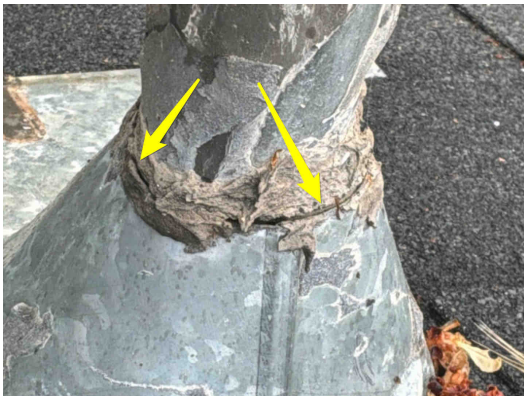
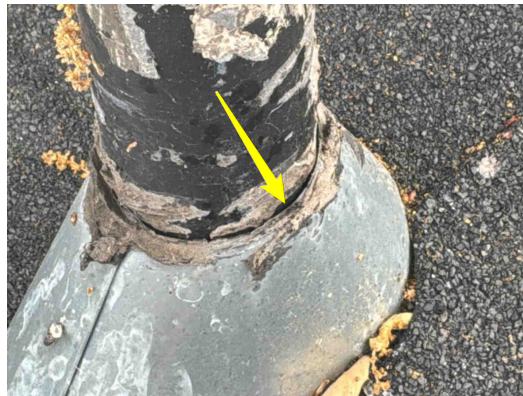
**MR 54:** Deteriorated sealant at some roof flashings, around the roof penetrations. Maintenance recommended to help prevent water intrusion into areas of the attic. Have roofer evaluate the roof flashings and correct as needed.

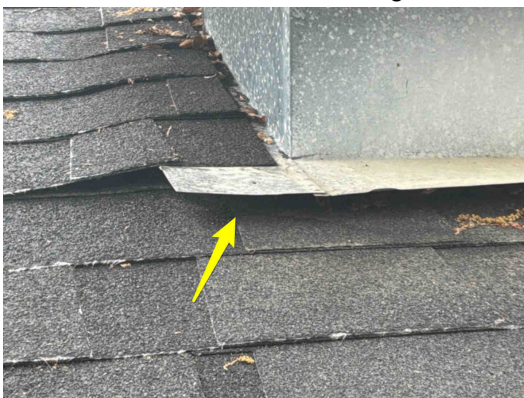
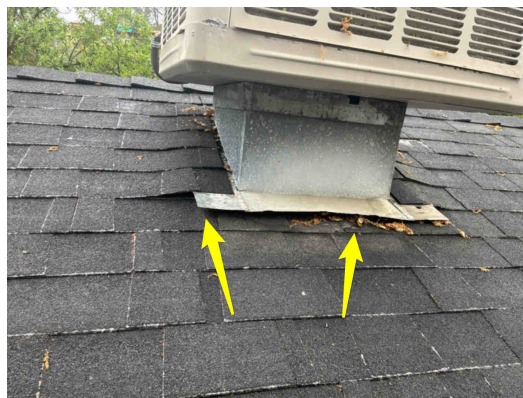
**E&C MR 55:** Some lifting roof flashings. Corrections, maintenance or repairs are recommended to help prevent water intrusion and/or roof leakage from windy, wet weather.

Example. at the swamp cooler

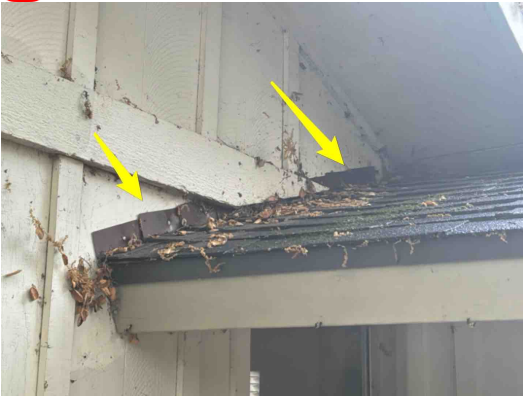
**E&C 56:** Improper head wall flashing at the southside porch cover at the cover to house connection.

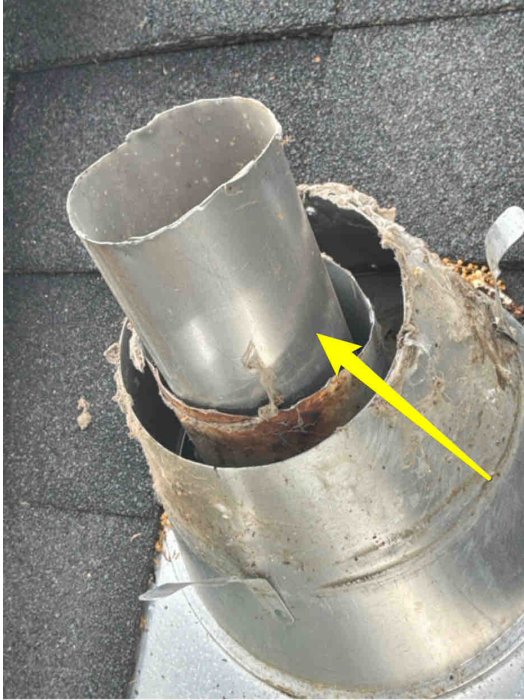
**SC 86:** The water heater "B" vent double-wall type pipe found to have a damaged and disconnected interior sleeve. Contact a qualified plumbing professional to replace the damaged section of water heater and pipe for safety.

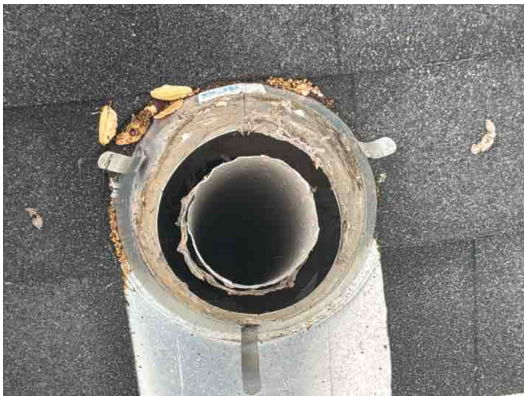
**SC 88:** Improper oversized roof jack flashing used at the water heater vent pipe roof termination. The water heater vent pipe roof jack flashing must seal tight against the vent pipe to help prevent back-venting of exhaust into the attic space.

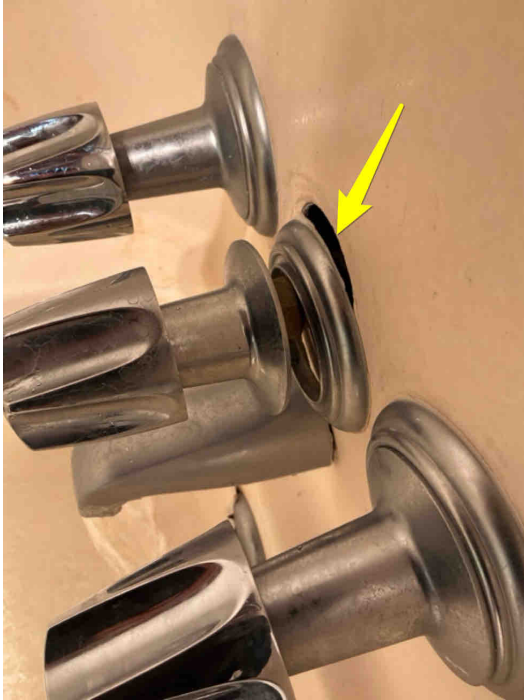
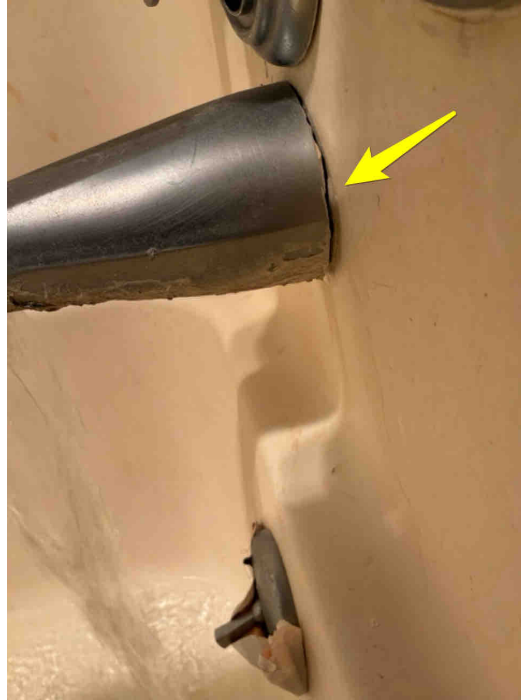
**MR 130:** Tub spout and shower diverter found loose and not sealed well at the shower wall connection in the: HALLWAY BATHROOM

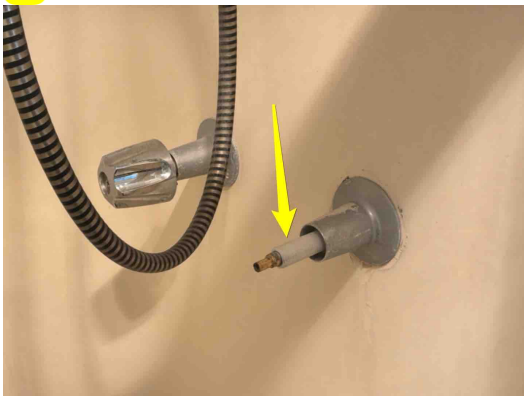
**MR 134:** Shower faucet missing a handle: PRIMARY BEDROOM BATHROOM

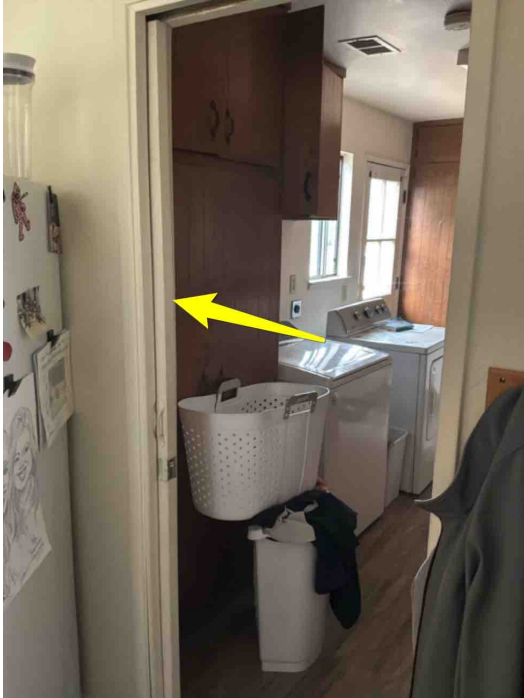
**E&C 142:** Interior pocket door found not operating properly: LAUNDRY ROOM

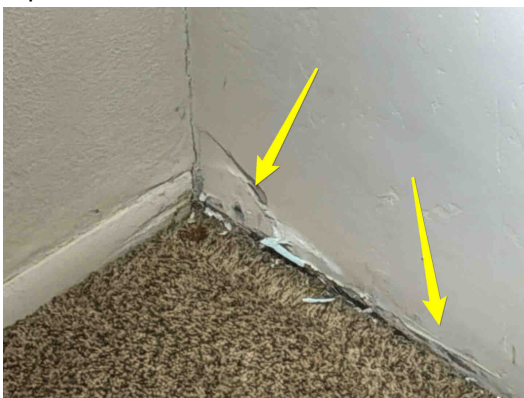
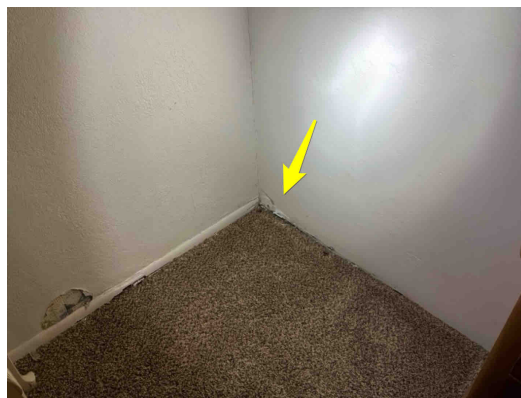
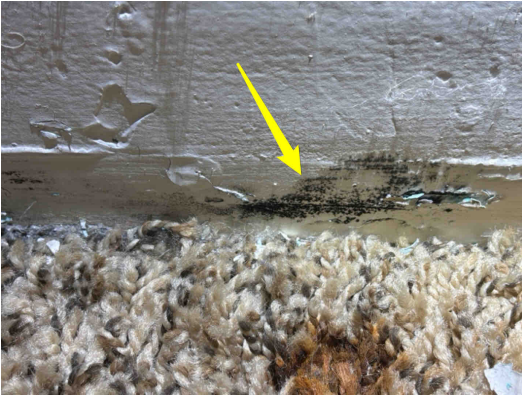
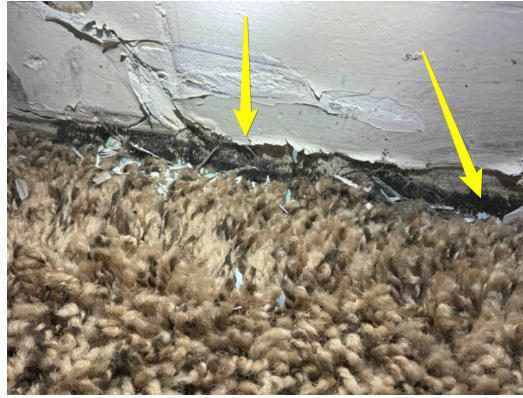
**FI 156:** Evidence of past moisture stains & damage at wall area in the BEDROOM-2 and MASTER BEDROOM CLOSET. Recommend further review of the water stains to determine the cause, the current condition and if repairs are needed.

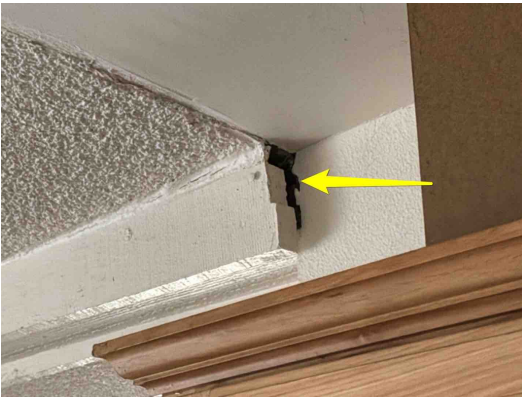
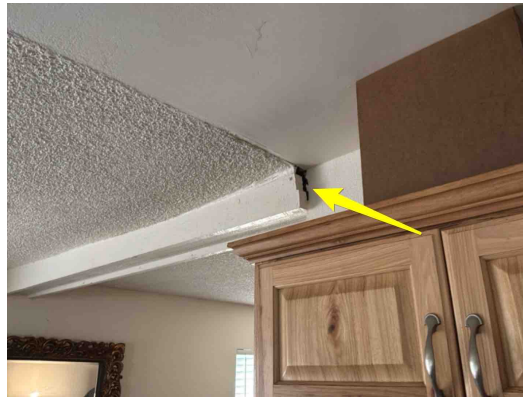
**FI 157:** Invisible separation at the wood trim, beam between the living room and the kitchen above the kitchen cooktop hood. Contact a qualified licensed contractor to evaluate determine cause, current conditions and correct as needed.

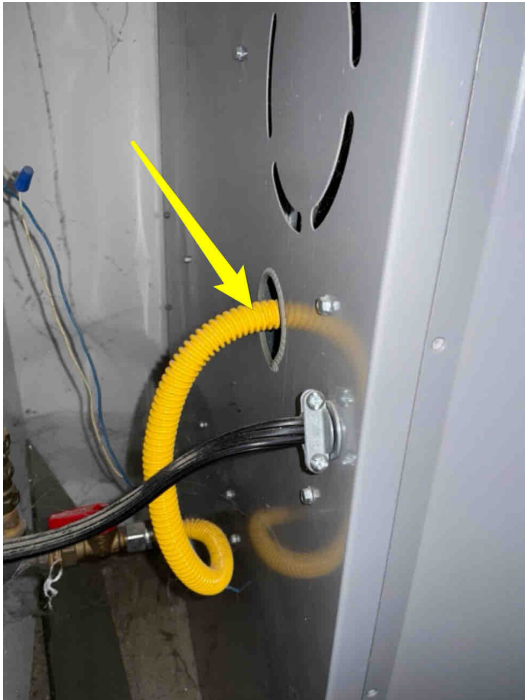
**SU 161: Disclosure:** It is considered an improper installation to have the flex gas connector pass through the metal sidewall of the furnace cabinet. Upgrades recommended.

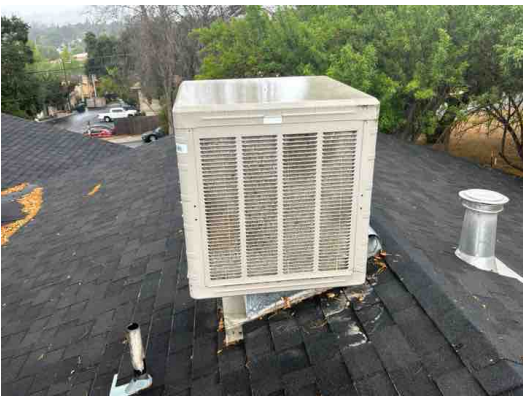
**SC UPG 173:** The evaporative cooler is not properly fastened or attached to the roof and can fall during certain seismic activity or heavy winds, etc. Proper upgrades repairs are warranted for safety

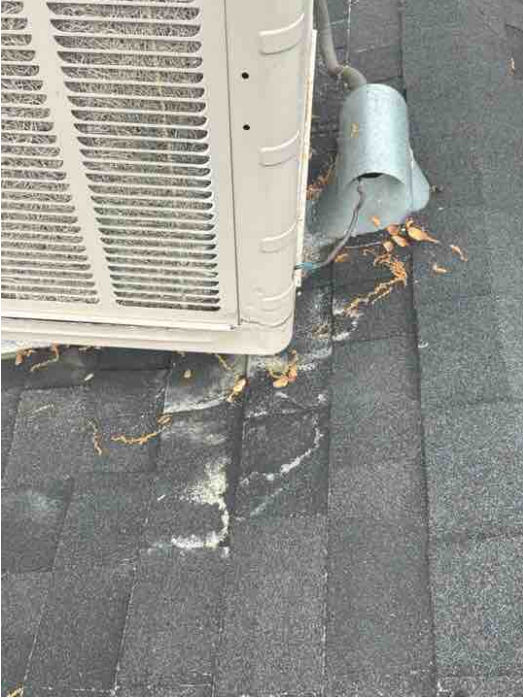
**FI 174:** Evidence of past water leak from the evaporative cooler with heavy buildup of corrosion on the roof shingles. Additional review by licensed HVAC contractor is recommended.

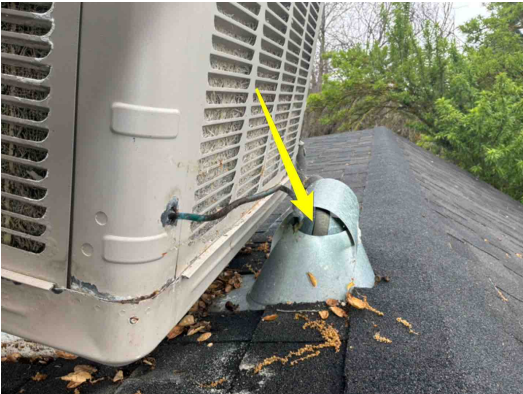
**E&C UPG 175:** Recommend sealing the hole for which the water and electric electricity pass through the roof to help prevent water and critter intrusion into the attic.

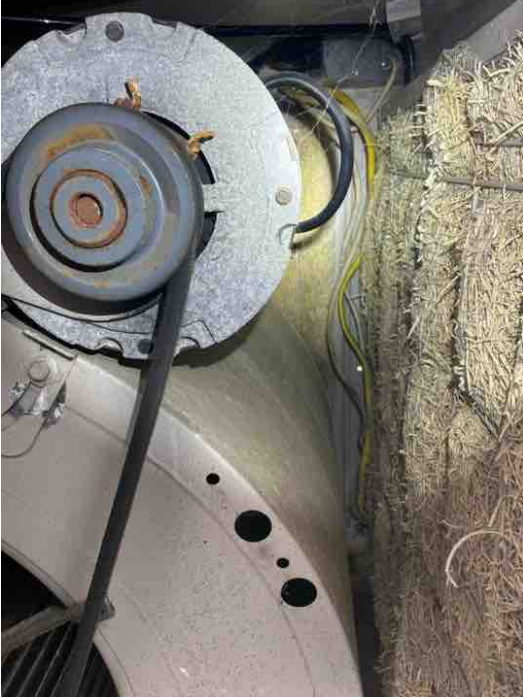
**SC SU 176:** Improper use an installation of Romax through the evaporative cooler. The wire should be in a conduit all the way to the electrical connection inside the unit.

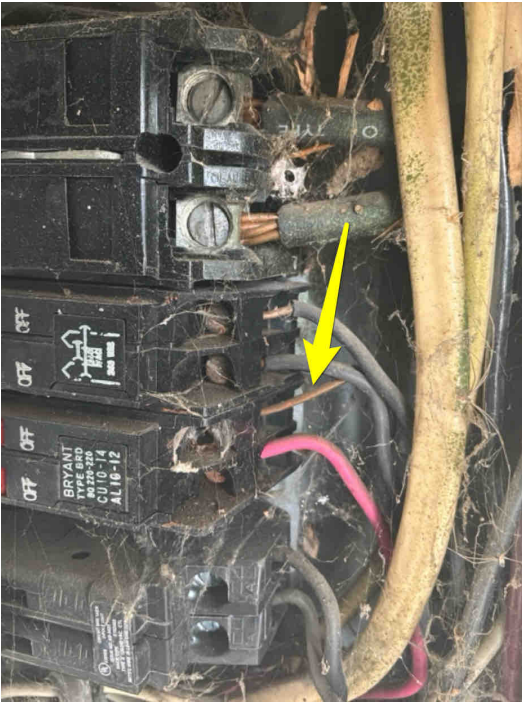
**SC 180:** Some of the protective coating around the outside of the electrical wire found to be over-stripped exposing the energized portion of the wire at some circuit breakers connections inside the MAIN ELECTRICAL PANEL. Exposed electrical wires should be protected to help prevent accidental contact.

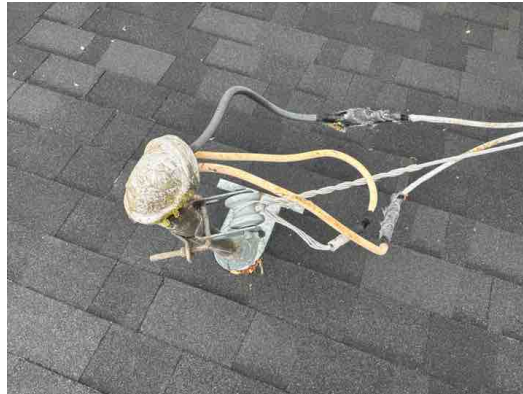
**SC 182:** Improper use of non-exterior rated wire as the coating on the wire found excessively damaged with exposed metal wire at the main electrical main overhead service where the wires enter the electrical mast. Recommend contacting a qualified electrical professional to evaluate and correct. This is considered a safety hazard and warrants repair.

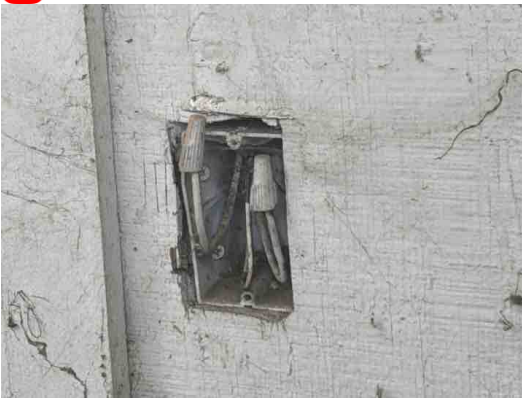
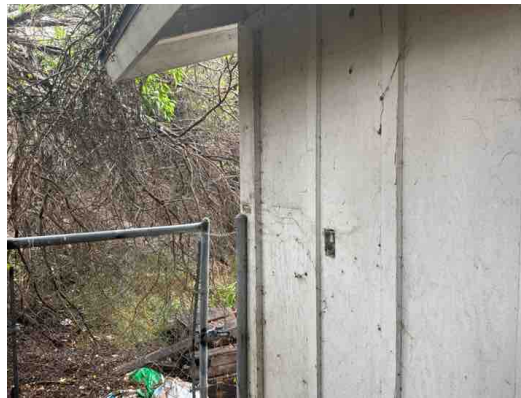
**E&C 186:** Exposed electrical wires missing box cover on the exterior of the home on the north west corner.

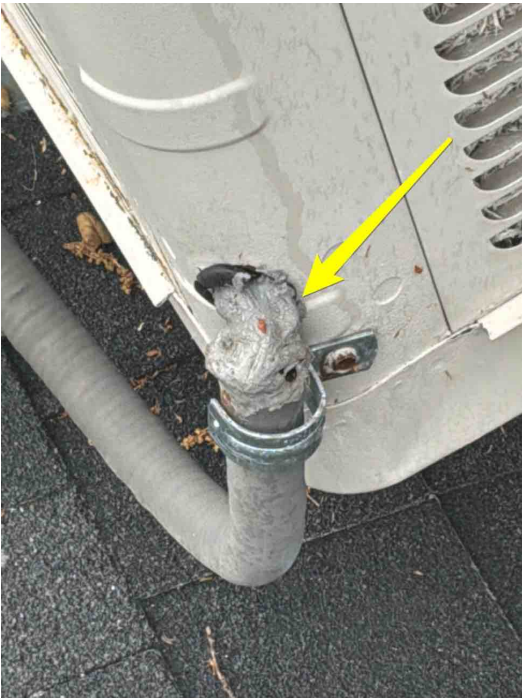
**E&C 187:** Proper electrical wiring and conduit connections at the evaporative cooler installed on the roof. Recommend review of the electrical provided for the swamp cooler and have corrected by a licensed electrician

Improper, unsafe conduit connection

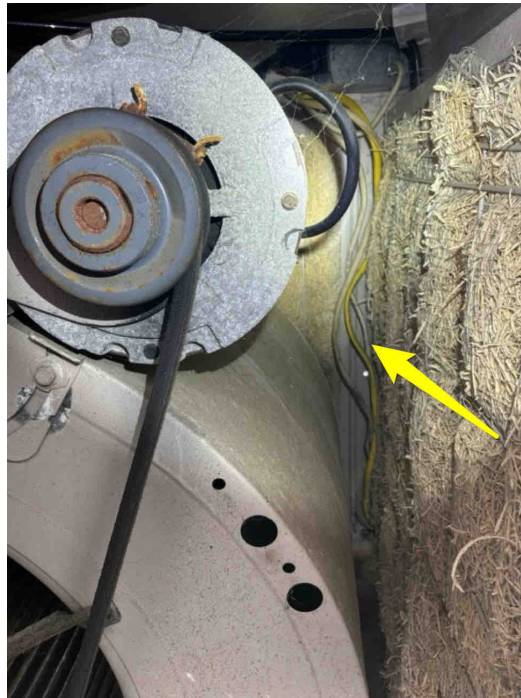
Improper and unsafe use of exposed Romax inside the unit

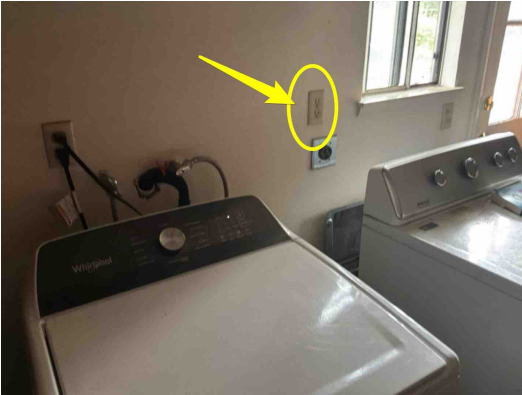
- SC 188:** Miswired electrical outlet (Reverse polarity) found in the;
1. LAUNDRY ROOM - right side outlet
  2. PRIMARY BEDROOM BATHROOM
  3. PRIMARY BEDROOM. Have electrician check all outlets and correct as needed.

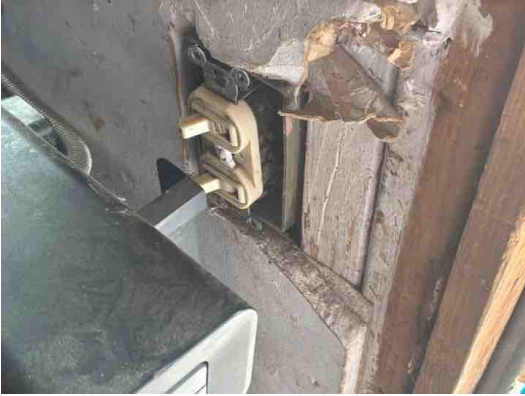
**SC 192:** Missing and damaged electrical cover plate at outlets and switches throughout. Electrician evaluate and test all outlets and switches and make appropriate corrections as needed.

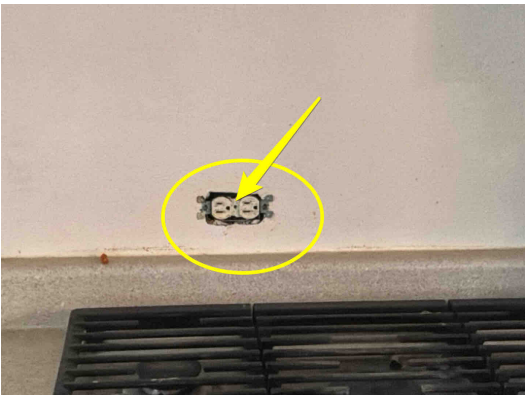
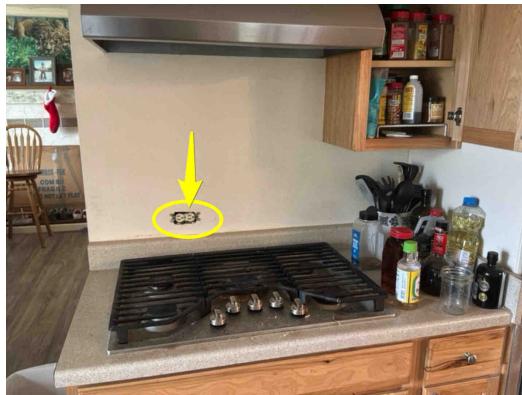
**SC 194:** Missing electrical cover plate at the outlet behind the kitchen gas cooktop. This is an improper and inappropriate location for the outlet. Outlet should be moved to the small countertop between the oven and the cooktop for safety.

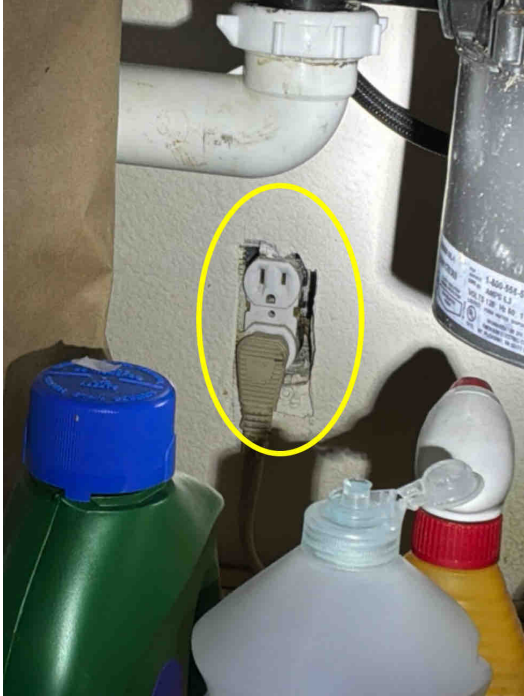
**SC 195:** Missing electrical cover plate at IN IN THE KITCHEN CABINET BELOW THE KITCHEN SINK FOR THE DISPOSAL OUTLET.

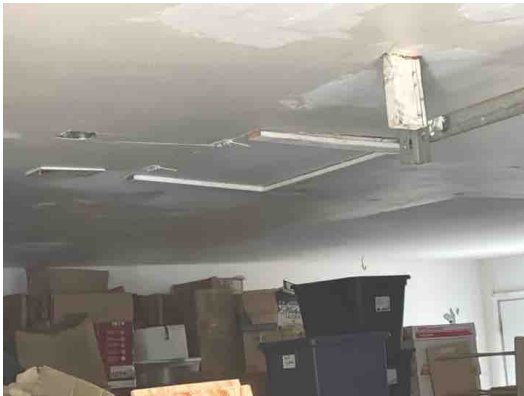
**SC 205:** The attic access in the garage does not meet minimum garage fire wall requirements. Upgrades are recommended.

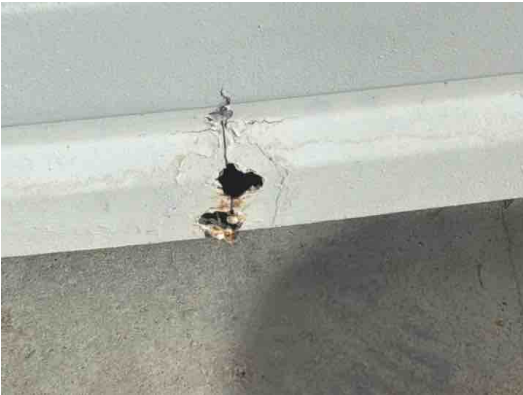
**E&C 209:** Cracked, damaged and dented panels at garage vehicle roll-up door. Recommend contacting a garage vehicle door contractor to evaluate and make recommendations to repair or replace the damaged panels.

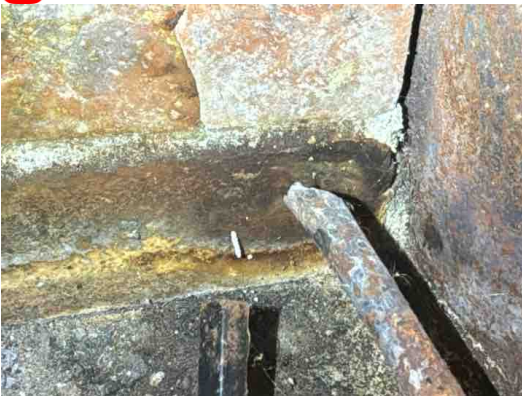
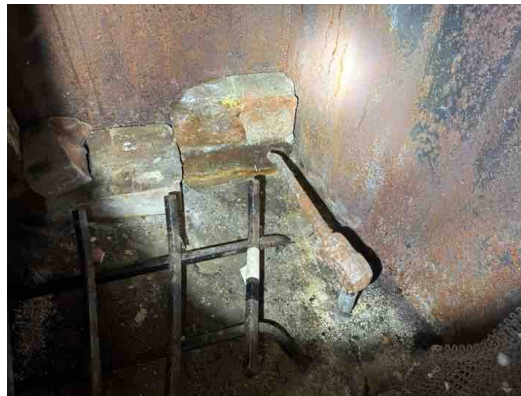
**SC** 216: Damaged log lighter inside the fireplace. Recommend removing and capping the gas pipe for safety.

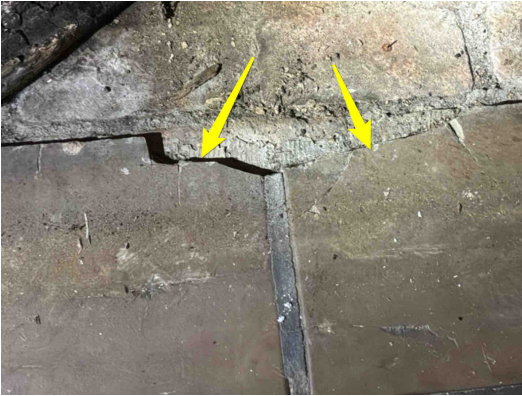
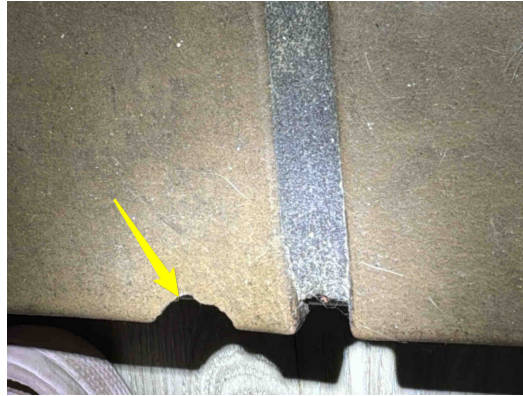
**220:** Cracked damaged tiles at the LIVING ROOM tiled heart extension.

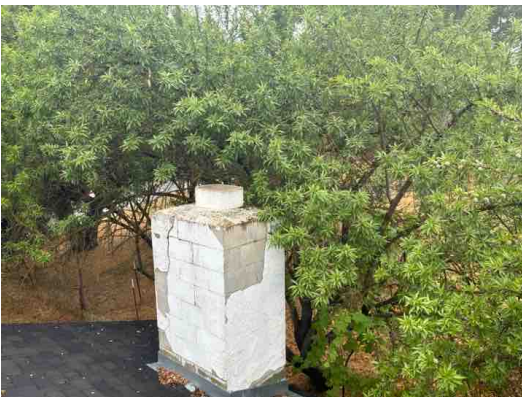
**SC 222:** Tree too close to LIVING ROOM fireplace chimney termination. This can negatively affect the drafting of smoke from the fireplace. Potential fire hazard. Maintenance recommended.

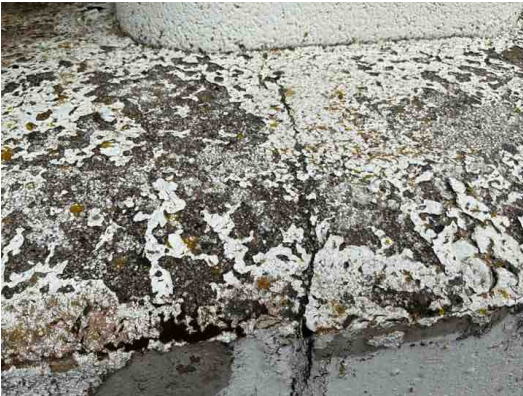
**MR 223:** Visible cracks and separations found in the mortar crown located at the top of the LIVING ROOM fireplace chimney. Maintenance / caulking or sealing is recommended to help prevent water intrusion into the confined spaces within the masonry chimney.

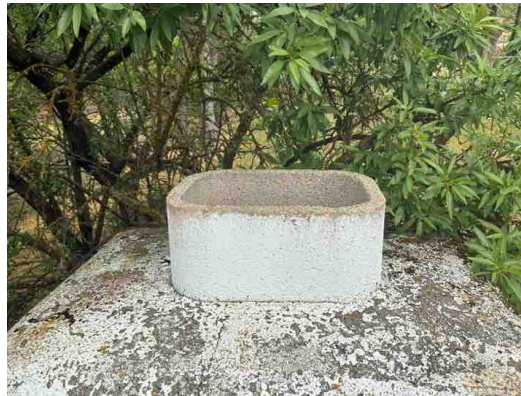
**SC 224:** Missing a proper spark screen & rain cap at the top of the LIVING ROOM fireplace masonry chimney per standards. Safety concern. A cap and screen is needed at the top of the fireplace chimney for fire safety and to help prevent water and critter intrusion.

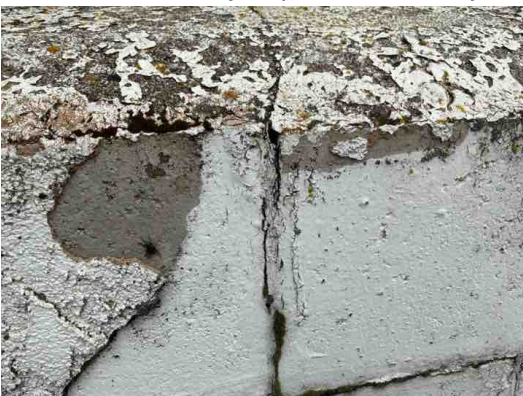
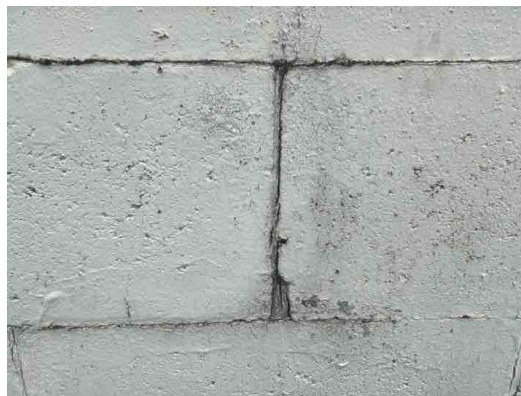
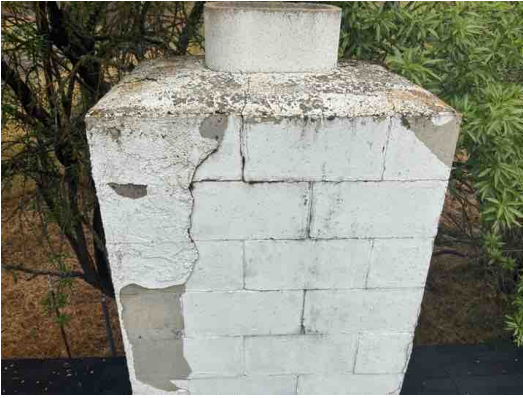
**FI 225:** Some cracked mortar joints and bricks with visible with some minor separations at the LIVING ROOM exterior masonry chimney. These types of cracks generally do not cause a significant negative affect to the overall structural integrity of the masonry fireplace chimney structure. However, the visible separations can damage the flue liners, throat, fireboxes and can allow water to penetrate through the masonry and could cause deterioration and or damage to the steel reinforcement (rebar). All cracks and separations in the masonry chimney structure should be sealed by a qualified masonry contractor.

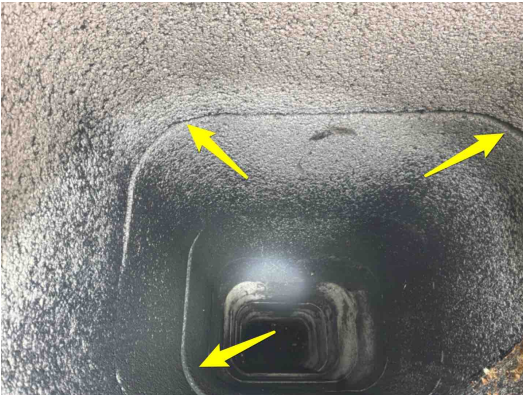
**SC FI 226:** Some visible separations due to the improper / poor installation of the mortar joints between the fireplace chimney flue liners inside the LIVING ROOM masonry fireplace chimney. This can allow super-heated gasses from a fire in the fireplace to exit the chimney flue and enter confined spaces within the structure. Recommend further review and repair of the fireplace & chimney by a qualified chimney sweep / contractor.
