WOOD DESTROYING PESTS AND ORGANISMS INSPECTION REPORT

Building No. 3567	Street Bridle Lane	City Chico	ZIP 95973	Date of Inspection 02/02/2026	Number of Pages 4
----------------------	-----------------------	---------------	--------------	----------------------------------	----------------------

HOUSE DETECTIVE TERMITE CONTROL INC

Report # : 16515
Registration # : PR5960
Escrow # :
 CORRECTED REPORT

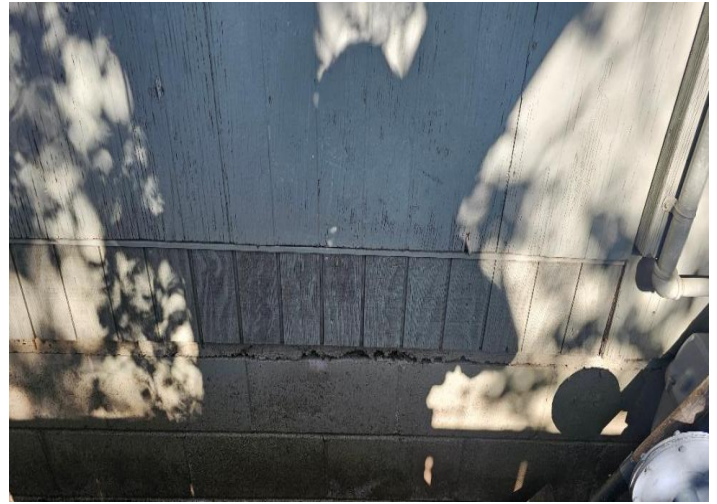
FINDING: Fungus damage was found to areas of wood siding where indicated. Several areas of siding were loose and/or bowed with some voids noted.

3A - Damaged siding.

RECOMMENDATION: Remove the damaged wood members and replace with new material. Prime paint only. Owner should keep exterior surfaces well sealed and painted.

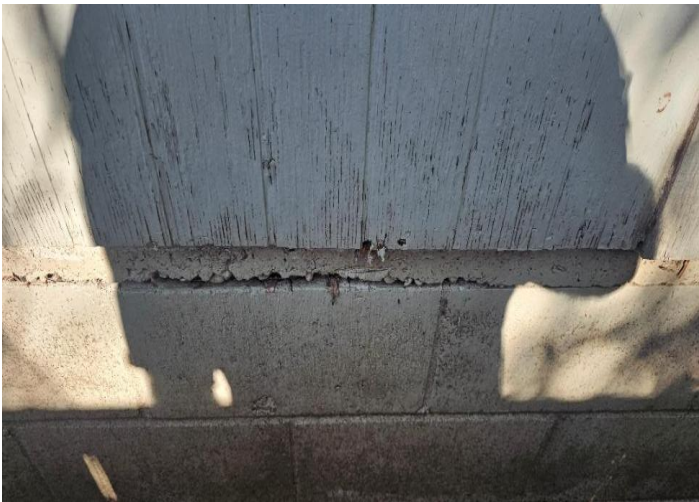
3A - Damaged siding.

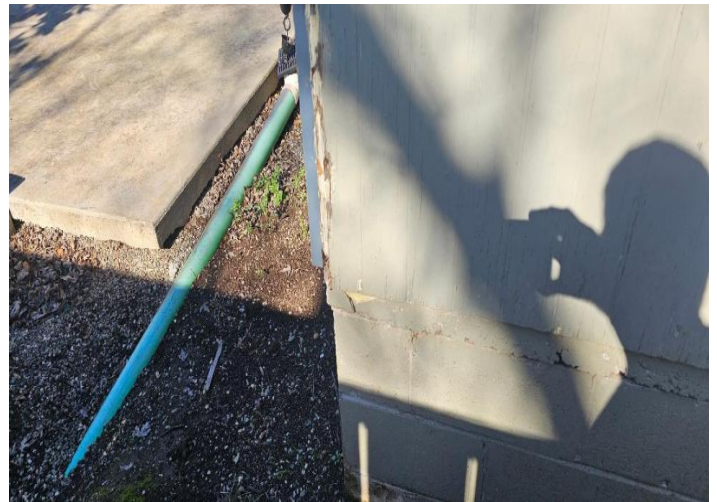
3A - Damaged siding.

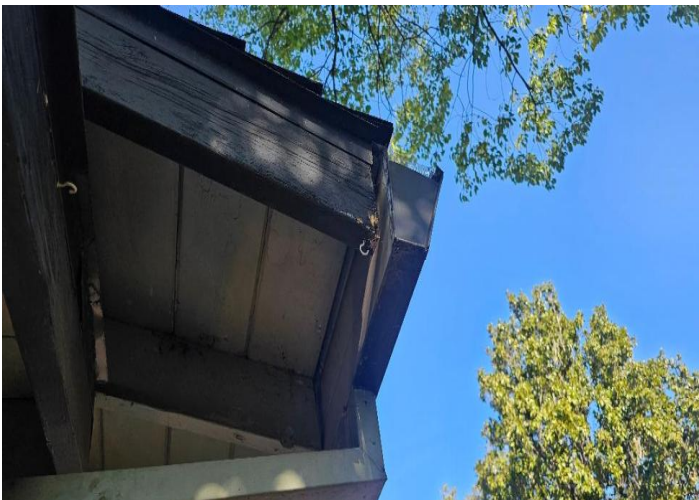
FINDING: Fungus damage was found to roof rafters where indicated. Several past roof repairs were noted in other areas from apparent past roof leaks.

3B - Damaged roof rafter.

RECOMMENDATION: We recommend the owner/agent engage the services of a licensed roofing contractor to remove all damaged members and to replace with new appropriate material.

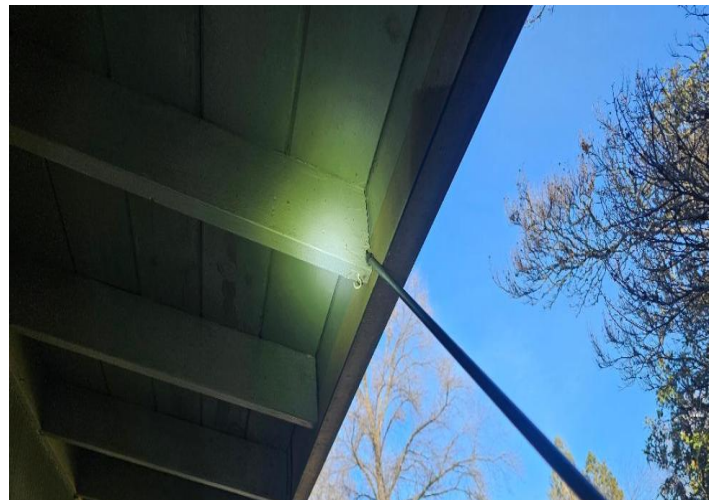
3B - Damaged roof rafter.
