# WOOD DESTROYING PESTS AND ORGANISMS INSPECTION REPORT

| Building Address:<br><b>1740 Westfield Rd., Paso Robles, CA 93446</b> | | Date of Inspection<br><b>04/22/2026</b> | Number of Pages<br><b>5</b> |
| General Description:<br>Duplex, comp roof, stucco exterior, vacant | | Inspection Tag Posted:    Garage<br><br>Other Tags Posted:<br>None | |

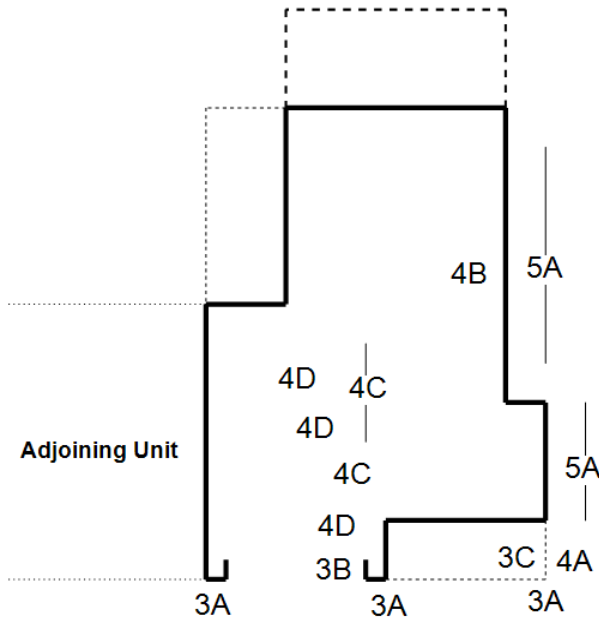
This Diagram is not to scale

- 3A PRICE: \$845.00 (Section I)  
FINDINGS: Fungus damage was noted at the fascia.  
RECOMMENDATION: Remove and replace damaged wood members with new material. Painting is included, color match may not be exact.
- 3B PRICE: \$115.00 (Section I)  
FINDINGS: Fungus damage was noted at the garage door jamb.  
RECOMMENDATION: Remove and replace damaged wood members with new material. Painting is included, color match may not be exact.
- 3C PRICE: \$600.00 (Section I)  
FINDINGS: Fungus damage was noted at the porch beam.  
RECOMMENDATION: Remove and replace damaged wood members with new material. Painting is included, color match may not be exact.

- 4A PRICE: Not Estimated (Section II)  
FINDINGS: The rain gutters were noted to be leaking.  
RECOMMENDATION: Re-seal gutters at area of water leakage with an approved water tight sealer.
- 4B PRICE: \$175.00 (Section II)  
FINDINGS: Missing or deteriorated caulking/grout was noted at the hallway bathroom shower.  
RECOMMENDATION: Re-caulk or re-grout the area to prevent future problems.
- 4C PRICE: \$550.00 (Section II)  
FINDINGS: Moisture damage was noted to the sheetrock at the garage wall.  
RECOMMENDATION: Remove the damaged sheetrock for further inspection. If no further damage is found, install new sheetrock, tape, texture, and paint. Color and texture may not be an exact match.

4D PRICE: Informational (Section II)  
FINDINGS: Water stains noted at the garage ceiling and the walls. 805 Termite Control does not guarantee the presence or non-presence of any leaks.  
RECOMMENDATION: Periodic inspections advised.

5A PRICE: \$55.00 (Further Inspection)  
FINDINGS: Inaccessible areas at portions of the exterior due to vegetation preventing inspection.  
RECOMMENDATION: Owner to make area accessible for further inspection.
