Southland Pest Control Inc.

9145 Garfield St.
Riverside, CA 92503

WOOD DESTROYING PESTS AND ORGANISMS INSPECTION REPORT

Building No. 9145	Street Garfield St.	City Riverside	ZIP 92503	Date of Inspection 01/05/2026	Number of Pages 9
----------------------	------------------------	-------------------	--------------	----------------------------------	----------------------

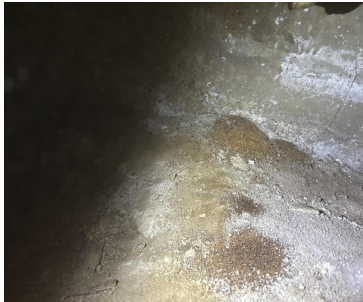
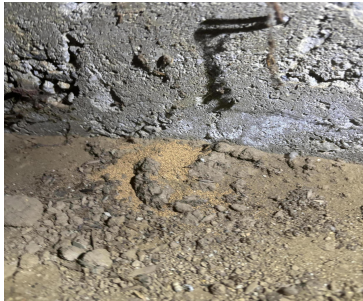
1A - Section I

Dry-wood Termites Finding: Evidence of dry-wood termite infestation was found at the found thru out the crawl space area in multiple corners of home. Wood was not brittle to the touch but there were mounds of termite grass in multiple locations as indicated on the attached diagram.

Pursuant to Section 1990, Report Requirements Under Section 8516(b)(1-9), Due to the extent of activity found in the property.

Recommendation to fumigate - SEE 11B

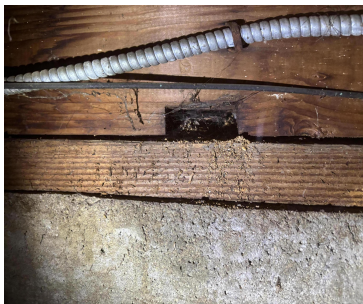
1B - Further Inspection

Finding - Section 2516(c)(1) of Title 24 of the California Code of Regulations, Excessive Moisture Condition(s) (Water Stains / Water damage) noted at time of inspection at multiple areas of home. Major concerned area the main plumbing area. Has visual damage and some active water near the front of the home. May have been due to recent rain.

Recommendation - Southland Pest Control recommends a further inspection to the areas. Owner(s) or parties of interest to call a licensed contractor (Plumber) to do open area to further inspect the moisture condition to determine cause and correct properly, any sub contractor is authorized to perform work under Section 8556.

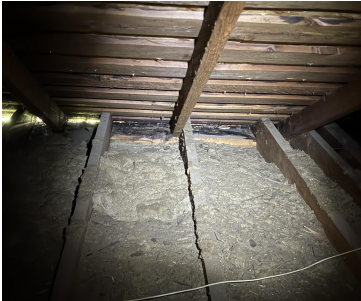
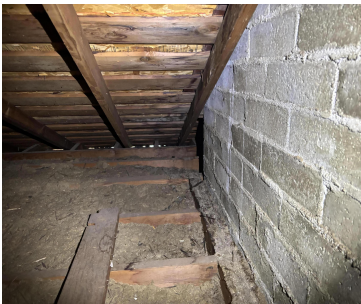
9A - Section I

Dry-wood Termites Finding: Evidence of dry-wood termite infestation was found at the Drywood termites found in 4 by 8 beam and 4 by 4 post. Visual wood damage. Brittle to the touch. Frase coming from lumber as indicated on the attached diagram.

Pursuant to Section 1990, Report Requirements Under Section 8516(b)(1-9), Due to the extent of activity found in the property.

Recommendation to fumigate - SEE 11B

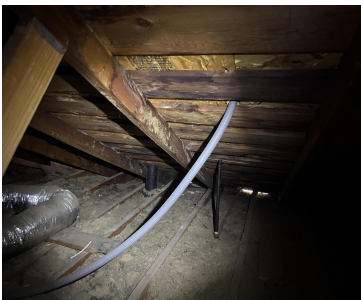
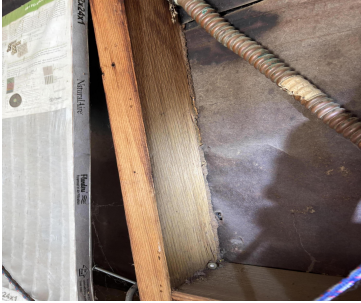
11A - Further Inspection

Finding - Section 2516(c)(1) of Title 24 of the California Code of Regulations, Excessive Moisture Condition(s) (Water Stains / Water damage) noted at time of inspection at 2 X4 material used for fascia/soffit. Visual water damage coming from improper flow of water on roof.

Recommendation - Southland Pest Control recommends to call a professional (roofer to fix leak and damaged wood problem), and for a further inspection to the areas. Owner(s) or parties of interest to call a licensed contractor to do open area to further inspect the moisture condition to determine cause and correct properly, any sub contractor is authorized to perform work under Section 8556.

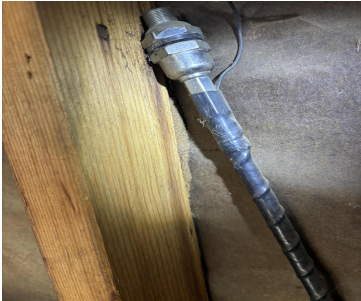
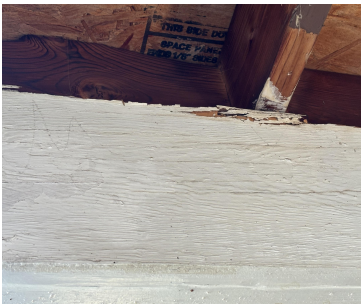
11B - Section I

Dry-wood Termites Finding: Evidence of dry-wood termite infestation was found at the K seen inside of crawl space air vent. Visual frass/termite droppings leading into IA of the structure as indicated on the attached diagram.

Pursuant to Section 1990, Report Requirements Under Section 8516(b)(1-9), Due to the extent of activity found in the property.

Recommendation to fumigate - 2 Year warranty.

Fumigation (3 day - 2 nights tenting) - enclose the structure for an all encompassing treatment unitizing materials listed in Section 8505. 1 of the code,
