Inspection Report

Property Address:
6520 Mira Cielo (Main, Pool, Barn)
San Luis Obispo CA 93401

3/12/2026

Harper Homes: Home Inspection Services

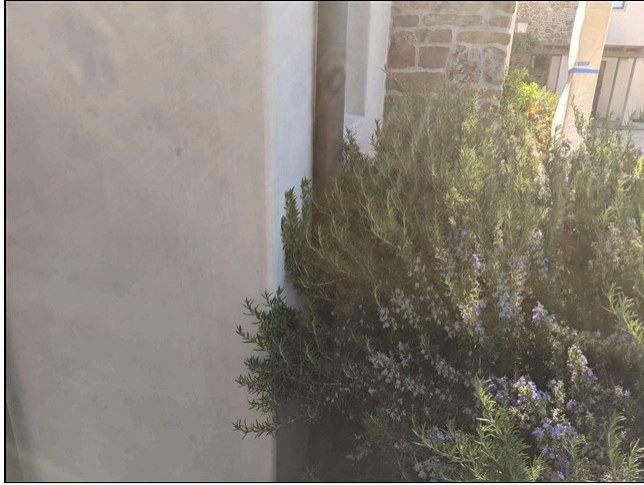
1.5 Item 1(Picture)

Foliage needs trimmed back from contacting the siding. This will decrease the probability of moisture and pest intrusion.

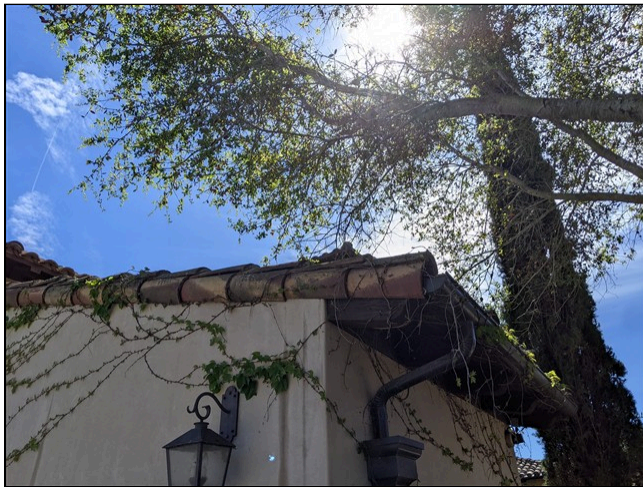
2.0 Item 1(Picture)

Tree limbs need trimmed back at the barn to prevent contact with the roof and excessive debris buildup.

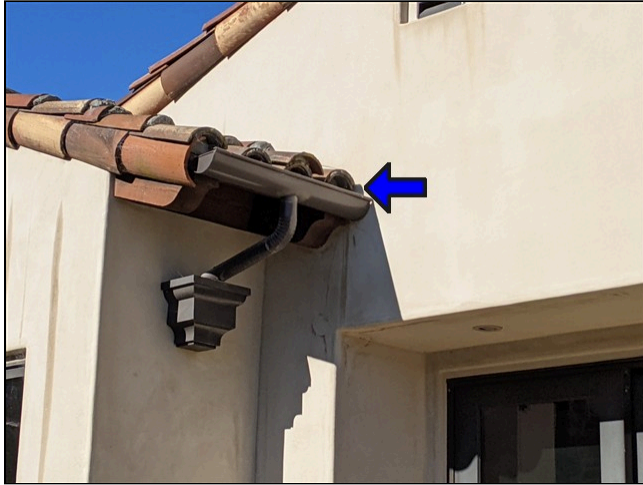
2.1 Item 1(Picture)

Kick out flashing not installed at the various locations around the home where the roof returns back into the siding. Recommend kick out flashing be properly installed to prevent moisture intrusion at the siding in this area.

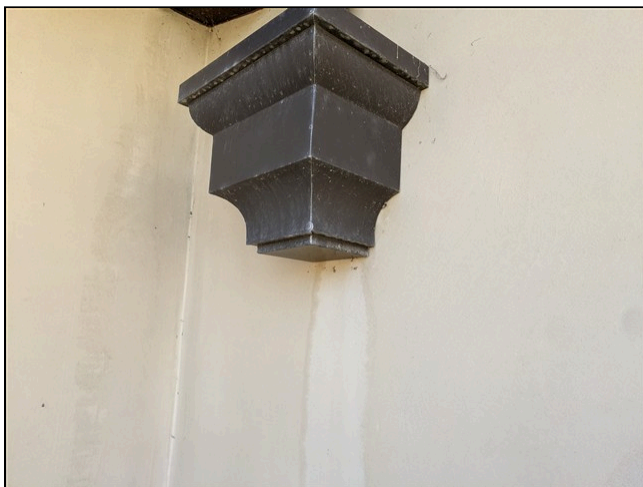
2.3 Item 1(Picture)

Staining was noted on the stucco siding near the roof drain and downspout at the front exterior of the home. This condition may indicate that water has been contacting the stucco in this area. Recommend sealing the connection points and ensuring the drain and downspout are properly secured to help prevent continued moisture exposure to the stucco. Routine maintenance and sealing will help protect the exterior wall surface and reduce the potential for moisture-related deterioration over time.

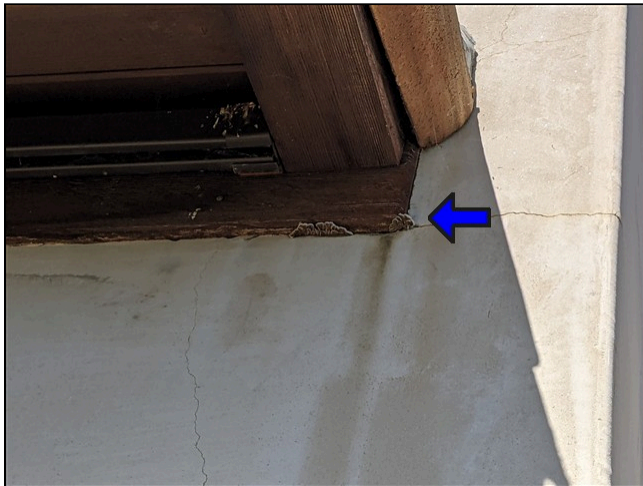
2.4 Item 1(Picture)

Areas of the ledger at the barn contains fungal growth. Refer to the pest report for further information on this condition and make repairs as prescribed.

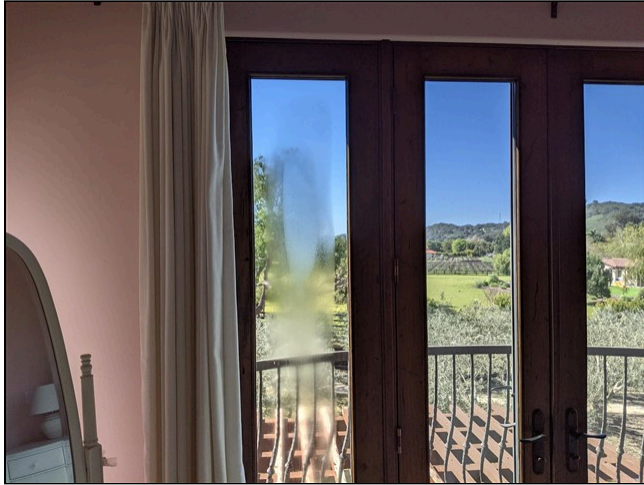
2.6 Item 1(Picture)

Failed seals in dual pane windows, noted at the rear right second story bedroom and condensation build up or stains were noted within the window. Recommend windows repaired or replaced to ensure full insulation capabilities and improve aesthetics.

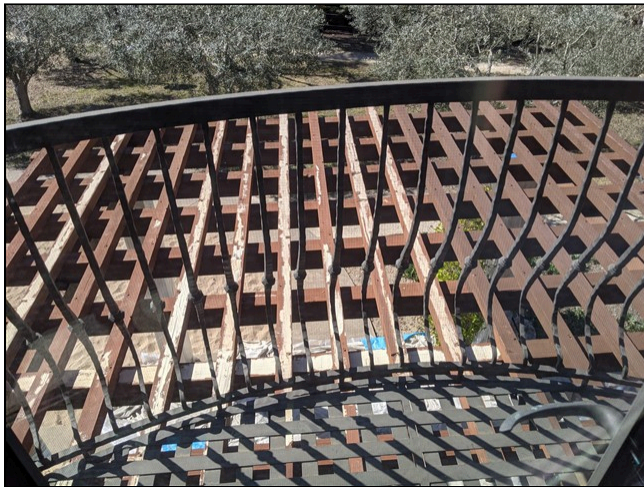
2.8 Item 1(Picture)

Peeling paint was noted at the right exterior patio cover and paint maintenance is needed.

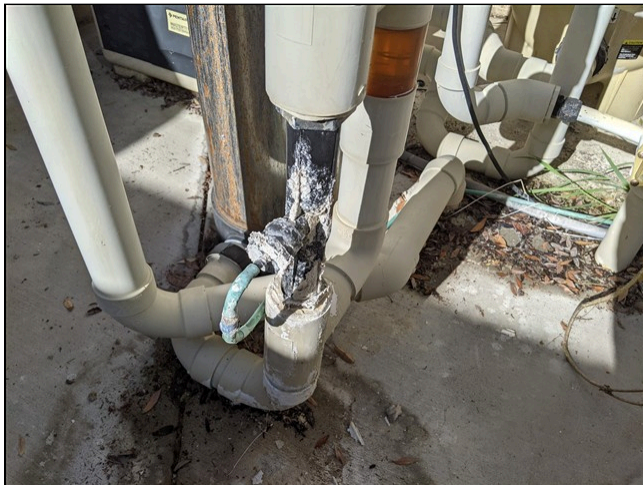
3.0 Item 1(Picture)

Corrosion and signs of a leak were noted at the pool equipment. Recommend further evaluation and repairs are made to prevent water waste and ensure proper function.

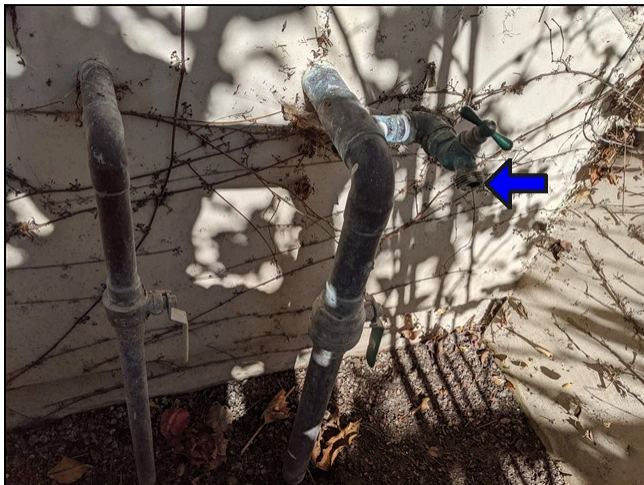
6.5 Item 1(Picture)

Exterior hose spigot at the rear exterior drips when turned off and should be repaired or replaced to prevent water waste and moisture saturation in this area.

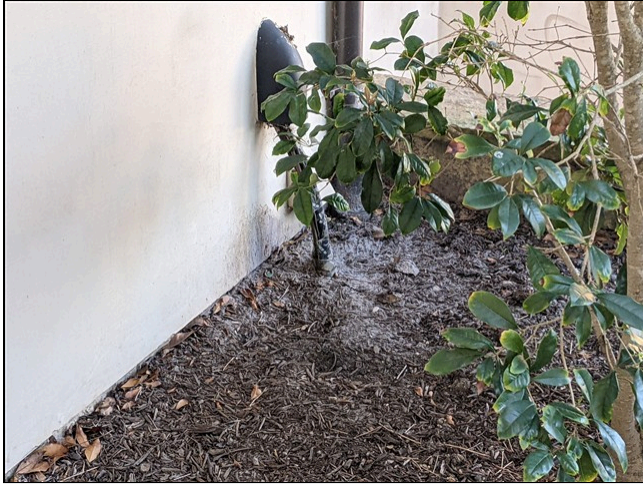
6.6 Item 1(Picture)

Dryer vent is partially blocked by dryer lint and the vent flap is stuck open. Recommend proper cleaning of the dryer vent to insure maximum efficiency and prevent pest or rodent intrusion.

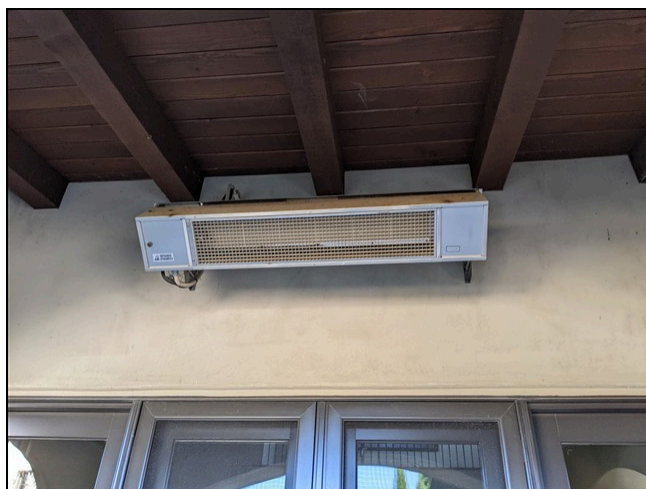
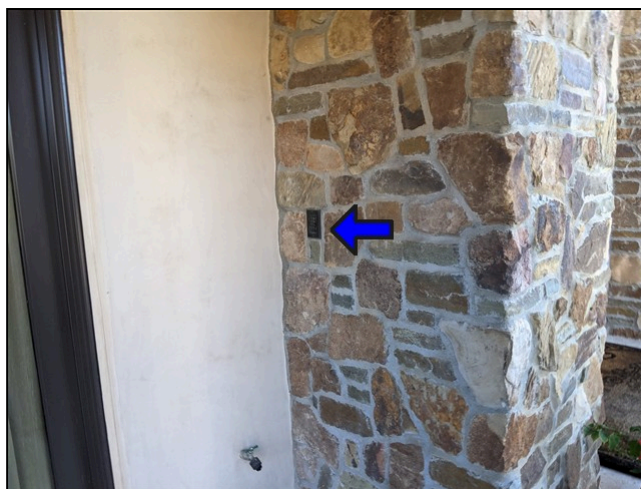
The wall switch located at the front exterior that controls the gas patio heater did not operate properly at the time of the inspection. When the switch was activated, the heater did not turn on as intended and a loud buzzing noise was noted from the switch area during operation. This condition is not typical and may indicate a faulty switch, wiring issue, or problem with the heater control system. Recommend further evaluation and repair by a qualified electrician or appropriate contractor to determine the cause and restore proper and safe operation of the heater. The heater should not be relied upon until repairs have been completed.

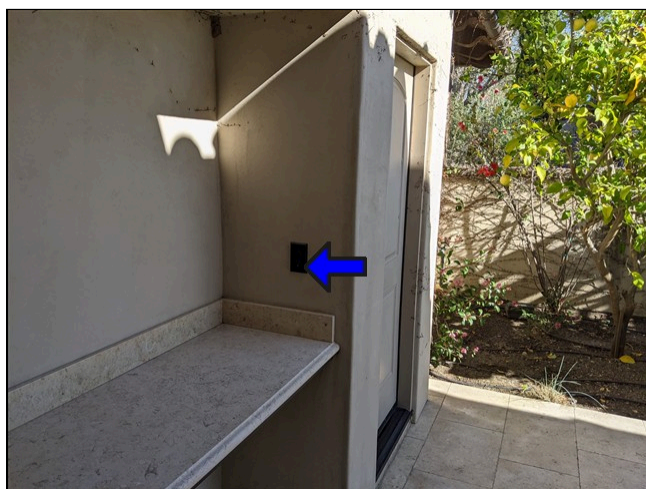
7.6 Item 1(Picture)

Exterior receptacle without a weather cover noted at the rear exterior. Installation is needed to insure full safety of this system.

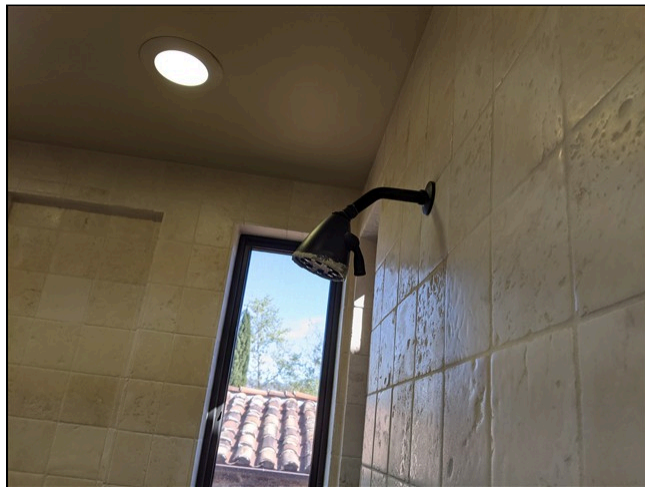
8.0.A Item 1(Picture)

Corrosion was noted at the showerhead in the master bathroom. Corrosion can occur over time due to mineral deposits and moisture exposure and may eventually affect the performance or longevity of the fixture. Recommend cleaning or replacement of the showerhead as needed to restore proper function and improve overall condition.

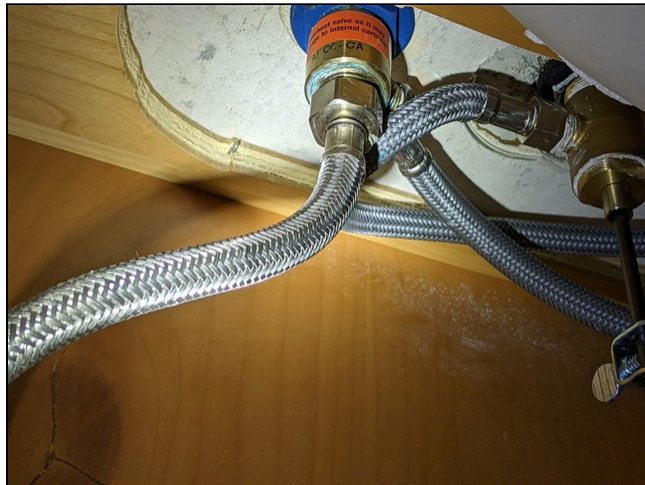
8.1.E Item 1(Picture)

A leak was noted at the faucet under the sink. Recommend repairs are needed before further use of the sink.

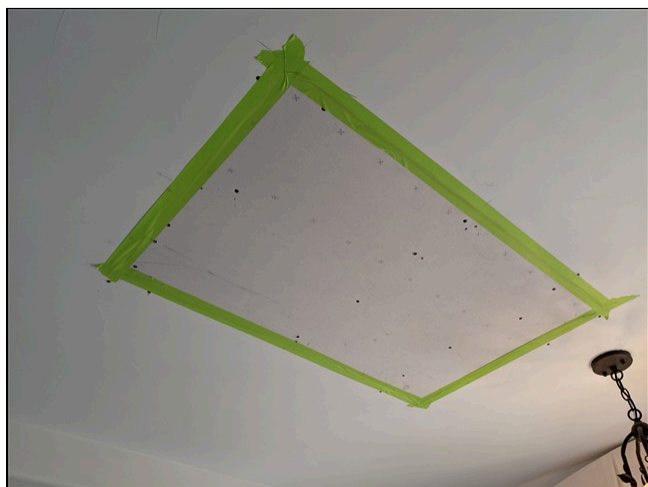
9.0 Item 1(Picture)

Signs of a drywall repair was noted on the ceiling in the rear right second story ensuite bathroom. Recommend referring to the sellers disclosures for more information on previous repairs made at this location.
