# Inspection Report

**Nancy Heins**  
**1032 Scott Street**  
**Paso Robles, CA 93446**

Inspection location: 1032 Scott Street
Paso Robles, CA 93446

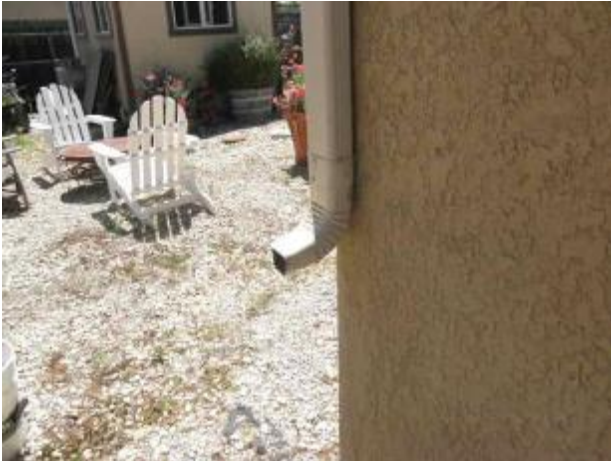
**Roof # R**

**Maintenance Note:** Some of the down spouts have no splash block or extension to divert the runoff water from the roof away from the foundation. Recommend installing proper drainage of roof water away from the structure to reduce foundation moisture and potential foundation settlement.

**Down spouts should terminate away from the home.**

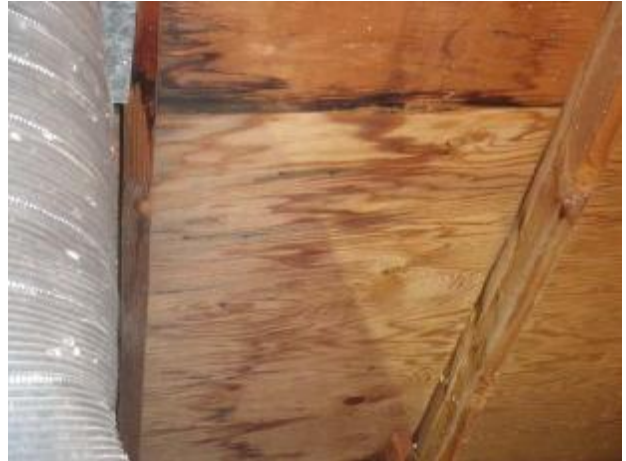
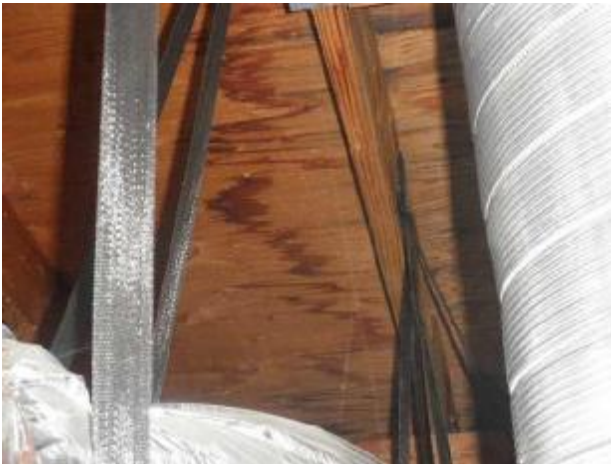
**Roof # R**

1.) The skylight is improperly installed with no visible flashing. Also, there is evidence of leaks below the skylight as seen from inside the attic space.

**Evidence of leaks around the skylight.**

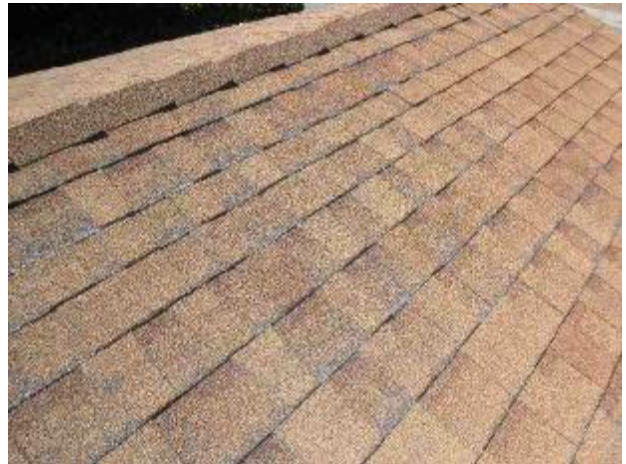
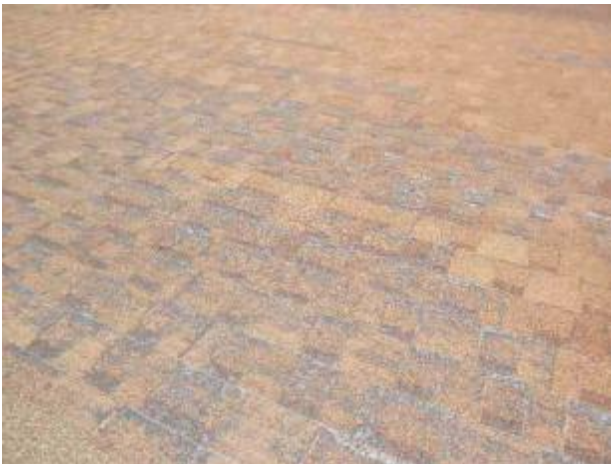
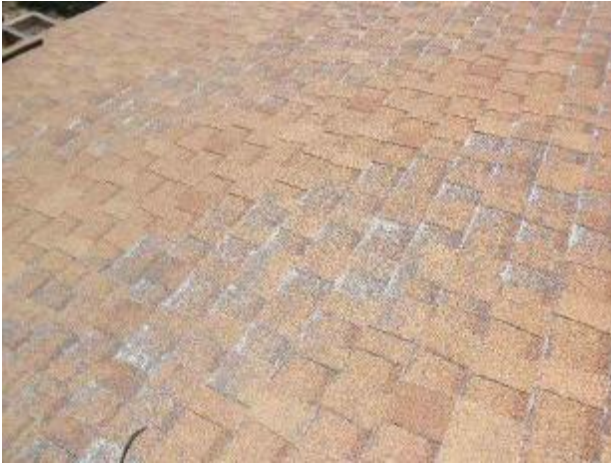
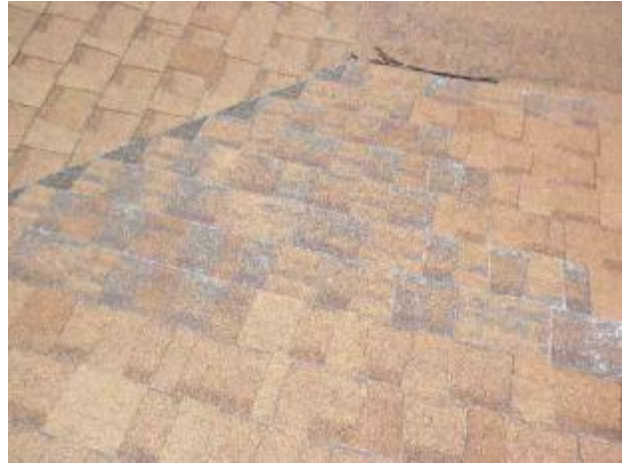
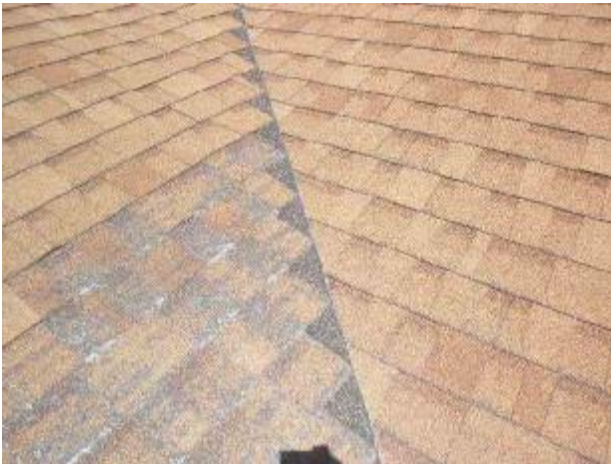
**Information Note:** The roof appears to be in average condition however, it is older and nearing the end of a normal life expectancy. General deterioration, cracking and delamination of the aggregate coating was observed. Budget for replacement soon.

**Example of deteriorated roof shingles.**

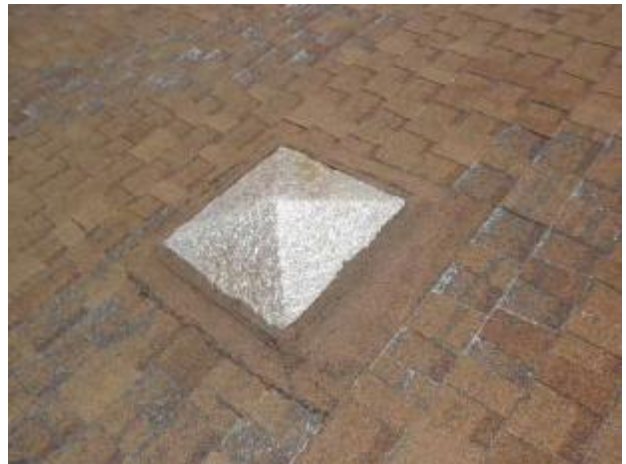
**Roof # R**

**Skylight improperly installed with no visible flashings.**

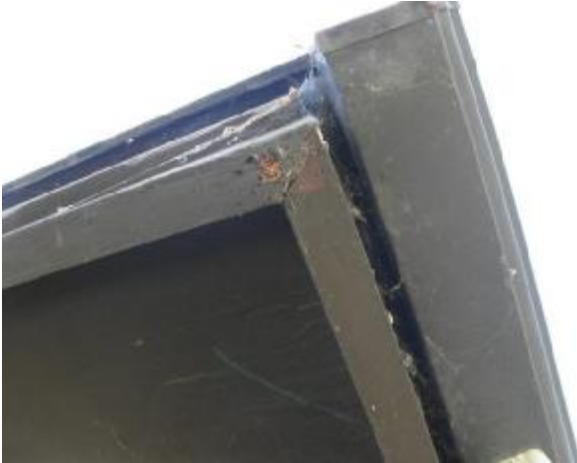
**# EX**

**Moisture damage at the fascia boards.**

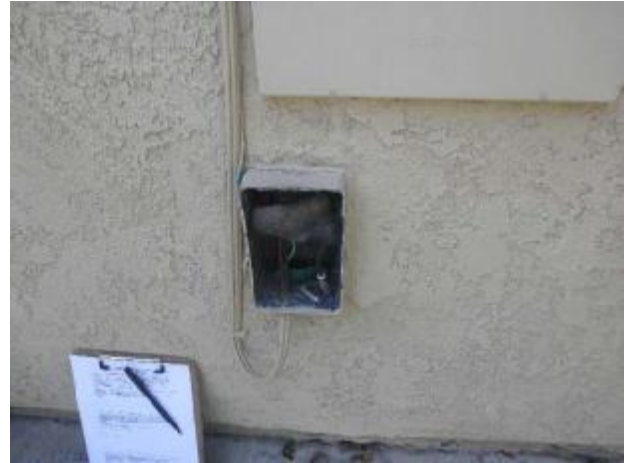
**# EX**

**TV box cover is missing.**

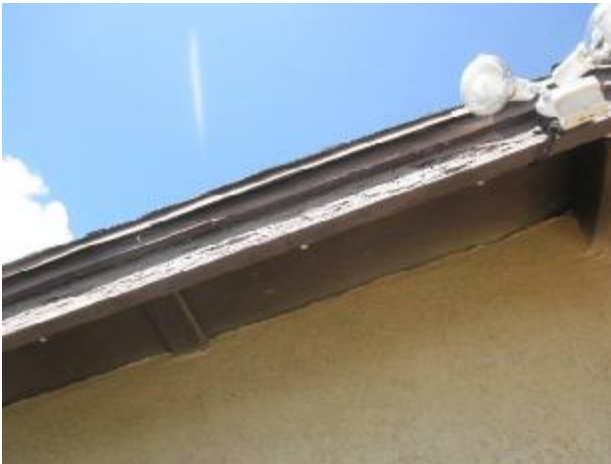
**# EX**

**Painting needed at the south fascia boards.**

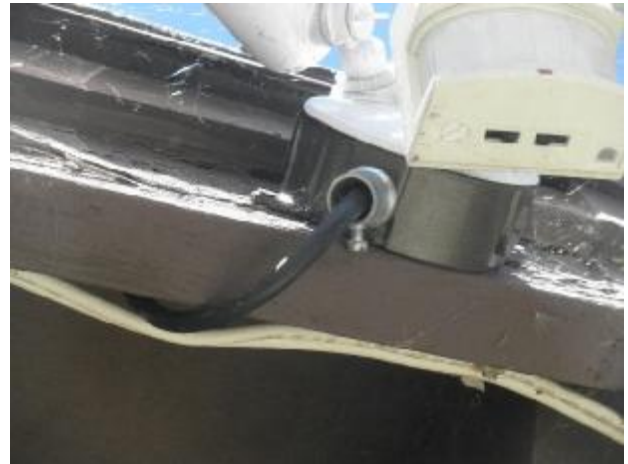
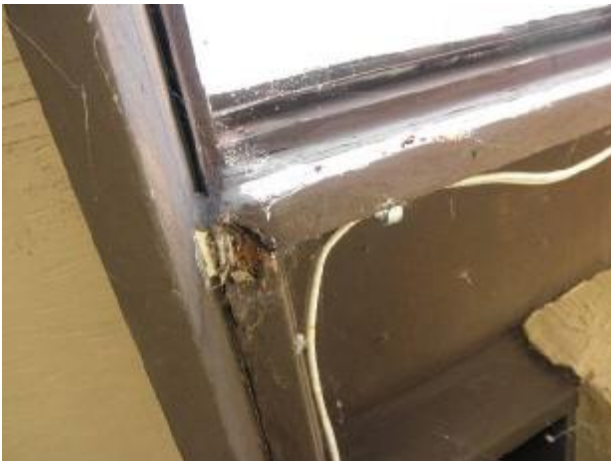
**# EX**

**Moisture damage at the south fascia board.**

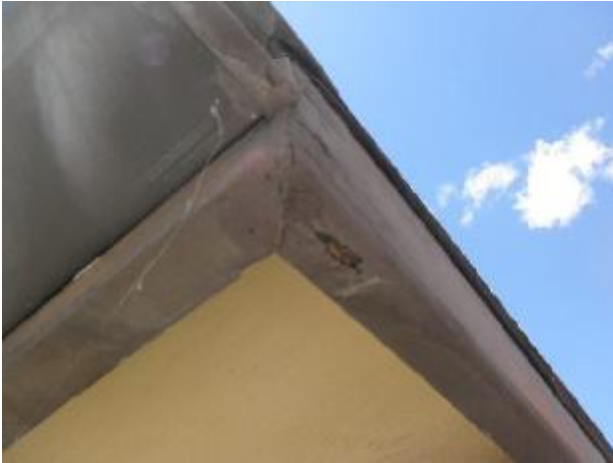
**# GD**

1.) There is moisture damage at the SW patio cover.

**Moisture damage at the SE patio cover.**

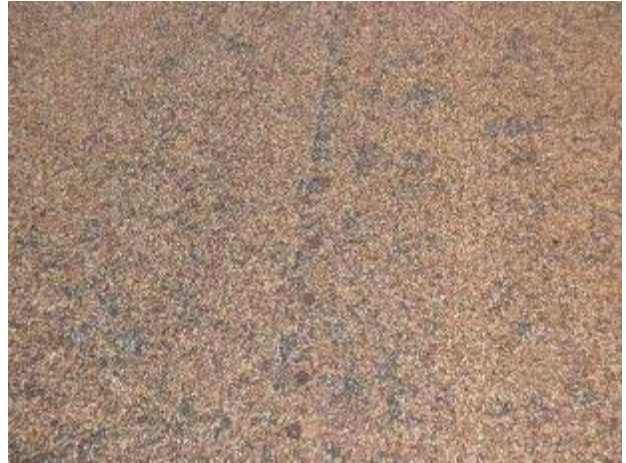
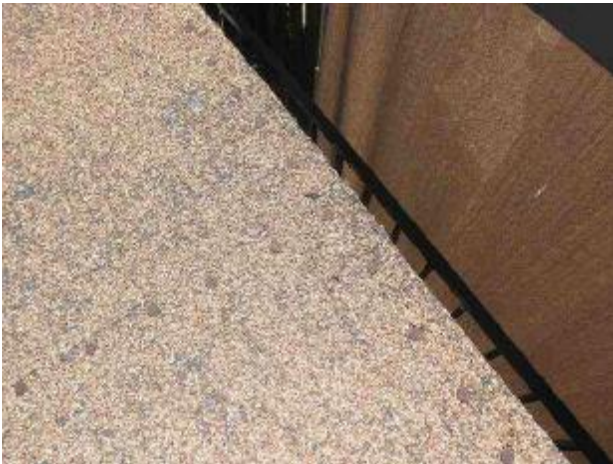
**# GD**

2.) The backyard patio roof was improperly installed with nails. These nails may be conduits for leaks.

**Patio cover roof improperly installed with nails.**

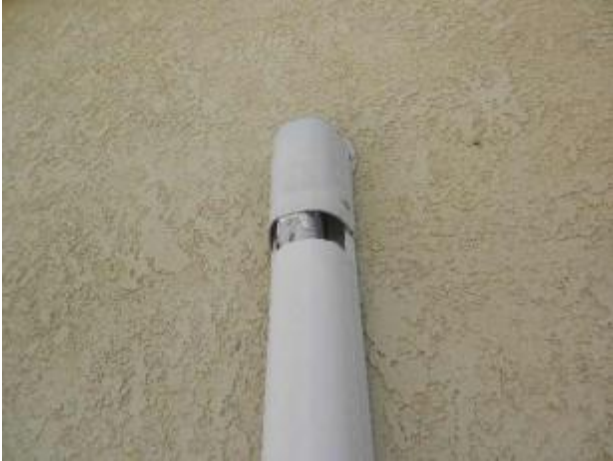
# HC

1.) The plastic piece of conduit has separated for the A/C low pressure refrigerant lines.

Plastic conduit for the A/C system has separated.

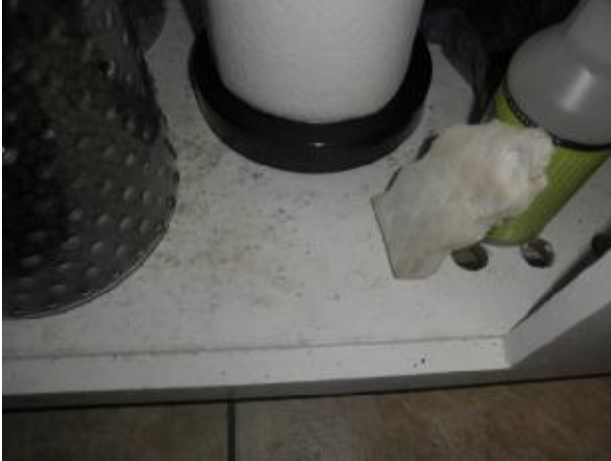
**# K**

1.) There is some minor moisture damage to the base of the kitchen sink cabinet.

**Minor moisture damage to the kitchen sink cabinet.**

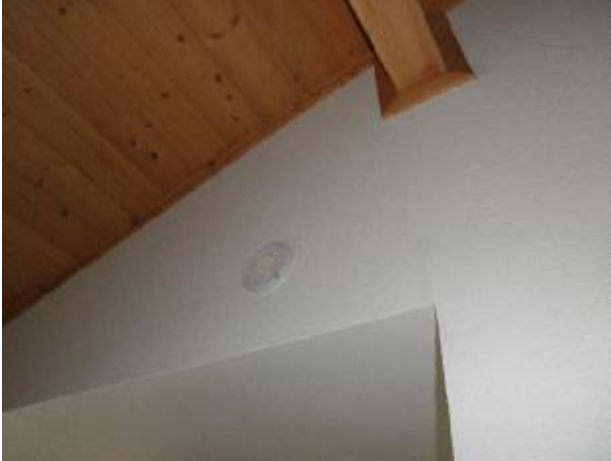
# IR

**Fire Safety Hazard:** There is no smoke detector installed outside of the bedrooms as required.

Missing smoke detector outside of the bedrooms.

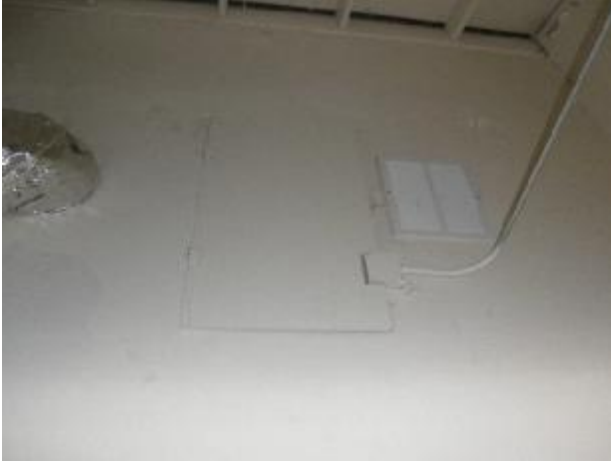
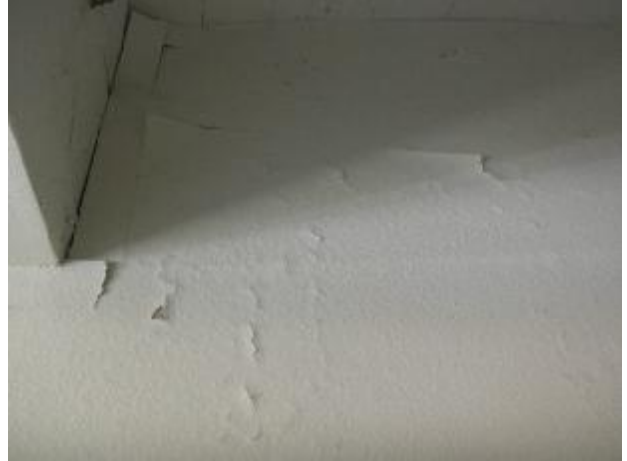
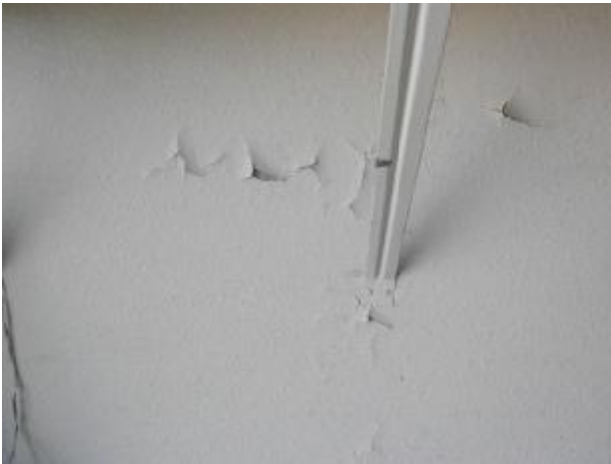
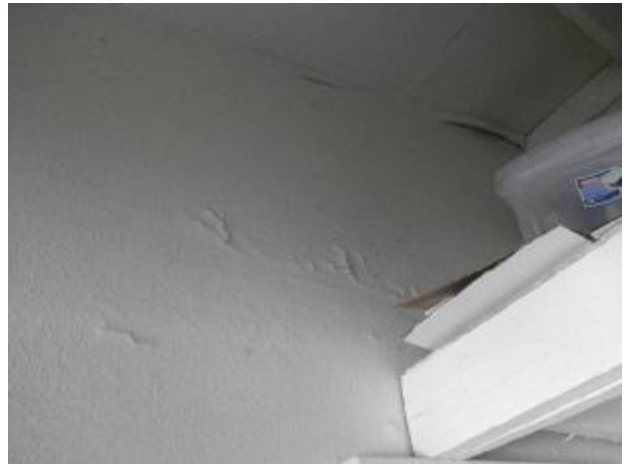
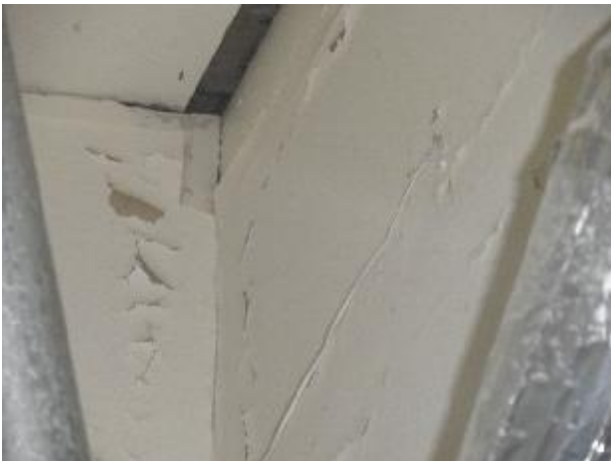
**Garage & Carport # GC**

1.) There is peeling paint at the interior of the garage.

**Peeling paint inside the garage.**
