# Home Inspection Report

3229 Westridge Drive, Kelseyville , CA 95451

Monday February 2, 2026

2133

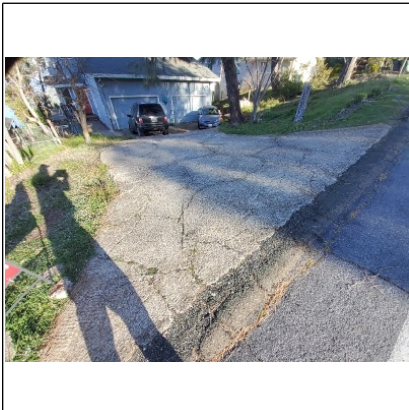
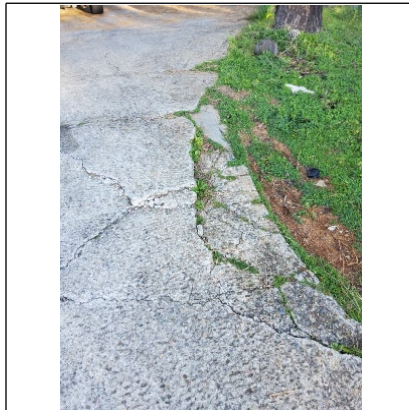
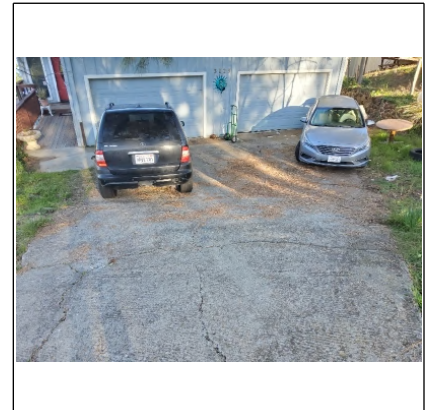
**Comments** Driveway has significant cracks that are not only a SAFETY HAZARD but is beyond repair, recommend replacement by a licensed concrete contractor

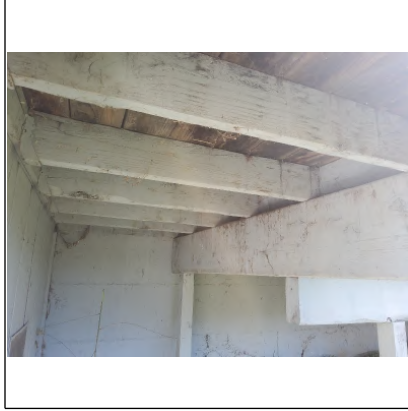
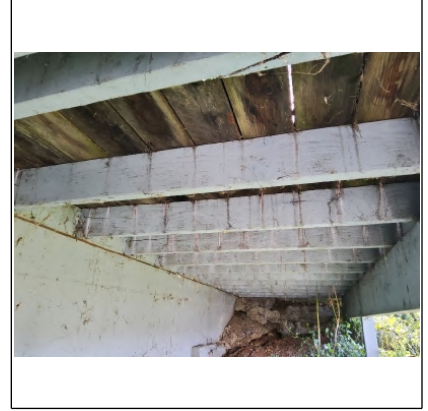
**Comments** Nails are popping up, recommend having all nails replaced with 3 1/2" exterior screws to properly fasten tread members.

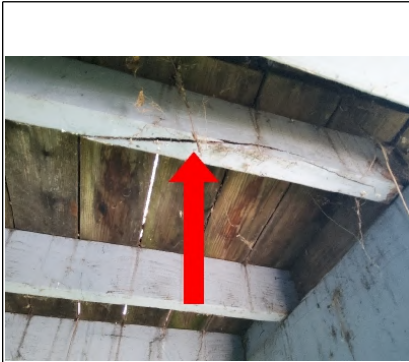
Cracked joist, recommend replacing

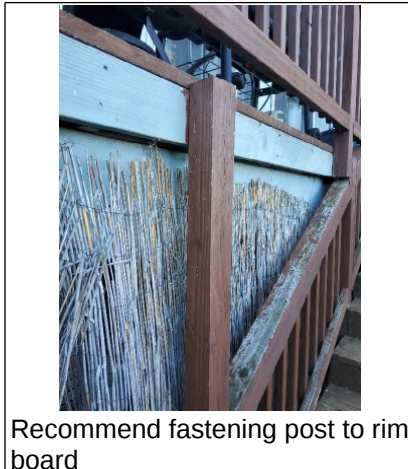
Recommend fastening post to rim board

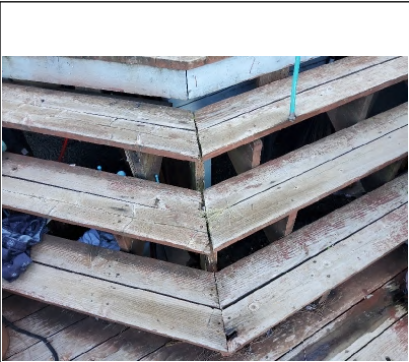
Damaged tread members, recommend replacing

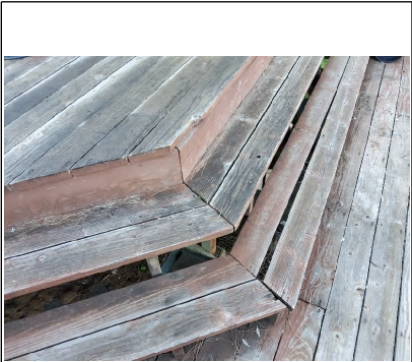
Damaged tread members, recommend replacing

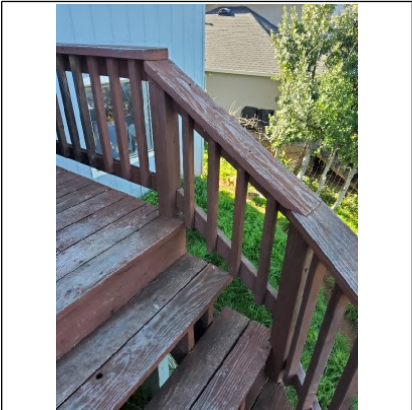
Railing is less then 36" this could be a SAFETY HAZARD for children. Recommend new railing that is minimum 42" to meet new code.

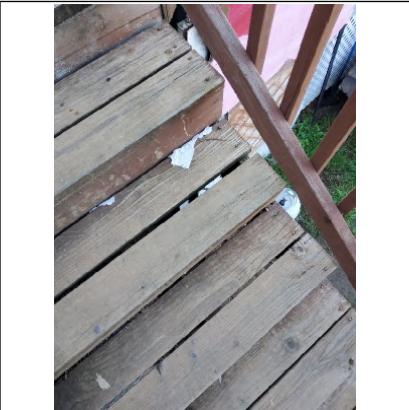
Loose plank needs to be fastened, recommend repair

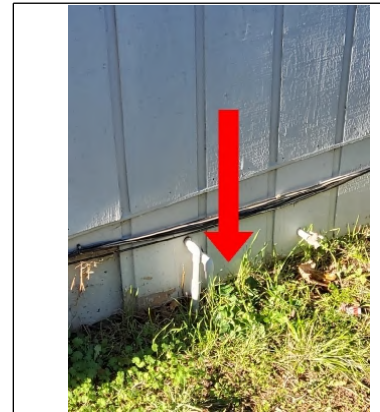
Wood in contact with dirt, recommend pulling dirt away from direct contact.

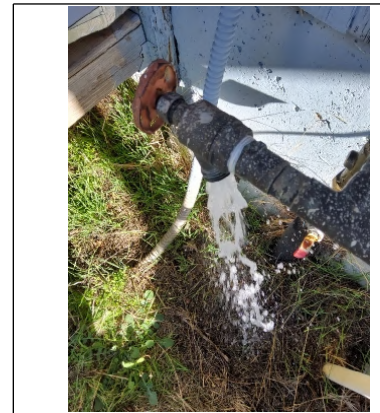
Hose bib is leaking, recommend repair

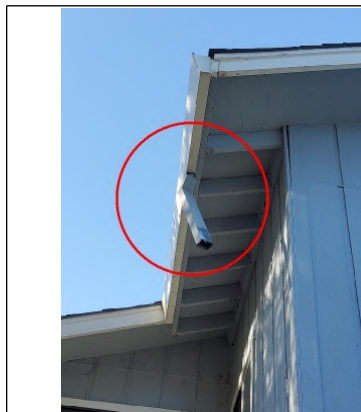
New downspout that spans to the bottom is needed, recommend repair

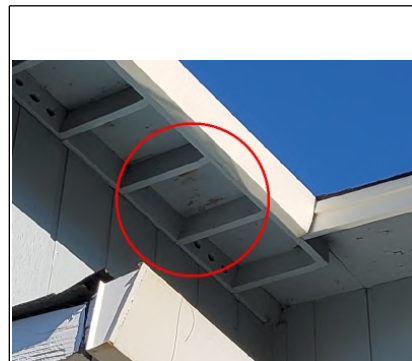
Overhang has exposed wood, recommend sanding and repainting

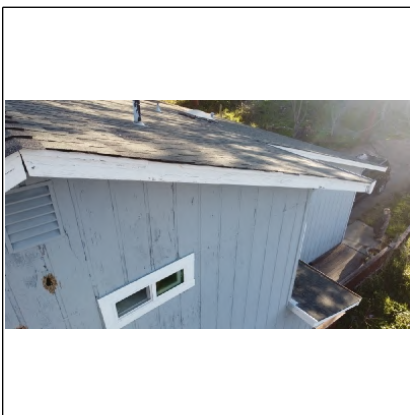
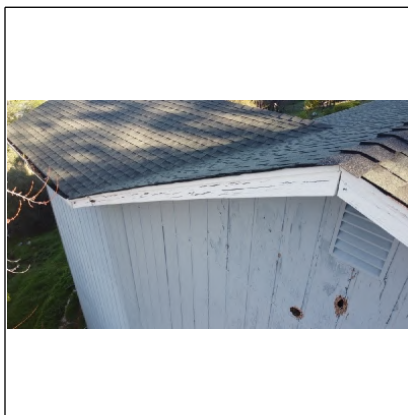
**Fascia at location is need of repainting, recommend repair**

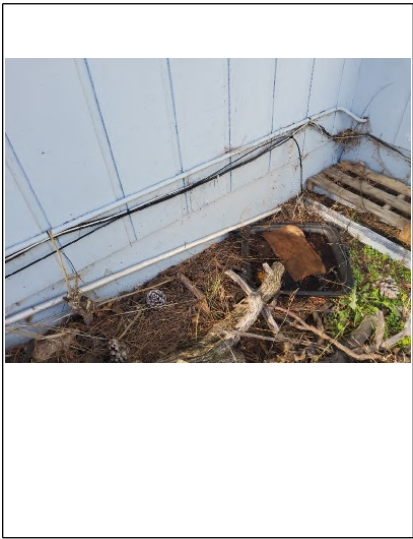
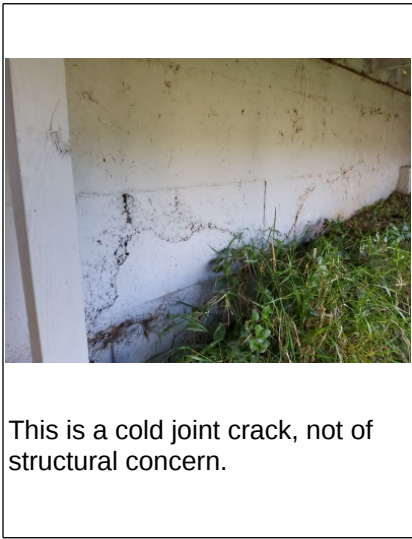
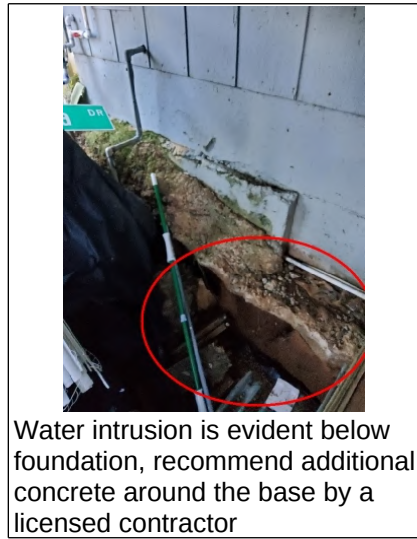
**Comments**     **Water intrusion is evident below foundation at noted location, recommend additional concrete around the base by a licensed contractor**

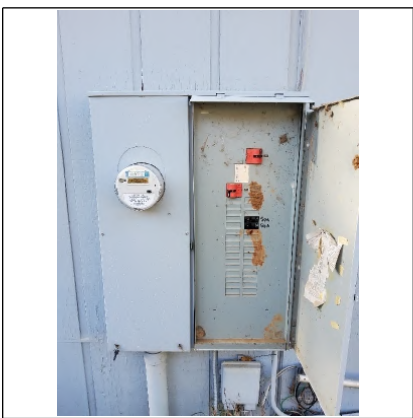
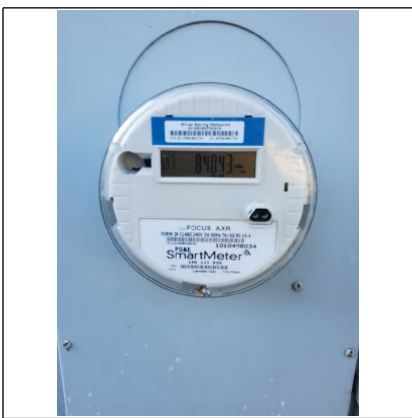
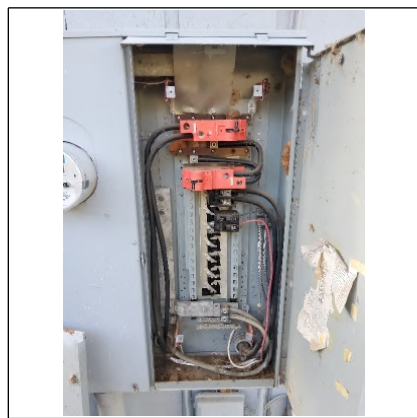
**Comments**     **Wasps nests appear to be evident in service entry panel, recommend having removed from panel box**

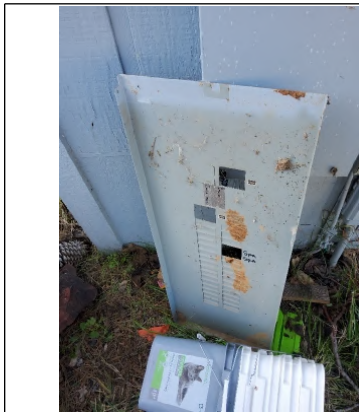
Cover is missing screws, recommend repair

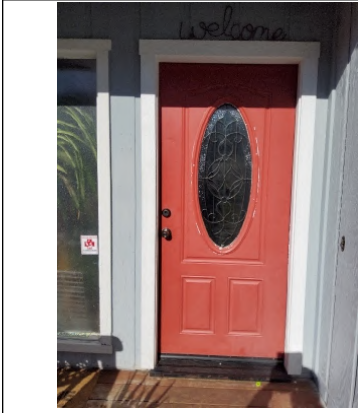
Doorbell doesn't properly operate, recommend repair

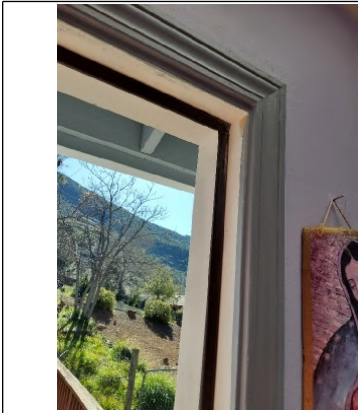
Recommend replacing damaged trim

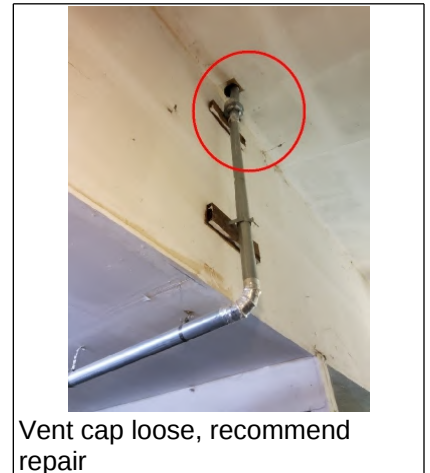
Vent cap loose, recommend repair

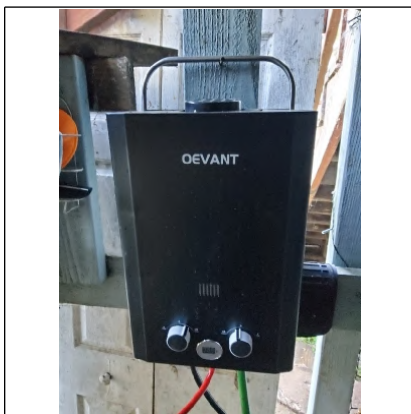
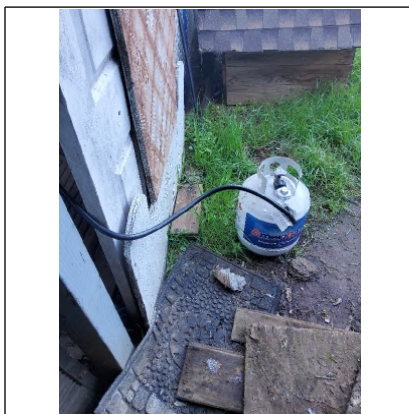
Not operable during time of inspection, recommend further evaluation by a licensed plumber. Seller has noted that the water heater is not staying

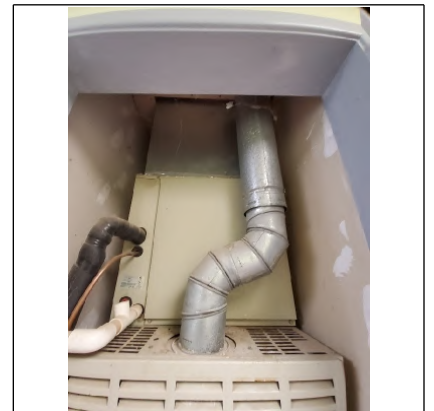
**Comments** **Recommend having unit serviced by a licensed HVAC contractor, unit operated but doesn't pull heat as lined is capped off.**

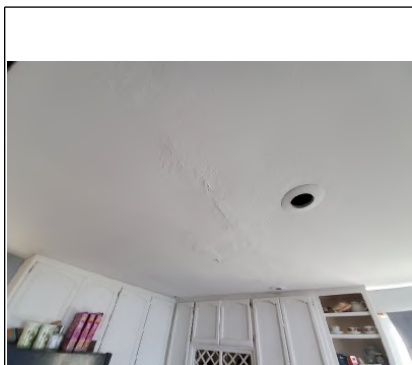
Moisture damage is evident on ceiling, sellers noted that the leak was repaired.

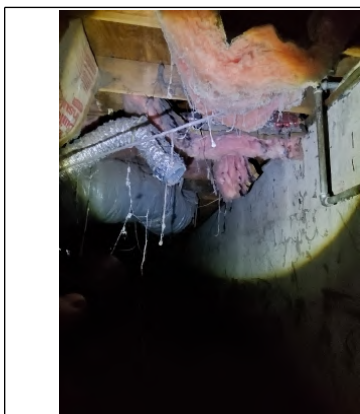
Dryer vent disconnected,  
recommend repair

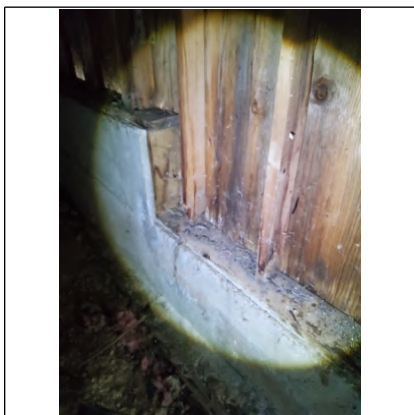
Moisture intrusion evident,  
recommend having a pest  
inspection for proper treatment.

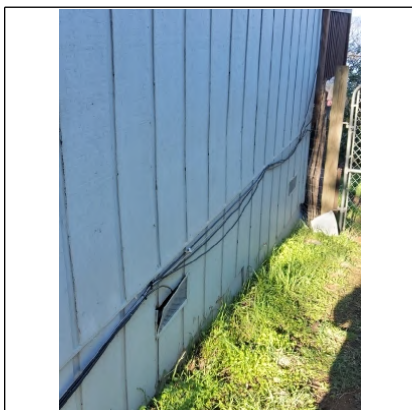
Screen is not properly fastened to siding, recommend repair

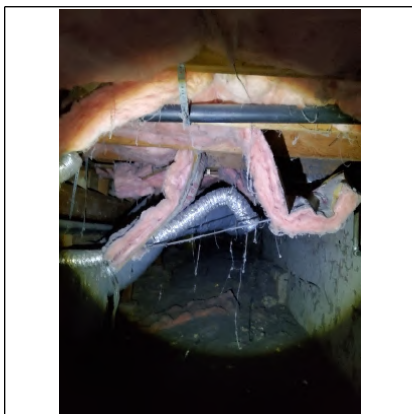
**Comments** **Insulation was damaged/missing , recommend repair**

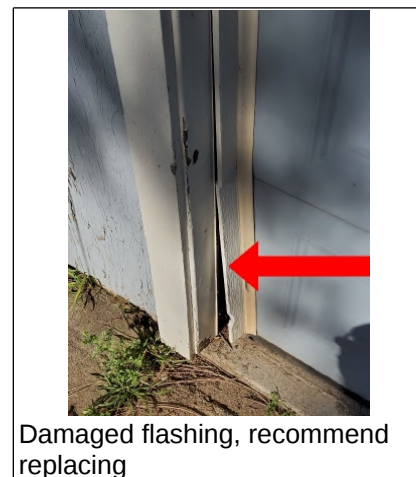
Damaged flashing, recommend replacing

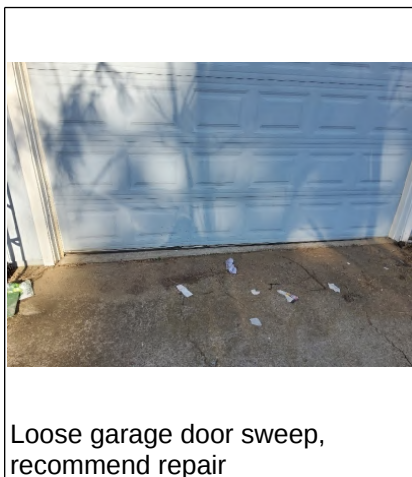
Loose garage door sweep, recommend repair

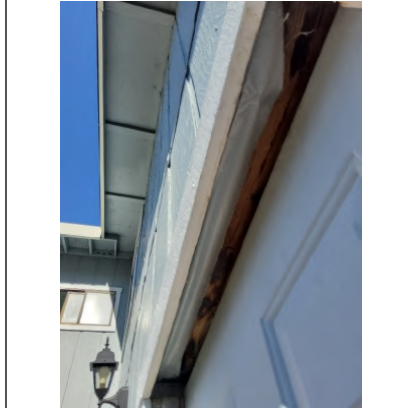
Missing casing trim, recommend repair
