# Professional

### *Inspection Report*

Address: 1595 Los Osos Valley Rd Spc 10C Los Osos, CA 93402 04/27/2026

Inspector: Keith Vreeken, MCI, FCI  
P.O. Box 415 Templeton, CA 93465 O: 805.462.1978 C: 805.440.5050

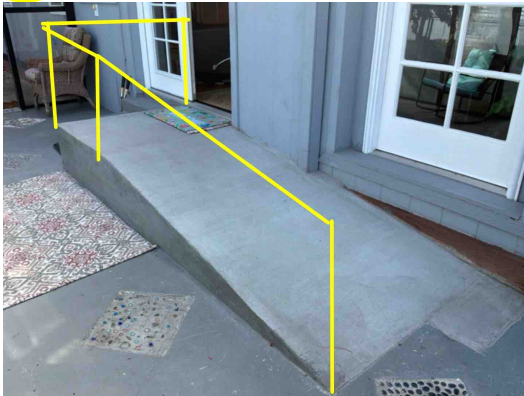
Example location

**SU** 20: A Railing is recommended for safety at the FRONT ENTRY sidewalk ramp to help prevent a fall.

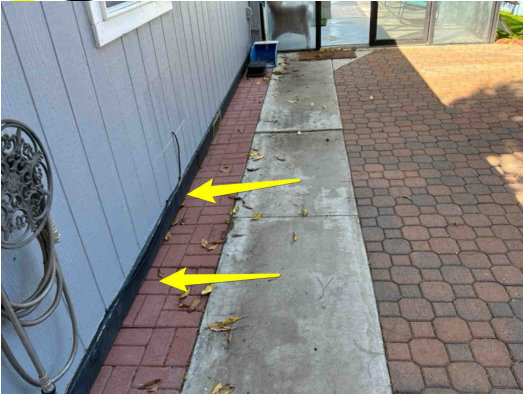
Example location

**UPG DS 23:** Areas of poor drainage with a visible improper slope of the patio(s) toward the house.

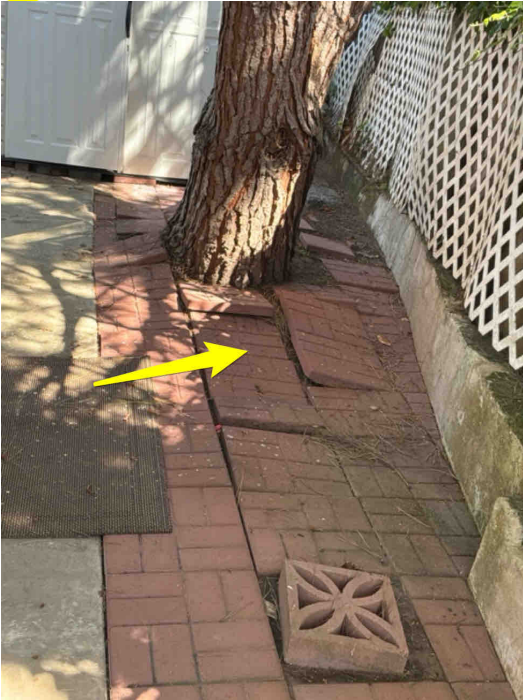
**SU 24:** Areas of the SOUTH SIDE YARD Paver patio are raised, settled and/or uneven with potential trip hazards.

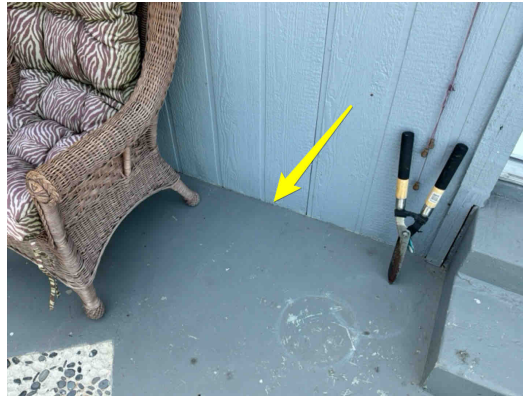
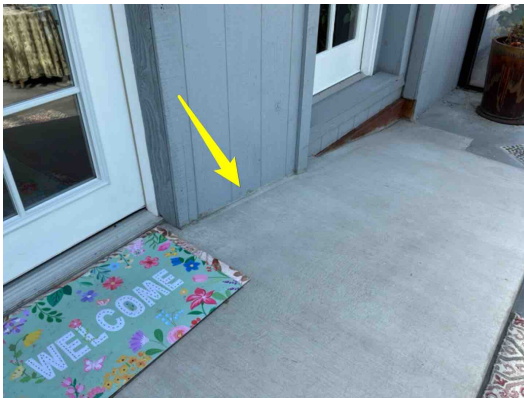
Example

**UPG DS 25: Disclosure:** Areas of some patios were installed high at or above the exterior siding. This can potentially under certain conditions, allow for moisture to accumulate at the base of the siding and can cause deterioration or water intrusion inside the wall cavities.

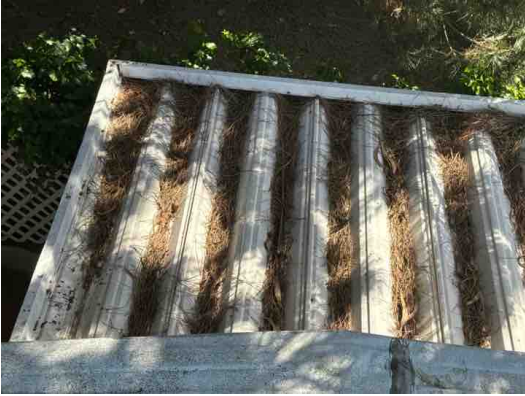
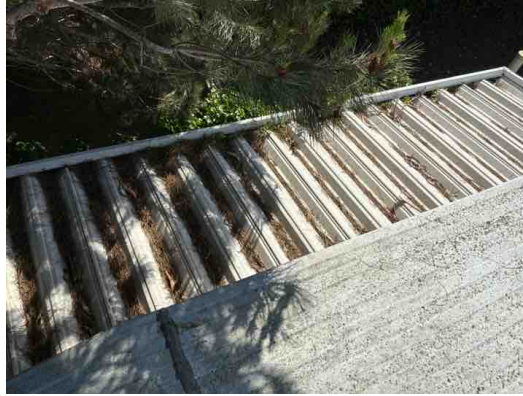
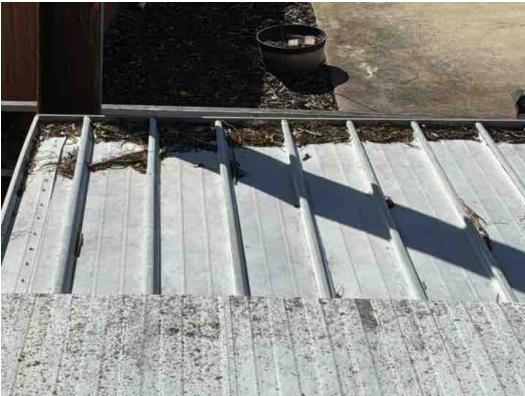
**MR** 29: Debris covers portions of the ALUMINUM AWNING roofs. Continuous cleaning recommended.

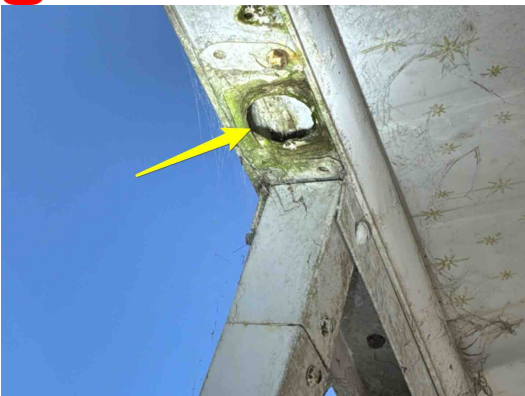
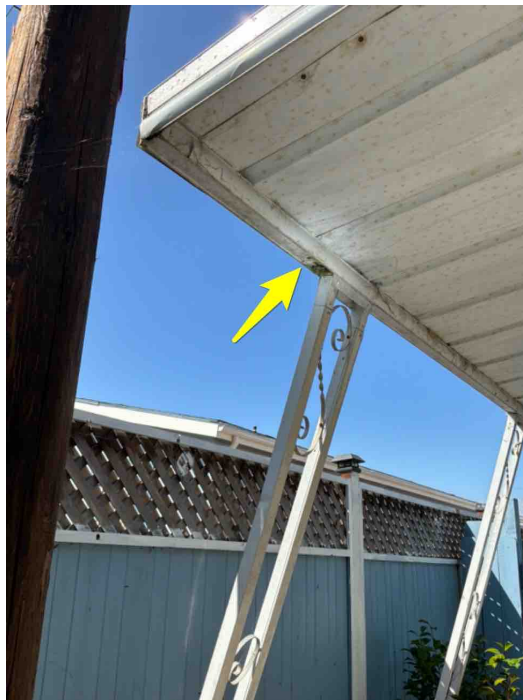
**E&C** 30: Missing a ring gutter downspout at the back southwest corner of the CARPORT ALUMINUM AWNING

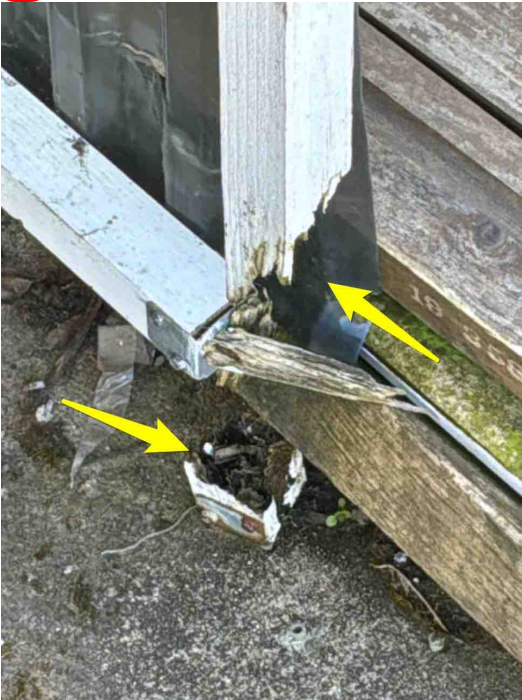
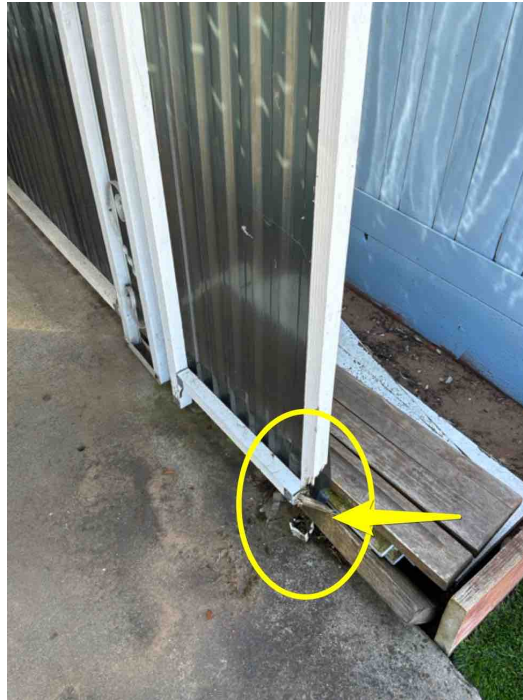
**E&C** 31: A damaged wood support at the front of the carport wind shade. Corrections recommend recommended

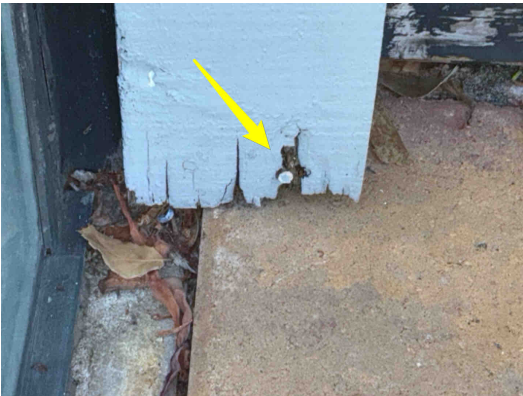
Example

**E&C 38:** Some moisture and/or bug type damage & deterioration found at exterior areas. Refer to the termite report for locations and extent.

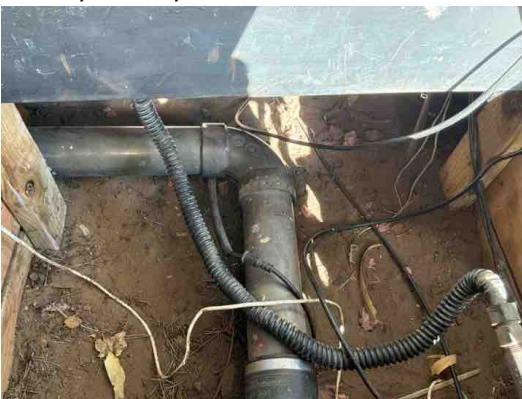
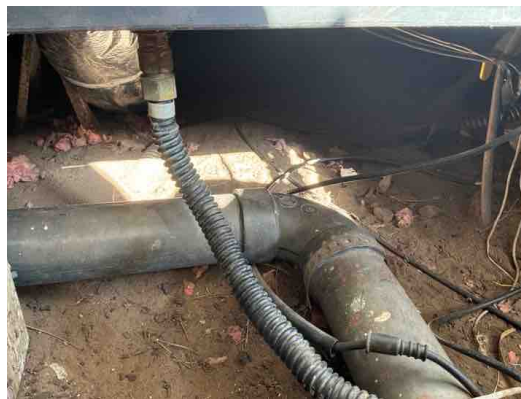
**UPG 46: CRAWLSPACE CONDITION:** An Inadequate access opening size to the crawlspace found. *The crawlspace had a limited inspection and was only inspected from the current undersized crawlspace access opening.*

*Recommend additional review of the the entire crawlspace including all its systems and components, including, but not limited to the plumbing, electrical, ventilation, structural components, etc, with repairs if needed by a qualified repair professional or an appropriate licensed contractor once appropriate access is made available.*

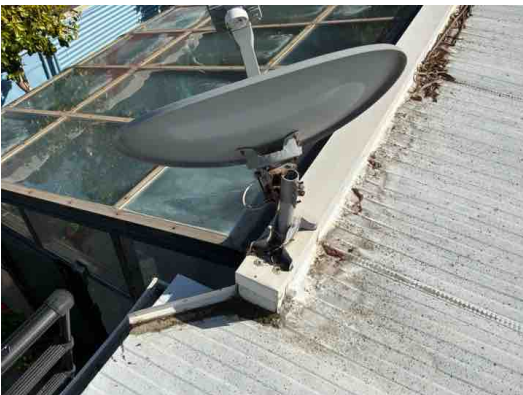
**SC 57:** Some moderate to heavy rushed deterioration and damage found at the roof mounted TV satellite dish. Recommend removal.

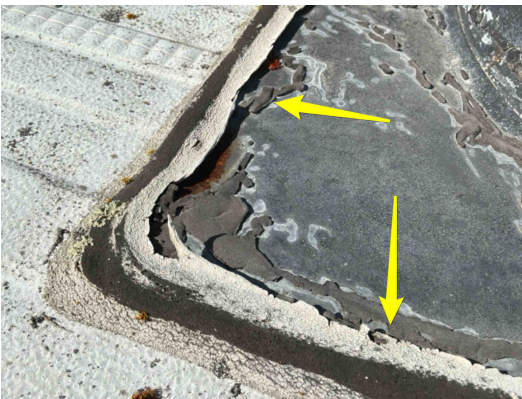
**MR 60:** Deteriorated sealant at some roof flashings, around the roof penetrations. Maintenance recommended to help prevent water intrusion into areas of the attic. Have roofer evaluate the roof flashings and correct as needed.

Deteriorated sealant around the fireplace chimney roof flashing

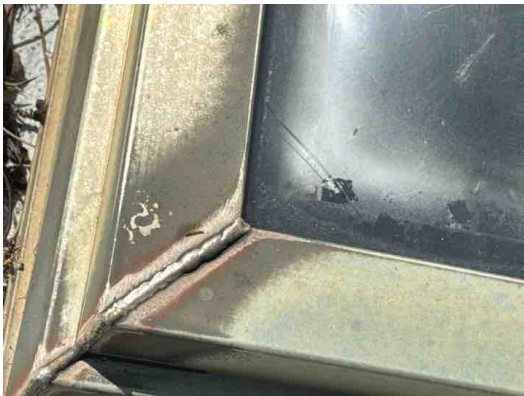
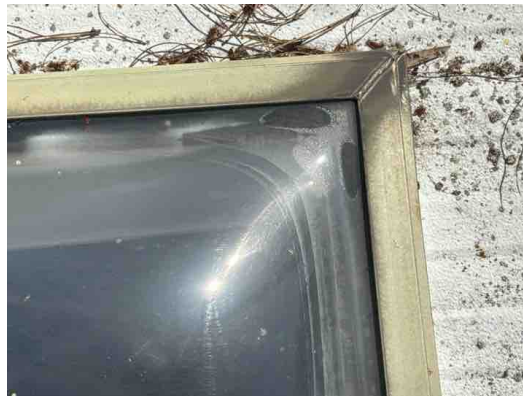
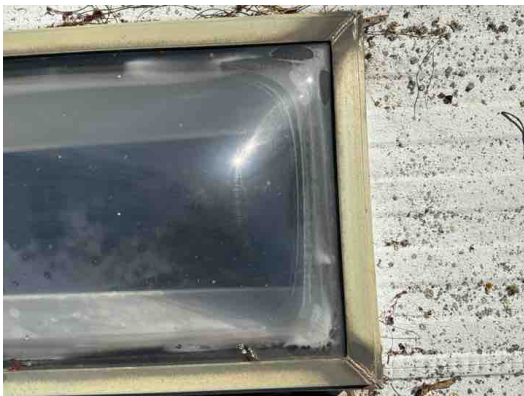
**E&C 61:** The PRIMARY BEDROOM BATHROOM plastic roof skylight is cracked, damaged and fills with water during certain weather conditions. Replacement is recommended. Contact a qualified roofer to evaluate and replace damaged skylights.

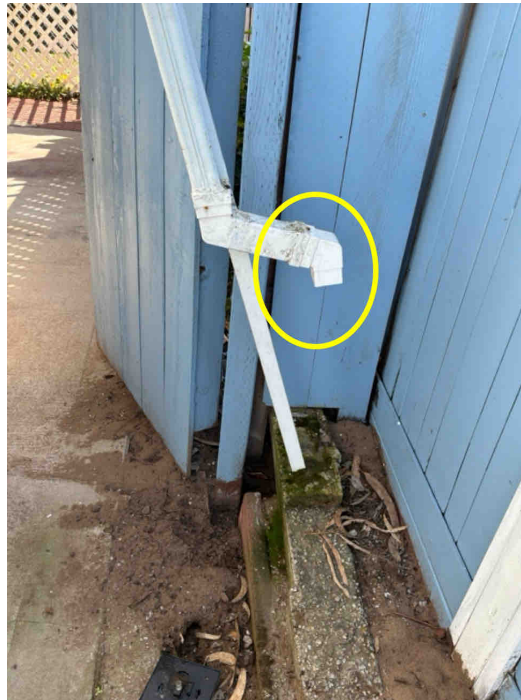
**UPG 65:** Improper termination of some rain gutter downspouts. Rain gutter downspout should be terminated in such a way that it directs the water away from the building. Missing the lower angled portion of the rain gutter downspout diverting the water away from the building.

Improper termination of the carport awning downspouts

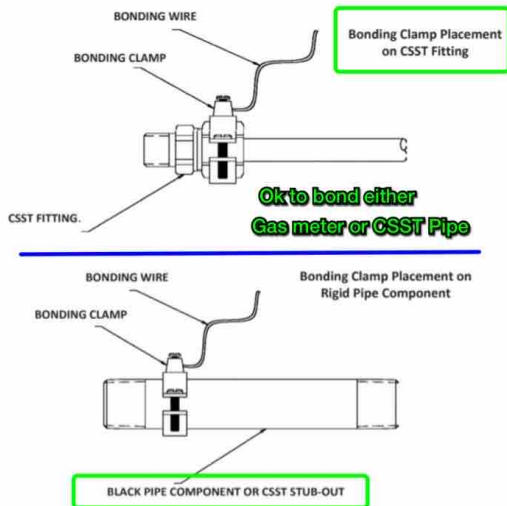
**SC SU 80:** Missing / recommend the required electrical bonding or grounding of the gas piping and/or gas meter due to the installation of CSST flex gas pipe for safety per the Manufacturer's installation instructions and California Building Standards (since 2009). Bonding / grounding connections may be installed in areas not visible however, should be visible or labeled for inspection if installed in a non-visible space.

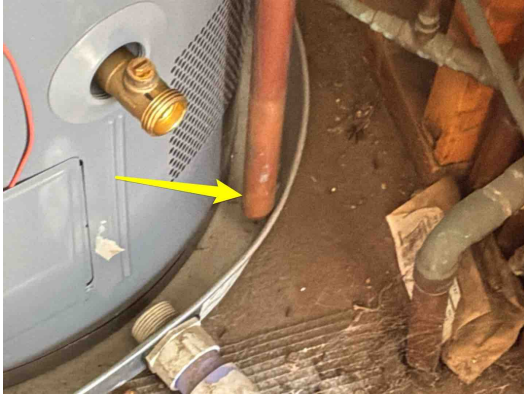
**SC 85:** Water heater TPR (Temperature Pressure Relief) pipe found improperly terminating into the water heater catch pan drain. This is considered a safety concern and warrants correction per minimum standards.

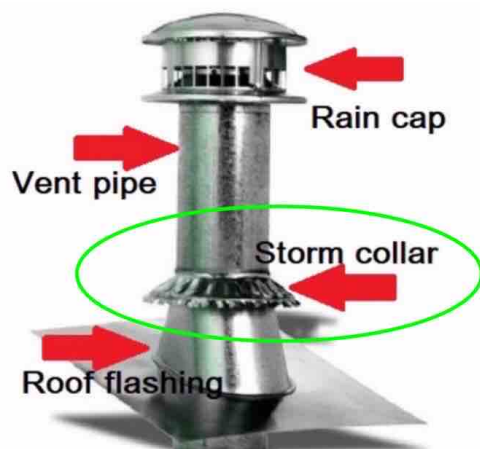
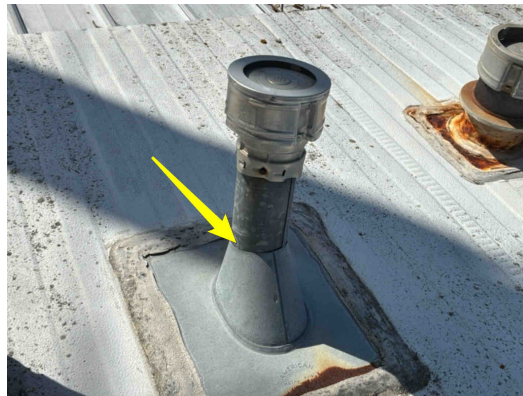
**E&C 86:** Missing / Recommend a proper storm collar per standards at the water heater vent pipe at the roof termination.

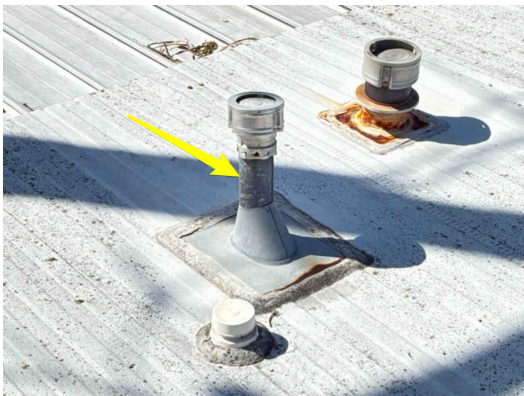
**E&C 87:** Improper use of single-wall vent pipe through the roof framing. Recommend the proper installation of double-wall vent pipe through the roof and roof flashing with appropriate clearances.

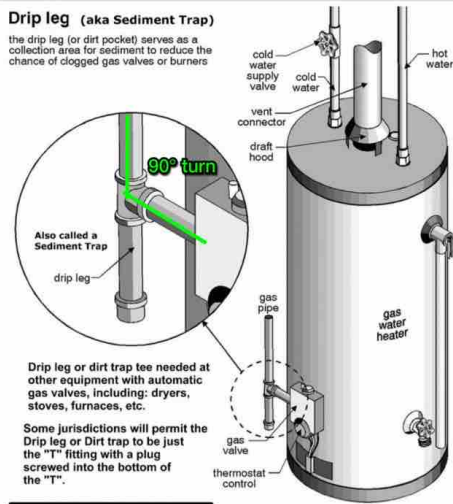
**UPG 89:** Recommend the installation of a sediment trap / drip leg at the WATER HEATER gas piping at flex connection by a certified or licensed plumbing professional familiar with minimum requirements.

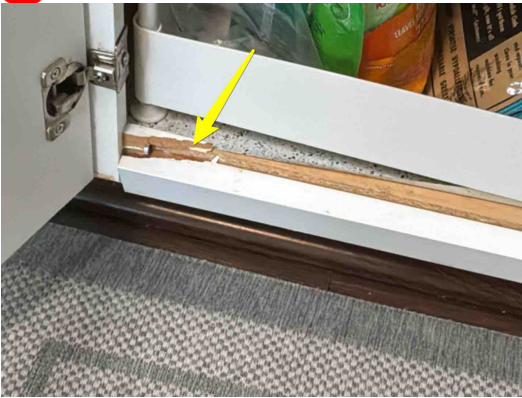
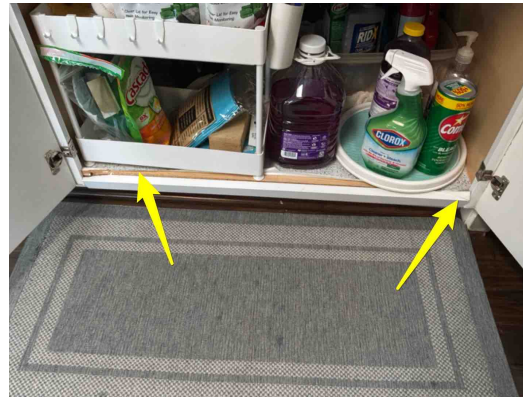
**FI 97:** Damaged cabinet trim at the front floor area at the kitchen sink cabinet.

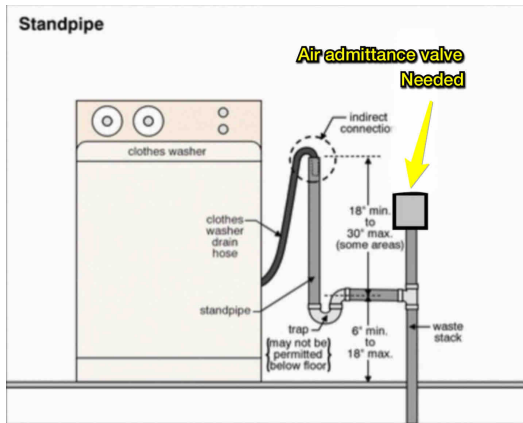
**SC 118:** Improper waste piping noted at the laundry. Missing a proper air admittance valve / vent at the added waist standpipe. Recommend further review with proper upgrades or corrections by qualified plumbing professional.

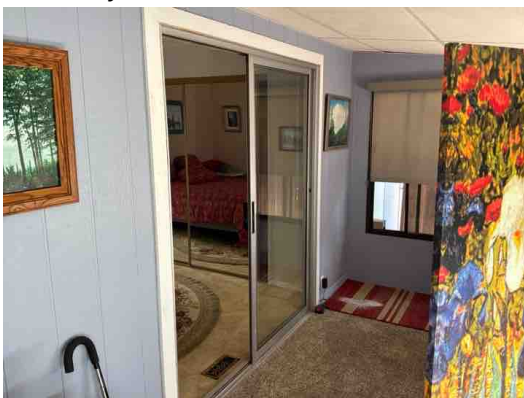
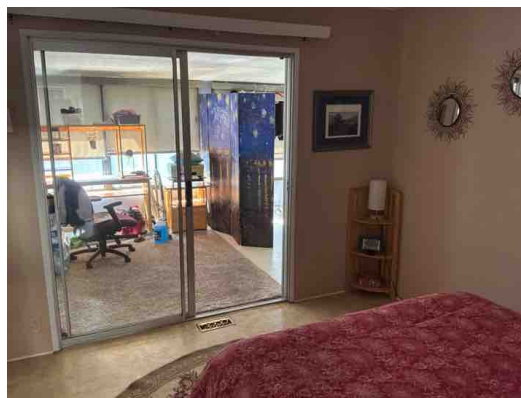
**SU 145:** BEDROOM-1 should not be used as a sleeping room due to inadequate emergency egress. The installation of the enclosed sunroom at the west side of the home obstructs the required direct egress to the exterior. Emergency escape and rescue openings (doors/windows) are required to open directly to the exterior and be readily accessible. CRC R310.1

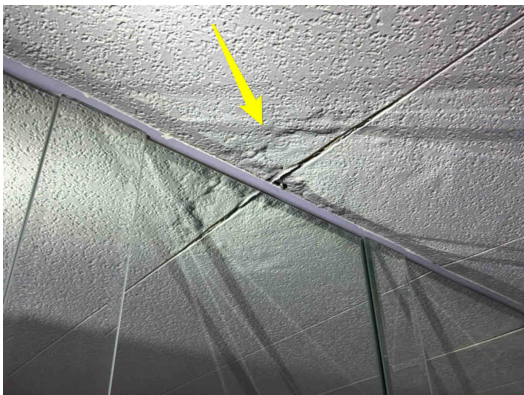
**FI 154:** Evidence of past moisture stains & damage at ceiling area in the LIVING ROOM - right of the fireplace above the window. Recommend further review of the water stains to determine the cause, the current condition and if repairs are needed.

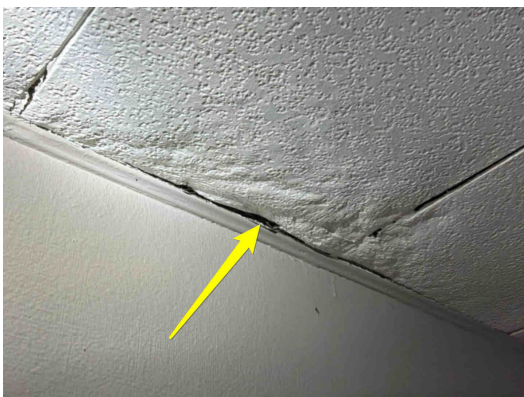
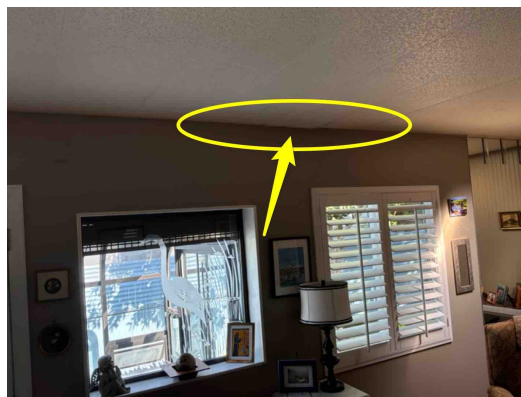
**FI 155:** Evidence of past moisture stains & damage at ceiling area in the FAMILY ROOM OVER THE WINDOW. Recommend further review of the water stains to determine the cause, the current condition and if repairs are needed.

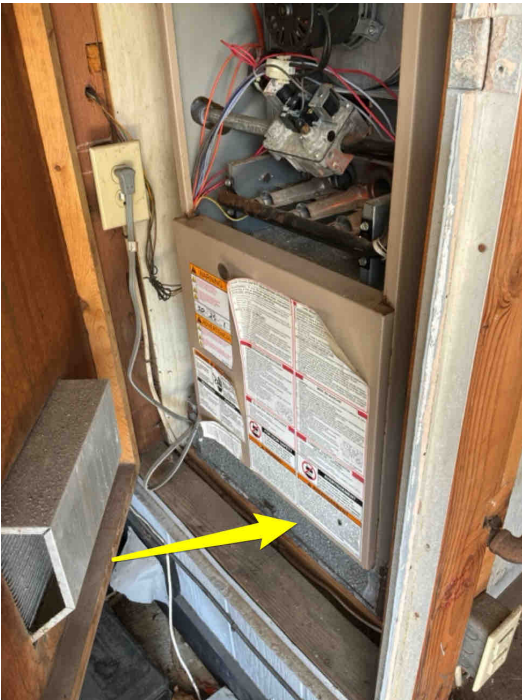
**MR 164:** Dirty Heating air filter found inside the furnace blower box at the furnace. Recommend cleaning or changing the furnace air filters as part of ongoing maintenance.

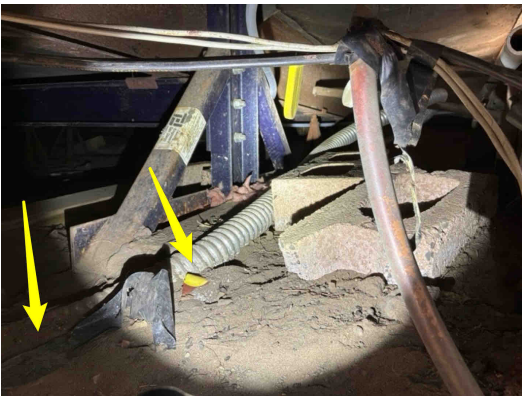
**SC 170:** The metal electrical service conduit from the main electrical panel (park riser) to the house sub panel found laying in contact with the ground in the crawlspace. This has or can cause deterioration or damage to the conduit as this conduit is NOT rated for earth contact. Evaluation and correction recommended for electrical safety.

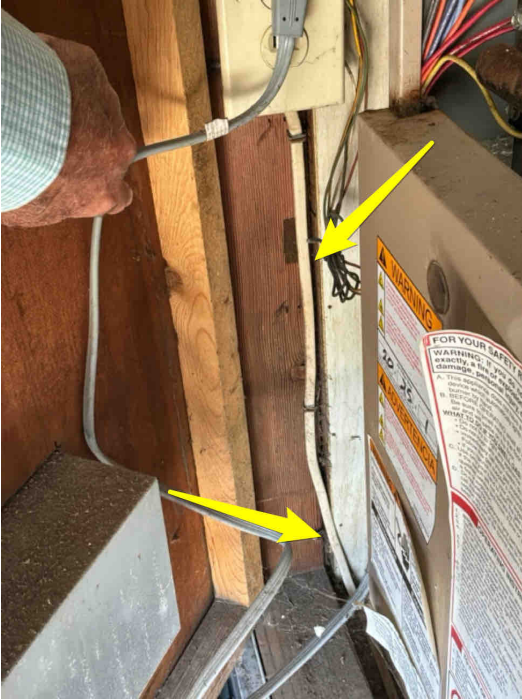
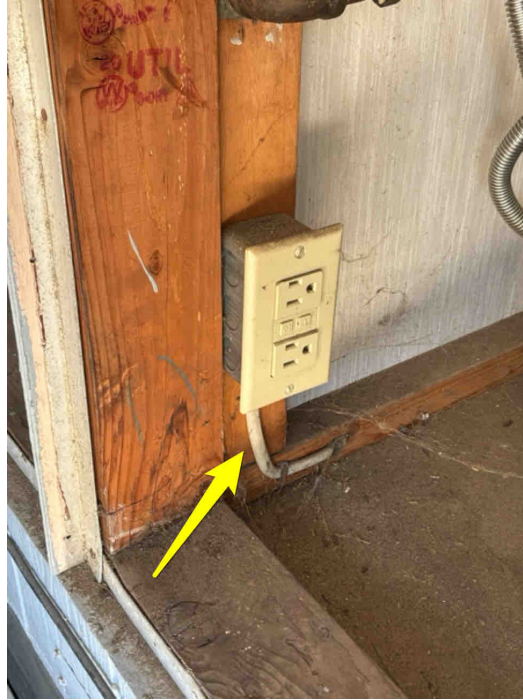
**SC 174:** Improper exposed electrical wiring, "Romex" improperly installed subject to physical damage, not in a conduit or raceway per standards: INSIDE THE FURNACE ENCLOSURE FOR THE ADDED ELECTRICAL OUTLET IN THE WATER HEATER CLOSET

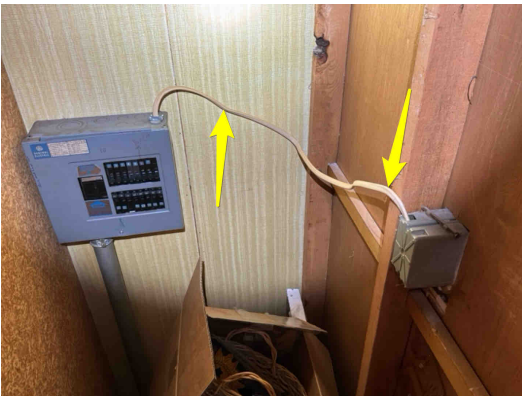
**SC 175:** Improper and unsafe electrical wiring: INSIDE THE PRIMARY BEDROOM CLOSET. Ex. Exposed electrical wiring, "Romex" improperly installed subject to physical damage, not in a conduit or raceway per standards.

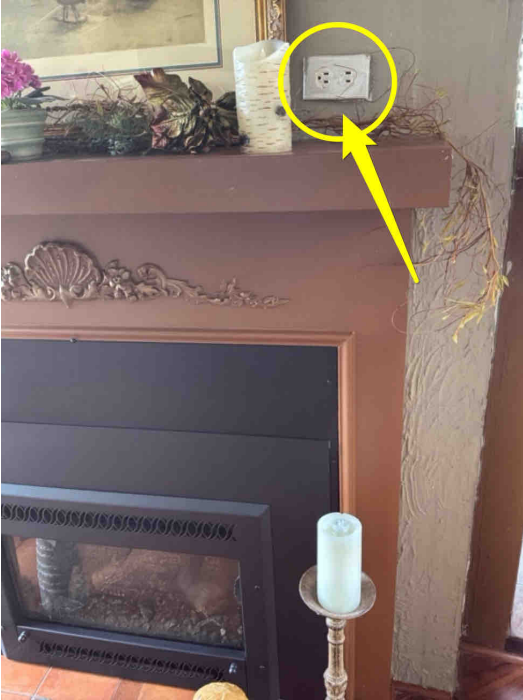
**SC 176:** An electrical an outlet found loose in wall. Corrections warranted for safety: IN THE LIVING ROOM ABOVE THE FIREPLACE.

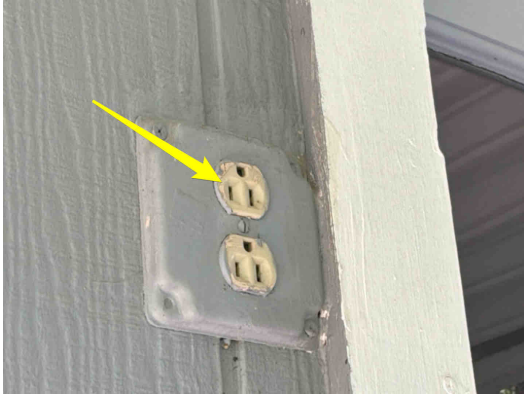
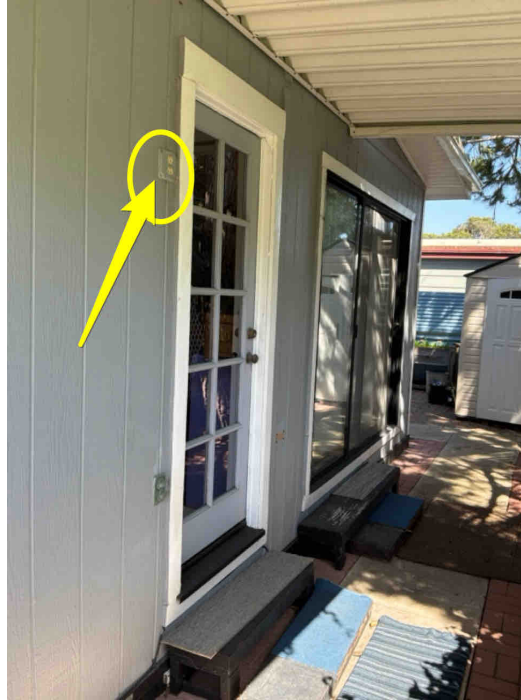
**SC 178:** Missing a proper weather tight cover at the UPPER EXTERIOR OUTLET OFF THE PRIMARY BEDROOM EXTERIOR DOOR.

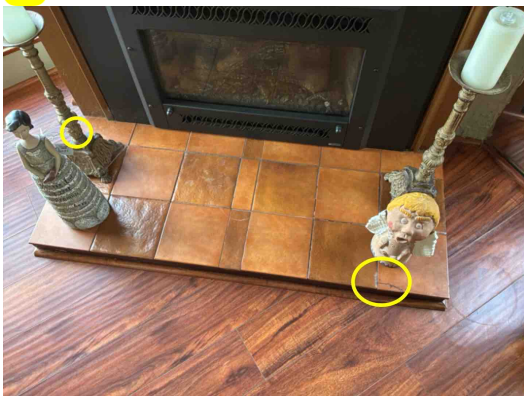
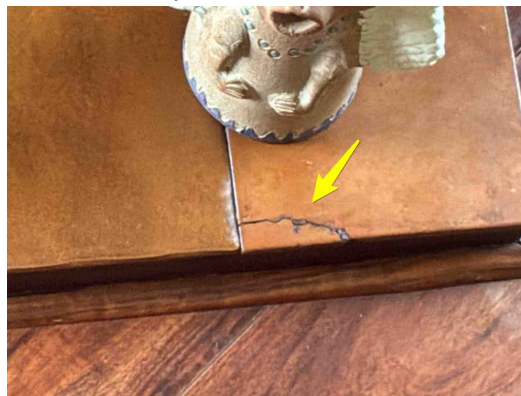
**UPG 185:** Some cracked loose tiles at the LIVING ROOM Fireplace Tiled hearth.
