ENSLING property works

Inspected By: Travis Ensling

Prepared For: Victoria Aiken, Alexis Aiken

Inspected On Fri, Apr 24, 2026 at 9:00 AM

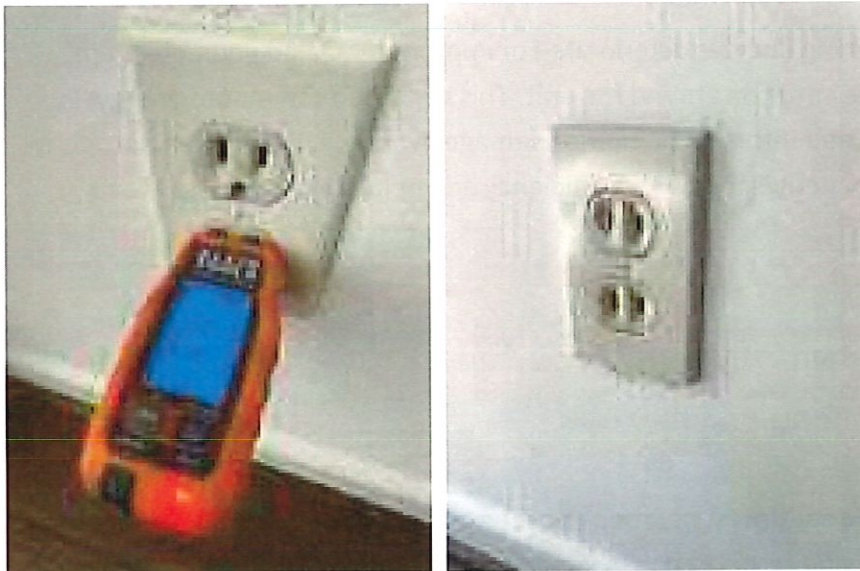
The electrical system appears outdated overall. Several newer-style receptacles tested indicated open grounds, while many original two-prong ungrounded receptacles remain installed throughout the home. The wet environments within the home are not GFCI protected. Cloth-insulated wiring visible within the attic and crawlspace appeared old and brittle in accessible areas. Further evaluation and recommendations from a licensed electrical contractor are advised.

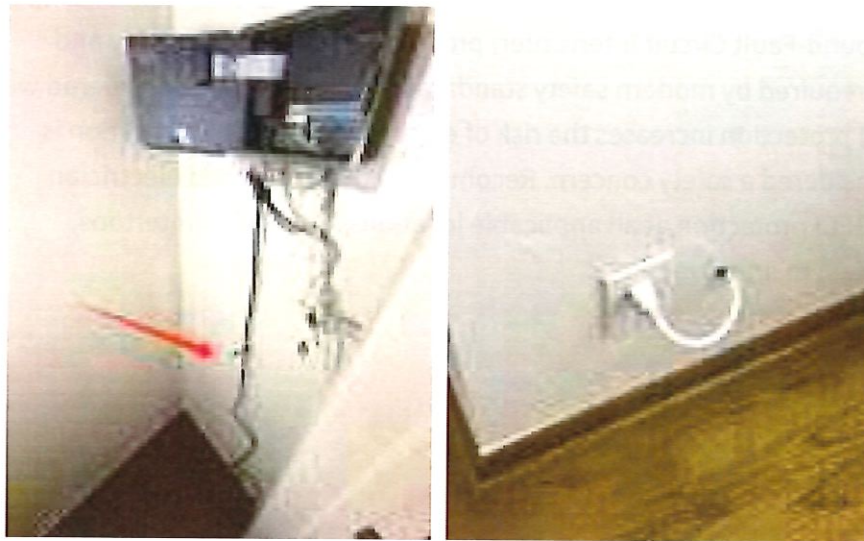
An irrigation controller located in the closet/laundry area was observed with a spliced power cord routed through the wall to an exterior outlet. This installation method is improper and may present a potential electrical safety concern. Recommend evaluation and correction by a qualified electrician or irrigation contractor.

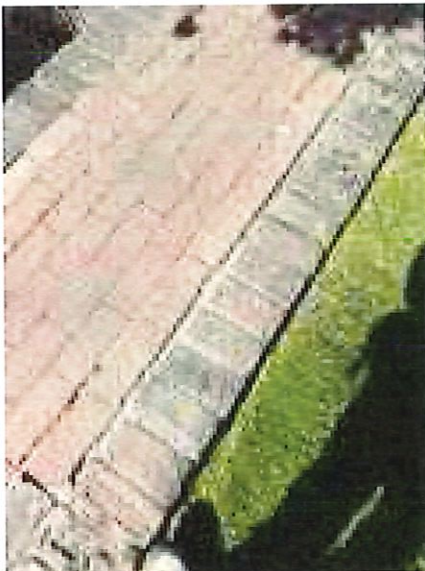
Comment 2 Monitor Condition

The brick walkway has cracked and mortar joints between the brick rows. This condition can allow water intrusion and may lead to loosening or shifting of the bricks over time. Recommend repairing/repointing the mortar joints as needed to maintain stability and help prevent further deterioration.

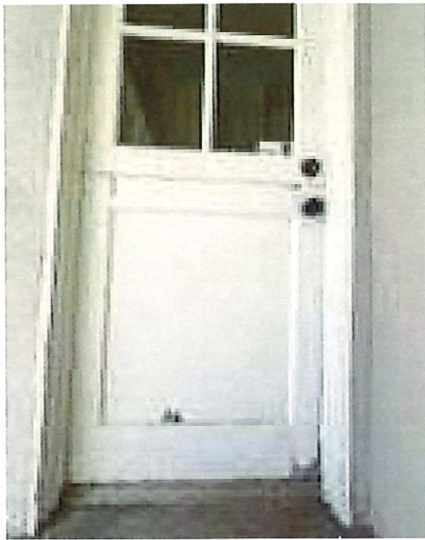
Comment 3

Missing paint, minor visible water damage on lower panel and threshold of southwest rear entrance

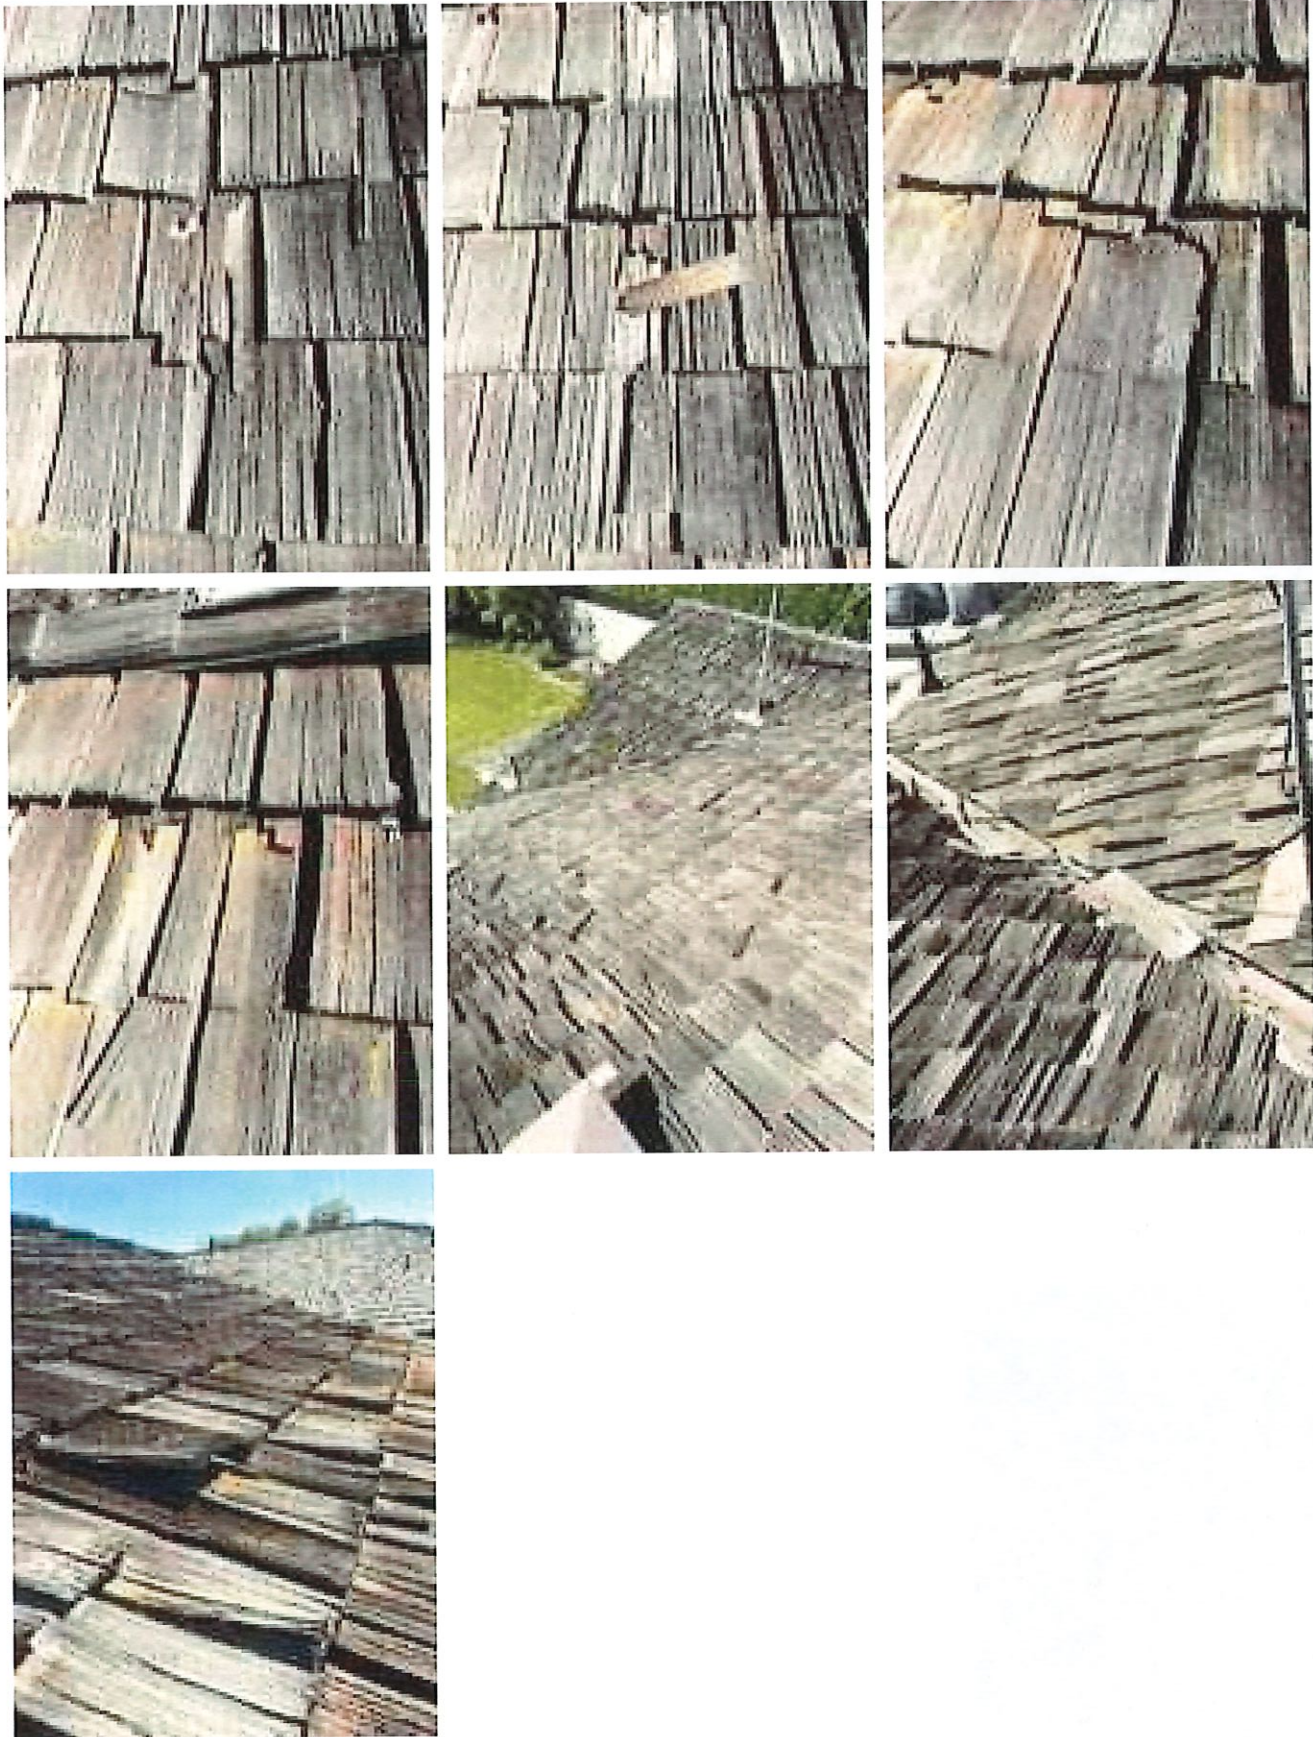
Comment 4

The roof covering has loose, missing, and broken shingles, with some debris observed in drainage areas. These conditions can allow water intrusion and interfere with proper roof drainage.

potentially leading to deterioration of underlying materials, necessitating repairing or replacing damaged and missing shingles and clearing debris from drainage areas to help maintain a watertight and properly functioning roof.

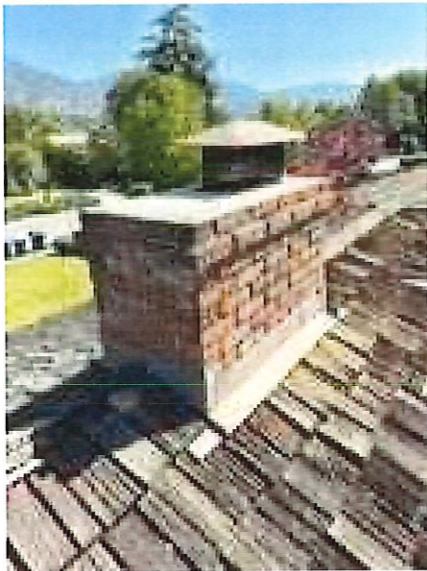
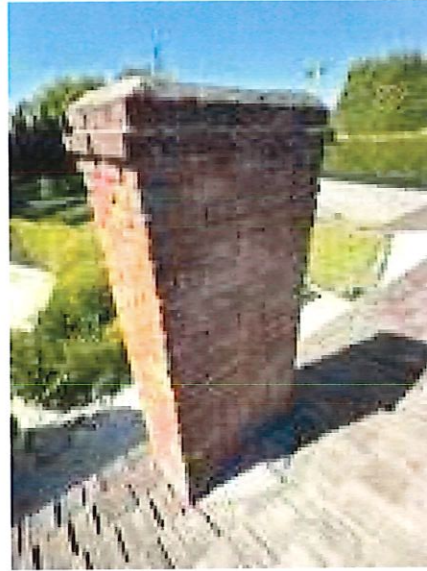
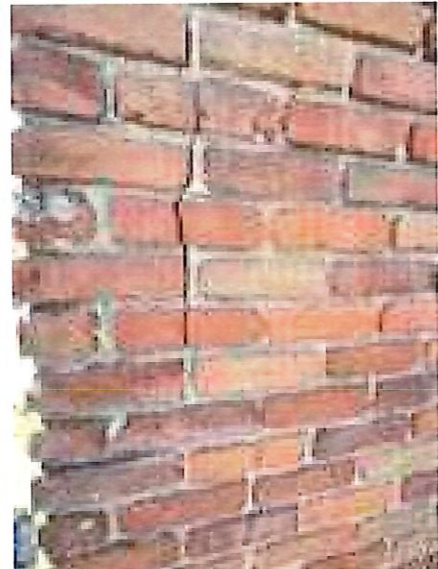
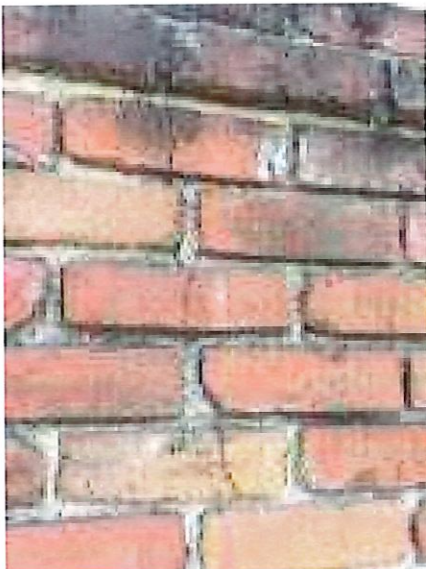
Comment 5

Visible vertical cracking observed in the exterior brick fireplace chimney/smokestack at the roof level. Cracking may allow moisture intrusion and may indicate movement or deterioration of the masonry components over time. Recommend further evaluation and repair by a qualified masonry contractor.

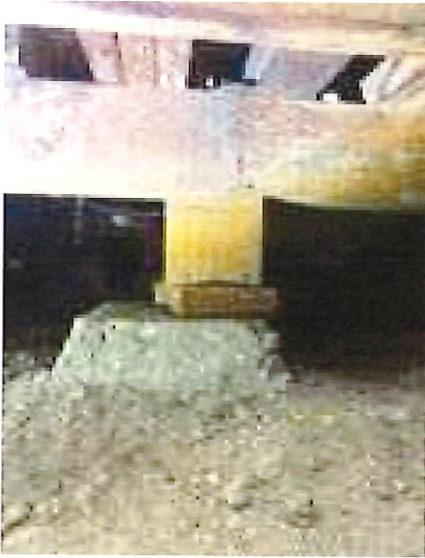
Comment 7

A pier-and-beam support post is not properly centered on its concrete foundation/pier, resulting in an eccentric load condition. This may reduce load distribution efficiency and could contribute to movement or structural stress over time. Recommend evaluation and correction by a qualified contractor or structural specialist to ensure proper support and alignment.

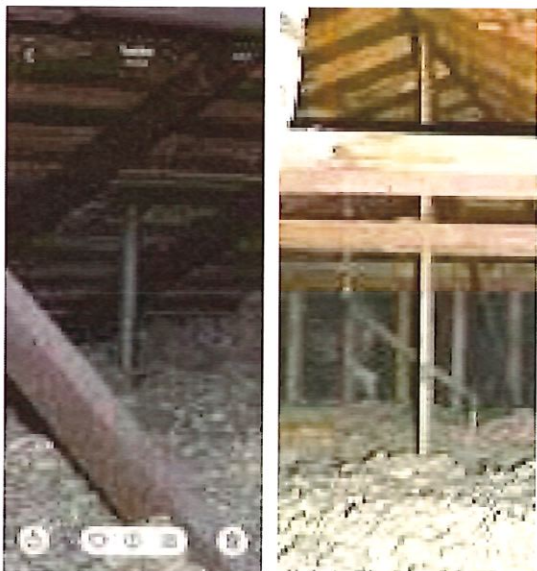
Comment 8

Attic insulation appears thinner or uneven in some areas. Evidence of rodent activity was observed within the attic space. Recommend evaluation and remediation by a qualified pest control contractor and replacement or redistribution of affected insulation as needed.

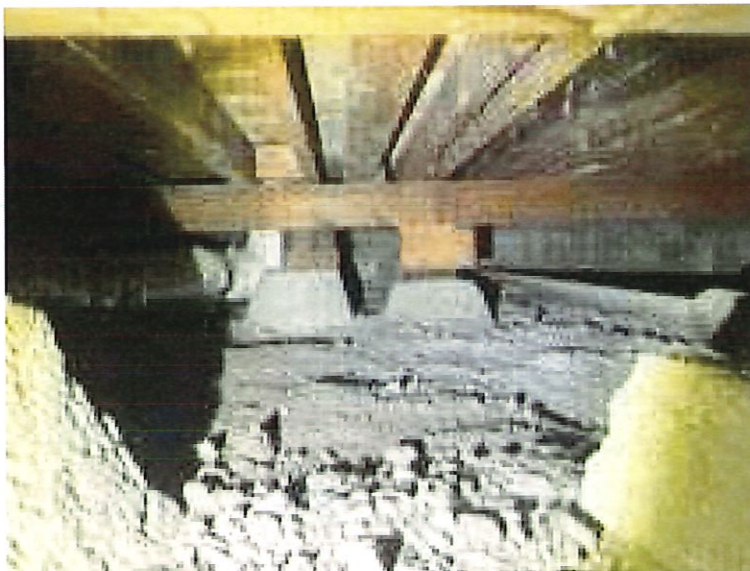
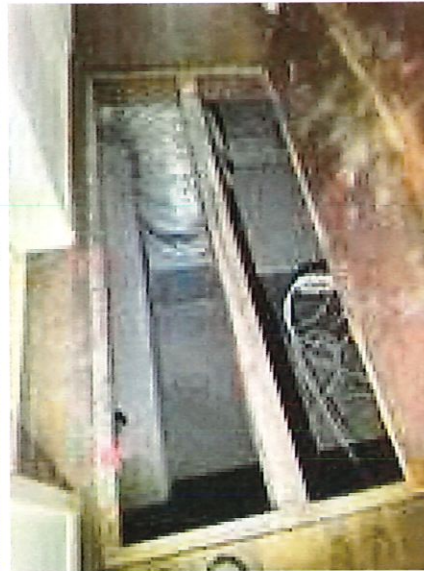
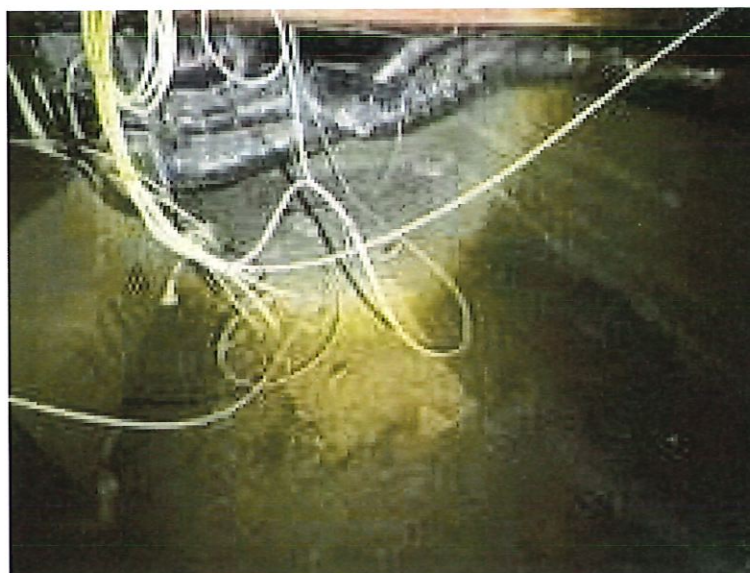
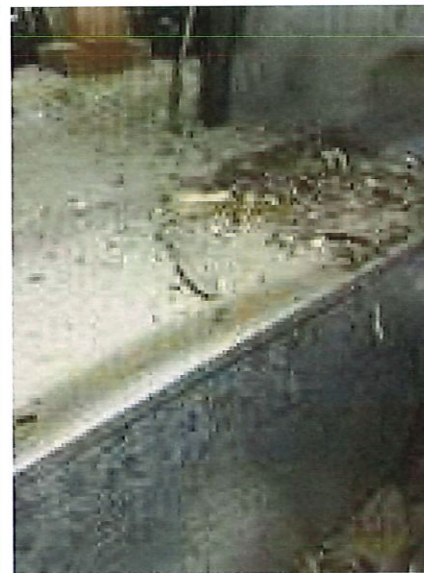
Comment 10
Repair or Replacement Needed

...vidence of rodent activity (e.g., droppings, nesting, etc.) observed in the crawlspace. This condition may lead to damage to insulation, wiring, and building materials, and can pose health concerns. Recommend evaluation and treatment by a licensed pest control professional, and repair/cleaning of affected areas as needed.

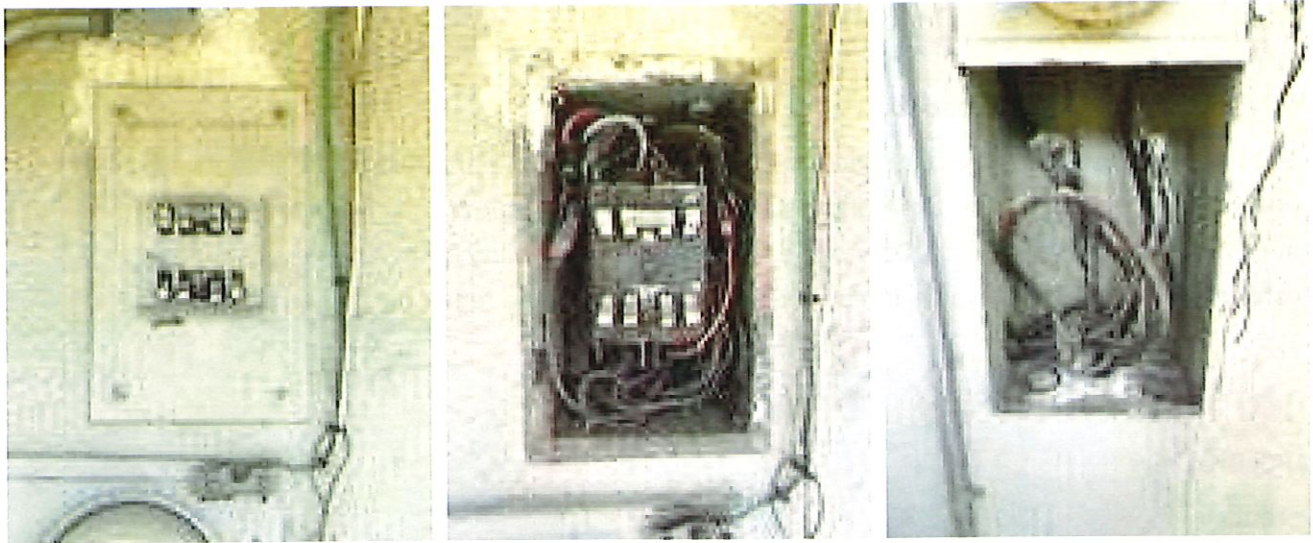
Comment 11

The electrical panel (possibly Schneider Electric) is missing a front cover (dead front), leaving breakers and internal components exposed; the panel is also obsolete and shows visible corrosion and deterioration. Recommend evaluation by a licensed electrician and repair or replacement as needed; full panel replacement is likely due to age and condition.
