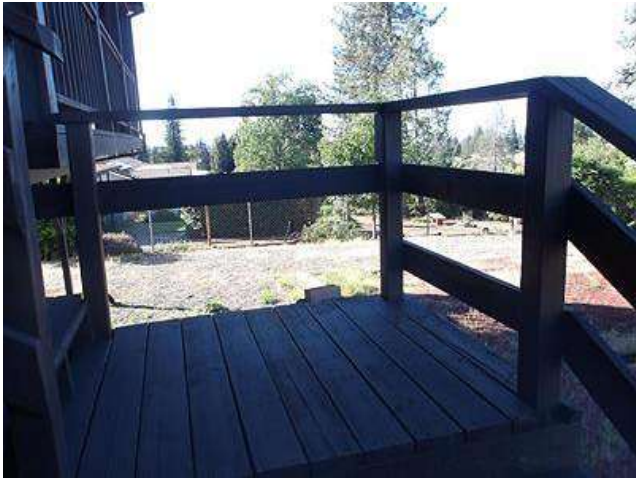
Photo 2-1 Deck stair landing

Guardrails in some areas with drop-offs higher than 30 inches were climbable and/or with gaps over 4". This is a safety hazard. Standard building practices require that they:

A qualified contractor should evaluate and repair, replace or install guardrails as necessary, and as per standard building practices.

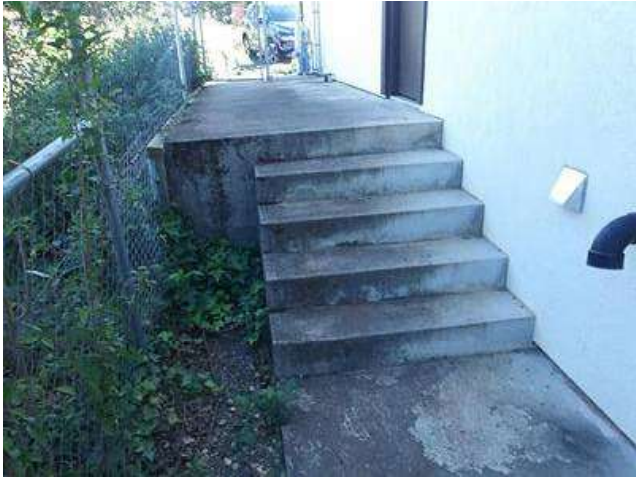
Photo 3-1 North stairs

Handrails at one or more flights of stairs were missing. This is a safety hazard. Standard building practices require that handrails be:

A qualified person should repair, replace or install as necessary and as per standard building practices.

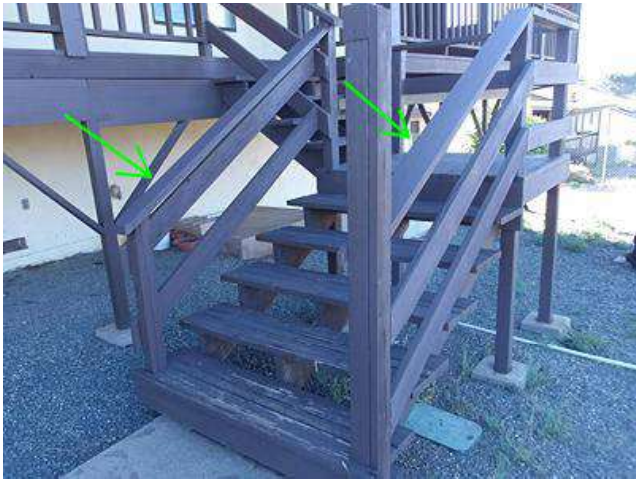
Photo 4-1 Deck stairs

4) 🚧 🛠️ Handrails at one or more flights of stairs were deteriorated and/or loose. This is a safety hazard. A qualified person should repair or replace as necessary and as per standard building practices.

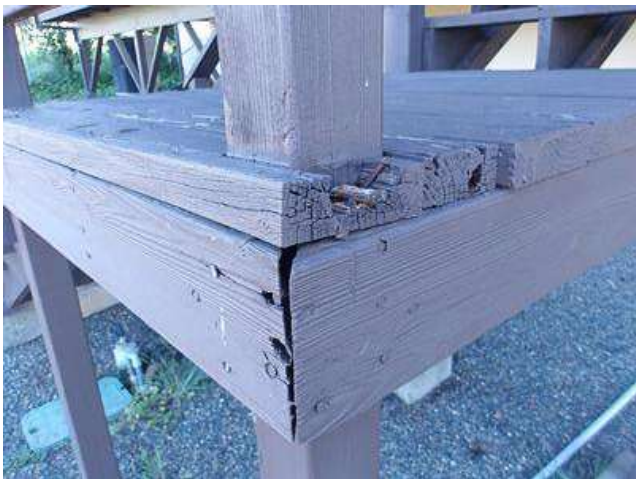
Photo 5-1 Deck stair landing

5) 🔍 🪵 🪵 Rot or water damage was found at one or more decks, porches or balconies in decking boards, joists, beams and/or support posts. A qualified person should evaluate and repair as necessary. All rotten wood should be replaced.

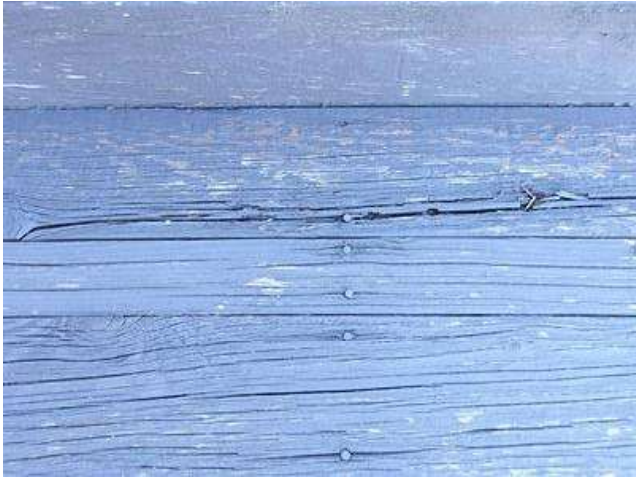
Photo 6-1 Deck stairs

Rot or water damage was found at one or more sets of exterior stairs in treads. A qualified person should evaluate and repair as necessary. All rotten wood should be replaced.

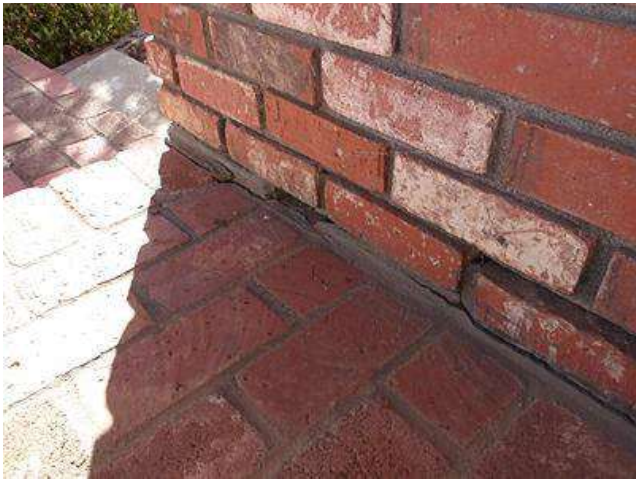
Photo 7-1 Front porch

One or more decks, porches and/or balconies were damaged and/or deteriorated. A qualified person should evaluate and repair or replace as necessary.

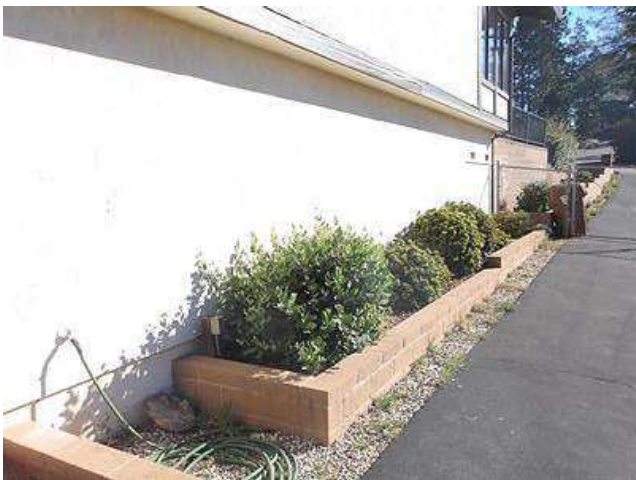
Photo 8-1 South side

Vegetation such as trees, shrubs and/or vines was in contact with or less than one foot from the building exterior. Vegetation can serve as a conduit for wood destroying insects and may retain moisture against the exterior after it rains. Vegetation should be pruned and/or removed as necessary to maintain a one foot clearance between it and the building exterior.

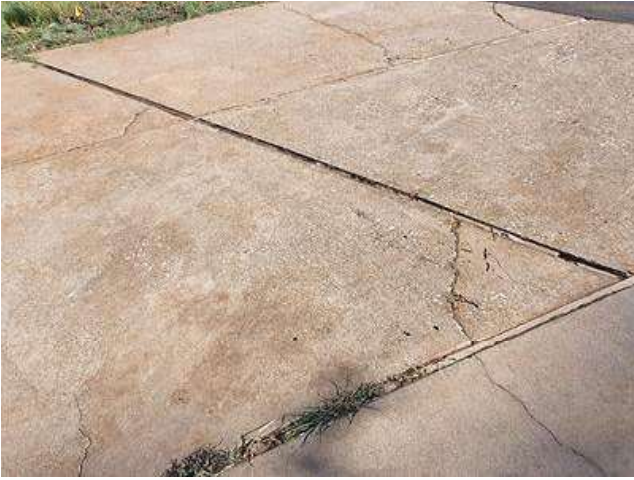
Photo 11-1 Driveway

-
- 11) ⓘ Minor cracks, settlement, heaving and/or deterioration were found in the driveway. However they don't appear to be a structural concern and no trip hazards were found. No immediate action is recommended, but the client may wish to have repairs made or have cracked sections replaced for aesthetic reasons.

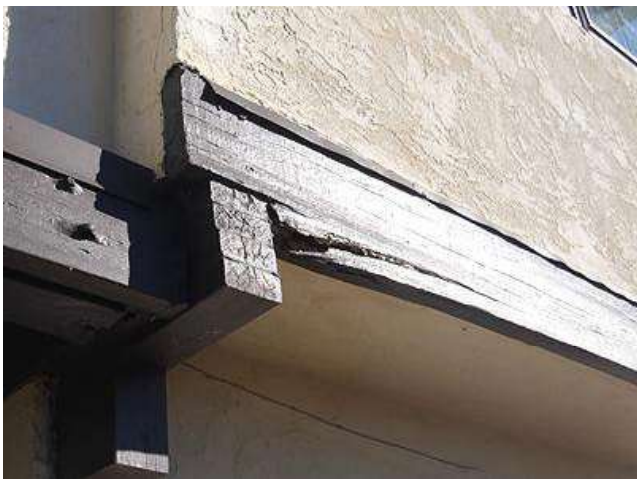
Photo 12-1 SW corner

Rot or water damage was found at one or more sections of trim, fascia and/or exposed beams. A qualified person should evaluate and repair as necessary. All rotten wood should be replaced.

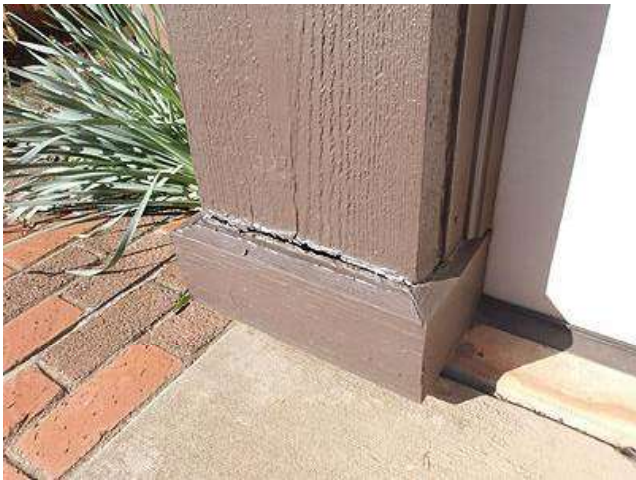
Photo 13-1 SE corner garage

Some sections of siding and/or trim were deteriorated. A qualified person should evaluate and repair, replace or install as necessary.

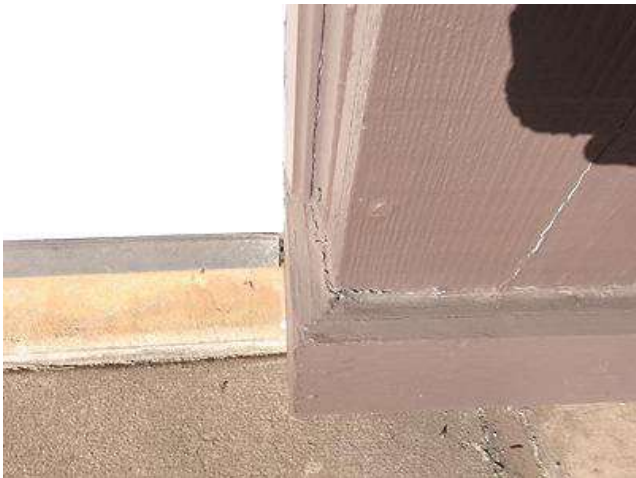
Photo 14-1 East side garage

Caulk was deteriorated at siding-trim junctions. A qualified person should repair or replace as necessary. For more information, visit: https://www.reporthost.com/docs/FPL_Caulking_Ins_Out.pdf

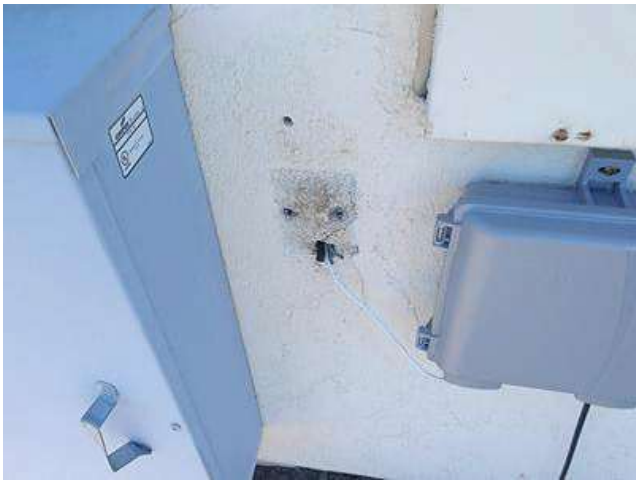
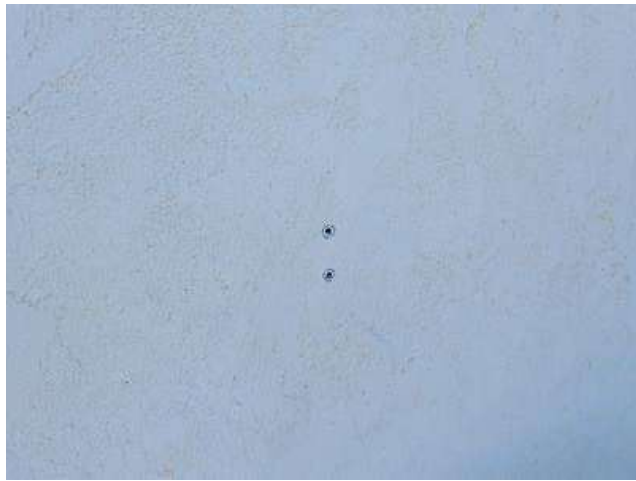
Minor deterioration and/or damage were found in one or more areas of the stucco siding. A qualified contractor should evaluate and make repairs and/or replace stucco siding as necessary.

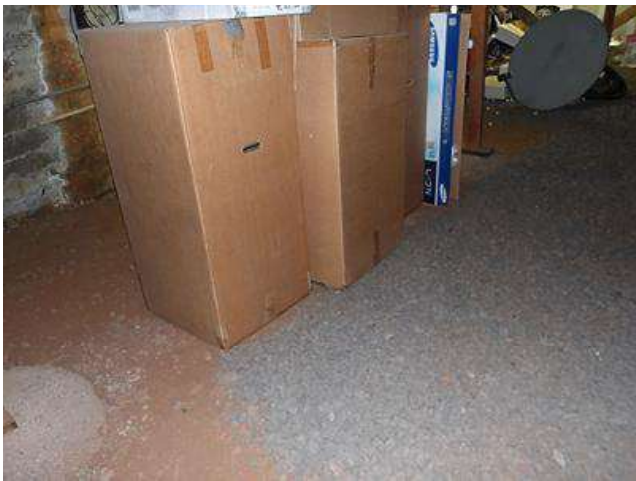
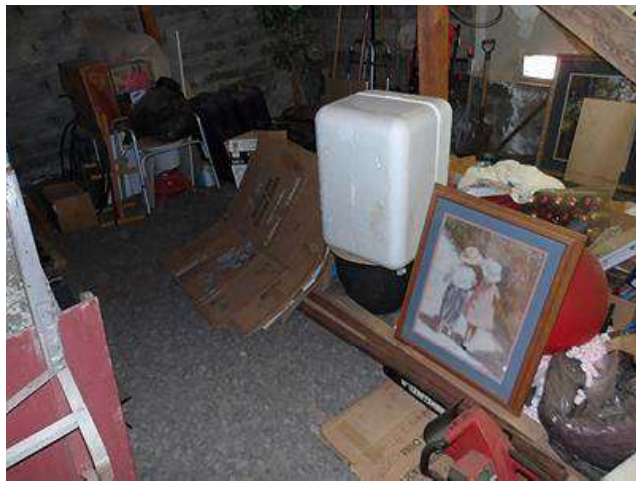
16) 🗑️💧 Scrap wood, Cardboard and/or Paper was found in the crawl space. All cellulose-based debris or stored items should be removed to avoid attracting wood destroying insects.

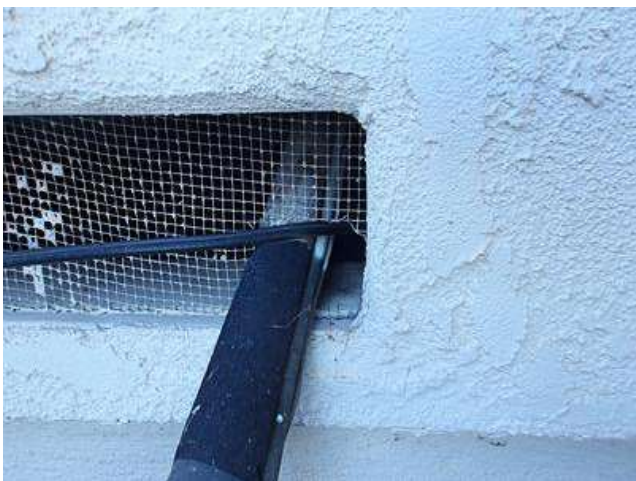
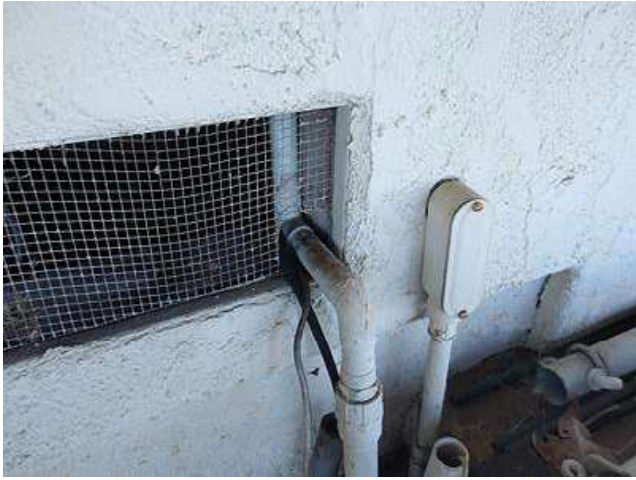
17) 🗑️🔧 Gaps existed at one or more openings around the exterior, such as those where outside faucets, refrigerant lines, and/or gas supply pipes penetrate the exterior. Gaps should be sealed as necessary to prevent moisture intrusion and entry by vermin.

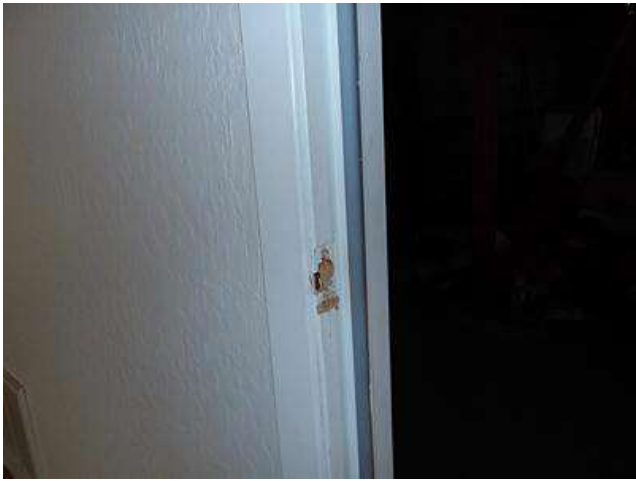
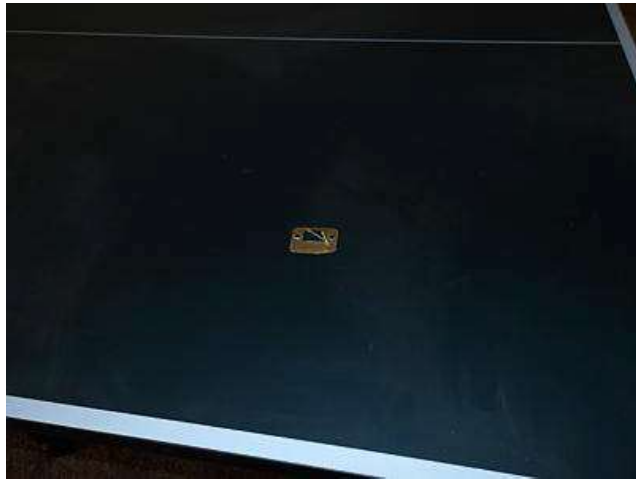
18) 🚧 The crawl space access hatch was deteriorated. A qualified person should repair, replace or install as necessary to prevent water and vermin intrusion.

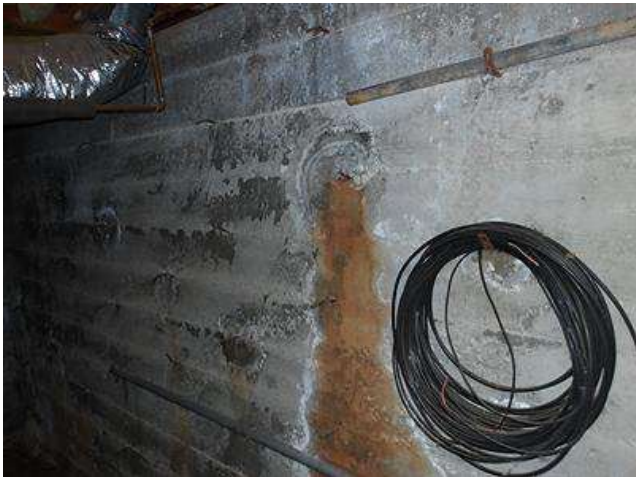
Photo 19-1 Crawl space East wall

19) 🔍🔧💧 Evidence of prior water intrusion was found in one or more sections of the crawl space. Accumulated water is a conducive condition for wood destroying insects and organisms and should not be present in the crawl space. The client should review any disclosure statements available and ask the property owner about past accumulation of water in the crawl space. The crawl space should be monitored in the future for accumulated water, especially after heavy and/or prolonged periods of rain. If water is found to accumulate, a qualified contractor should evaluate and repair as necessary.

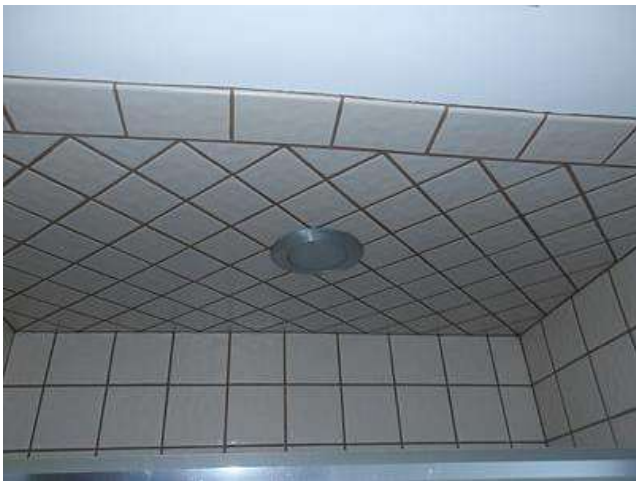
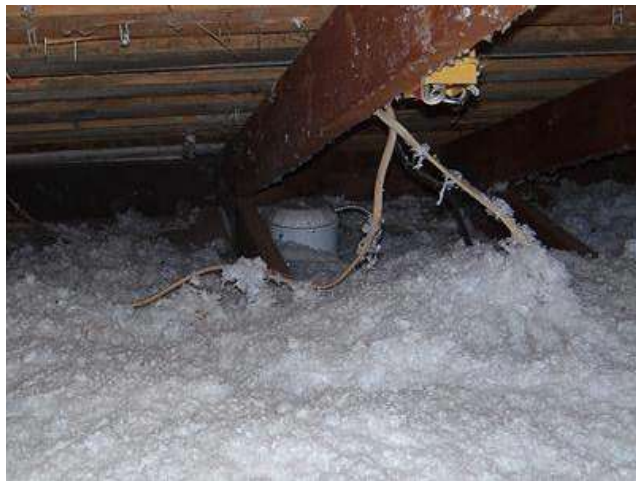
20) 🚧 🛠️ Recessed "can" lights that are not rated for contact with insulation were installed in the ceiling below the attic. One or more of these lights are in contact with insulation. This is a fire hazard. Insulation should be moved, and wells or barriers should be installed or repaired as necessary to keep the insulation away from these lights as per the manufacturer's installation instructions.

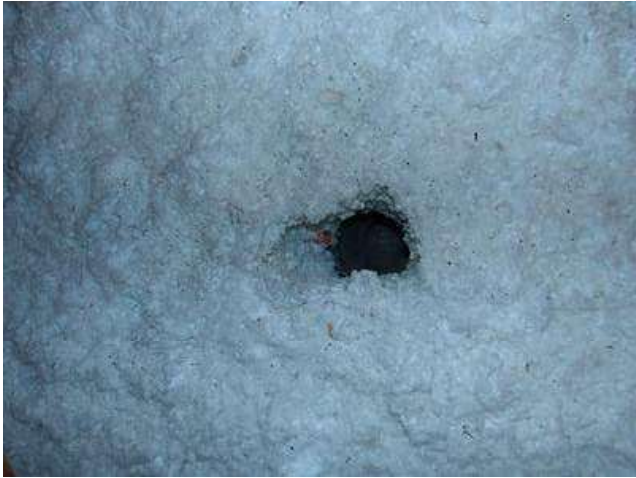
Photo 21-1 Hall bathroom exhaust fan termination

21) 🛠️ 💧 One or more exhaust fan ducts in the attic were not connected to a vent cap. This is a conducive condition for wood destroying insects and organisms due to increased moisture levels in the attic from the exhaust air. A qualified person should evaluate and make permanent repairs as necessary and as per standard building practices, so all exhaust air is vented outside.

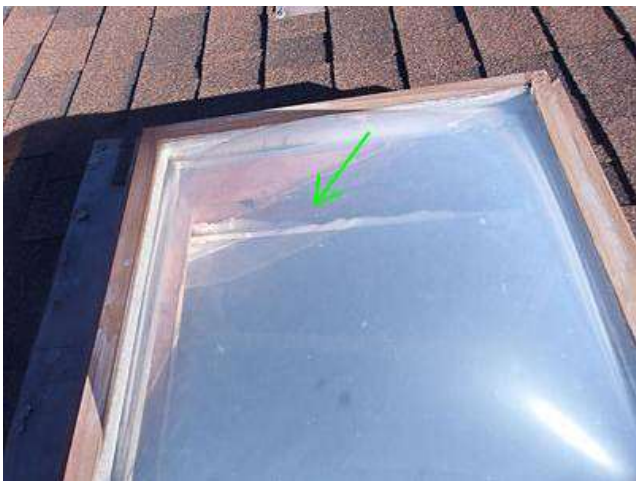
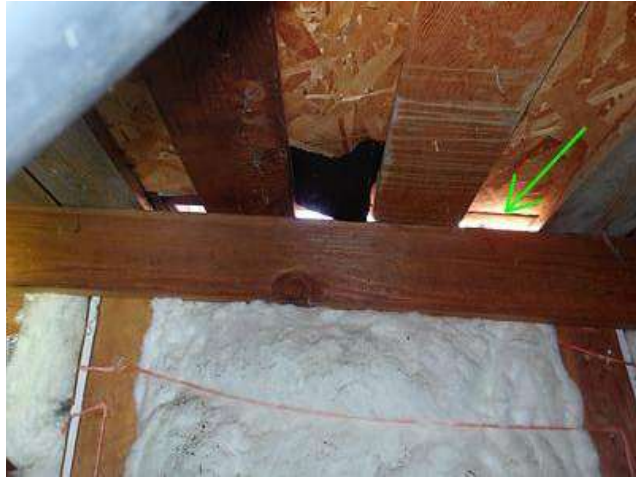
One or more skylights have been installed with substandard or non standard construction methods. A qualified contractor should evaluate and repair as necessary, and as per standard building practices.

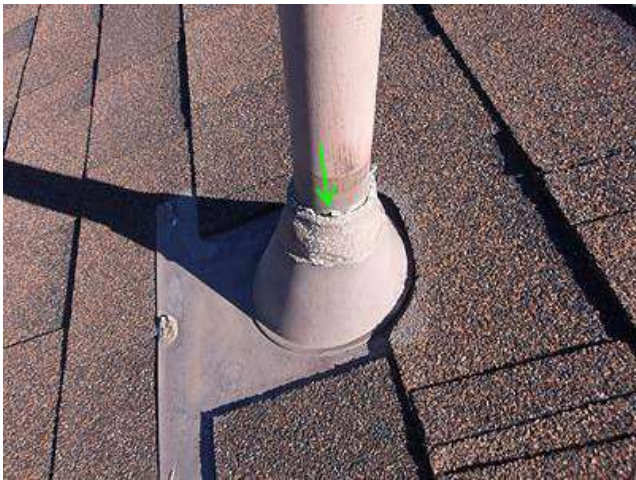
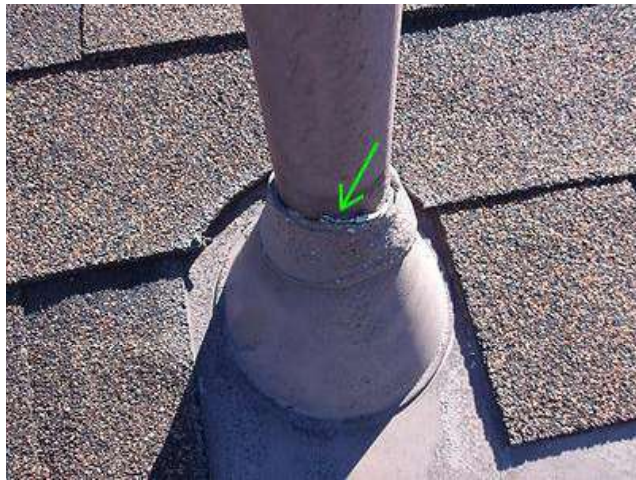
23) 🛠️🔍💧 Some roof flashings were deteriorated. Leaks may occur as a result. A qualified contractor should evaluate and repair as necessary.

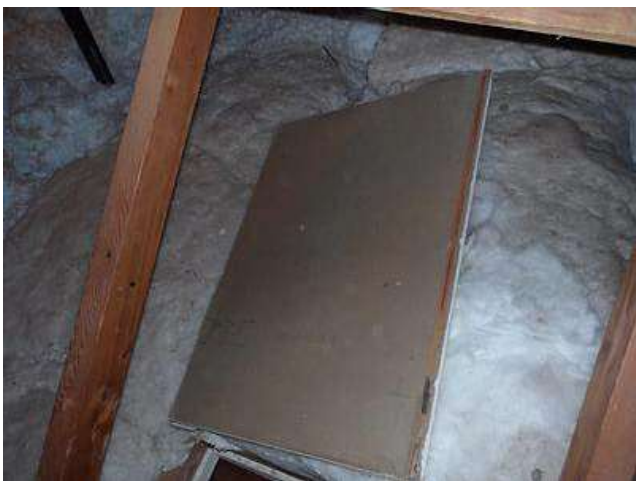
Photo 24-1 Attic hatch

24) 🛠️🏠 No insulation was installed at the attic access hatch. Recommend installing insulation at hatch for better energy efficiency. For more information, visit:

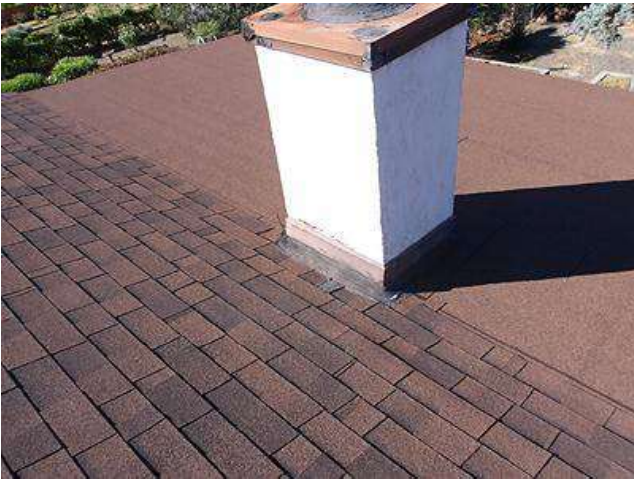
Photo 26-1 Chimney

One or more roof surface sections were designed so as to be much more likely to accumulate debris and snow. This includes the following: slope descends to vertical wall. Leaks may occur as a result. The client should monitor such areas for accumulated debris in the future and clean as necessary.

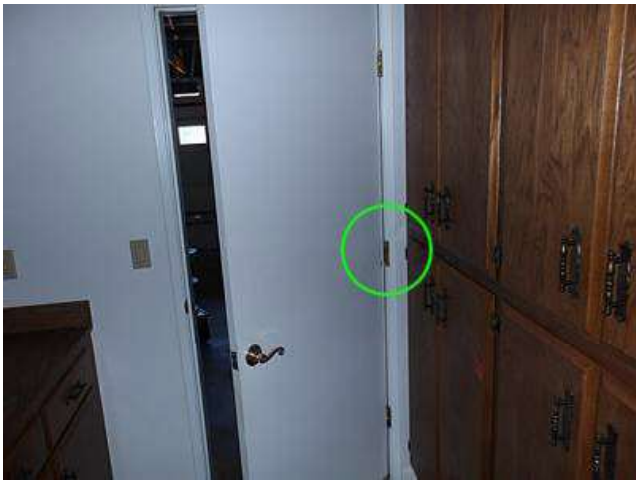
Photo 29-1 Garage-dwelling door

The self-closing device on the garage-dwelling door is missing. This door is intended to prevent vehicle fumes from entering living spaces and to slow the spread of fire from the garage to living spaces. A qualified person should evaluate and make repairs as necessary.

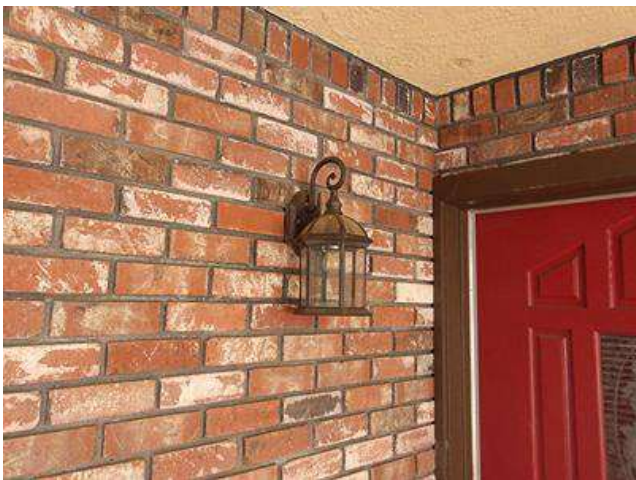
Photo 34-1 Front entry

Some light fixtures were missing, deteriorated and/or loose. A qualified person should evaluate and repair or replace as necessary.

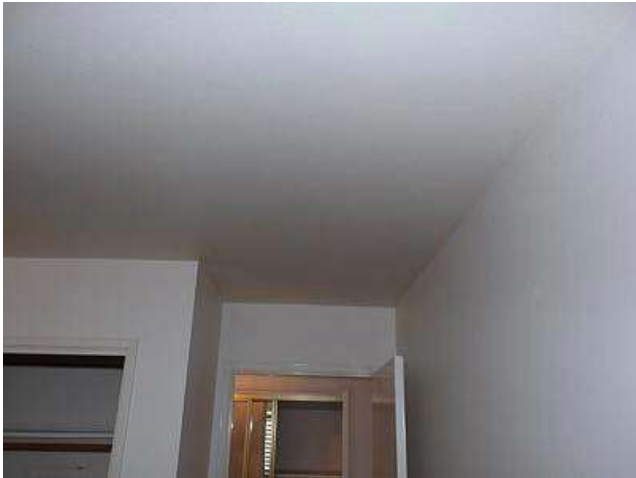
Photo 35-1 SE bedroom

Smoke detectors were missing from bedrooms and/or on one or more levels. Additional smoke detectors should be installed as necessary so a functioning one exists in each hallway leading to bedrooms, in each bedroom, and one each level of the building. For more information, visit <http://www.cpsc.gov/cpsc/pub/pubs/5077.html>

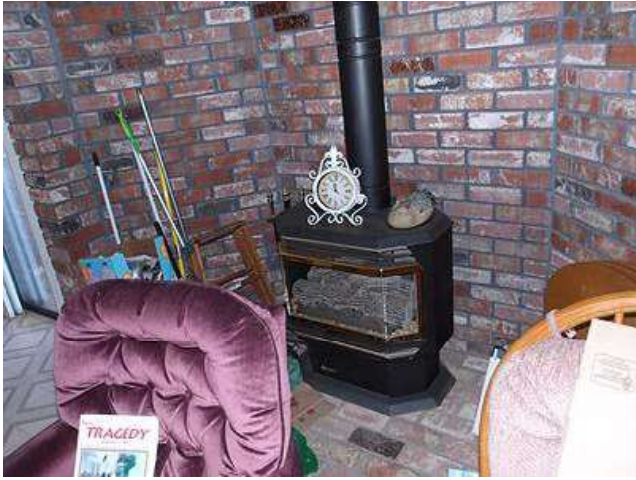
Photo 36-1 Gas stove

This property had one or more fuel burning appliances and/or an attached garage, and no carbon monoxide detectors were visible. This is a safety hazard. Recommend installing one or more carbon monoxide detectors as necessary and as per the manufacturer's instructions. For more information, visit <http://www.cpsc.gov/CPSC/PUB/PREREL/prhtml05/05017.html>

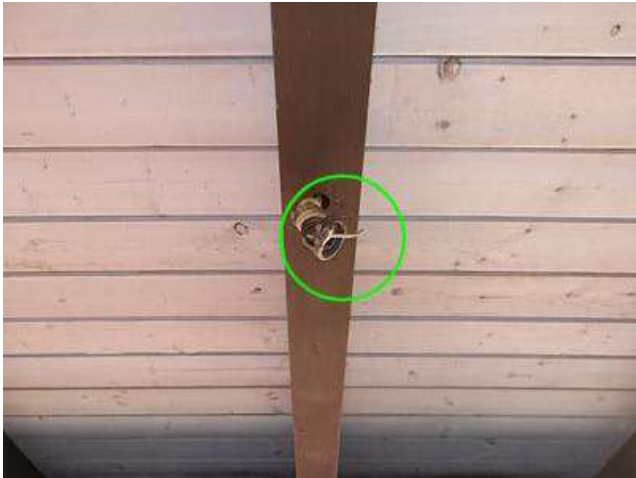
Photo 37-1 Deck outside master bedroom

One or more sections of wiring that weren't terminated were found. This is a potential safety hazard due to the risk of shock. A qualified electrician should evaluate and repair as necessary. For example, cutting the wire to length and terminating the wire with wire nuts in a securely anchored, covered, properly sized junction box.

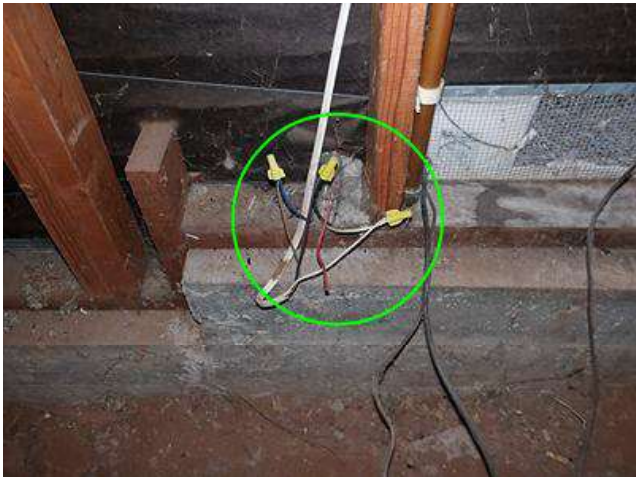
Photo 38-1 Crawl space West side

Wire splices were exposed due to not being contained in a covered junction box. This is a safety hazard due to the risk of shock and fire. A qualified electrician should evaluate and make repairs as necessary. For example, install securely mounted junction boxes with cover plates where needed to contain wiring splices.

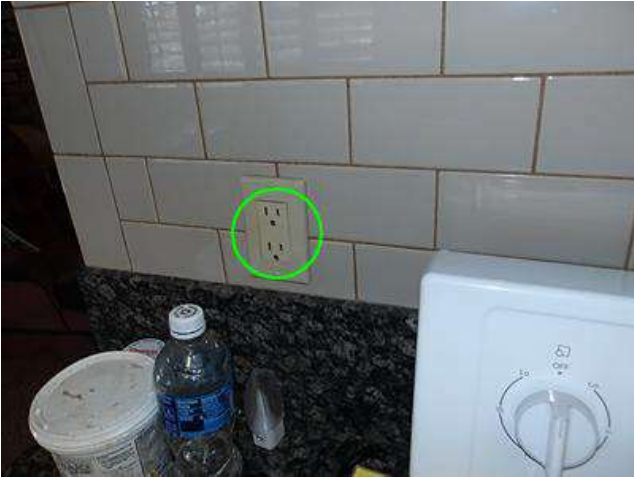
Photo 39-1 Kitchen

39) 🛠️ 🔍 One or more electric receptacles and/or the boxes they are installed in were loose and/or not securely anchored. Wire conductors may be damaged due to repeated movement and/or tension on wires, or insulation may be damaged. This is a safety hazard due to the risk of shock and fire. A qualified electrician should evaluate and repair as necessary.

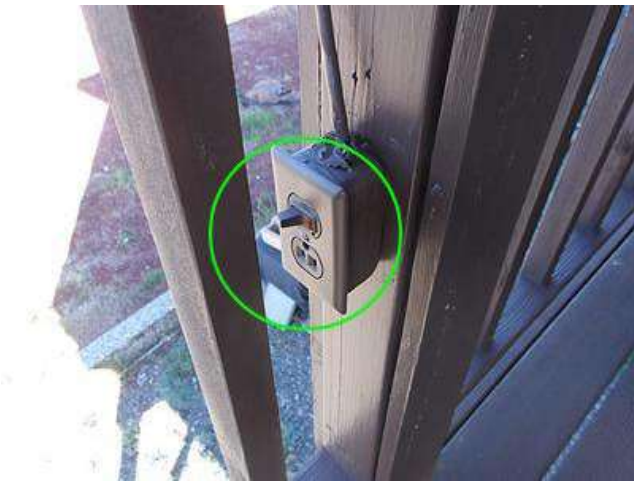
Photo 40-1 Deck rail

40) 🛠️ 🔍 One or more cover plates used at the building exterior were not rated for exterior use. This is a potential safety hazard for fire or shock. A qualified electrician should evaluate and repair as necessary.

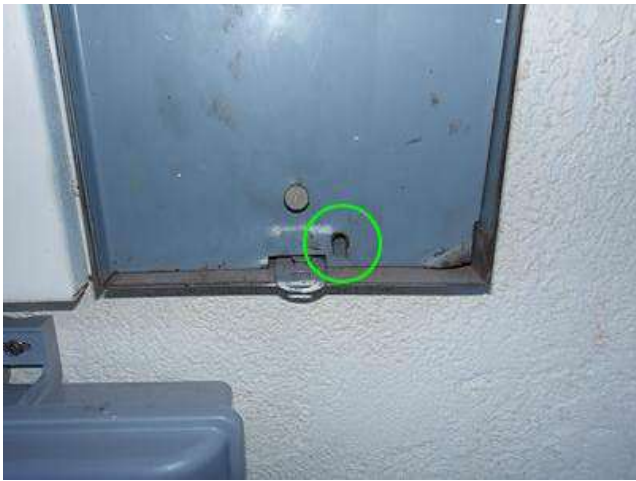
Photo 41-1 Main panel

41) 🛠️ 🔍 One or more screws were missing from the dead front to panel #A and should be replaced. Because energized wiring may exist behind the holes with the missing screws, recommend that a qualified, licensed electrician replace these screws, or that care be taken to ensure that the new screws do not come in contact with wiring inside the panel when they are installed. Stock screws from the panel manufacturer should be used, or their equivalent.

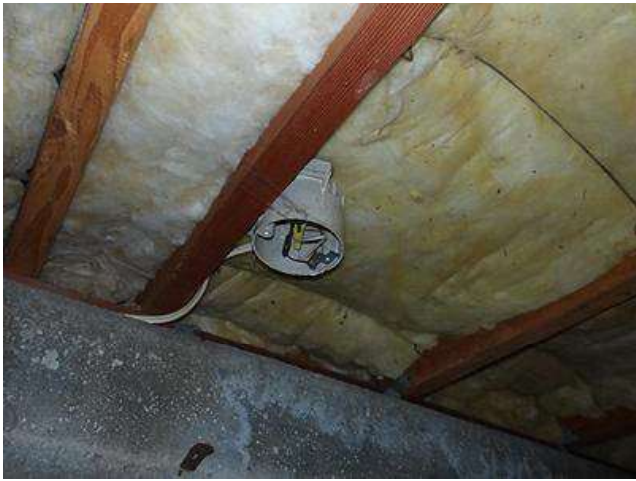
Photo 42-1 Crawl space

Some cover plates on junction boxes were missing. They are intended to contain fire and prevent electric shock from exposed wires. This is a safety hazard due to the risk of fire and shock. A qualified person should repair as necessary.

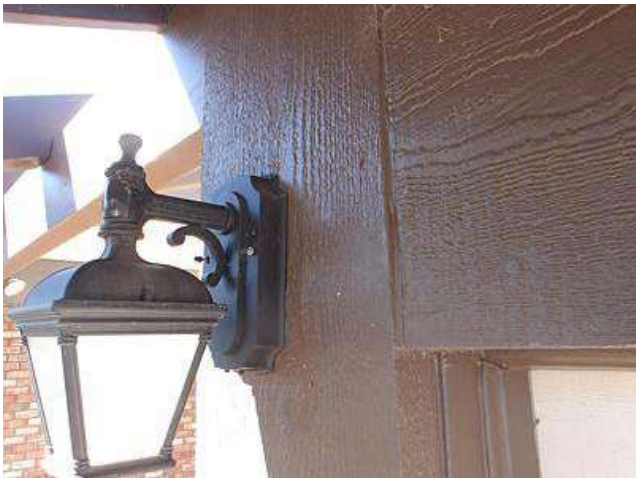
Photo 43-1 SE corner garage

One or more wall-mounted exterior light fixtures had wiring that's subject to water intrusion due to caulk not being installed around the light fixture's back plate. Caulk should be applied around the perimeter of back plates where missing. A gap should be left at the bottom for condensation to drain out.

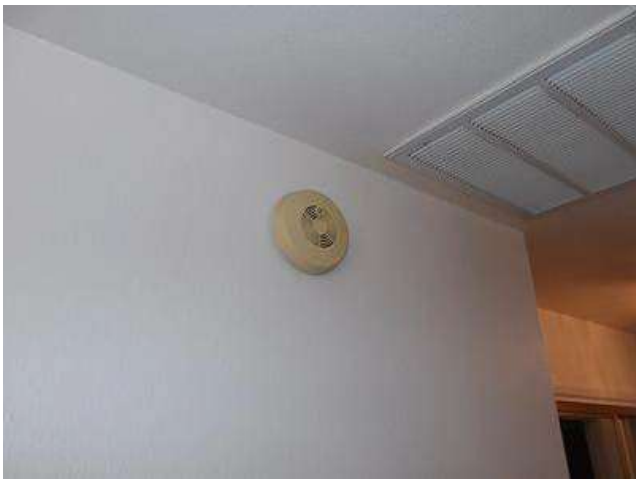
Photo 44-1 Hall entry

Based on the age of this structure and the appearance of existing smoke alarms, the alarms may be older than 10 years old. According to [National Fire Protection Association](#), aging smoke alarms don't operate as efficiently and often are the source for nuisance alarms. Older smoke alarms are estimated to have a 30% probability of failure within the first 10 years. Newer smoke alarms do better, but should be replaced after 10 years. Unless you know that the smoke alarms are new, replacing them when moving into a new residence is also recommended by NFPA. For more information, visit this article: [NFPA urges replacing home smoke alarms after 10 years](#).

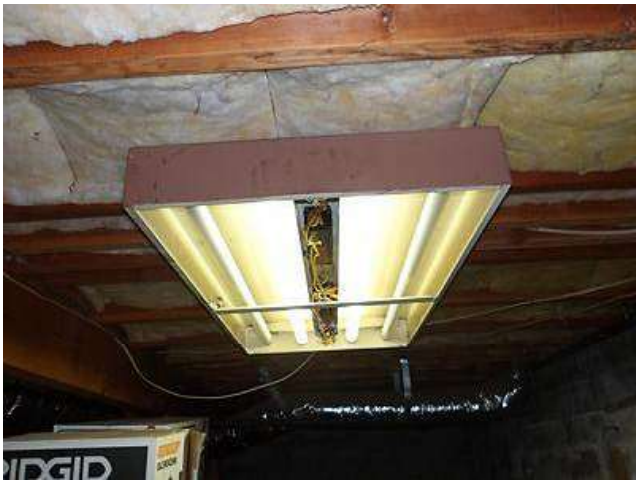
Photo 45-1 Crawl space

One or more lamp covers were missing and should be replaced as necessary.

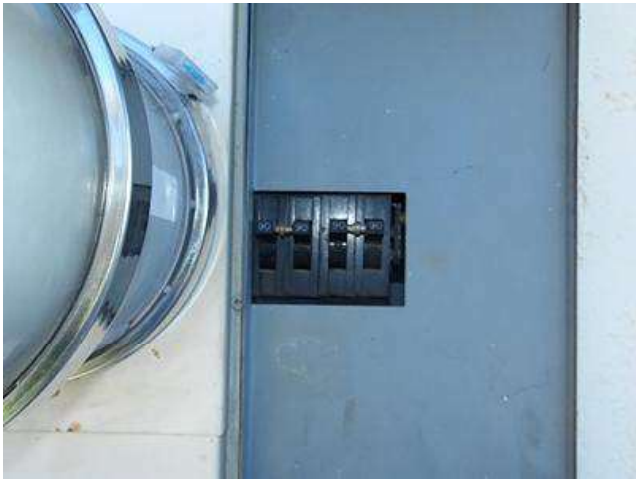
Photo 46-1 Main panel

The legend for overcurrent protection devices (breakers or fuses) in panel #A and C was missing and/or substandard. Recommend installing, updating or correcting the legend as necessary so it's accurate. Evaluation by a qualified electrician may be necessary.

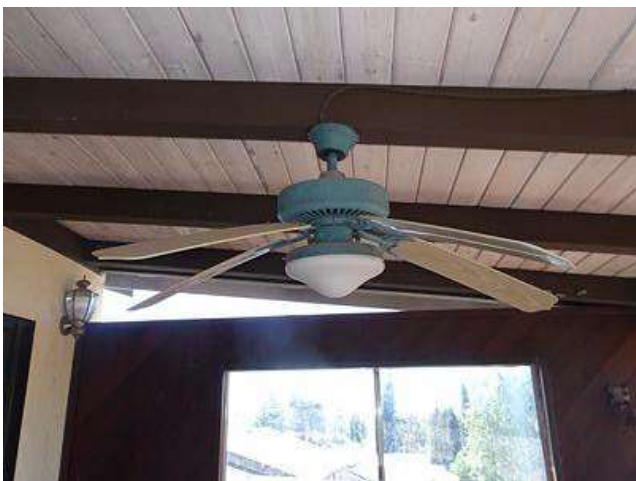
Photo 47-1 Deck

Some light fixtures were inoperable. Recommend further evaluation by replacing bulb(s) and/or consulting with the property owner. Repairs or replacement of the light fixture(s) by a qualified electrician may be necessary.

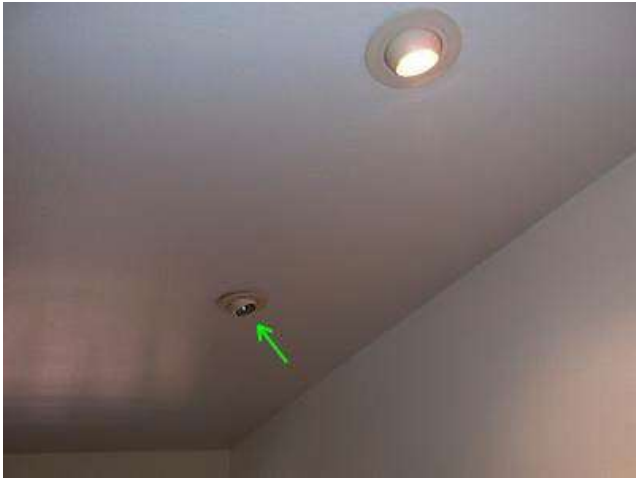
Photo 49-1 Family room

49) **i** Some bulbs in light fixtures were inoperable. As a result, some light fixtures couldn't be fully evaluated. Recommend replacing bulbs to fully evaluate fixtures where necessary.

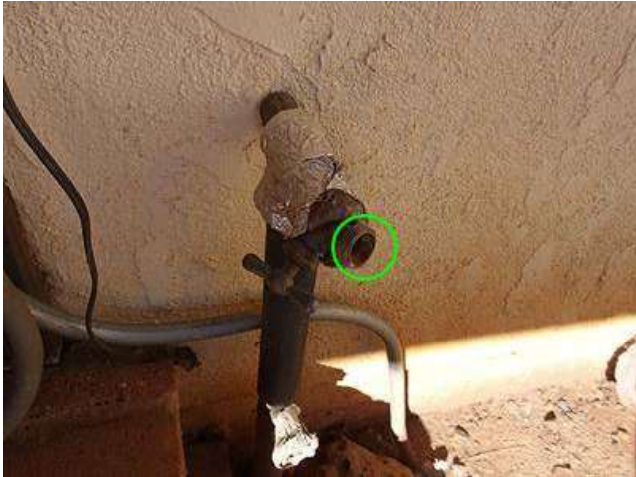
Photo 53-1 East side

One or more outside faucets were missing [backflow prevention devices](#). These devices reduce the likelihood of polluted or contaminated water entering the potable water supply. This condition can occur when an outside faucet is left in the "on" position with a hose connected and the sprayer head turned off. When pressure in the system fluctuates, water can be drawn back into the water supply pipes from the building. If a chemical sprayer is being used with the hose, those chemicals can enter the water supply pipes.

Client(s) may wish to consider installing backflow prevention devices on all exterior hose bibs where missing. They are available at most home improvement stores and are easily installed. For more information, visit: http://edis.ifas.ufl.edu/BODY_AE079

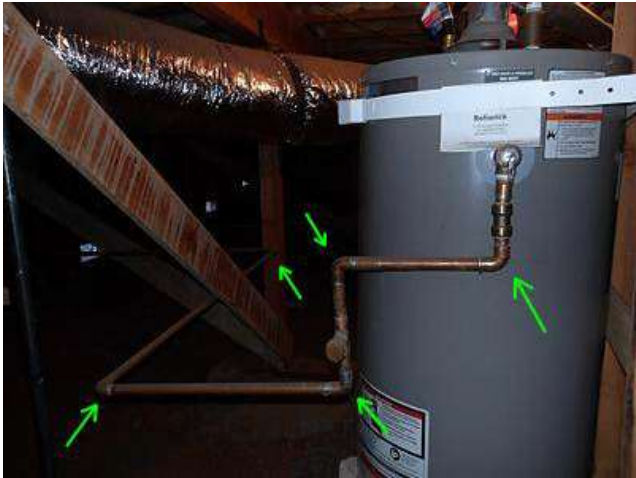
Photo 55-1 T&P drain line

The temperature/pressure relief valve drain line was longer than 15 feet and/or had more than 4 elbows. This is a potential safety hazard due to the risk of explosion from restricted flow. A qualified plumber should evaluate and repair as necessary so the drain line complies with the temperature-pressure relief valve manufacturer's installation instructions. For more information, visit: <https://www.reporhost.com/docs/TPvalve.pdf>

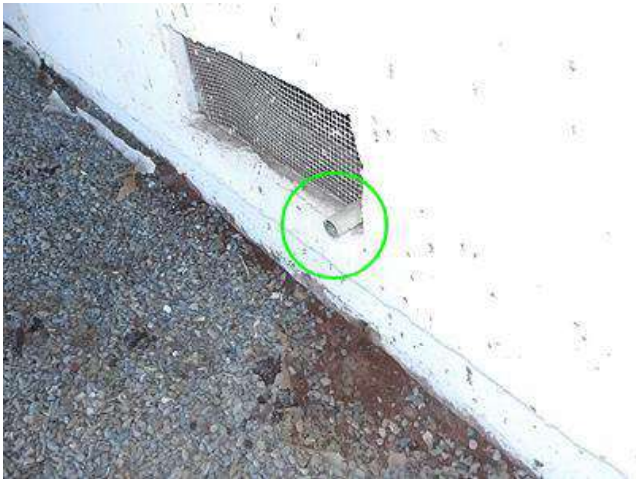
Photo 56-1 T&P drain line termination

Temperature-pressure relief valve drain line was too short. This is a potential safety hazard due to the risk of scalding if someone is standing next to the drain line when the valve opens. A qualified plumber should extend the drain line to 6 inches from, and directed at, the ground.

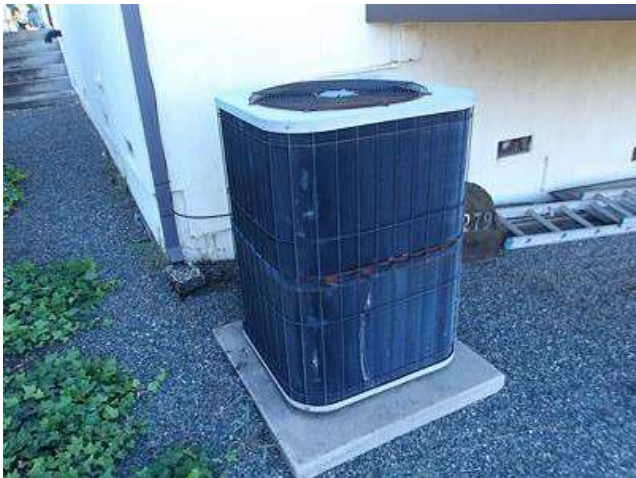
Photo 62-1 AC condenser

The estimated useful life for most cooling systems and heat pumps is 10 to 15 years. This system appears to be beyond this age and may need replacing or significant repairs at any time.

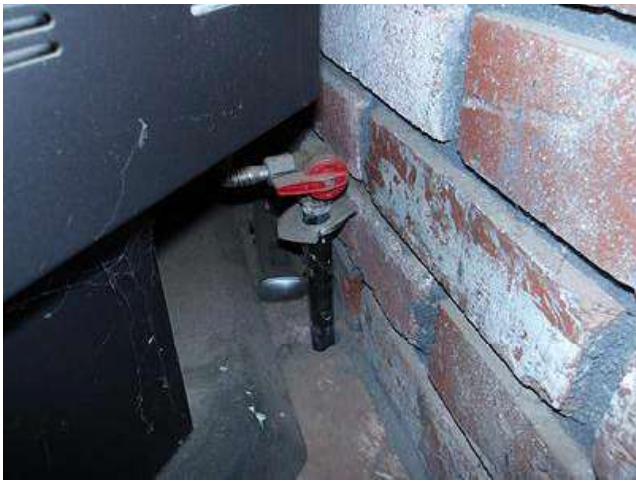
The gas stove at location #A was not fully evaluated because of the following conditions: pilot light turned off. As per the Standards of Practice for both the [National Association of Certified Home Inspectors \(NACHI\)](#) and the [American Society of Home Inspectors \(ASHI\)](#) the inspector does not operate gas shut off valves or light pilot lights during inspections.

Photo 63-1 Gas off (?)

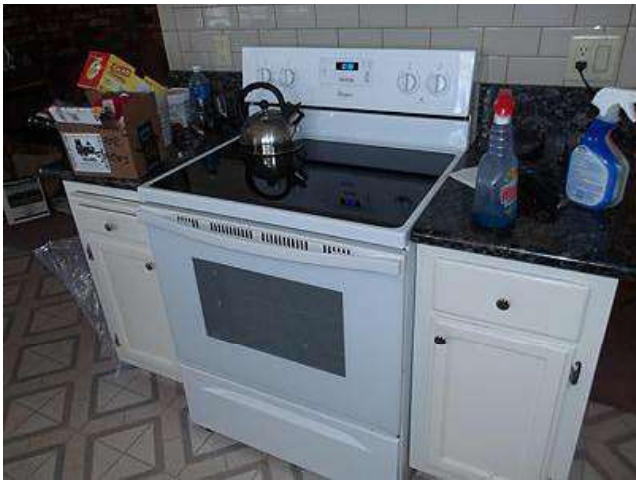
Photo 64-1

64) 🚧🔧 The range can tip forward, and no anti-tip bracket appeared to be installed. This is a safety hazard since the range may tip forward when weight is applied to the open door, such as when a small child climbs on it, or if heavy objects are dropped on it. Anti-tip brackets have been sold with all free standing ranges since 1985. An anti-tip bracket should be installed to eliminate this safety hazard. For more information, visit http://www.hgtv.com/hgtv/remodeling/article/0,1797,HGTV_3659_2017492,00.html

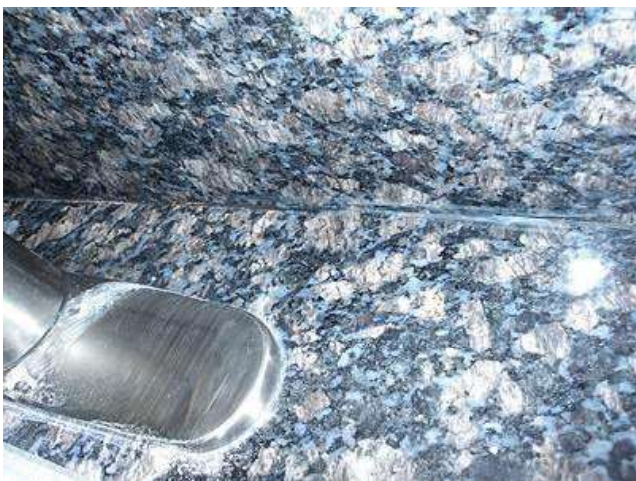
Photo 66-1

Caulk was deteriorated where counters meet backsplashes. A qualified person should repair as necessary.

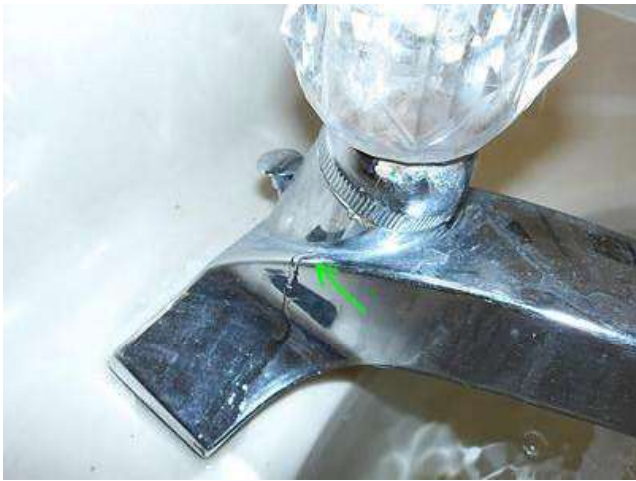
Photo 69-1 Hall bathroom

Leaking or dripping was found at the sink supply valves at location #A. A qualified plumber should evaluate and repair as necessary.

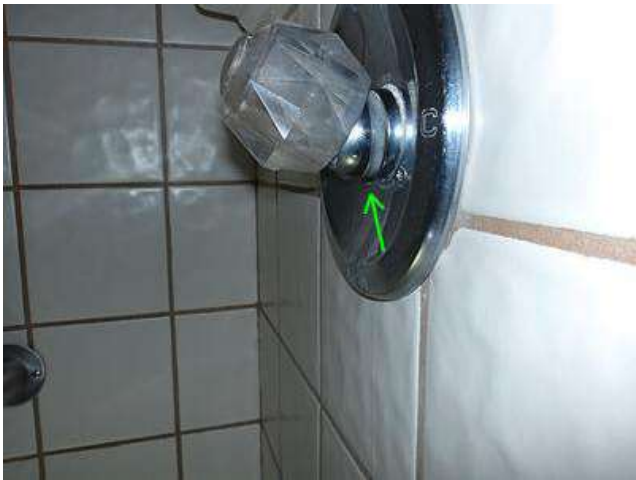
Photo 70-1 Master bathroom

Leaking or dripping was found at the shower supply valves at location #B. A qualified plumber should evaluate and repair as necessary.

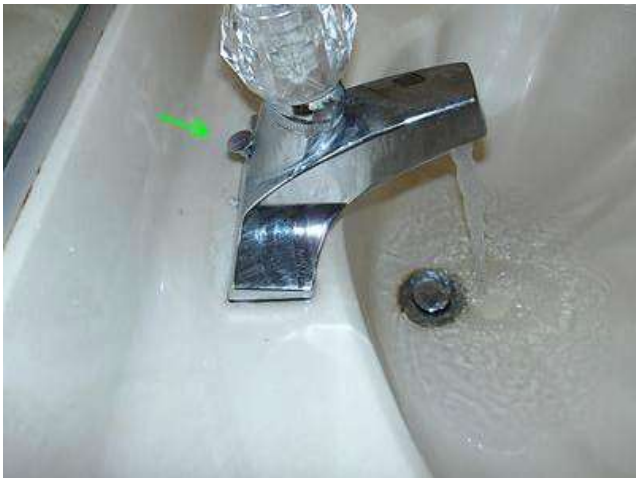
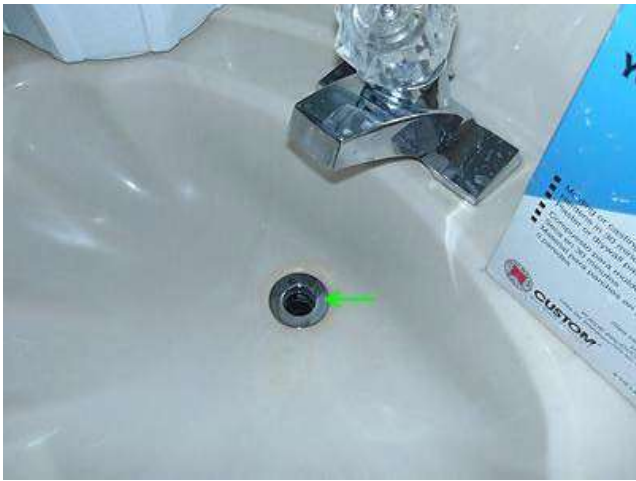
The sink drain stopper mechanism at location #A and B was missing and/or inoperable. A qualified person should repair or replace as necessary.

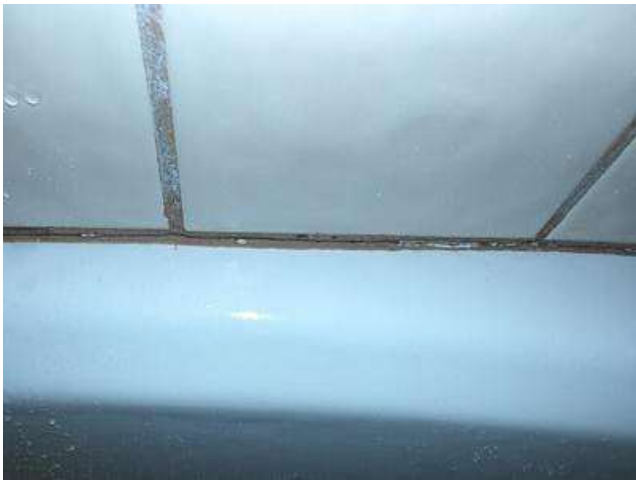
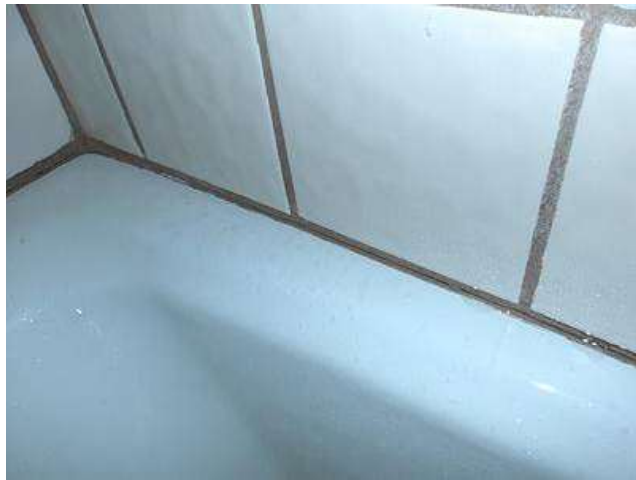
72) 🛠️💧 Grout was deteriorated by the wall at the bathtub at location #A. A qualified person should repair as necessary.

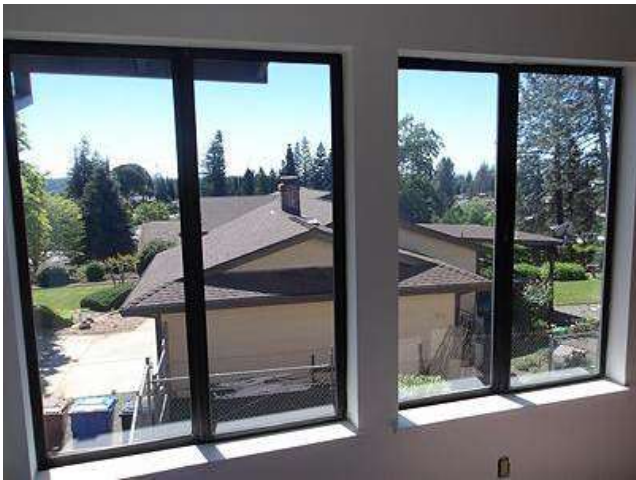
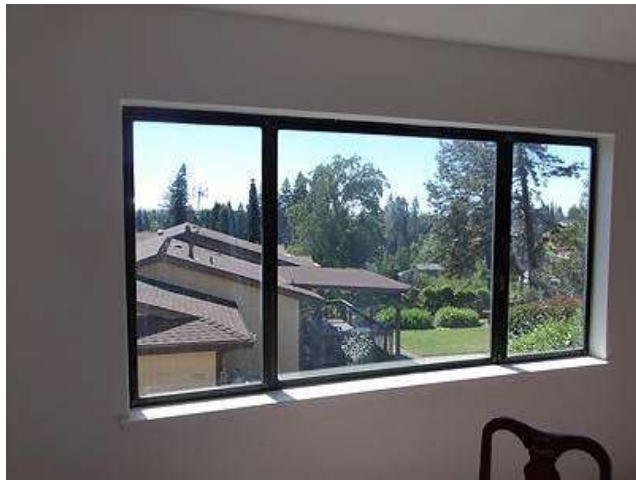
79) **i** Screens in some windows were missing.
