Professional
Inspection Network

INSPECTION REPORT
3616 N Bellflower Blvd
Long Beach CA 90808

INSPECTED BY
Christopher Vella
Professional
Inspection
Network

INSPECTION DATE
📅 4/24/2026
🕒 03:30 PM

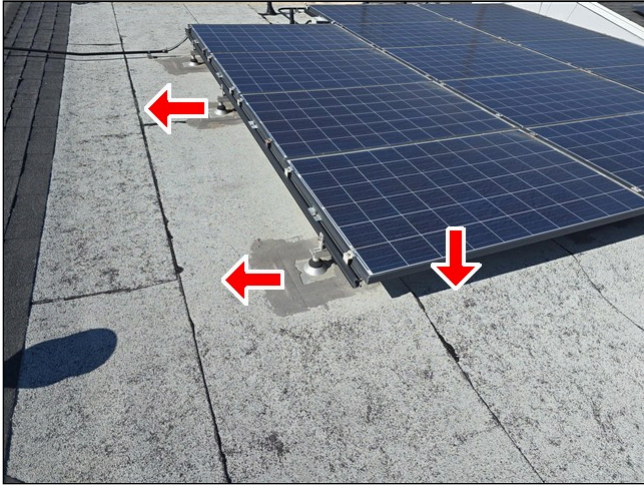
Item 1 - Item 1 (Picture)

- 1. (1) Repair or Replace:** The rolled asphalt roofing at the flat roof areas shows visible signs of deterioration. The roofing material appears worn and weathered, indicating reduced effectiveness in protecting against water intrusion. Deteriorated rolled roofing is more susceptible to cracking, blistering, and leaks over time. Evaluation and replacement by a qualified roofing contractor is recommended to restore a watertight condition.

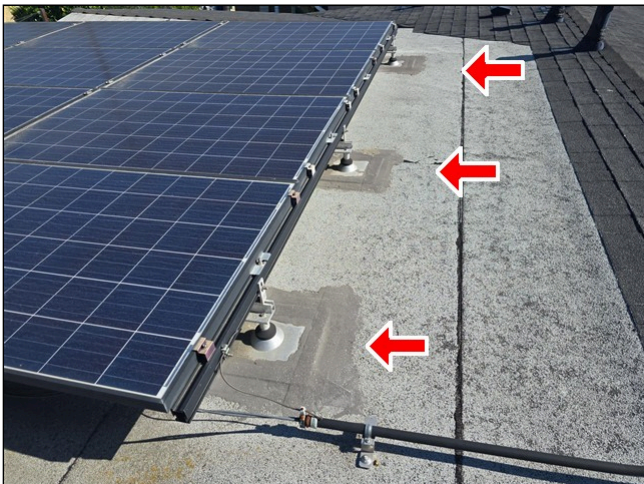
Item 2 - Item 1 (Picture)

2. Repair or Replace: The support posts for the solar panels at the flat roof have flashing that is surface-mounted. This type of installation is considered non-conforming, as proper flashing for roof penetrations should be integrated into the roofing system to ensure a watertight seal. Surface-mounted flashing is prone to failure and can allow water intrusion at the penetration points. Evaluation and correction by a qualified roofing contractor is recommended to properly flash and seal these penetrations and prevent potential leaks.

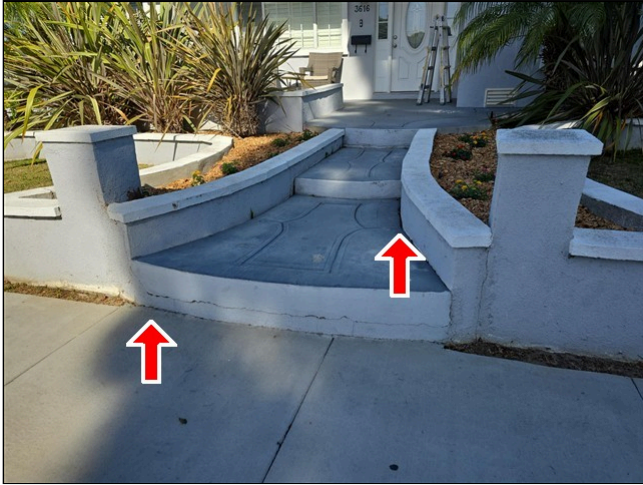
Item 3 - Item 1 (Picture)

3. (1) **Safety Issue:** The steps located at the front entry are of a non-conforming configuration. The step geometry appears inconsistent and may not meet typical standards for uniform riser height and tread depth. This condition poses a safety hazard due to the increased risk of misstep and potential fall. Evaluation and correction by a qualified contractor is recommended to improve safety and achieve a more compliant configuration.

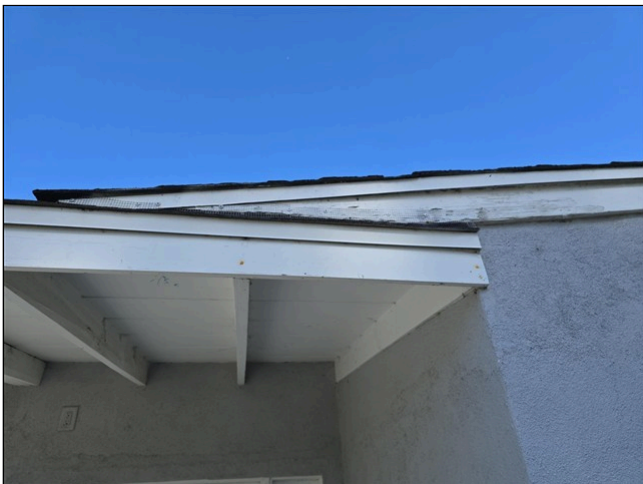
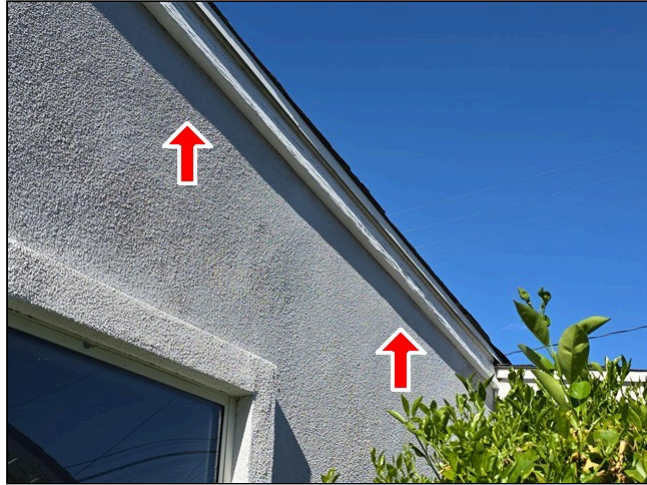
Item 4 - Item 1 (Picture)

4. (2) **Repair or Replace:** There is wood deterioration observed at the fascia boards in one or more locations. This deterioration can be caused by various factors such as moisture, pests, or age-related wear and tear. It is important to address this issue to prevent further damage. Due to the presence of wood deterioration, it is advisable to have a pest control company inspect the area for any signs of pest activity or infestation. Certain pests can cause significant damage to wood structures. A professional inspection will help determine if pests are present and if further treatment is necessary. It is recommended to hire a licensed contractor experienced in wood repairs and replacements. They will assess the extent of the wood deterioration and provide appropriate recommendations. Depending on the severity of the damage, the contractor may suggest repair techniques such as wood patching, reinforcement, or complete replacement of deteriorated wood components. Please be aware that this report is based on a visual inspection, and it is essential to consult a qualified professional, such as a licensed contractor and a pest control company, for a comprehensive assessment and appropriate repairs.

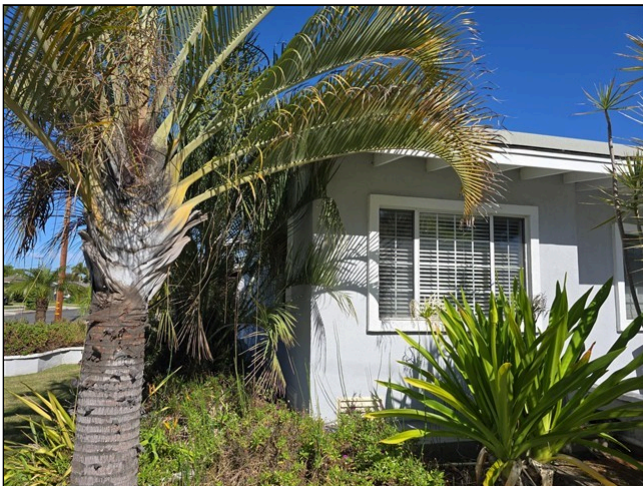
Item 5 - Item 1 (Picture)

5. (3) **Improve:** Trees, vegetation, and vines that are in contact with or in close proximity to the home should be removed or trimmed back to a safe distance. This is a crucial maintenance step to protect the structural integrity and safety of the home. Vegetation in direct contact with the house can lead to several issues. Trees and plants can retain moisture against the surfaces of the home, potentially leading to wood rot, mold growth, and deterioration of siding materials. Growing vines or large tree branches can exert physical force on siding, windows, and roofs, leading to damage over time. Vegetation close to the home can act as a bridge or attractant for pests, including insects and rodents, making it easier for them to access the house. Overgrown plants can obstruct pathways, windows, and potentially interfere with the home's ventilation systems. It is advisable to regularly inspect and maintain the landscaping around the home, ensuring that all trees, shrubs, and vines are kept at a safe distance. Professional landscaping services or an arborist can provide assistance in safely removing or trimming any problematic vegetation. Regular upkeep not only preserves the aesthetic appeal of the property but also plays a critical role in safeguarding the home against potential damage.

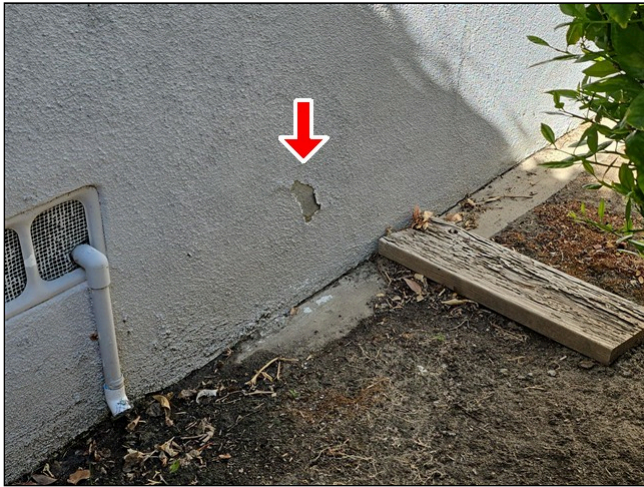
Item 6 - Item 1 (Picture)

6. (4) **Repair or Replace:** The stucco cladding at the exterior walls is deteriorated in one or more areas, which is common with older homes. Additionally, a weep screed flashing detail was not observed at the base of the wall. The absence of a proper weep screed can prevent moisture from draining out of the wall assembly, increasing the risk of water intrusion and deterioration of underlying materials. Evaluation and repair by a qualified contractor is recommended to address the damaged stucco and to verify proper installation of drainage components at the base of the wall system.

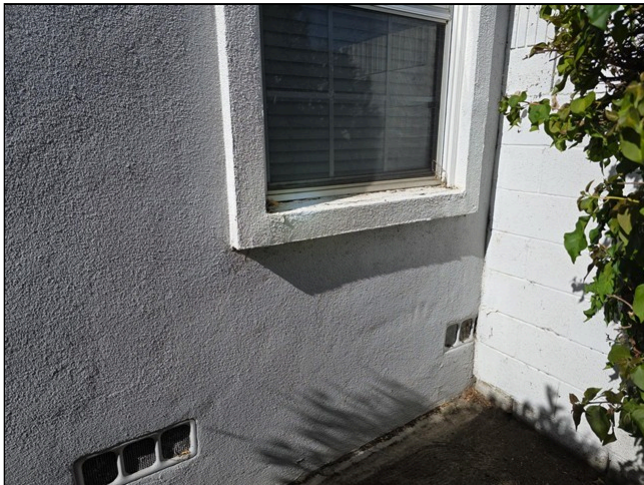
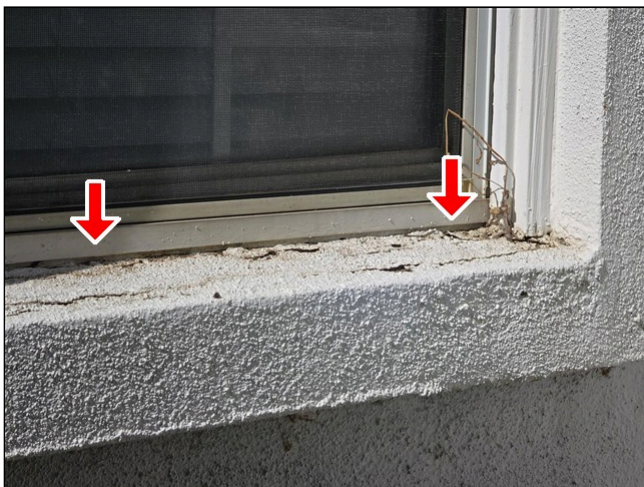
Item 7 - Item 1 (Picture)

7. (1) **Repair or Replace:** A gap was observed between the exterior cladding and the window frame at the south exterior wall of the home. This condition can allow water intrusion, air infiltration, and pest entry, potentially leading to concealed damage within the wall assembly. Evaluation and repair by a qualified contractor is recommended to properly seal the gap and restore a weather-resistant condition.

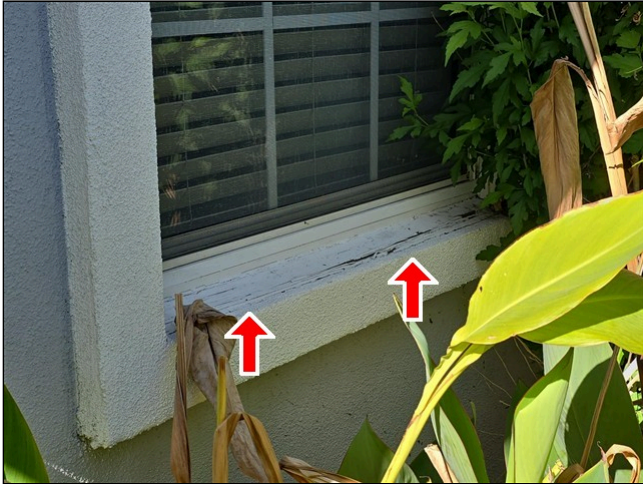
Item 8 - Item 1 (Picture)

8. (2) **Repair or Replace:** The stucco cladding and/or paint at the exterior window frames is cracked and separated in one or more areas. These openings can allow water intrusion around the window assemblies, potentially leading to deterioration of surrounding materials and concealed damage within the wall

system. Evaluation and repair by a qualified contractor is recommended to properly seal and restore the affected areas and maintain a weather-resistant exterior.

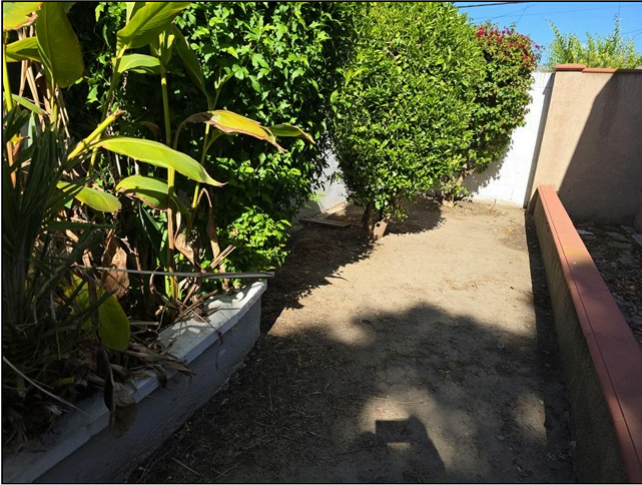
Item 10 - Item 1 (Picture)

- 10. (2) Improve:** There is a noticeable negative slope and several flat areas towards the home in various locations around the property. During periods of rain or extended irrigation, water tends to accumulate and pond near the foundation. This improper grading can contribute to various structural and moisture-related problems over time. Continuous water ponding near the foundation can lead to erosion and weakening of the foundation materials, potentially resulting in cracks and settling. It is advisable to engage a professional landscaping or civil engineering service to regrade the affected areas. The ground should be sloped away from the home at a minimum gradient (typically at least 5% or 6 inches drop over 10 feet) to ensure effective runoff away from the foundation.

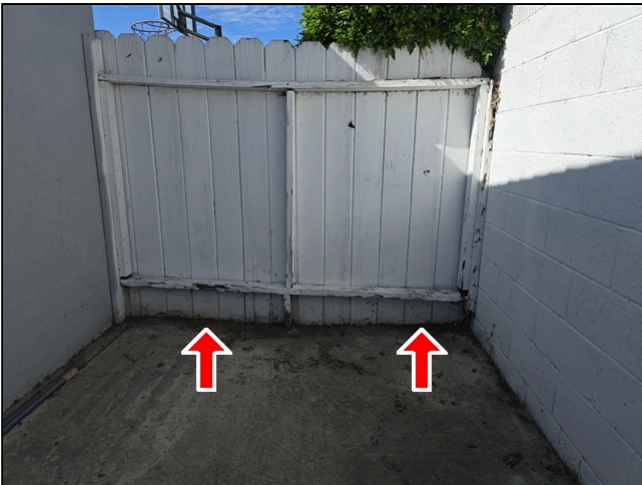
Item 11 - Item 1 (Picture)

- 11. Repair or Replace:** The fence at the sidewall of the garage is deteriorated. This condition may affect structural stability, reduce security, and allow for further damage over time. It is recommended that the fence be evaluated and repaired or replaced by a qualified contractor to restore proper function and durability.

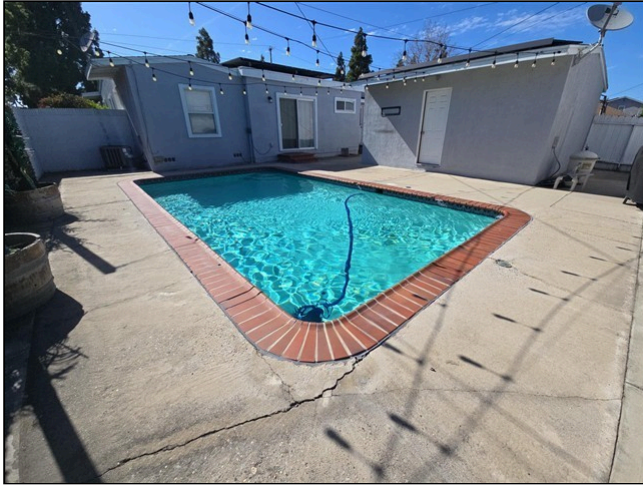
Item 12 - Item 1 (Picture)

- 12. (1) Safety Issue:** The swimming pool/spa is required by law to be equipped with at least two drowning prevention safety features. Acceptable options include: An enclosure that isolates the pool/spa from the home. Removable mesh fencing with a self-closing, self-latching, and lockable gate (ASTM F2286). An approved safety pool cover. Exit alarms on doors providing direct access to the pool/spa. Self-closing, self-latching devices on doors with release mechanisms at least 54 inches above the floor. A certified ASTM F2208 pool/spa alarm that sounds upon unauthorized or accidental entry. Other protective devices providing equal or greater protection, independently verified to ASTM or ASME standards. If the pool/spa is not currently equipped with at least two of these safety features, it is strongly recommended that upgrades be made by a qualified contractor to meet current safety requirements and reduce the risk of drowning accidents.

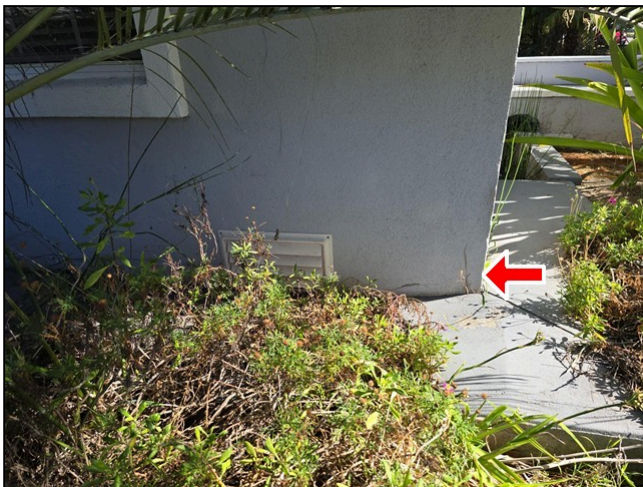
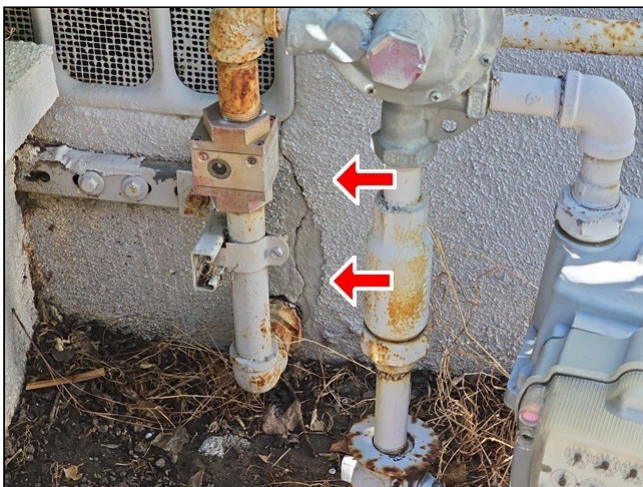
Item 13 - Item 1 (Picture)

- 13. (1) Repair or Replace:** Signs of cracking and movement were visible in portions of the foundation at more than one location. Although the cracking is isolated to these areas, we feel this could affect the performance of the entire foundation, especially during seismic activity. We suggest a qualified foundation contractor or structural engineer should evaluate the foundation, and determine what repairs are needed.

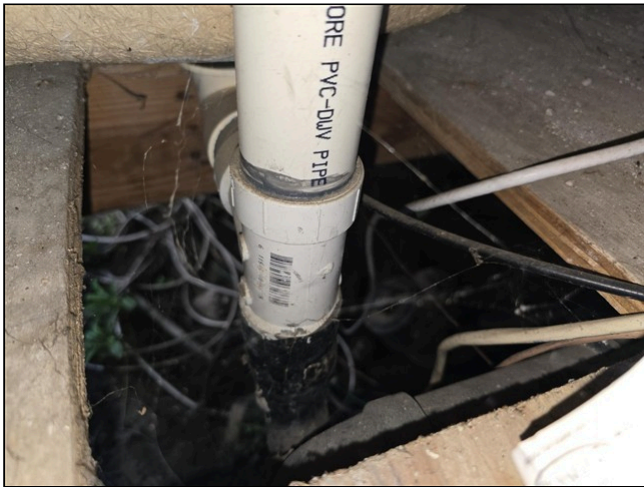
Item 14 - Item 1 (Picture)

- 14. (2) Improve:** The soil at the rear area of the crawl space is wet and/or damp. The source of the moisture could not be determined at the time of inspection and may be related to poor exterior drainage or a

possible active plumbing leak. Elevated moisture conditions in the crawl space can contribute to wood deterioration, potential structural concerns, and possible organic growth. Further evaluation is recommended to identify the source of moisture, and corrective measures by a qualified contractor should be taken to address the issue and dry the affected area.

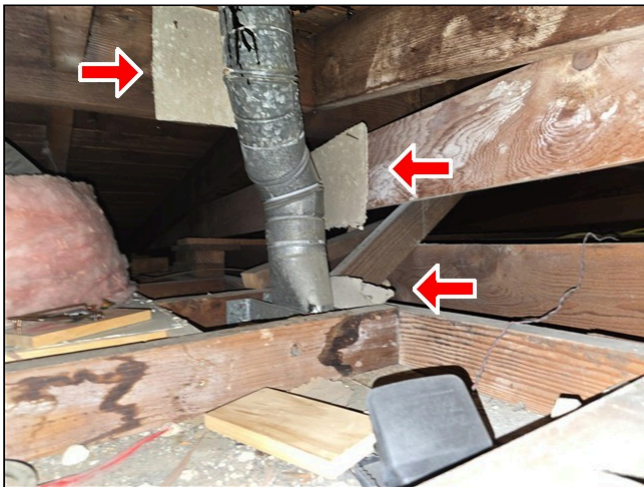
Item 16 - Item 1 (Picture)

- 16. Safety Issue:** Materials were observed within the home that may resemble asbestos-containing materials. Identification of asbestos cannot be confirmed through a visual inspection alone. If disturbed, asbestos-containing materials can pose potential health risks. It is recommended that a qualified asbestos specialist collect samples and perform laboratory testing to determine the presence of asbestos. If confirmed, appropriate handling, repair, or abatement should be conducted in accordance with applicable regulations.

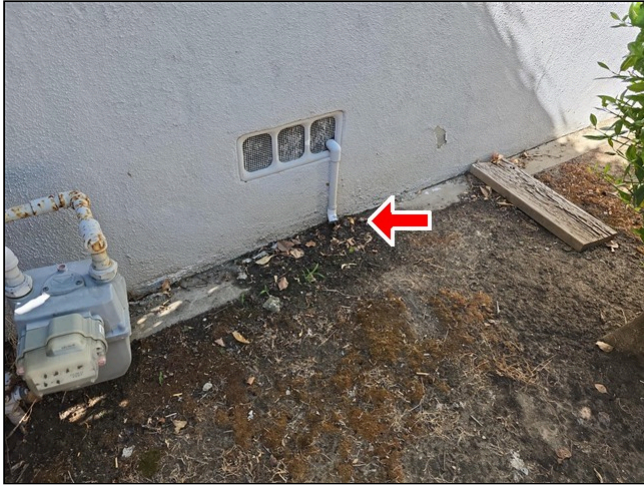
Item 17 - Item 1 (Picture)

- 17. (1) Improve:** The condensate drain line(s) for the indoor air component of the air conditioning system should be improved. It is suggested that the drain line terminate in a graveled area and or pit to prevent soil saturation when operating the system.

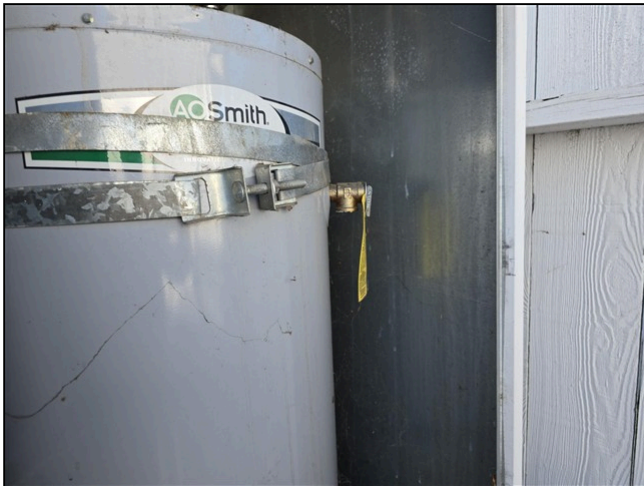
Item 18 - Item 1 (Picture)

- 18. (1) Safety Issue:** The water heater temperature and pressure relief (TPR) valve lacks a discharge pipe. This is a significant safety concern, as the TPR valve is designed to release hot water and pressure in the event of an overpressure condition. Without a proper discharge pipe, expelled water or steam can pose a risk of scalding and damage to surrounding areas. It is recommended that a properly installed discharge pipe be added by a qualified plumber, terminating in an appropriate location in accordance with accepted safety standards.

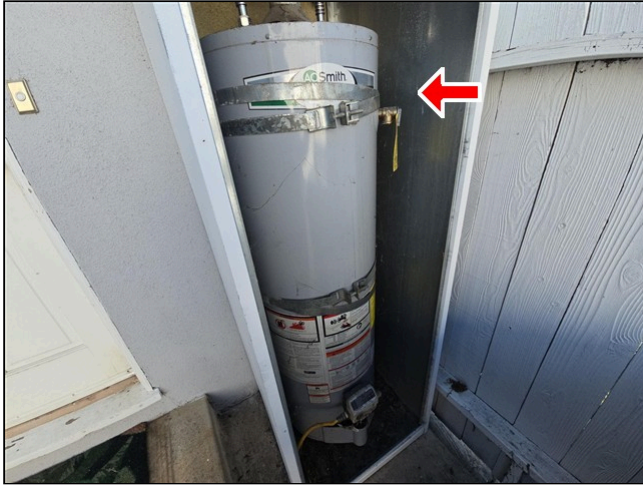
Item 19 - Item 1 (Picture)

- 19. (2) Repair or Replace:** The water heater top seismic strap was not installed in the correct location. The straps should be located within the top 1/3 of the water heater unit and one at the bottom 1/3. The bottom strap must be located at least 4" away from the water heater controls. Suggest conforming installation by a qualified plumber.

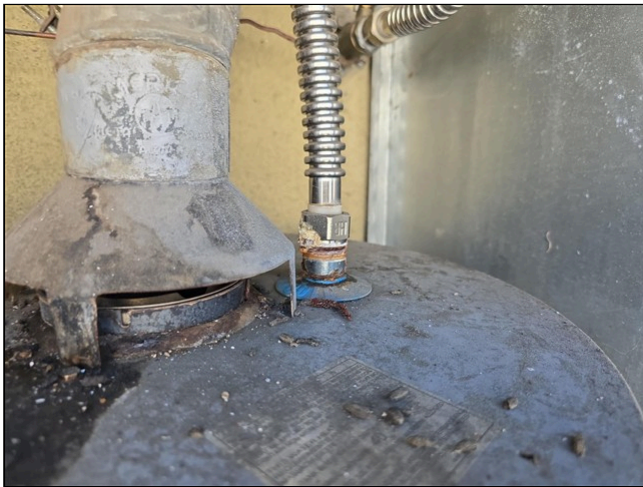
Item 20 - Item 1 (Picture)

- 20. (3) Repair or Replace:** The water heater water supply connections are corroded. Corrosion at these connections can lead to leaks, reduced flow, and potential failure of the fittings over time. It is recommended that a qualified plumber evaluate and replace the affected connections to prevent water damage and ensure proper operation.

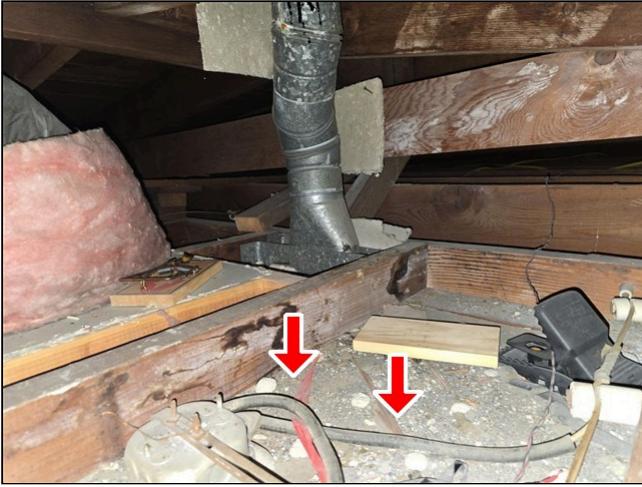
Item 21 - Item 1 (Picture)

- 21. (1) Safety Issue:** Older cloth-covered electrical wiring is visible in the attic space of the home. Cloth-covered wiring is indicative of aging electrical systems, typically installed in homes decades ago. This type of wiring can pose safety risks as the cloth insulation may degrade over time, leading to exposed wires and increased risk of electrical fires or short circuits. Additionally, such wiring may not meet current electrical codes and can have limitations in capacity that are unsuitable for modern electrical demands. A thorough evaluation by a licensed electrician is recommended to assess the condition of the cloth-covered wiring and determine if replacement or upgrading is necessary. It is advisable to consider rewiring areas with outdated or deteriorating materials to ensure electrical safety and compliance with modern standards. This will also help improve the home's overall electrical system performance and safety.

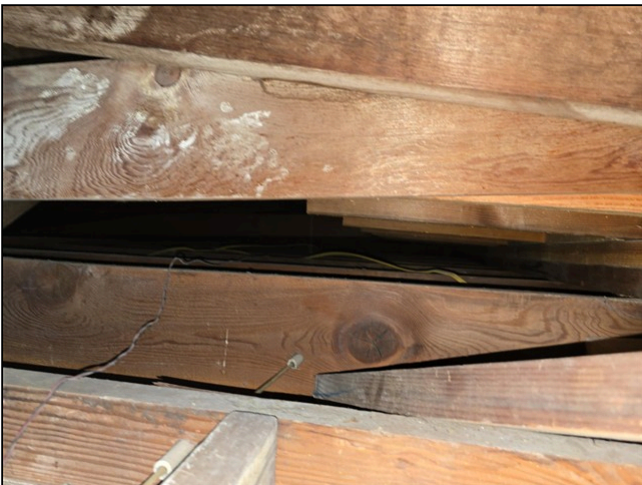
Item 22 - Item 3 (Picture)

- 22. (2) Monitor:** Older knob-and-tube wiring was observed in the attic space. Due to the presence of newer Romex wiring installed adjacent to the older conductors, it was not possible to determine whether the knob-and-tube system is still active or has been fully abandoned. Knob-and-tube wiring is considered obsolete and may present safety concerns, particularly if it remains energized or has been modified. Evaluation by a licensed electrician is recommended to determine if any of the knob-and-tube wiring is still in use and to advise on proper decommissioning or upgrading as needed.

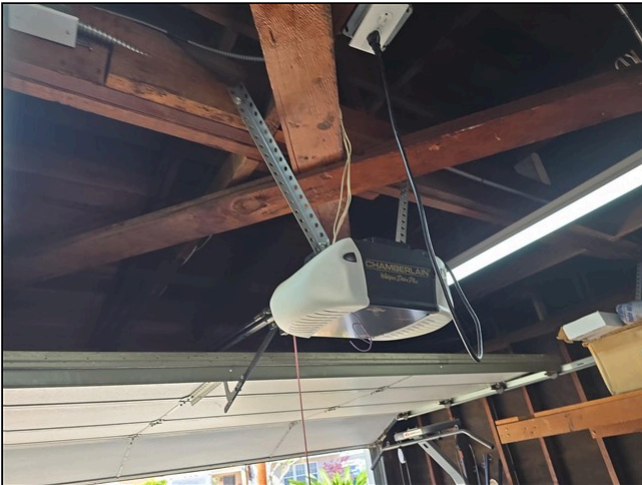
Item 24 - Item 1 (Picture)

- 24. Monitor:** The garage door and opener were functional and opened and closed the door. The light beams responded when tested and caused the door(s) to stop and auto reverse. Testing of the downward force (pressure test) was not performed as this can damage the door and is outside the scope of this inspection. Proper operation of the reversing mechanism should be verified prior to the close of the inspection contingency period. Information on garage door openers is available from the Consumer Product Safety Commission at www.cpsc.gov.

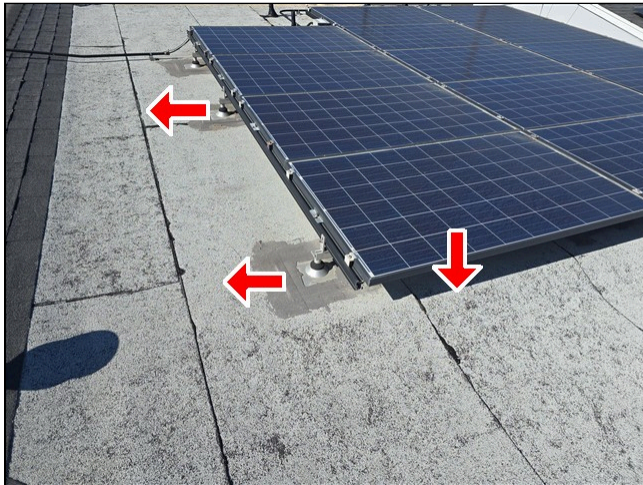
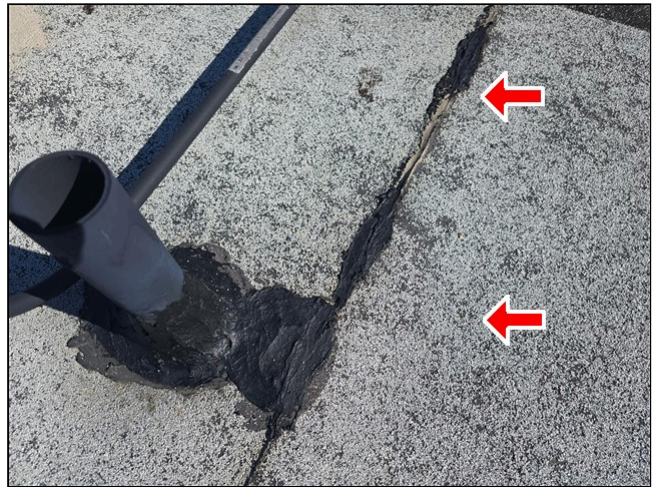
1.0 Item 1 (Picture)

(1) **Repair or Replace:** The rolled asphalt roofing at the flat roof areas shows visible signs of deterioration. The roofing material appears worn and weathered, indicating reduced effectiveness in protecting against water intrusion. Deteriorated rolled roofing is more susceptible to cracking, blistering, and leaks over time. Evaluation and replacement by a qualified roofing contractor is recommended to restore a watertight condition.

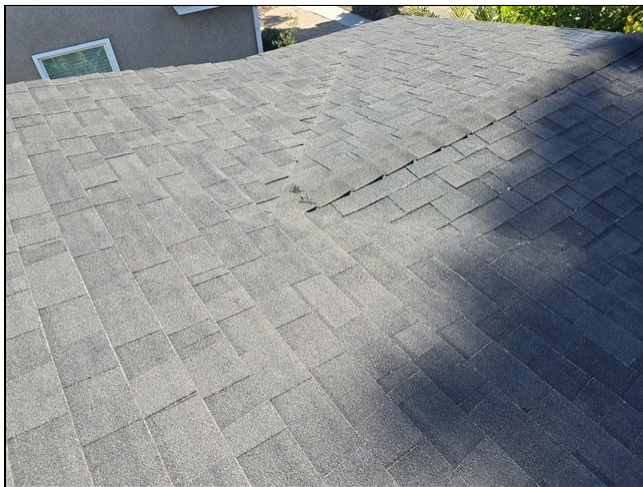
1.0 Item 5 (Picture)

(2) **Monitor:** During the home inspection, it was observed that the composition shingle roofing is currently in good condition. However, it is important to note that accurately determining the remaining serviceable lifespan of the roofing is challenging. To ensure the longevity and proper maintenance of the roof, periodic reviews by a licensed roof contractor are highly recommended. The composition shingle roofing of the property is currently in good condition, exhibiting no visible signs of significant damage or deterioration during the home inspection. However, it is important to note that accurately predicting the exact remaining serviceable lifespan of the roofing is difficult due to various factors such as weather conditions, installation quality, and maintenance history. As with any roof, it is advised to engage the services of a licensed roof contractor for periodic evaluations and necessary repairs. This proactive approach will help identify any potential issues or areas requiring attention and ensure the longevity and integrity of the roofing system.

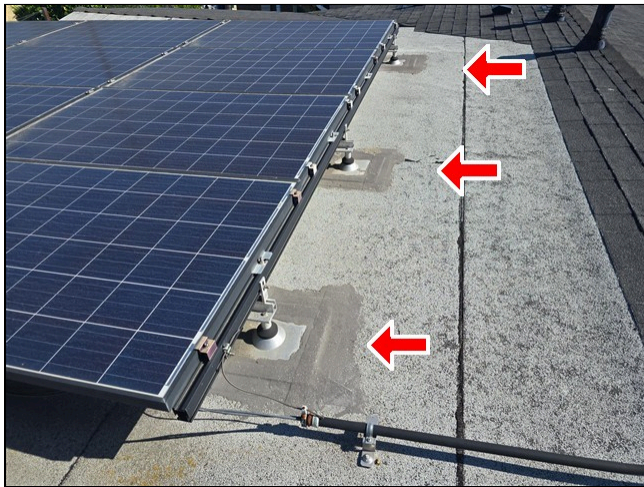
1.1 Item 1 (Picture)

Repair or Replace: The support posts for the solar panels at the flat roof have flashing that is surface-mounted. This type of installation is considered non-conforming, as proper flashing for roof penetrations should be integrated into the roofing system to ensure a watertight seal. Surface-mounted flashing is prone to failure and can allow water intrusion at the penetration points. Evaluation and correction by a qualified roofing contractor is recommended to properly flash and seal these penetrations and prevent potential leaks.

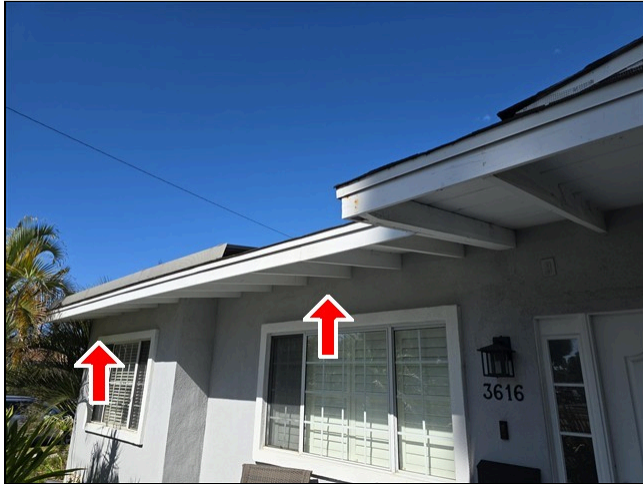
1.3 Item 1 (Picture)

in water cascading directly down the exterior walls during rainfall. This continuous exposure to moisture can lead to deterioration of siding materials, paint damage, and potential water intrusion into the building envelope. To address these concerns, it is recommended that gutters and downspouts be installed throughout the roof of the home. This will effectively collect rainwater and direct it away from critical areas, mitigating the risk of foundation damage, exterior wall deterioration, and landscape issues.

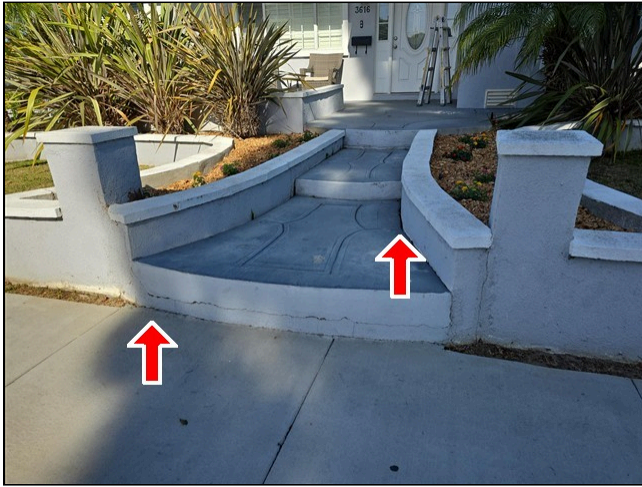
2.0 Item 1 (Picture)

(1) **Safety Issue:** The steps located at the front entry are of a non-conforming configuration. The step geometry appears inconsistent and may not meet typical standards for uniform riser height and tread depth. This condition poses a safety hazard due to the increased risk of misstep and potential fall. Evaluation and correction by a qualified contractor is recommended to improve safety and achieve a more compliant configuration.

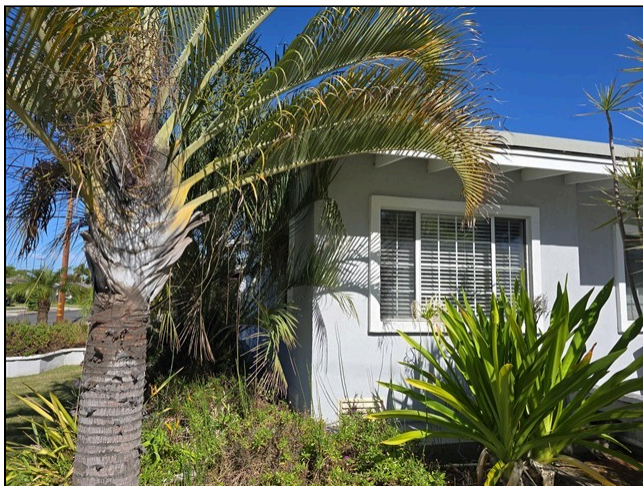
2.0 Item 6 (Picture)

(3) **Improve:** Trees, vegetation, and vines that are in contact with or in close proximity to the home should be removed or trimmed back to a safe distance. This is a crucial maintenance step to protect the structural integrity and safety of the home. Vegetation in direct contact with the house can lead to several issues. Trees and plants can retain moisture against the surfaces of the home, potentially leading to wood rot, mold growth, and deterioration of siding materials. Growing vines or large tree branches can exert physical force on siding, windows, and roofs, leading to damage over time. Vegetation close to the home can act as a bridge or attractant for pests, including insects and rodents, making it easier for them to access the house. Overgrown plants can obstruct pathways, windows, and potentially interfere with the home's ventilation systems. It is advisable to regularly inspect and maintain the landscaping around the home, ensuring that all trees, shrubs, and vines are kept at a safe distance. Professional landscaping services or an arborist can provide assistance in safely removing or trimming any problematic vegetation. Regular upkeep not only preserves the aesthetic appeal of the property but also plays a critical role in safeguarding the home against potential damage.

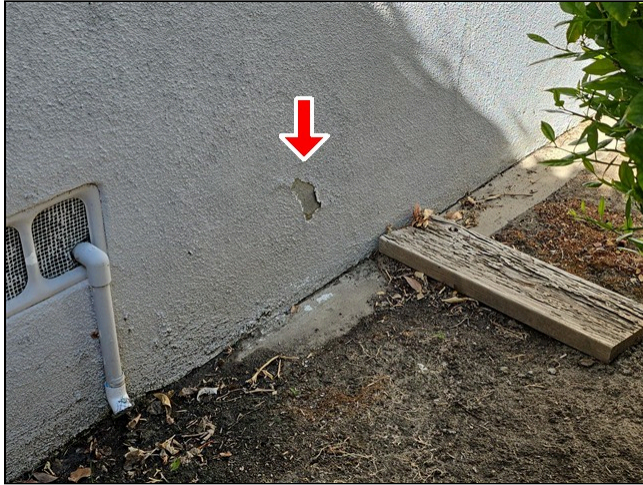
2.0 Item 7 (Picture)

from draining out of the wall assembly, increasing the risk of water intrusion and deterioration of underlying materials. Evaluation and repair by a qualified contractor is recommended to address the damaged stucco and to verify proper installation of drainage components at the base of the wall system.

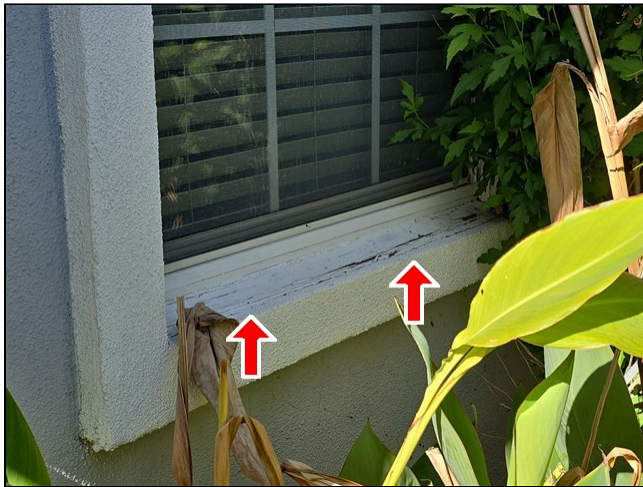
2.2 Item 4 (Picture)

(2) **Repair or Replace:** The stucco cladding and/or paint at the exterior window frames is cracked and separated in one or more areas. These openings can allow water intrusion around the window assemblies, potentially leading to deterioration of surrounding materials and concealed damage within the wall system. Evaluation and repair by a qualified contractor is recommended to properly seal and restore the affected areas and maintain a weather-resistant exterior.

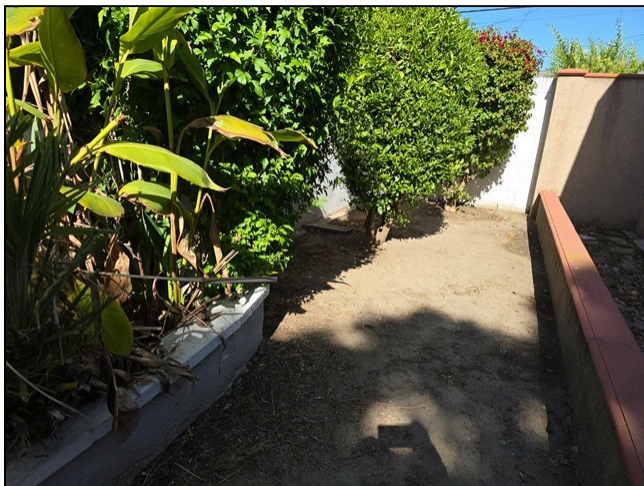
2.3 Item 8 (Picture)

(2) **Improve:** There is a noticeable negative slope and several flat areas towards the home in various locations around the property. During periods of rain or extended irrigation, water tends to accumulate and pond near the foundation. This improper grading can contribute to various structural and moisture-related problems over time. Continuous water ponding near the foundation can lead to erosion and weakening of the foundation materials, potentially resulting in cracks and settling. It is advisable to engage a professional landscaping or civil engineering service to regrade the affected areas. The ground should be sloped away from the home at a minimum gradient (typically at least 5% or 6 inches drop over 10 feet) to ensure effective runoff away from the foundation.

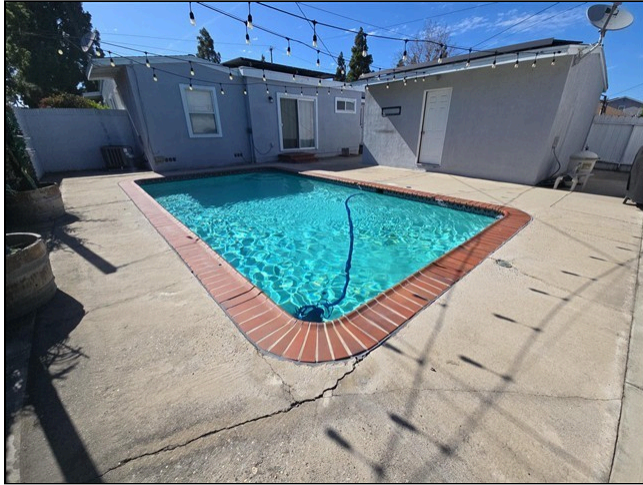
2.10 Item 1 (Picture)

accidental entry. Other protective devices providing equal or greater protection, independently verified to ASTM or ASME standards. If the pool/spa is not currently equipped with at least two of these safety features, it is strongly recommended that upgrades be made by a qualified contractor to meet current safety requirements and reduce the risk of drowning accidents.

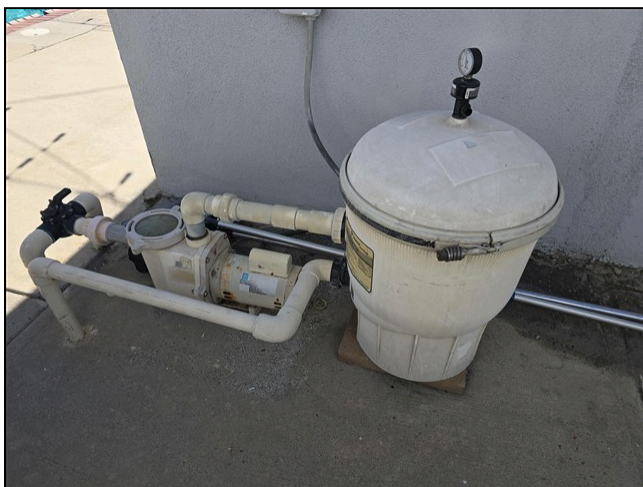
2.10 Item 2 (Picture)

(2) **Monitor:** The spa/pool and all associated components located at the rear of the property are beyond the scope of this inspection and were not inspected or tested. If the spa will remain in service, recommend further evaluation by a qualified spa/pool contractor. It should also be noted that spas in California are subject to specific safety requirements and guidelines, which may include (as applicable) compliant barriers and self-closing/self-latching gates, required safety covers, appropriate entrapment protection (e.g., compliant suction fittings/drain covers), and properly protected electrical systems (bonding/grounding and GFCI protection). Verify current compliance with the applicable authority having jurisdiction and make any necessary upgrades to reduce safety risks.

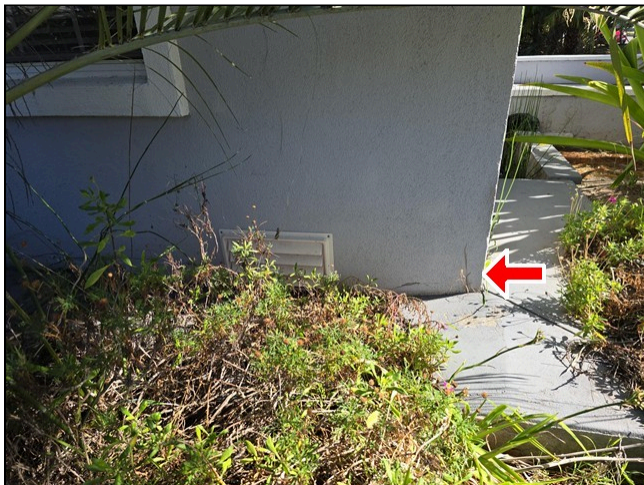
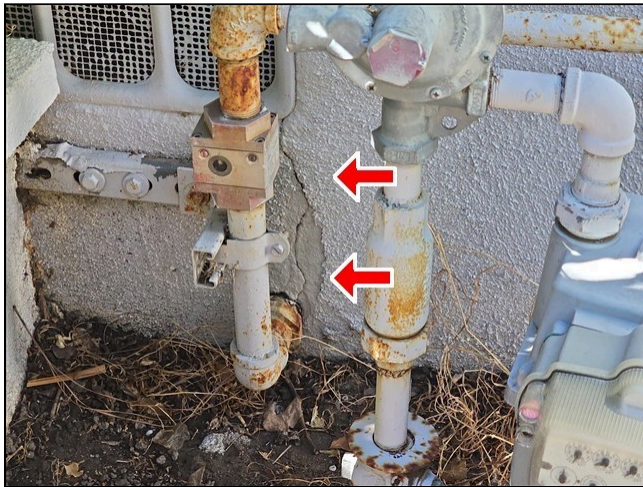
3.0 Item 1 (Picture)

(1) **Repair or Replace:** Signs of cracking and movement were visible in portions of the foundation at more than one location. Although the cracking is isolated to these areas, we feel this could affect the performance of the entire foundation, especially during seismic activity. We suggest a qualified foundation contractor or structural engineer should evaluate the foundation, and determine what repairs are needed.

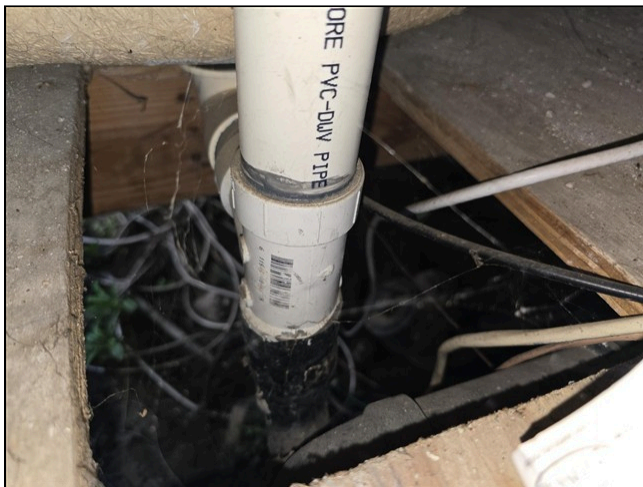
3.0 Item 4 (Picture)

(2) **Improve:** The soil at the rear area of the crawl space is wet and/or damp. The source of the moisture could not be determined at the time of inspection and may be related to poor exterior drainage or a possible active plumbing leak. Elevated moisture conditions in the crawl space can contribute to wood deterioration, potential structural concerns, and possible organic growth. Further evaluation is recommended to identify the source of moisture, and corrective measures by a qualified contractor should be taken to address the issue and dry the affected area.

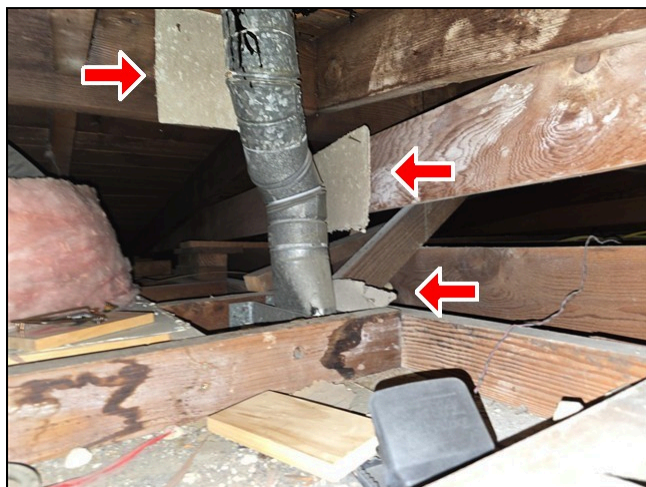
3.3 Item 1 (Picture)

a qualified asbestos specialist collect samples and perform laboratory testing to determine the presence of asbestos. If confirmed, appropriate handling, repair, or abatement should be conducted in accordance with applicable regulations.

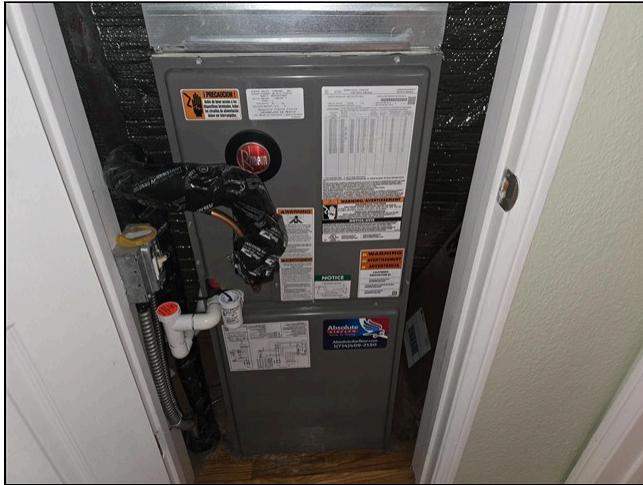
4.0 Item 1 (Picture)

Monitor: During the inspection of the property, it was observed that the heating and cooling system installed for the home was operational and provided adequate heating and cooling. The system was tested and found to be functioning properly, effectively maintaining the desired temperature within the home. This positive finding indicates that the home is equipped with a functional and efficient heating and cooling system, allowing for comfortable use of the space throughout the year. Please note that the specific details of the heating and cooling system, including its type, capacity, and any maintenance or service records, should be obtained from the seller or previous owner for a complete understanding of the system's condition and history.

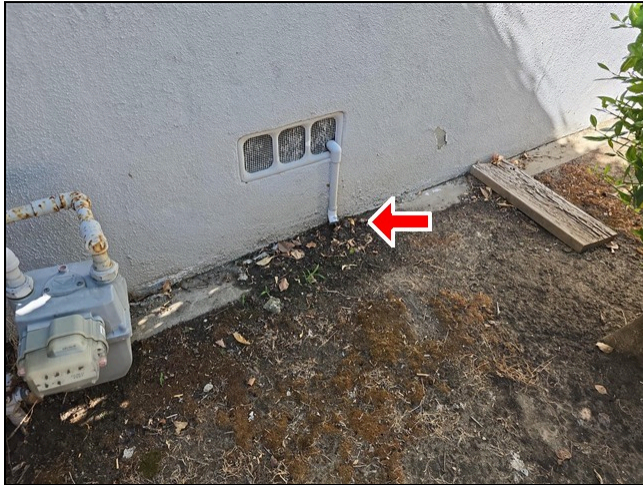
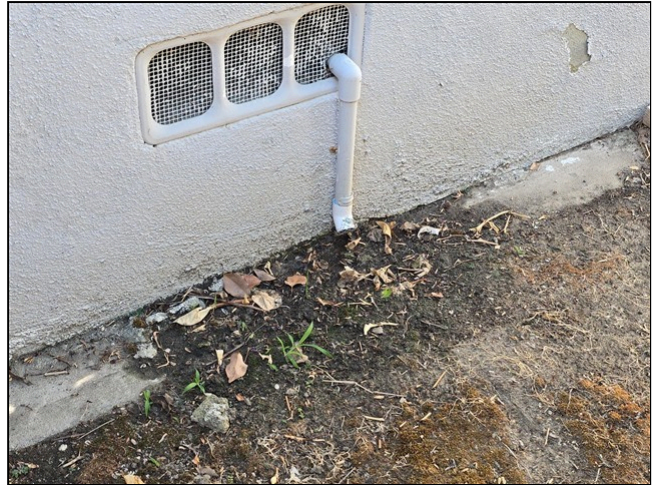
4.7 Item 1 (Picture)

(1) **Improve:** The condensate drain line(s) for the indoor air component of the air conditioning system should be improved. It is suggested that the drain line terminate in a graveled area and or pit to prevent soil saturation when operating the system.

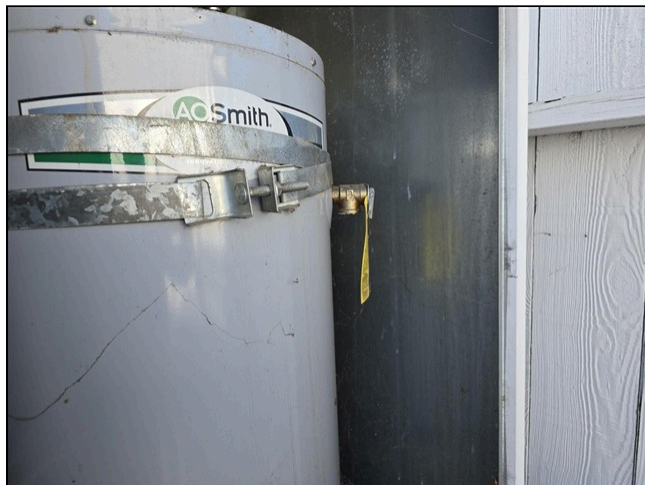
5.2 Item 1 (Picture)

(1) **Safety Issue:** The water heater temperature and pressure relief (TPR) valve lacks a discharge pipe. This is a significant safety concern, as the TPR valve is designed to release hot water and pressure in the event of an overpressure condition. Without a proper discharge pipe, expelled water or steam can pose a risk of scalding and damage to surrounding areas. It is recommended that a properly installed discharge pipe be added by a qualified plumber, terminating in an appropriate location in accordance with accepted safety standards.

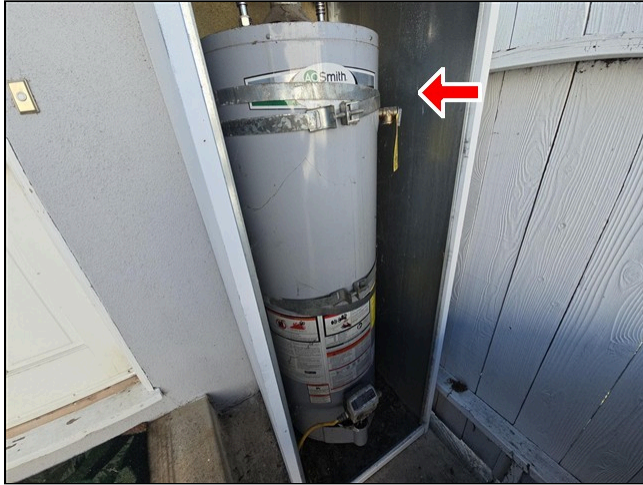
5.2 Item 2 (Picture)

(2) **Repair or Replace:** The water heater top seismic strap was not installed in the correct location. The straps should be located within the top 1/3 of the water heater unit and one at the bottom 1/3. The bottom strap must be located at least 4" away from the water heater controls. Suggest conforming installation by a qualified plumber.

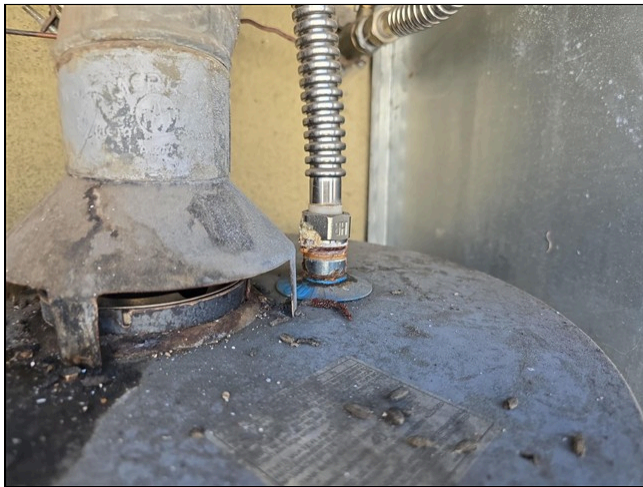
5.2 Item 3 (Picture)

(3) **Repair or Replace:** The water heater water supply connections are corroded. Corrosion at these connections can lead to leaks, reduced flow, and potential failure of the fittings over time. It is recommended that a qualified plumber evaluate and replace the affected connections to prevent water damage and ensure proper operation.

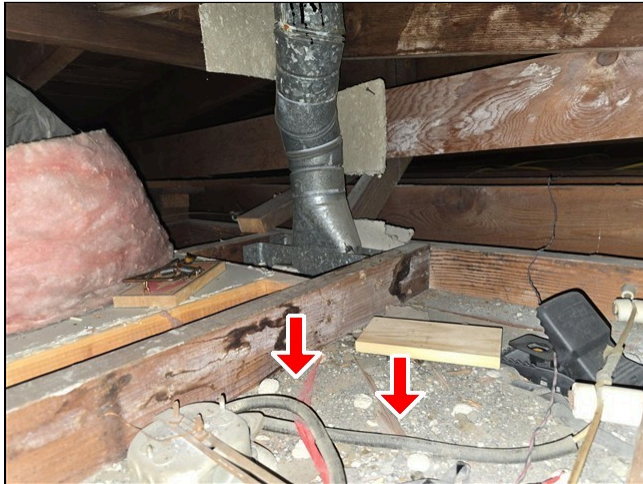
6.1 Item 1 (Picture)

deteriorating materials to ensure electrical safety and compliance with modern standards. This will also help improve the home's overall electrical system performance and safety.
