Chimney Inspection Report

For: Ian Herzog
4 Jib St Apt 13,
Marina del Rey, CA 90292
ian.heartzog@gmail.com

Date: 10/16/2025

The 3 prefabricated all-metal gas and wood burning fireplaces at the property were inspected today.

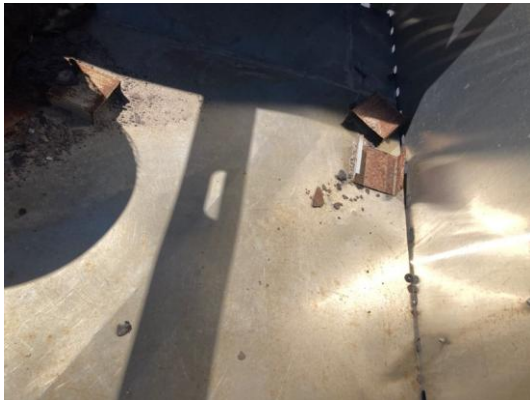
At the top of the chimney, the chase cover is in acceptable condition. There is no gap between the metal chase cover and the stucco chase which is not ideal. A gap is a desirable feature as it allows venting/cooling of the system.

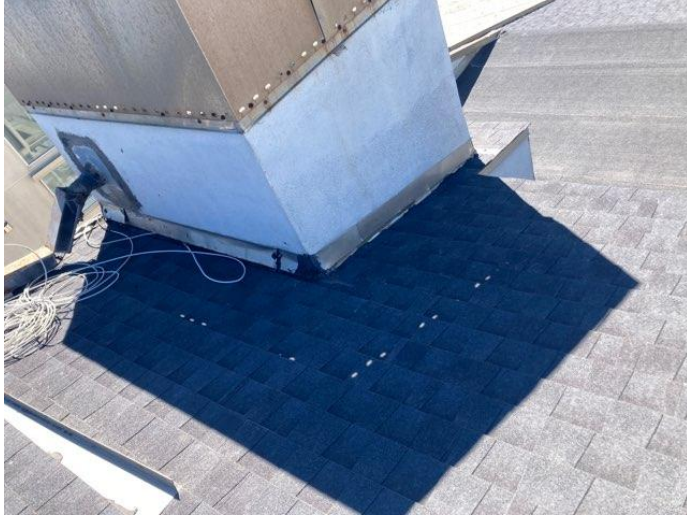
At the top of the chimney, the chimney structure is shared by all the units below Unit #13 and are not identified by unit #. The chimney seems structurally sound. There are no structural anomalies detectable on the exterior surfaces. Prefabricated chimneys are 100 times lighter than their masonry counterparts and are thus less susceptible to earthquake damage.

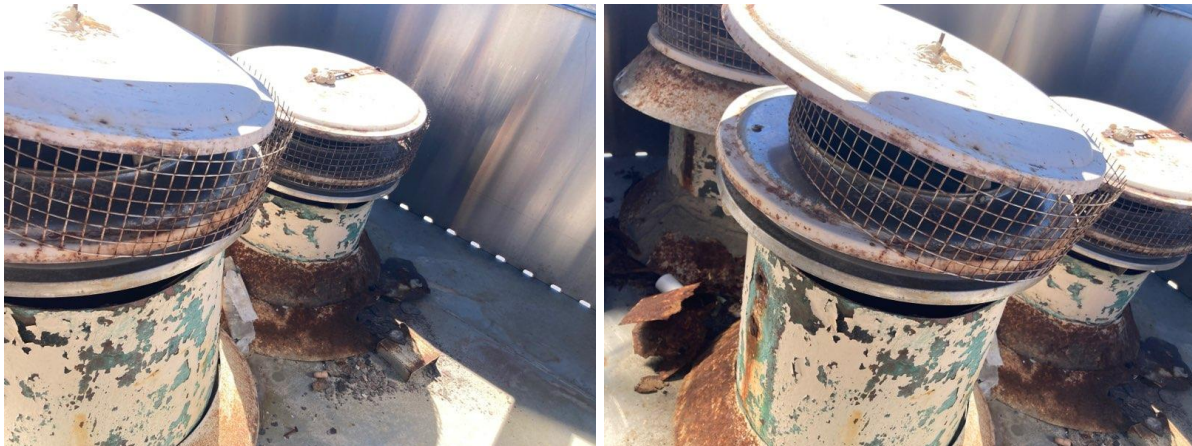
There is an approved spark arrester cap on top of the chimney. There are gaps between the chimney cap and the flue pipe which could allow debris to fly into the chimney flue. This area should have a mesh installed around it. Also, the storm collar is very rusty and should be replaced.

1. Fill the gap around the gas line where it enters the firebox.
2. Install a clamp on the damper to keep it FULLY open at all times per California code.
3. Seal any gaps in the face seal.
4. Have a qualified chimney technician assess the hollow facing around the firebox to see if it needs to be remediated with non-flammable material with correct clearances from flammable material on both sides of the firebox opening and above the firebox opening.
5. Install fire screens provided by the client.
6. Seal the screw holes in the sides of the firebox or install glass doors and screens that would seal these screw holes.
7. Install mesh around the gap between the chimney cap and the flue pipe on the roof so that no debris can fly into the chimney flue.

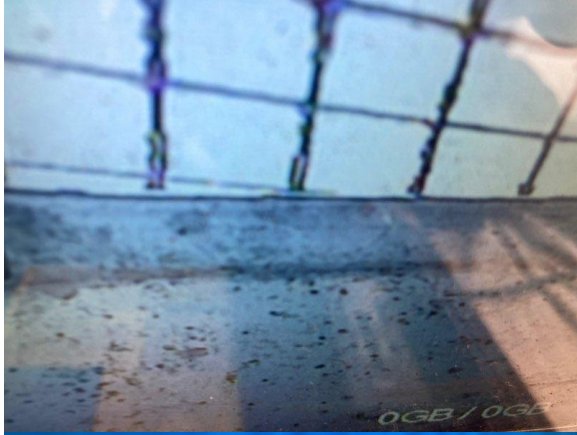
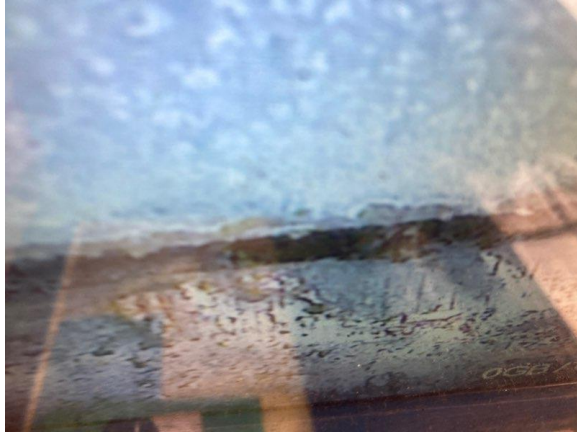
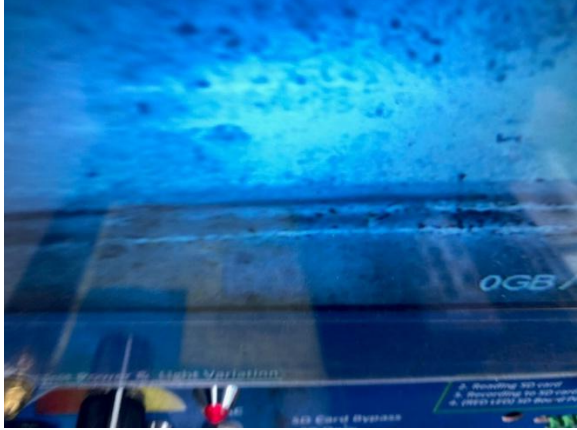
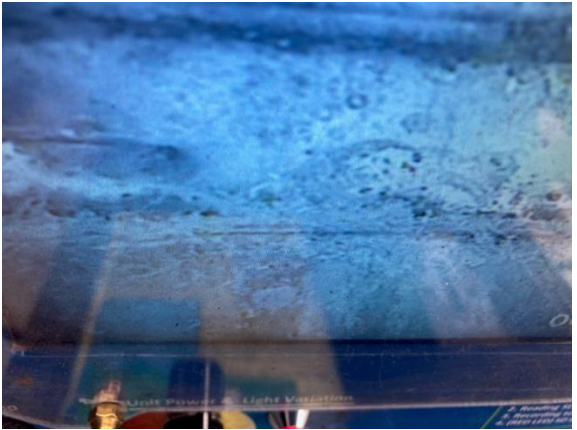
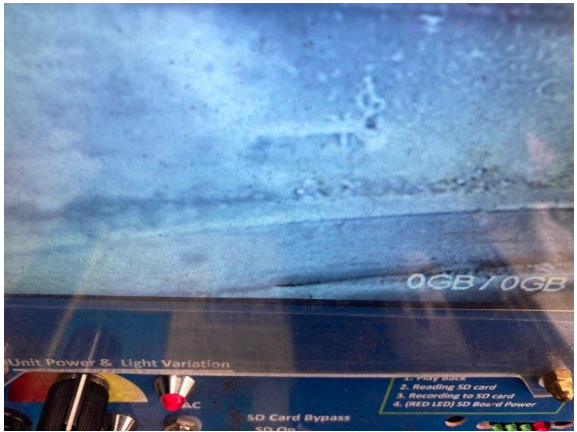
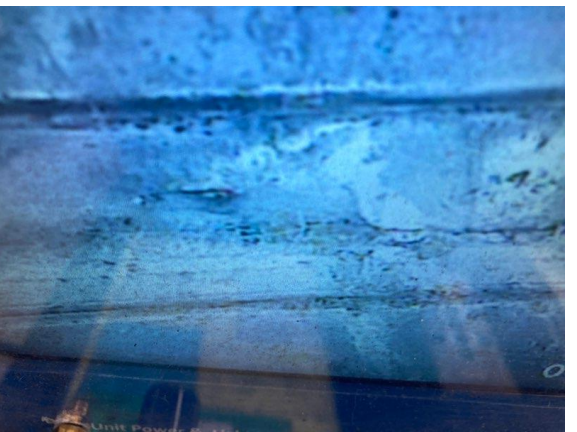
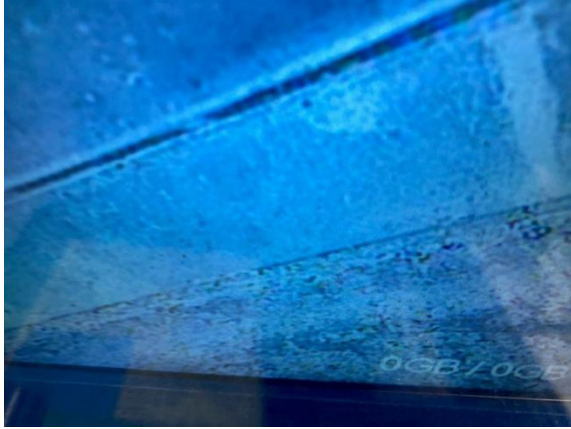
The video inspection of the interior of the flue shows that all the pipes are well connected to each other.

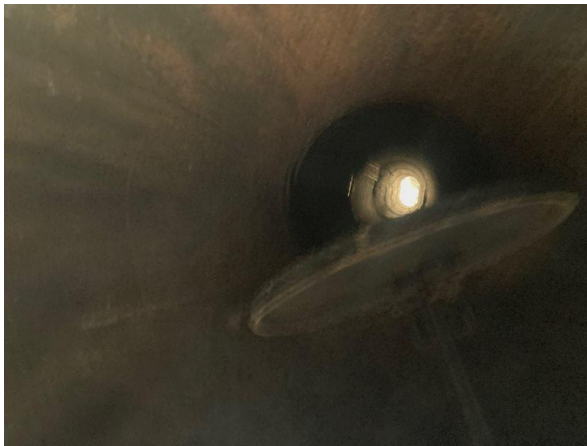
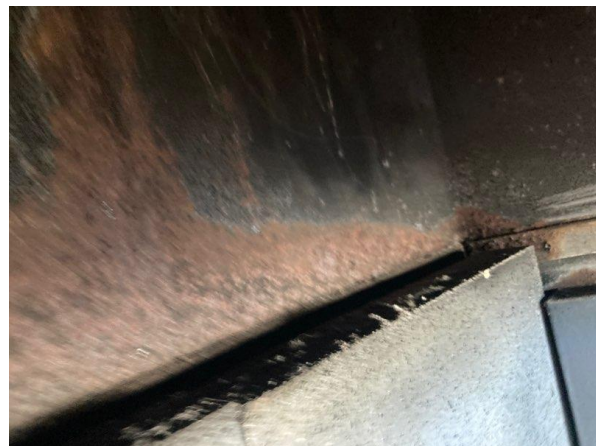
The metal smoke chamber has areas of rust that should be wire brushed and repainted with high temperature paint to prevent/deter further rust deterioration.

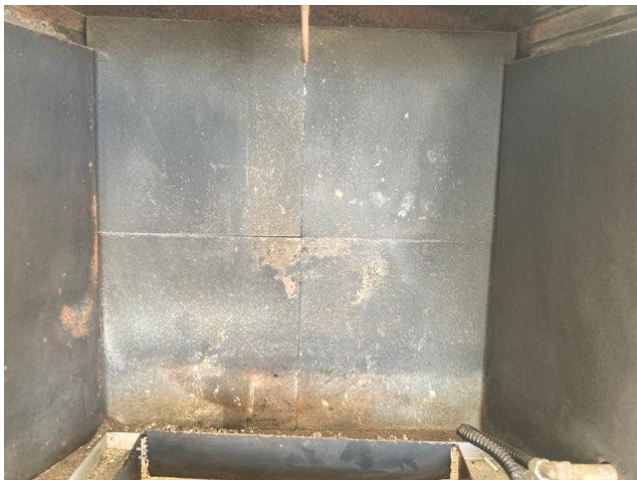
The firebox and panels are in acceptable condition.

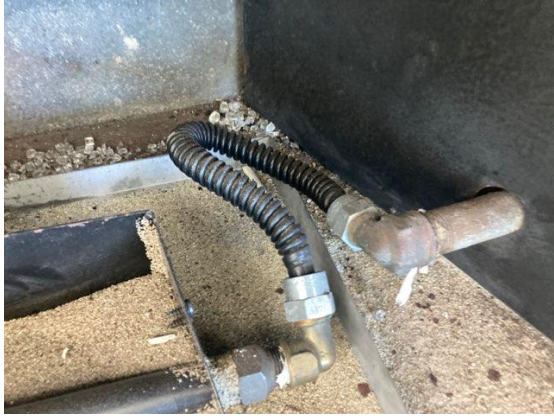
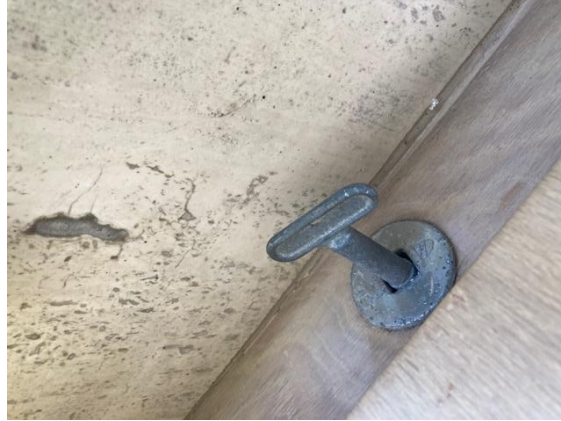
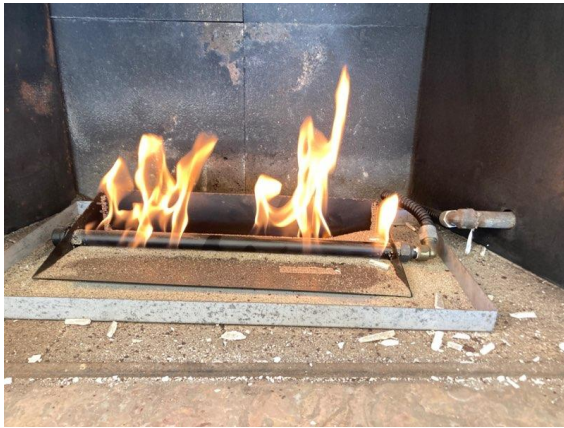
There is a gas line into the firebox. The gas valve worked and gas flow through the gas log burner was verified. Gas valves sometimes go bad. At the time of the inspection, this one functioned normally. We do not check for gas leaks. The gas company offers that service for free.

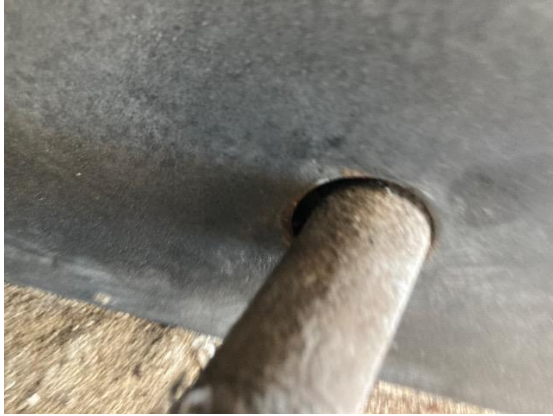
There is a gap around the gas line where it enters the firebox. This should be sealed.

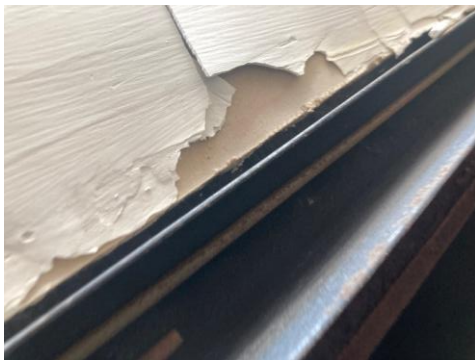
There are gaps at the face seal and peeling paint which should be scraped off and filled with high temperature sealant.

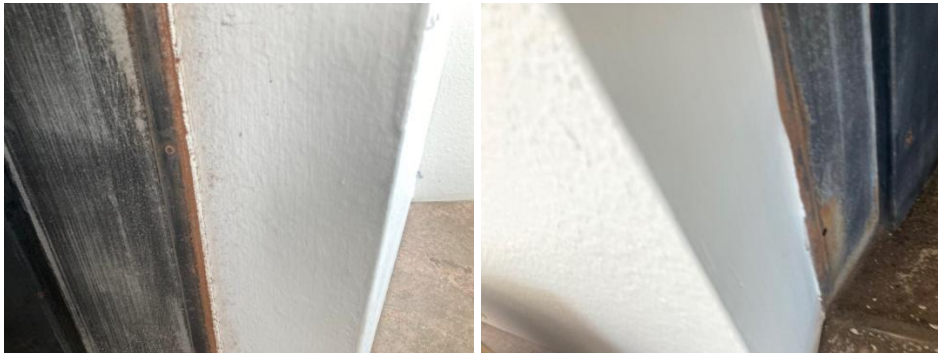
The composition of the hollow facing on both sides of the firebox opening and above the firebox opening is unknown and could be a fire hazard. The facing on both sides of the firebox opening and above the firebox opening should be made of non-flammable material with a 6-inch clearance on both sides and a 12-inch clearance above the firebox opening. Have a qualified chimney technician assess the hollow facing around the firebox to see if it needs to be remediated with non-flammable material with correct clearances from flammable material on both sides of the firebox opening and above the firebox opening.

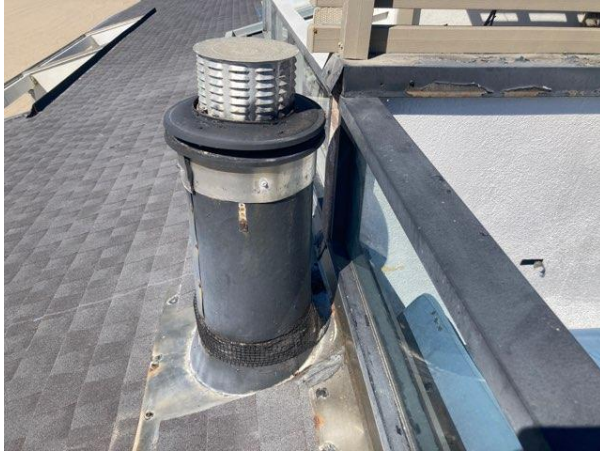
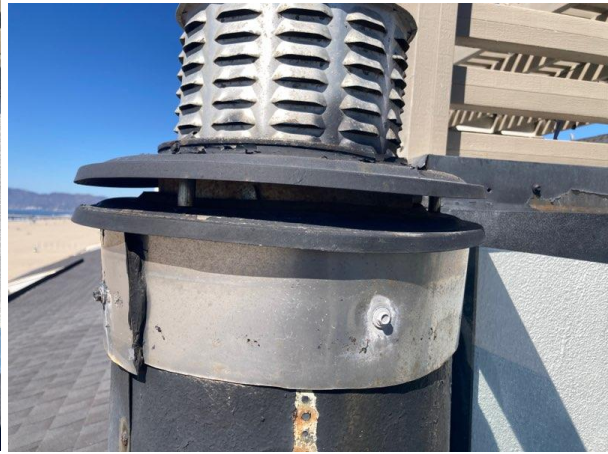
The chimney seems structurally sound. There are no structural anomalies detectable on the exterior surfaces. Prefabricated chimneys are 100 times lighter than their masonry counterparts and are thus less susceptible to earthquake damage.

There is an approved spark arrester cap on top of the chimney. It is missing a storm collar and there is a gap between the chimney cap and the flue pipe which can allow debris to fly into the flue pipe. This area should have a mesh installed around it.

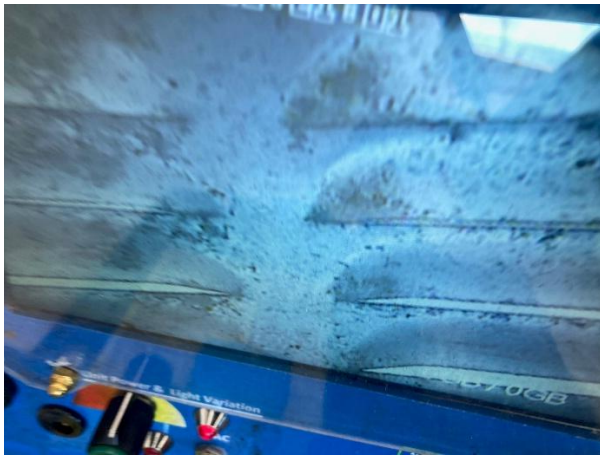
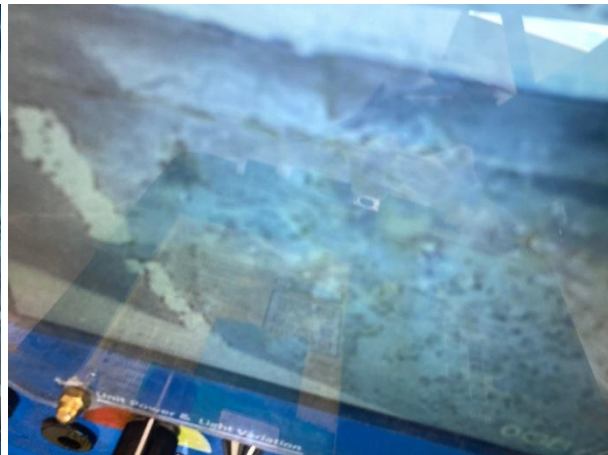
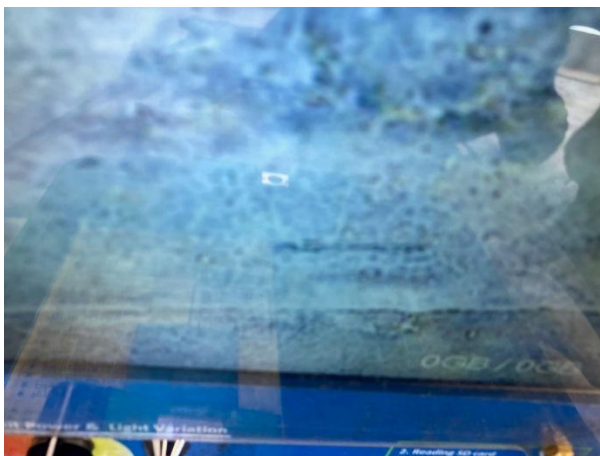
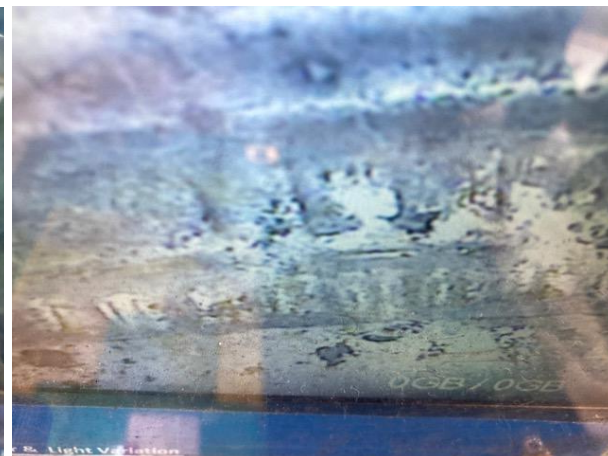
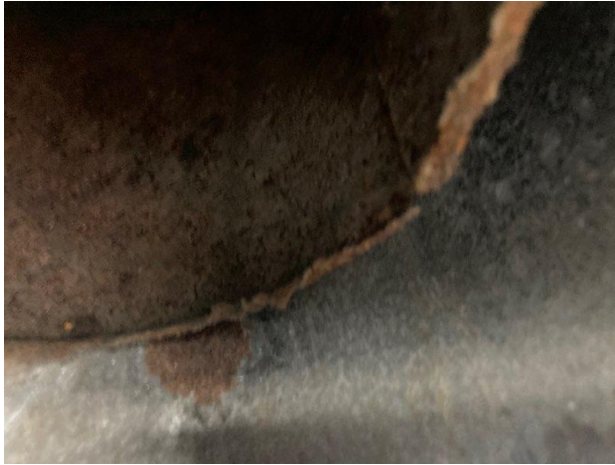
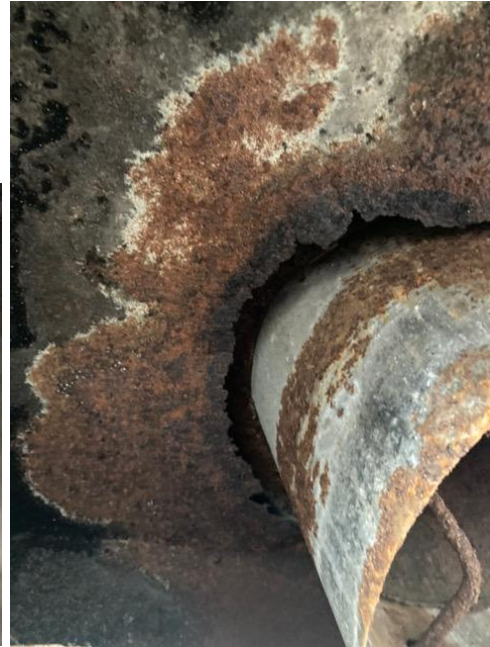
The video inspection of the interior of the flue shows that the flue pipe has disconnected from the smoke chamber and has dropped down below the smoke chamber for more than a foot and the chimney has been compromised due to rust deterioration. It is beyond repair and will need to be replaced with a new chimney system.

1. Remove/seal the damaged 2-story chimney system and replace it with a Bio-ethanol fireplace that does not require an exhaust vent as it burns cleanly.
2. Have a qualified chimney technician assess the hollow facing below the firebox opening to see if it needs to be remediated with non-flammable material and with correct clearances from flammable material below the firebox opening.

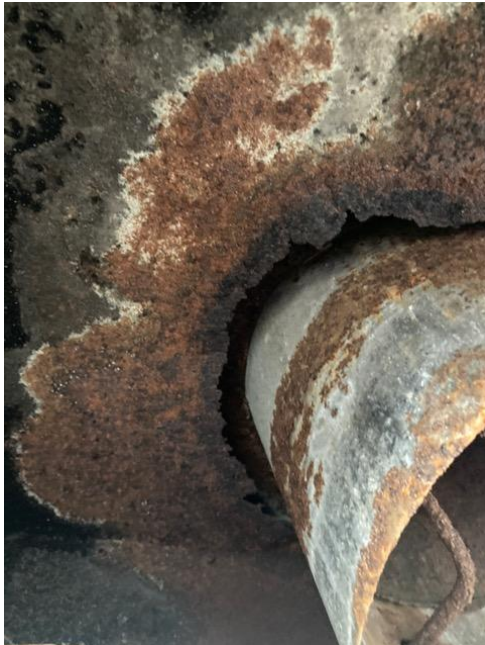
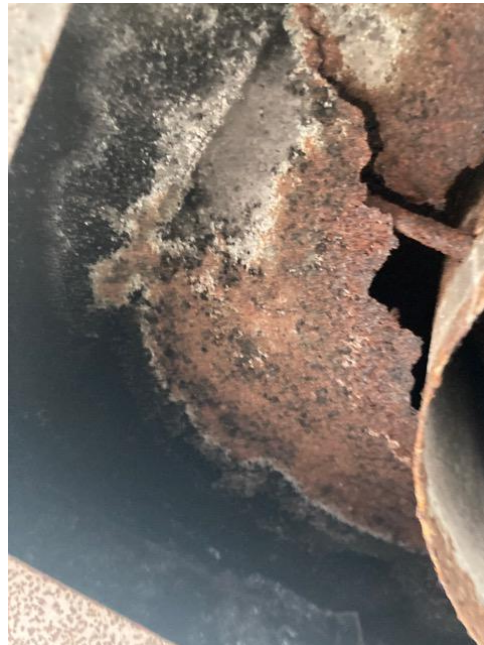
The metal smoke chamber is rusted through with numerous gaps and the flue pipe has dropped down past the smoke chamber which has compromised the entire system. The fireplace/chimney system needs to be replaced, and the fireplace cannot be used safely.

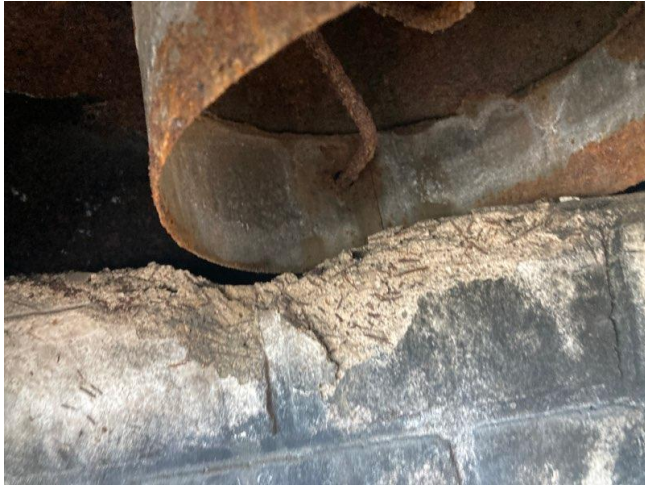
The firebox back panel is damaged and should be replaced.

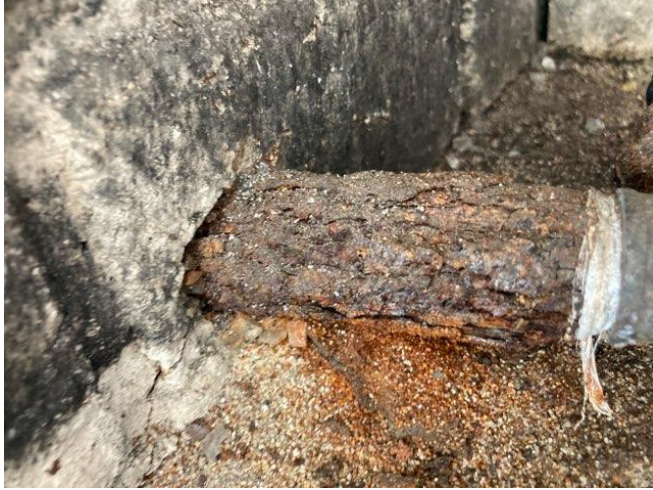
There is a gap around the gas line where it enters the firebox. This should be sealed.

The damper is missing a clamp to keep it fully open as a precaution against combustion gas emission as per CA code. For safety a clamp should be installed.

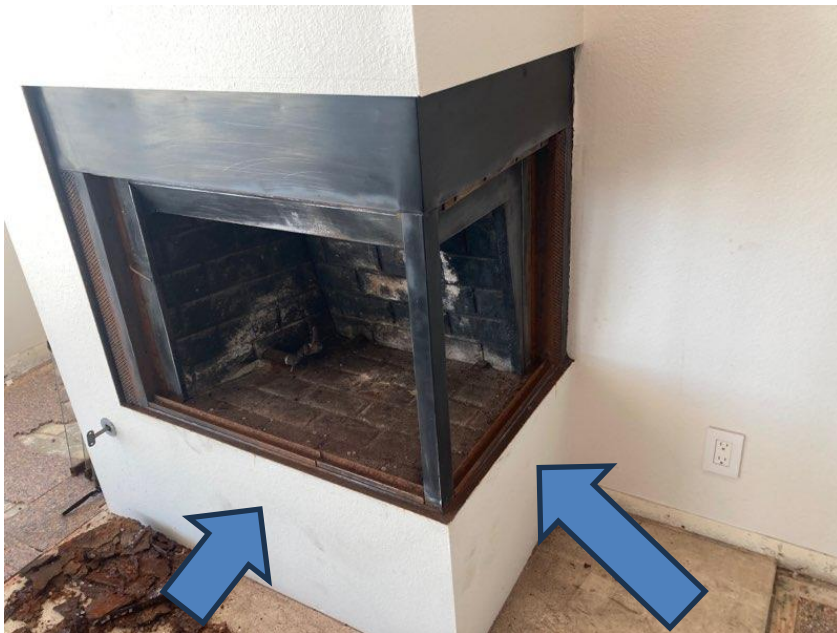
There is no clearance between the bottom of the firebox opening and the bottom facing. This can be a hazard. The composition of the bottom facing is not known. Have a qualified chimney technician assess the hollow facing below the firebox opening to see if it needs to be remediated with non-flammable material and with correct clearances from flammable material below the firebox opening.

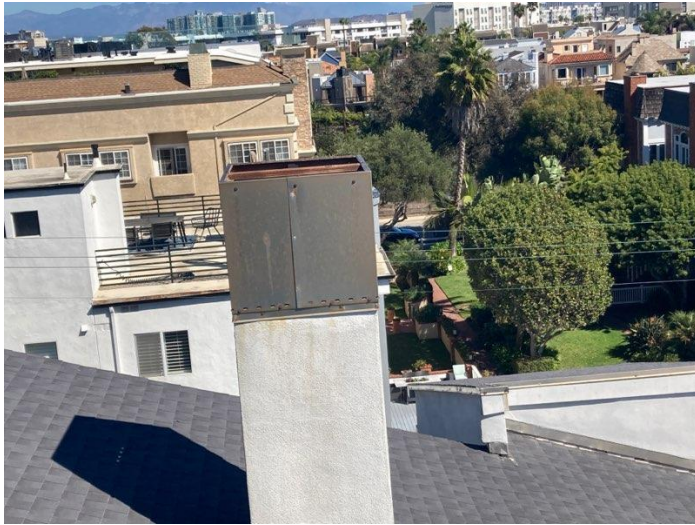
At the top of the chimney, the chase cover is in acceptable condition. There is no gap between the metal chase cover and the stucco chase which is not ideal. A gap is a desirable feature as it allows venting/cooling of the system.

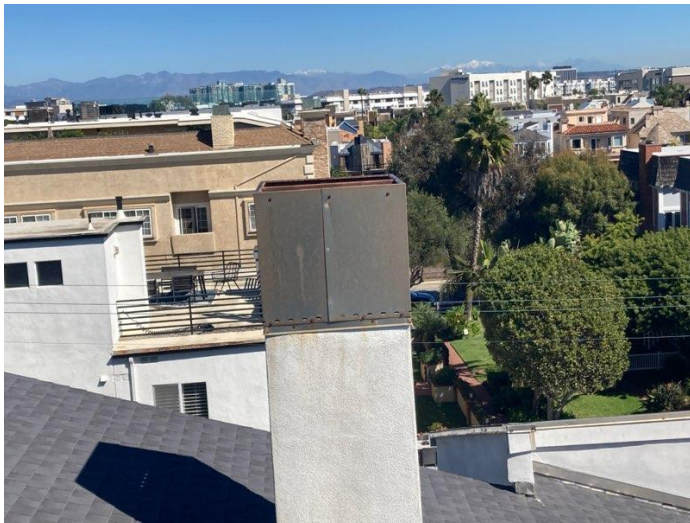
The chimney seems structurally sound. There are no structural anomalies detectable on the exterior surfaces. Prefabricated chimneys are 100 times lighter than their masonry counterparts and are thus less susceptible to earthquake damage.

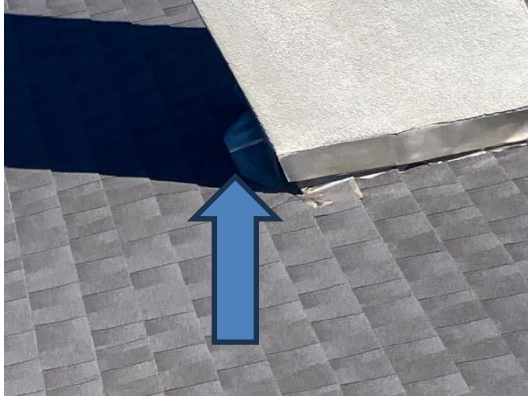
The chimney is 30 inches or more in width. It has a cricket. (a cricket is a metal saddle that diverts rainwater away from the base of the chimney). When the roof needs an overhaul, ask the roofers to install one as it is their specialty.

There is an approved spark arrester cap on top of the chimney.

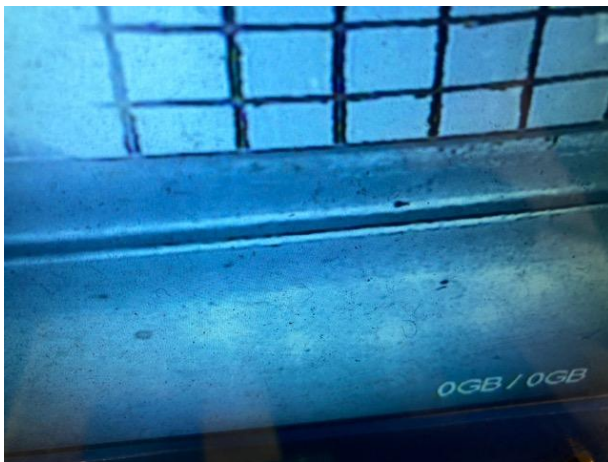
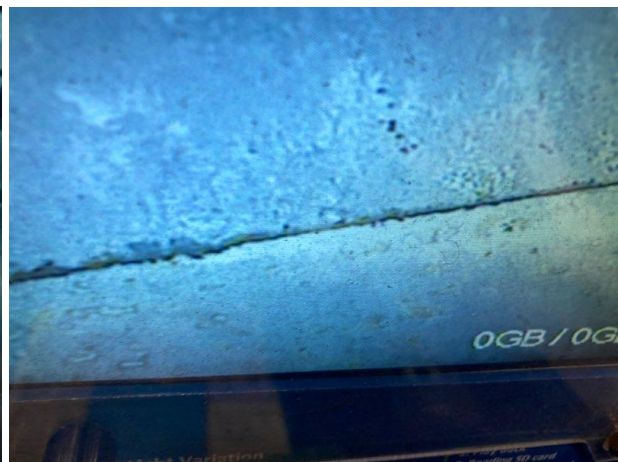
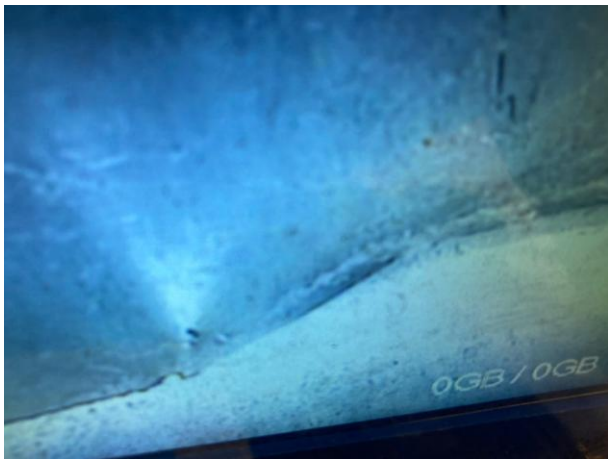
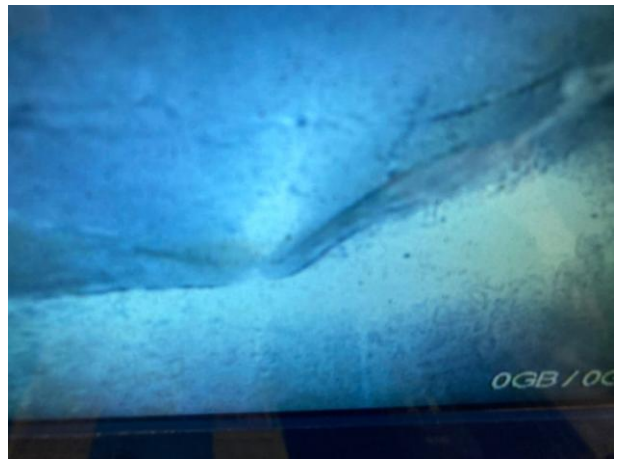
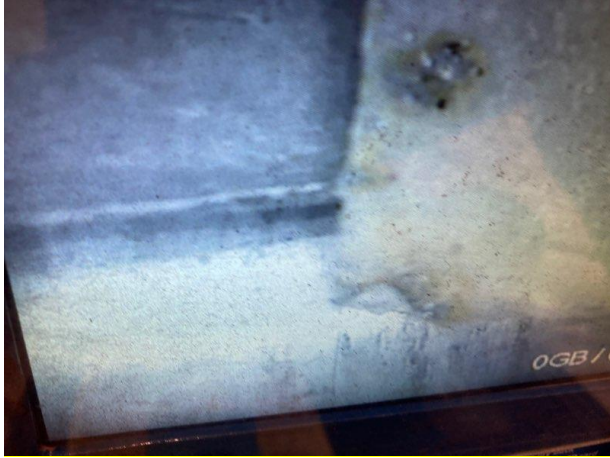
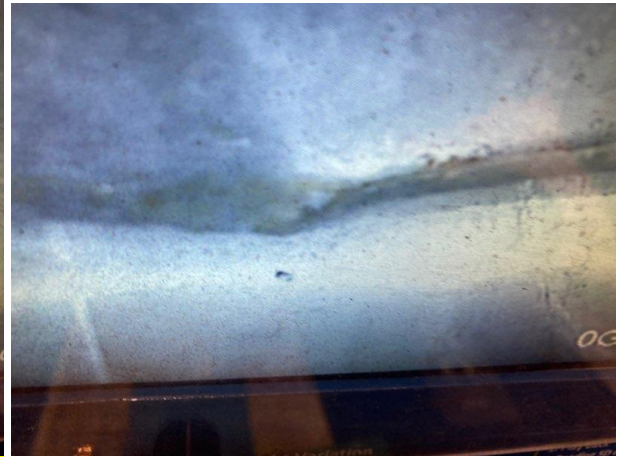
The video inspection of the interior of the flue shows that the flue pipe below the chimney cap portion of the flue is damaged and partially disconnected and there is a gap, and a partially disconnected flue pipe a few feet up from the bottom of the flue. These are a hazard, and they need to be replaced before being able to safely use the fireplace. The fireplace should not be used until it is replaced with a new system.

1. Remove/seal the damaged 2-story chimney system and replace it with a Bio-ethanol fireplace that does not require an exhaust vent as it burns cleanly.

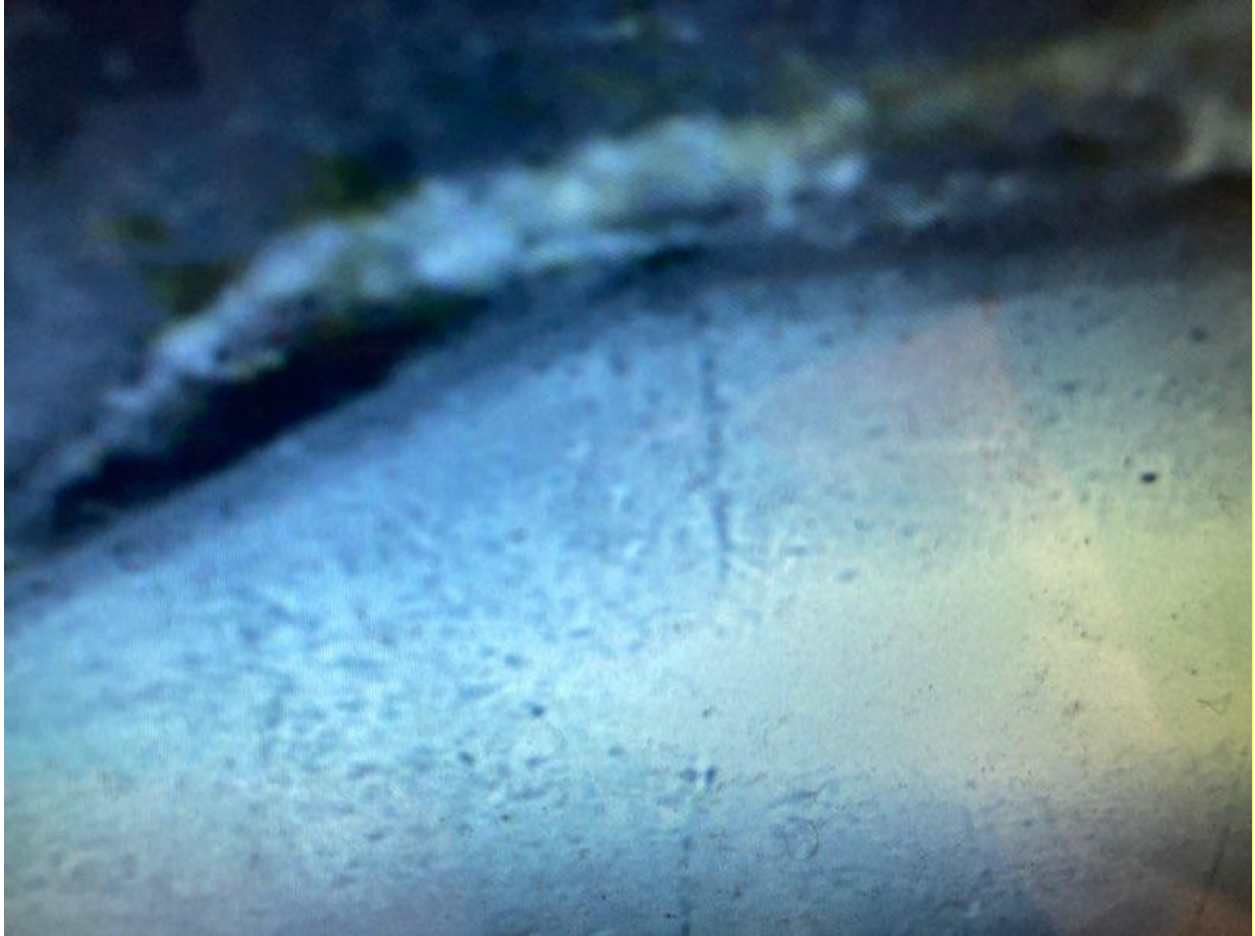
Gap and partial disconnection of the flue pipe a few feet from the top.

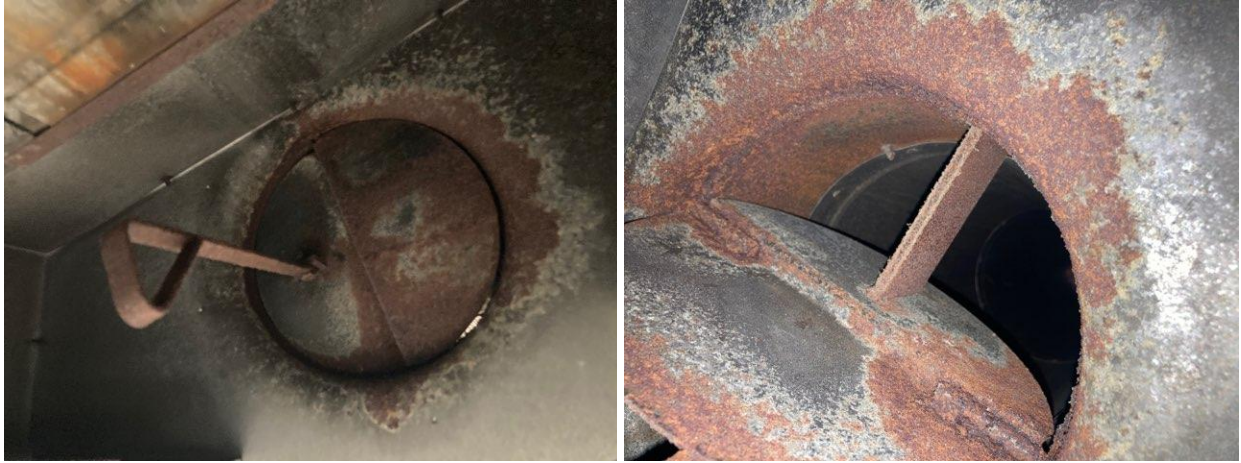
The metal smoke chamber has areas of rust that should be wire brushed and repainted with high temperature paint to prevent/deter further rust deterioration.

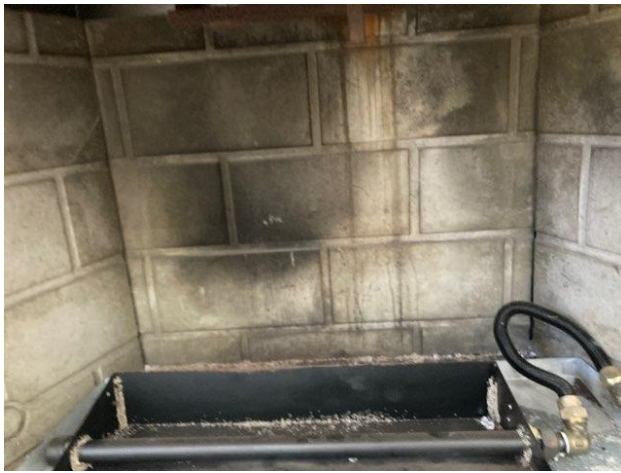
The firebox and panels are in acceptable condition.

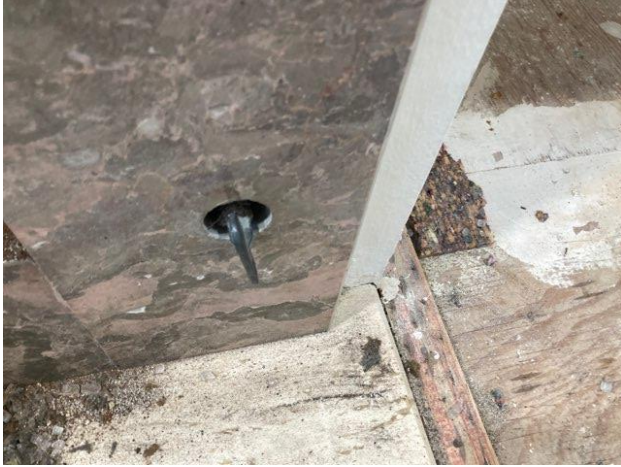
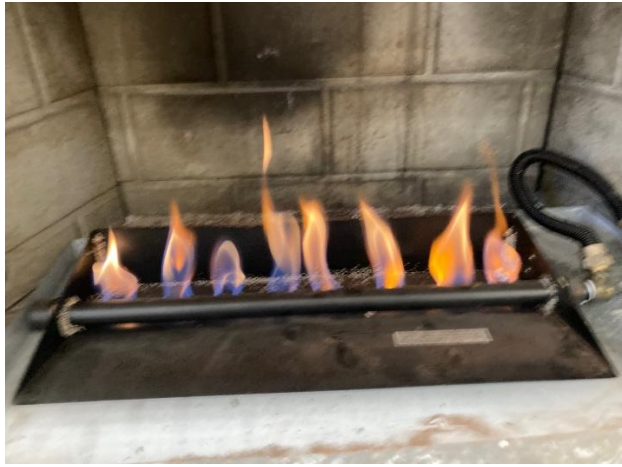
There is a gas line into the firebox. The gas valve worked and gas flow through the gas log burner was verified. Gas valves sometimes go bad. At the time of the inspection, this one functioned normally. We do not check for gas leaks. The gas company offers that service for free.

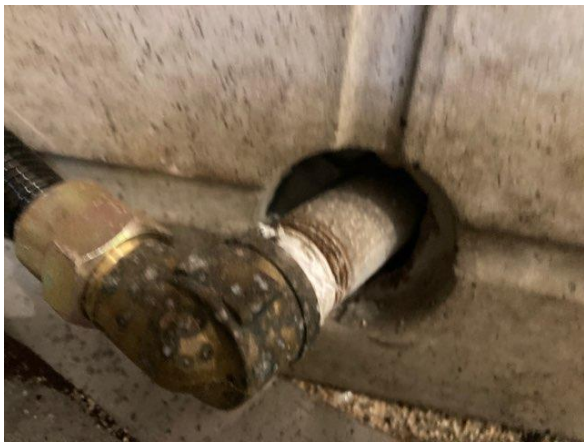
There is a gap around the gas line where it enters the firebox. This should be sealed.

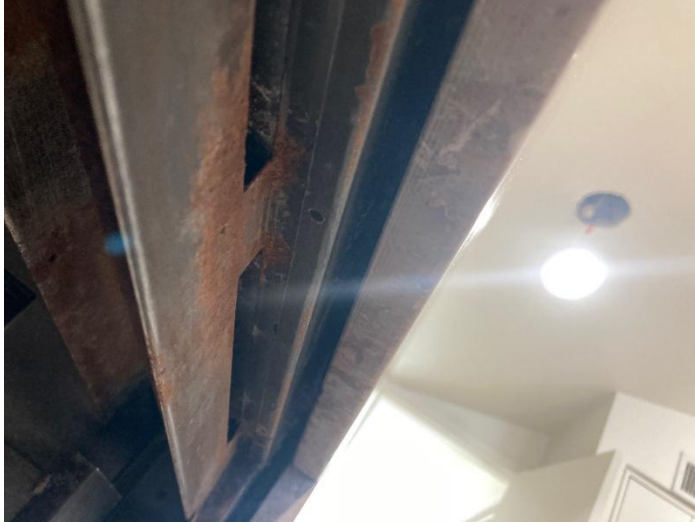
The face seal area has gaps and rust. The gaps should be sealed with high temperature sealant, and the rust should be wire brushed and painted with high temperature paint.

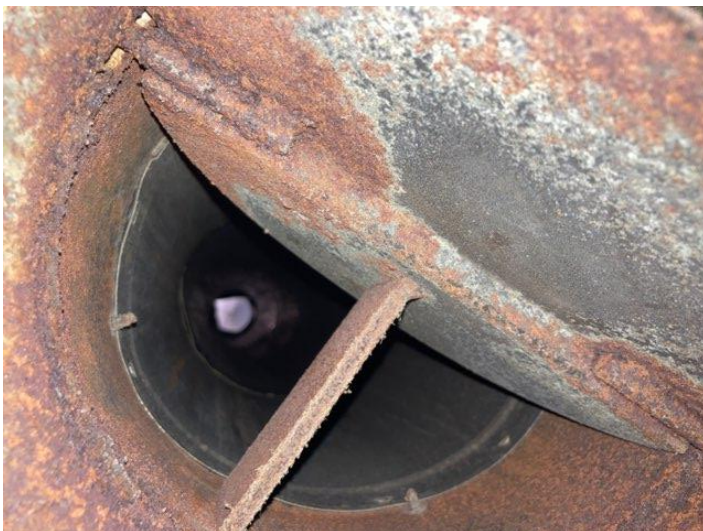
The damper is missing a clamp to keep it fully open as a precaution against combustion gas emission as per CA code. For safety a clamp should be installed.
