WOOD DESTROYING PESTS AND ORGANISMS INSPECTION REPORT

BUILDING NO. 1250	STREET, CITY, STATE, ZIP E St, Hayward CA 94541	Date of Inspection 9/10/2025	No. of Pages 12

261 Spring Street Pleasanton, CA 94566 Tel: (925) 249-9611 Fax: (925) 249-9511 www.specialtyteam.com			
Firm Registration No. PR 4380		Report No. 93519	Escrow No.
Ordered By: West Properties 1352 A St Hayward, CA 94541 Attn: Scott West scott@westproperties.com 510-582-2272		Property Owner/Party of Interest West Properties II 1250 E St Hayward, CA 94541	Report Sent To: West Properties 1352 A St Hayward, CA 94541 Attn: Scott West scott@westproperties.com 510-582-2272
COMPLETE REPORT <input checked="" type="checkbox"/> LIMITED REPORT <input type="checkbox"/> SUPPLEMENTAL REPORT <input type="checkbox"/> REINSPECTION REPORT <input type="checkbox"/>			
General Description: 8-plex		Inspection Tag Posted: Carport	
		Other Tags Posted: None noted	
An inspection has been made to the structure(s) shown on the diagram in accordance with the Structural Pest Control Act. Detached porches, detached steps, detached decks and any other structures not on the diagram were not inspected.

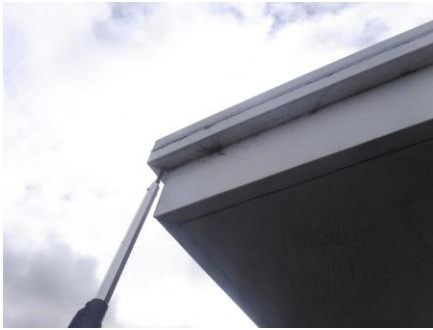
Item 1

ITEM 1 **FINDING:** The roof framing is fungus damaged at the area(s) indicated on the diagram.

RECOMMENDATION: Remove the damaged wood members and replace with new material, as necessary. Paint to match existing color as closely as possible. Install new felt paper and patch the disturbed areas of the roof covering. If an exact match to existing roof covering is not readily available, a similar color or style roofing material will be used.

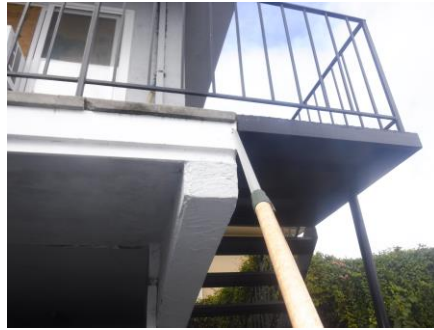
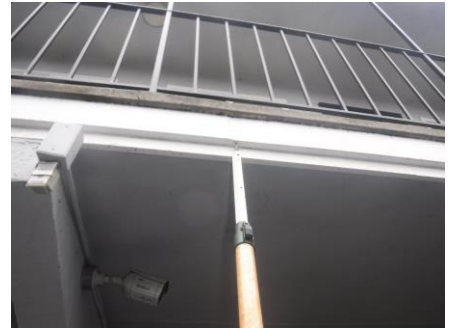
Item 2

ITEM 2 **FINDING:** The wood trim at the elevated walkway outer trim is fungus damaged.

RECOMMENDATION: Remove the damaged wood members and replace with new material as necessary. Paint to match as closely as possible.

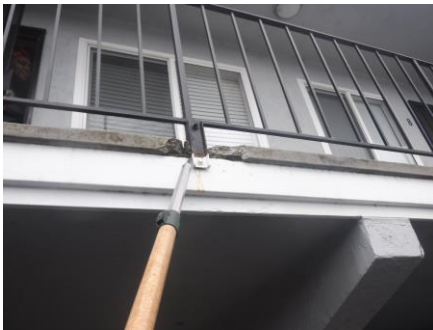
Item 3

ITEM 3 **FINDING:** The elevated walkway concrete is damaged and fungus infections were found at the underlayment.

RECOMMENDATION: Remove the concrete and make underlayment repairs with new material as necessary, then pour new concrete.

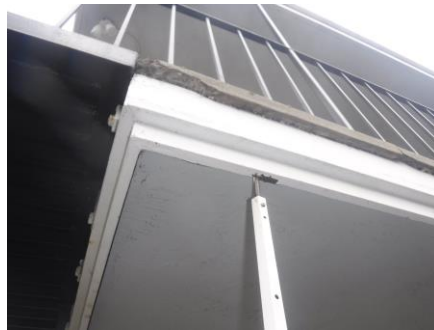
Item 4,6

ITEM 4 **FINDING:** The elevated walkway outer trim is drywood termite damaged.

ITEM 6 **FINDING:** Evidence of a dry-wood termite infestation was found in the area indicated on the diagram.

RECOMMENDATION: Remove the damaged wood members and replace with new material as necessary. Paint to match as closely as possible.

PRIMARY RECOMMENDATION: Fumigate the structure with Vikane Gas containing Sulfuryl fluoride for the control of these termites. It will be necessary for the property to be vacant for approximately 24-74 hours in order to undertake this recommendation. This company and the fumigator cannot be held responsible for any damage to the roof covering or plant life around the structure during the course of the work. All reasonable care will be taken to avoid damage of any type. The owner must trim back any bushes which abut the structure and remove all television antennas prior to the fumigation. Our price for this recommendation will be given upon request.

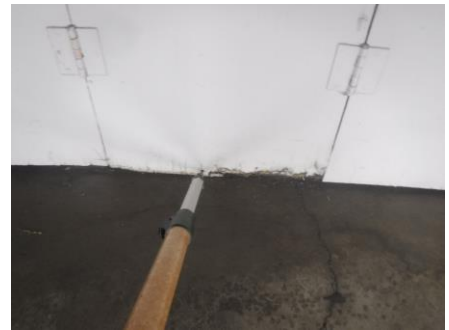
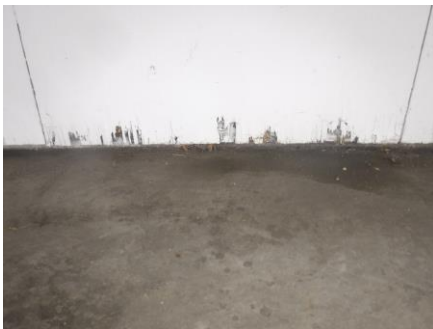
Item 5,6

ITEM 5 **FINDING:** The carport storage locker wall siding is fungus and/or drywood termite damaged.

RECOMMENDATION: Remove the damaged wood members and replace with new material as necessary. Paint to match as closely as possible.

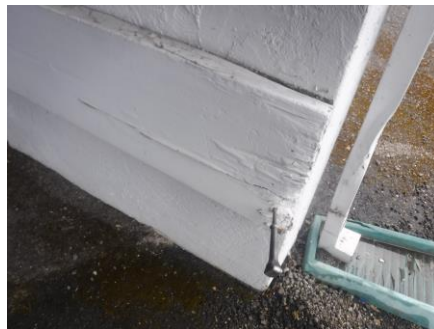
Item 7

ITEM 7 **FINDING:** The wood trim at the area(s) indicated on the diagram is fungus damaged.

RECOMMENDATION: Remove the damaged wood members and replace with new material as necessary. Paint to match as closely as possible.

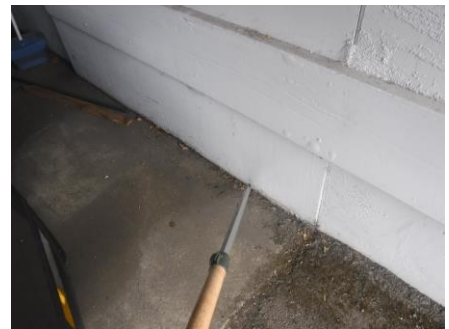
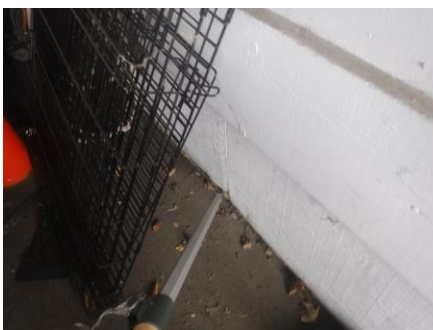
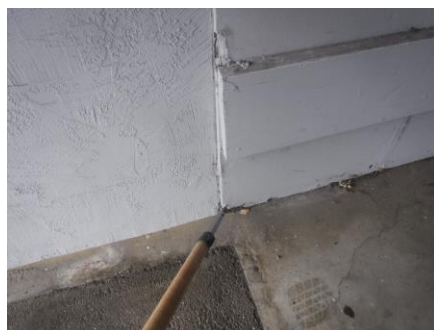
Item 8

ITEM 8 **FINDING:** The wood siding at the carport siding is fungus damaged.

RECOMMENDATION: Remove the damaged wood members and replace with new material as necessary. Paint to match as closely as possible.

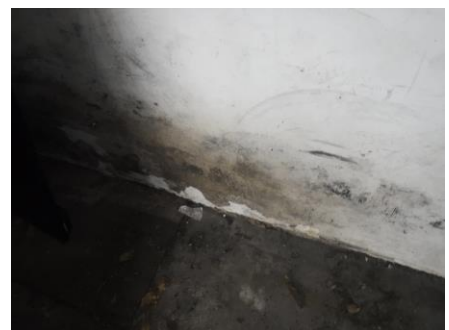
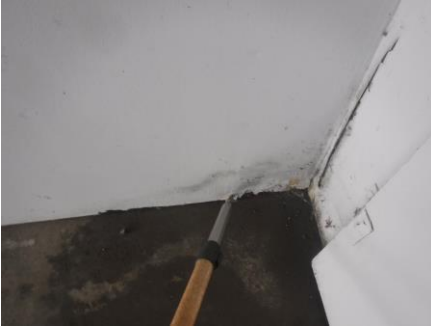
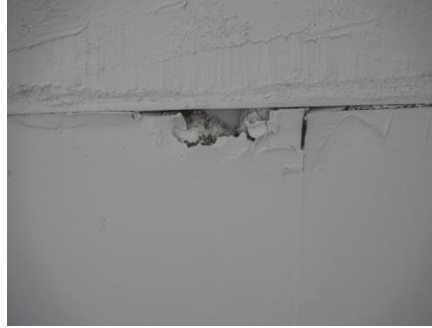
Item 9

ITEM 9 **FINDING:** The drywall at the area indicated has been damaged by excessive moisture.

RECOMMENDATION: Remove and replace the drywall. The bid given includes tape, texture, and paint. Owner to supply matching paint. If matching paint is not supplied, we will install one coat of white primer/sealant.

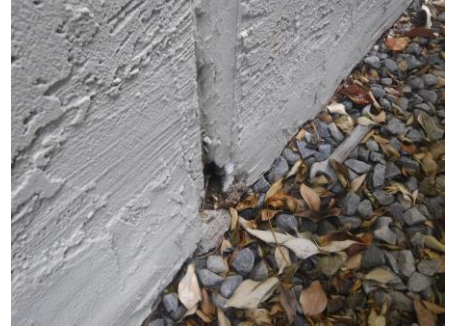
Item 10

ITEM 10 **FINDING:** The wood trim at the area(s) indicated on the diagram is fungus damaged.

RECOMMENDATION: Remove the damaged wood members and replace with new material as necessary. Paint to match as closely as possible.

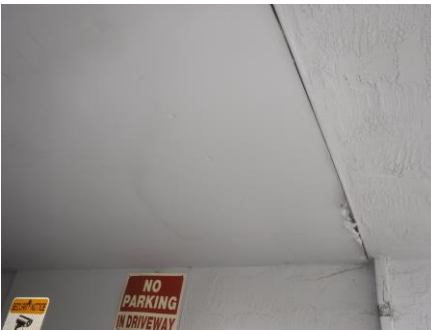
Item 11

ITEM 11 **FINDING:** Water stains were noted on the drywall at the carport ceiling.

RECOMMENDATION: Open this area to allow for further inspection. If no adverse conditions are noted, we will close this area, tape, texture, and paint the repaired area only. The bid given does not include any repairs or treatments that may be necessary. It will be the owner's responsibility to provide matching paint or we will install one coat of primer/sealant.

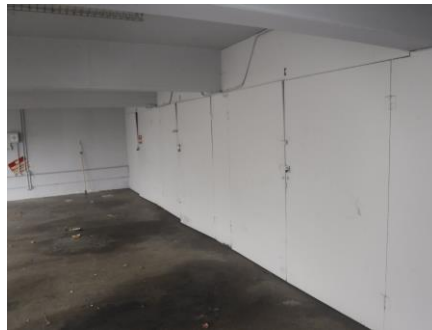
Item 12

ITEM 12 **FINDING:** Except for locker D, all the carport personal storage lockers were locked, making the interior of the lockers inaccessible for inspection.

RECOMMENDATION: After access is created by others, we will return to the property and inspect the lockers.

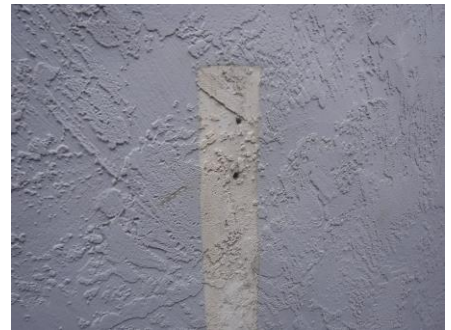
Item 13

ITEM 13 **FINDING:** Holes were noted at the exterior stucco where a jamb was previously attached.

RECOMMENDATION: Stucco patch and seal the wall.

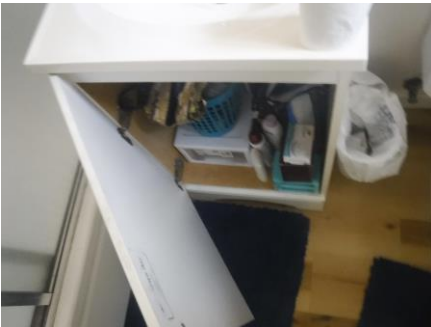
Item 14

ITEM 14 **FINDING:** There is storage in the interior of all units at various areas. We inspected these areas as thoroughly as possible, but can make no representations concerning the condition of the inaccessible wood members, in the inaccessible areas.

RECOMMENDATION: If the interested parties so desire, we will return to the property after all of the storage has been removed and inspect these areas. This will be done at an additional charge.

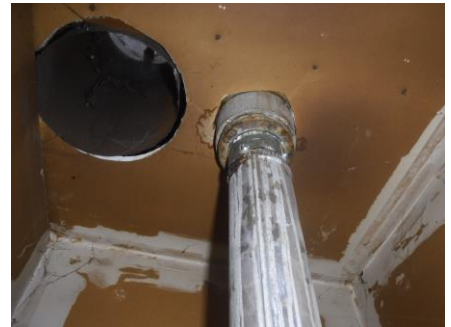
Item 16

ITEM 16 **FINDING:** Water staining and signs of possible leakage were found at the utility closet ceiling at Units 2, 3, 5, 7, and 8.

RECOMMENDATION: If additional information is desired on this item, a roofing contractor should be consulted.

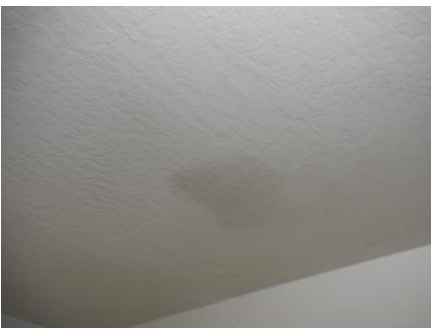
Item 17

ITEM 17 **FINDING:** Water staining and signs of possible leakage were found at the ceiling at Unit 3.

RECOMMENDATION: If additional information is desired on this item, a roofing contractor should be consulted.

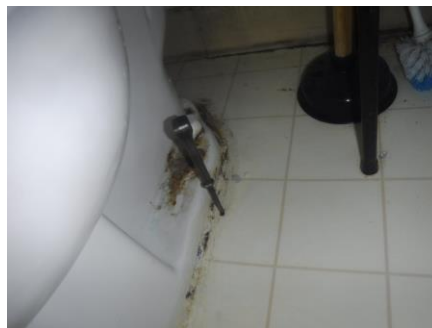
Item 18

ITEM 18 **FINDING:** There is visible evidence of a fungus infection and damage to the underlayment in the hall bathroom Unit 3.

RECOMMENDATION: Remove the toilet, make necessary underlayment repairs, install new standard grade flat lay vinyl, and re-secure the toilet on a new wax seal.

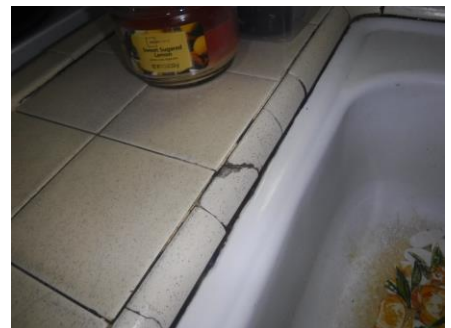
Item 19

ITEM 19 **FINDING:** Cracked tiles were found at the kitchen countertop at Unit 3.

RECOMMENDATION: We recommend the appropriate contractor make repairs as deemed necessary.

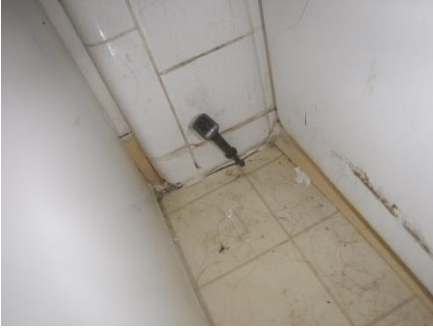
Item 20

ITEM 20 **FINDING:** There is visible evidence of a fungus infection and damage to the underlayment and framing below in the hall bathroom at Unit 4.

RECOMMENDATION: Remove the toilet, make necessary underlayment repairs, install new standard grade flat lay vinyl, and re-secure the toilet on a new wax seal.

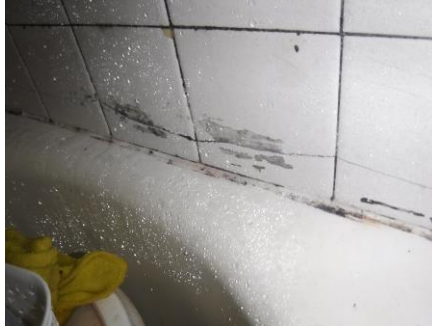
Item 21

ITEM 21 **FINDING:** The tub shower walls are deteriorated at Unit 4.

RECOMMENDATION: Remove the existing shower wall covering and sheetrock backing, install new appropriate backing, and new ceramic tile..

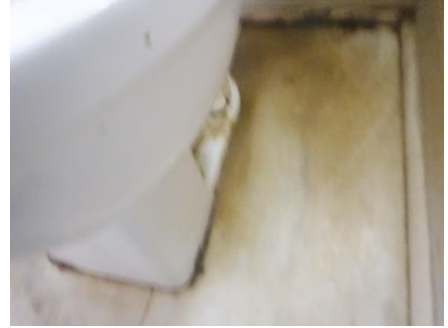
Item 22

ITEM 22 **FINDING:** The toilet is actively leaking at Unit 5.

RECOMMENDATION: Re-secure the toilet on a new wax seal.

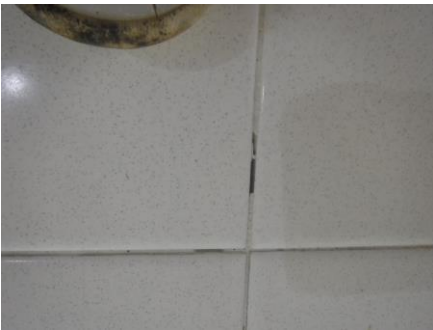
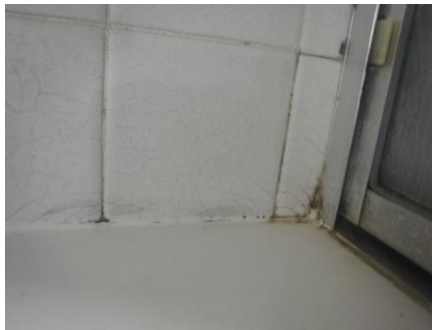
Item 23

ITEM 23 **FINDING:** The tub shower walls are deteriorated at Unit 5.

RECOMMENDATION: Remove the existing shower wall covering and sheetrock backing, install new appropriate backing, and new ceramic tile..

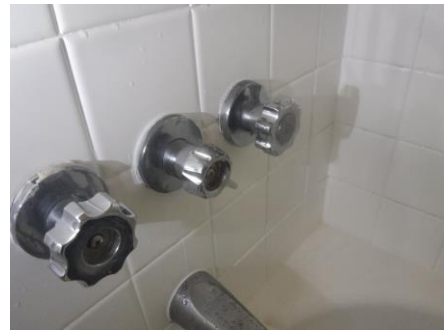
Item 24

- ITEM 24 **FINDING:** Evidence of a plumbing leak was noted at the tub shower valve stems at Unit 6.
- RECOMMENDATION:** The owner should contact a plumbing tradesperson to inspect the area and make necessary repairs.

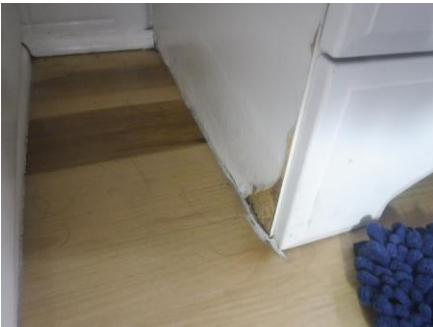
Item 25

***** This is a Section 2 Item *****
- ITEM 25 **FINDING:** The bathroom vanity fixture is swollen and moisture damaged at Unit 7.
- RECOMMENDATION:** Replace the vanity fixture with a new vanity fixture.

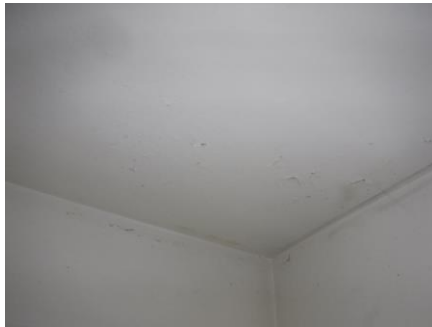
Item 26

***** This is a Section 1 Item *****
- ITEM 26 **FINDING:** Water staining and signs of possible leakage were found at the ceiling at Unit 8.
- RECOMMENDATION:** If additional information is desired on this item, a roofing contractor should be consulted.

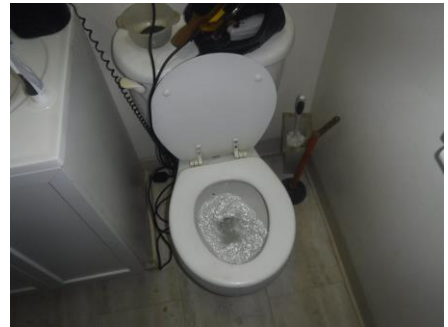
Item 27

***** This is a Section 2 Item *****
- ITEM 27 **FINDING:** The hall bathroom toilet is loose at Unit 8.
- RECOMMENDATION:** Re-secure the toilet on a new wax seal.

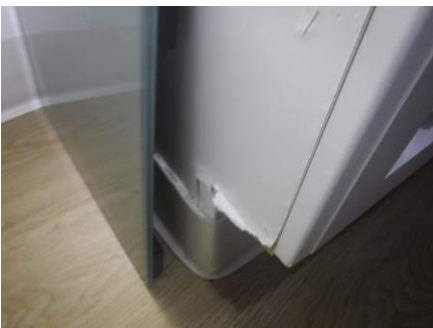
Note A

A. Swelling was noted at the bathroom sink vanity framing at Units 1, 4, 6, and 7. No fungus infections were found.
