## PROPERTY INSPECTION REPORT

27703 Ortega Hwy Spc. 30  
San Juan Capistrano, CA 92675

Shari Kelley  
MAY 21, 2026

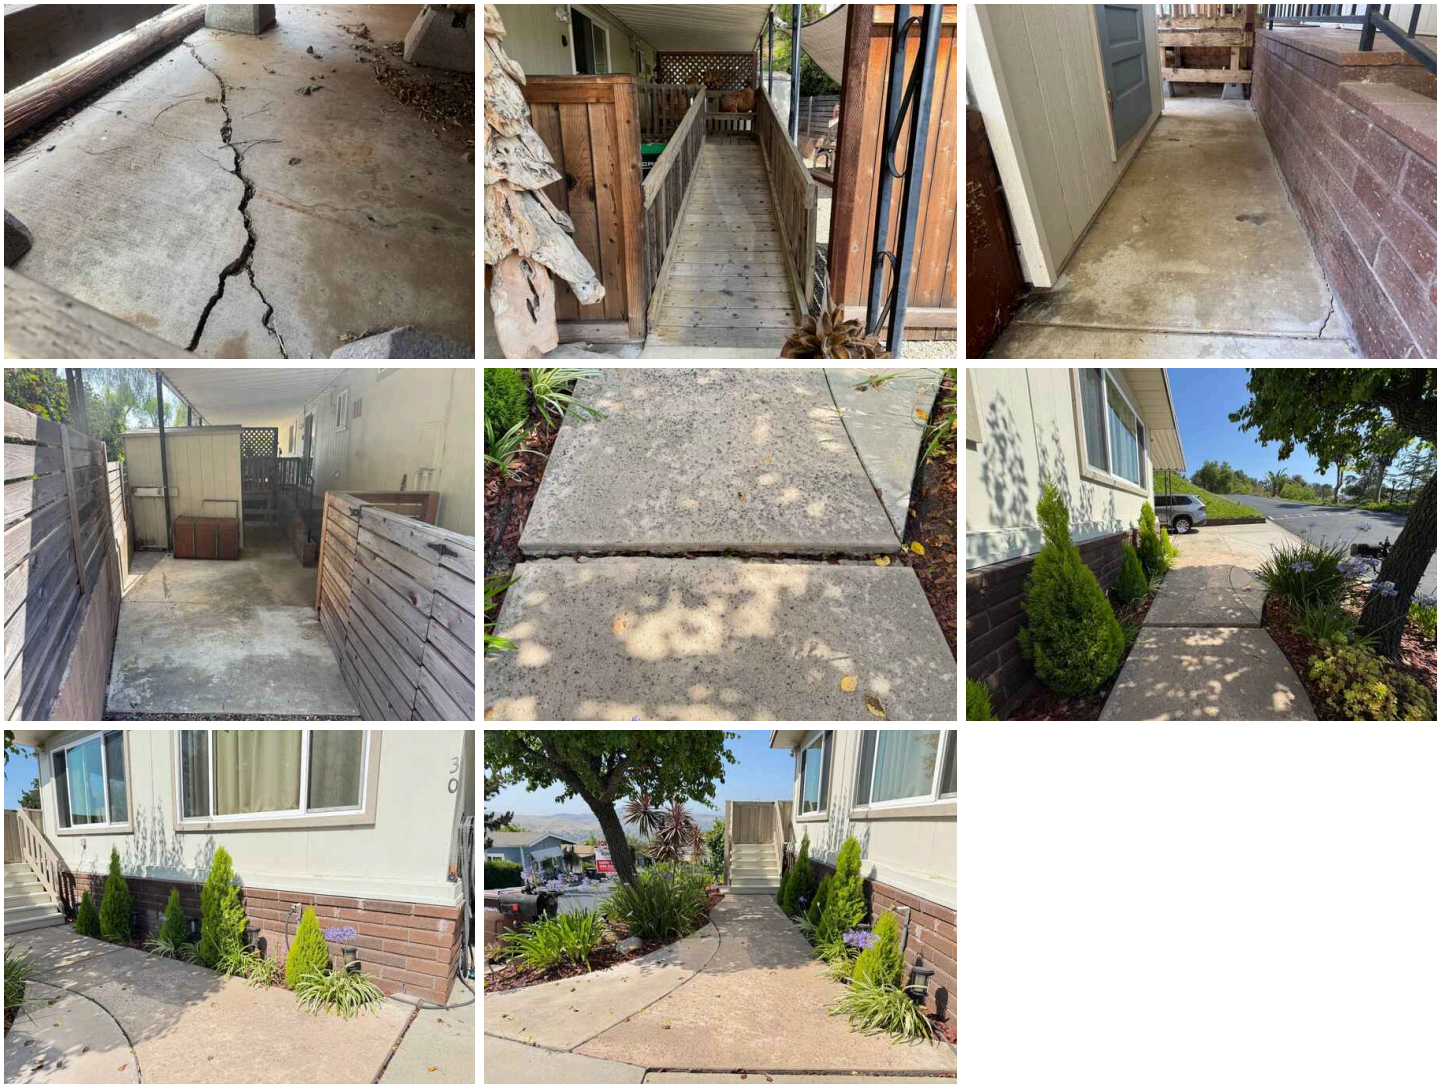
EAST/NORTH SIDES OF HOUSE

**CRACKING & HEAVING TRIPPING HAZARD**

There is cracking and heaving at the sidewalk. The could present a tripping hazard. I recommend evaluation by a licensed contractor.

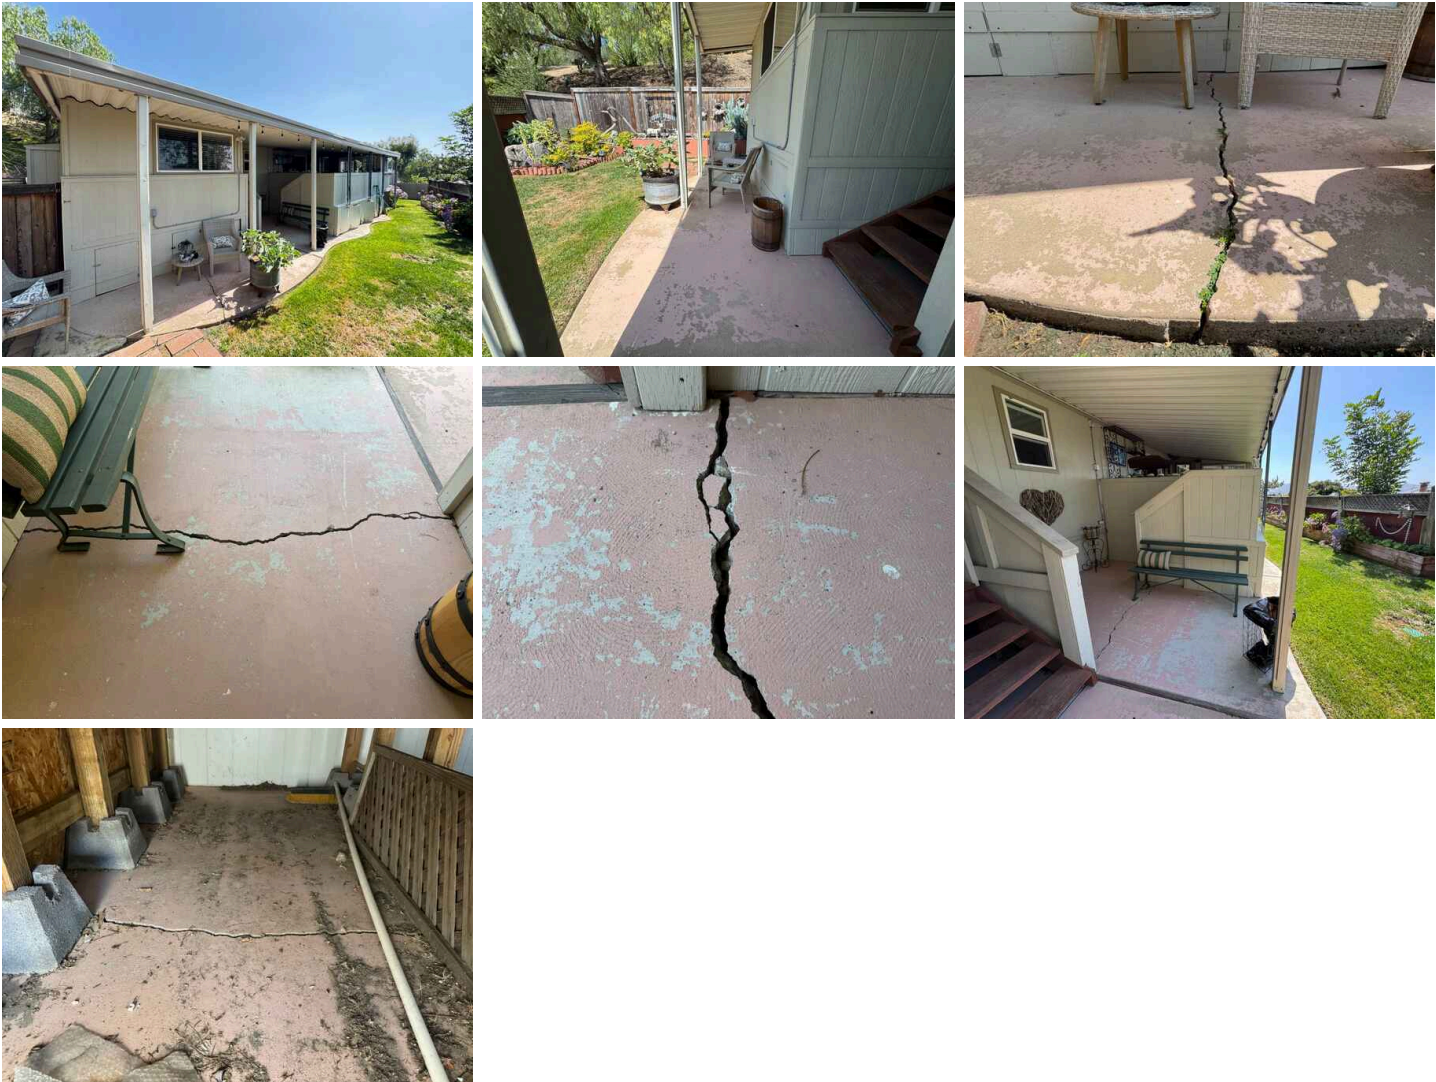
3.3.1 Patio

CRACKING & HEAVING TRIPPING HAZARD

There is cracking and heaving at the patio. This could present a tripping hazard. I recommend evaluation by a licensed contractor.

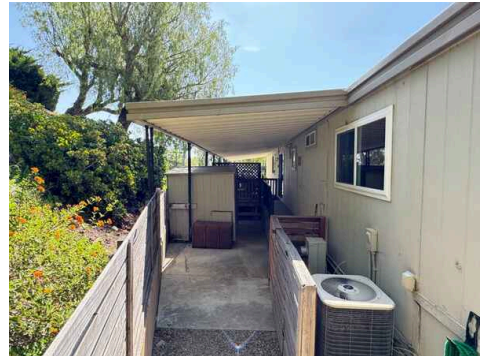
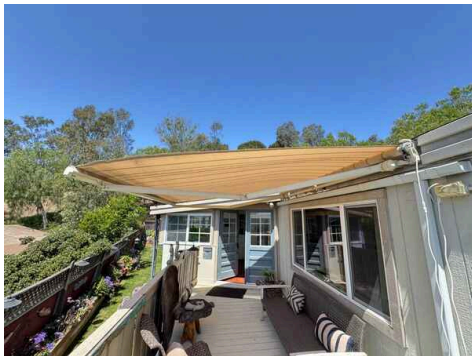
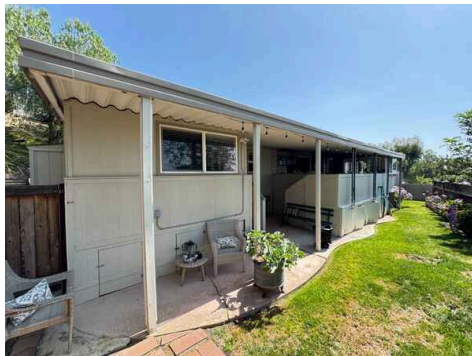
### 3.6.1 Porch and Carport Covers

#### **POSTS NOT CONNECTED TO GROUND**

The carport cover support posts are not properly connected to the ground. I recommend evaluation by a licensed contractor.

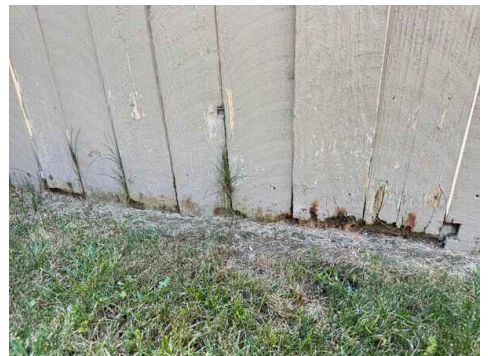
### 3.7.1 Fences/Gates

#### **MOISTURE/INSECT DAMAGE**

There is moisture and/or insect damaged wood at the fencing. I recommend evaluation by a licensed contractor.

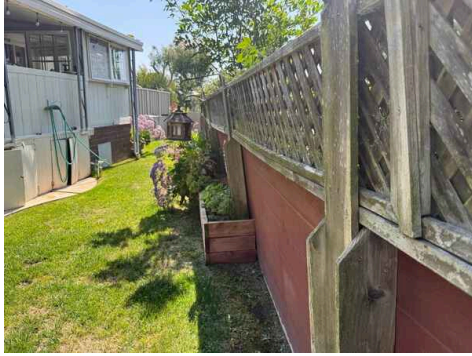
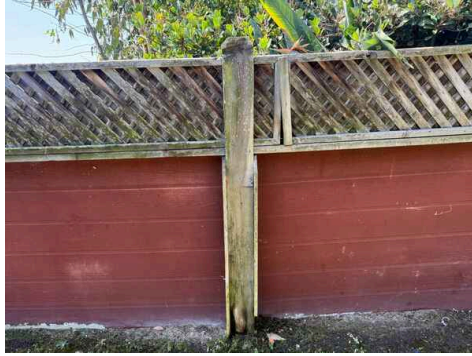
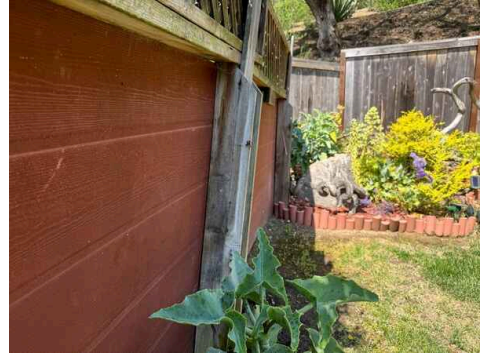
## 3.7.2 Fences/Gates

**FENCE LEANING**

The fencing is damaged. I recommend evaluation by a licensed contractor.

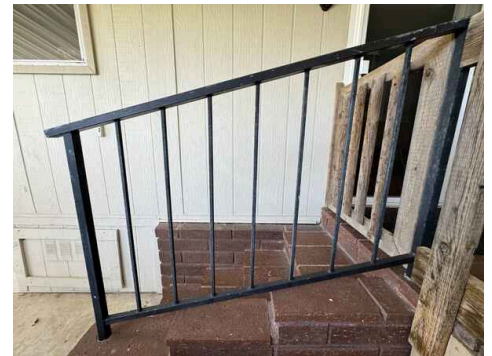
## CARPORT STAIRS

The openings in the exterior stairway railings do not conform to current building safety standards. Current building safety standards do not allow openings large enough for a four-inch sphere to pass through. I recommend evaluation by a licensed contractor.

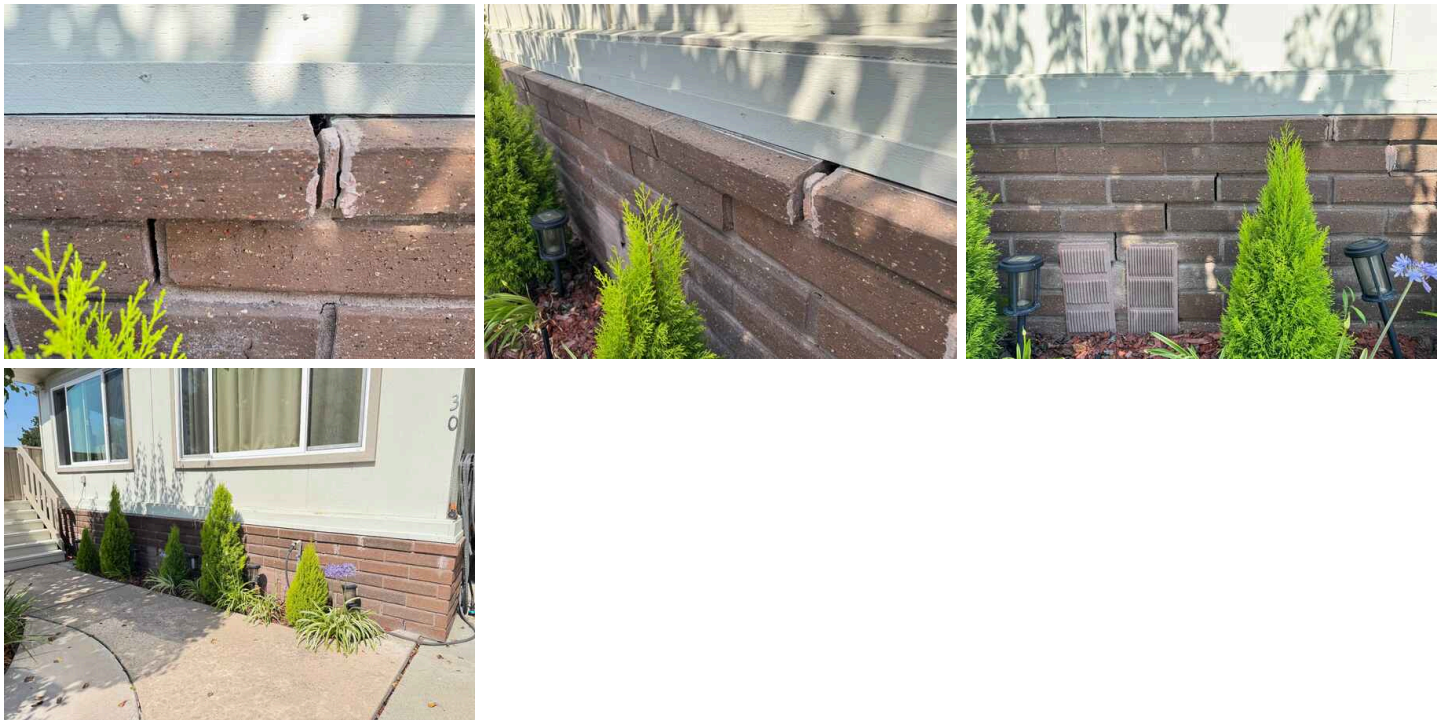
4.3.1 Skirting

**MASONRY VENEER SEPARATING FROM STRUCTURE**

The Masonry veneer is separating from the front of the house. I recommend evaluation from a licensed contractor.

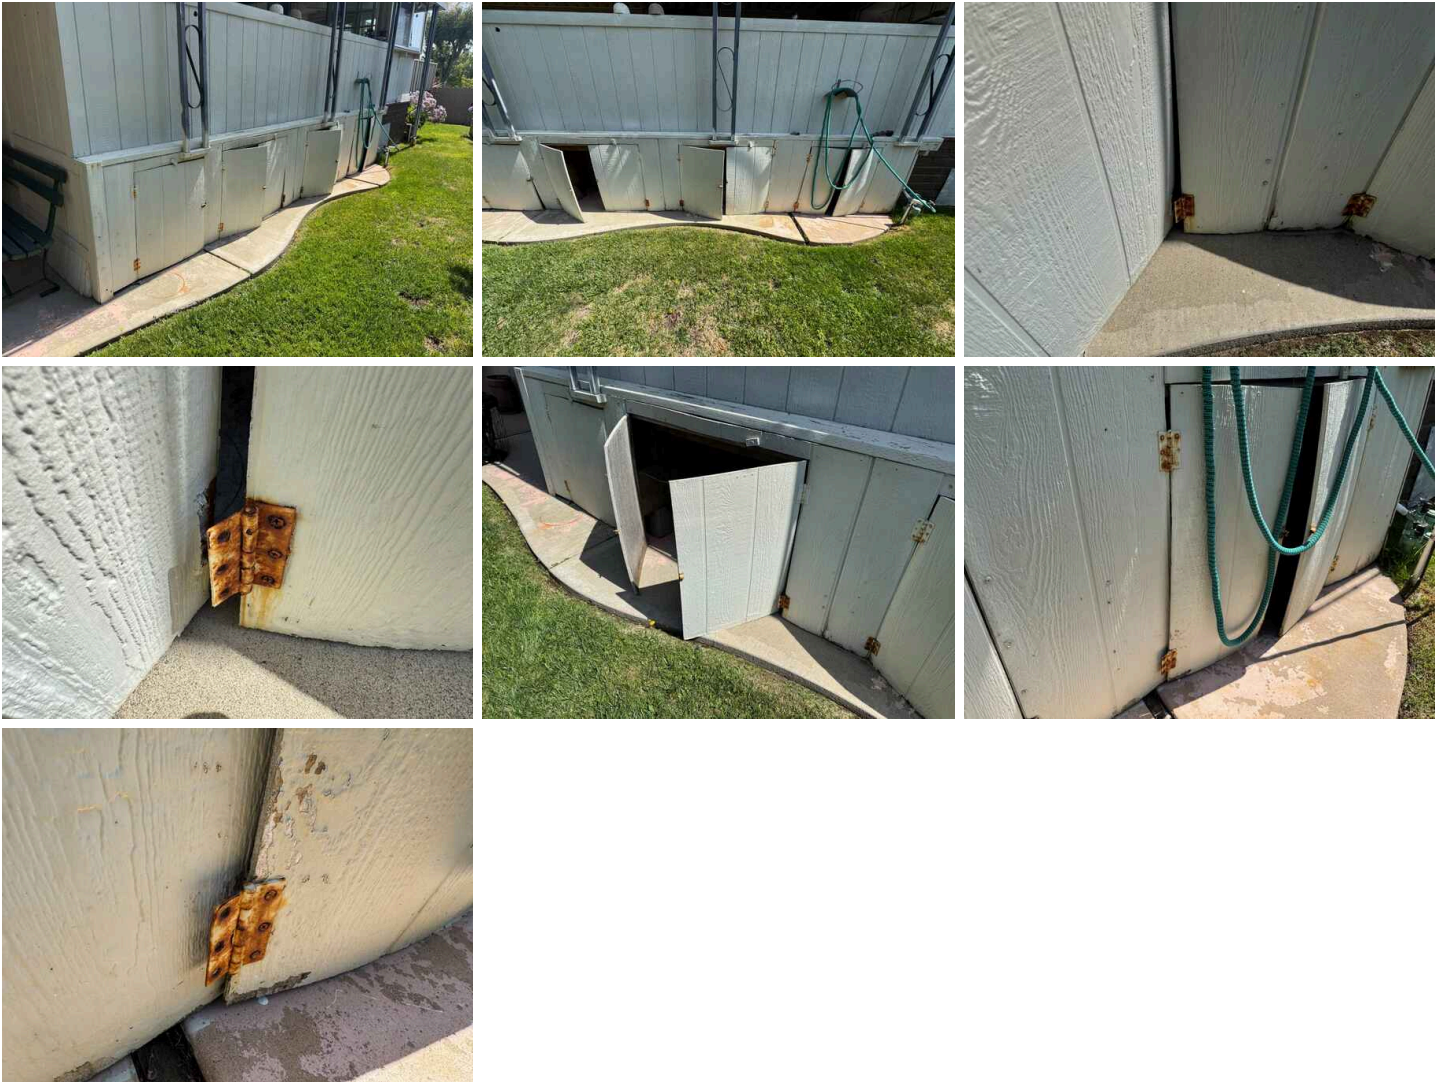
4.3.2 Skirting

**DAMAGED SKIRTING ACCESS DOORS**

The skirting access doors and hinges on the south side of the exterior are damaged. I recommend evaluation by a licensed contractor.

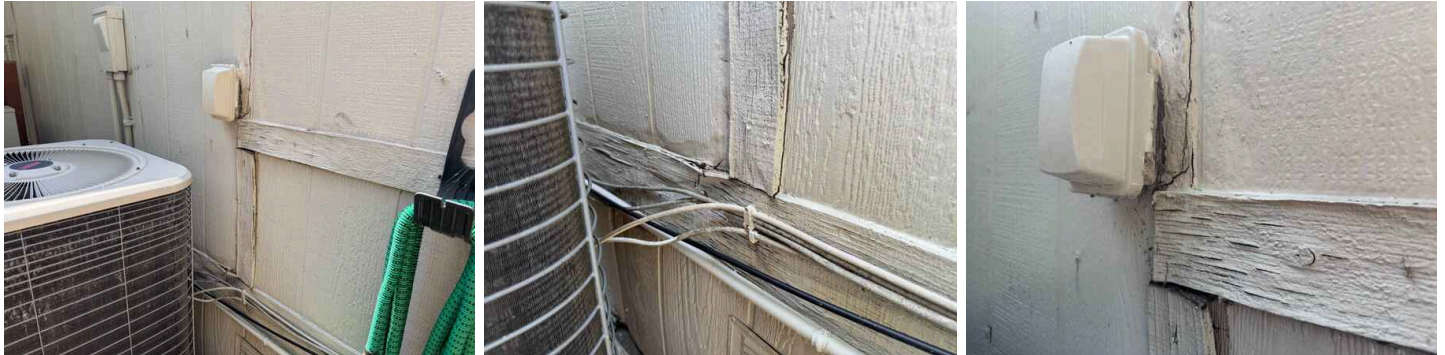
## 4.5.1 Exterior Trim

**MOISTURE/INSECT DAMAGE**

There is moisture and/or insect damaged trim at the exterior trim, rafter tails, and fascia. I recommend evaluation by a licensed contractor. Refer to a qualified structural pest control report for additional information.

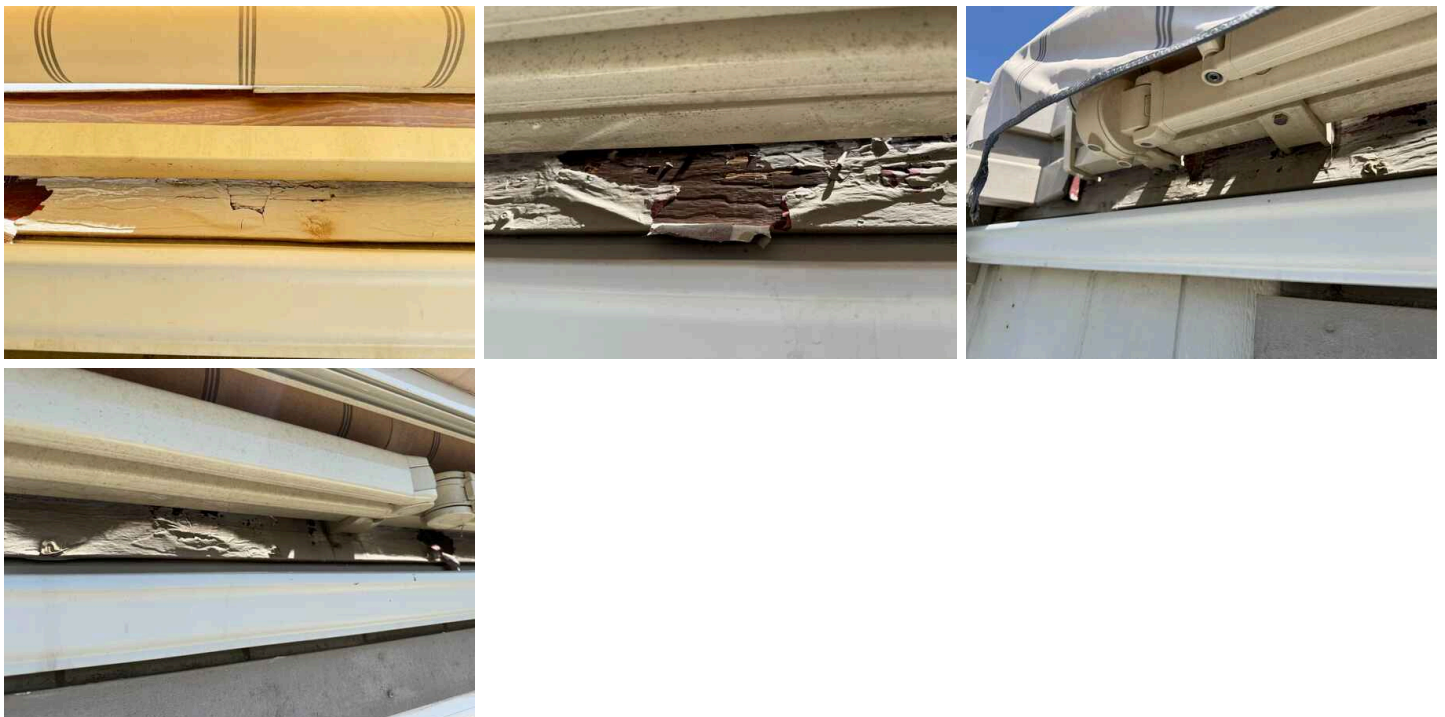
## 4.5.2 Exterior Trim

**MOISTURE/INSECT DAMAGE 2**

There is moisture and/or insect damaged trim at the exterior trim, rafter tails, and fascia. I recommend evaluation by a licensed contractor. Refer to a qualified structural pest control report for additional information.

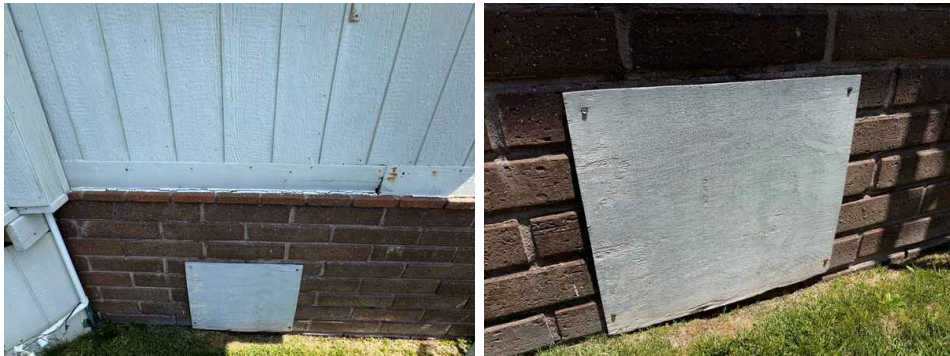
##### SOUTH SIDE OF HOUSE

The crawl space under the south sitting room was inaccessible due to an obstructed access panel (bolts are rusted into the masonry). This section does not connect to the main home's crawl space. The foundation for this part of the house was not visible or accessible and was not evaluated.

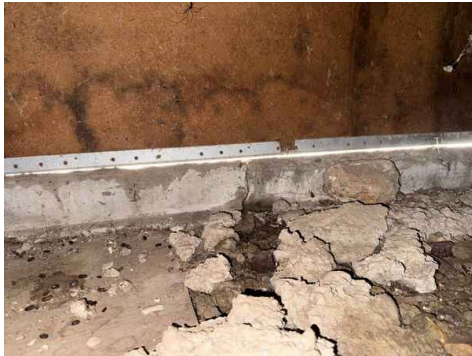
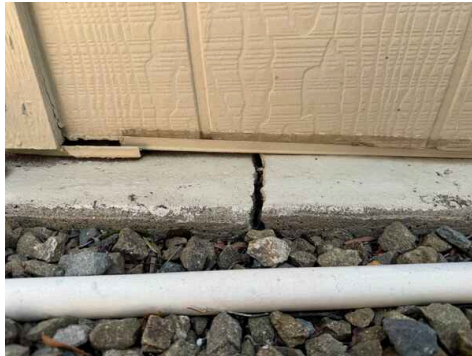
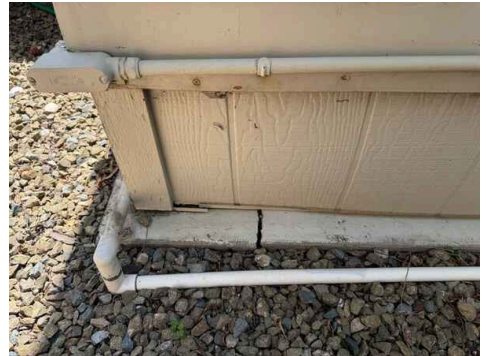
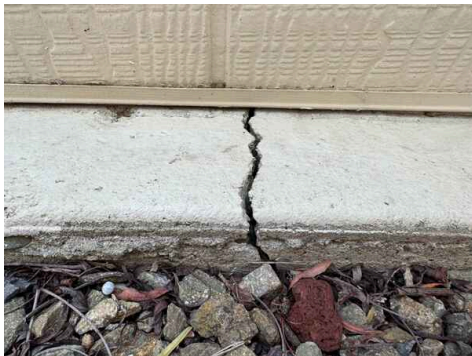
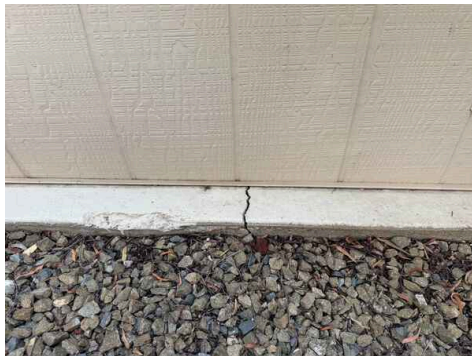
## 5.2.2 Foundation

**CRACKS IN CONCRETE STEM WALLS**

There is some cracking in the stem walls in the Northwest corner of the house. I recommend evaluation by a licensed contractor.

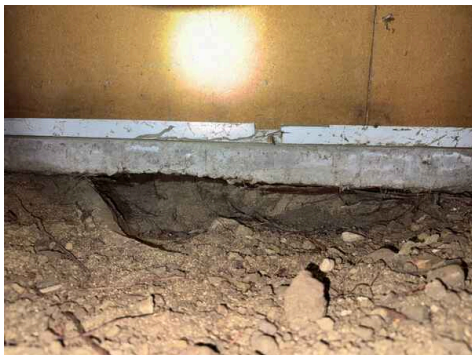
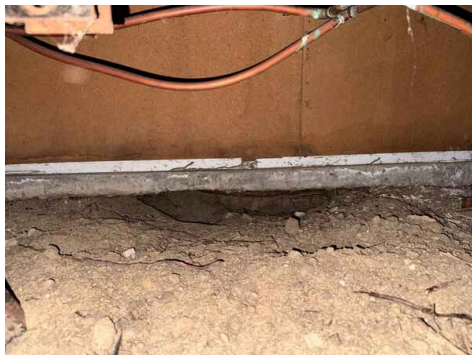
## 5.2.3 Foundation

**DIRT TO CONCRETE GAP**

There is a noticeable gap between the soil and the interior edge of the perimeter concrete foundation/skirting support on the South side of the crawlspace. I recommend evaluation and repair by a licensed contractor.

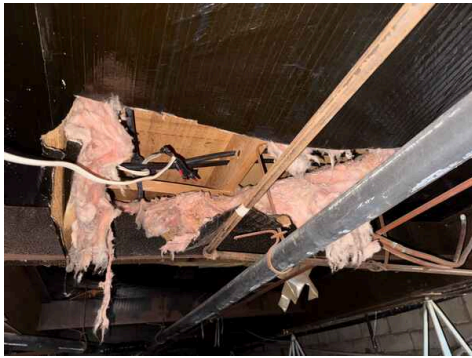
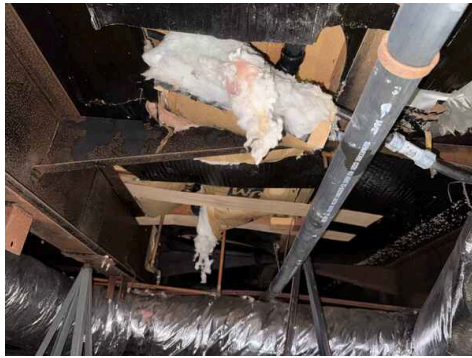
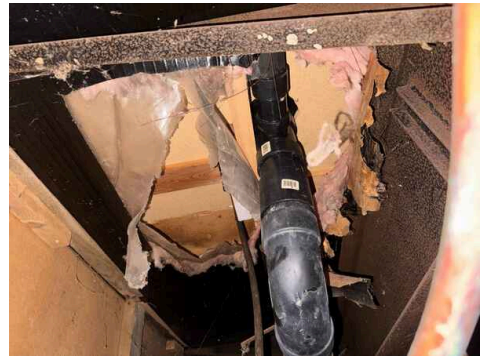
## 5.3.1 Crawl Space

**DAMAGE/HOLES IN BARRIER**

There are holes in the barrier under the home. I recommend evaluation by a licensed contractor.

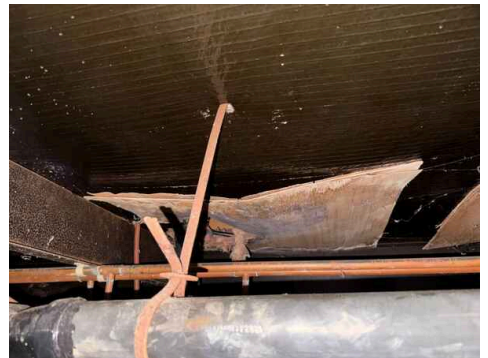
## 5.3.2 Crawl Space

**MOISTURE STAINING ON THE BARRIER**

There is moisture staining on the plywood barrier. I recommend evaluation by a licensed contractor.

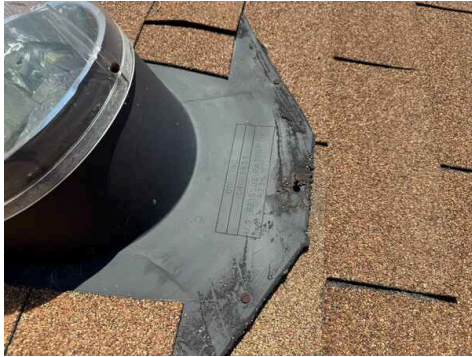
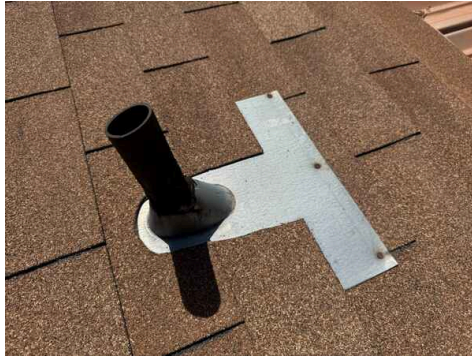
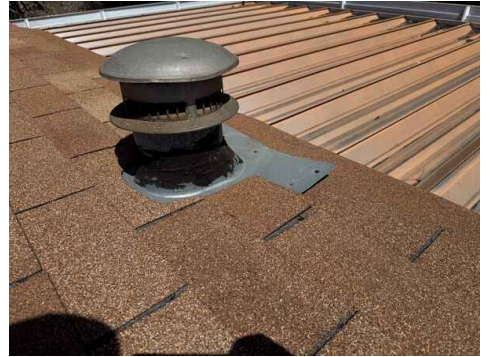
### 6.2.1 Roof Flashings and Penetrations

There are exposed fasteners (nails) on the flashings on the roof. I recommend repair by a licensed roofing contractor.

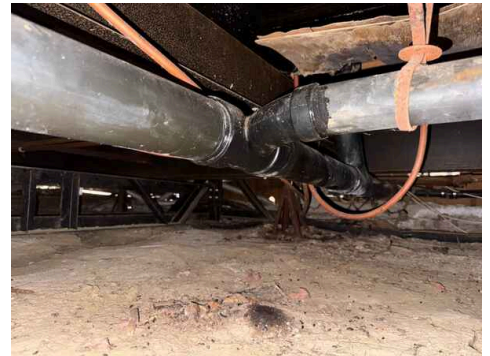
**Observations:****7.4.1 Waste Piping****LEAK AT WASTE PIPING****CRAWLSPACE**

There is a leak at the waste piping within the crawl space under the hallway near the hall bathroom. The ground is wet in this area. I recommend evaluation and repair by a licensed contractor.

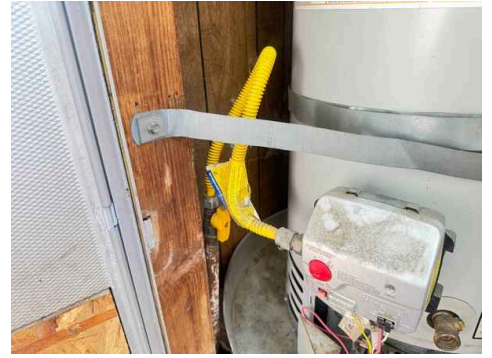
### WATER HEATER

A sediment trap has not been installed at the gas supply to the water heater. I recommend evaluation by a licensed plumbing contractor.

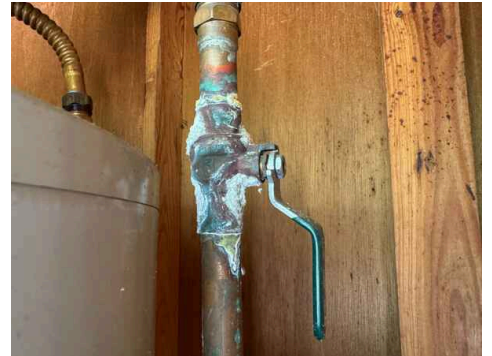
### 8.10.1 Water Shut off Valve

## **SHUT OFF VALVE CORRODED**

There is heavy corrosion at the cold water shut off valve above the water heater. I recommend evaluation by a licensed plumbing contractor.

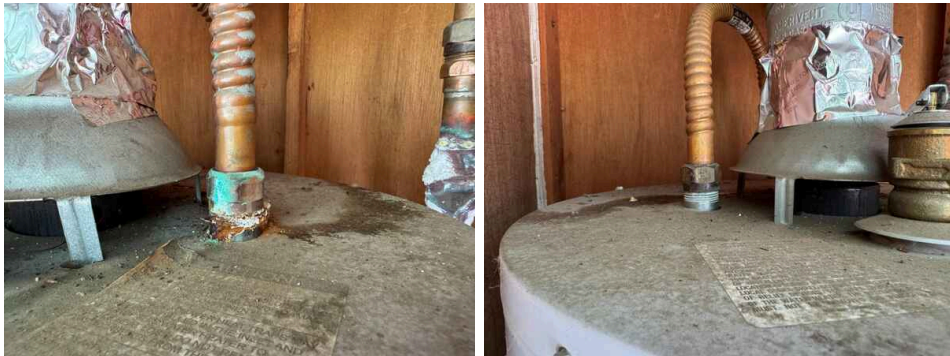
### 8.11.1 Water supply connections

## **RUST/CORROSION AT WATER SUPPLY CONNECTIONS**

There is rust and/or corrosion at the water supply connections above the water heater. I recommend evaluation by a licensed plumbing contractor.

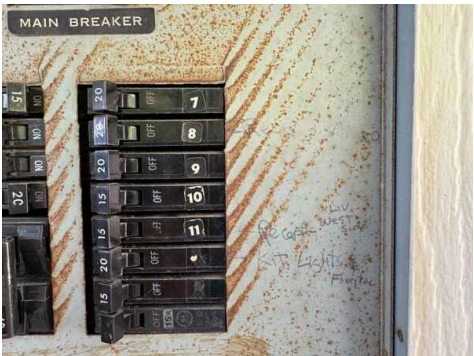
SUBPANEL

There are some unlabeled breakers within the subanel. I recommend evaluation by a licensed electrical contractor.

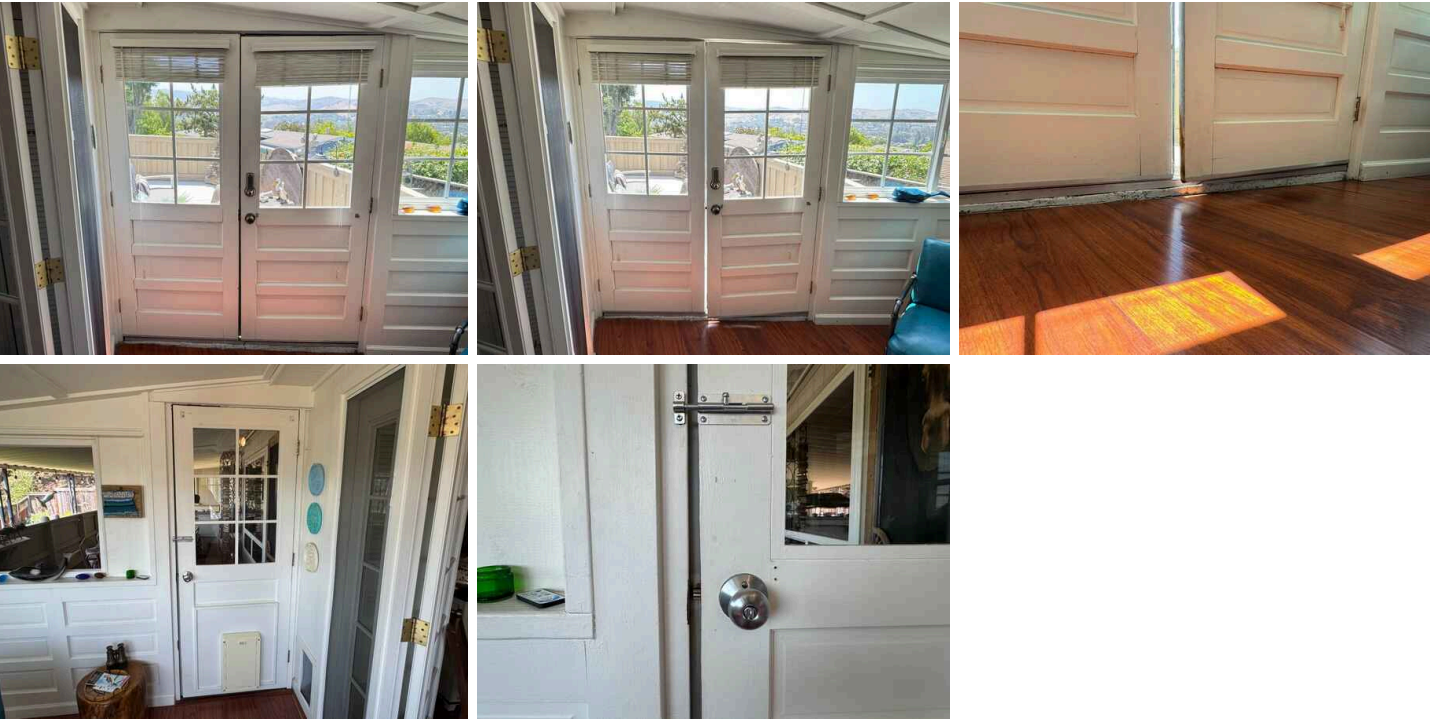
SOUTH SITTING ROOM

The French doors in the South sitting room are sagging and does not close properly. I recommend evaluation by a licensed door and window contractor.

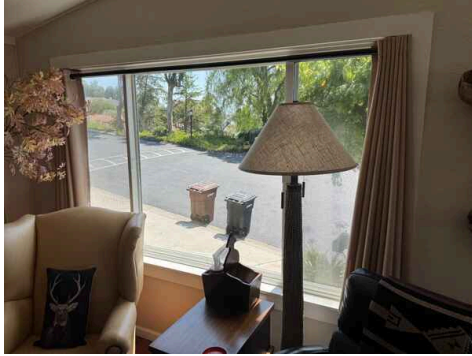
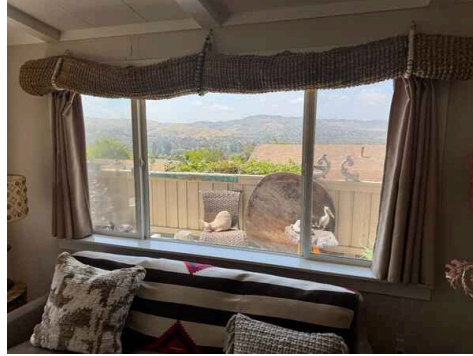
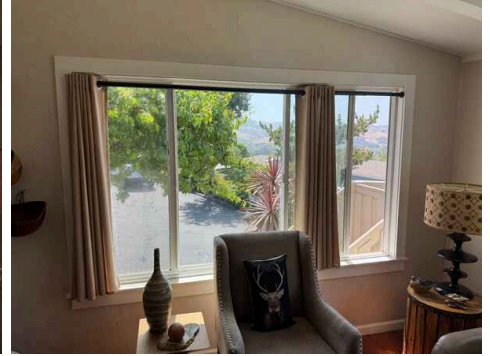
## 11.4.1 Windows

**FAILED WINDOW SEALS**

There appears to be moisture between the glass panes at the six moveable windows in the Family Room. This condition occurs when the seals separating the glass panes fail, allowing moisture vapor into the space between the glass. I recommend evaluation by a licensed window contractor.

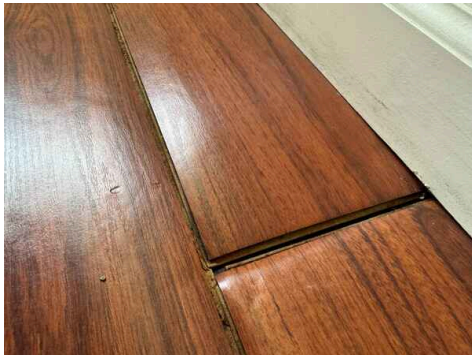
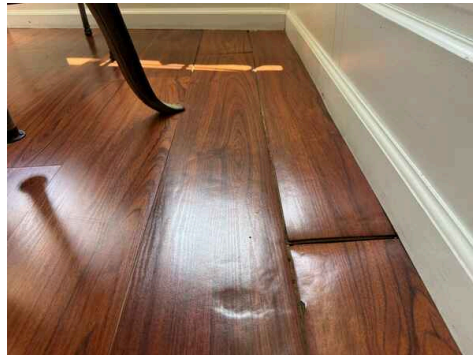
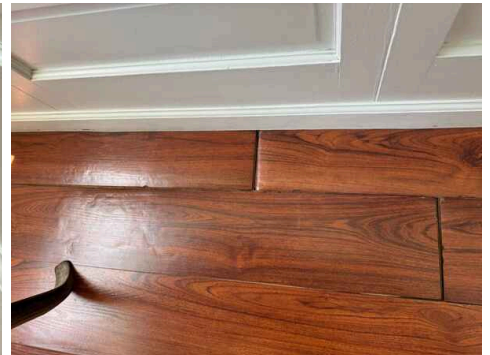
## 11.5.1 Floors

**MOISTURE DAMAGE**

There appears to be moisture damage at the subfloor and baseboard. I recommend evaluation by a licensed contractor.

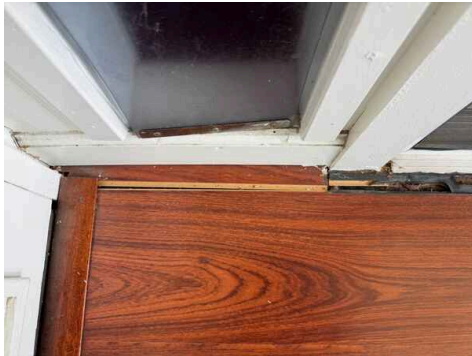
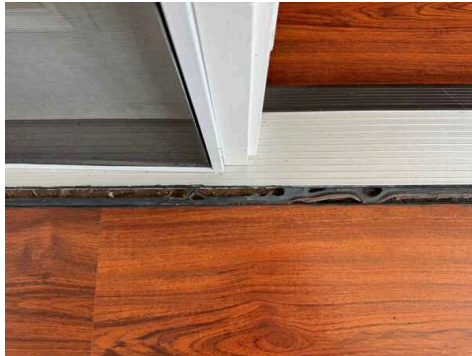
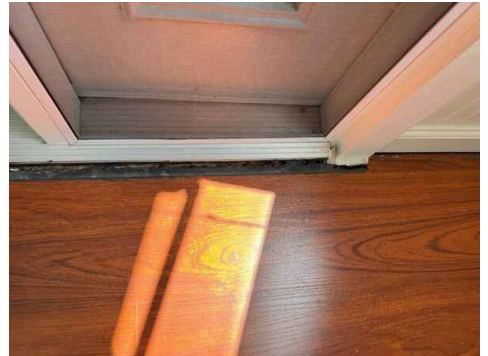
## 11.5.2 Floors

**FLOOR SEPARATON**

The Floor of the South Sitting room appears to be separating from the main structure. I recommend evaluation by a licensed contractor

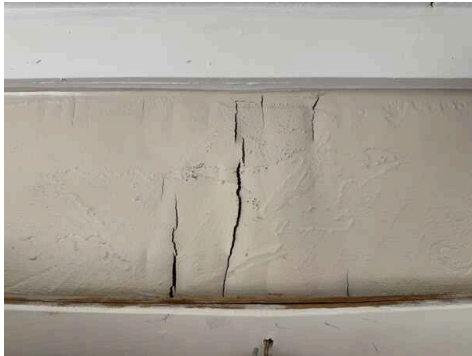
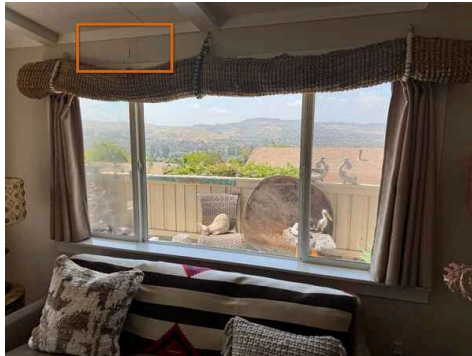
## 11.6.1 Interior Walls

**MOISTURE DAMAGE**

There appears to be moisture damage on the Family Room Wall, directly behind the exterior retractable awning. I recommend evaluation by a licensed contractor.

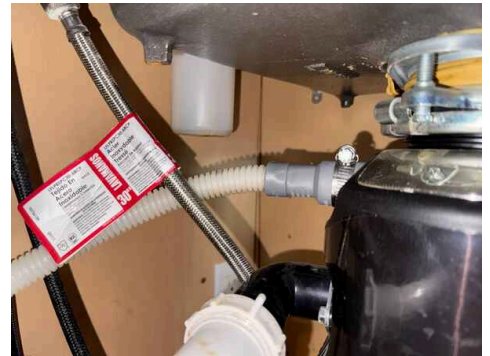
##### UNDER KITCHEN SINK

The dishwasher drains into the garbage disposal without going through an air gap device. An air gap device prevents waste products from backing up into the dishwasher. I recommend evaluation by a licensed plumbing contractor.

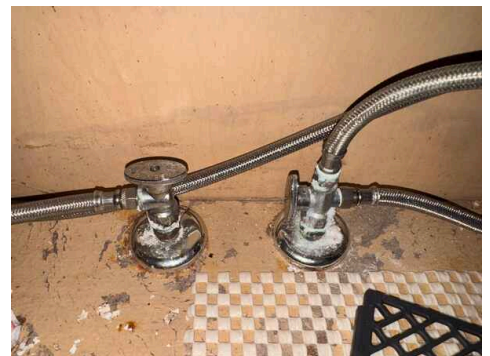
### 12.3.2 Kitchen Sink Plumbing

#### **CORROSION AT ANGLE STOPS**

There is corrosion at the angle stop valves within the cabinet below the sink. I recommend evaluation by a licensed plumbing contractor.
