# ***Cornerstone Inspection***

## **Property Inspection Report**

***5990 Sunny Glenn Lane, Paso Robles, CA 93446***

***Date of Inspection: 6/17/2025 Time: 9:00 AM***

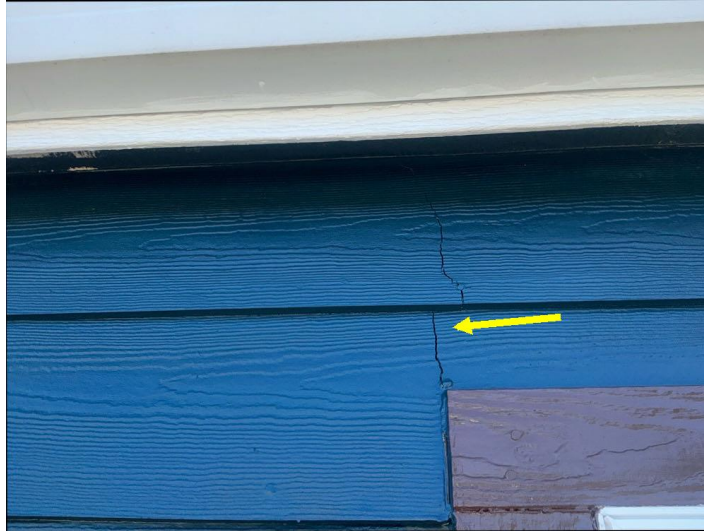
There are stress fractures at some cement-fiber planks that should be serviced.

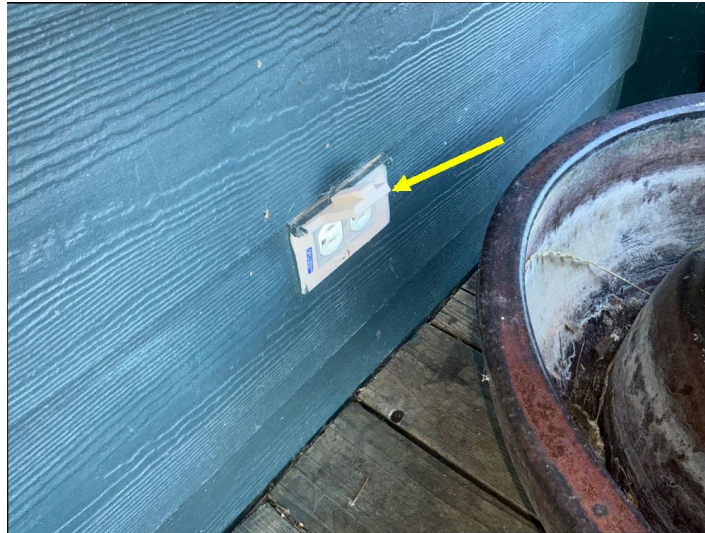
Some of the exterior electrical outlets do not have a weather rated cover or the cover is damaged and should be serviced.

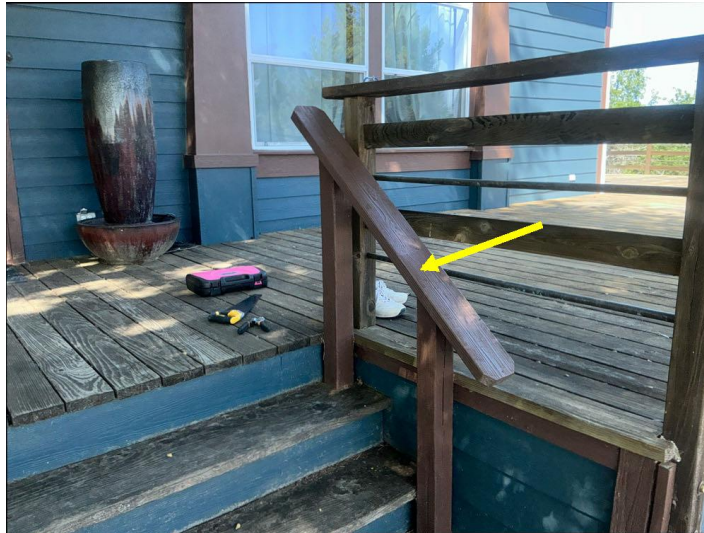
The handrail does not meet current standards as graspable, meaning fingers and thumb can rap around or into grooves so a hand would not easily slip off the handrail.

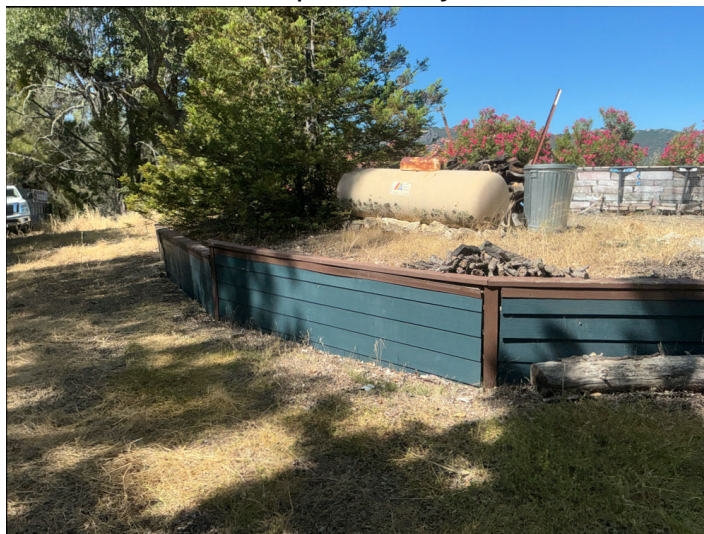
The wooden planks at the rear of the property have no structural value, and are intended to inhibit surface soil movement, and should be periodically monitored for damage or stability.

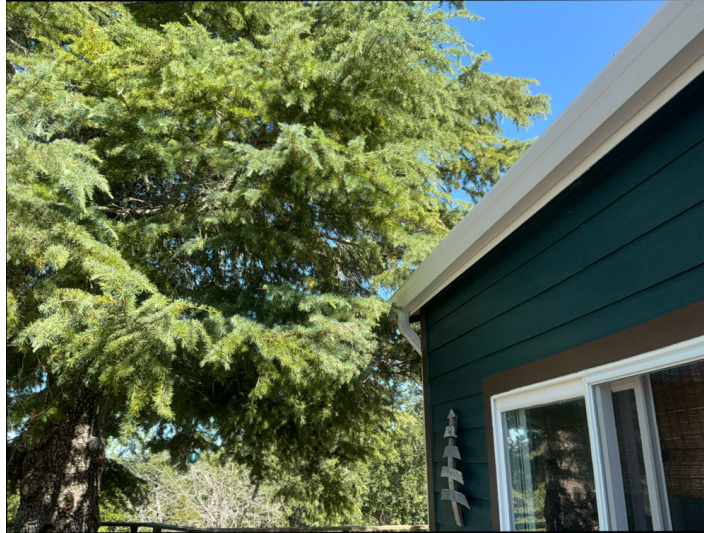
There are tree limbs overgrowing the residence that should be trimmed or monitored, to insure that they do not impact of damage the roof or its components.

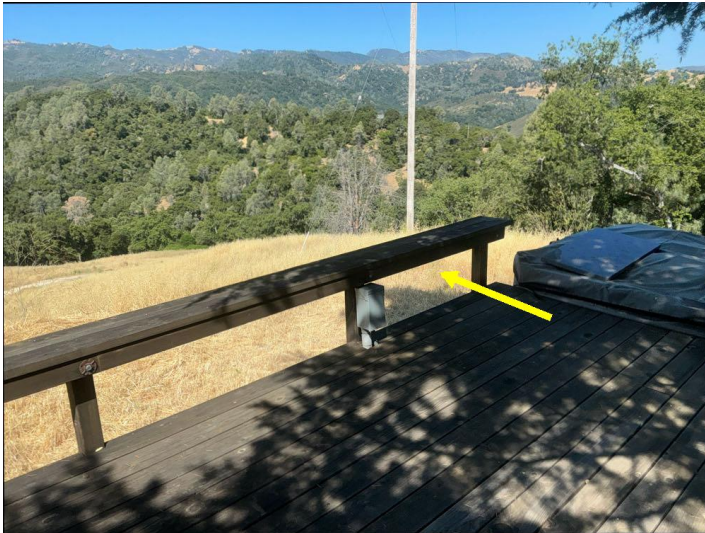
There are areas of this property that do not have guardrails, which are required for walk-offs greater than thirty inches, and appropriate precautions should be taken to safeguard children and the elderly.

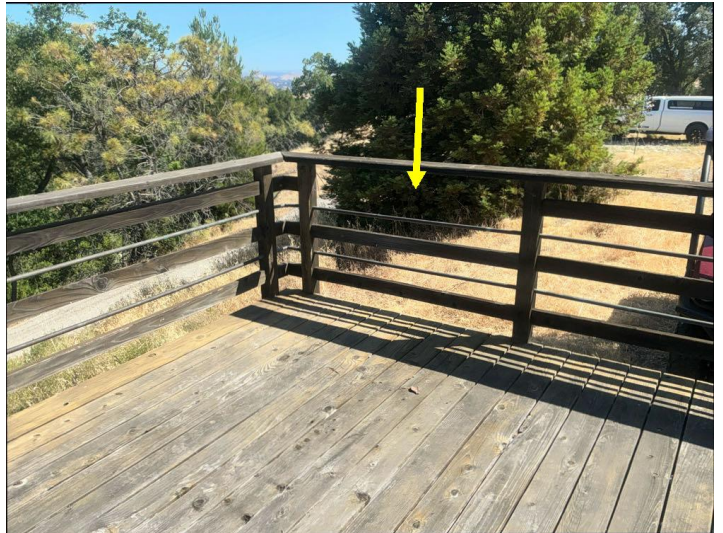
There is damage to the wood guardrail that should be serviced.

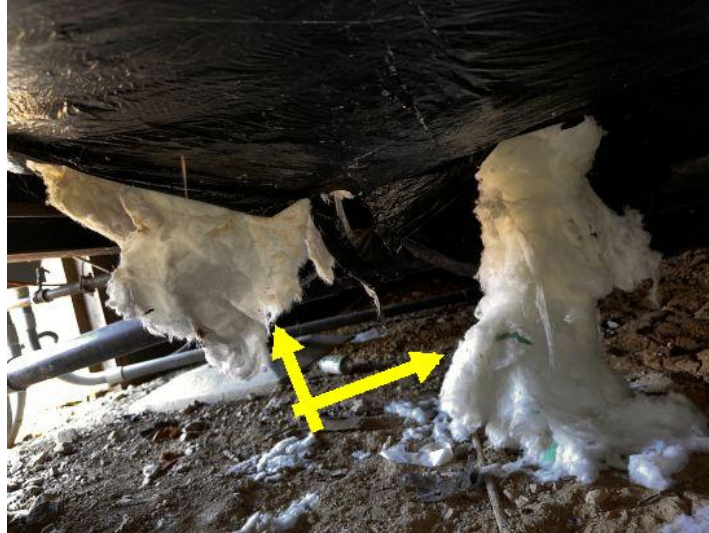
1.11. The rodent barrier has voids or openings that should be sealed. This could also imply that there has been some leaks or plumbing repairs done in the past. You may want to ask the seller regarding this issue.

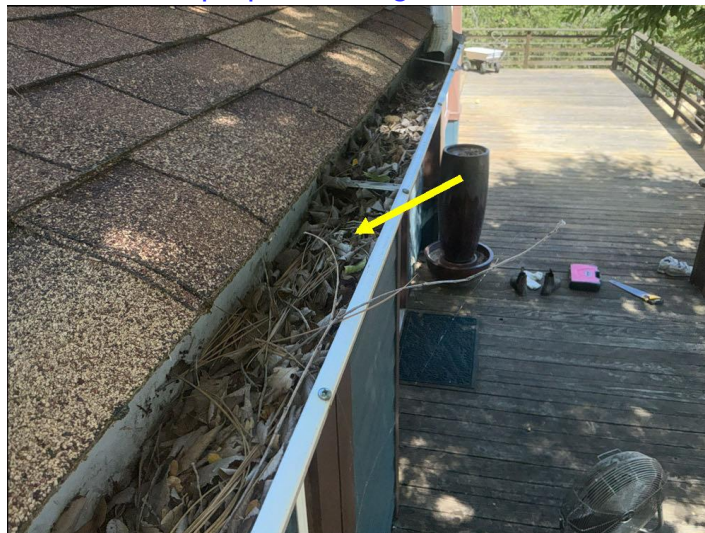
We recommend that you install gutter guards to restrict leaves and other debris from entering the gutter system, which could restrict proper drainage.

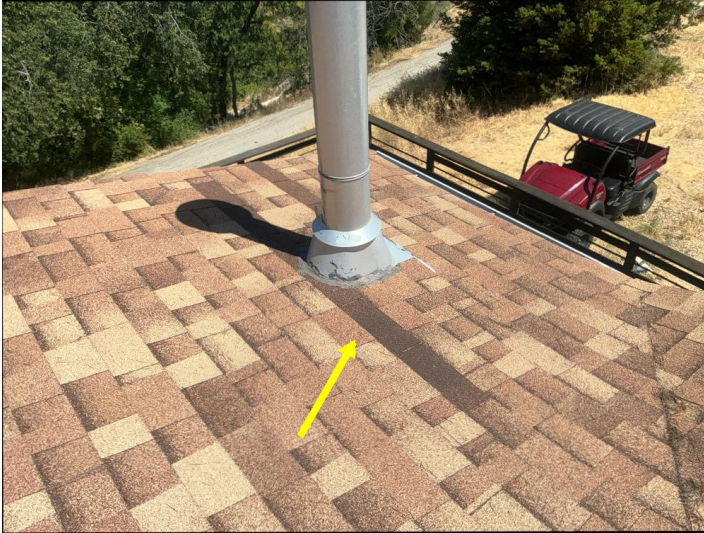
We observed repairs done to the roof that should be explained by the sellers as to why these repairs were needed.

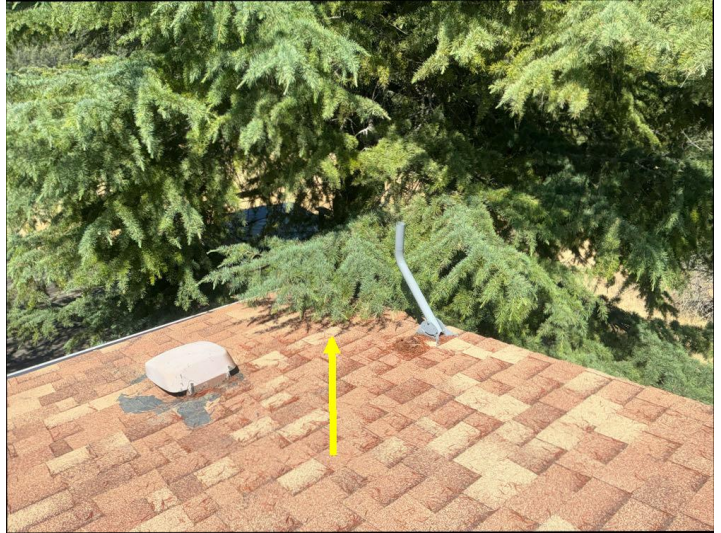
The roof needs to be cleaned and any foliage trimmed away to promote and insure proper drainage.

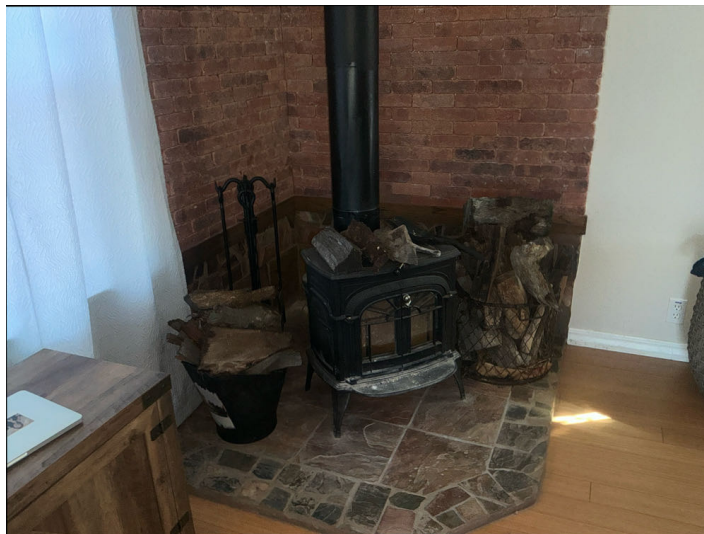
The residence includes a modern reproduction of a free-standing metal chimney and fireplace, which is functional. However, you should obtain the installation permit, and any other relevant documents that would instruct you in its proper use and maintenance.

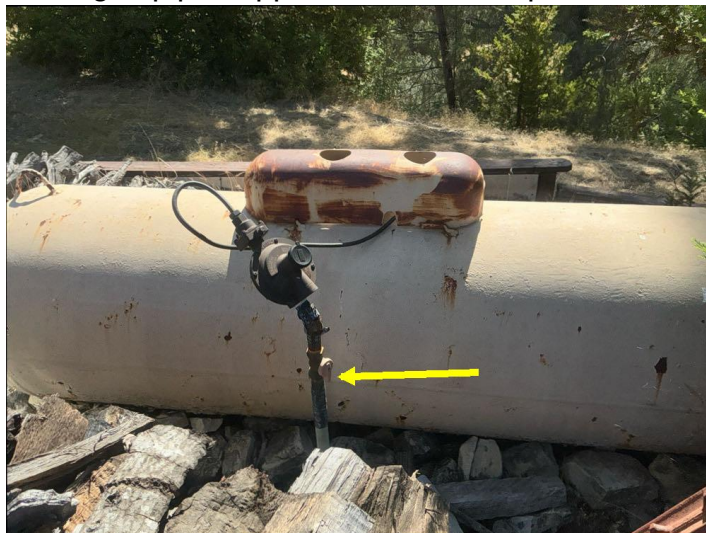
The gas shutoff is located at the propane tank, which is not ideal and you may want to add a shut-off valve at the house.

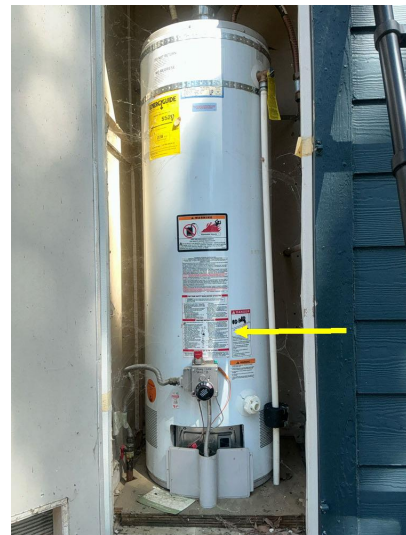
The water heater is not correctly secured, and needs to be seismically strapped and braced in accordance with local standards.

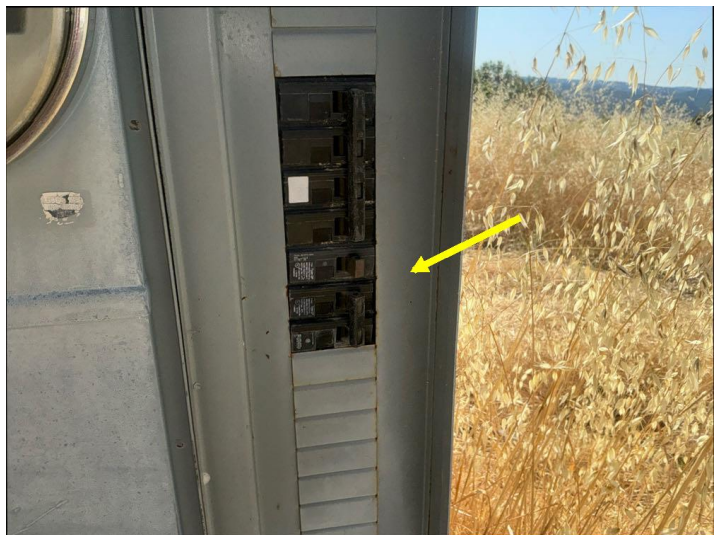
Various circuits are not labeled, which is recommended.

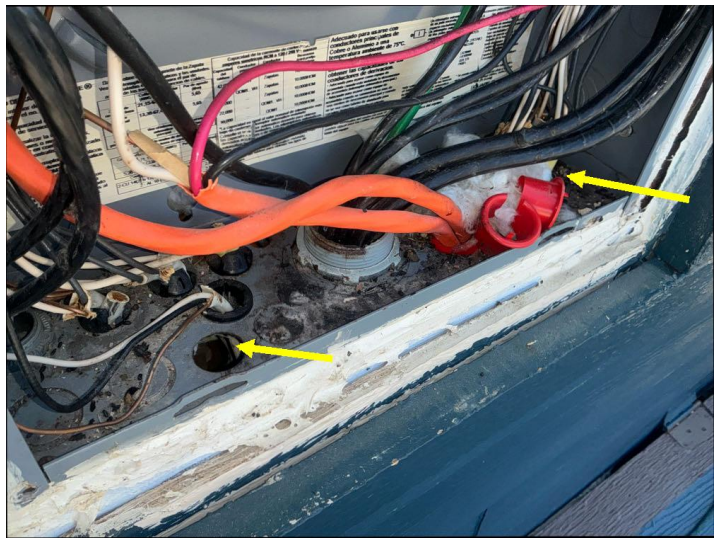
There are open knockouts that is allowing animal activity. We recommend further evaluation by a qualified licensed electrical contractor and serviced as needed.

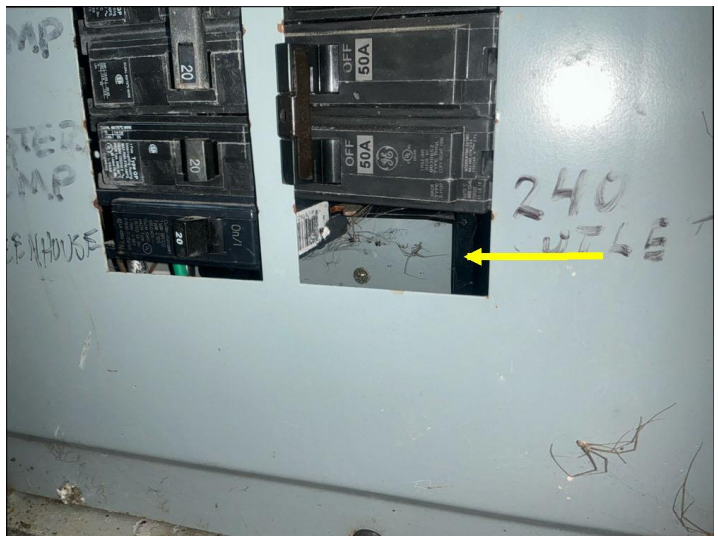
| Page 23 Item: 3 | Sub Panel #2 Observations | 3.10. The interior panel cover has voids, or open knock-outs that should be covered, could prove to be hazardous to small children. |

The interior panel cover has voids, or open knock-outs that should be covered, could prove to be hazardous to small children.

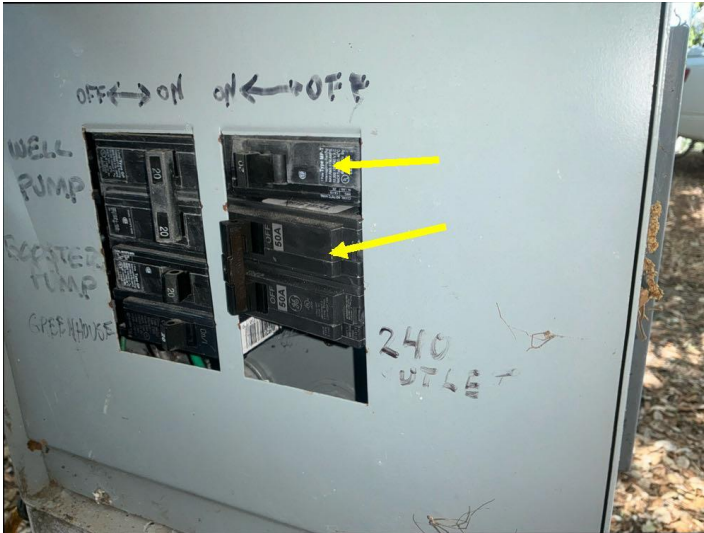
Various circuits within the sub-panel are not labeled, and should be serviced by an electrician so that the appropriate load calculations and breaker sizes could be determined.

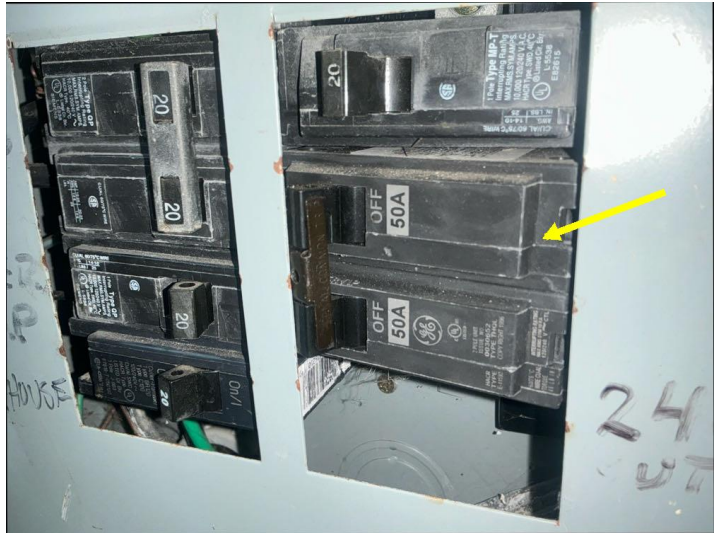
A 50 circuit breaker is not properly installed and should be serviced by a qualified licensed electrical contractor.

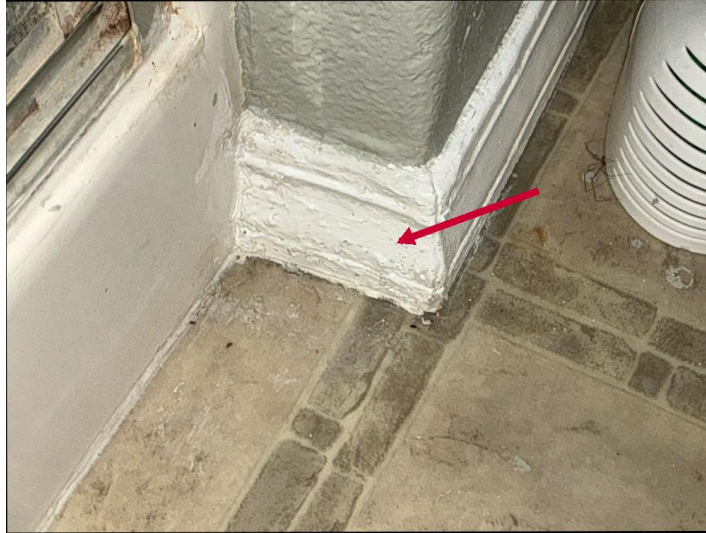
The baseboards adjacent the shower are moisture damaged. We recommend they be removed and further evaluated to insure the moisture damage does not extend deeper into the wall.

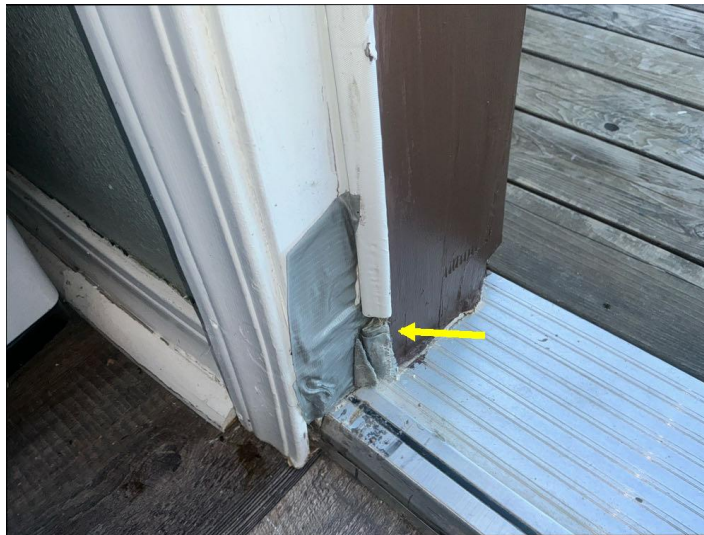
The exterior door is functional but some weather stripping is damaged and could be subject to moisture intrusion especially during wind driven rain. We recommend it be serviced to be weather tight.

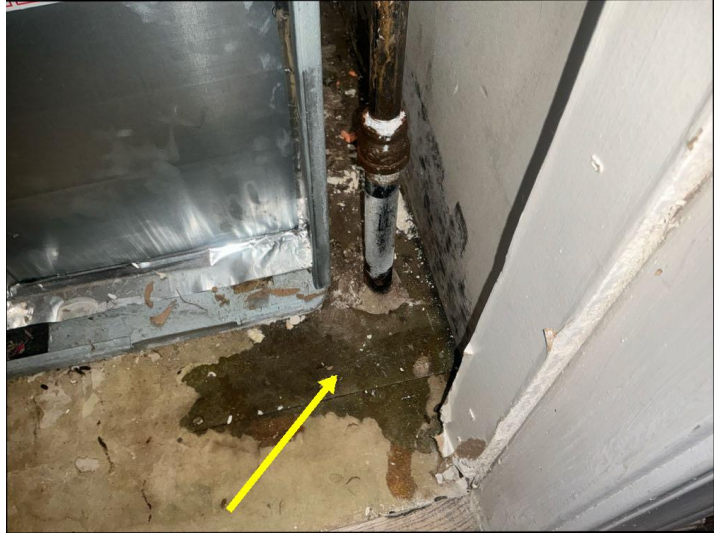
There is a moisture stain on the wall that should be explained or explored further. The area is currently dry.

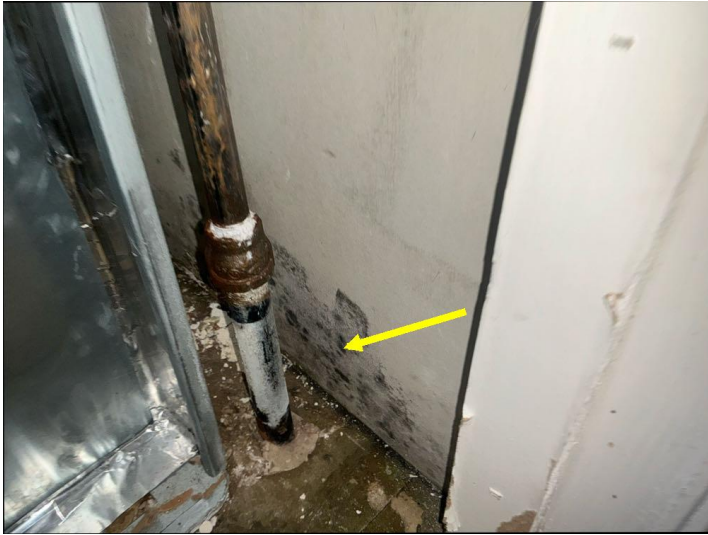
There is a bio-organic substance adjacent the water heater that should be evaluated by a specialist. All molds flourish in a damp environment and many are commonplace, but some are toxic and pose a health risk.

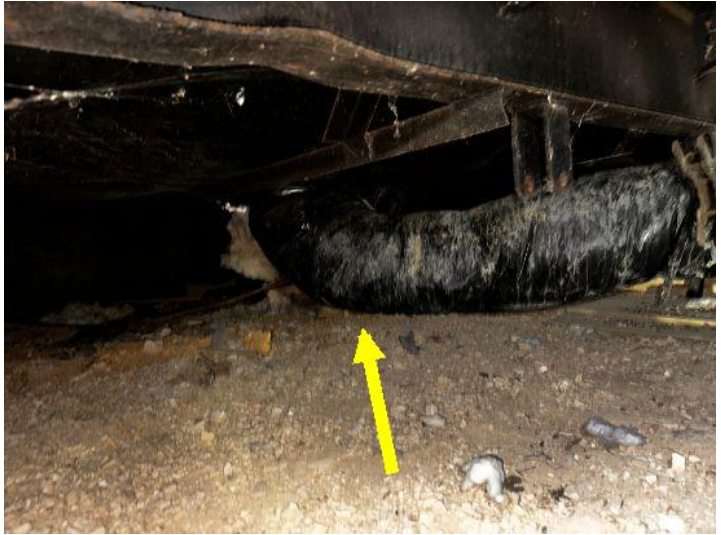
The flexible ducts in the crawlspace are in contact with the soil and should be a minimum of 4" off the ground. The plastic covering will deteriorate when in contact with the soil.

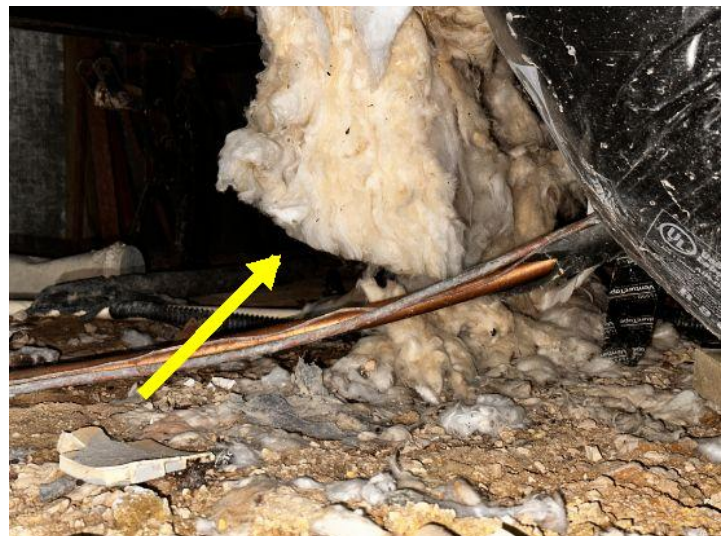
Some pieces of insulation are hanging or have fallen from between the floor joists. This does not have any serious consequences, but you may wish to have it serviced.

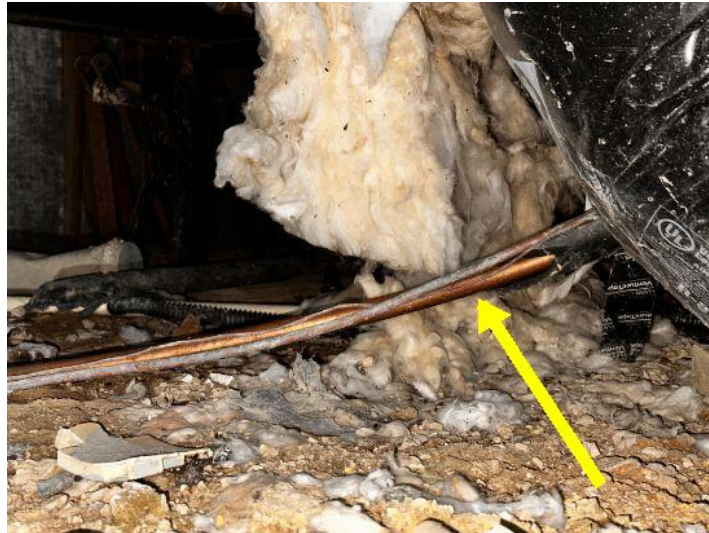
Insulation is missing from the refrigerant lines in the crawlspace, which will allow condensation to form and drip, and should be installed.
