**JG Home Inspections**  
PO BOX 941314  
Simi Valley CA 93094  
805-551-5744  
james@jginspections.com

**Confidential Inspection Report**  
**24713 Choke Cherry Ln**  
**Newhall, CA 91321**

**Prepared for: James & Aalice Tolle**

September 13, 2025

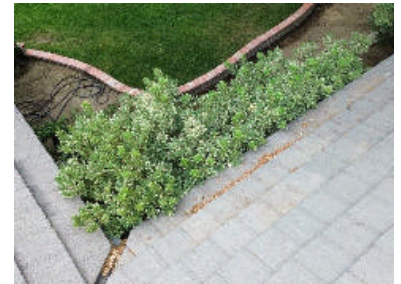
1.6 Bushes and Shrubs Condition: **Attention Needed** - The shrubs and/or bushes need to be trimmed or maintained. Bushes and shrubs need to be trimmed away from the structure at least 2 inches. This space is needed to prevent direct access to the structure by insects and to keep the bushes from damaging the siding.

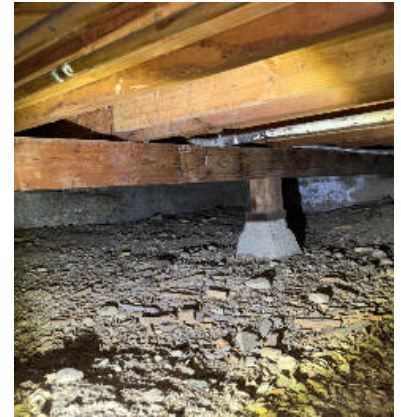
**Attention needed-** Efflorescence was observed on foundation walls in one or more areas. It is caused by past or present deficiencies with the site drainage . Proper grading, surface water control and waterproofing surrounding areas is recommended. If further information is desired I recommend consulting with a qualified and licensed drainage professional.

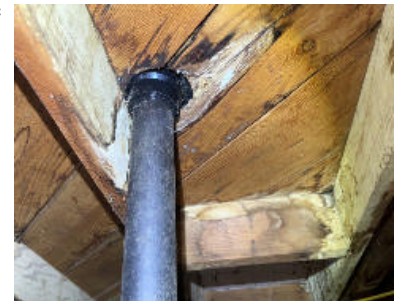
3.15 *Main Beam/Subfloor:*

Dry moisture staining at subfloor observed. Signs of prior leaking.

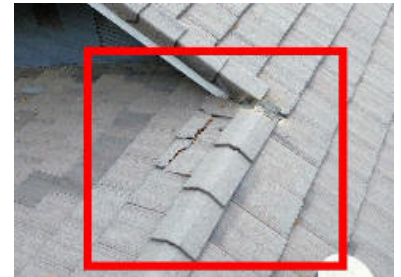
4.5 Condition of Roof Covering Material: **Action needed-** Cracked, broken and/or loose tiles were noted on the roof. Important that the tiles remain intact to protect the underlayment membrane under the tiles. Refer to a licensed roofing contractor to evaluate this roof , inspect the underlayment to determine it condition and repair/replaced items mentioned as needed.

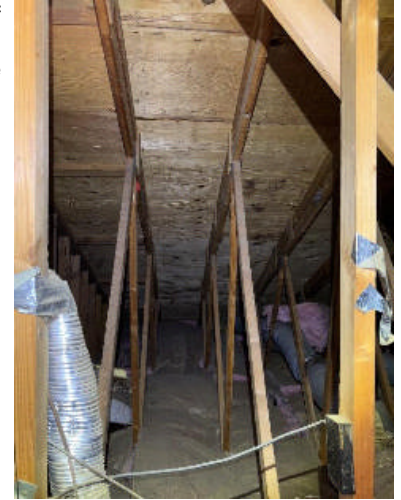
There is water staining on the underside of the roof decking or rafters. The stains are not currently wet nor do they have an elevated moisture content. The inspector was unable to determine if noted leaks have been repaired.

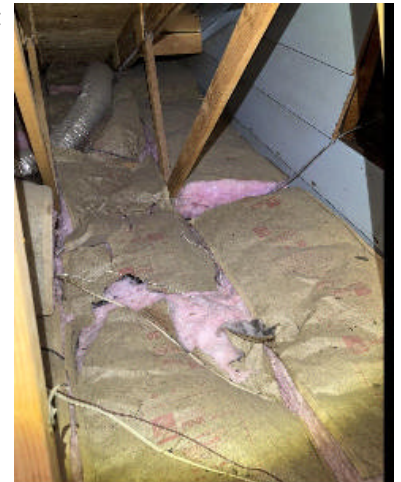
**Attention Needed -** The attic insulation appears not to be correctly installed and should be reinstalled. Paper side should be facing downwards between ceiling. Refer to a qualified professional and/or see manufactures installation instructions.

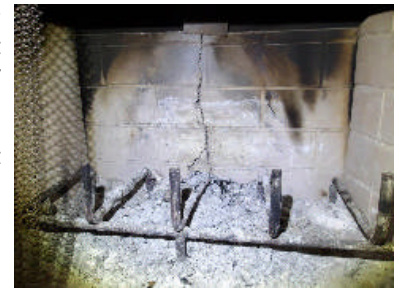
5.17 Fireplace Fuel: Gas capped off at time of inspection. Not tested or verified **Action needed-** Gap around gas inlet that enters firebox not sealed to prevent the potential for heat or a spark from entering the wall cavity and posing a fire hazard. The gap should be sealed all the way around with a high temperature cement before fireplace is used again.

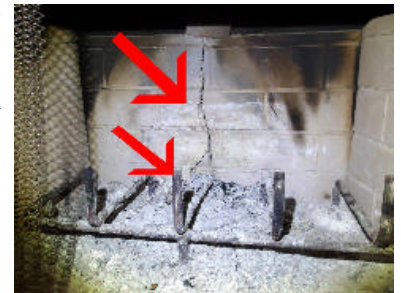
5.18 Firebox Condition: **Action Necessary** - Cracked refractory panels or voids in the firebox may present an unsafe condition during normal usage. The firebox is in a condition that needs cleaning and further evaluation by a professional chimney sweep. Refer to a chimney professional.

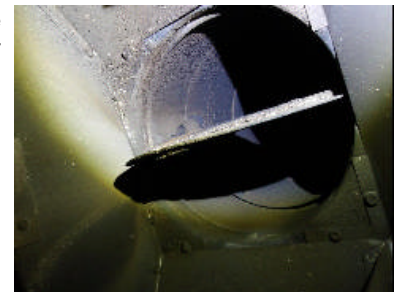
5.20 Flue Condition from Firebox: **Attention Needed** - The visible portions of the fireplace box and flue show evidence of soot and/or creosote build-up. Cleaning and further evaluation by a qualified professional are recommended.

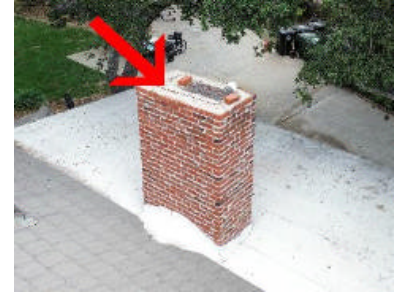
**Attention Needed** - The chimney cap is made of mortar. Its function is to keep water from entering the masonry stack, causing deterioration. This cap needs some repair so that it can function as intended.

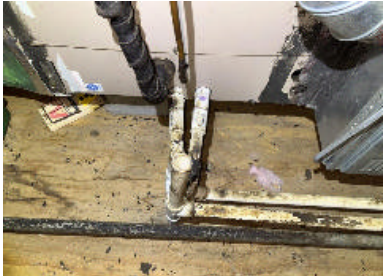
- 6.12 *Condensing Coil Condition:* **Attention Needed** - The condensing coil appears to be dirty, which will reduce the unit's efficiency. Cleaning is needed.
- 6.13 *Service Disconnect:* Satisfactory - The installed service disconnect is located within sight of the condensing coil cabinet and not more than 50 feet from the unit.
- 6.14 *Condensate Line:* **Attention needed-** The unit lacks a secondary drain pan and line that terminates to an approved location under attic installed furnace. A secondary drain pan & line should be installed where condensation could cause structural damage. A moisture switch sensor at secondary drain line connection should be installed as an alternative method if needed. Corrections recommended

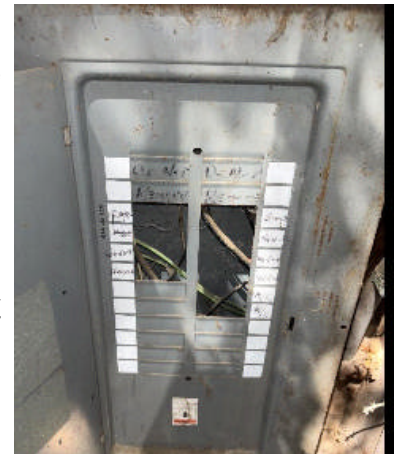
**Action Necessary** - The electrical panel requires further evaluation and repairs by a licensed electrician due to conditions observed. There are missing knock-outs in the panel enclosure. There are open slots in the panel breaker cover where a breaker is missing. The breakers are not all marked as to the rooms, areas, or appliances controlled. It is recommended that they be noted as soon as possible. Electrical modifications and/or alterations have been made to this property. I recommend verifying permits and/or receipts that a qualified & licensed electrician performed work done and/or upgrade.

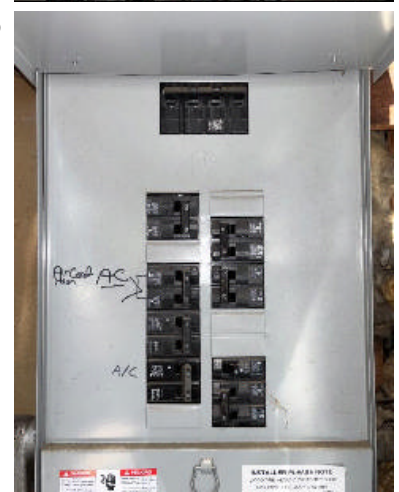
**Action needed-** The breakers are not marked as to the rooms, areas, or appliances controlled. It is recommended that they be noted as soon as possible.

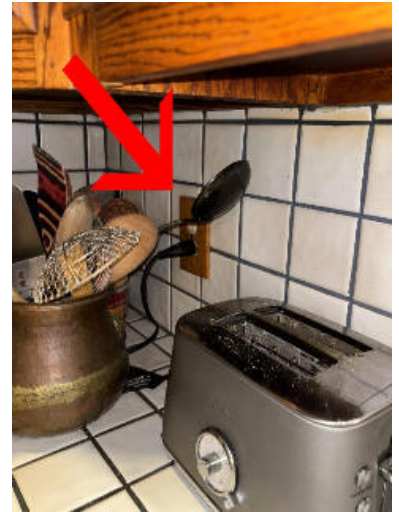
**Action Necessary** - There is no GFCI protection at the counter receptacles. I recommended upgrading all counter receptacles to have GFCI protection. Refer to a licensed electrician.

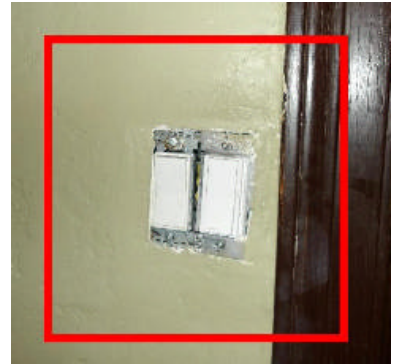
Satisfactory - The light and light switch were functional at the time of the inspection. No light may be present but a half/hot receptacle was verified. Missing cover plate at light switch needs to be installed.

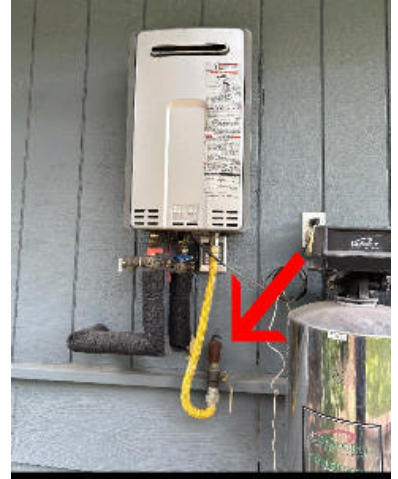
**Attention needed-** There is no sediment trap installed on the incoming gas line to the water heater. Installation of a sediment trap is recommended to prevent debris from getting into the gas valve and required by most manufactures . Refer to a licensed plumber.

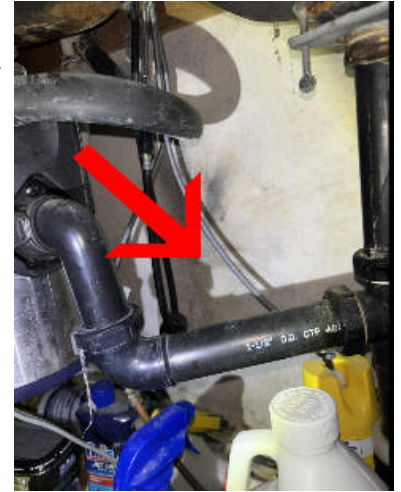
**Attention Needed** - The walls in the kitchen show a condition that needs some attention. Due to stored personal items in the closet(s), pantry(s) and/or under sink area it is not possible to determine the condition of the walls and ceiling that are not visible and/or readily accessible. Dry moisture staining under sink area. No invasive inspection was performed.

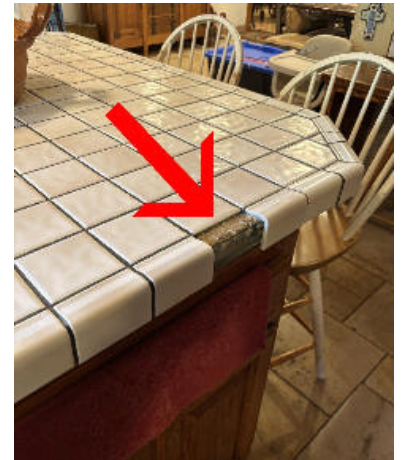
**Attention Needed** - The countertop in kitchen is in need of repair. Cracked & broken tile observed.
