# PROPERTY INSPECTION REPORT

**FOUR POINT**  
HOME INSPECTION INC.

**4960 Glenhill Ln**

**Date of Inspection: 4/29/2026**

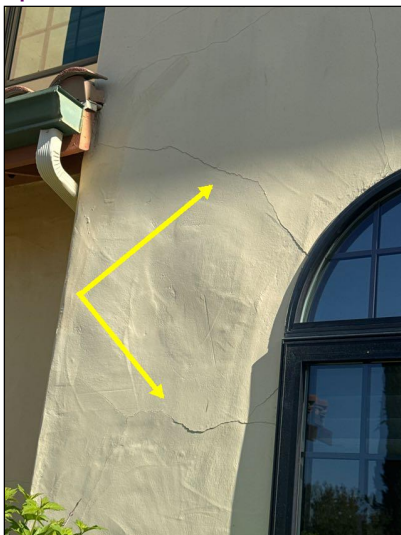
**Monitor:** Normal cracking was visible in stucco covering exterior walls of the home at the time of the inspection.

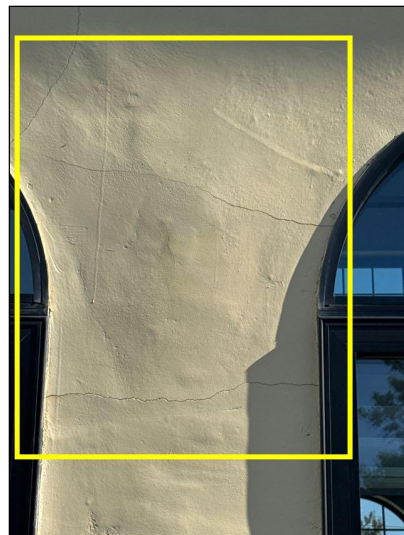
**Monitor:** Normal cracking was visible in stucco covering exterior walls of the home at the time of the inspection.

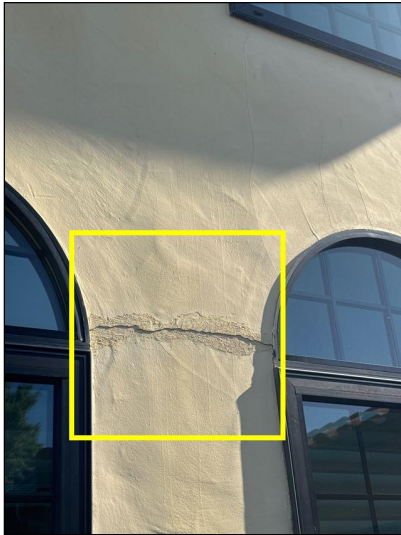
**Monitor:** Normal cracking was visible in stucco covering exterior walls of the home at the time of the inspection.

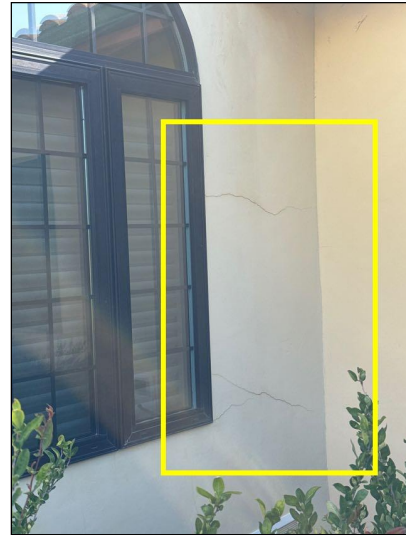
**Monitor:** Normal cracking was visible in stucco covering exterior walls of the home at the time of the inspection.

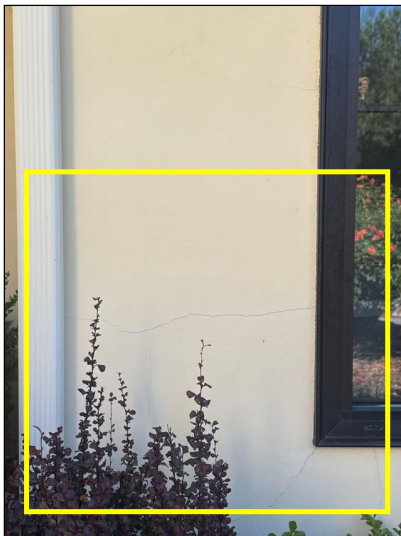
**Monitor:** Normal cracking was visible in stucco covering exterior walls of the home at the time of the inspection.

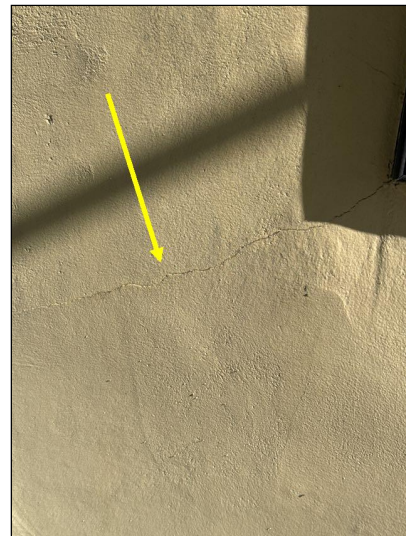
**Monitor:** Normal cracking was visible in stucco covering exterior walls of the home at the time of the inspection.

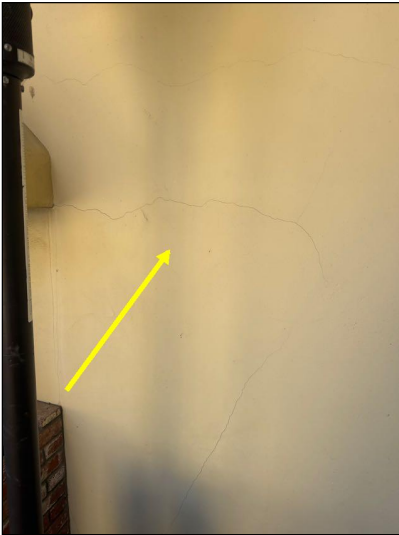
**Monitor:** Normal cracking was visible in stucco covering exterior walls of the home at the time of the inspection.

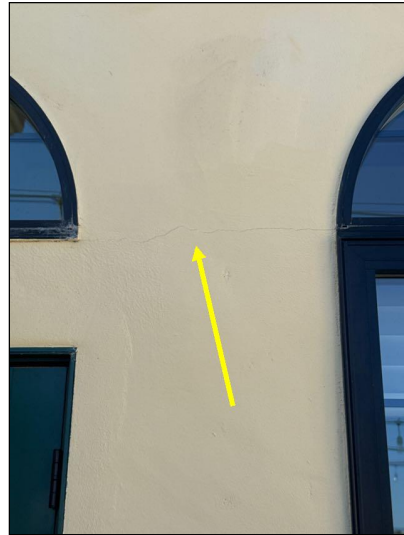
**Monitor:** Normal cracking was visible in stucco covering exterior walls of the home at the time of the inspection.

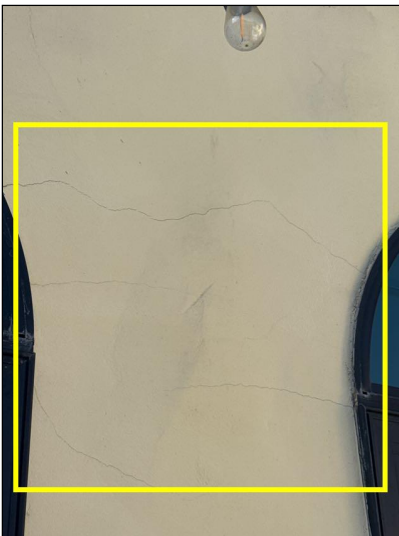
**Monitor:** Normal cracking was visible in stucco covering exterior walls of the home at the time of the inspection.

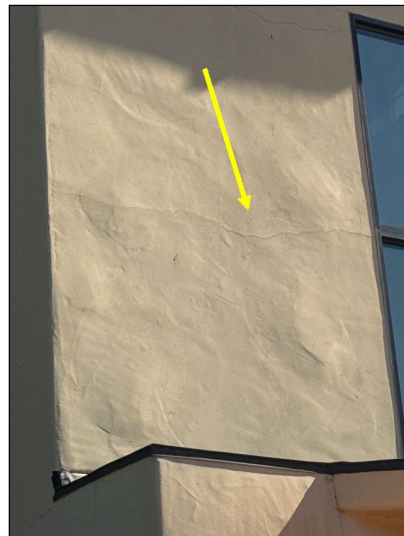
**Monitor:** Normal cracking was visible in stucco covering exterior walls of the home at the time of the inspection.

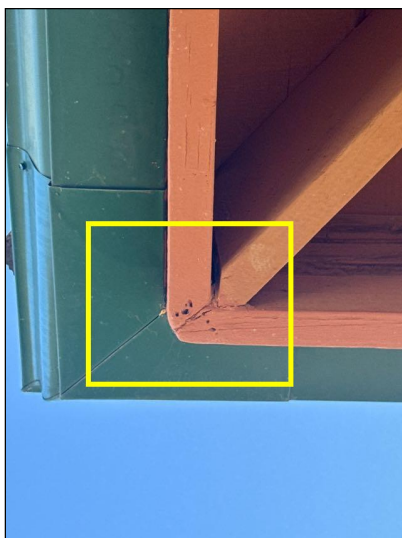
| | Page 16 Item: 3 | Soffits & Fascia | Moisture damage, wood rot, observed. Refer to pest report for further details and repair damage as needed. |

Moisture damage, wood rot, observed. Refer to pest report for further details and repair damage as needed.

Moisture damage, wood rot, observed.

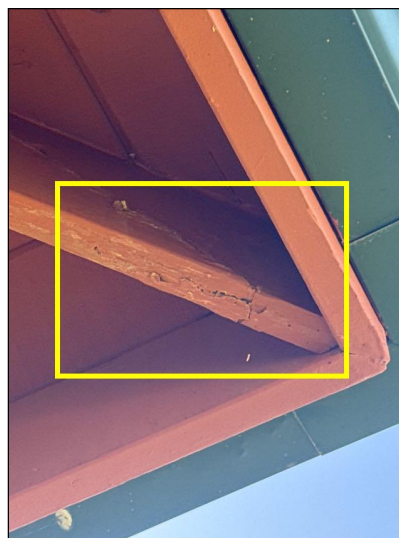
Moisture damage, wood rot, observed.

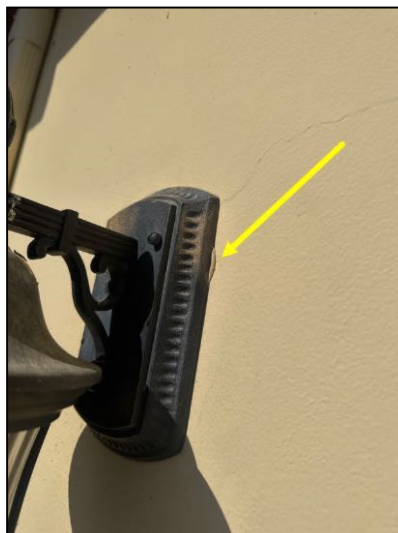
| | Page 20 Item: 7 | Exterior Lighting | Exterior lighting was installed in a manner that left energized electrical components exposed to moisture intrusion. This condition will deteriorate electrical connections and is a potential fire hazard. The inspector recommends correction by a qualified electrical contractor. |

**Exterior lighting was installed in a manner that left energized electrical components exposed to moisture intrusion. This condition will deteriorate electrical connections and is a potential fire hazard. The inspector recommends correction by a qualified electrical contractor.**

Exterior lighting was installed in a manner that left energized electrical components exposed to moisture intrusion. (Front of garage)

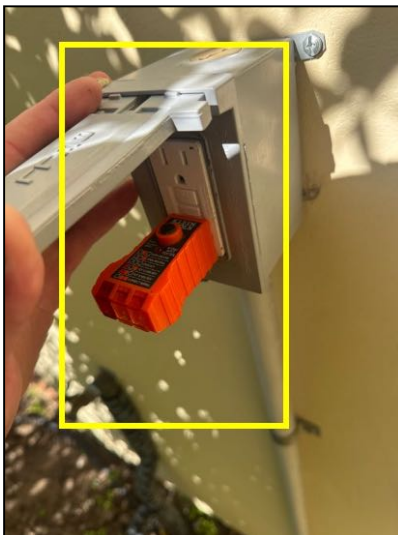
| | Page 21 Item: 8 | Exterior Outlets/GFCI | <b>GFCI</b> electrical receptacle was inoperable at the time of the inspection. The Inspector recommends evaluation and correction by a qualified electrical contractor. |

**GFCI electrical receptacle was inoperable at the time of the inspection. The Inspector recommends evaluation and correction by a qualified electrical contractor.**

GFCI electrical receptacle was inoperable at the time of the inspection. (Left side of front entry)

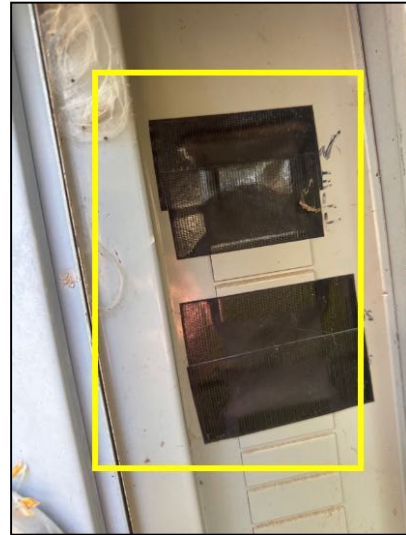
| | Page 26 Item: 2 | Electrical Panel | Unfilled openings in the electrical service panel were covered with tape. This condition is improper, may allow persons to come into contact with energized electrical components, is a potential shock/electrocution hazard and should be corrected by a qualified electrical contractor. |

Unfilled openings in the electrical service panel were covered with tape. This condition is improper, may allow persons to come into contact with energized electrical components, is a potential shock/electrocution hazard and should be corrected by a qualified electrical contractor.

Unfilled openings in the electrical service panel were covered with tape.

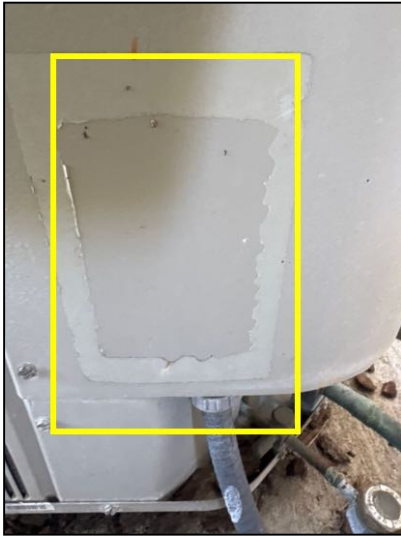
The data plate containing information about this A/C unit was illegible.

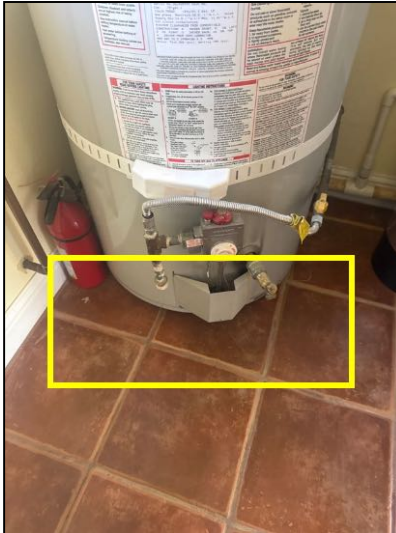
**Improvement:** Although this water heater was installed in a location in which leakage of the tank or plumbing connections would cause damage, no drip pan was installed. A proper drip pan should be installed by a qualified plumbing contractor to prevent possible water damage.

**Improvement:** no drip pan was installed.

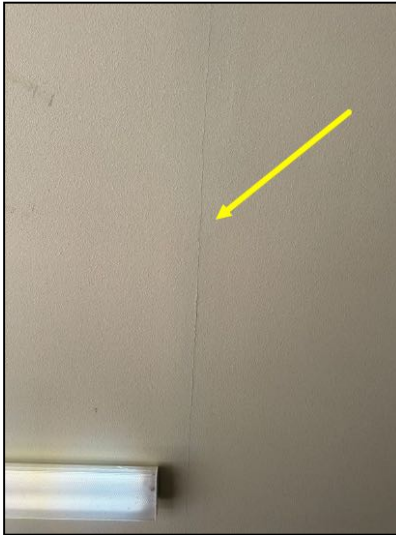
**Monitor:** Normal settlement cracking was visible in interior walls of the home at the time of the inspection.

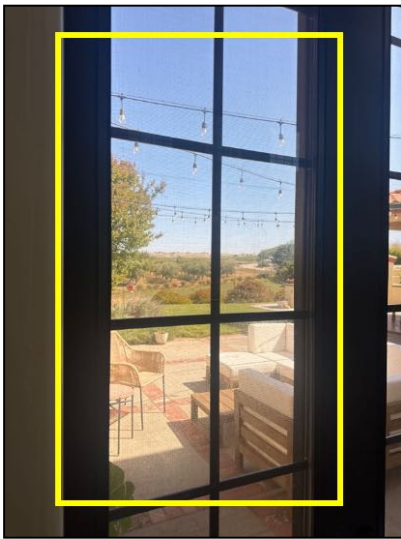
| Interior Areas | | | |
|---|---|---|---|
| | Page 52 Item: 7 | Window Condition | Although no condensation was visible at the time of the inspection, staining and etching of the glass at a window in the Living Room indicated a loss of thermal integrity. Etching of the glass from long-term exposure to condensation constitutes permanent damage. The Inspector recommends that before the expiration of your Inspection Objection Deadline you consult with a qualified contractor to discuss options and costs for replacement. |

Although no condensation was visible at the time of the inspection, staining and etching of the glass at a window in the Living Room indicated a loss of thermal integrity. Etching of the glass from long-term exposure to condensation constitutes permanent damage. The Inspector recommends that before the expiration of your Inspection Objection Deadline you consult with a qualified contractor to discuss options and costs for replacement.

Staining and etching of the glass at the window indicated a loss of thermal integrity.

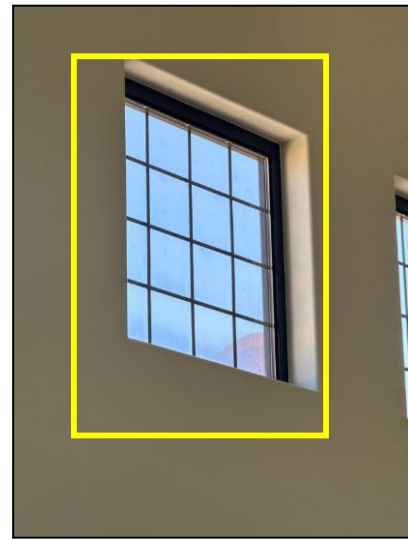
Staining and etching of the glass at the window indicated a loss of thermal integrity.

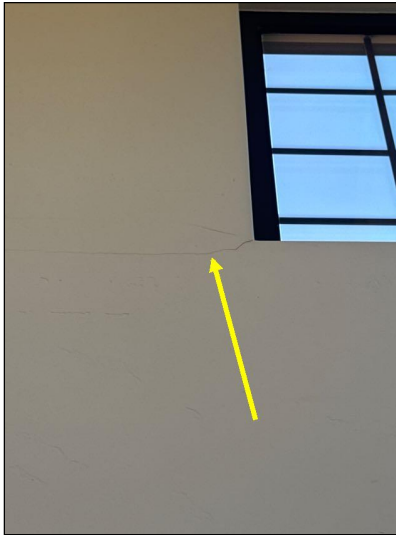
**Monitor:** Normal settlement cracking was visible in interior walls of the home at the time of the inspection.

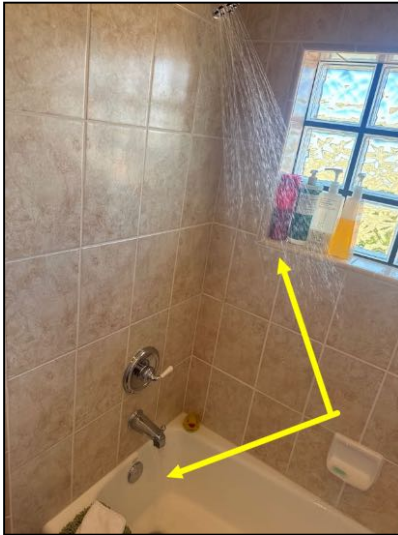
| Interior Areas | | | |
|---|---|---|---|
| | Page 61 Item: 6 | Bath Tubs | The diverter valve was leaking during operation or did not operate correctly (the diverter is the valve which diverts water from the tub faucet to the shower head). At the time of inspection water continued to flow from the tub spout when the shower was on. This is most commonly caused by a deteriorated diverter valve seal in the tub spout. The Inspector recommends maintenance/repair be performed by a qualified contractor. |

The diverter valve was leaking during operation or did not operate correctly (the diverter is the valve which diverts water from the tub faucet to the shower head).

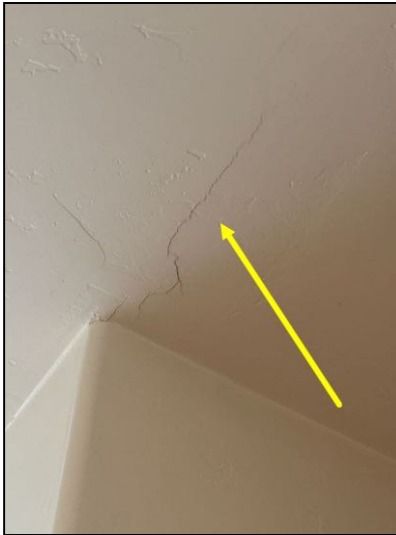
**Monitor:** Normal settlement cracking was visible in interior ceiling at the time of the inspection.

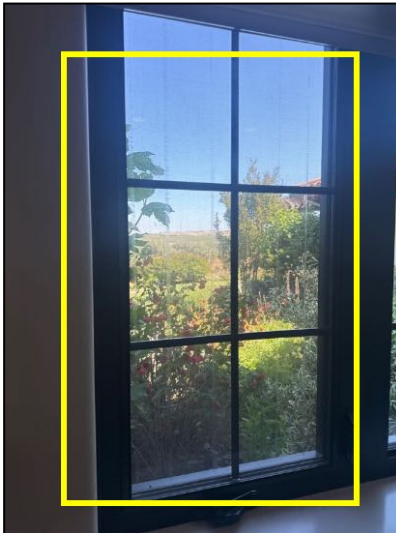
| Interior Areas | | | |
|---|---|---|---|
| | Page 76 Item: 11 | Window Condition | Although no condensation was visible at the time of the inspection, staining and etching of the glass at a window indicated a loss of thermal integrity. Etching of the glass from long-term exposure to condensation constitutes permanent damage. The Inspector recommends that before the expiration of your Inspection Objection Deadline you consult with a qualified contractor to discuss options and costs for replacement. |

Although no condensation was visible at the time of the inspection, staining and etching of the glass at a window indicated a loss of thermal integrity. Etching of the glass from long-term exposure to condensation constitutes permanent damage. The Inspector recommends that before the expiration of your Inspection Objection Deadline you consult with a qualified contractor to discuss options and costs for replacement.

Staining and etching of the glass at the window indicated a loss of thermal integrity.
