WOOD DESTROYING PESTS AND ORGANISMS INSPECTION REPORT

BUILDING NO. 34568	STREET, CITY, STATE, ZIP Calle Portola, Dana Point CA 92624	Date of Inspection 4/28/2026	No. of Pages 8
Top Gun Pest Control 1861 Skyline Way Fullerton, CA 92831 Tel: (949) 306-2364 Email: Office@TopGunPestControlOC.com www.topgunpestcontroloc.com			
Firm Registration No. PR 7808	Report No. 1420	Escrow No.	
Ordered By: RE/MAX Property Connection 26381 Crown Valley Pkwy Ste 180 Mission Viejo, CA 92691 Attn: Bryn Hutchinson	Property Owner/Party of Interest RE/MAX Property Connection 26381 Crown Valley Pkwy Ste 180 Mission Viejo, CA 92691 Attn: Bryn Hutchinson	Report Sent To: RE/MAX Property Connection 26381 Crown Valley Pkwy Ste 180 Mission Viejo, CA 92691 Attn: Bryn Hutchinson	
COMPLETE REPORT <input checked="" type="checkbox"/> LIMITED REPORT <input type="checkbox"/> SUPPLEMENTAL REPORT <input type="checkbox"/> REINSPECTION REPORT <input type="checkbox"/>			
General Description: 1-STORY HOUSE, ATTACHED GARAGE, COMPOSITION ROOF, CONCRETE SLAB, STUCCO EXTERIOR		Inspection Tag Posted: ATTIC

1420

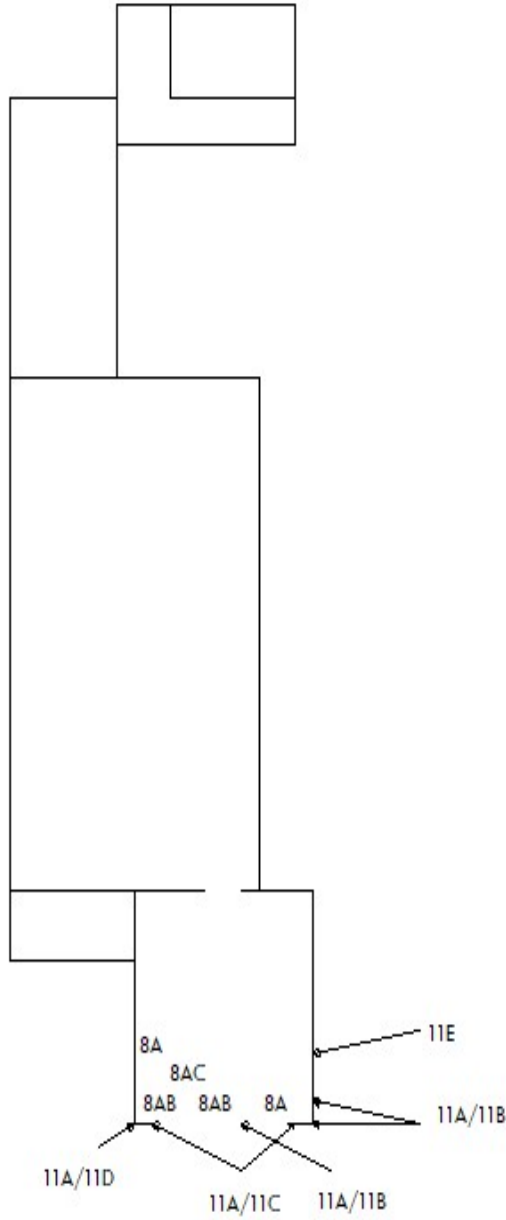
DIAGRAM NOT TO SCALE

ITEM 8A Evidence of drywood termites was noted in garage areas as marked 8A on the diagram.

ITEM 8B Drywood termites have damaged garage double topplate framing area as marked 8B on the diagram.

ITEM 8C Drywood termites have damaged garage collar framing area as marked 8C on the diagram.

ITEM 11A Evidence of drywood termites was noted in exterior areas as marked 11A on the diagram.

ITEM 11B Drywood termites have damaged roof rafter areas as marked 11B on the diagram.

ITEM 11C Drywood termites have damaged door jamb areas as marked 11C on the diagram.

ITEM 11D Drywood termites have damaged roof eave sheeting areas as marked 11D on the diagram.

ITEM 11E Dryrot/fungus damage noted in roof eave sheeting area as marked 11E on the diagram.

RECOMMENDATION: Fumigation of structure with a registered fumigant. Mask/cover or remove the termite pellets. While all due care will be taken: we cannot be responsible for any damage to roof, plants, and/or antennas.

RECOMMENDATION: Replace/reinforce and/or wood fill damaged wood with new material as needed. Painting is not included.

RECOMMENDATION: Fumigation of the structure with a registered fumigant. Mask/Cover or remove the termite pellets. While all due care will be taken: we cannot be responsible for any damage to roof, plants, and/or antennas.

RECOMMENDATION: Cut out damaged wood and replace with new lumber as needed. (Painting not included) NOTE: AREAS THAT WOULD BE FURTHER WEAKENED BY REPLACEMENT WILL BE SCRAPED, TREATED WITH A STATE APPROVED FUNGICIDE AND REPAIRED(WOOD FILLED).
