WOOD DESTROYING PESTS AND ORGANISMS INSPECTION REPORT

Building Address: 1209 Citrus Pl., Costa Mesa, CA 92626		Date of Inspection 04/29/2026	Number of Pages 11

W34833

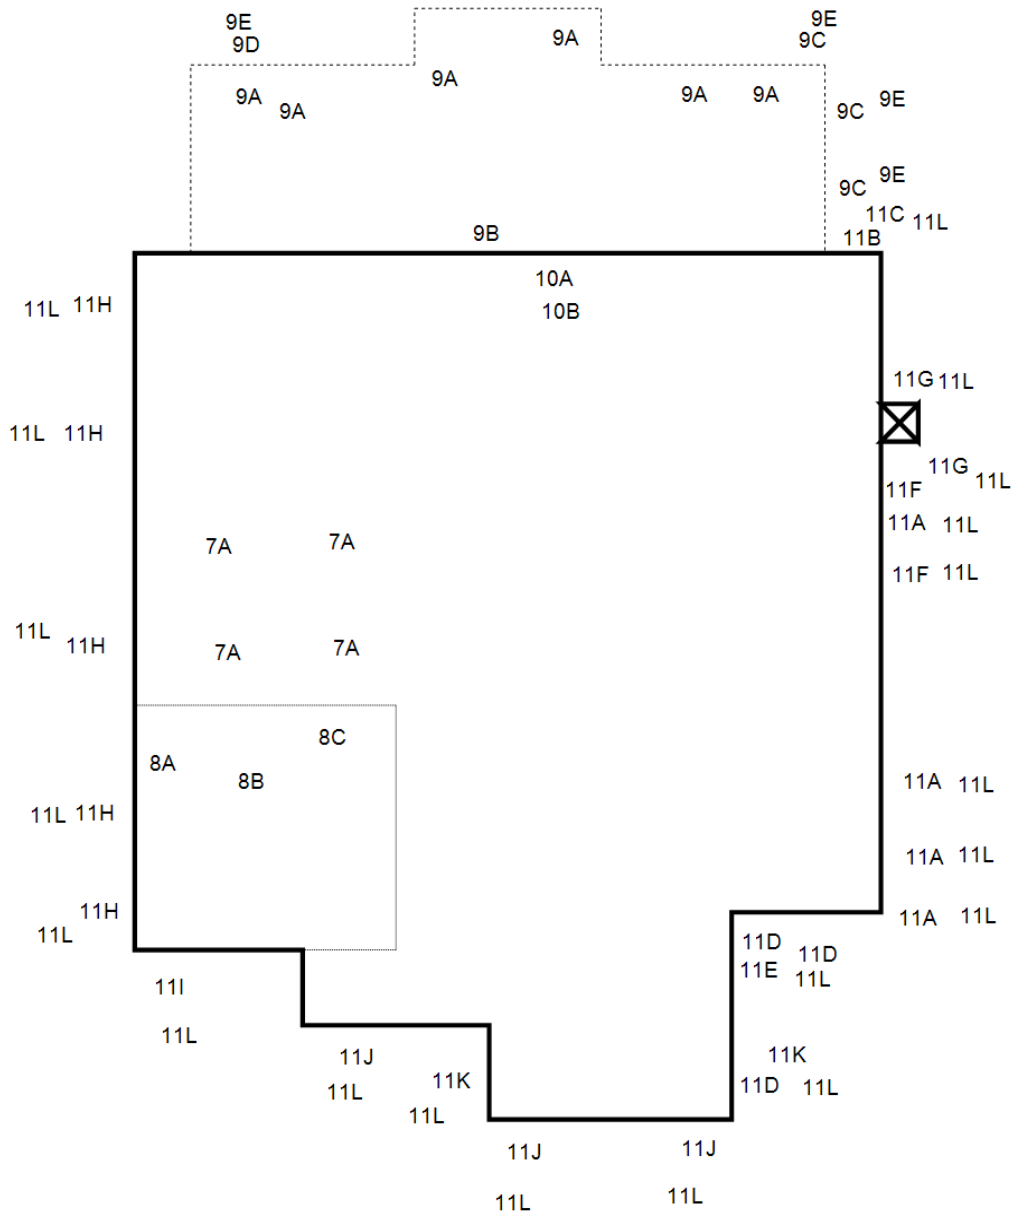
This Diagram is not to scale

7A PRICE: \$2,999.00 (Section I)
 FINDINGS: Evidence of dry-wood termite infestations at attic as indicated on the diagram.
 RECOMMENDATION: Vacate the premises and seal the structure for fumigation with Sulfuryl fluoride. Remove or cover accessible evidence of infestation. Fumigation warranted for two years. Fumigation awareness notice must be signed prior to fumigation. See fumigation notice for terms and liabilities. Tent fumigation is for eradication of the target pest only, as described in this report. Bell Termite is not responsible for removal of any pest that are eradicated as a result of the tent fumigation, during , before and/or after the tent fumigation.

8A PRICE: See 11A (Section I)
 FINDINGS: Dry-rot damaged wood members found at time of inspection at garage bottom door trim, 1x4x3 as indicated on the diagram.
 RECOMMENDATION: Replace dry-rot damaged wood members as necessary. No paint is included in this estimate. If additional adverse conditions are uncovered during repairs, further inspection will be recommended and a supplemental report will be issued indicating any infection, or additional repairs. It is recommended to maintain the lumber by properly painting / sealing to prevent future dry-rot.

- 9A PRICE: See 11A (Section I)
FINDINGS: Dry-rot damaged wood members found at time of inspection at patio shade slats, 8pcs 2x3x14 as indicated on the diagram.
RECOMMENDATION: Replace dry-rot damaged wood members as necessary. No paint is included in this estimate. If additional adverse conditions are uncovered during repairs, further inspection will be recommended and a supplemental report will be issued indicating any infection, or additional repairs. It is recommended to maintain the lumber by properly painting / sealing to prevent future dry-rot.

- 9B PRICE: See 11A (Section I)
FINDINGS: Minor dry-rot was found at time of inspection at patio ledger board as indicated on the diagram
RECOMMENDATION: Dig-out, treat and fill dry-rot damaged wood members as necessary. No paint is included in this estimate. If additional adverse conditions are uncovered during repairs, further inspection will be recommended and a supplemental report will be issued indicating any infection, or additional repairs. It is recommended to have wood treated with Bora-Care, to prevent future dry-rot.

- 9C PRICE: See 11A (Section I)
FINDINGS: Evidence of drywood termite damaged wood members noted at time of inspection at patio rafter (3 areas) as indicated on the diagram.
RECOMMENDATION: Fill termite damaged wood members as necessary. No paint is included in this estimate. During course of repairs if additional wood damage is discovered supplemental will be issued with new repairs . There may be an additional charge.

- 9D PRICE: See 11A (Section I)
FINDINGS: Evidence of drywood termite damaged wood members noted at time of inspection at patio post as indicated on the diagram.
RECOMMENDATION: Fill termite damaged wood members as necessary. No paint is included in this estimate. During course of repairs if additional wood damage is discovered supplemental will be issued with new repairs . There may be an additional charge.

- 9E PRICE: See 7A (Section I)
FINDINGS: Evidence of dry-wood termite infestations at patio as indicated on the diagram.
RECOMMENDATION: Vacate the premises and seal the structure for fumigation with Sulfuryl fluoride. Remove or cover accessible evidence of infestation. Fumigation warrantied for two years. Fumigation awareness notice must be signed prior to fumigation. See fumigation notice for terms and liabilities. Tent fumigation is for eradication of the target pest only, as described in this report. Bell Termite is not responsible for removal of any pest that are eradicated as a result of the tent fumigation, during , before and/or after the tent fumigation.

- 10A PRICE: See 11A (Section I)
FINDINGS: Evidence of drywood termite damaged wood members noted at time of inspection at 2 door jambs and door as indicated on the diagram.
RECOMMENDATION: Fill termite damaged wood members as necessary. No paint is included in this estimate. During course of repairs if additional wood damage is discovered supplemental will be issued with new repairs . There may be an additional charge.

- 10B PRICE: See 7A (Section I)
FINDINGS: Evidence of dry-wood termite infestations at interior door as indicated on the diagram.
RECOMMENDATION: Vacate the premises and seal the structure for fumigation with Sulfuryl fluoride. Remove or cover accessible evidence of infestation. Fumigation warranted for two years. Fumigation awareness notice must be signed prior to fumigation. See fumigation notice for terms and liabilities. Tent fumigation is for eradication of the target pest only, as described in this report. Bell Termite is not responsible for removal of any pest that are eradicated as a result of the tent fumigation, during , before and/or after the tent fumigation.

- 11A PRICE: \$4,500.00 (Section I)
FINDINGS: Evidence of drywood termite damaged wood members noted at time of inspection at 2nd story blocking, 4pcs 2x4x1 as indicated on the diagram.
RECOMMENDATION: Repair, replace or re-inforce termite damaged wood members as necessary. Timbers not structurally weakened will be repaired with a wood filler. No paint is included in this estimate. During course of repairs if additional wood damage is discovered supplemental will be issued with new repairs . There may be an additional charge.

- 11C PRICE: See 11A (Section I)
FINDINGS: Evidence of drywood termite damaged wood members noted at time of inspection at spruce fascia, 2x8x18 as indicated on the diagram.
RECOMMENDATION: Replace termite damaged wood members as necessary. Timbers not structurally weakened will be repaired with a wood filler. No paint is included in this estimate. During course of repairs if additional wood damage is discovered supplemental will be issued with new repairs . There may be an additional charge.

- 11D PRICE: See 11A (Section I)
FINDINGS: Evidence of drywood termite damaged wood members noted at time of inspection at 2 rafter tails as indicated on the diagram.
RECOMMENDATION: Fill termite damaged wood members as necessary. No paint is included in this estimate. During course of repairs if additional wood damage is discovered supplemental will be issued with new repairs . There may be an additional charge.

- 11E PRICE: See 11A (Section I)
FINDINGS: Evidence of drywood termite damaged wood members noted at time of inspection at rafter tail, 2x4x2 as indicated on the diagram.
RECOMMENDATION: Repair, replace or re-inforce termite damaged wood members as necessary. Timbers not structurally weakened will be repaired with a wood filler. No paint is included in this estimate. During course of repairs if additional wood damage is discovered supplemental will be issued with new repairs . There may be an additional charge.

- 11F PRICE: See 11A (Section I)
FINDINGS: Evidence of drywood termite damaged wood members noted at time of inspection at spruce gables, (2nd story 2x8x18, 2x8x12), 2x8x6 as indicated on the diagram.
RECOMMENDATION: Replace termite damaged wood members as necessary. Timbers not structurally weakened will be repaired with a wood filler. No paint is included in this estimate. During course of repairs if additional wood damage is discovered supplemental will be issued with new repairs . There may be an additional charge.

- 11G PRICE: See 11A (Section I)
FINDINGS: Evidence of drywood termite damaged wood members noted at time of inspection at rafter tails, 2pcs 2x8x1 as indicated on the diagram.
RECOMMENDATION: Repair, replace or re-inforce termite damaged wood members as necessary. Timbers not structurally weakened will be repaired with a wood filler. No paint is included in this estimate. During course of repairs if additional wood damage is discovered supplemental will be issued with new repairs . There may be an additional charge.

- 11H PRICE: See 11A (Section I)
FINDINGS: Evidence of drywood termite damaged wood members noted at time of inspection at 2nd story spruce fascias, 2pcs 2x8x16, 1pc 2x8x10 as indicated on the diagram.
RECOMMENDATION: Replace termite damaged wood members as necessary. Timbers not structurally weakened will be repaired with a wood filler. No paint is included in this estimate. During course of repairs if additional wood damage is discovered supplemental will be issued with new repairs . There may be an additional charge.

- 11I PRICE: See 11A (Section I)
FINDINGS: Evidence of drywood termite damaged wood members noted at time of inspection at 2nd story spruce fascia, 2x8x6 as indicated on the diagram.
RECOMMENDATION: Replace termite damaged wood members as necessary. Timbers not structurally weakened will be repaired with a wood filler. No paint is included in this estimate. During course of repairs if additional wood damage is discovered supplemental will be issued with new repairs . There may be an additional charge.

- 11J PRICE: See 11A (Section I)
FINDINGS: Evidence of drywood termite damaged wood members noted at time of inspection at 2nd story spruce gables, 3pcs 2x8x10 as indicated on the diagram.
RECOMMENDATION: Repair, replace or re-inforce termite damaged wood members as necessary. Timbers not structurally weakened will be repaired with a wood filler. No paint is included in this estimate. During course of repairs if additional wood damage is discovered supplemental will be issued with new repairs . There may be an additional charge.

- 11K PRICE: See 11A (Section I)
FINDINGS: Evidence of drywood termite damaged wood members noted at time of inspection at spruce fascias, 1pc 2x8x8, 1pc 2x8x6 as indicated on the diagram.
RECOMMENDATION: Replace termite damaged wood members as necessary. Timbers not structurally weakened will be repaired with a wood filler. No paint is included in this estimate. During course of repairs if additional wood damage is discovered supplemental will be issued with new repairs . There may be an additional charge.

- 11L PRICE: See 7A (Section I)
 FINDINGS: Evidence of dry-wood termite infestations at exterior termite damaged areas as indicated on the diagram.
 RECOMMENDATION: Vacate the premises and seal the structure for fumigation with Sulfuryl fluoride. Remove or cover accessible evidence of infestation. Fumigation warranted for two years. Fumigation awareness notice must be signed prior to fumigation. See fumigation notice for terms and liabilities. Tent fumigation is for eradication of the target pest only, as described in this report. Bell Termite is not responsible for removal of any pest that are eradicated as a result of the tent fumigation, during , before and/or after the tent fumigation.
- 11M PRICE: Included in Contract
 *** primer is included at repairs made by Bell Termite***
