Inspector: Nicholas Bylsma

Date: 20 May 2026

SEWER LINE INSPECTION REPORT

Client Name: Patrick Barnes Property Address: 1633 Loma Crest St, Glendale, CA 91205	Sewer Line Access: 2" cleanout on side of house, 4" cleanout in downstairs hall and 4" cleanout in driveway.
----------------------------------------------------------------------------------------------------------	---------------------------------------------------------------------------------------------------------------------

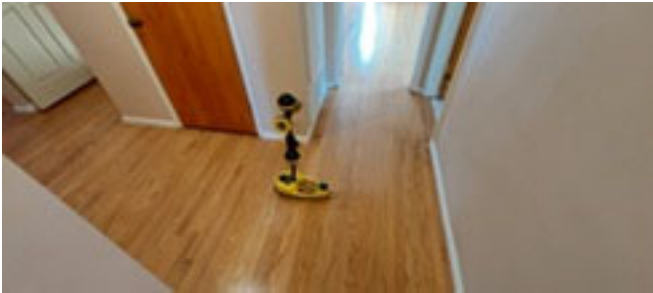
Transition from cast iron to plastic pipe. Depth 2'.

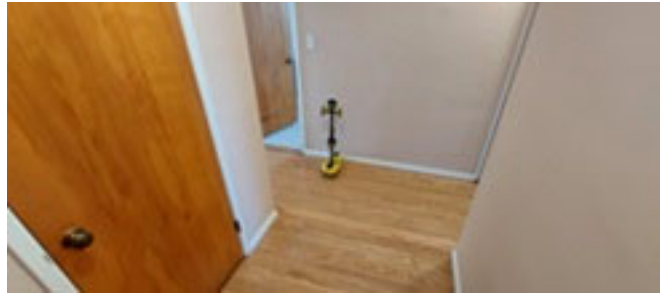
Furthest point reached with first inspection attempt. Depth 4'.

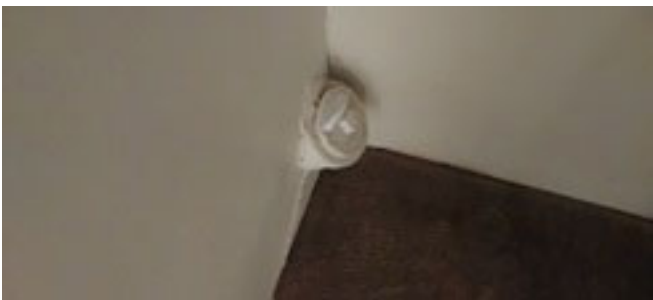
Second inspection attempted here.

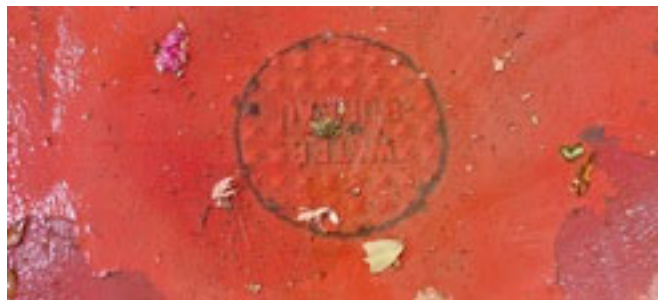
Third inspection through this main cleanout.

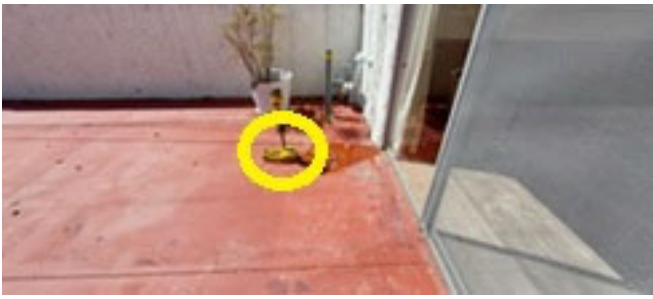
Location of main cleanout. Transition from cast iron to plastic pipe. Depth about 2'.

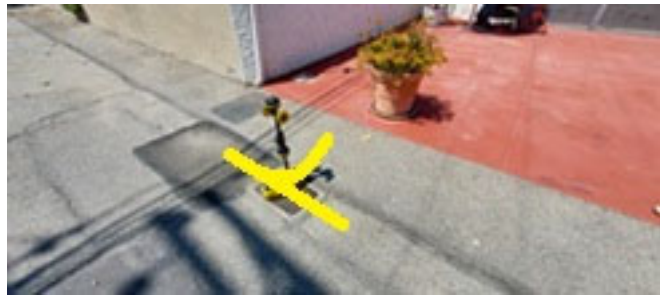
Needs attention - The main sewer line for this property appears to be shared with the neighbor's. The paperwork for the property should be checked to find if allowance for this has been included in the documentation for the house. If not, it is advised to obtain some agreement in writing allowing for the line to be shared. Typically an arrangement splitting the costs of maintenance and repair is sufficient to gain written agreement for a shared sewer line. Note - Not all municipalities allow for shared sewer lines for different properties.

Path of pipe. Possible side line connection from neighbor. Depth 2 ½'.

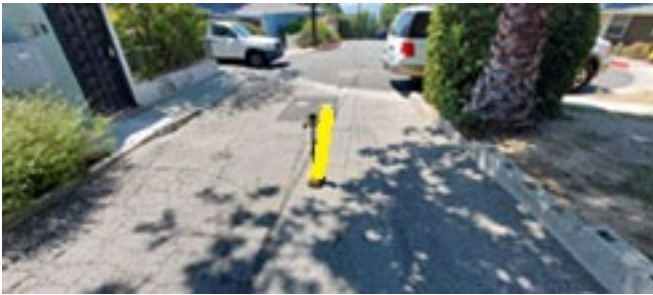
Section of fiberglass liner. Depth about 2 ½'.

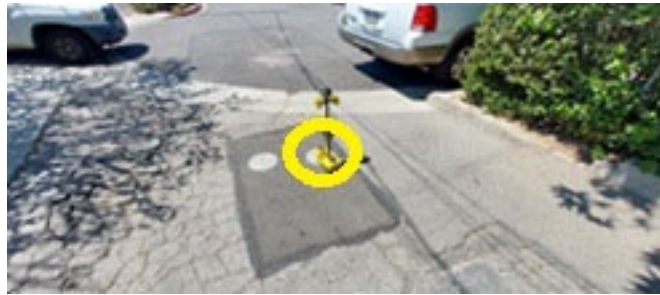
This is your cleanout. Depth about 2 ½'.

Hydrojet from the cleanout near the street shown in the images below should be done in 3 years. Review every 4-5 years should be done for this line. Be careful to avoid damaging the existing liner with any future cleaning. The technician should always use a camera to help dial in the cleaning tools.

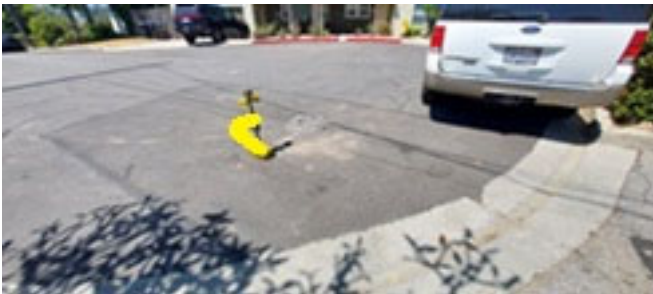
Additional section of fiberglass lined pipe. Depth 4'.

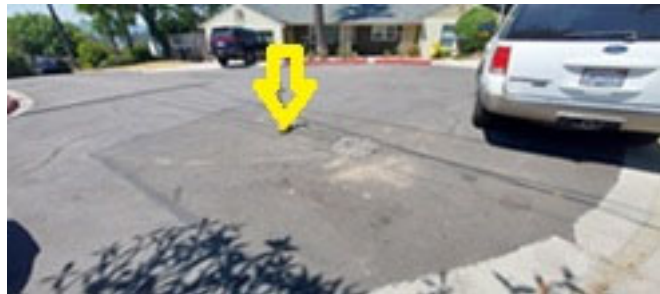
The connection to the city sewer line has minor roots through a joint which connects your line to the city pipe. These roots are next to the end of a fiberglass liner. They are not thick enough to effect the function of the system at this time however they should be cleared within 3 years. Also, you should consider installation of a top hat liner after these roots have been cleared out to prevent them coming back into the line. Top hat liners can be installed robotically so they can cost little enough to pay for themselves with reduced maintenance over reasonable timescales.

Connection to city sewer line. Depth about 10'.

It looks like the last inch of pipe at the connection to the city sewer line is clay. It was open and functioning but you may want to put a top hat liner in this section so that roots can't get in and so you save on the cost of hydrojets every few years. While this is an optional repair, I think it would make sense for this system.

If you use a contractor that installs the top hat liner with their own equipment, it might cost around \$3,500. Consider this after your next hydrojet in 3 years.

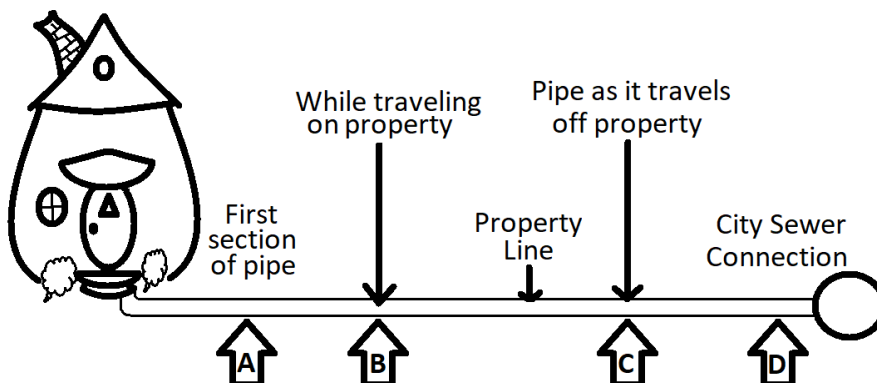
A: Cast iron

B: Plastic

C: Plastic with some fiberglass lined pipe.

D: Fiberglass liner up to city sewer with some roots at connection to city.
