# Inspection Report

**Ernest Kim & Doris Kim  
123 Ramona Drive  
San Luis Obispo, CA 93405**

Report Date: 5/22/2026

Inspection location: **123 Ramona Drive**  
**San Luis Obispo , CA 93405**

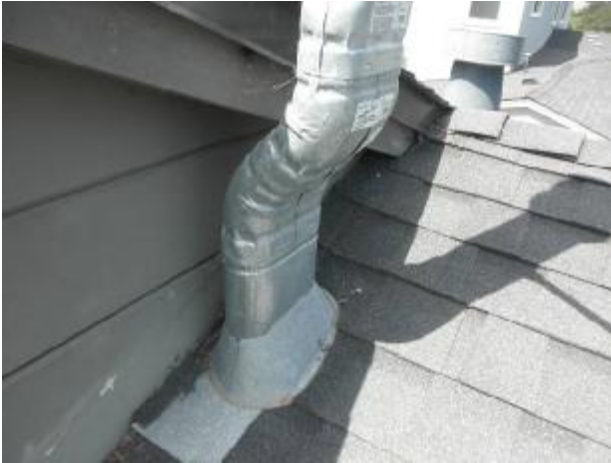
4.) The storm collar is missing at the water heater exhaust vent flashing. This may render this flashing to leak.

Missing storm collar at the wall heater exhaust vent flashing.

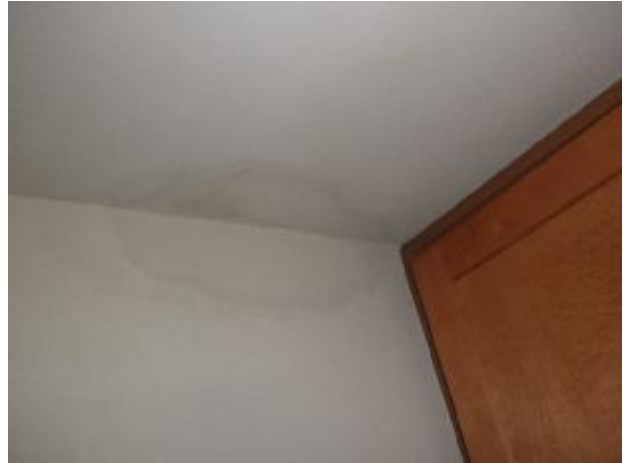
1.) There is evidence of a past roof leak at the base of the valley above the alcove in the family room. This area was sealed by Nieporte Roofing

Water stain at the family room alcove.

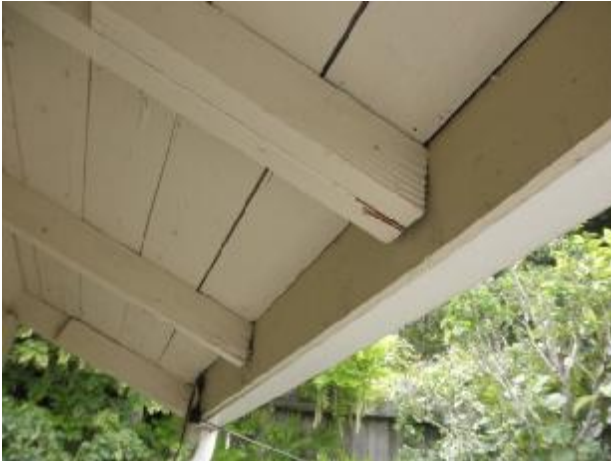
Termite infestation/damage at the eave and rafter tails.

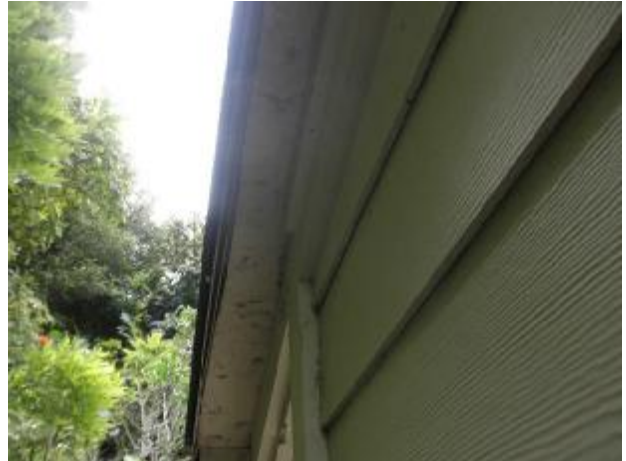
**Information Note:** OSB plywood has been used at parts of the exterior eaves. This type of plywood is not rated for the exterior use and may be subject to moisture damage.

OSB plywood used at parts of the exterior eaves.

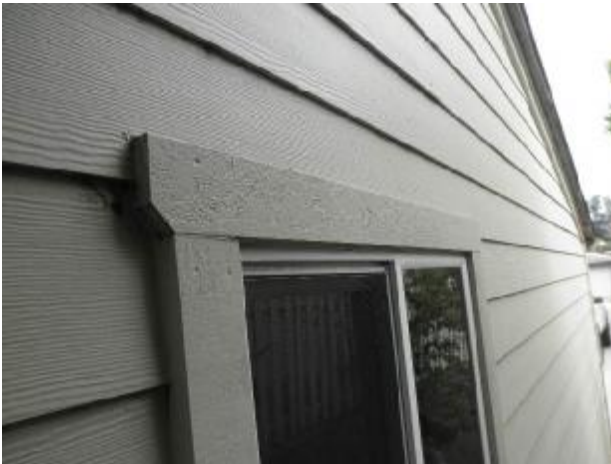
Missing Z bar flashing above the header trim where the cement board siding is installed.

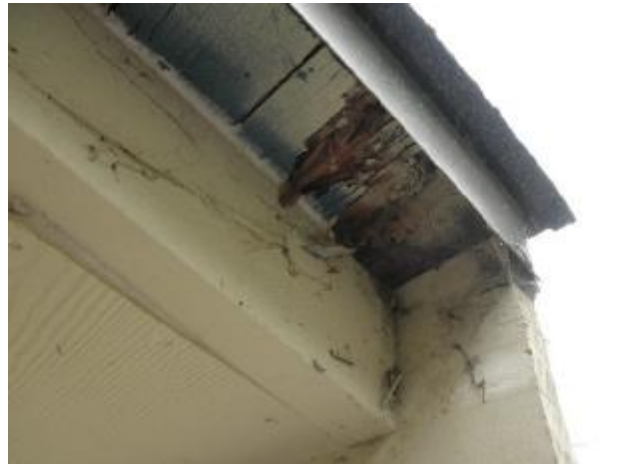
Old termite damage to the eave at the NE corner of the garage.

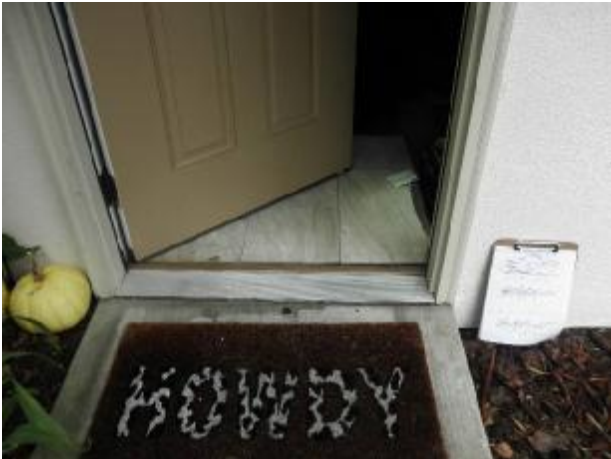
Low threshold condition at the entry door to the front bedroom.

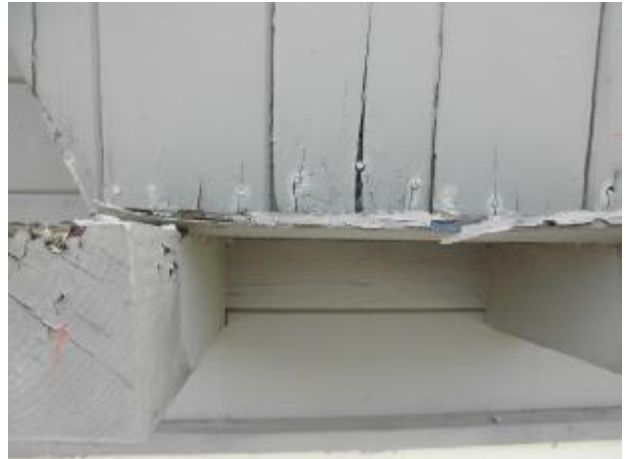
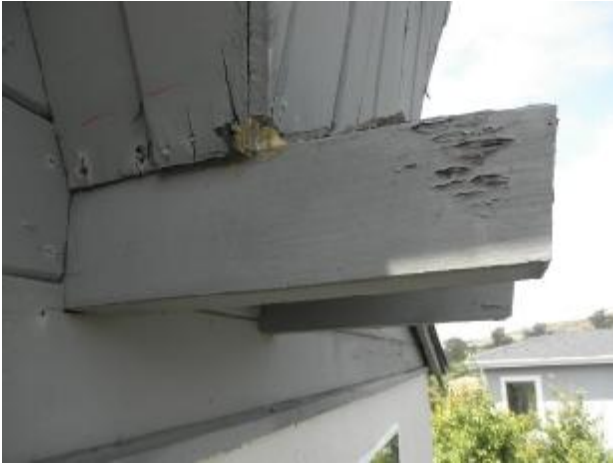
Moisture damage to the wood siding and beam at the second story Copula.

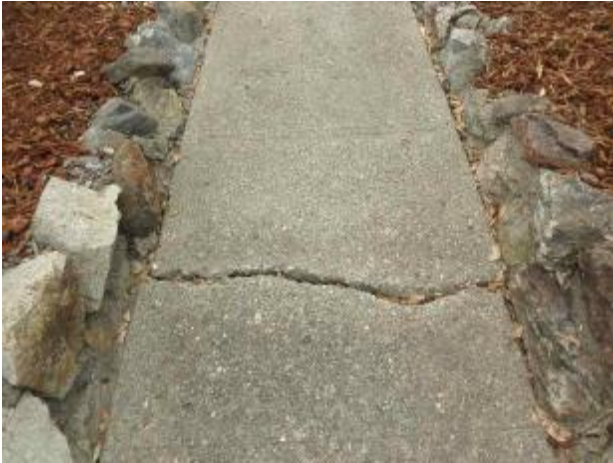
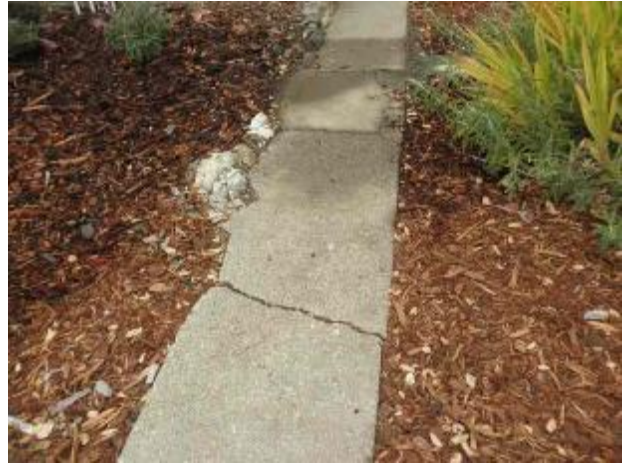
- 1.) Parts of the fencing in the backyard are damaged/leaning.
- 2.) There are some general settlement cracks in the front yard concrete walkways.

General settlement cracks in the front yard concrete walkways.

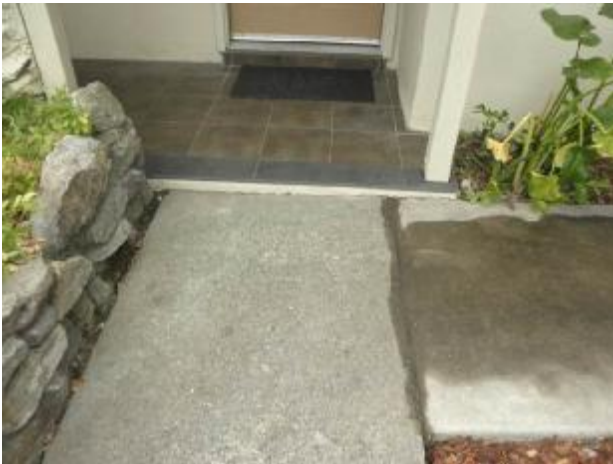
**Safety Hazard Note:** There is a tripping hazard at the interface of the front yard concrete walkway and the front entry tile patio.

Tripping hazard at the interface of the front concrete walkway and the front patio.

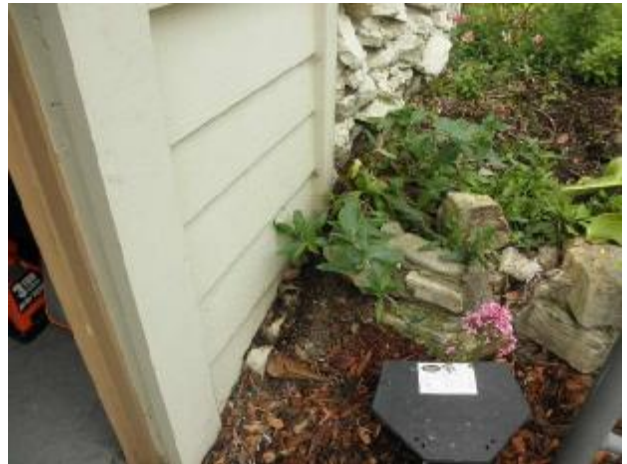
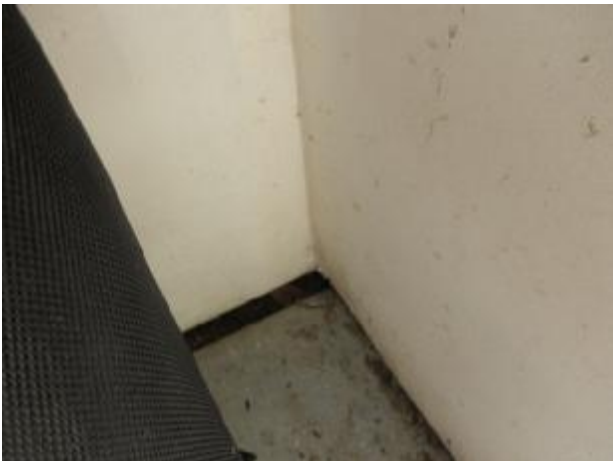
Faulty grade at the front NW corner of the garage with evidence of water intrusion.

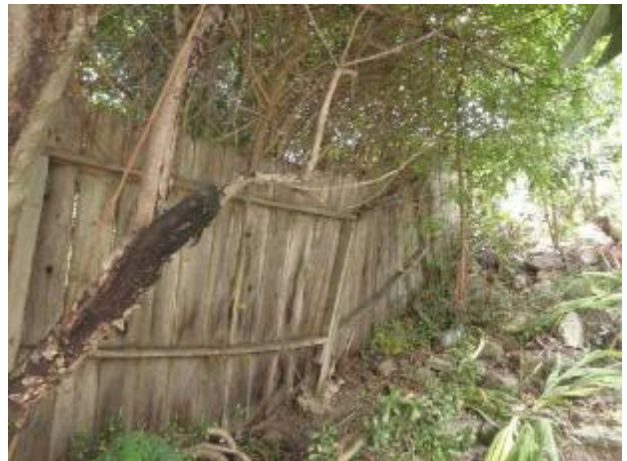
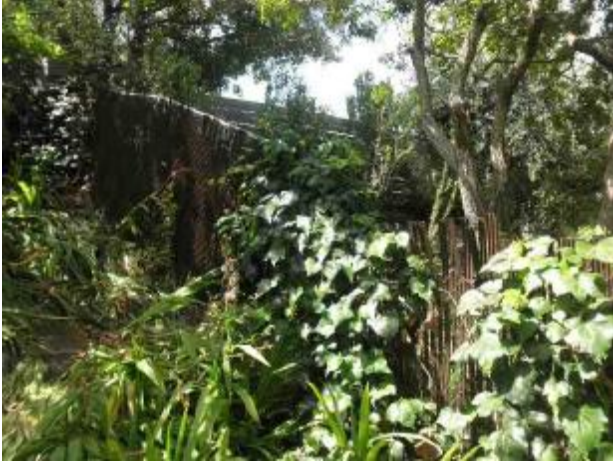
Parts of the fencing in the backyard is damaged.

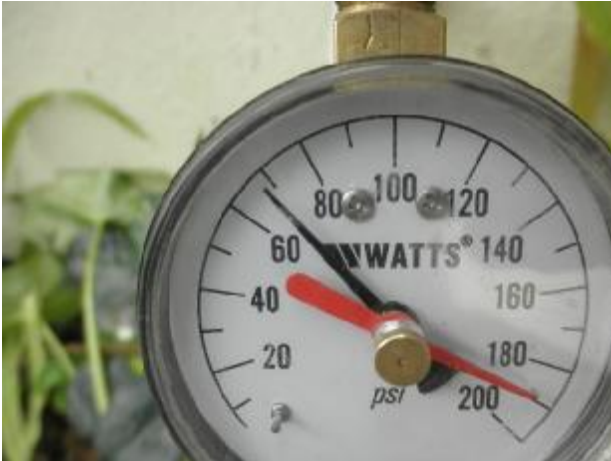
The water pressure was measured at 65 psi.

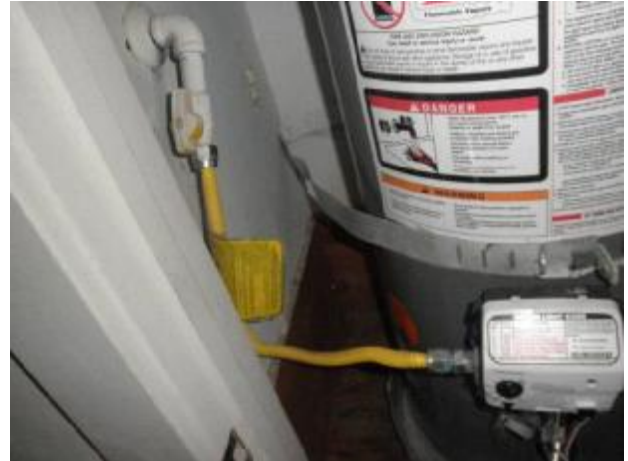
Missing sediment trap at the gas line connection to the water heater.

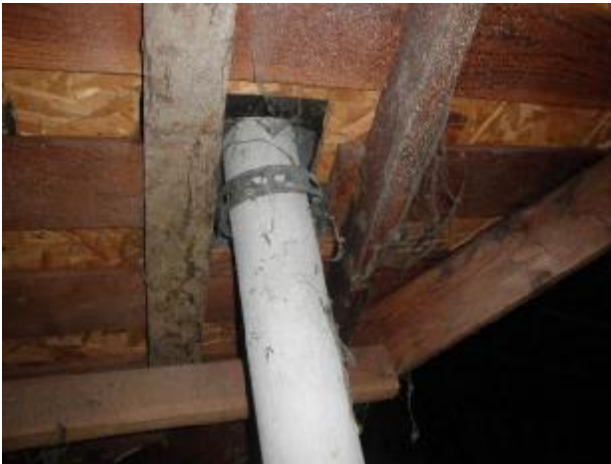
Transit pipe for the water heater exhaust.

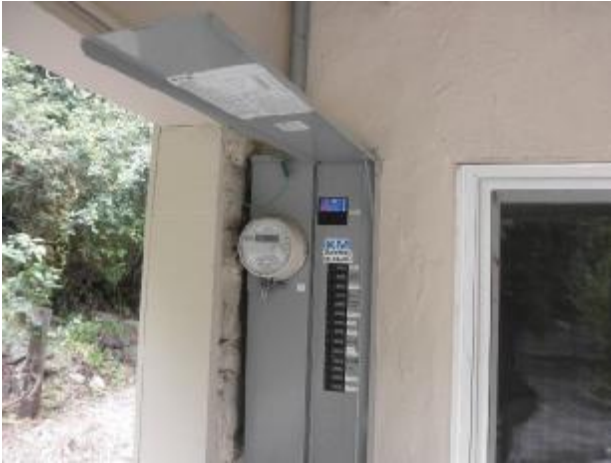
The main electrical service panel has been upgraded.

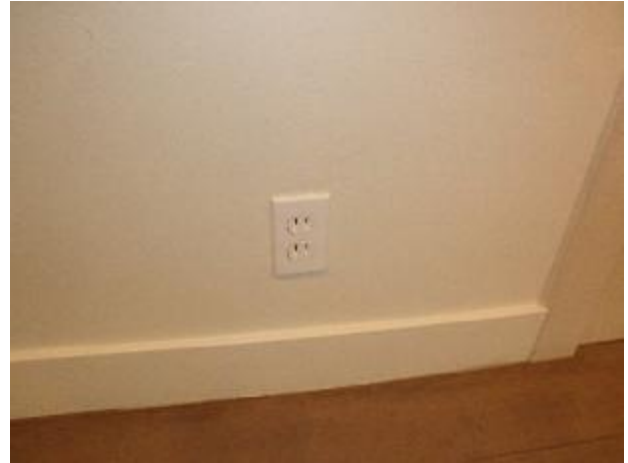
**Safety Upgrade Note:** There are two prong non grounded outlets installed in the living room which was typical for the era in which it was built. Recommend upgrading to grounded outlets as needed for the proper function of today's electrical needs.

Two prong outlets in the living room.

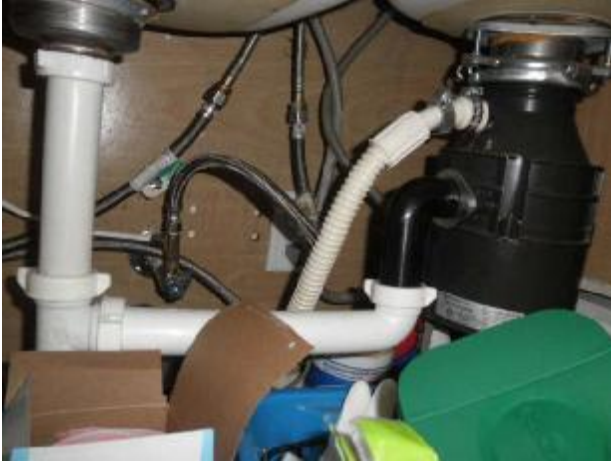
**Repair Note:** The dishwasher drain line is directly connected to the garbage disposal. This is considered a cross connection and has the potential for sewage backups or syphonage to contaminate the potable water supply. Recommend installing an air gap or a one-way check valve in the drain line.

Dishwasher drain line is directly connected to the drain.

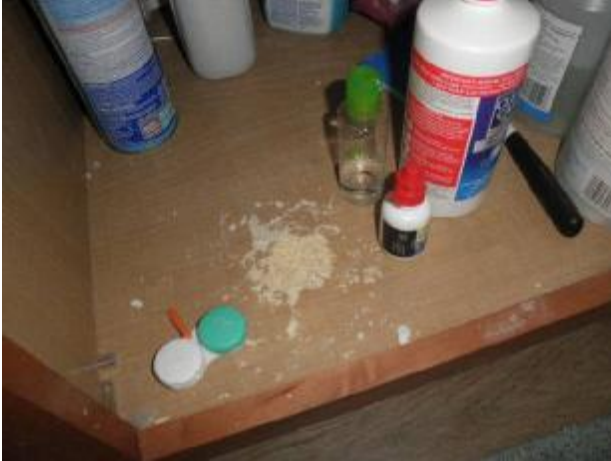
- 1.) There is a slow drain at the left sink in the master bathroom.
- 2.) There is moisture damage to the base of the sink cabinet in the hall bathroom.
- 3.) There is a slow drain at the sink in the hall bathroom.

Moisture damage at the sink cabinet in the hall bathroom.

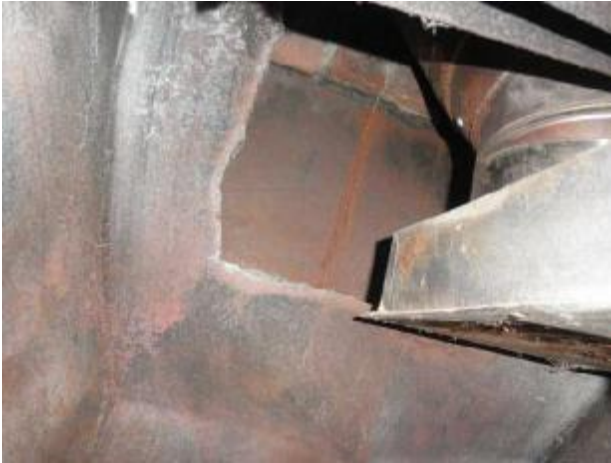
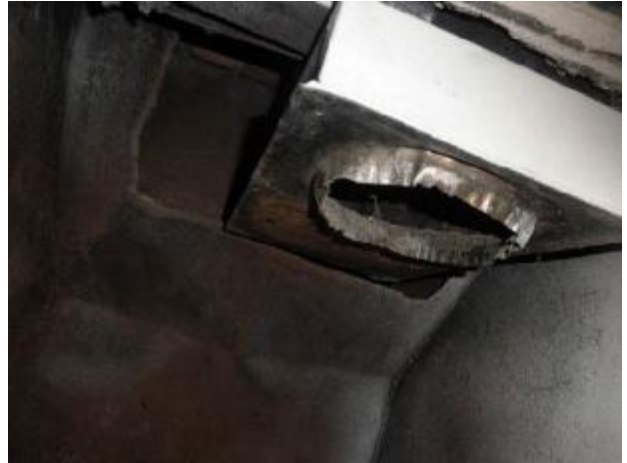
- 17 **Fire Safety Hazard Note:** The firebox has been cut open inside the family room fireplace to be converted for a wood stove insert. This conversion should be inspected by a qualified and certified Fireplace Contractor to determine if the conversion was installed properly.

Fireplace has been cut open for a wood stove conversion.

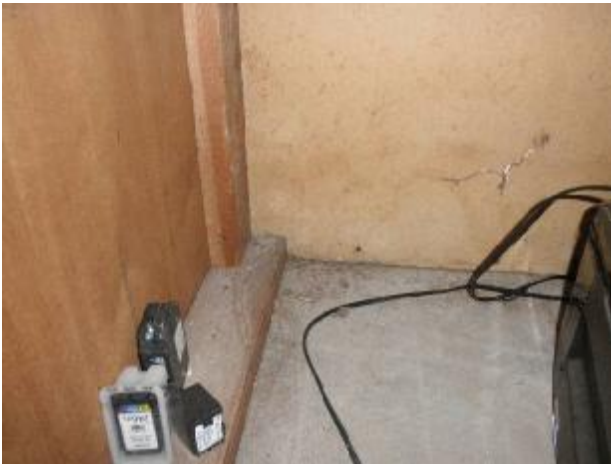
1.) There is evidence of subterranean termites in the area below the interior stairs. Recommend further evaluation by a qualified and licensed Pest Control Inspector prior to the close of escrow.

Subterranean termites in the cabinet below the stairs.
