# Cornerstone Home Inspections

## Home Inspection Report

**20550 Ponderosa Way  
Tuolumne, CA 95379**

Inspected on Tue, Jan 13 2026 at 9:17AM

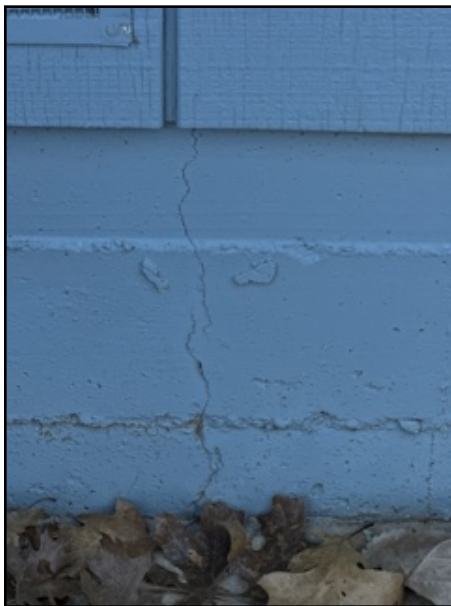
Figure 1-1

Minor cracks noted on various areas of foundation. Considering these cracks are less than 1/8" in width, not considered a structural issue. This is a common find.

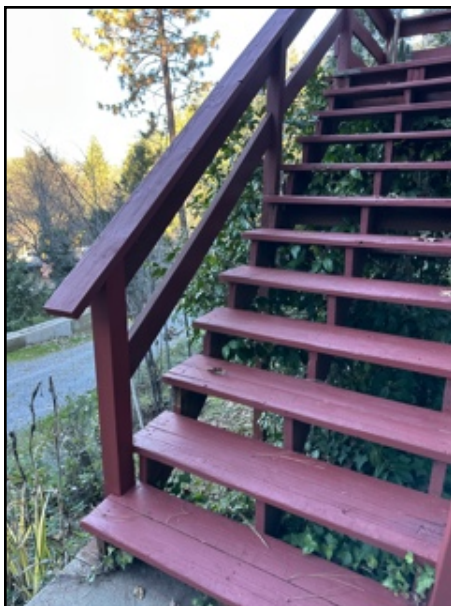
Figure 2-1

Deck/stair railing picket spacing is not up to code. Current CA building code allows a maximum picket spacing of 4". However, this spacing was acceptable at the original time of construction and would only need replaced if there was a permit pulled on the structure.

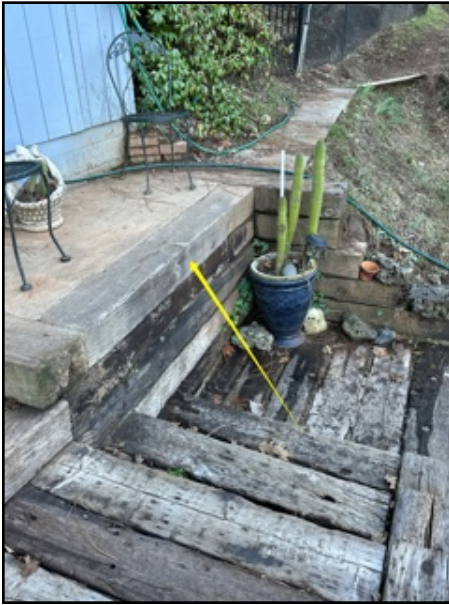
Figure 4-1

Recommend installing a proper railing on retaining wall above entry steps. Current CA building code requires a railing be installed with a maximum picket spacing of 4" above any ledge with a 30" or larger drop. Refer to a licensed contractor.

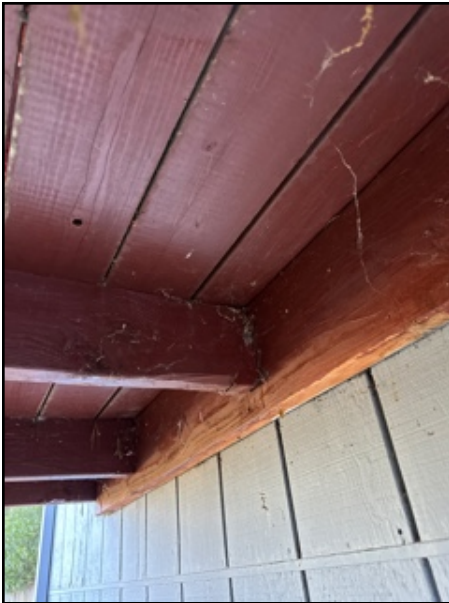
Figure 5-1

No flashing installed on deck ledger. Recommend installing to prevent any future moisture damage from occurring.

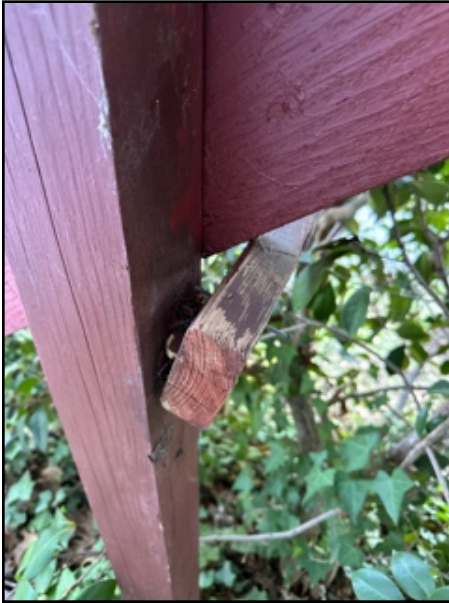
Figure 6-1

Center stair stringer brace in front of home is loose.

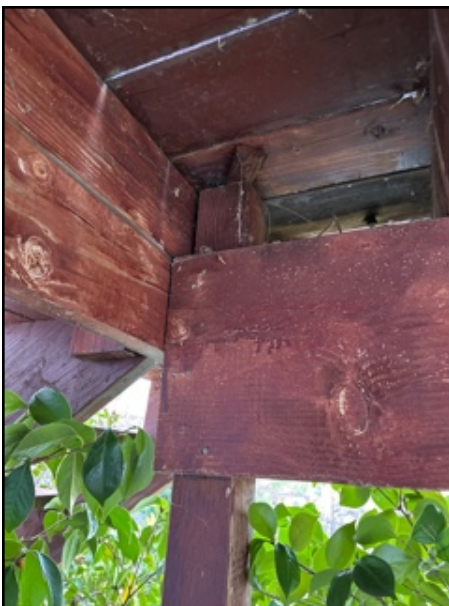
Figure 7-1

Recommend bolting deck/porch girders to the posts.

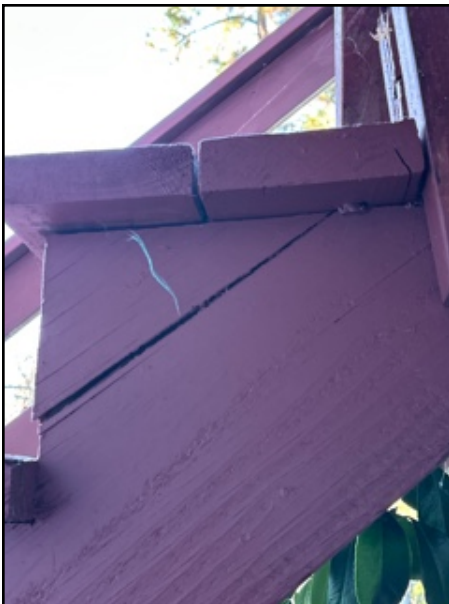
Figure 9-1

**Comment 9:**  
Stairs stringers in front of home noted as cracked/ damaged.

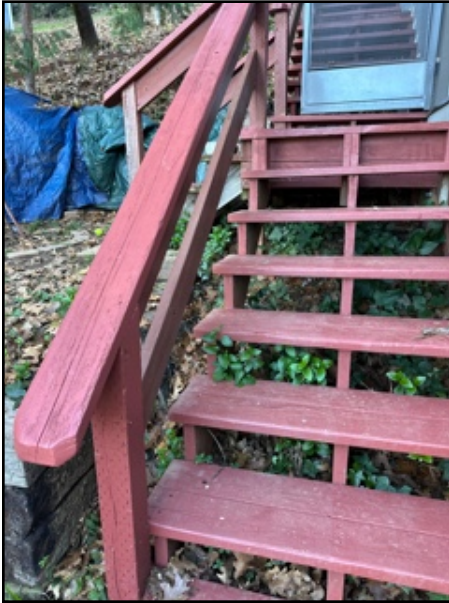
Figure 10-1

Comment 10:  
Railing to lower apartment noted as loose.

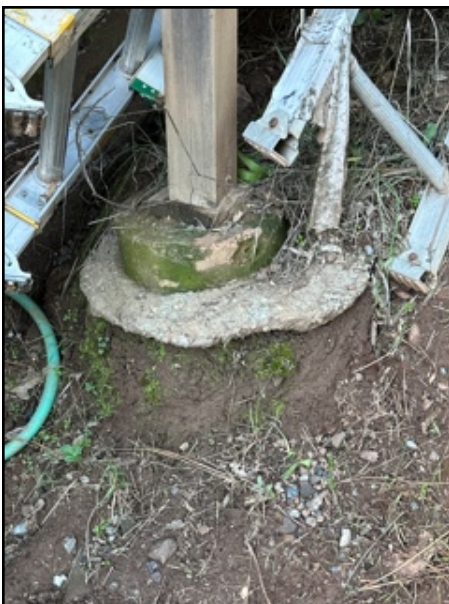
Figure 13-1

**Comment 13:**  
Soil has eroded away below the deck piers on right side of home. Refer to a licensed contractor for repair.

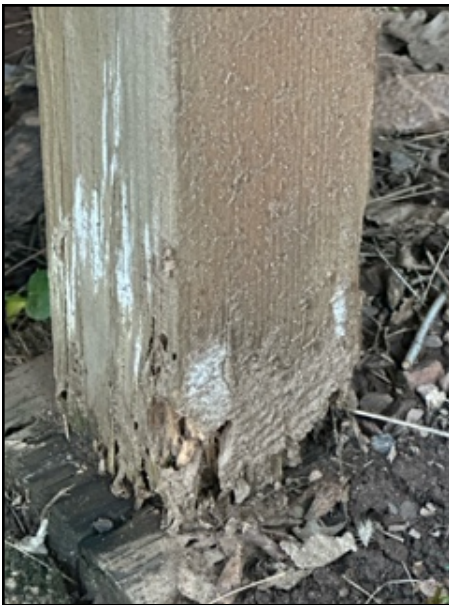
Figure 14-1

Fungus and decay noted on various areas throughout deck structures/attached sidings. Refer to a licensed pest inspector for further evaluation.

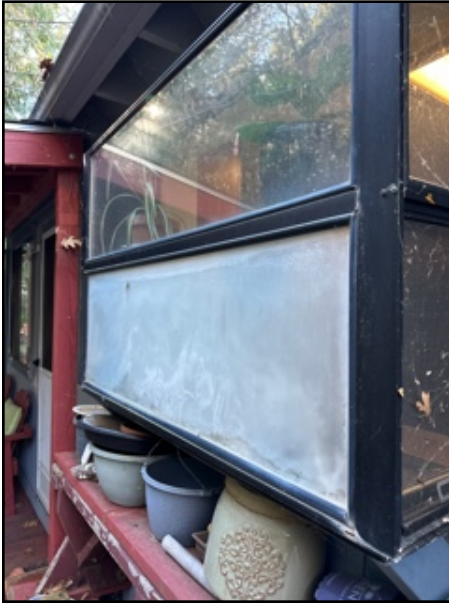
Figure 17-1

Kitchen window noted to sweat & in poor condition.

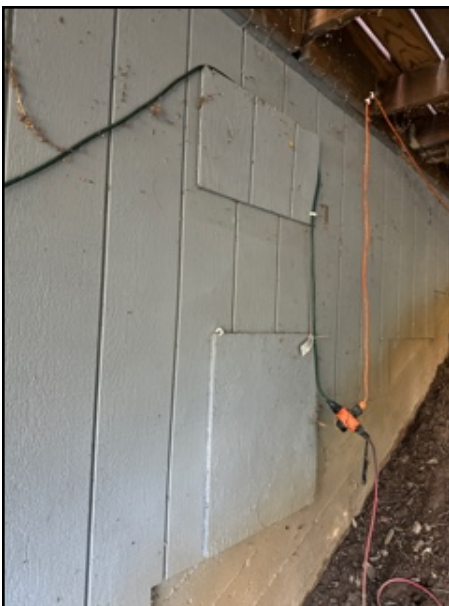
Figure 20-1

Improper siding patched noted below deck on right side of home.

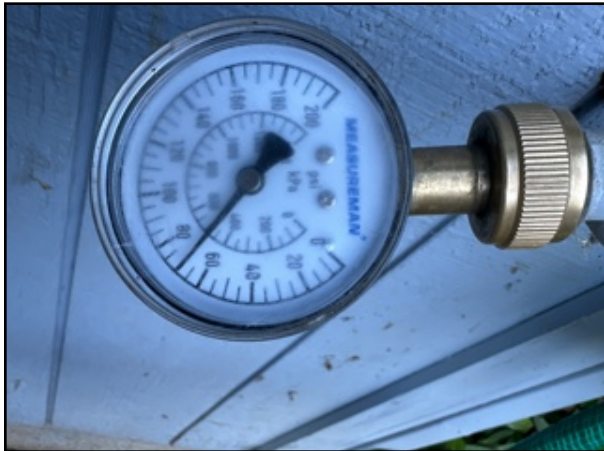
Figure 33-1

Comment 33:  
Water pressure noted at 70 psi. Current CA building code allows a maximum pressure of 80 psi. Condition is functional.

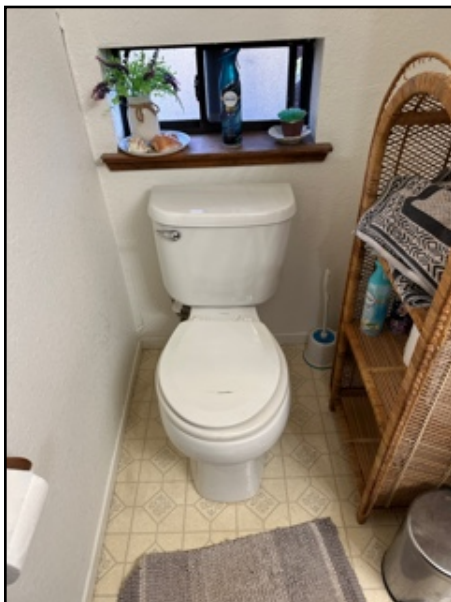
Figure 34-1

Comment 34:  
Apartment-  
Bathroom toilet noted as loose. Recommend tightening to prevent any future leaks.

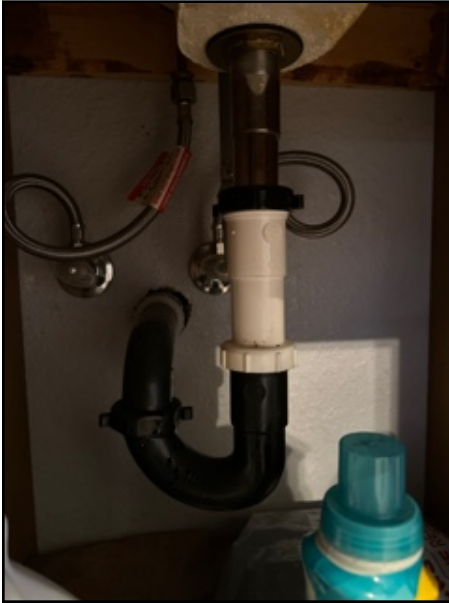
Figure 35-1

**Comment 35:**  
Upstairs bathroom sink drain noted to leak. Refer to a licensed plumber.

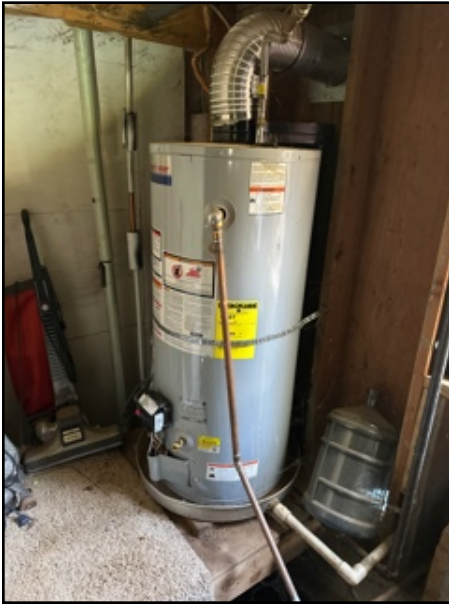
Figure 38-1

Water heater is not properly strapped. One strap should be in the top third, and one strap installed in the bottom third a minimum of 4 inches above the control. Recommend installing as required.

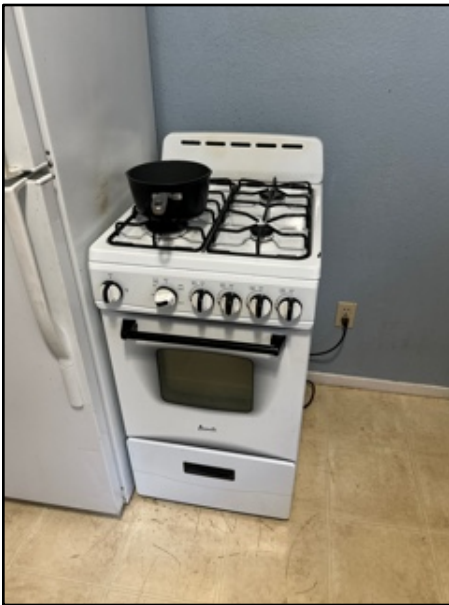
Figure 40-1

No anti-tip bracket installed on oven. Recommend installing to ensure the safety of the appliance.

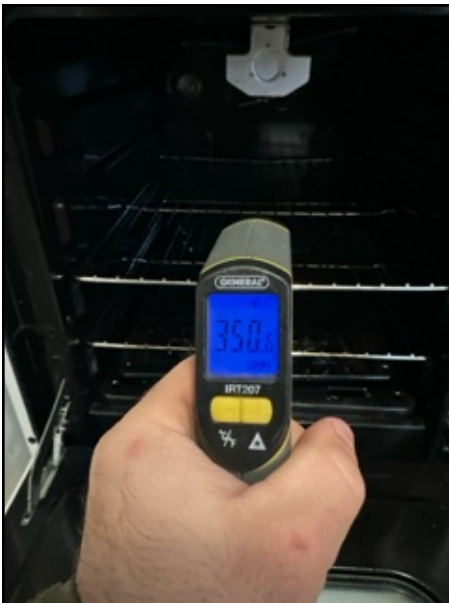
Figure 42-1

Oven set at 350 recorded a temperature of 350 degrees. Condition is functional.

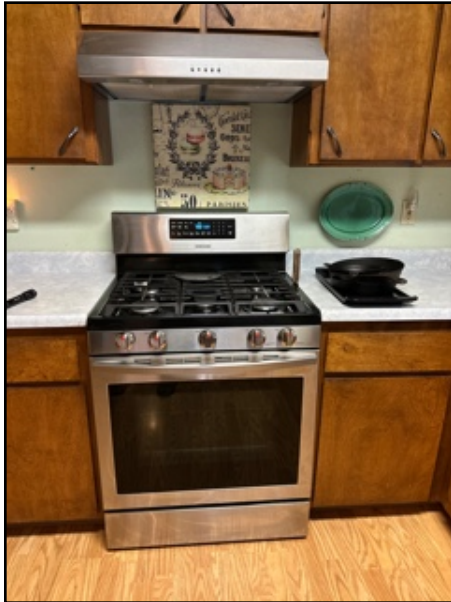
Figure 43-1

No anti-tip bracket installed on oven. Recommend installing to ensure the safety of the appliance.

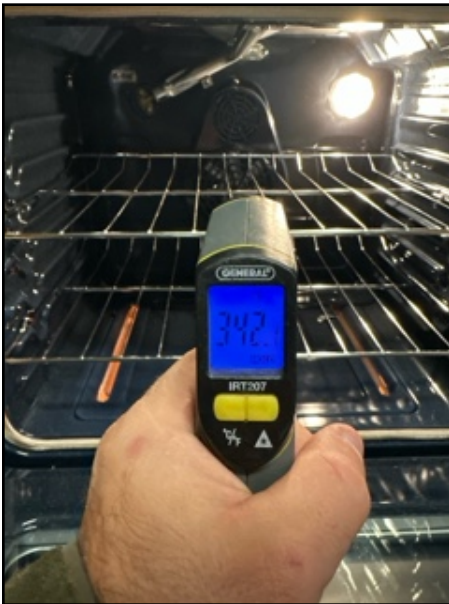
Figure 45-1

Oven set at 350 recorded a temperature of 342 degrees. Condition is functional.

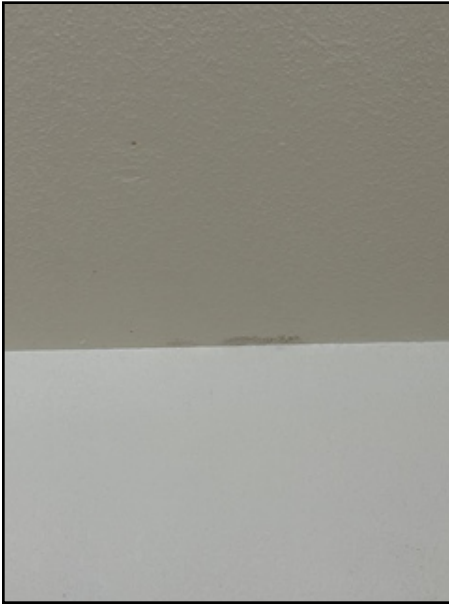
Figure 47-1

Organic type growth noted above shower on ceiling.

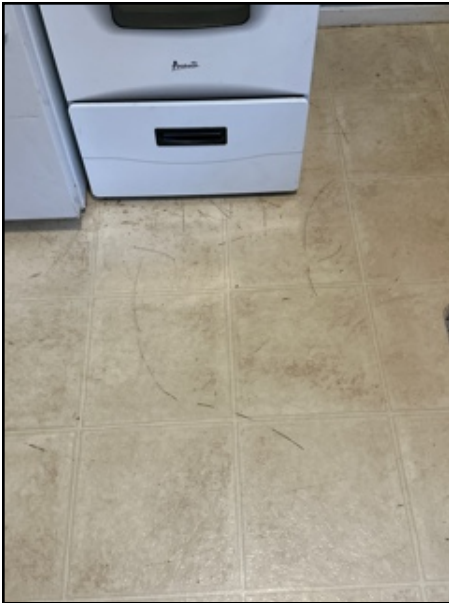
Figure 48-1

Comment 48:  
Apartment-  
Damaged floor noted in kitchen.

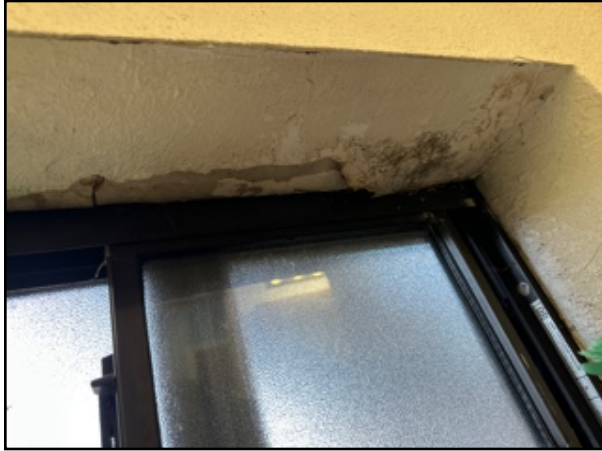
Figure 49-1

Moisture damage & poor drywall tape job noted in area surrounding bathroom window. Refer to a licensed contractor.

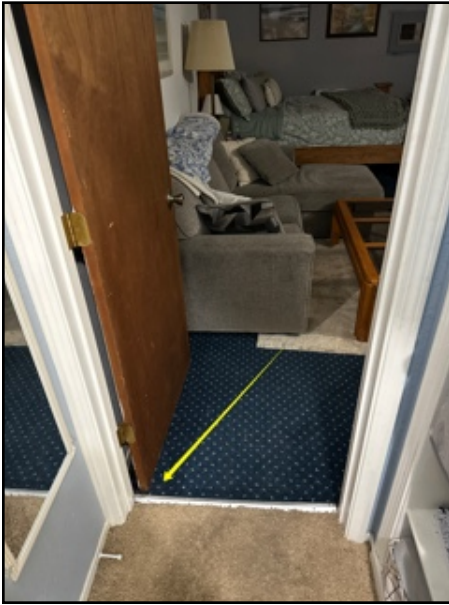
Figure 50-1

Bedroom door hits transition and fails to close.

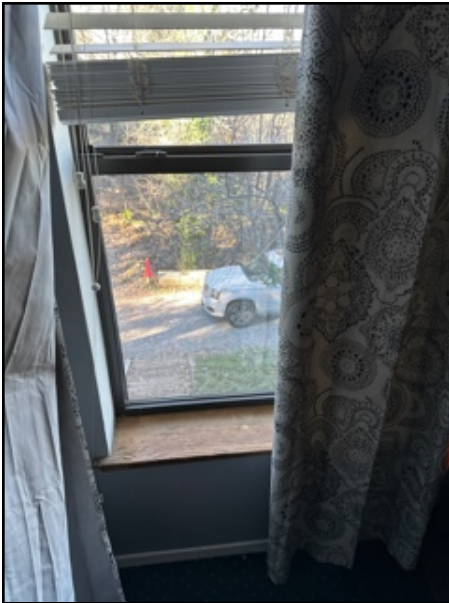
Figure 51-1

Comment 51:  
Apartment-  
Left bedroom window fails to stay open.

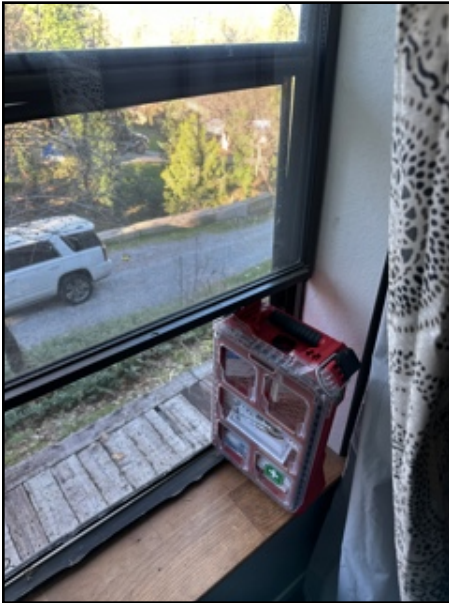
Figure 52-1

Right bedroom window is outside the frame and propped up. Refer to a qualified tradesman for repair. Frame also noted to contain large dents.

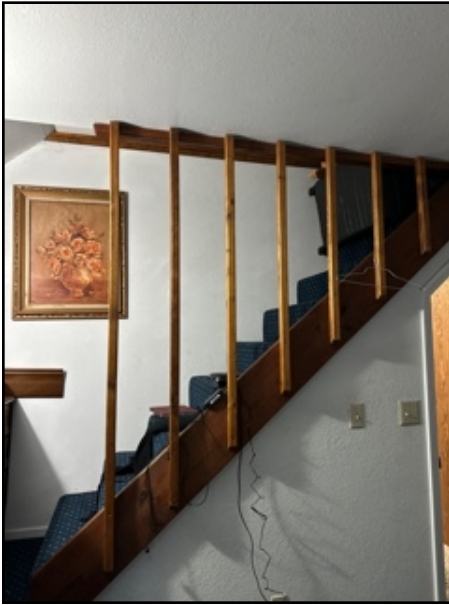
Figure 53-1

Stairs are not closed off. Any area with a 30" + drop must be secured with a guardrail. Current CA building code requires pickets be installed with a spacing of 4" or less. Recommend repair, refer to a licensed contractor.

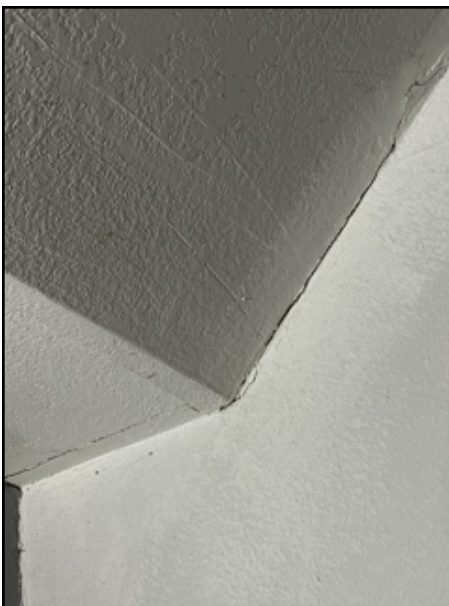
Figure 54-1

Cracked drywall noted in area around stairs. Considering these cracks only occur on tape seams, likely caused due to a poor drywall tape job.

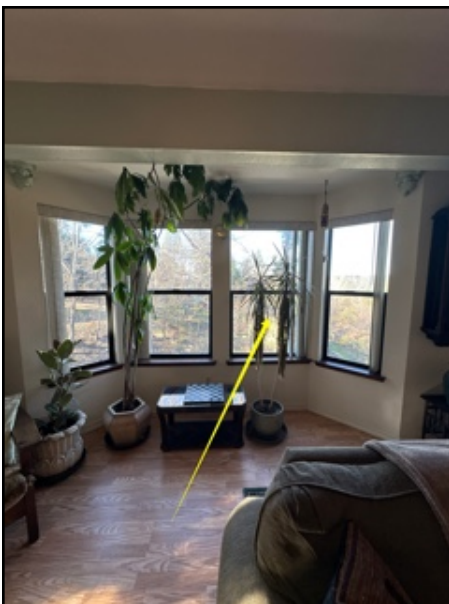
Figure 56-1

Comment 56:  
Window shown in living area has a broken or disconnected channel balance on right side.

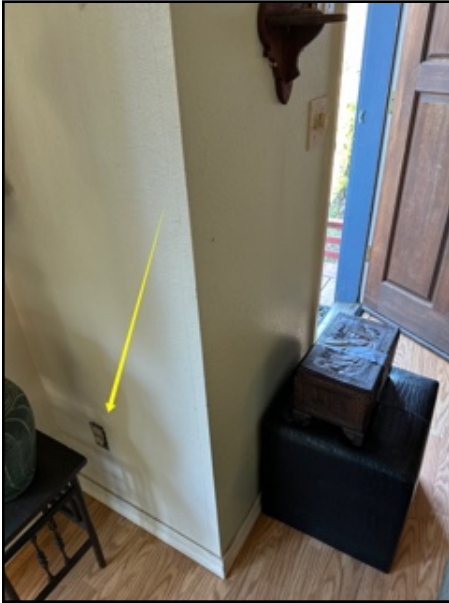
Figure 57-1

Receptacle near front door is missing the faceplate.

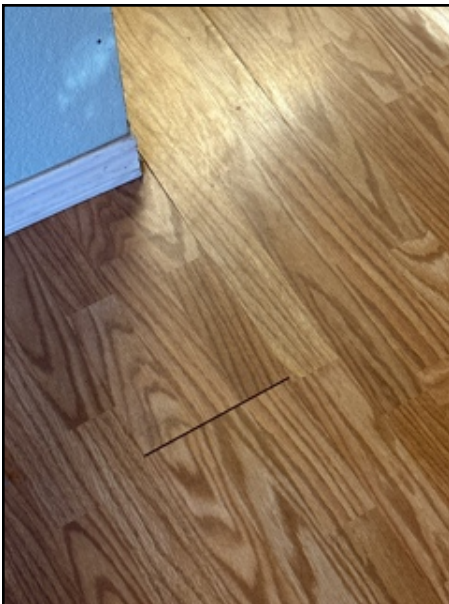
Figure 58-1

Laminate floor in kitchen area noted as damaged.

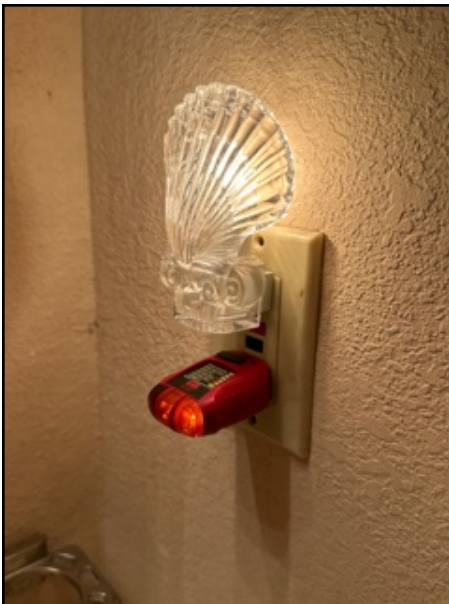
Figure 59-1

GFCI in bathroom on main level fails to trip.

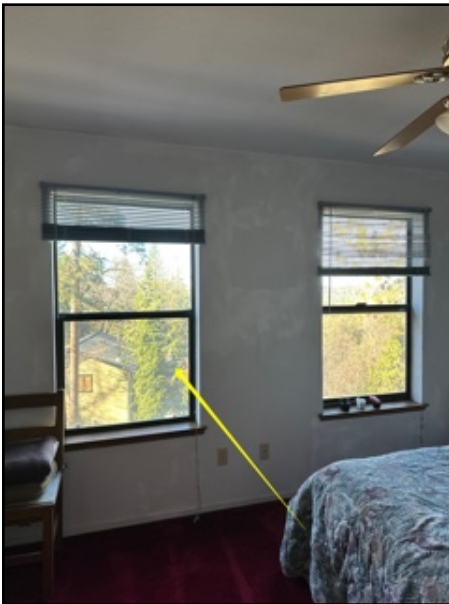
Figure 62-1

Left guest bedroom window shown has broken/ disconnected channel balances.

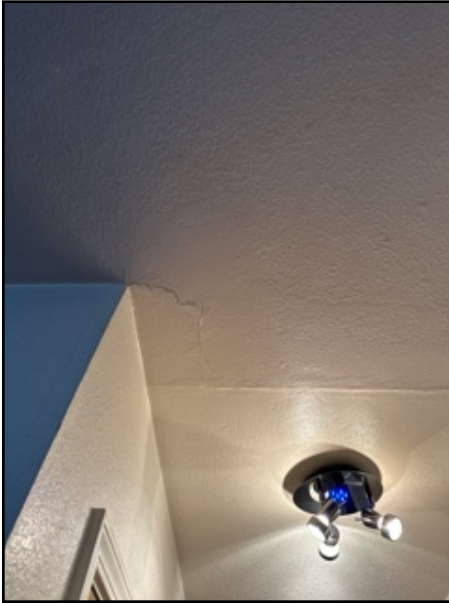
Figure 65-1

Comment 65:  
Drywall cracks noted in various areas throughout home.

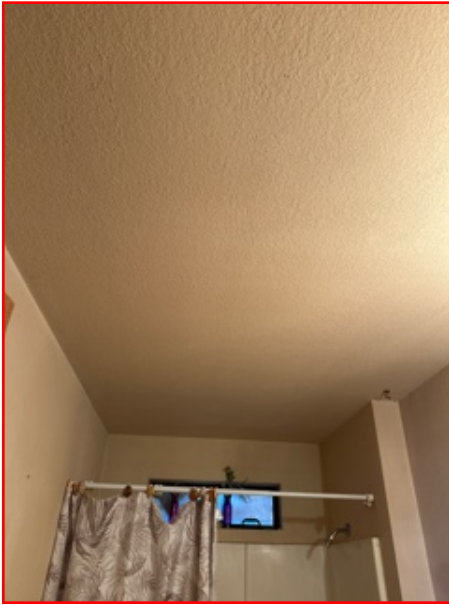
Figure 60-1

51) No vent fan installed in hallway bathroom. Current CA building code states an exhaust vent fan must be installed in all bathrooms that contain a tub or shower.

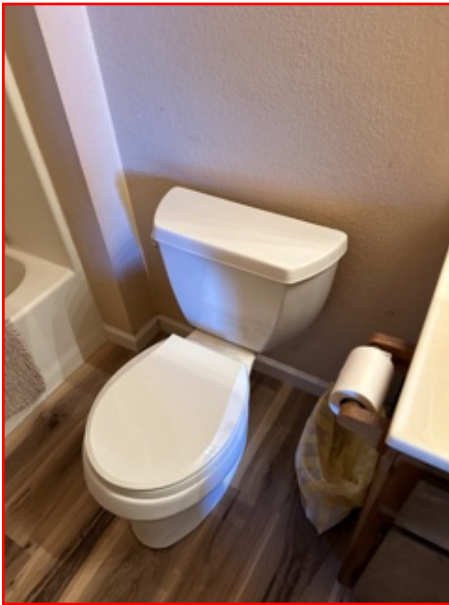
Figure 61-1

52) Guest bathroom toilet noted as loose. Recommend tightening to prevent any future leaks.

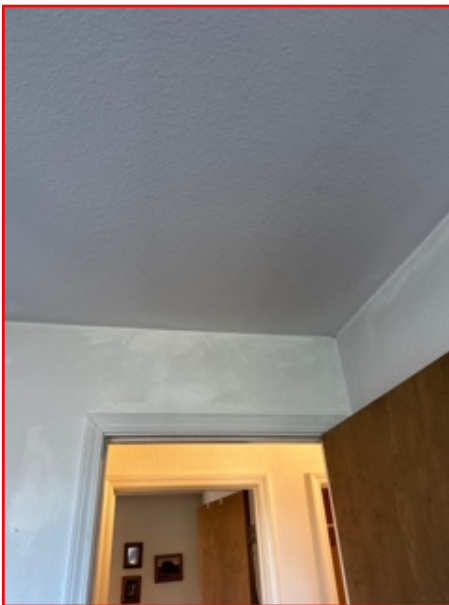
Figure 63-1

54) Multiple smoke alarms missing in home. Recommend to install as required.

Section 310.9.1.4 of the California Building Code. One smoke alarm should be placed on each floor in non-sleeping areas. In addition, one smoke alarm must be installed in each room where sleeping occurs and one smoke alarm should be located in each hallway that leads directly to sleeping rooms.

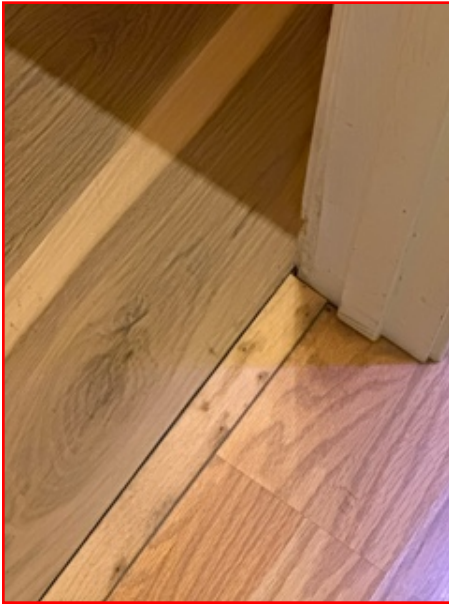
Figure 64-1

55) Bathroom transition strip does not overlap the edge of bathroom flooring.
