### *Inspection Report*

Address: 280 Spruce St Arroyo Grande, CA 93420

09/15/2026

Inspector: Taylor Vreeken, CCI

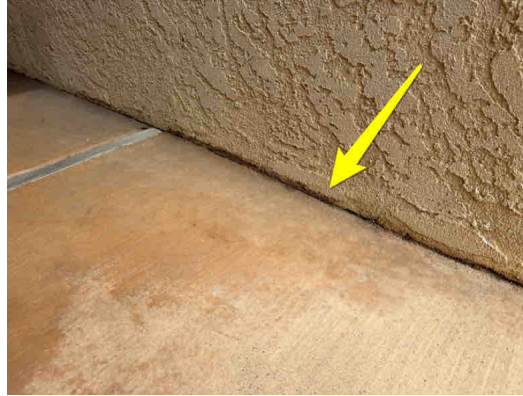
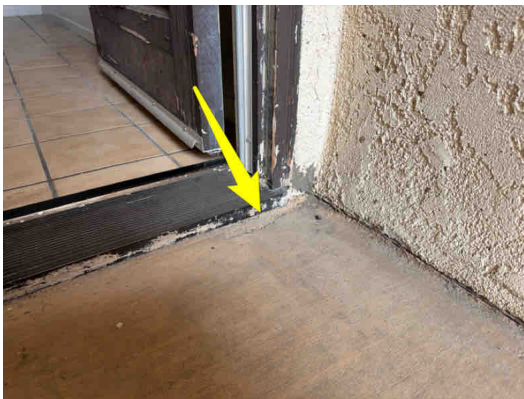
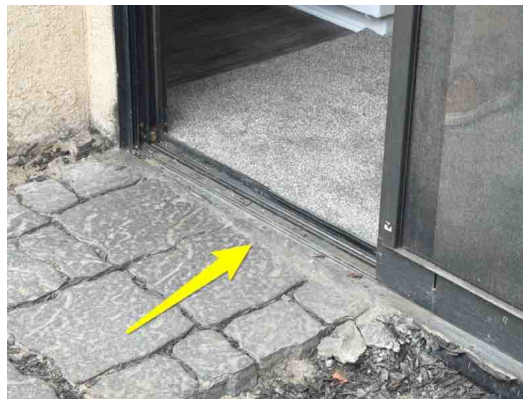
**UPG DS** 23: Areas of the exterior walkways found to be improperly installed high, at or above the exterior siding and and/or the door threshold. This can allow for moisture or water to buildup and collect behind the exterior siding and trim and can potentially wick water into the wall framing and living spaces. This can also allow water to intrude into the framing or living spaces from under the door thresholds.

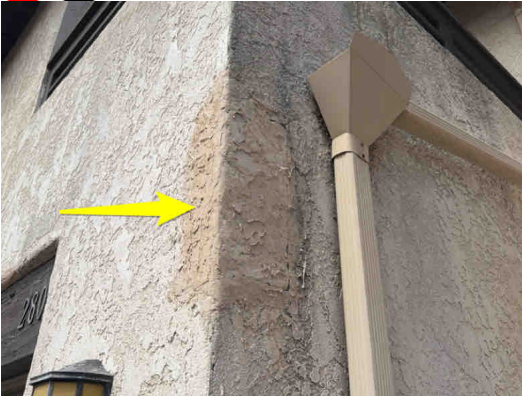
**FI DS 34:** Multiple past stucco repairs noted throughout. Ask seller for details.

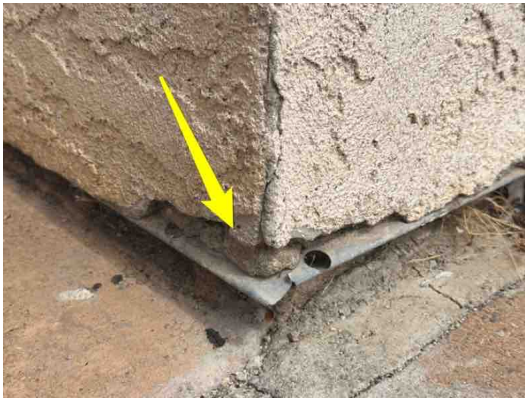
**MR DS 35:** Some moderate and heavy chipping or damage to the exterior stucco. Maintenance or repairs recommended.

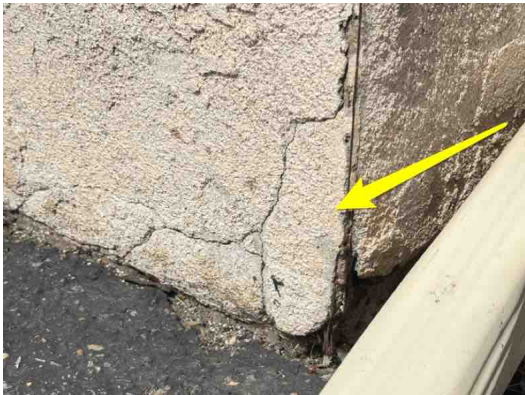
**E&C FI 36:** Some moderate and heavy deterioration or damage to the exterior stucco color coat. Maintenance or repairs recommended.

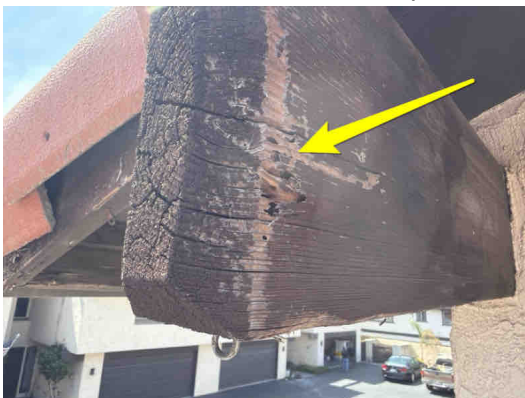
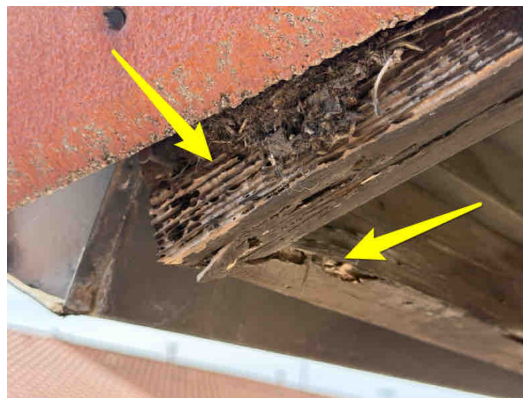
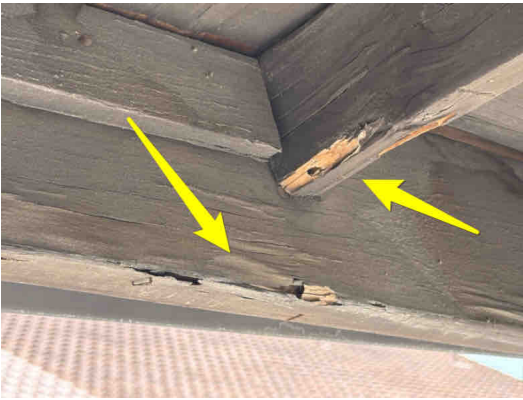
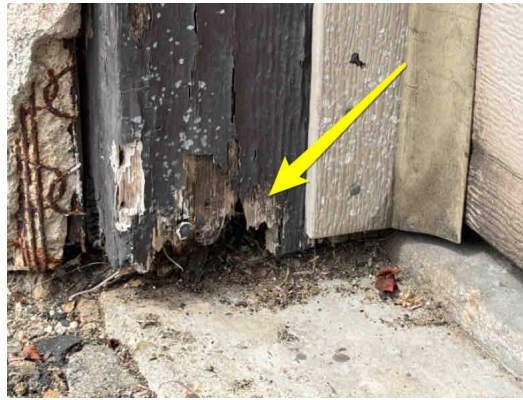
**E&C 40:** Some moisture and/or bug type damage & deterioration found at exterior areas such as eaves, fascia and/or trim. Refer to the termite report for locations and extent.

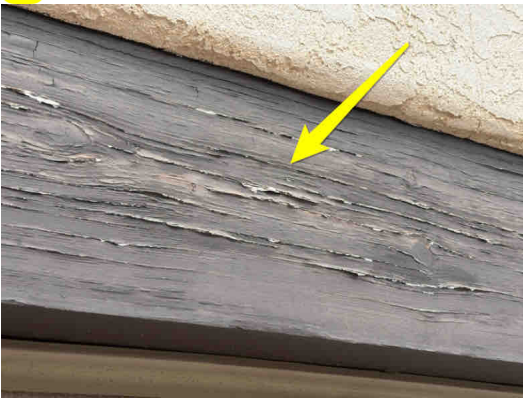
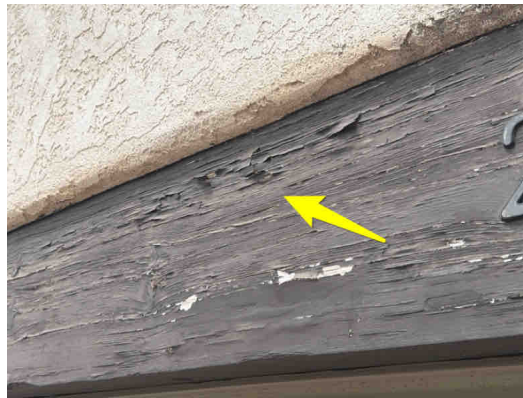
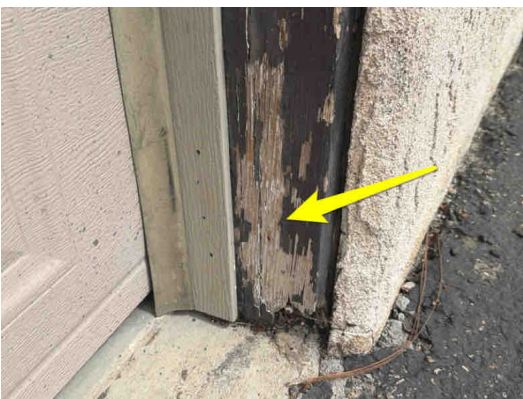
**MR 42:** Deteriorated paint or finish at areas of the exterior.

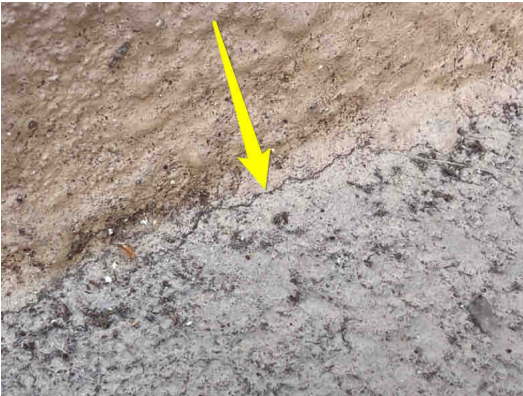
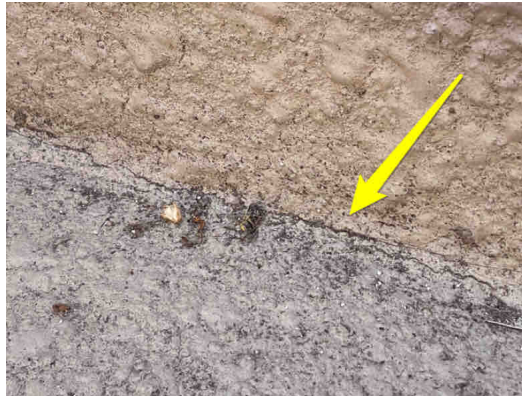
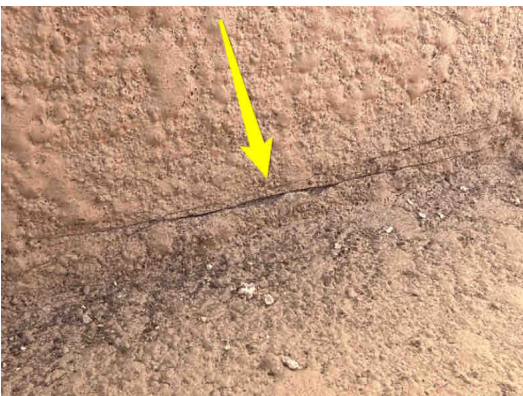
**E&C 44:** Areas of deterioration, cracking of the waterproof deck coating noted at areas of the UPSTAIRS DECK OFF THE PRIMARY BEDROOM. Maintenance or repairs needed. Recommend further review and/or repairs by a certified or licensed waterproof deck coating professional familiar with minimum requirements.

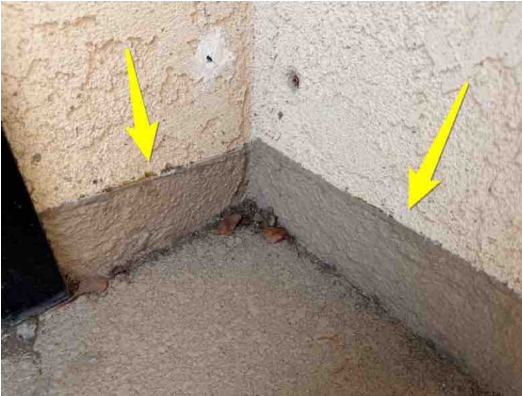
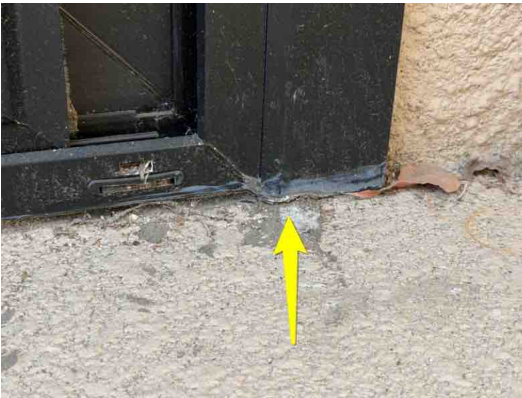
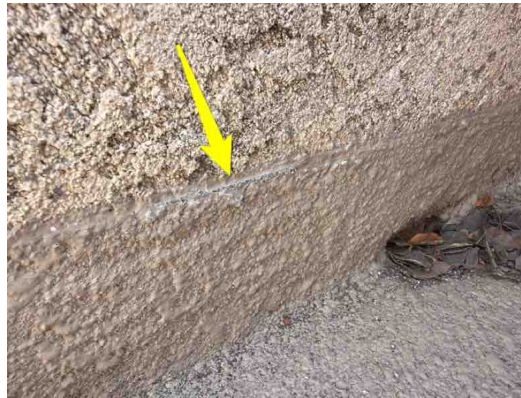
**45:** The waterproof deck coating was not properly separated or flashed at portions of the adjoining stucco walls and exterior sliding-glass door. The coating appears to terminate directly against the stucco and door frame with surface-applied sealant used at the transitions. These conditions can allow moisture intrusion as the sealant deteriorates or separates. Recommend evaluation and correction of the perimeter waterproofing and flashing details by a qualified waterproof-deck contractor.

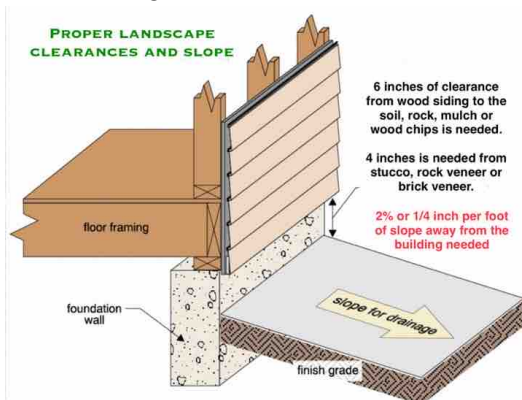
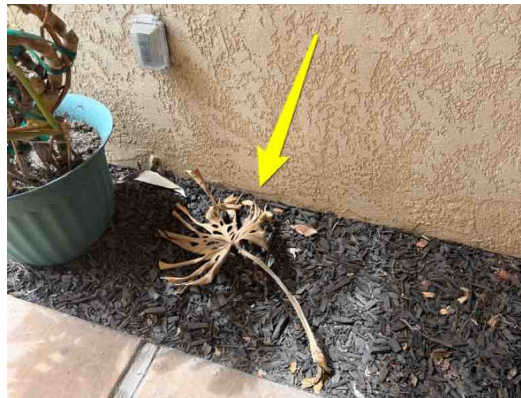
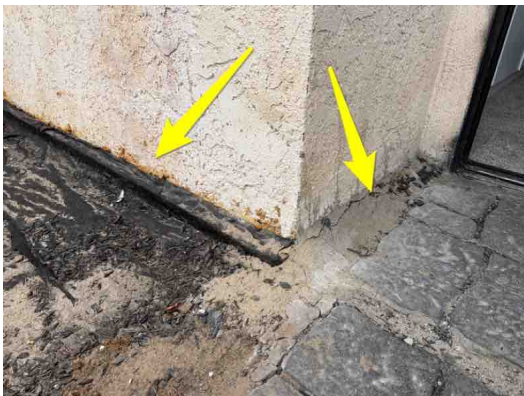
**E&C MR 48:** Soil level found high at areas of the foundation. (Recommend 4 inches from the bottom of the exterior stucco siding to dirt, rock, mulch or wood chips).

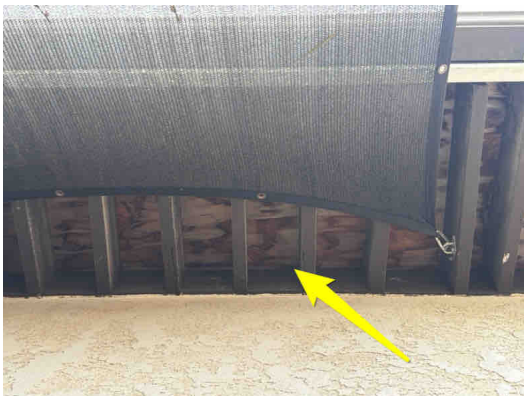
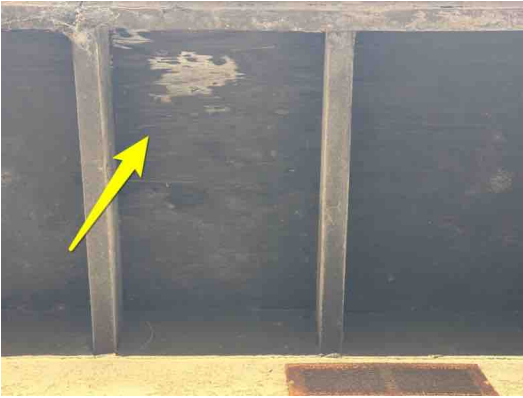
**FI 55:** Evidence of recent roof leakage was observed at the roof overhang area, including visible moisture staining and damage: BACKYARD. These conditions indicate a failure of roofing components and possible concealed damage. Recommend further evaluation by a qualified roofing contractor to determine the source, full extent of damage, and to perform necessary repairs.

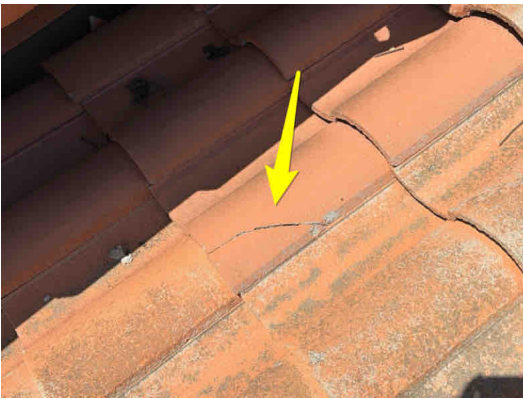
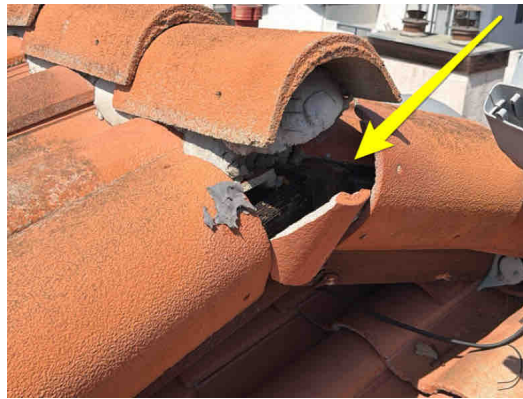
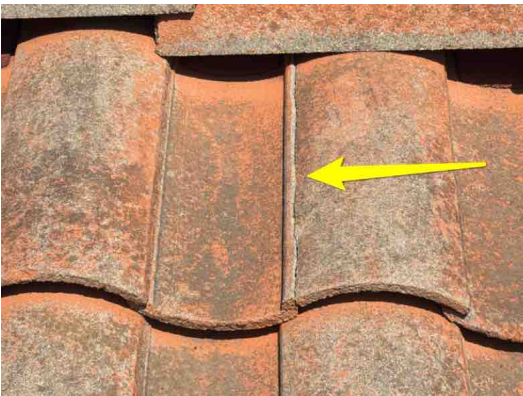
**E&C 56:** Multiple cracked and damaged roof tiles needing repair or replacement. Contact a licensed roofing contractor for further evaluation of the roof and to determine location(s) and quantity of the roof tiles needing repair or replacement.

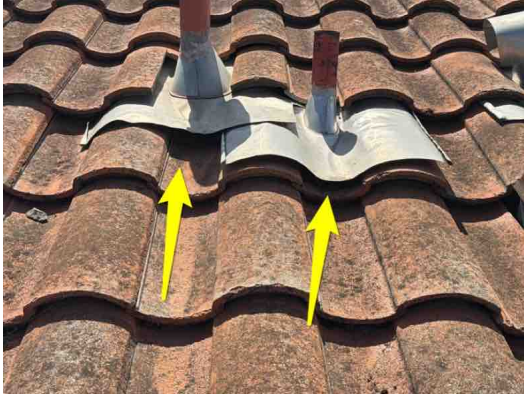
**E&C 59:** Some loose and lifting roof flashings found needing to be serviced or repaired to help prevent a roof leakage.

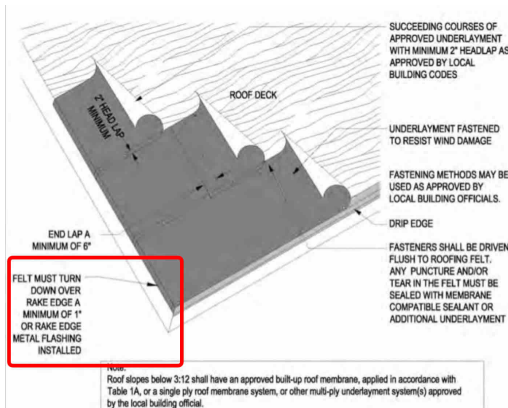
**E&C 60:** Areas found where the roof tar paper was not properly folded over the rake edges along the fascia. Contact a licensed roofer to evaluate and repair as needed. Refer to the manufacturer's requirements.

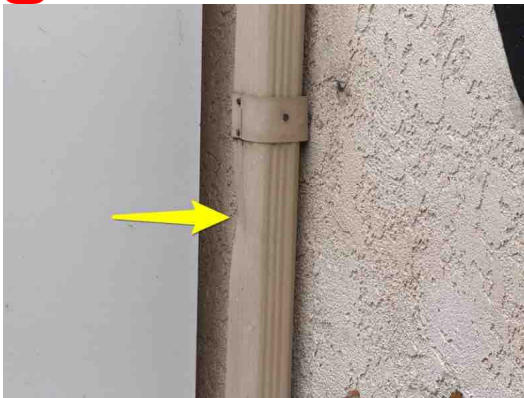
**E&C** 64: Disclosure: Areas of the rain gutters and downspouts found dented or damaged.

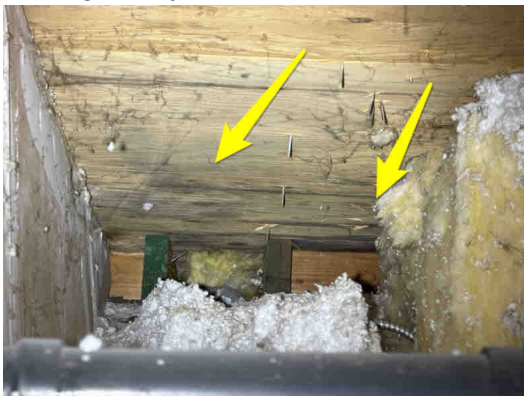
**FI DS 72:** Some moderate moisture stains noted in areas throughout the attic. All water stains should be investigated by a licensed roofer. Refer to termite report for additional comments and/or recommendations.

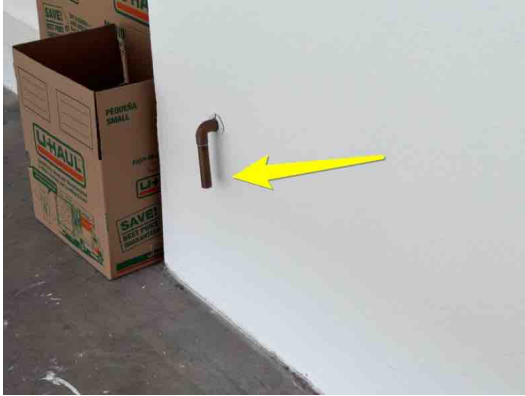
**SC 90:** The Water heater TPR (temperature pressure relief) pipe improperly terminates. Must terminate downward at the exterior at 6 to 24 inches from the ground.

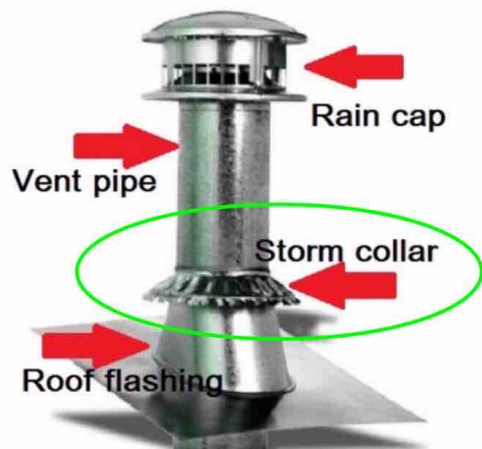
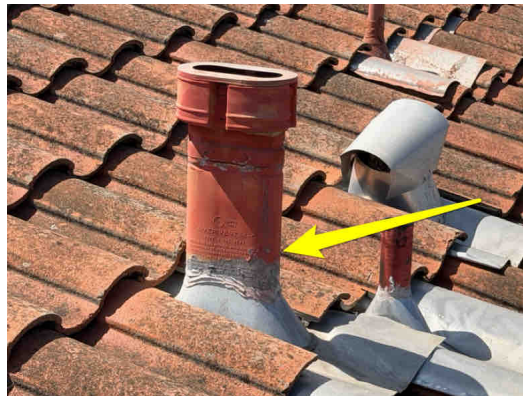
**E&C 92:** Missing / Recommend a proper storm collar per standards at the water heater vent pipe at the roof termination.

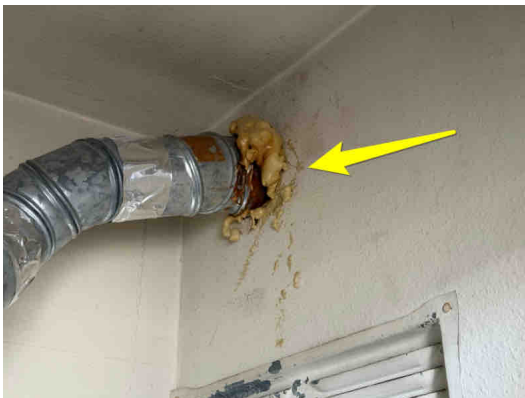
**SC 93:** Water heater vent pipe too close to combustibles as it passes through the drywall. Proper corrections are recommended per standards. Contact a qualified plumber.

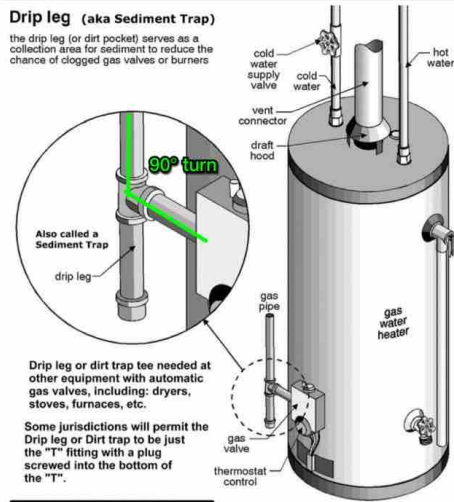
**SU 97:** Recommend the installation of the missing sediment trap / drip leg at the WATER HEATER gas piping at flex connection by a certified or licensed plumbing professional familiar with minimum requirements. [CPC 1212.8]

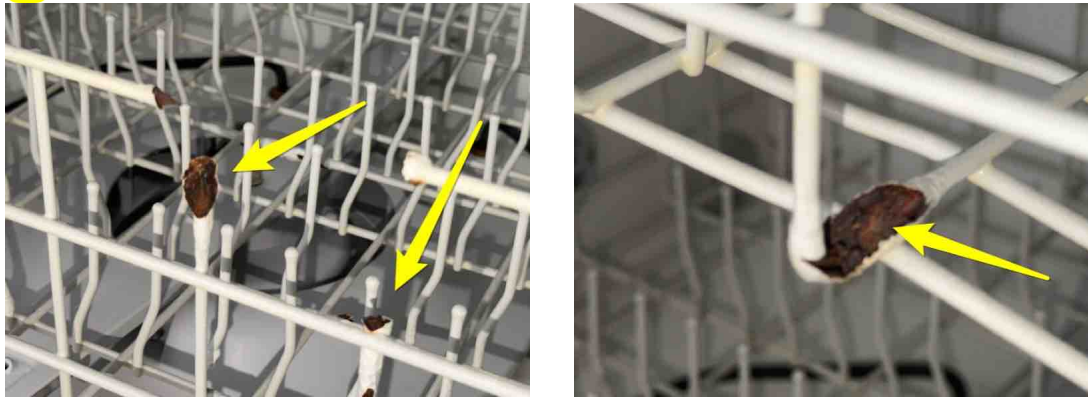
**MR 109: Disclosure:** Some rusting and deterioration of the metal racks in dishwasher.

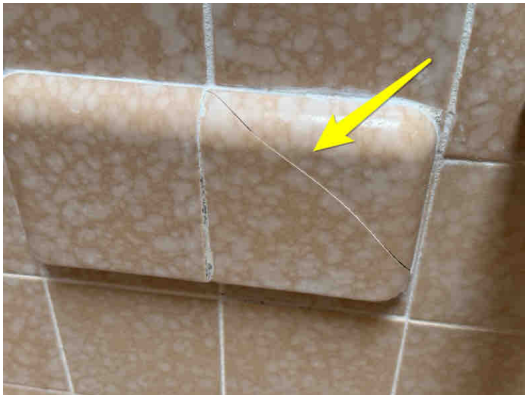
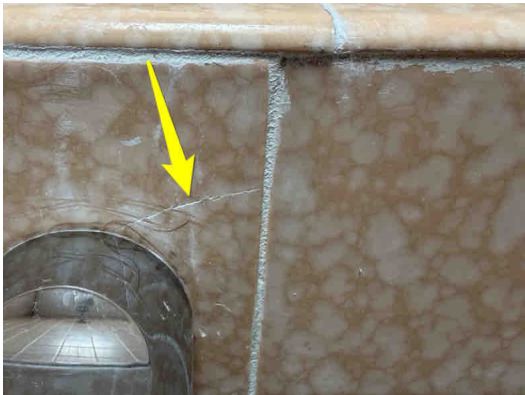
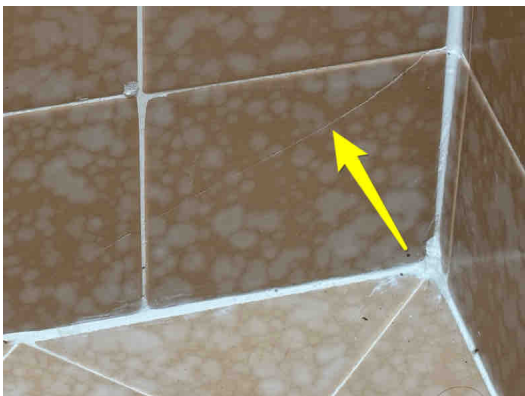
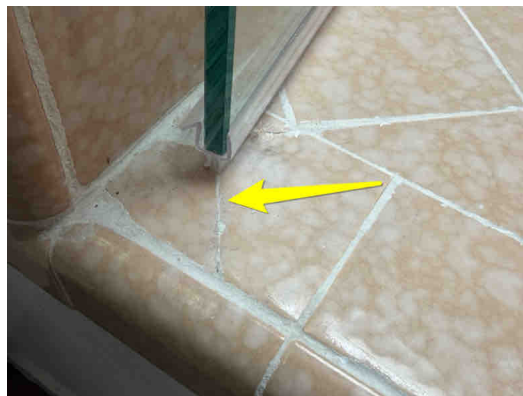
**FI 139:** Some cracked tiles in the UPSTAIRS HALL BATHROOM shower enclosure. Recommend contacting a tile professional to evaluate and determine cause, condition and if repairs are warranted.

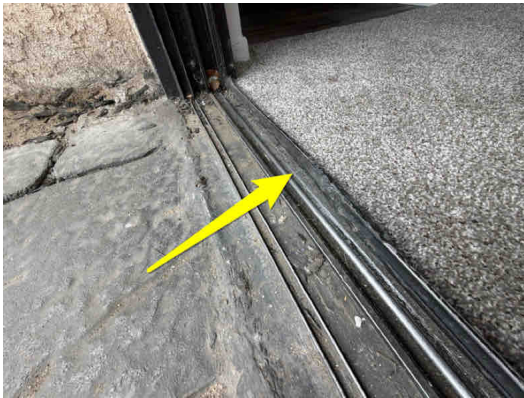
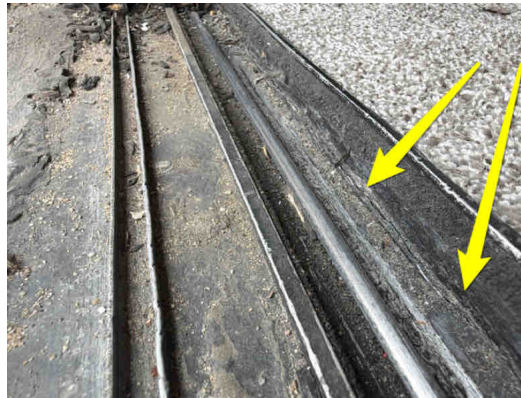
**E&C 150:** The BACKYARD ALUMINUM sliding glass door frame found cracked-damaged. Recommend evaluation by a qualified professional to retain waterproofing and warranties.

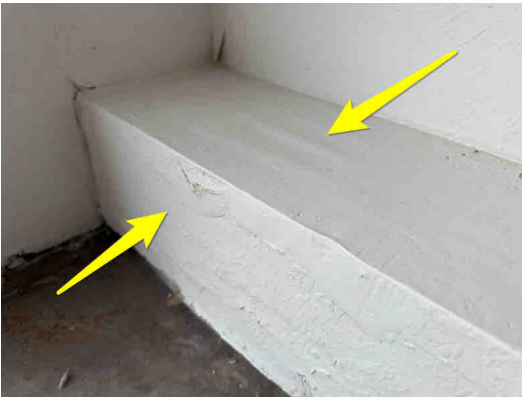
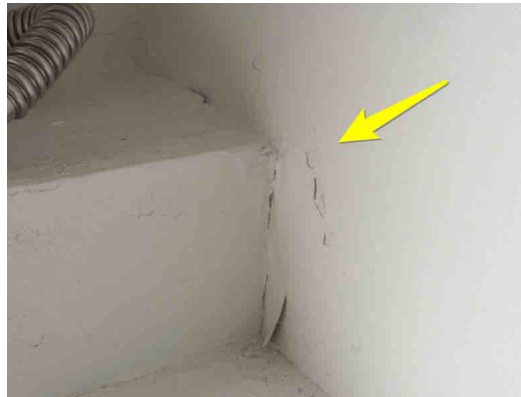
**FI 165:** Evidence of moisture stains and/or damage at the walls in the GARAGE. Recommend further review of the water stains to determine the cause, the current condition and if repairs are needed.

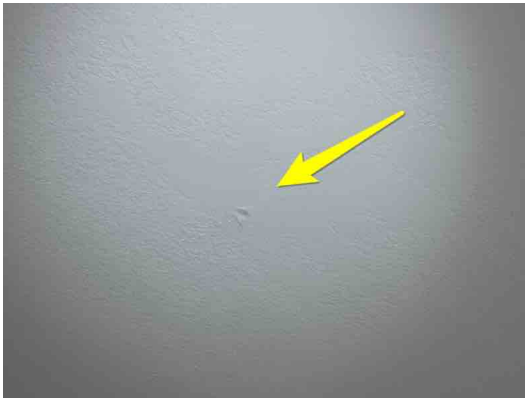
**E&C 166:** Multiple areas of apparent moisture staining and/or paint deterioration were observed at the top of the interior stairway and in the living room. The interior appears to have been recently painted, which limits the ability to determine whether these conditions are recent, ongoing, or related to previous moisture intrusion. Recommend determining the source and repairing as needed, and monitoring these areas for evidence of continued moisture intrusion.

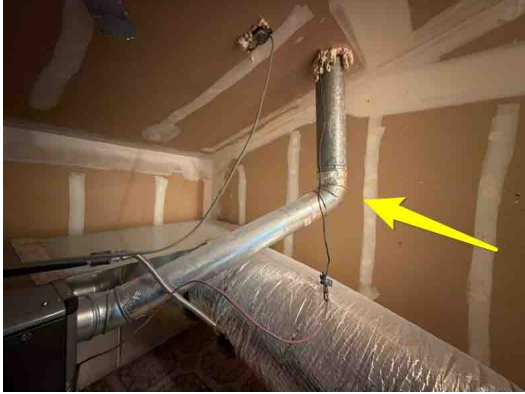
**SC 176:** The furnace vent pipe is not properly supported or strapped at the horizontal to vertical transition. This can allow the pipe to slip downward and could become dislodged.

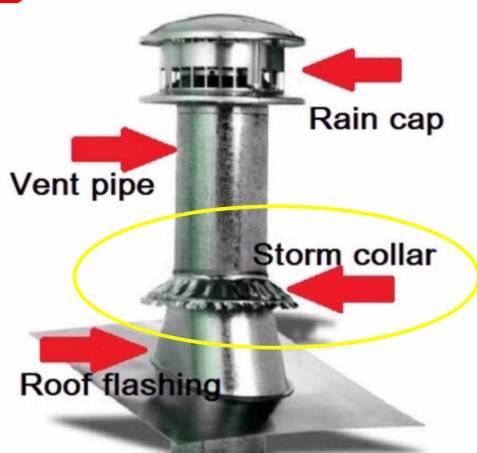
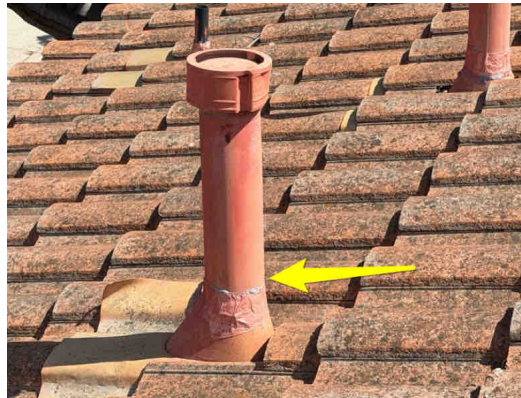
**E&C 177:** Missing / Recommend a proper storm collar per standard at the furnace vent pipe at the roof termination.

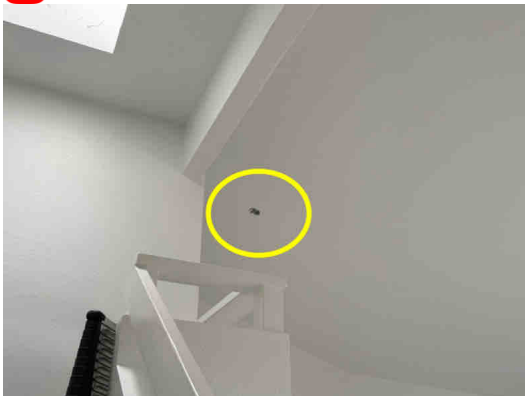
**SC 188:** Light fixture is missing, exposed wiring. Recommend repair or replacement: LIVING ROOM CEILING

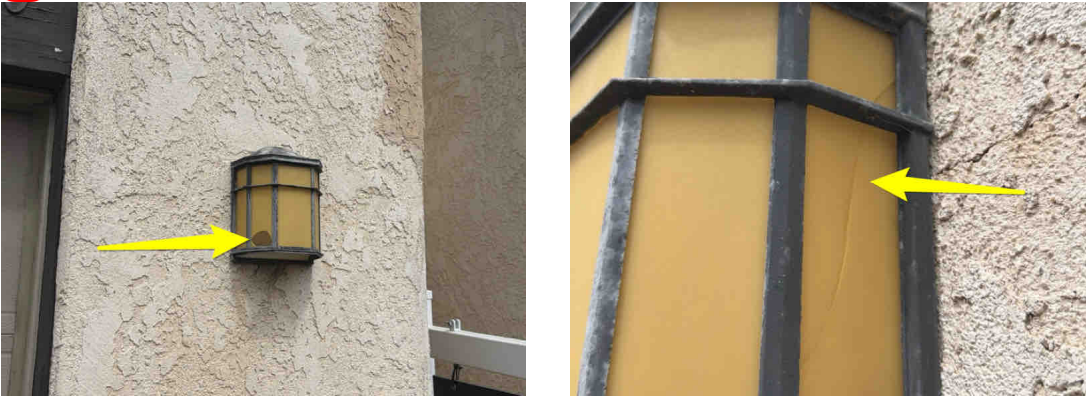
**E&C 189:** Lens at light fixture is missing: PRIMARY BEDROOM CLOSET

**E&C 190:** Lens at light fixture is damaged: EXTERIOR NEAR GARAGE VEHICLE DOOR

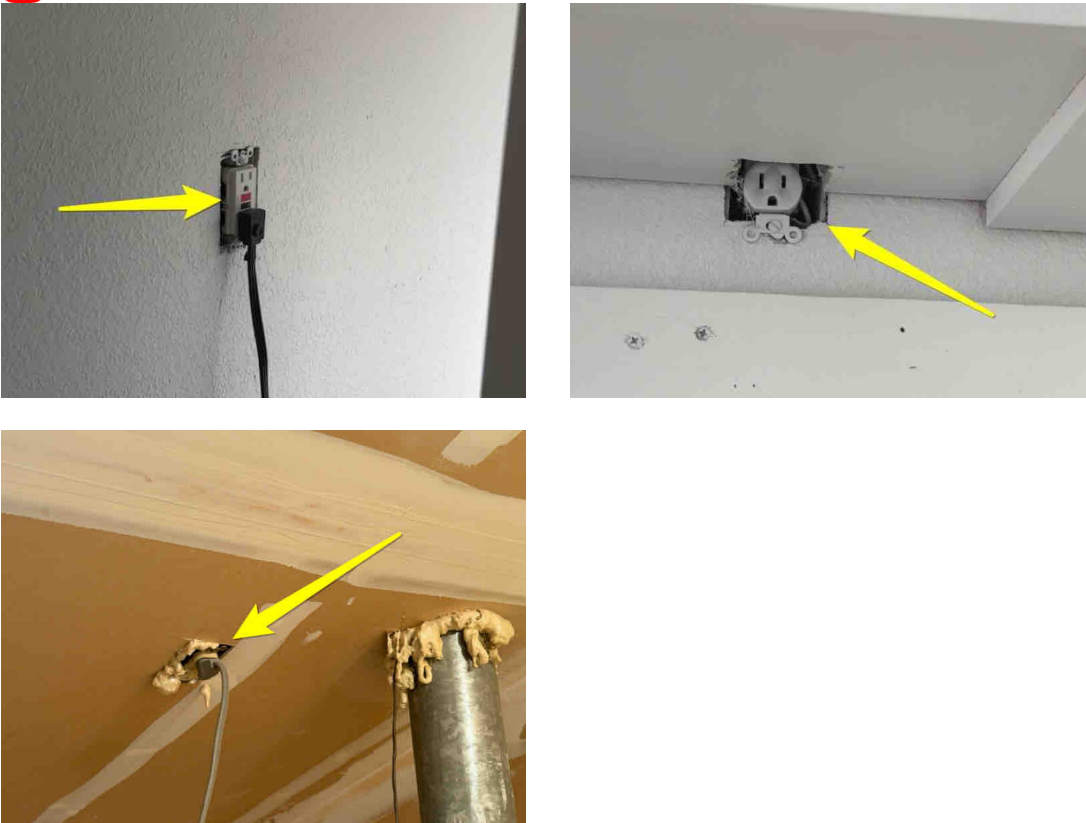
**SC 191:** Missing electrical cover plate: GARAGE EAST WALL/ KITCHEN ABOVE COOKTOP/ ATTIC

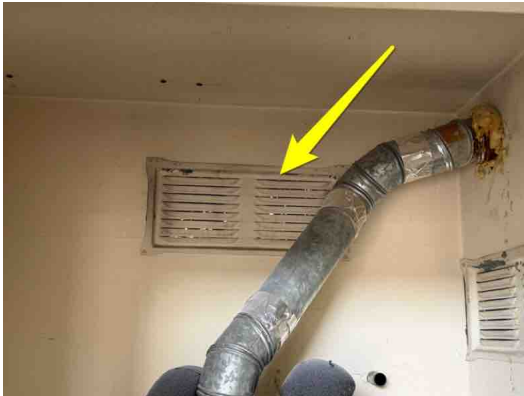
**E&C 206:** The water heater is located in a closet that opens directly to the interior of the dwelling; however, combustion-air openings were observed between the water heater closet and the attached garage. These openings compromise the required separation between the garage and dwelling and can allow garage fumes and combustion products to enter the living space. Recommend correction by a qualified contractor, including providing the required garage/dwelling separation and an approved source of combustion air for the water heater.

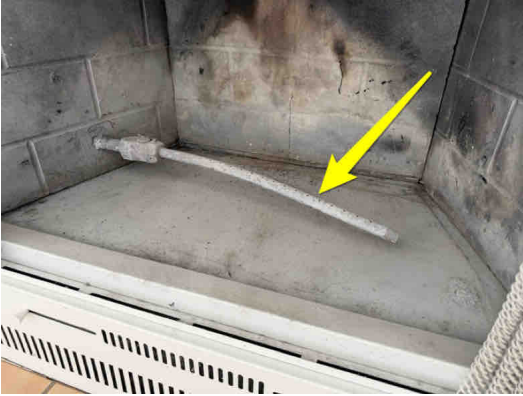
**SC 211:** Damaged metal gas log lighter installed inside the fireplace. Recommend replacement for safety.

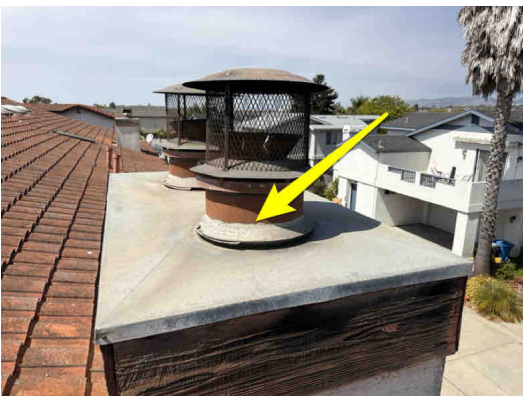
**MR 214:** Some deterioration of the sealant around the LIVING ROOM fireplace chimney chase collar. This is an area where water can intrude and warrants continuous maintenance.
