INSPECTION REPORT
1899 N Gladys Ave
Signal Hill CA 90755

INSPECTED BY
Christopher Vella
Professional
Inspection
Network

INSPECTION DATE
📅 5/13/2026
🕒 03:30 PM

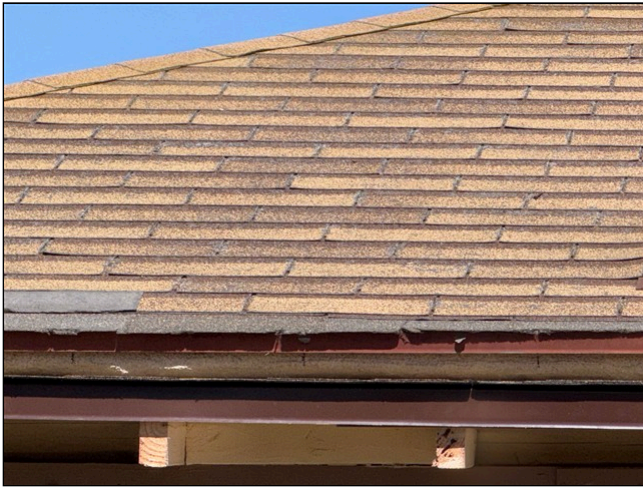
Item 1 - Item 1 (Picture)

- 1. Major Concern:** The composition shingle roofing is significantly deteriorated and shows extensive wear. The shingles exhibit curling, cracking, granule loss, and overall diminished integrity. These conditions are consistent with an aging roof that appears to have exceeded its expected service life and is at increased risk for leakage and water intrusion. Have the roofing system replaced by a licensed roofing contractor. The contractor should remove the existing roofing materials down to an appropriate substrate, evaluate the roof sheathing and flashing components, and complete any needed repairs prior to installing a new composition shingle roof. The replacement roof should be installed using current, manufacturer-approved materials and methods, including proper underlayment, flashing integration, and ventilation. Obtain documentation of permits/warranties (as applicable) and confirm the selected shingle type, rating, and warranty terms based on durability, aesthetics, and budget.

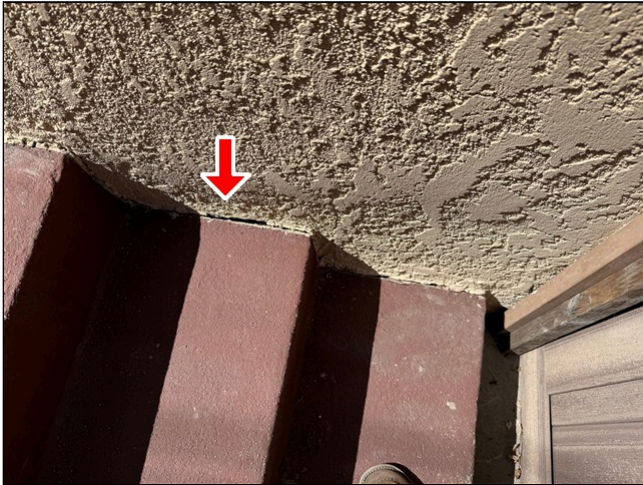
Item 3 - Item 1 (Picture)

3. (1) **Repair or Replace:** The concrete steps at the exterior wall have separated from the wall structure, and a visible gap was observed between the steps and the exterior wall. This condition may be the result of movement and/or settlement and could present a potential safety concern. Further evaluation and repair by a qualified contractor is recommended.

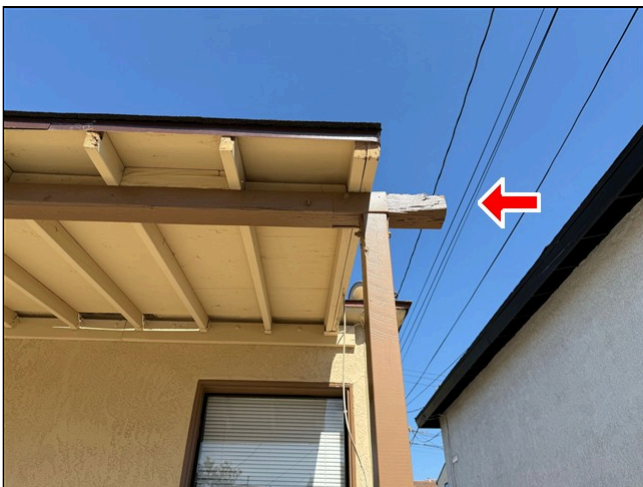
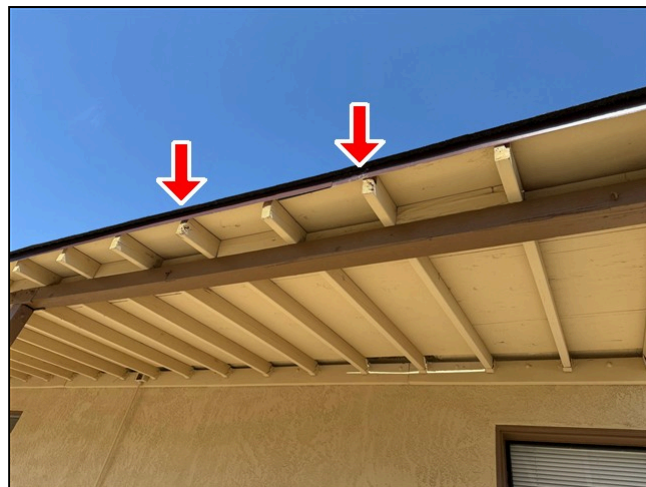
4. (2) **Repair or Replace:** There is wood deterioration observed at the rear patio covering in one or more locations. This deterioration can be caused by various factors such as moisture, pests, or age-related wear and tear. It is important to address this issue to prevent further damage. Due to the presence of wood deterioration, it is advisable to have a pest control company inspect the area for any signs of pest activity or infestation. Certain pests can cause significant damage to wood structures. A professional inspection will help determine if pests are present and if further treatment is necessary. It is recommended to hire a licensed contractor experienced in wood repairs and replacements. They will assess the extent of the wood deterioration and provide appropriate recommendations. Depending on the severity of the damage, the contractor may suggest repair techniques such as wood patching, reinforcement, or complete replacement of deteriorated wood components. Please be aware that this report is based on a visual inspection, and it is essential to consult a qualified professional, such as a licensed contractor and a pest control company, for a comprehensive assessment and appropriate repairs.

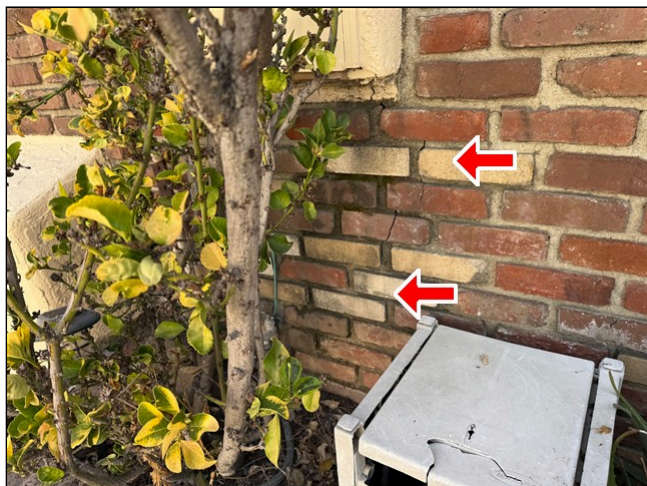
Item 5 - Item 1 (Picture)

5. (3) **Repair/Replace/Monitor:** The brick veneer at the front wall of the home is cracked due to apparent

settlement and possible movement related to tree roots and/or tree growth at the front wall area. Continued movement may result in additional cracking and deterioration of the veneer system over time. Further evaluation and repair by a qualified contractor is recommended.

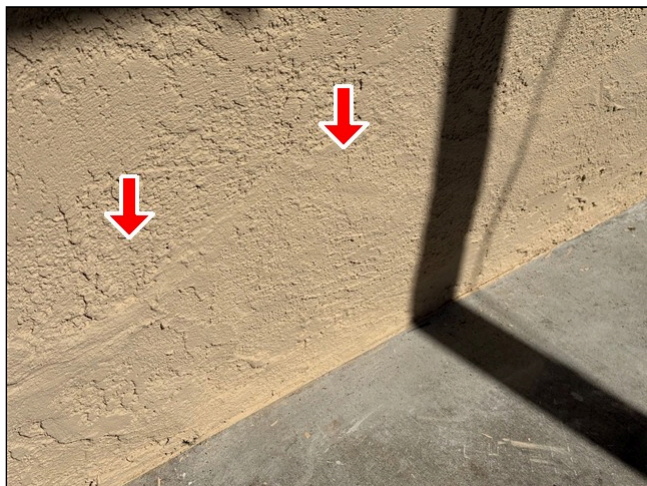
Item 6 - Item 1 (Picture)

- 6. (4) Repair/Replace/Monitor:** Visible cracking was observed in the stucco cladding on the exterior walls of the home. Such cracking occurs when the stress placed on the wall exceeds the material's capacity to withstand it. Potential underlying causes include issues with the wall's framing, contraction or expansion of the wood sheathing, settling of the structure, thermal expansion or contraction, rapid temperature changes, weak points in the wall, or abnormal ground vibrations. Consult a licensed contractor or structural engineer to assess the severity of the cracking and identify the root cause. Repairs may include sealing and patching the cracks using appropriate stucco materials, and if necessary, addressing structural or environmental factors contributing to the stress. Regular maintenance of stucco surfaces, including inspections and timely repairs, is recommended to prevent further damage and maintain the structural integrity and appearance of the home.

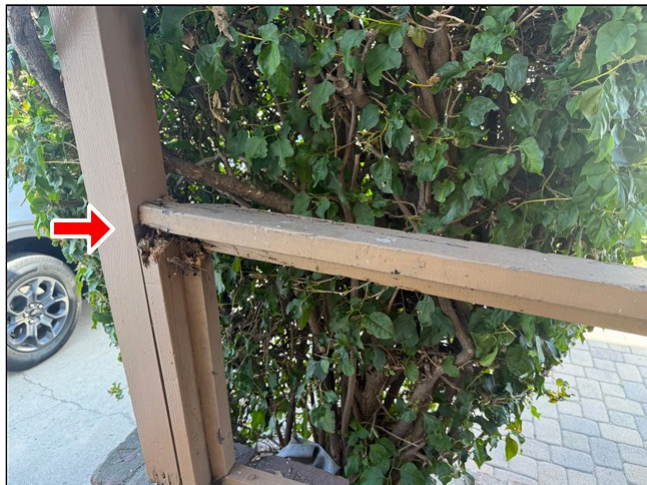
Item 7 - Item 1 (Picture)

- 7. (5) Repair or Replace:** There is wood deterioration observed at the front porch railing. This deterioration can be caused by various factors such as moisture, pests, or age-related wear and tear. It is important to address this issue to prevent further damage. Due to the presence of wood deterioration, it is advisable to have a pest control company inspect the area for any signs of pest activity or infestation. Certain pests can cause significant damage to wood structures. A professional inspection will help determine if pests are present and if further treatment is necessary. It is recommended to hire a licensed contractor experienced in wood repairs and replacements. They will assess the extent of the wood deterioration and provide appropriate recommendations. Depending on the severity of the damage, the contractor may suggest repair techniques such as wood patching, reinforcement, or complete replacement of deteriorated wood components. Please be aware that this report is based on a visual inspection, and it is essential to consult a qualified professional, such as a licensed contractor and a pest control company, for a comprehensive assessment and appropriate repairs.

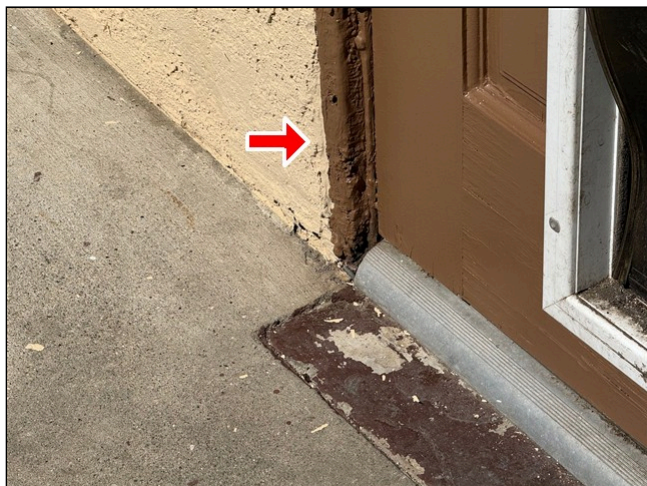
Item 8 - Item 1 (Picture)

- 8. Repair or Replace:** There is wood deterioration observed at the rear rear wall door frame. This deterioration can be caused by various factors such as moisture, pests, or age-related wear and tear. It is important to address this issue to prevent further damage. Due to the presence of wood deterioration, it is advisable to have a pest control company inspect the area for any signs of pest activity or infestation. Certain pests can cause significant damage to wood structures. A professional inspection will help determine if pests are present and if further treatment is necessary. It is recommended to hire a licensed contractor experienced in wood repairs and replacements. They will assess the extent of the wood deterioration and provide appropriate recommendations. Depending on the severity of the damage, the contractor may suggest repair techniques such as wood patching, reinforcement, or complete replacement of deteriorated wood components. Please be aware that this report is based on a visual inspection, and it is essential to consult a qualified professional, such as a licensed contractor and a pest control company, for a comprehensive assessment and appropriate repairs.

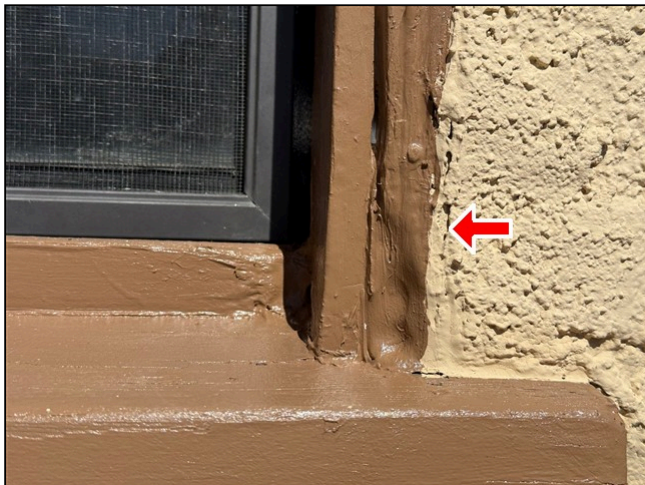
Item 9 - Item 1 (Picture)

- 9. (1) Repair or Replace:** The exterior wood window frames of the home are deteriorated in one or more areas. Deterioration of wood window frames can lead to several problems, including compromised structural integrity, increased susceptibility to weather damage, and potential water intrusion, which can further damage the surrounding wall structures. Additionally, deteriorated frames can negatively impact the building's energy efficiency by allowing air leaks. A comprehensive assessment of all exterior wood window frames is recommended to determine the extent of the damage. Replacement of the deteriorated frames with new, durable materials that are resistant to weathering and decay is advised to protect the structure and improve energy efficiency. A qualified contractor should be consulted to perform the replacements, ensuring proper installation and sealing to prevent future issues. Regular maintenance and inspections should also be scheduled to monitor the condition of the new frames.

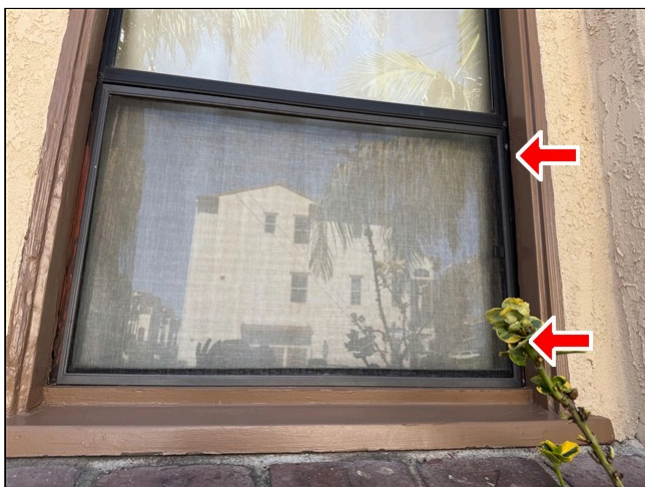
Item 10 - Item 1 (Picture)

- 10. (2) Repair or Replace:** The installation of the replacement windows throughout the home appears to be non-professional. The windows are considered non-conforming, and deficiencies in the installation may allow water intrusion into the wall assemblies. Continued leakage may result in hidden damage, deterioration, and possible organic growth within surrounding materials. Further evaluation and correction by a qualified window contractor is recommended.

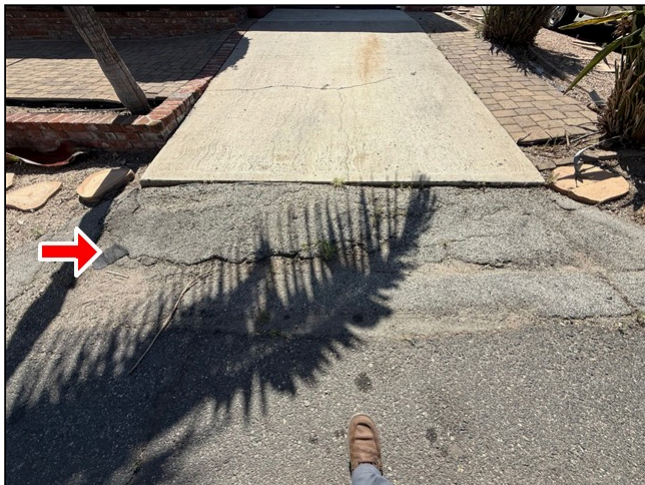
Item 11 - Item 1 (Picture)

- 11. (1) Repair or Replace:** The driveway surface at the transition between the concrete and asphalt sections is uneven. This condition may present a trip hazard and may worsen over time due to movement and settlement. Further evaluation and repair by a qualified contractor is recommended as needed.

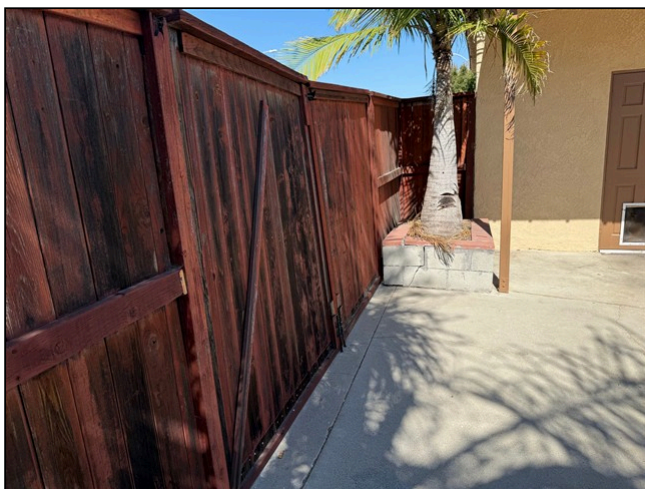
Item 13 - Item 1 (Picture)

- 13. Repair or Replace:** The wooden fence throughout the subject property is weathered and shows signs of deterioration in various locations. The fence is in need of repair and/or replacement. Suggest repair/replacement as required by a qualified professional.

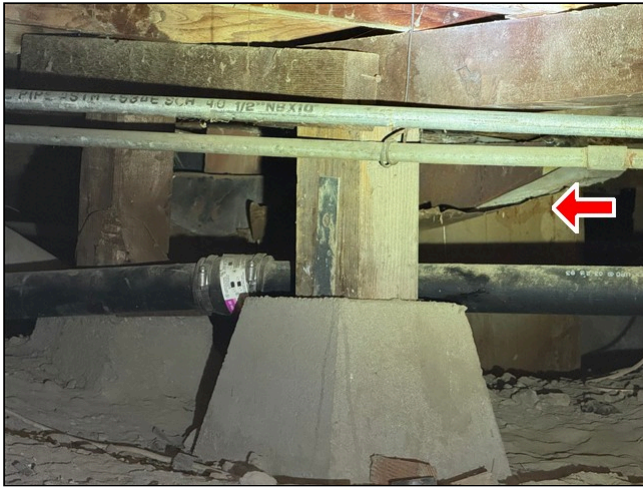
Item 14 - Item 1 (Picture)

- 14. (2) Improve:** An abandoned floor furnace was observed at the crawl space of the home. The unit is no longer in use and is recommended for removal. Components associated with the older furnace system may contain asbestos-containing materials. Further evaluation and removal by qualified professionals familiar with asbestos handling procedures is recommended.

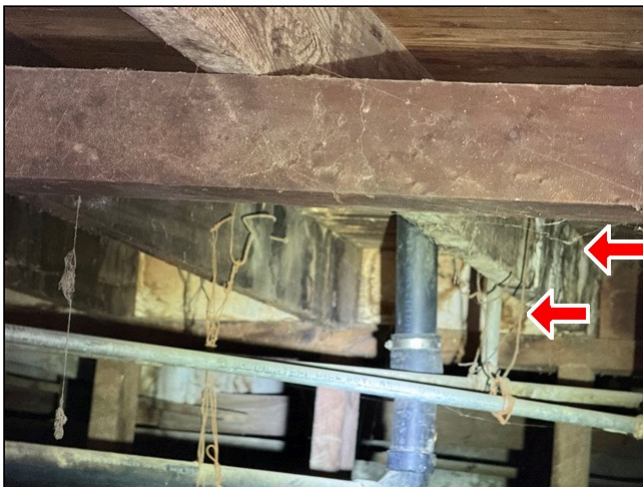
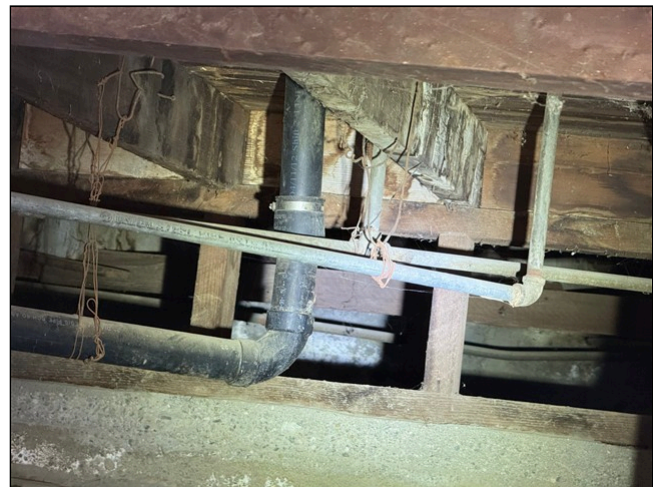
- 15. (1) Repair or Replace:** Water staining, wood deterioration, and potential fungus were observed at the hallway bathroom subfloor. The presence of water staining and deterioration suggests possible past or ongoing moisture intrusion. Wood deterioration can compromise the structural integrity of the subfloor, leading to potential safety hazards. The presence of fungus indicates the potential for mold growth, which can have adverse health effects. It is strongly recommended to have a qualified contractor assess the condition of the subfloor below the hallway bathroom. Based on the contractor's evaluation, necessary repairs or replacement of the subfloor may be required to address any structural or moisture-related issues. Identify and address the source of moisture to prevent future damage. This may involve addressing leaks, improving ventilation, or other moisture control measures. Timely intervention and professional assessment are crucial to address potential structural issues and ensure the safety and integrity of the bathroom subfloor.

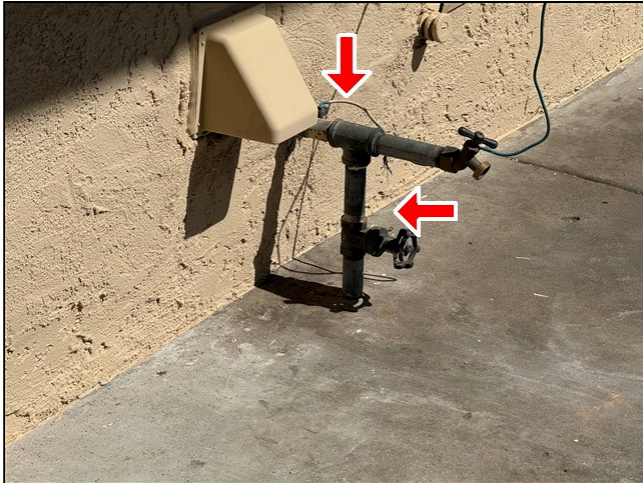
Item 18 - Item 1 (Picture)

- 18. (1) Major Concern:** The main water supply pipe routed from the street to the home is a galvanized steel pipe. Galvanized steel pipes are used in the interior water supply, and generally have a finite life span. The quality of the plating, installation methods, water temperature, water quality and water usage all factor into the actual serviceable life. Scale builds up inside the pipe which eventually restricts the flow of water to the fixtures. Corrosion eats away at the inside of the pipes, eventually causing leaks. Thirty to forty years is the average life of galvanized pipes. Replacement of the galvanized steel supply pipes will eventually be required. Note: There is visible debris, and possible metal flakes, when water is run to the sinks in the home. The makeup of this debris is unknown.

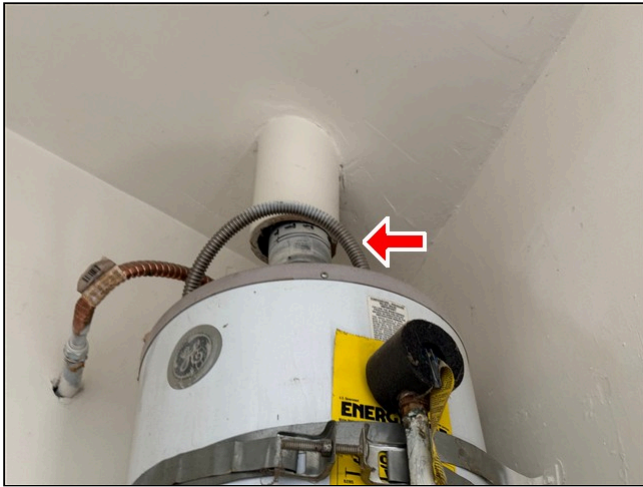
Item 19 - Item 1 (Picture)

- 19. (1) Repair/Replace/Monitor:** The modern, sheet metal water heater vent terminates inside of an old, concrete/asbestos Transite vent. The usual consequence is the formation of condensation from the Transite material, which can lead to corrosion and/or deterioration of both the flue and the water heater. This configuration does not meet the manufacturer's specifications or industry standards. The vent should be reconfigured by a qualified technician to meet the manufacturer's specifications.

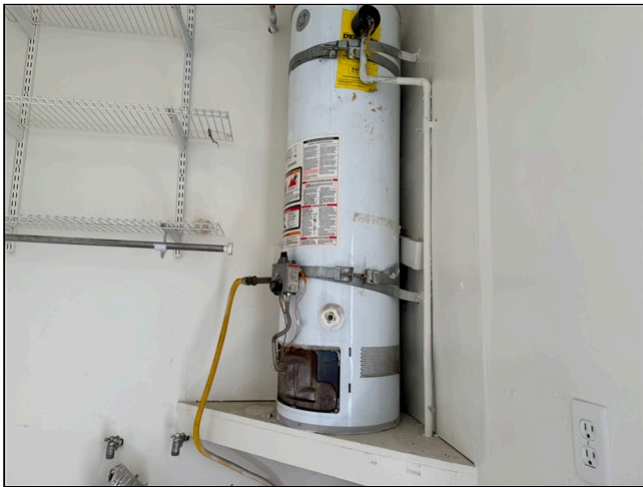
Item 20 - Item 1 (Picture)

- 20. (2) Repair/Replace/Monitor:** The water heater is an older unit. The water heater may be nearing the end of its service life. Typical life expectancy of water heaters is 7 to 12 years. The existing unit is 14 years old. It is difficult to determine when replacement will be necessary. Suggest replacement of the water heater by a licensed and qualified plumber.

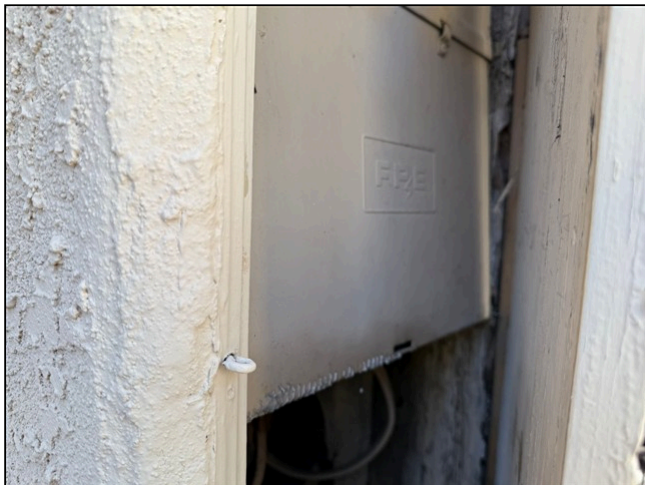
Item 21 - Item 1 (Picture)

- 21. Safety Issue:** The main electrical panel for the home is manufactured by a company known as Federal Pacific. Federal Pacific electrical equipment is considered obsolete, due to design flaw in which the circuit breaker's connection to the bus bar becomes loose, causing arcing and subsequent overheating. Long term exposure to this heat can cause the breaker(s) to fuse to the bus bar, making it impossible to remove. Even worse, it can cause the breaker's contacts to fuse together, thus preventing the breaker from tripping even in an overcurrent situation, thereby causing a potential fire hazard. Federal Pacific Electric (FPE) electrical panels were widely used in residential homes and buildings from the 1950s through the 1980s. However, over the years, these panels have been found to have significant defects that could lead to serious safety concerns. These defective panels may fail to trip, even in the event of a power surge or electrical overload, causing electrical fires. The Consumer Product Safety Commission (CPSC) conducted an investigation in the 1980s and found that some FPE panels and breakers failed to trip and that many of these panels were still in use in residential homes. As a result, the CPSC recommended that homeowners replace these panels, especially those with a Type Stab-Lok circuit breaker, which was found to have the most significant defects. Replacing an FPE panel can be a costly and time-consuming process, but it is essential for the safety of your family and your home. It is strongly urged and advised that the main electrical panel for the home be replaced with a new, modern and safe electrical system/panel by a licensed and qualified electrician.

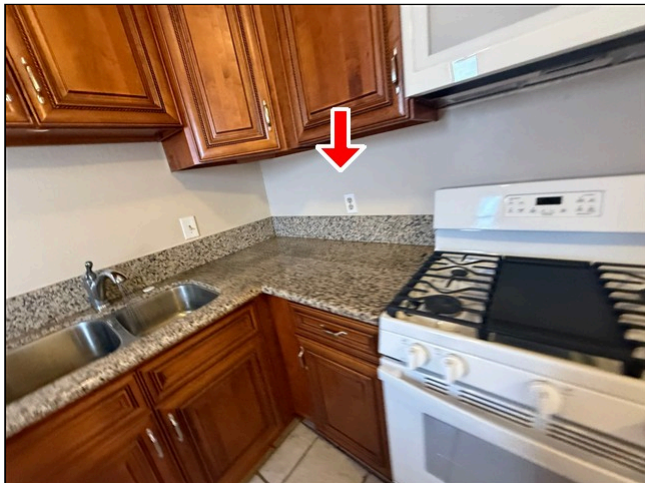
Item 22 - Item 1 (Picture)

- 22. Safety Issue:** The kitchen countertop outlets were found to lack Ground Fault Circuit Interrupter (GFCI) protection during the inspection. GFCI outlets are essential safety devices that help protect against electrical shocks and potential hazards in wet areas, such as kitchens and bathrooms. It is highly recommended to have GFCI outlets installed at the kitchen countertop to ensure the safety of the electrical system in the area. GFCI outlets detect imbalances in electrical currents and quickly interrupt the power supply, reducing the risk of electrical shock. To address this issue, it is advised to consult with a qualified electrician who can install GFCI outlets at the kitchen countertop according to local electrical codes and regulations. This will help ensure compliance with safety standards and provide enhanced protection for you and your household.

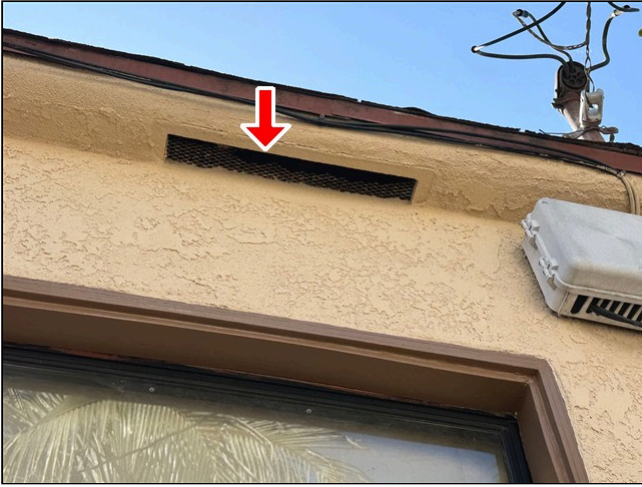
Item 23 - Item 1 (Picture)

- 23. Repair or Replace:** The screens for the crawl space vent openings are loose, torn or displaced in various locations. These areas are large enough to allow pest entry into the building. We suggest the screens be repaired/replaced to prevent vermin/animals from entering the home.

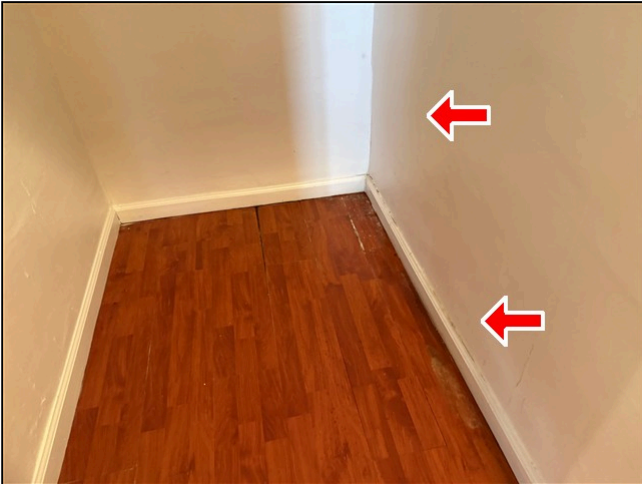
Item 24 - Item 1 (Picture)

- 24. Major Concern:** A significant amount of water damage was observed at the interior walls and floor of the middle North hallway closet. The condition appears to indicate moisture intrusion and/or water intrusion from an exterior source. The exact source of the moisture could not be determined during the inspection. There is an extra risk of hidden damage and possible concealed deterioration within these areas. Further evaluation and repair by a qualified contractor is recommended to determine the source of the moisture intrusion and repair all damaged materials.

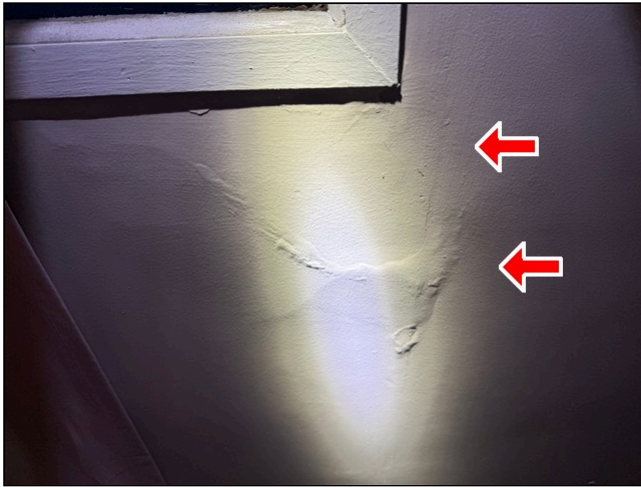
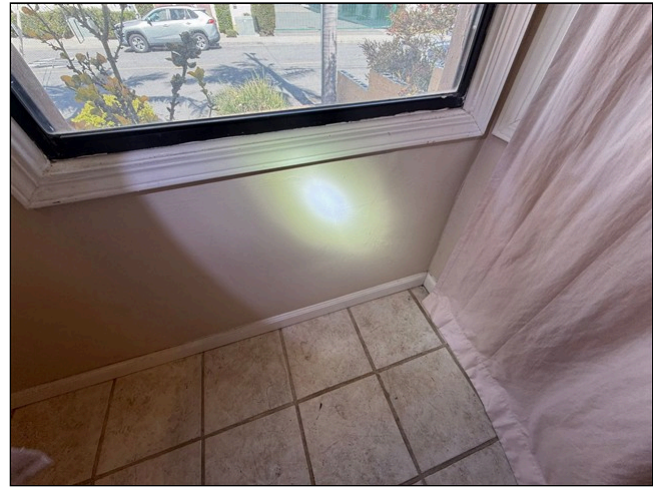
- 25. (1) Major Concern:** Water damage was observed at the interior walls below the windows, indicating that the windows may be leaking. The condition appears to be related to the non-professional installation of the replacement windows. Continued water intrusion may result in additional hidden damage, deterioration, and possible organic growth within the wall assemblies. Further evaluation and correction by a qualified window contractor is recommended.

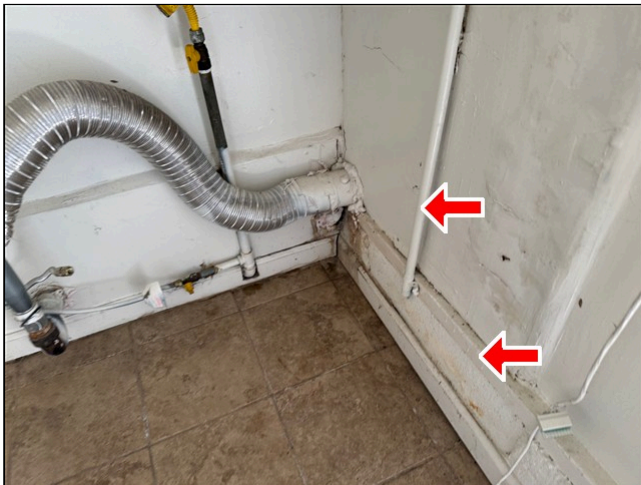
Item 26 - Item 1 (Picture)

- 26. (2) Major Concern:** A significant amount of water damage was observed at the interior walls of the garage along the rear interior wall. The damage appears to be related to prolonged moisture intrusion and/or water penetration. Continued moisture exposure may result in additional deterioration and possible concealed damage within the wall assembly. Further evaluation and repair by a qualified contractor is recommended.

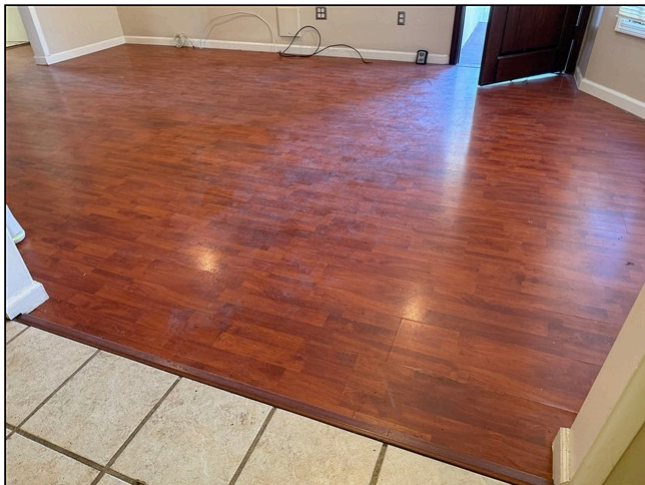
Item 27 - Item 1 (Picture)

- 27. Monitor:** The interior floor of the home has an apparent slope in several locations. If the interior floor of a building has an apparent slope in several locations, it may indicate a structural problem or issue with the foundation of the building. Contact a structural engineer or a licensed contractor to evaluate the slope of the floors. They will be able to determine the cause of the slope and assess whether there are any safety concerns. If the slope is determined to be a safety concern, take steps to ensure that the area is safe for use. This may include restricting access to the area or providing temporary support or reinforcement. Address any underlying issues with the building's foundation or structure. This may involve repairs to the foundation or installation of additional support structures to stabilize the building. Ensure that the building is up to code and meets safety standards. This may involve obtaining permits and inspections from local building authorities. It's important to address any issues with the slope of a building's floor as soon as possible, as it can affect the safety and structural integrity of the building. A professional evaluation is crucial to identifying the underlying issue and determining the appropriate course of action to address it. This might be the result of the age and framing design of the home. Suggest further evaluation by a qualified trades person and structural engineer for determination, evaluation and/or corrective repairs if required. Since this inspection is visual in nature, it is always recommended that any movement observed be further evaluated to prevent damage and to insure the integrity of the structure is kept in tact.

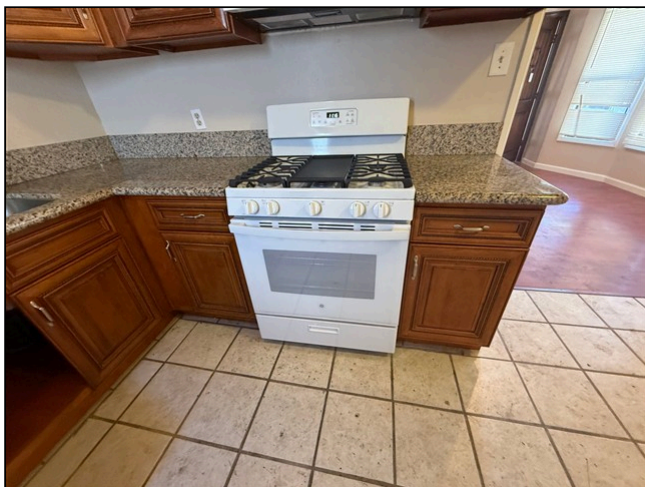
Item 28 - Item 1 (Picture)

- 28. Safety Issue:** The stove at the kitchen lacks an anti-tip bracket. An anti-tip bracket is an important safety feature that helps prevent the stove from tipping over, especially in situations where excessive weight or force is applied to the open oven door or if a child were to climb or hang on the stove. The absence of an anti-tip bracket increases the risk of the stove tipping over, which can result in serious accidents or injuries. It is recommended to have anti-tip brackets installed for each stove to enhance the safety of the property. It is advisable to consult with a qualified professional or appliance technician to properly install the appropriate anti-tip brackets for the stoves. They can ensure that the brackets are correctly attached to the stove and securely anchored to the floor or wall, following the manufacturer's guidelines and local building codes. Improving the safety features of the stoves by installing anti-tip brackets is an important step in preventing accidents and promoting the well-being of the occupants.

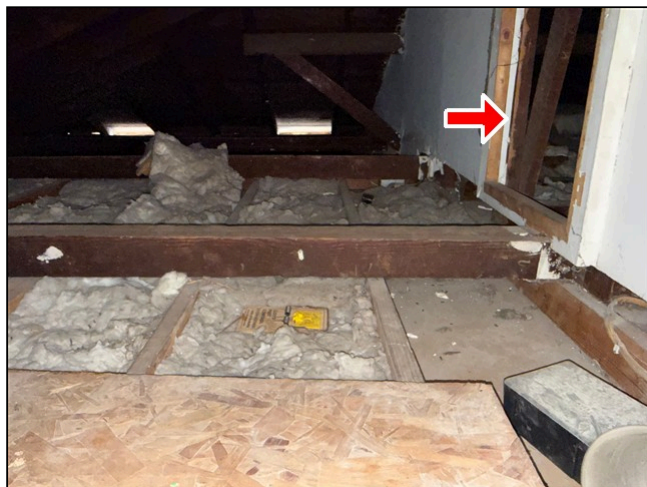
Item 29 - Item 1 (Picture)

- 29. (2) Safety Issue:** The firewall separation between the home and the garage is missing and/or sections have been removed in one or more areas. This condition is considered a fire and safety concern, as the required fire-resistive barrier between the garage and living areas has been compromised. Further evaluation and repair by a qualified contractor is recommended to restore the proper firewall separation.

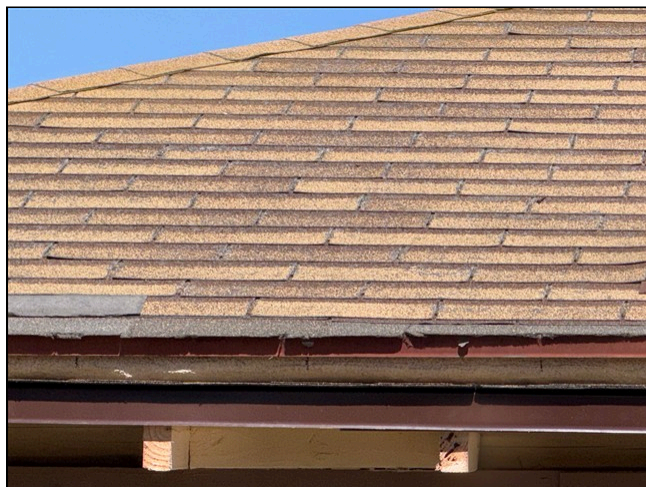
1.0 Item 1 (Picture)

Major Concern: The composition shingle roofing is significantly deteriorated and shows extensive wear. The shingles exhibit curling, cracking, granule loss, and overall diminished integrity. These conditions are consistent with an aging roof that appears to have exceeded its expected service life and is at increased risk for leakage and water intrusion. Have the roofing system replaced by a licensed roofing contractor. The contractor should remove the existing roofing materials down to an appropriate substrate, evaluate the roof sheathing and flashing components, and complete any needed repairs prior to installing a new composition shingle roof. The replacement roof should be installed using current, manufacturer-approved materials and methods, including proper underlayment, flashing integration, and ventilation. Obtain documentation of permits/warranties (as applicable) and confirm the selected shingle type, rating, and warranty terms based on durability, aesthetics, and budget.

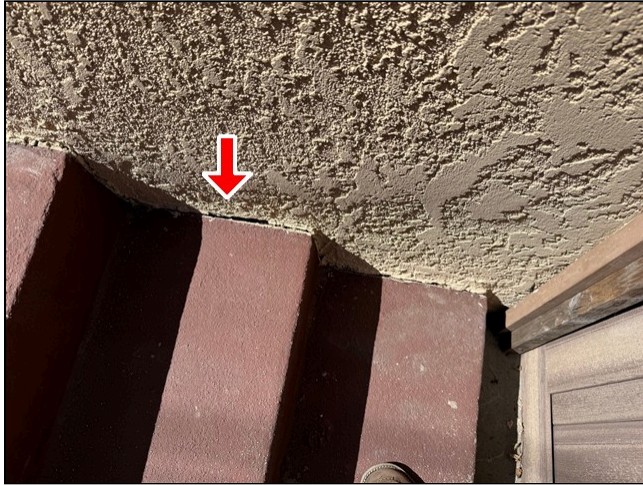
2.0 Item 1 (Picture)

(1) **Repair or Replace:** The concrete steps at the exterior wall have separated from the wall structure, and a visible gap was observed between the steps and the exterior wall. This condition may be the result of movement and/or settlement and could present a potential safety concern. Further evaluation and repair by a qualified contractor is recommended.

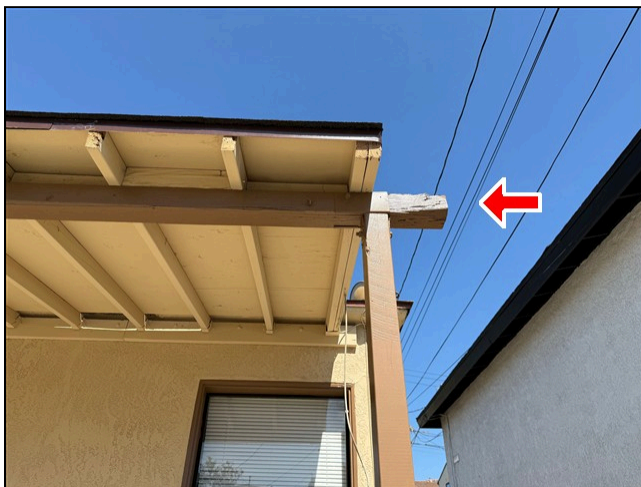
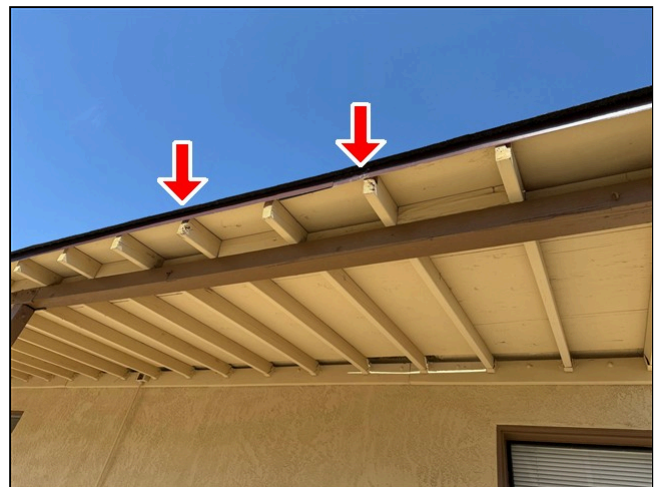
(2) **Repair or Replace:** There is wood deterioration observed at the rear patio covering in one or more locations. This deterioration can be caused by various factors such as moisture, pests, or age-related wear and tear. It is important to address this issue to prevent further damage. Due to the presence of wood deterioration, it is advisable to have a pest control company inspect the area for any signs of pest activity or infestation. Certain pests can cause significant damage to wood structures. A professional inspection will help determine if pests are present and if further treatment is necessary. It is recommended to hire a licensed contractor experienced in wood repairs and replacements. They will assess the extent of the wood deterioration and provide appropriate recommendations. Depending on the severity of the damage, the contractor may suggest repair techniques such as wood patching, reinforcement, or complete replacement of deteriorated wood components. Please be aware that this report is based on a visual inspection, and it is essential to consult a qualified professional, such as a licensed contractor and a pest control company, for a comprehensive assessment and appropriate repairs.

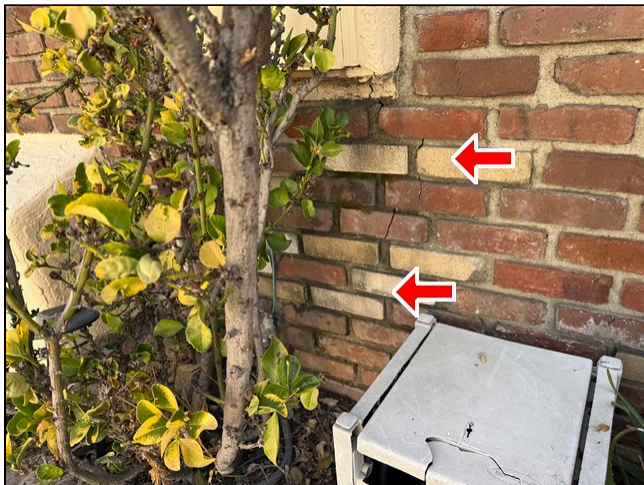
2.0 Item 4 (Picture)

(3) **Repair/Replace/Monitor:** The brick veneer at the front wall of the home is cracked due to apparent settlement and possible movement related to tree roots and/or tree growth at the front wall area. Continued movement may result in additional cracking and deterioration of the veneer system over time. Further evaluation and repair by a qualified contractor is recommended.

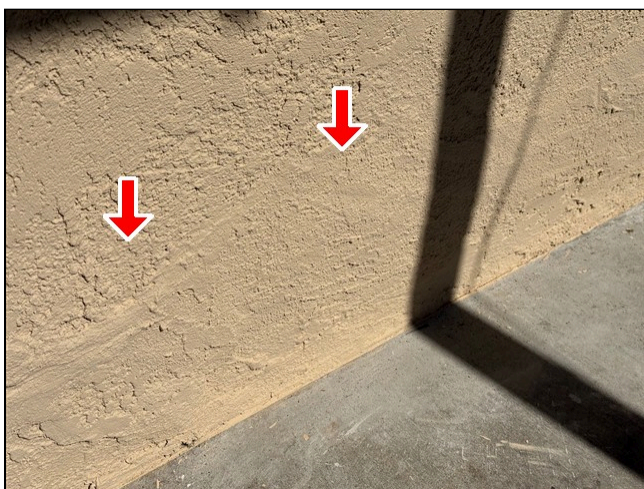
2.0 Item 5 (Picture)

(4) **Repair/Replace/Monitor:** Visible cracking was observed in the stucco cladding on the exterior walls of the home. Such cracking occurs when the stress placed on the wall exceeds the material's capacity to withstand it. Potential underlying causes include issues with the wall's framing, contraction or expansion of the wood sheathing, settling of the structure, thermal expansion or contraction, rapid temperature changes, weak points in the wall, or abnormal ground vibrations. Consult a licensed contractor or structural engineer to assess the severity of the cracking and identify the root cause. Repairs may include sealing and patching the cracks using appropriate stucco materials, and if necessary, addressing structural or environmental factors contributing to the stress. Regular maintenance of stucco surfaces, including inspections and timely repairs, is recommended to prevent further damage and maintain the structural integrity and appearance of the home.

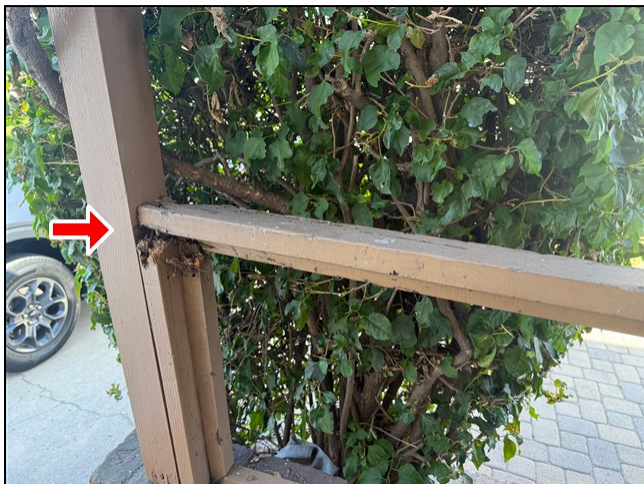
2.0 Item 6 (Picture)

tear. It is important to address this issue to prevent further damage. Due to the presence of wood deterioration, it is advisable to have a pest control company inspect the area for any signs of pest activity or infestation. Certain pests can cause significant damage to wood structures. A professional inspection will help determine if pests are present and if further treatment is necessary. It is recommended to hire a licensed contractor experienced in wood repairs and replacements. They will assess the extent of the wood deterioration and provide appropriate recommendations. Depending on the severity of the damage, the contractor may suggest repair techniques such as wood patching, reinforcement, or complete replacement of deteriorated wood components. Please be aware that this report is based on a visual inspection, and it is essential to consult a qualified professional, such as a licensed contractor and a pest control company, for a comprehensive assessment and appropriate repairs.

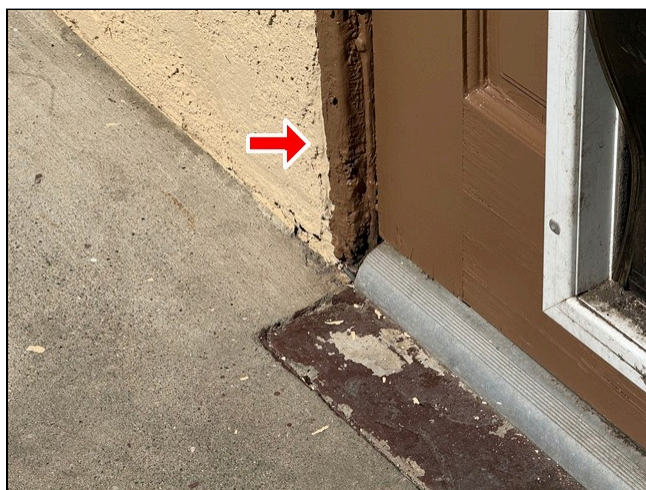
2.1 Item 1 (Picture)

Repair or Replace: There is wood deterioration observed at the rear rear wall door frame. This deterioration can be caused by various factors such as moisture, pests, or age-related wear and tear. It is important to address this issue to prevent further damage. Due to the presence of wood deterioration, it is advisable to have a pest control company inspect the area for any signs of pest activity or infestation. Certain pests can cause significant damage to wood structures. A professional inspection will help determine if pests are present and if further treatment is necessary. It is recommended to hire a licensed contractor experienced in wood repairs and replacements. They will assess the extent of the wood deterioration and provide appropriate recommendations. Depending on the severity of the damage, the contractor may suggest repair techniques such as wood patching, reinforcement, or complete replacement of deteriorated wood components. Please be aware that this report is based on a visual inspection, and it is essential to consult a qualified professional, such as a licensed contractor and a pest control company, for a comprehensive assessment and appropriate repairs.

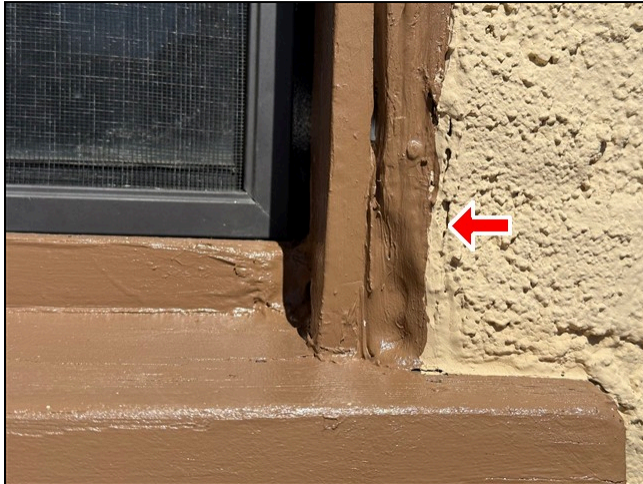
2.2 Item 1 (Picture)

(1) **Repair or Replace:** The exterior wood window frames of the home are deteriorated in one or more areas. Deterioration of wood window frames can lead to several problems, including compromised structural integrity, increased susceptibility to weather damage, and potential water intrusion, which can further damage the surrounding wall structures. Additionally, deteriorated frames can negatively impact the building's energy efficiency by allowing air leaks. A comprehensive assessment of all exterior wood window frames is recommended to determine the extent of the damage. Replacement of the deteriorated frames with new, durable materials that are resistant to weathering and decay is advised to protect the structure and improve energy efficiency. A qualified contractor should be consulted to perform the replacements, ensuring proper installation and sealing to prevent future issues. Regular maintenance and inspections should also be scheduled to monitor the condition of the new frames.

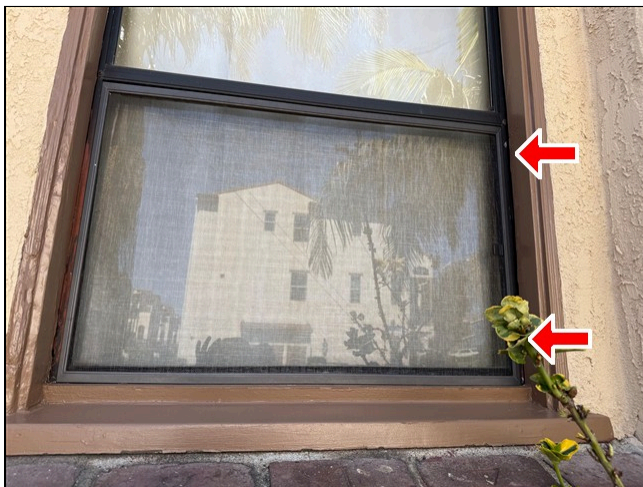
2.2 Item 2 (Picture)

(2) **Repair or Replace:** The installation of the replacement windows throughout the home appears to be non-professional. The windows are considered non-conforming, and deficiencies in the installation may allow water intrusion into the wall assemblies. Continued leakage may result in hidden damage, deterioration, and possible organic growth within surrounding materials. Further evaluation and correction by a qualified window contractor is recommended.

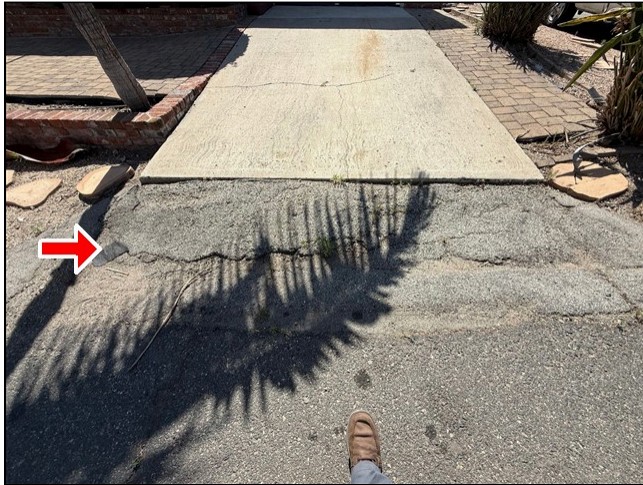
2.3 Item 1 (Picture)

(1) **Repair or Replace:** The driveway surface at the transition between the concrete and asphalt sections is uneven. This condition may present a trip hazard and may worsen over time due to movement and settlement. Further evaluation and repair by a qualified contractor is recommended as needed.

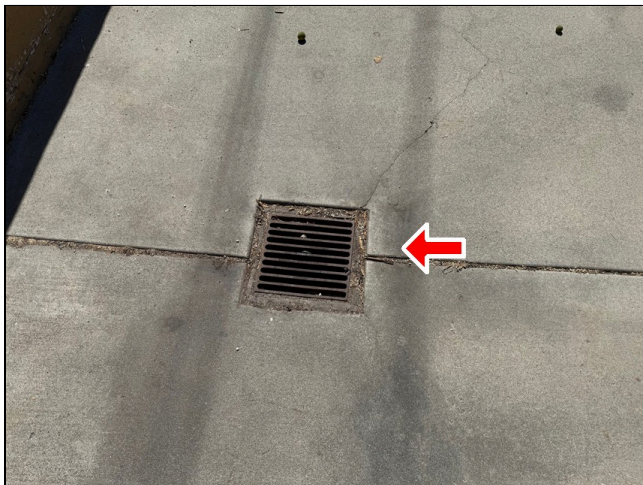
2.3 Item 2 (Picture)

(3) **Monitor:** The property drainage system was not water-tested during the inspection. We make no representations as to its nature or effectiveness. The operation of the drainage system should be observed during adverse weather. Inquires should be made to the seller(s) as to their knowledge of its past and present condition.

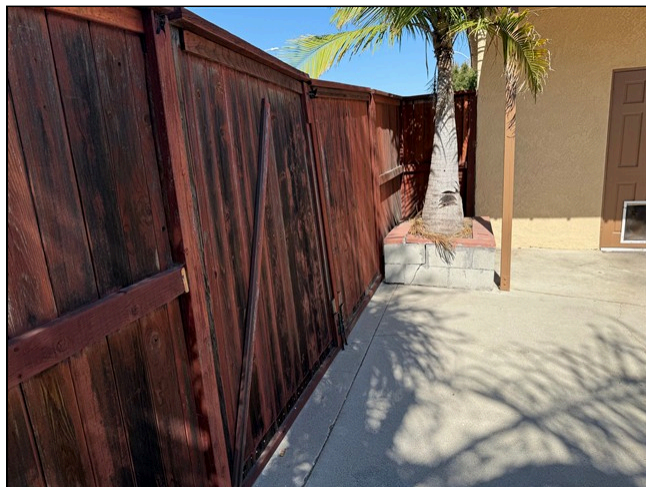
2.5 Item 1 (Picture)

Repair or Replace: The wooden fence throughout the subject property is weathered and shows signs of deterioration in various locations. The fence is in need of repair and/or replacement. Suggest repair/replacement as required by a qualified professional.

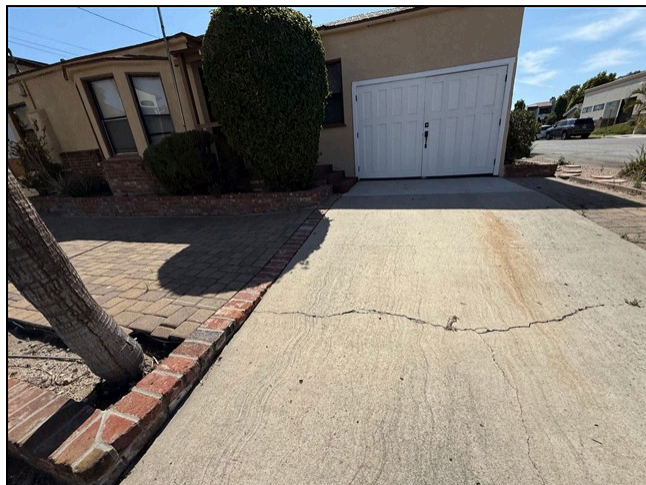
2.10 Item 1 (Picture)

long-term stability and safety of the property, especially when it is located on or near a hillside. Consulting with a geotechnical engineer will provide valuable insights and guidance in this regard.

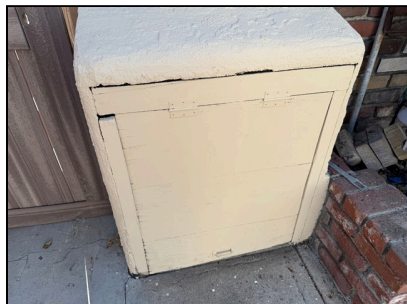
5.5 Item 1 (Picture)

(1) **Inspected:** The main gas meter is located at the East wall of the home.
