SUMMARY

19631 Country Haven Ln, Santa Ana,
CA 92705
Todd Moeller
04/15/2026

Robert Kruger
InterNACHI Certified Home Inspector
Pivot Property Inspection
714-992-6363
rob@pivotpropertyinspection.com

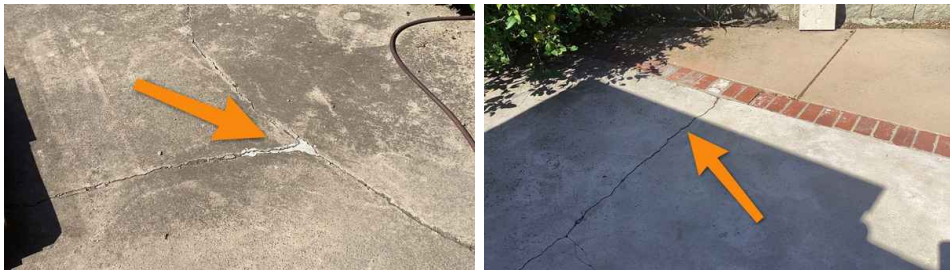
3.3.1 Patio

CRACKING & HEAVING - TRIPPING HAZARD

There is cracking and heaving at the patio. This could present a tripping hazard. I recommend evaluation by a licensed contractor.

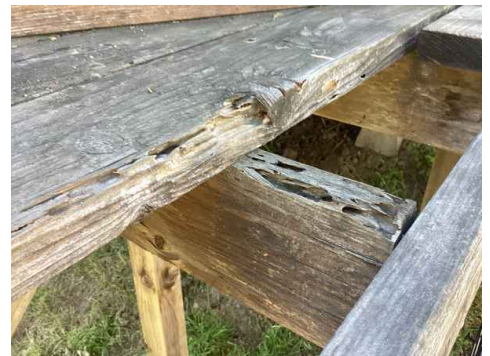
3.5.1 Deck/Patio Cover

MOISTURE/INSECT DAMAGE

There is moisture and/or insect damaged wood at the patio deck I recommend evaluation by a licensed contractor. Refer to a qualified structural pest control report for additional information.

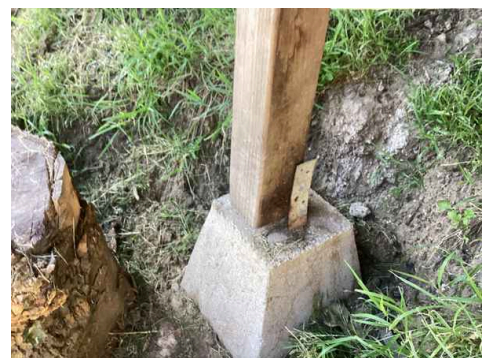
3.5.2 Deck/Patio Cover

POSTS NOT CONNECTED TO GROUND

The deck/patio cover posts are not properly connected to the ground or foundation. This structural connection failure compromises the stability and safety of the structure. A qualified contractor should evaluate the posts and install appropriate footings or connections to ensure proper support and prevent collapse or movement.

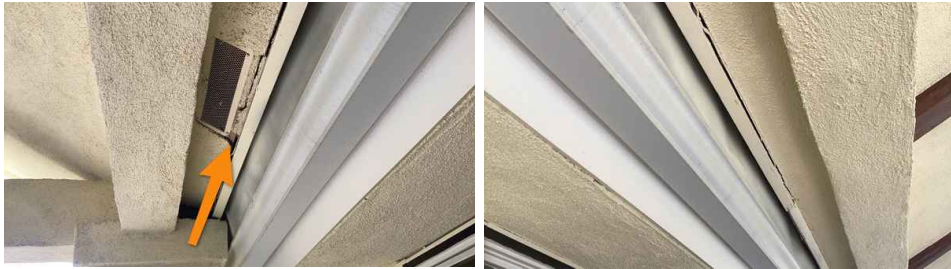
3.5.3 Deck/Patio Cover

STUCCO DAMAGE

Stucco damage was observed on the deck/patio cover during inspection. Damaged stucco can allow water infiltration behind the surface, potentially leading to structural deterioration and mold growth. A stucco repair contractor should evaluate the extent of the damage and perform necessary repairs or patching to restore the protective barrier.

Contact a qualified professional.

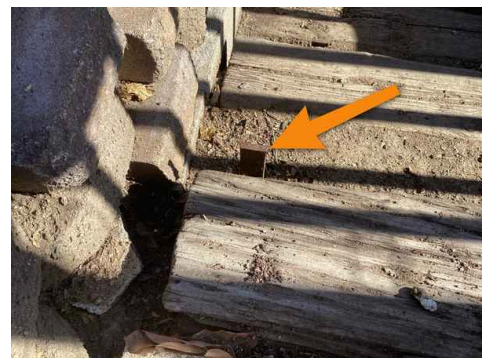
3.5.4 Deck/Patio Cover

TRIP HAZARD ON STAIRS

A trip hazard was identified on the deck or patio cover stairs during inspection. This condition creates a fall risk for anyone using the stairs. The specific hazard should be evaluated and corrected by a qualified contractor to ensure safe passage.

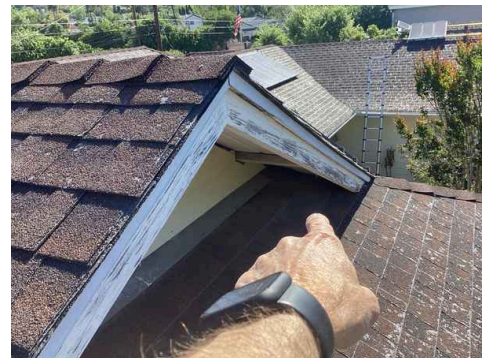
4.2.1 Exterior Trim

PAINT DAMAGE

There is paint damage on one of the roof Facia, recommend evaluation by painting contractor.

Contact a qualified professional.

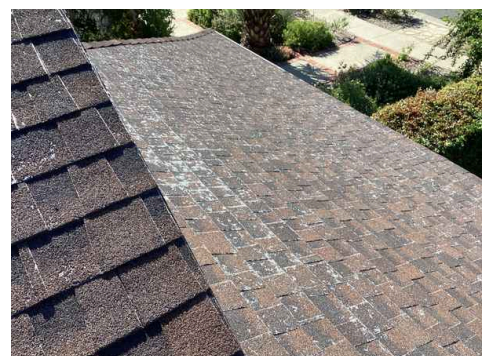
6.1.1 Roof

SHINGLES - END OF LIFESPAN

The roofing materials are showing signs of aging and wear. The roofing system appears to be at or near the end of its useful lifespan. The foregoing is an opinion of the general quality and condition of the roofing material. The inspector cannot and does not offer an opinion or warranty as to whether the roof leaks or may be subject to future leakage. This report is issued in consideration of the foregoing disclaimer. The only way to determine whether or not a roof is watertight is to observe it during a prolonged rainfall. Certification of the roofing system is beyond the scope of this inspection. I recommend a complete evaluation of the roofing system by a licensed roofing contractor.

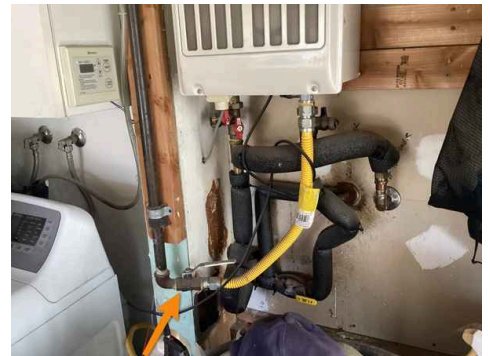
8.1.1 Water Heater

NO SEDIMENT TRAP

A sediment trap has not been installed on the gas supply to the water heater. I recommend evaluation by a licensed plumbing contractor.

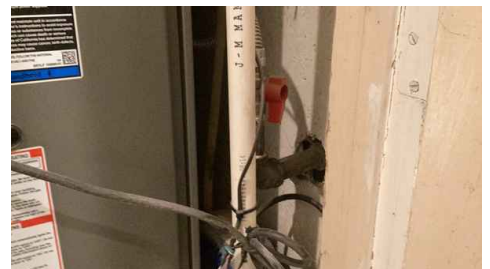
9.1.1 Furnace

SEDIMENT TRAP NOT INSTALLED AT FURNACE GAS SUPPLY

A sediment trap has not been installed on the gas supply to the furnace. I recommend evaluation by a licensed plumbing or heating contractor.

Recommendation
Contact a qualified professional.

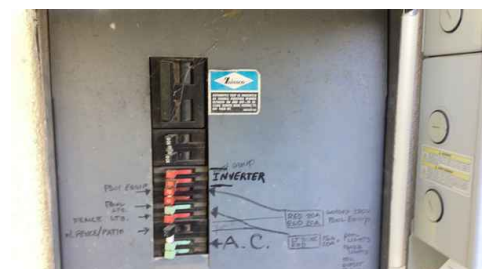
10.2.1 Main Electrical Panel

ZINSCO ELECTRICAL PANEL

A Zinsco brand electrical panel was observed during inspection. Zinsco panels have a documented history of reliability concerns, including potential issues with breaker performance and panel safety. A qualified electrical contractor should evaluate this panel to determine its current condition and whether replacement or monitoring is appropriate for this property.

Recommendation
Contact a qualified professional.

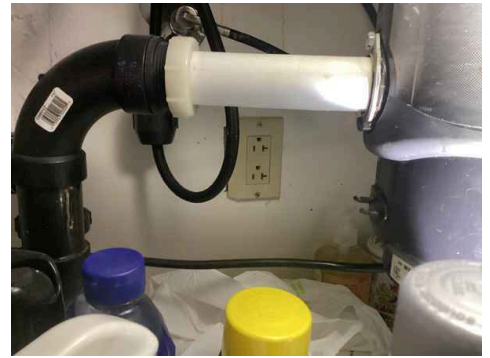
10.5.1 GFCI Protection

ELECTRICAL RECEPTACLES NOT PROTECTED BY A 'GFCI' DEVICE

The receptacles under the sink are not protected by a 'GFCI' device. I recommend evaluation by a licensed electrical contractor.

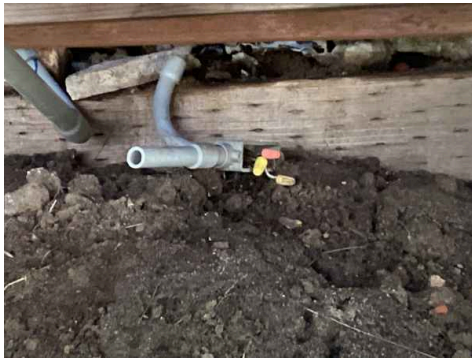
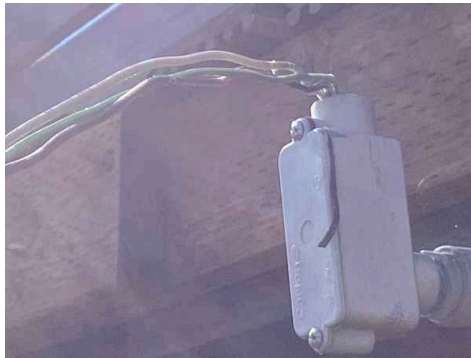
10.6.1 Electrical Notes

EXPOSED ELECTRICAL CONNECTIONS

There are exposed electrical connections not contained within junction boxes on the patio deck. Electrical connection must be contained within a covered junction box. I recommend evaluation by a licensed electrical contractor.

Recommendation
Contact a qualified professional.

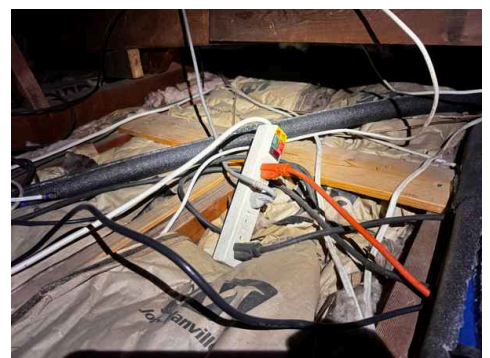
10.6.2 Electrical Notes

IMPROPER ELECTRICAL WIRING IN ATTIC

Extension cord wiring has been used as permanent electrical wiring. Extension cords are not designed, listed, or approved for use as permanent electrical wiring. I recommend evaluation by a licensed electrical contractor.

Recommendation
Contact a qualified professional.

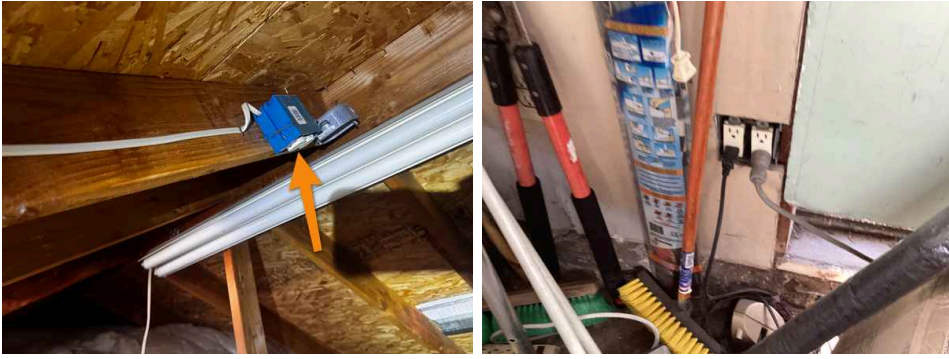
10.6.3 Electrical Notes

MISSING RECEPTACLE COVER PLATES

Receptacle cover plates are damaged or missing throughout the home. I recommend evaluation and repair.

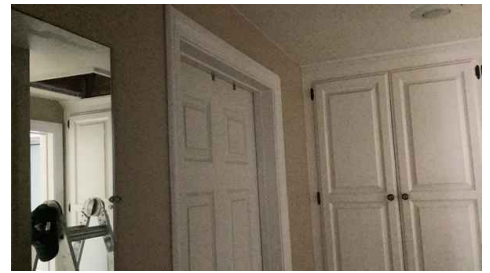
11.3.1 Interior Doors

DOOR RUBS ON FRAME

The door rubs on the frame head. I recommend evaluation and repair by a licensed contractor.

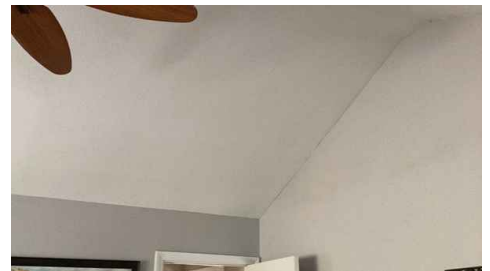
11.10.1 Smoke Alarm

ADDITIONAL SMOKE ALARMS REQUIRED - SINGLE LEVEL

Current building safety standards require smoke alarms within each bedroom and in the hallway areas immediately outside the bedrooms. Smoke alarms have not been installed within the bedrooms. I recommend operable smoke alarms within each of the bedrooms.

Contact a qualified professional.

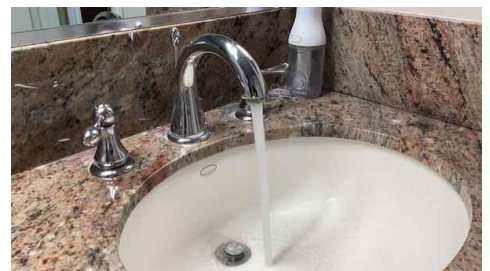
13.3.1 Sink Plumbing

DRAIN STOPPER - NOT FUNCTIONAL

The drain stopper does not function properly. I recommend evaluation and repair.

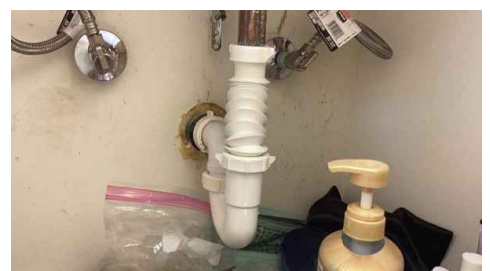
13.3.2 Sink Plumbing

IMPROPER MATERIALS IN WASTE PIPING

There are improper materials used in the waste piping in the cabinet under the sink. Only smooth walled nonflexible materials are listed or approved for use as waste piping. I recommend evaluation by a licensed plumbing contractor.

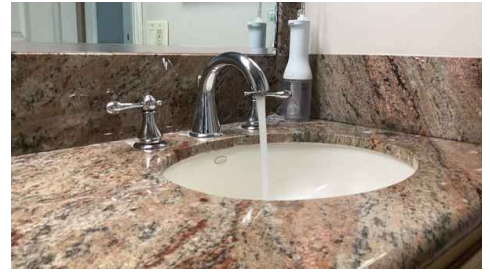
13.3.3 Sink Plumbing

LOOSE FIXTURE

Contact a qualified professional.

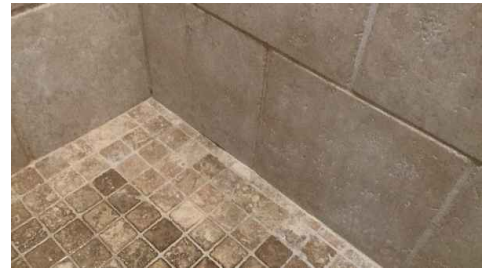
13.6.1 Tub/Shower Walls

CAULKING/GROUT DETERIORATED

The caulking and/or grout at the shower floor/walls is deteriorated. I recommend evaluation by a licensed contractor.

Contact a qualified professional.

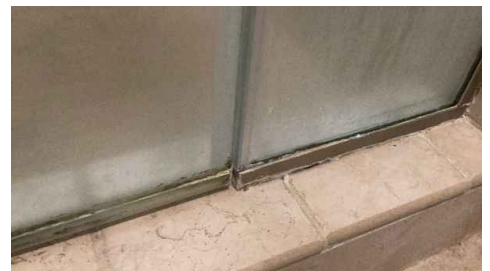
13.6.2 Tub/Shower Walls

GASKET/SEALANT DAMAGE

The shower enclosure gasketing and sealant are damaged. The enclosure appears to leak along the lower track. I recommend evaluation by a licensed contractor.

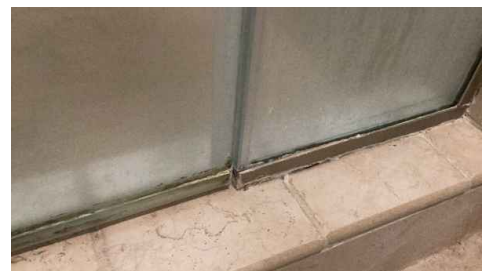
13.7.1 Shower Enclosure

GASKET/SEALANT DAMAGED

The shower enclosure gasketing and sealant are damaged. The enclosure appears to leak along the lower track. I recommend evaluation by a licensed contractor.

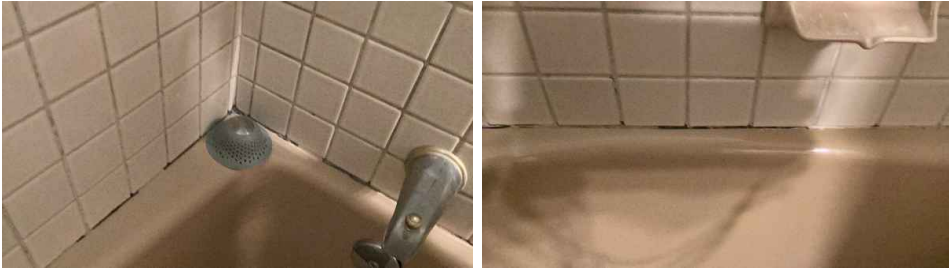
14.6.1 Tub/Shower Walls

CAULKING/GROUT DETERIORATED

The caulking and/or grout at the shower floor/walls is deteriorated. I recommend evaluation by a licensed contractor.

Contact a qualified professional.

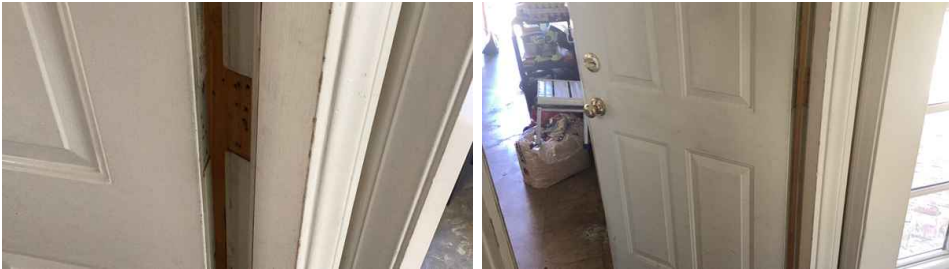
15.4.1 Door to Living Space

NOT SELF-CLOSING

The door leading from the garage to the living space is not self-closing and latching. This door forms part of the fire separation system separating the garage from the living space. The door must self-close and latch. I recommend evaluation and repair by a licensed contractor.

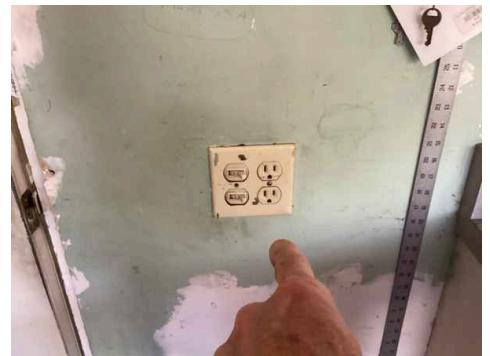
15.8.1 Garage Electrical

ELECTRICAL RECEPTACLES NOT 'GFCI' PROTECTED

The garage electrical receptacles are not protected by 'GFCI' devices. I recommend evaluation by a licensed electrical contractor.

Recommendation
Contact a qualified professional.
