Green Mantis Pest Control

11838 Gem St
Norwalk, CA 90650

WOOD DESTROYING PESTS AND ORGANISMS INSPECTION REPORT

Building No. 11838	Street Gem St	City Norwalk	ZIP 90650	Date of Inspection 06/02/2026	Number of Pages 9

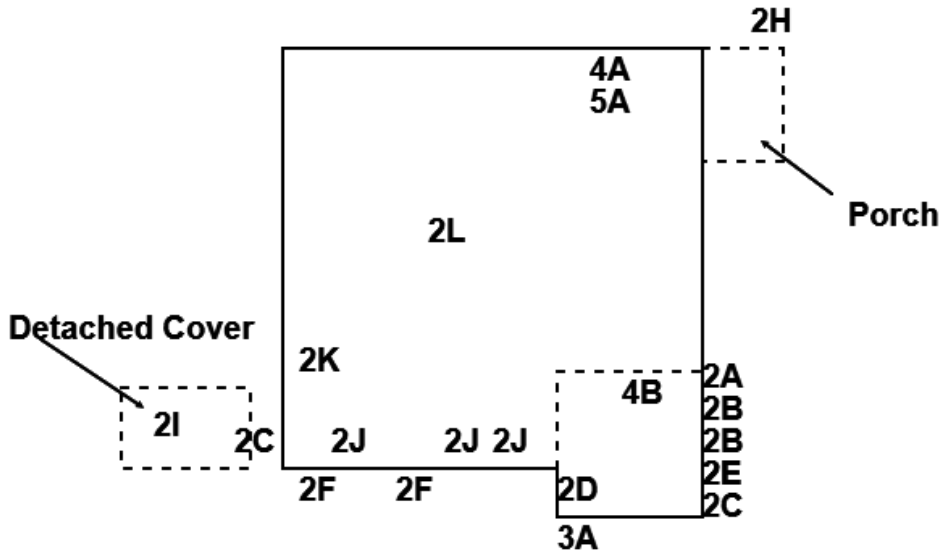
Diagram Not To Scale

Evidence of drywood termite activity was observed at **(garage 2x4)** (see diagram). Evidence may include **kick-out holes, fecal pellets, and/or localized wood damage**. The presence of this evidence indicates that the area has been affected by wood-destroying organisms.

Evidence of drywood termite activity was observed at **(garage trim)** (see diagram). Evidence may include **kick-out holes, fecal pellets, and/or localized wood damage**. The presence of this evidence indicates that the area has been affected by wood-destroying organisms.

Evidence of drywood termite activity was observed at **(garage top plate)** (see diagram). Evidence may include **kick-out holes, fecal pellets, and/or localized wood damage**. The presence of this evidence indicates that the area has been affected by wood-destroying organisms.

Evidence of drywood termite activity was observed at **(2 4x4 posts)** (see diagram). Evidence may include **kick-out holes, fecal pellets, and/or localized wood damage**. The presence of this evidence indicates that the area has been affected by wood-destroying organisms.

Evidence of drywood termite activity was observed at **(2x4 trim)** (see diagram). Evidence may include **kick-out holes, fecal pellets, and/or localized wood damage**. The presence of this evidence indicates that the area has been affected by wood-destroying organisms.

Evidence of drywood termite activity was observed at **(porch cover trim)** (see diagram). Evidence may include **kick-out holes, fecal pellets, and/or localized wood damage**. The presence of this evidence indicates that the area has been affected by wood-destroying organisms.

Evidence of drywood termite activity was observed at the (detached cover) (see diagram). Evidence may include kick-out holes, fecal pellets, and/or localized wood damage. The presence of this evidence indicates that the area has been affected by wood-destroying organisms.

Evidence of drywood termite activity was observed at **(living room window trim and baseboards)** (see diagram). Evidence may include **kick-out holes, fecal pellets, and/or localized wood damage**. The presence of this evidence indicates that the area has been affected by wood-destroying organisms.

Evidence of drywood termite activity was observed at **(front bedroom window trim)** (see diagram). Evidence may include **kick-out holes, fecal pellets, and/or localized wood damage**. The presence of this evidence indicates that the area has been affected by wood-destroying organisms.

Evidence of **drywood termite activity** was observed at **one or more locations SEE DIAGRAM**. Signs of infestation may include **kick-out holes, termite pellets, or damaged wood members**. While **structural integrity** does not appear to be compromised at the time of inspection, the presence of active or inactive infestation indicates that the area has been affected by **wood-destroying organisms**.

Evidence of fungal decay (dry rot) was observed at one or more locations at **(roof sheathing)** (see diagram). This condition is

This company will perform a **localized repair (patch)** of the affected wood members, removing damaged material and restoring the area with appropriate repair methods and materials.

This company will **remove and replace** the **visibly damaged and accessible wood members** at the noted location. Replacement materials will be of like kind and quality and installed in accordance with accepted trade practices. Repairs are limited to areas of visible and accessible damage at the time of inspection. If additional damage is discovered during the course of work, further repairs may be required and will be addressed by change order. Any necessary treatment will be performed in accordance with label directions and industry standards.

This company will perform a **localized repair (patch)** of the affected wood members, removing damaged material and restoring the area with appropriate repair methods and materials. Repairs are limited to areas of visible and accessible damage at the time of inspection. If additional damage is discovered during the course of repair, further work may be required and will be addressed by change order. Any necessary treatment will be performed in accordance with label directions and industry standards.

This company will **remove and replace** the **visibly damaged and accessible wood members** at the noted location.

It is recommended that the affected wood members be evaluated and repaired as necessary by a **licensed contractor of the owner's choice**. Repairs may include removal and replacement or appropriate patching of damaged wood, depending on the extent of deterioration discovered upon further evaluation.

To ensure complete eradication of **drywood termite infestations**, we recommend a **full-structure fumigation** using an **approved fumigant (like Vikane® gas (sulfuryl fluoride) or similar product)** in accordance with **label specifications** and **SPCB regulations**. This treatment is designed to eliminate **entire drywood termite colonies**, including those in **inaccessible or concealed areas**.

Based on visible and accessible conditions at the time of inspection, this company will **remove and replace the visibly damaged and accessible wood members** at the noted location. Replacement materials will be of like kind and quality and installed in accordance with accepted trade practices.
