# Inspection Report

**Property Address:**  
864 Lawrence  
San Luis Obispo CA 93401

11/5/2025

**Harper Homes: Home Inspection Services**

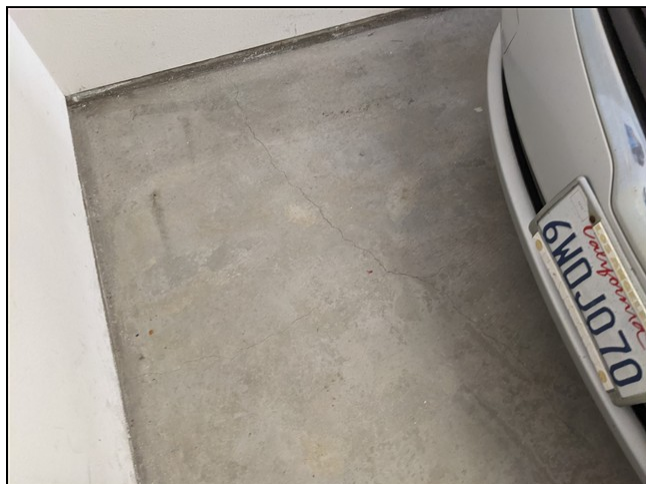
2.7 Item 1(Picture)

Common cracks were noted in the concrete slab, not of structural concern, and can be sealed as needed.

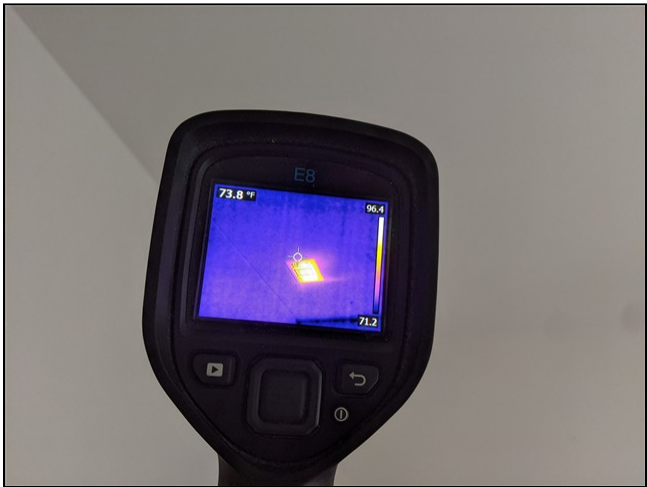
3.0 Item 1(Picture)

The furnace was tested and functional at the time of the inspection.

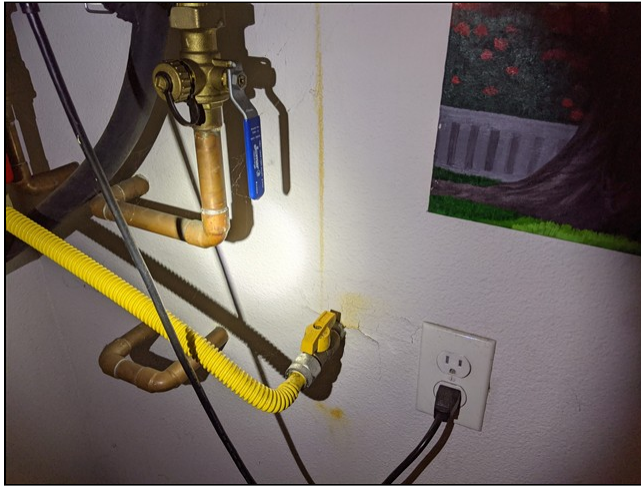
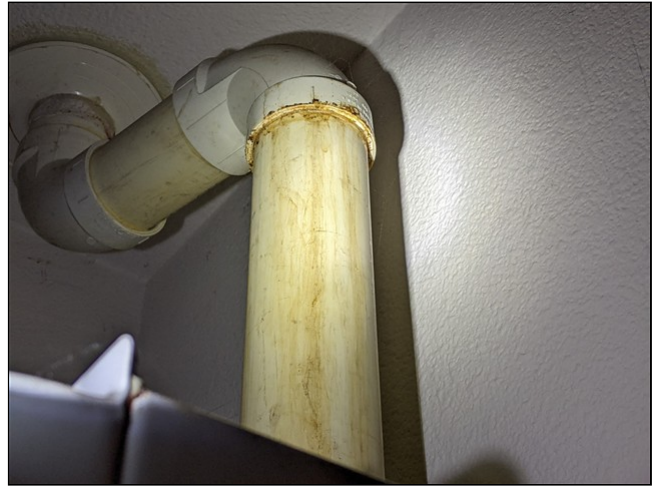
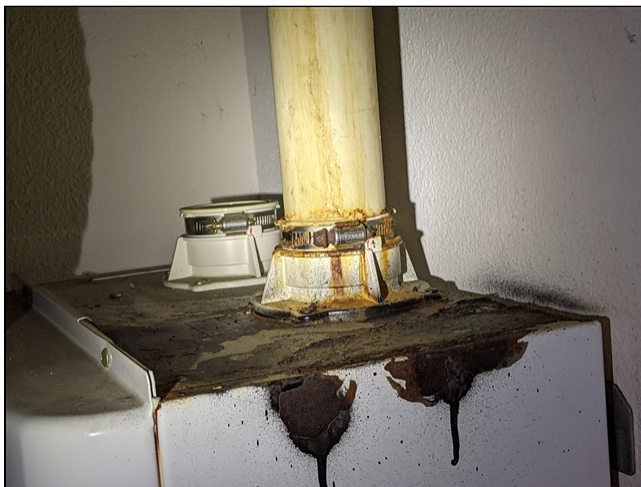
The water heater shows signs of improper ventilation that is creating a condensate issue. This is dripping onto the water heater and drywall causing damage. Recommend this condition is further evaluated and repaired by a licensed plumber.

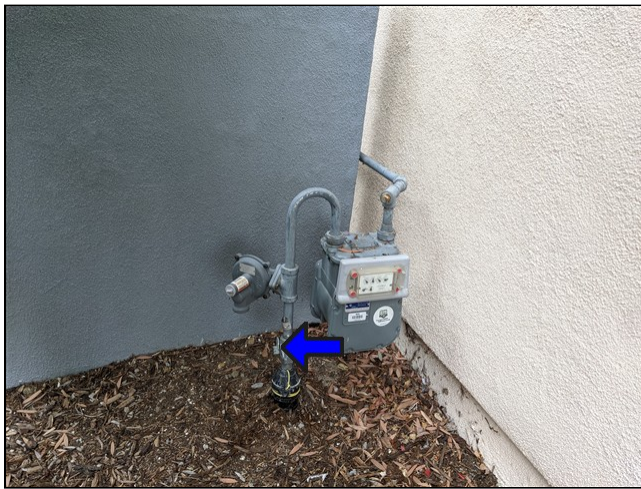
4.3 Item 1(Picture)

The gas shutoff is located at the front exterior of the home. To turn the gas off turn the valve perpendicular to the piping.

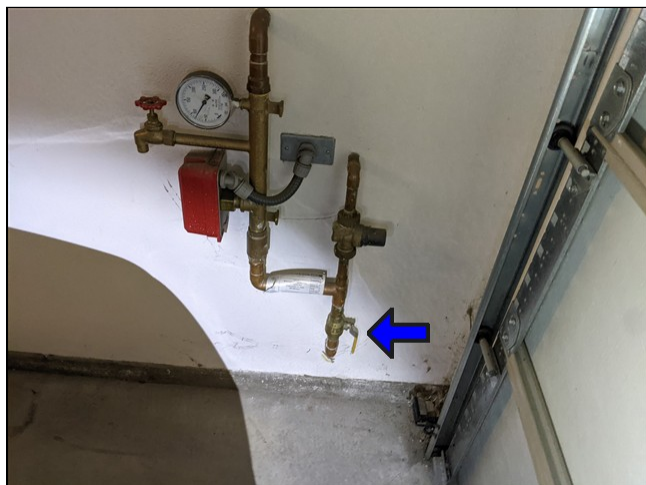
4.4 Item 1(Picture)

The water shutoff is located in the garage. To turn the water off turn the handle perpendicular to the piping.

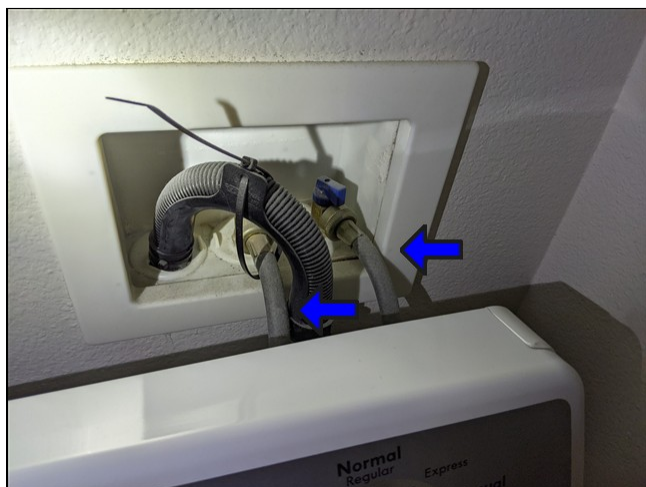
4.6 Item 1(Picture)

Recommend replacement of the rubber supply hoses to the clothes washer with leak and damage resistant steel braided hoses.

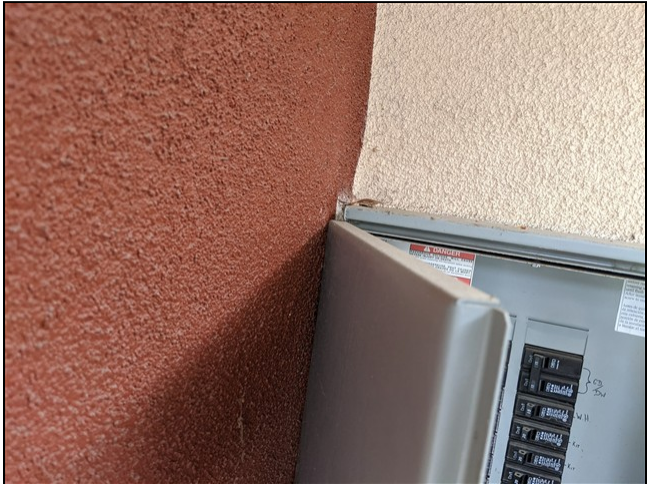
5.1 Item 1(Picture)

Main panel cover does not open completely due to contact with the siding. Stucco should be properly altered to allow full access and operation of the panel cover door.

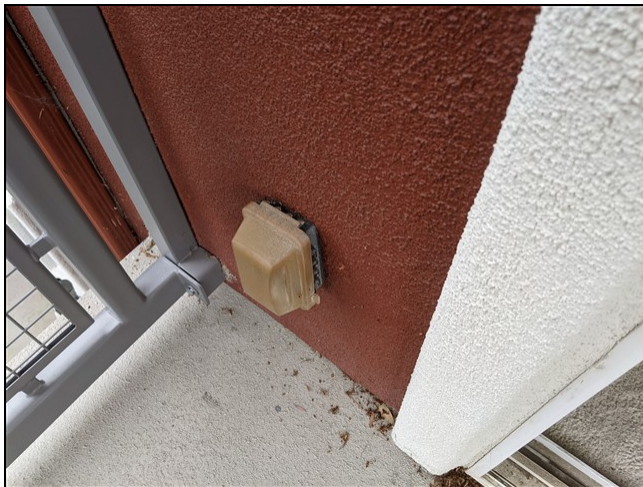
5.6 Item 1(Picture)

The receptacle weather cover at the front deck is loose and alterations are needed to secure the weather cover to prevent moisture intrusion.

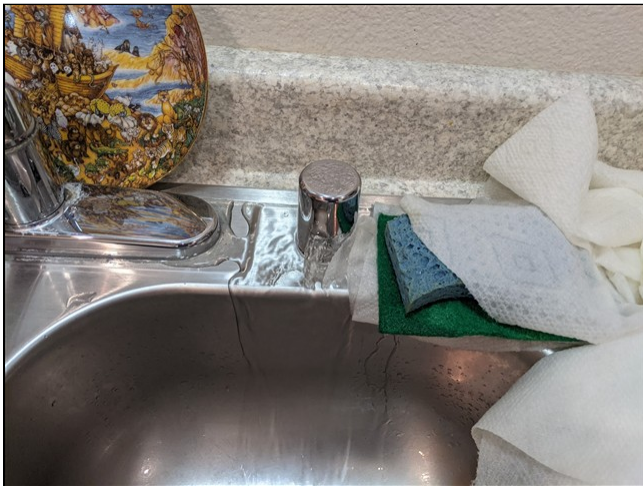
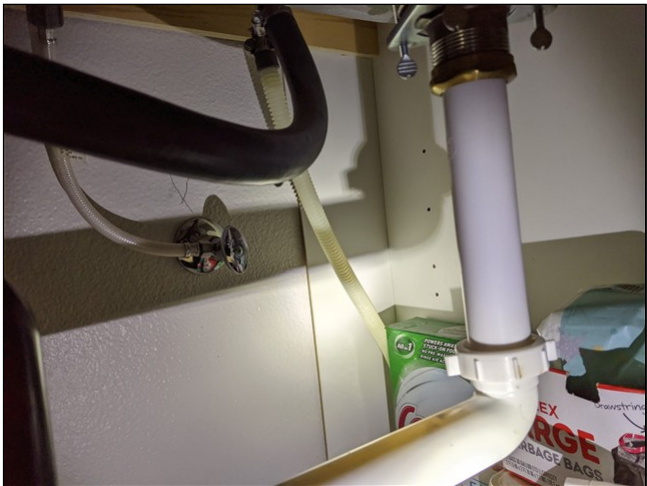
Probable drain line restriction at the dishwasher. Water runs from the air gap at the sink and under the sink when the dishwasher drains. Maintenance or repairs are needed.

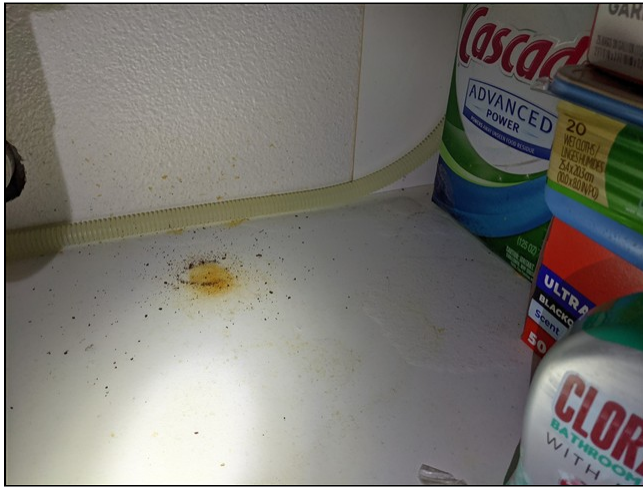
8.4 Item 1(Picture)

Slight moisture damage noted to the cabinet under the sink. Moisture damage may extend into the enclosed areas, and should be further evaluated and repaired, as needed.
