Property Inspection Report

Property address: 27741 Havana Ave
Hayward CA 94544-5005

Inspection date: Tuesday, June 16, 2026

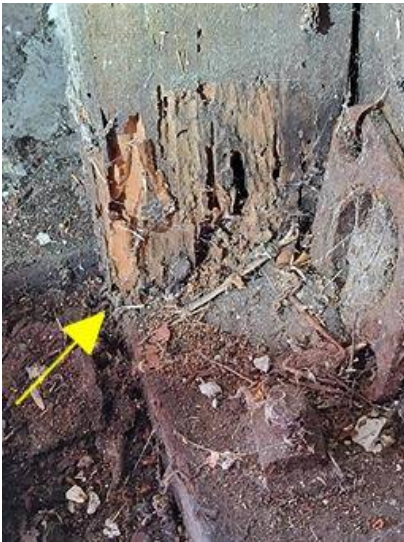
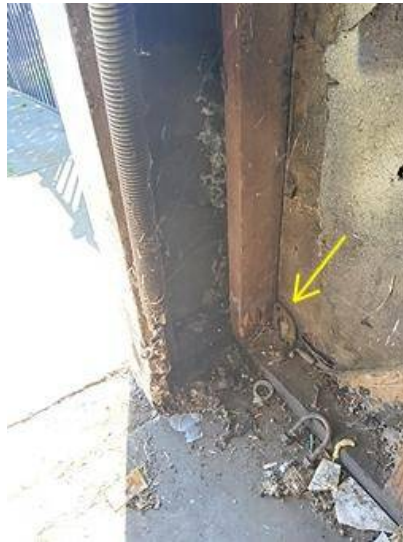
2) *Repair/Replace, Evaluate* - Dirt was found in damaged structural components in the garage. This is possibly the result of a wood destroying organism. Recommend having a state-licensed pest control operator evaluate further and make any necessary repairs per standard building practices.

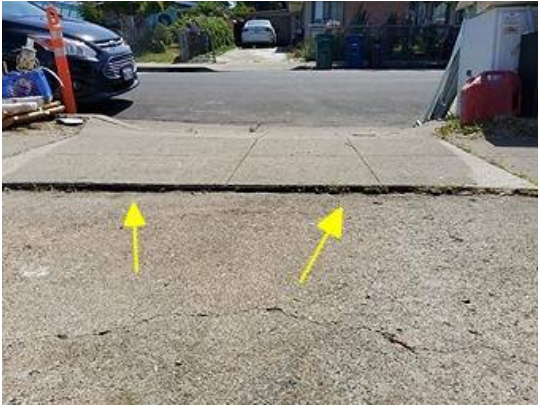
Photo 4-1

4) *Safety, Repair/Maintain* - Settlement and/or heaving resulting in trip hazards were found in the driveway. For safety reasons, recommend that a qualified contractor repair as necessary.

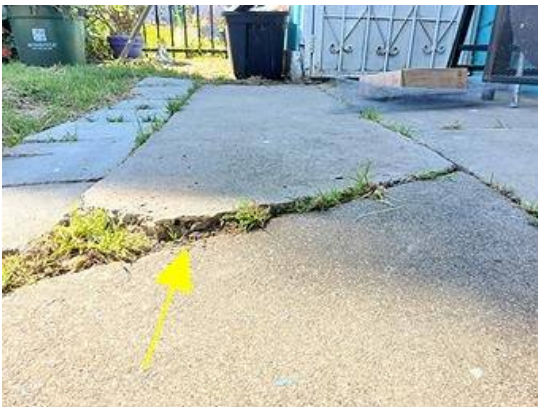
Photo 5-1

5) *Safety, Repair/Maintain* - Cracks, holes, settlement, heaving and/or deterioration resulting in trip hazards were found in the sidewalks or patios. For safety reasons, recommend that a qualified contractor repair as necessary to eliminate trip hazards.

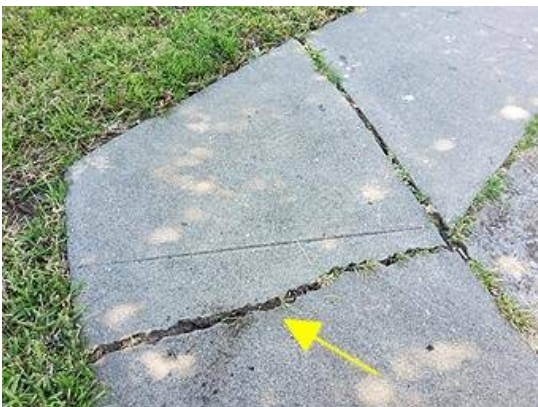
Photo 6-1

6) *Repair/Maintain* - Cracks and/or deterioration were found in the sidewalks. Recommend that qualified contractor repair as necessary.

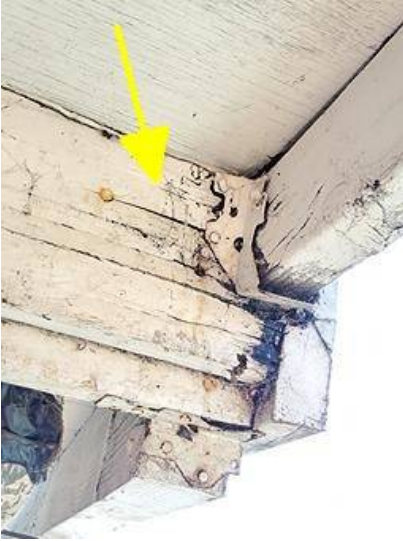
Photo 7-1

7) *Repair/Maintain* - Moisture damage was found in joists at the structures covering the back patio. Recommend that a qualified person repair as necessary. All rotten wood should be replaced.

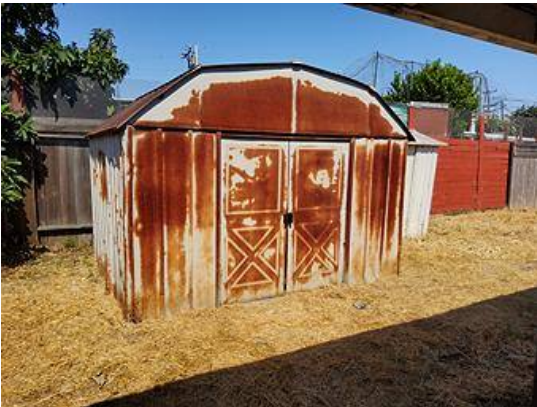
Photo 8-1

8) *Comment* - No outbuildings or detached structures were evaluated. They are excluded from this inspection.

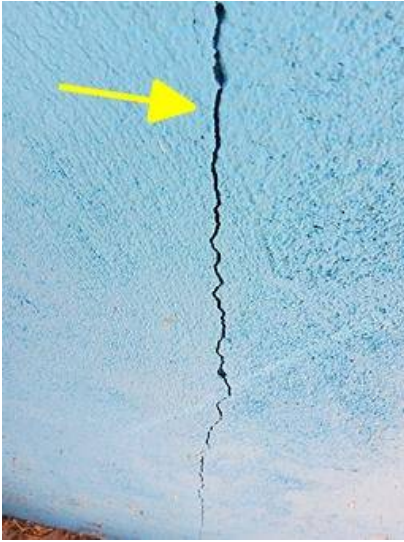
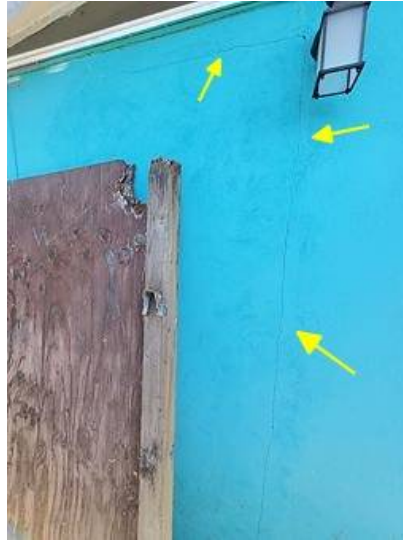
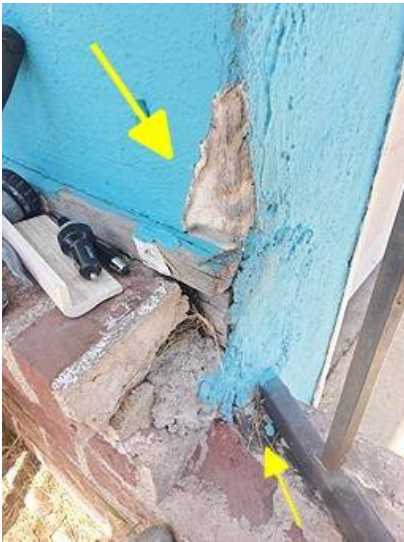
9) *Repair/Maintain* - Cracks, deterioration and/or damage were found in areas of the exterior stucco finish. In damp climates, moisture may enter cracks or damaged areas and further deteriorate the stucco. Also the wall behind the stucco may become damaged from moisture. Note that areas behind the stucco are inaccessible and excluded from this inspection. Recommend that a qualified contractor repair or replace stucco as necessary.

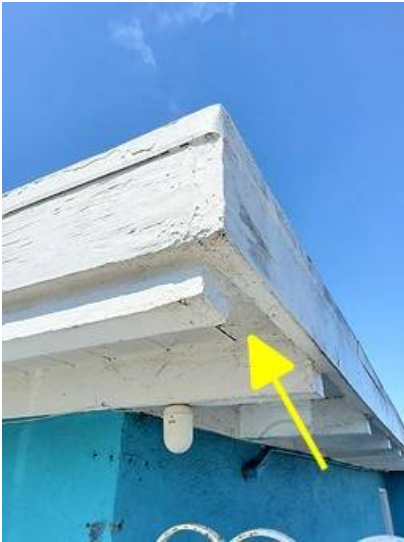
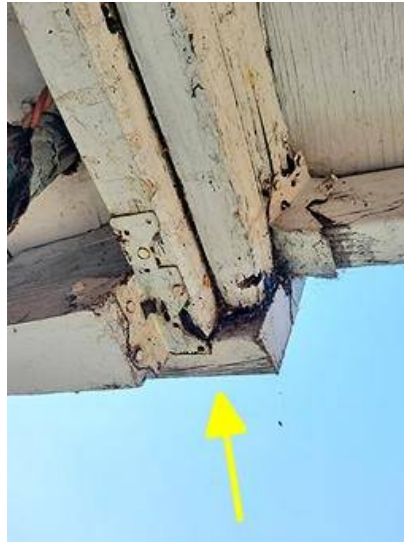
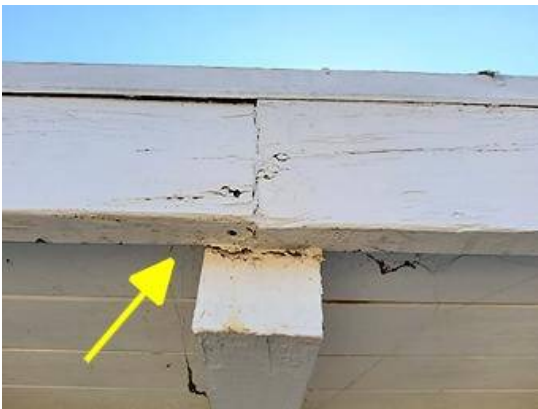
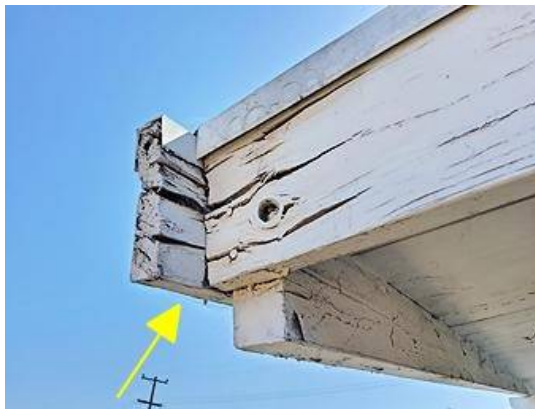
11) *Repair/Replace, Evaluate* - Moisture damage was found at barge and fascia boards. Moisture damage can continue to spread and further damage the structure over time. Recommend that a qualified contractor repair as necessary. For example, by replacing all rotten wood, priming and painting new wood and installing flashing where necessary.

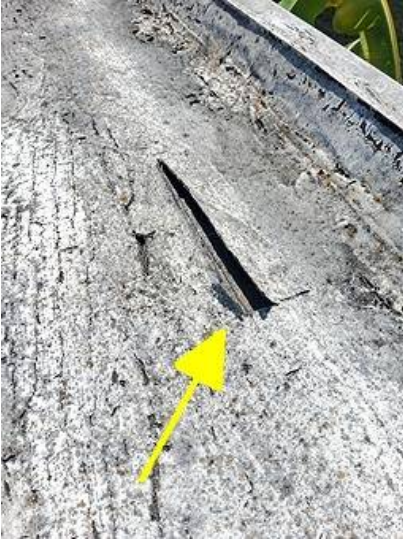
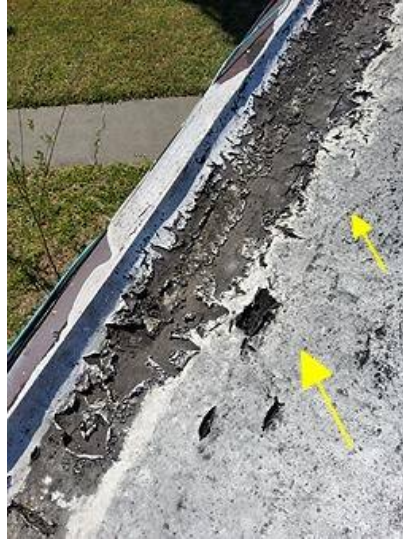
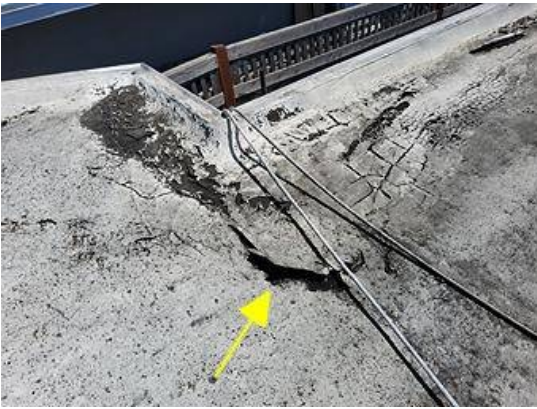
12) *Repair/Maintain* - Gaps, open cracks or holes were found in the flat or low-slope roof surface in multiple locations. Leaks can occur as a result. This is a conducive condition for wood-destroying organisms. Recommend that a qualified roofing contractor repair as necessary.

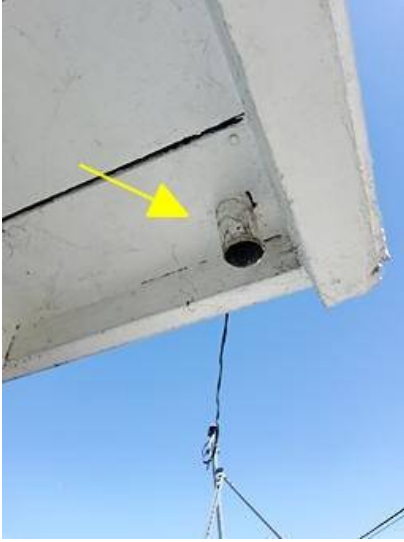
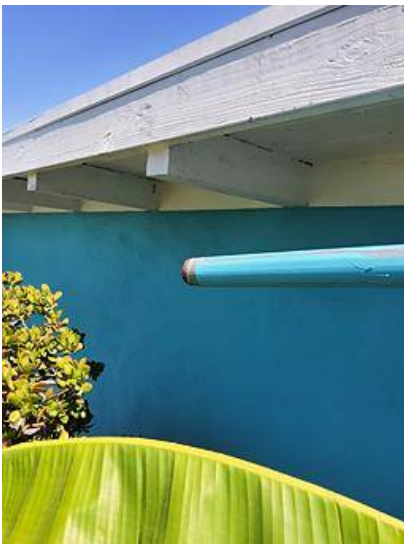
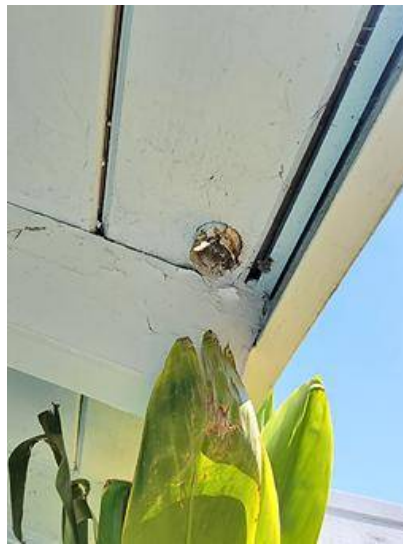
13) *Repair/Maintain* - Downspouts or elbows are loose, detached or missing. Rainwater can come in contact with the building exterior or accumulate around the foundation as a result. This is a conducive condition for wood-destroying organisms. Recommend that a qualified person repair as necessary.

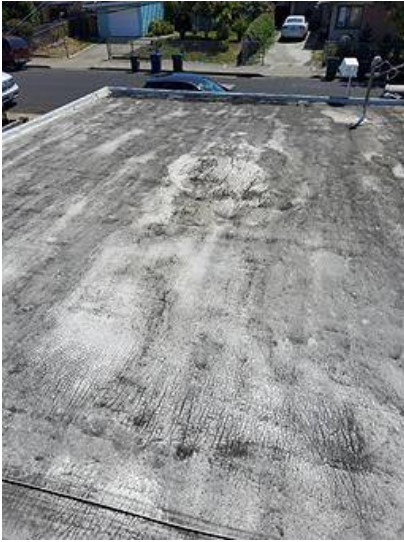
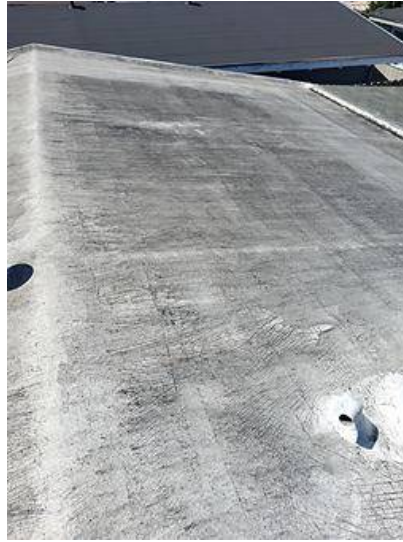
14) *Maintain* - The coating on the flat or low-slope roof surface is deteriorated. Such coatings are designed to protect against ultraviolet light and moisture, help prevent leaks and cracks, lower-roof surface temperatures, and maintain waterproofing properties. Recommend that a qualified person apply a new roof coating now and as necessary in the future. Typically this is done every four to five years.

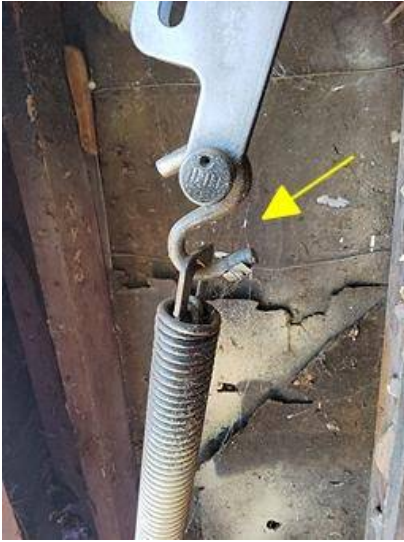
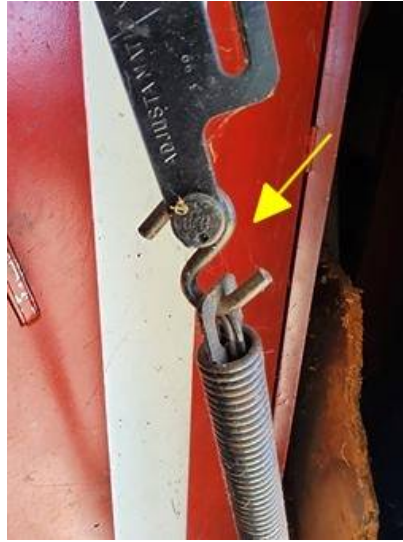
15) *Safety, Repair/Replace* - The extension springs supporting the garage vehicle door have no spring containment hook installed. These containment hooks prevent injury to people located nearby when springs eventually break. This is a potential safety hazard. Recommend that a qualified contractor install containment hooks where missing per standard building practices.

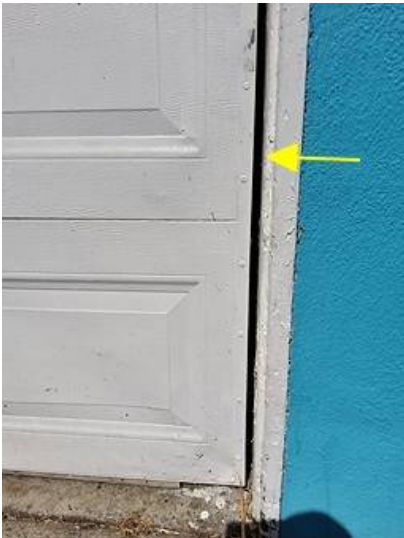
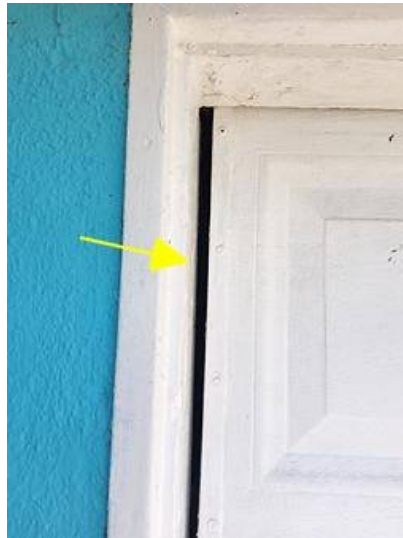
17) *Repair/Maintain* - Gaps were found below or around the garage vehicle door. Vermin and insects can enter the garage as a result. Recommend that a qualified person repair as necessary to eliminate or minimize gaps.

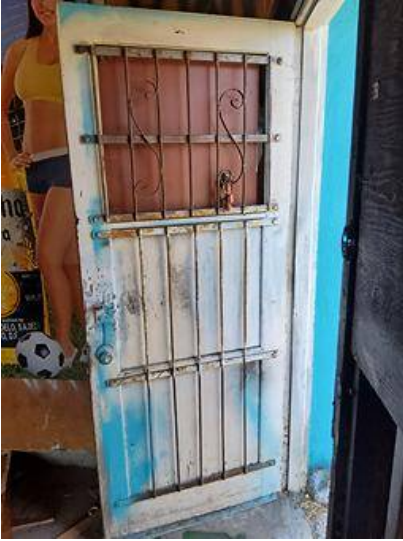
Photo 18-1

18) *Evaluate, Comment* - The exterior door has minor damage and/or deterioration. Although serviceable, the client may wish to repair or replace such doors for appearances' sake.

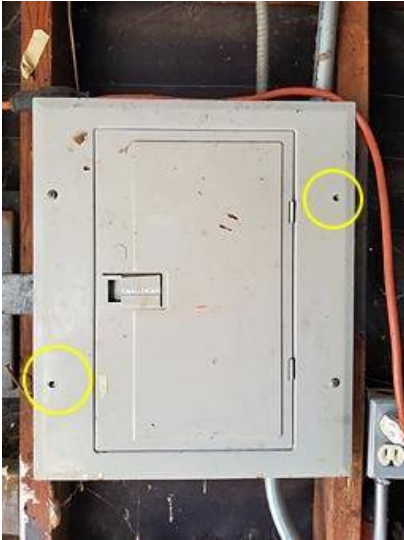
Photo 19-1

19) *Safety, Repair/Replace, Minor Defect* - Screws that attach the cover or dead front to panel(s) #main were missing or not installed. Recommend installing screws where missing so the cover or dead front is secure. Only screws with blunt tips approved for this purpose should be installed, so wiring inside the panel is not damaged. Because energized wires may be located directly behind screw holes, the client should consider having a qualified electrician replace missing screws.

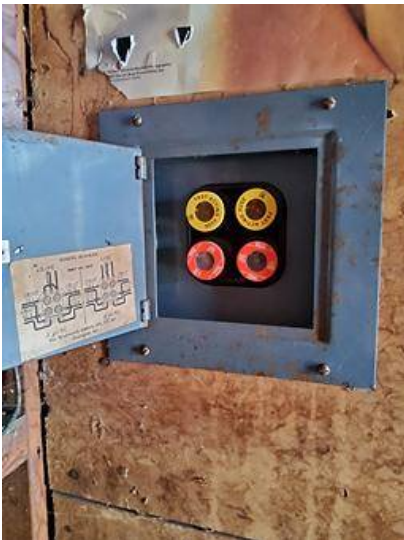
Photo 20-1

20) *Safety, Repair/Replace, Evaluate* - The garage sub panel uses screw-in fuses for the over-current protection devices. Fuses are prone to tampering and over-fusing, which can damage wiring and cause fire hazards. Insurance companies may deny coverage for homes with fused panels. Modern panels use circuit breakers for over-current protection devices, which can be reset easily after tripping rather than needing to replace fuses. Modern panels also offer more flexibility for new, safer protective technologies like ground fault circuit interrupters (GFCIs) and arc fault circuit interrupters (AFCIs). Consult with a qualified electrician and replace the fuse panel per standard building practices.

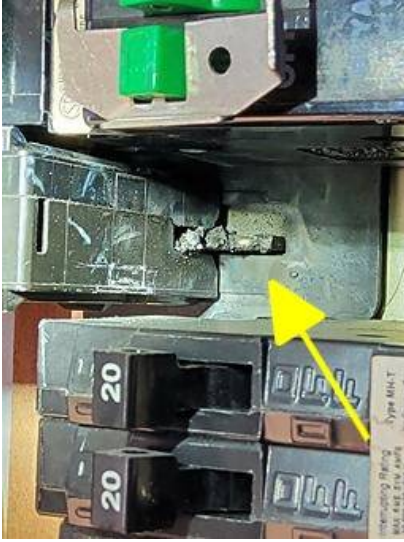
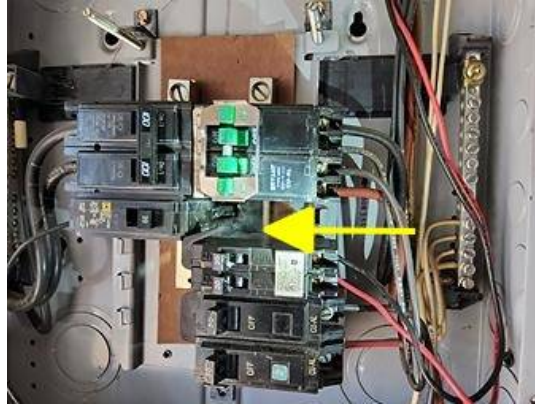
21) *Safety, Repair/Replace, Evaluate* - The bus bars in the main electrical panel are scorched or heat-damaged. This is a safety hazard for shock or fire. A qualified electrician should evaluate and make repairs or replace components as necessary.

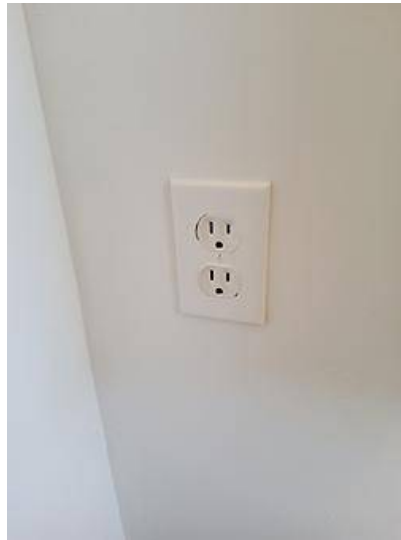
Photo 22-2

22) *Safety, Repair/Replace, Evaluate* - Electric receptacles (outlets) at the bathroom(s) and exterior had no visible ground fault circuit interrupter (GFCI) protection, or the inspector was unable to determine if GFCI protection was present. If not GFCI-protected, receptacles in wet areas pose a shock hazard. Recommend that a qualified electrician evaluate and install GFCI protection if necessary and per standard building practices. General guidelines for GFCI-protected receptacles include the following locations:

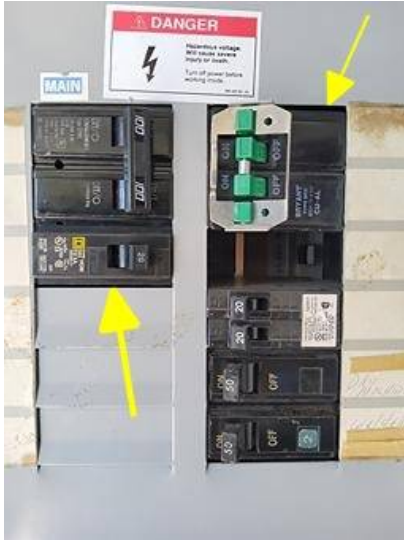
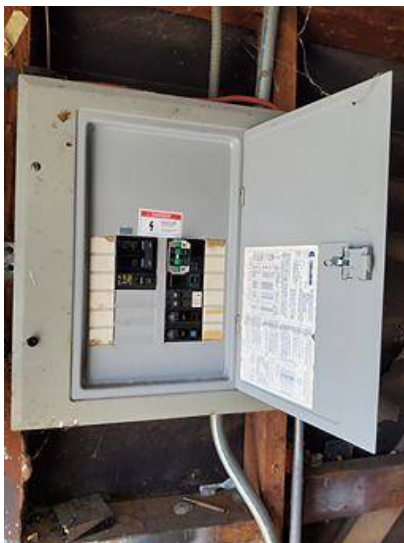
23) *Safety, Repair/Replace, Evaluate* - Breakers in the electrical main panel do not match the panels manufacturer. Electrical panels are not designed to accommodate other manufacturers equipment. This is a potential shock and/or fire hazard. Recommend having a qualified electrical contractor evaluate the panel and make repairs per standard building practices.

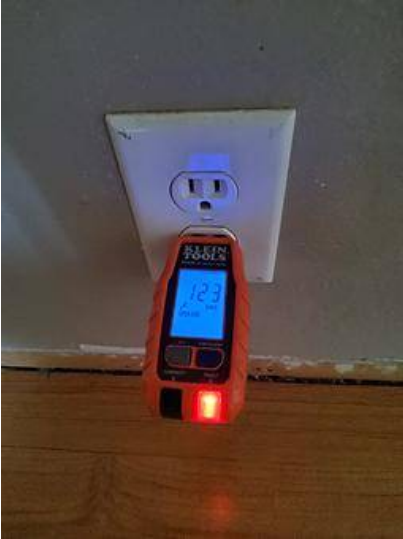
Photo 24-1

24) *Safety, Repair/Replace* - Some of the modern, 3-slot electric receptacles (outlets) were found with open grounds. This is a shock hazard when appliances that require a ground are used with these receptacles. Examples of such appliances include computers and related hardware, refrigerators, freezers, portable air conditioners, clothes washers, aquarium pumps, and electrically operated gardening tools. Recommend that a qualified electrician repair as necessary so all receptacles are grounded per standard building practices.

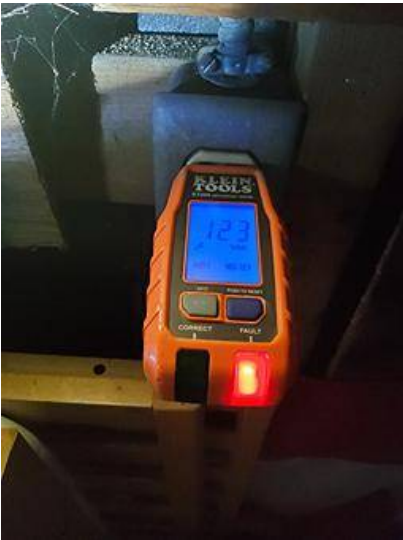
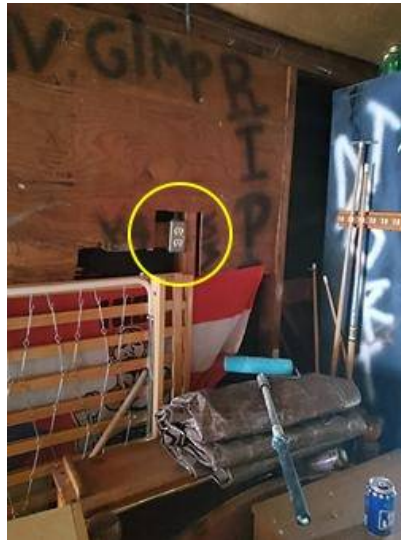
25) *Safety, Repair/Replace* - One of the electric receptacles (outlets) in the garage has reverse-polarity wiring, where the hot and neutral wires were reversed. This is a shock hazard. Recommend that a qualified electrician repair as necessary. For more information, visit:

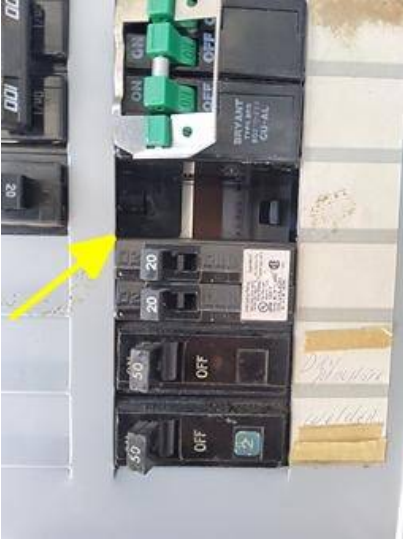
Photo 27-1

27) *Safety, Repair/Maintain* - A slot where circuit breakers are normally installed is open in the main electrical panel. Energized equipment was exposed and is a shock hazard. Recommend that a qualified person install closure covers where missing.

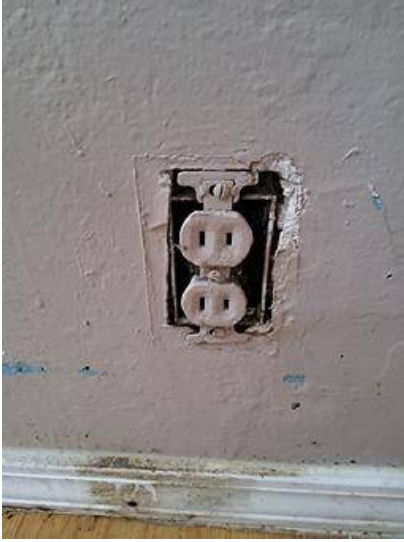
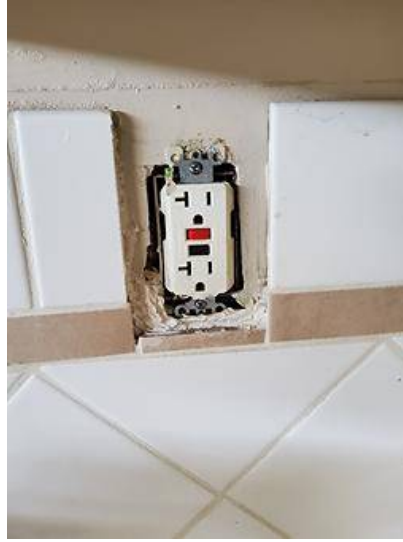
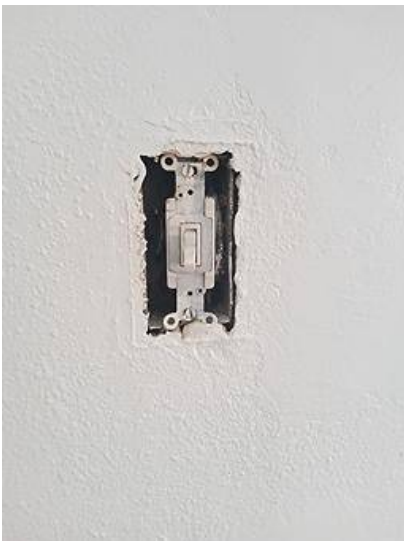
28) *Safety, Repair/Maintain* - Cover plates for switches, receptacles (outlets) or junction boxes are missing or broken. These plates are intended to contain fire and prevent electric shock from occurring due to exposed wires. Recommend that a qualified person install cover plates where necessary.

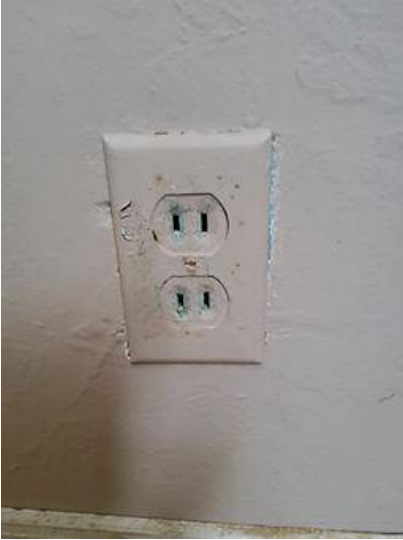
Photo 30-1

30) *Safety, Evaluate* - 2-slot receptacles (outlets) rather than 3-slot, grounded receptacles were installed in multiple areas. These do not have an equipment ground and are considered unsafe by today's standards. Appliances that require a ground should not be used with 2-slot receptacles. Examples of such appliances include computers and related hardware, refrigerators, freezers, portable air conditioners, clothes washers, aquarium pumps, and electrically operated gardening tools. The client should be aware of this limitation when planning use for various rooms, such as an office. Upgrading to grounded receptacles typically requires installing new wiring from the main service panel or sub-panel to the receptacle(s), in addition to replacing the receptacle(s). Consult with a qualified electrician about upgrading to 3-wire, grounded circuits.

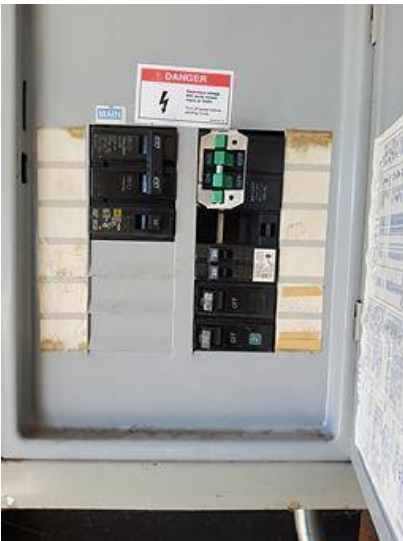
Photo 31-1

31) *Repair/Maintain, Evaluate* - The legend for circuit breakers and fuses in both electrical panels are missing, incomplete, illegible or confusing. This is a potential shock or fire hazard in the event of an emergency when power needs to be turned off. Recommend correcting the legend so it's accurate, complete and legible. Evaluation by a qualified electrician may be necessary.

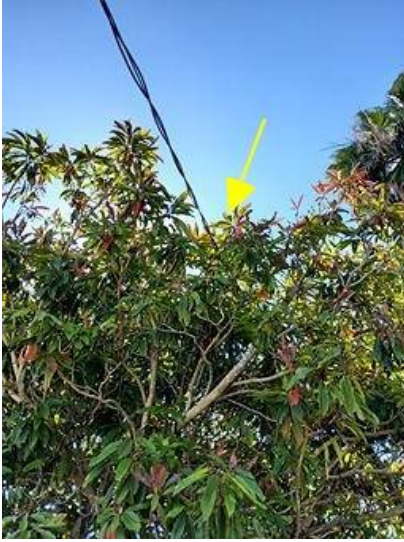
Photo 32-1

32) *Maintain* - The service drop wires are in contact with trees or vegetation. This can result in damage to wiring insulation or broken wires during high winds. Recommend pruning trees or vegetation as necessary. The utility company may prune trees at no charge.

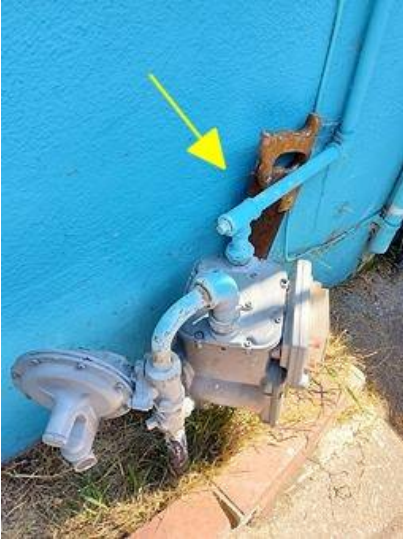
Photo 33-1

33) *Safety, Repair/Replace* - The gas line entering the home at the main gas meter is missing a seismic shutoff. In the event of an earthquake these devices can shut off the flow of gas to the home. Recommend having a qualified licensed plumber evaluate and install per standard building practices.

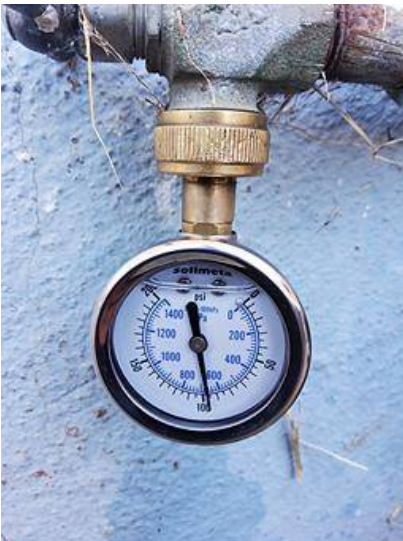
Photo 34-1

34) *Repair/Replace, Evaluate* - The water supply pressure is greater than 80 pounds per square inch (PSI). Pressures above 80 PSI may void warranties for some appliances such as water heaters or washing machines. Flexible supply lines to washing machines are likely to burst with higher pressures. 40-80 PSI is considered the normal range for water pressure in a home, and most plumbers recommend 50-60 PSI. Typically, the pressure cannot be regulated at the water meter. Recommend that a qualified plumber evaluate and make modifications to reduce the pressure to below 80 PSI. Installing a pressure reducing valve on the main service pipe is a common solution to this problem. If one exists, then it should be adjusted, repaired or replaced as necessary to maintain lower pressures. Note that installing a pressure reducing valve creates a "closed system," which may require installing an expansion tank at the water heater if one is not already installed.

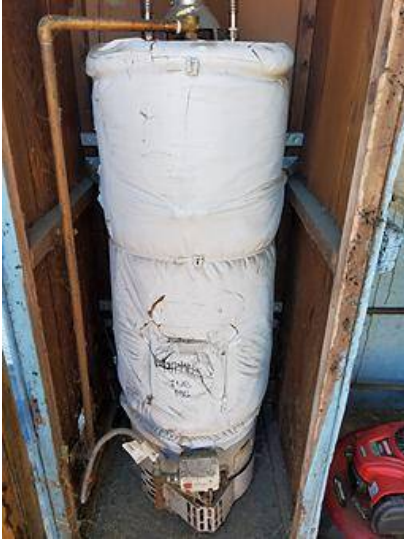
Photo 37-1

37) *Comment* - A permanently installed insulated jacket was installed on the water heater. It obscured the manufacturer's information label and/or most of the water heater. The inspector was unable to fully evaluate the water heater.

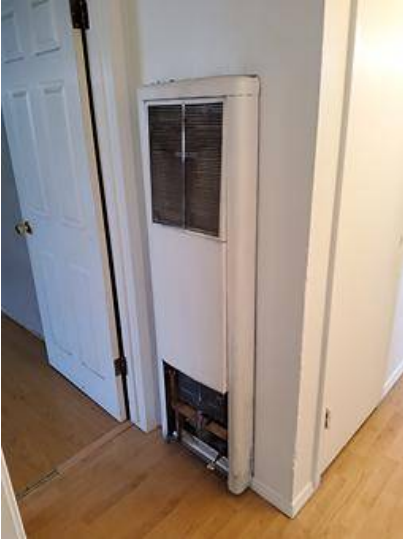
Photo 38-1

38) *Safety, Evaluate* - Because of the age and/or condition of the furnaces, recommend that a qualified HVAC contractor inspect the heat exchanger and perform a carbon monoxide test when it's serviced. Note that these tests are beyond the scope of a standard home inspection.

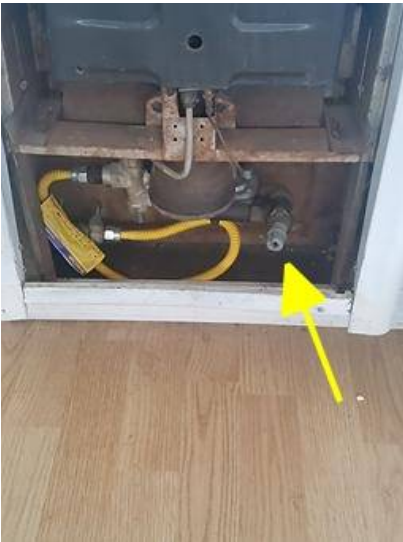
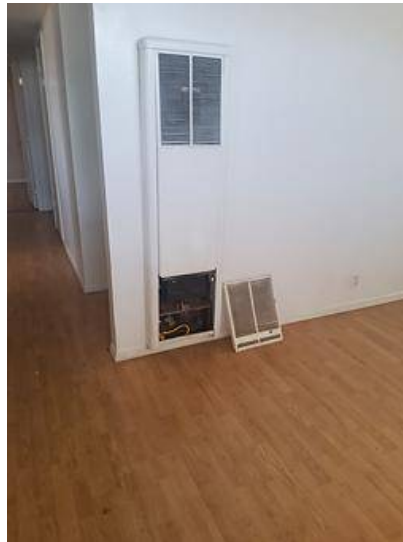
39) *Repair/Maintain* - The control knob for one of the furnaces is missing. Recommend replacing knobs as necessary.

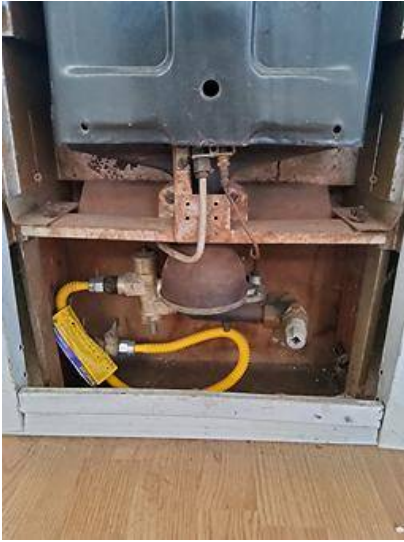
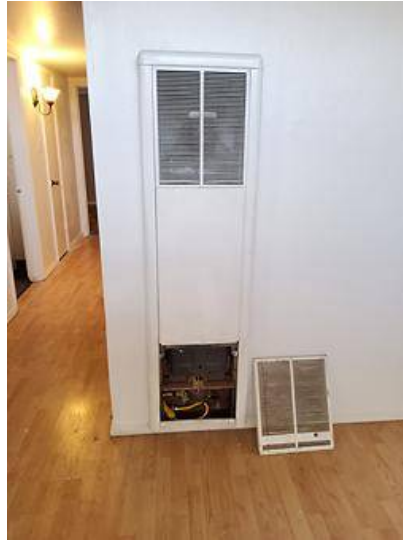
40) *Evaluate, Comment* - The furnace heating system in the living room was not fully evaluated because the pilot light was off. Recommend that a full evaluation be made by a qualified person when conditions have been corrected so the system is operable. Note that the inspector does not operate shut-off valves, pilot lights or circuit breakers, or any controls other than normal controls (thermostat).

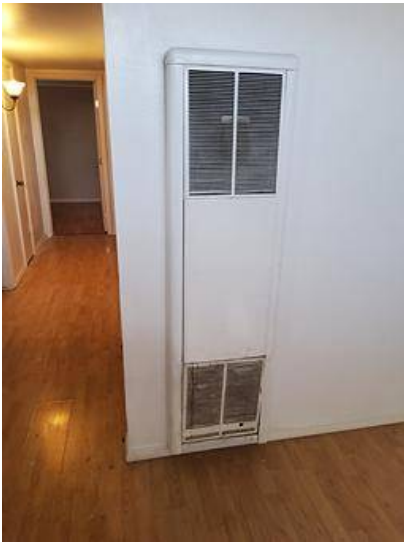
Photo 41-1

41) *Comment* - The estimated useful life for most forced air furnaces is 15-20 years. This furnace appeared to be beyond this age and/or its useful lifespan and may need replacing or significant repairs at any time. Recommend budgeting for a replacement in the near future.

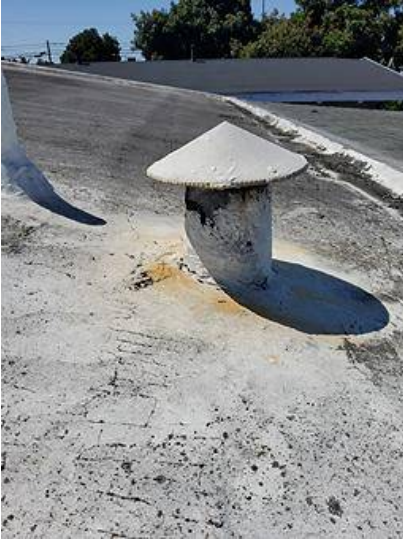
Photo 42-1

42) *Safety, Repair/Replace* - The metal flue caps for B-vent or L-vent flues are substandard. Such metal flues should terminate with a bird-proof and weatherproof cap. Recommend that a qualified person repair per standard building practices.

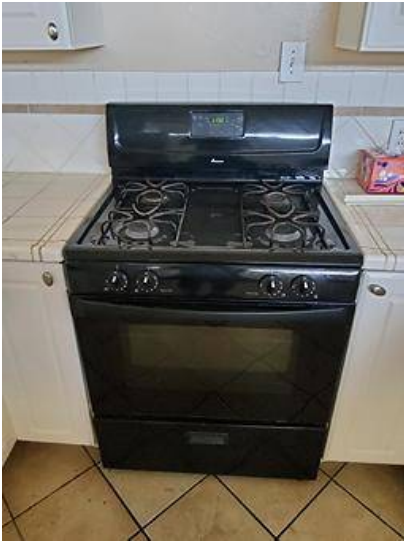
Photo 43-1

43) *Safety, Repair/Replace* - The range could tip forward. An anti-tip bracket may not be installed. This is a potential safety hazard since the range can tip forward when weight is applied to the open door, such as when a small child climbs on it or if heavy objects are dropped on it. Anti-tip brackets have been sold with all free-standing ranges since 1985. Recommend installing an anti-tip bracket to eliminate this safety hazard. For more information, visit: <https://www.reporhost.com/?ATB>

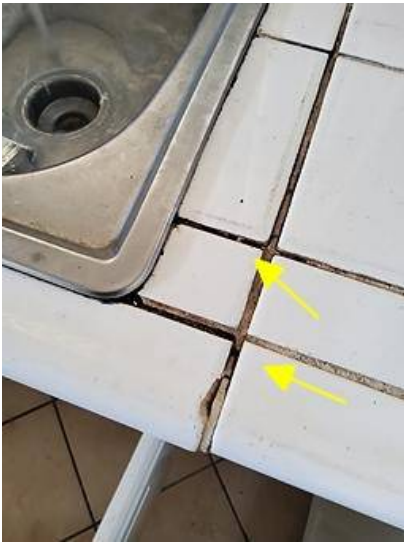
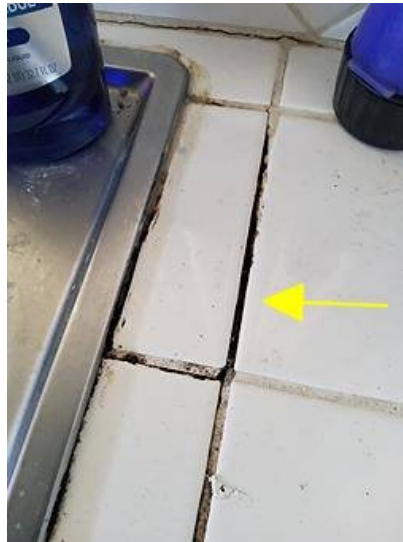
44) *Repair/Replace, Evaluate* - Countertops and/or backsplashes are damaged or deteriorated. Recommend repairing or replacing as necessary.

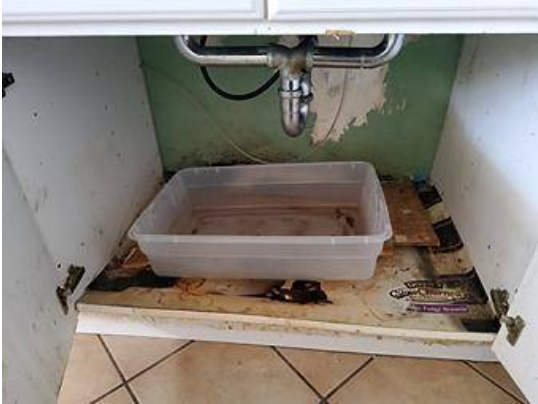
Photo 45-1

45) *Repair/Replace* - Water damage was found in shelving or cabinets below the sink. Recommend that a qualified contractor repair as necessary after any plumbing leaks have been repaired. If moisture is present then concealed areas should be dried thoroughly.

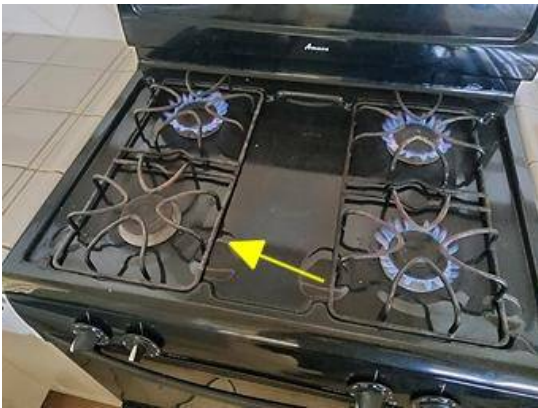
Photo 46-1

46) *Repair/Replace* - One of the cooktop burners is inoperable. Recommend that a qualified person repair as necessary.

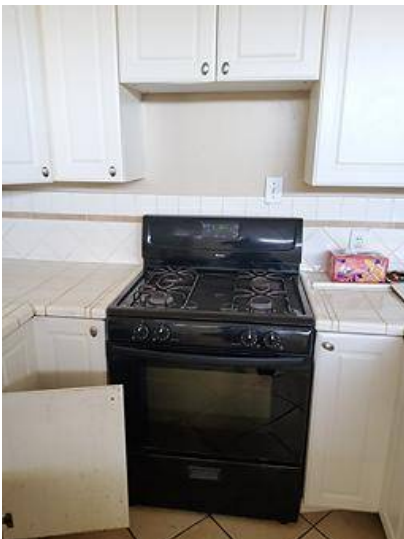
Photo 47-1

47) *Repair/Replace* - No exhaust hood was installed over the cook top or range, and no wall-mounted exhaust fan was found nearby. This can be a nuisance for odor and grease accumulation. Where a gas-fired range or cook top is installed, carbon monoxide and excessive levels of moisture can accumulate in living spaces. Lighting may also be inadequate. Recommend that a qualified contractor install a vented and lighted range hood, with the exhaust fan ducted outdoors.

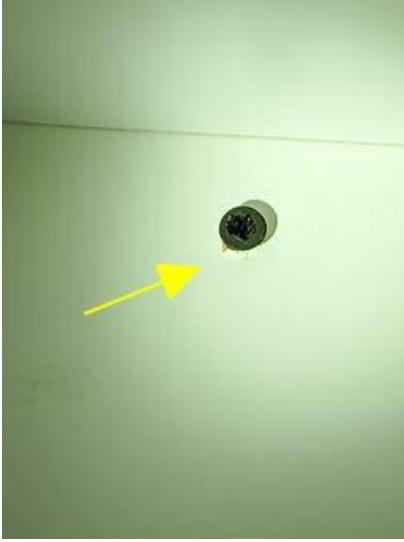
Photo 48-1

48) *Repair/Maintain* - The cabinets are secured with too few or substandard fasteners. An adequate number of appropriate fasteners should be used. For wall-hung cabinets, inadequate fasteners can pose a safety hazard if cabinets fall. Recommend that a qualified person repair as necessary.

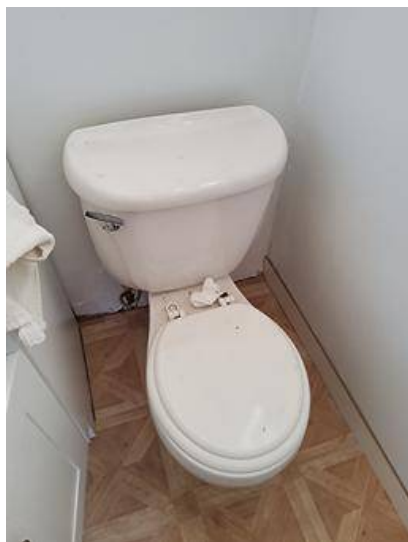
Photo 49-1

49) *Repair/Replace, Evaluate* - The toilet in the master bathroom didn't flush. Recommend that a qualified plumber evaluate and repair or replace the toilet as necessary.

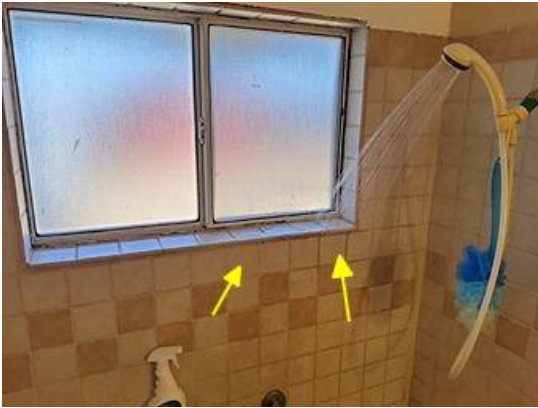
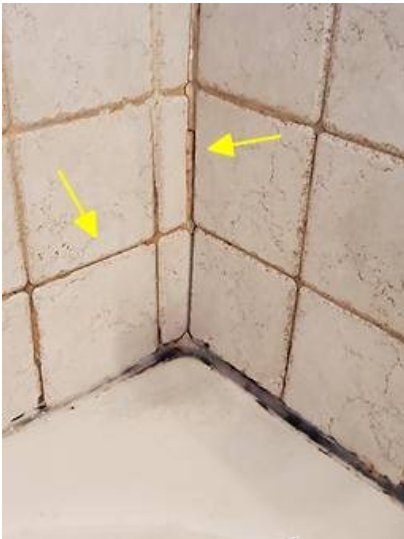
50) *Repair/Replace* - The shower enclosure in the hall bathroom is deteriorated, damaged or substandard. Water can damage the wall structure as a result. Recommend that a qualified contractor repair or replace the surround as necessary.

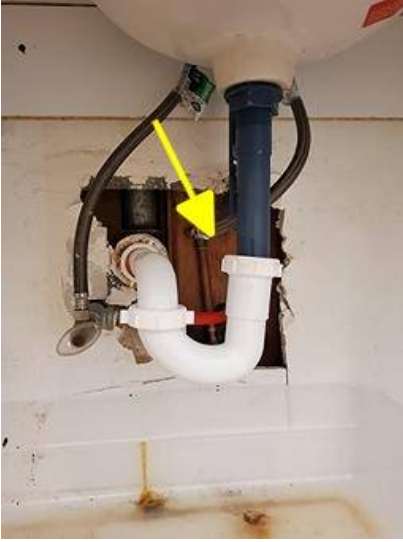
Photo 52-1

52) *Repair/Maintain* - The sink drain is leaking in the hall bathroom. A qualified plumber should repair as necessary.

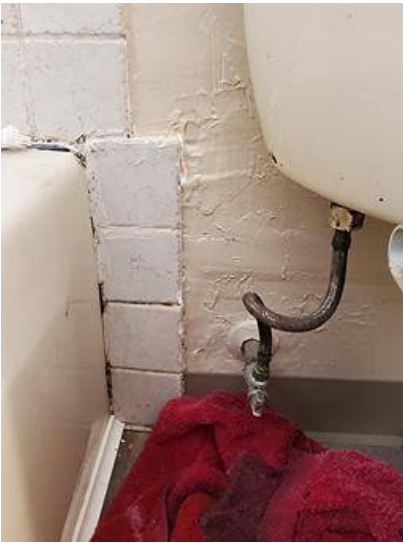
Photo 53-1

53) *Repair/Maintain* - The wall by the bathtub in the hall bathroom is water-damaged. Recommend that a qualified contractor repair as necessary.

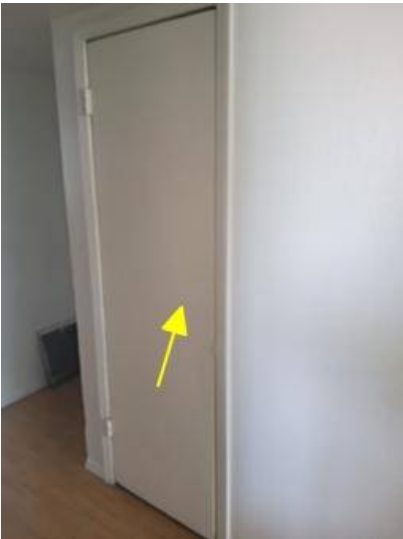
Photo 55-1

55) *Repair/Replace* - One of the interior doors hardware (handle) is missing. Recommend that a qualified person repair or replace as necessary.

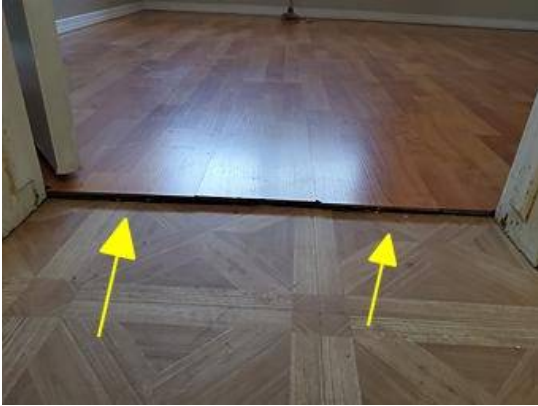
Photo 56-1

56) *Repair/Replace* - The threshold between the master bedroom and bathroom is missing. Recommend having a qualified person replace the threshold per standard building practices.
