### *Inspection Report*

**Address: 2760 Trenton Ave Cambria, CA 93428**

**07/09/2025**

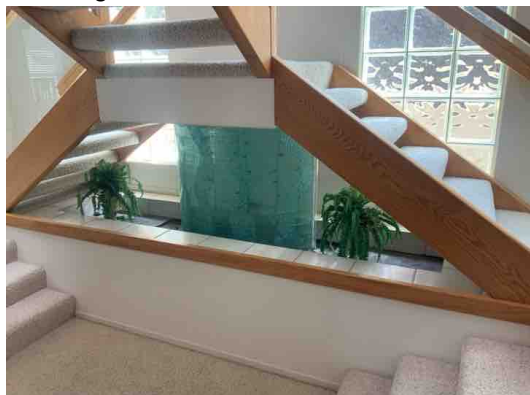
**DS** 13: Interior planter box. Interior planter box is currently not being used as a planter box. Unable to determine water tightness and current conditions of the waterproof interior planter box under the stairway.

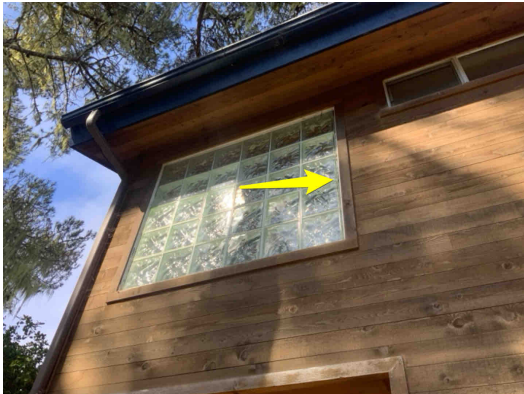
**E&C MR 32:** Deteriorated and missing sealant around the glass block windows installed on the back of the building. Contact the qualified painter or window installation professional to seal or reseal windows to help prevent additional deterioration and water intrusion.

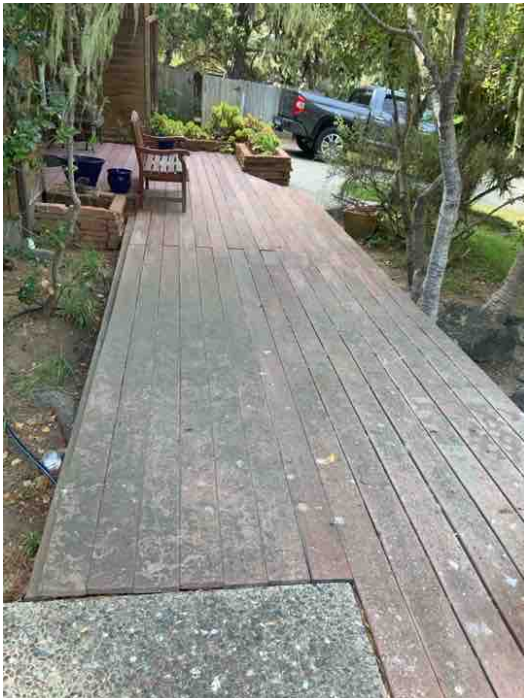
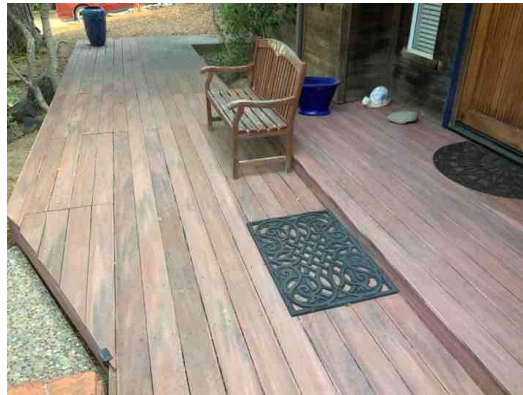
**37:** Some loose lifting boards found at the FRONT ENTRY DECK. Potential trip hazard.

**E&C 38:** Installation of the FRONT ENTRY DECK synthetic planks do not meet minimum installation standards. The end splices at the synthetic deck planks are required to have a minimum of 1-1/2 inch support under each side of the end splice. Currently the joints are only supported by splitting the single 1-1/2 inch joist and is supported by only 3/4 of an inch. Proper blocking at each splice per minimum standards is recommended per the installation requirements.

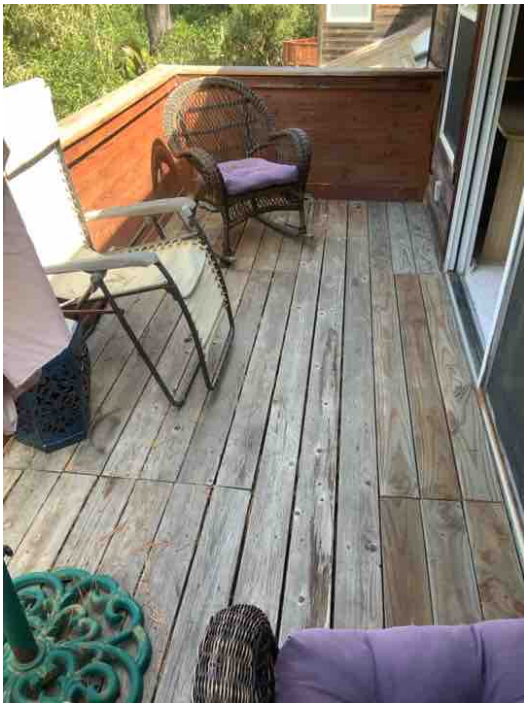
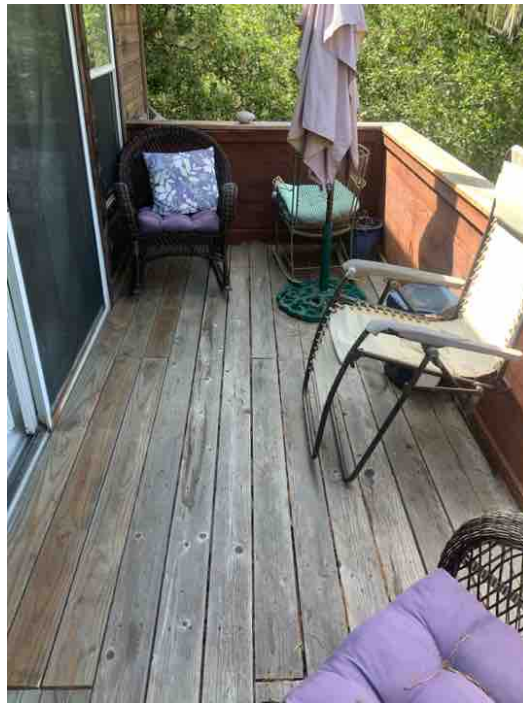
**MR** **UPG** **40:** Decking found to be installed unusually high at the exterior door threshold. This could lead to water intrusion under the door threshold. Upgrade and monitor as future moisture conditions could manifest.

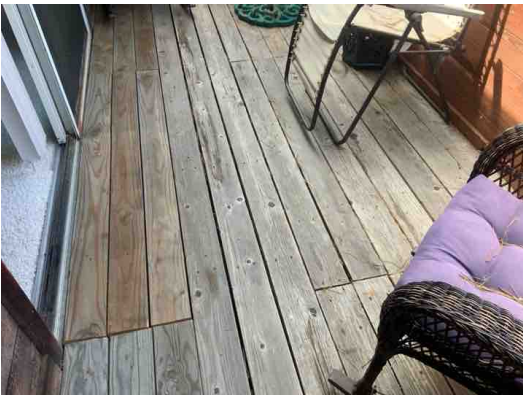
**E&C** **42:** Unable to view the deck waterproofing due to the wood planks installed. Condition of the waterproofing and flashing are unknown due to not being visible. Recommend additional review by licensed waterproof deck installation contractor.

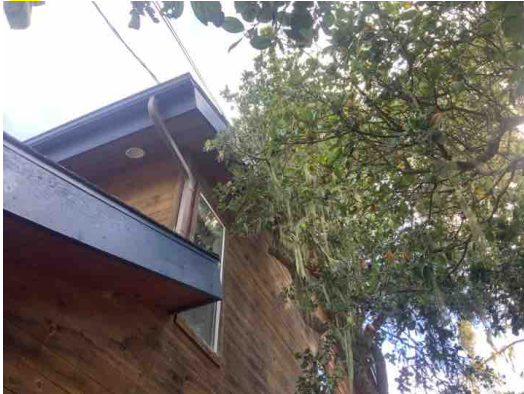
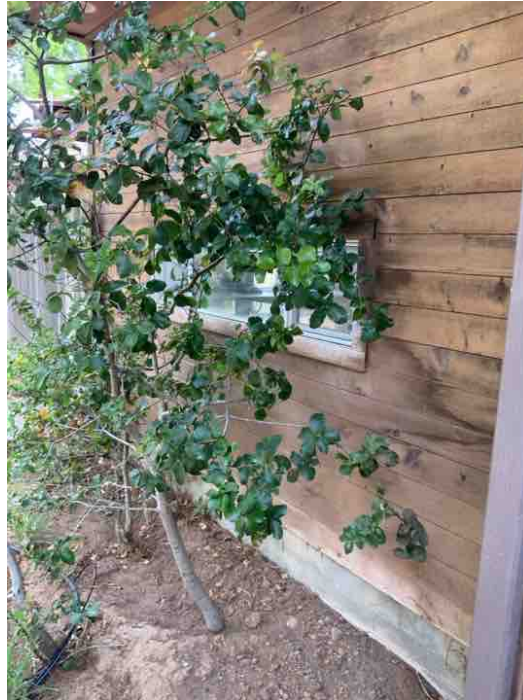
**MR 47:** Plants and/or trees touch the buildings exterior and/or the roof. Proper landscape maintenance needed.

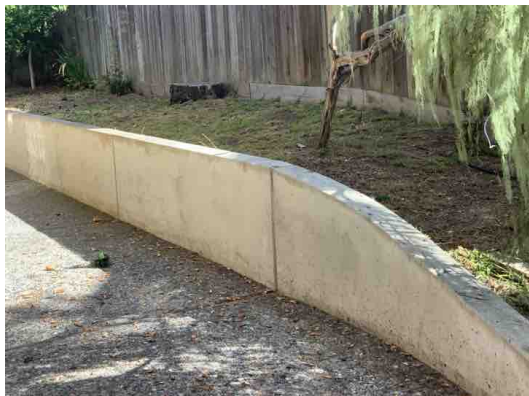
50: Retaining walls appear serviceable.

**DS** 51: **Disclosure:** Some common cracks noted at areas of the masonry, stuccoed and/or concrete retaining walls.

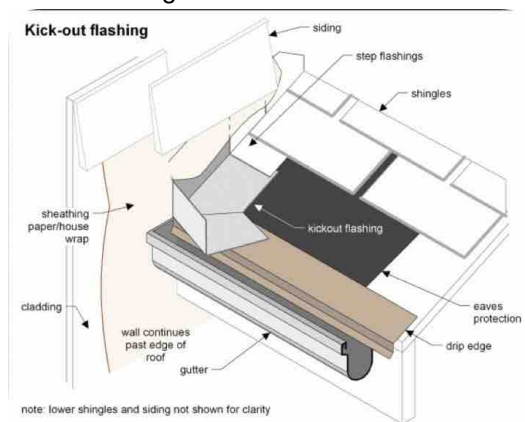
**E&C 59:** Recommend the installation of proper kick-outs at the bottom of the side headwall channel or step flashings. This can help prevent water intrusion into the wall cavities and help eliminate the discoloration of the exterior siding.

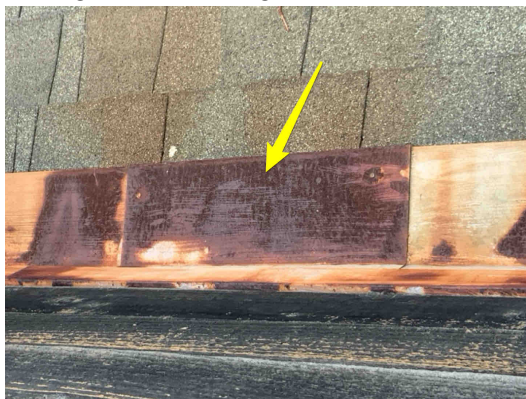
**FI 60:** Some roof flashings found rusted and deteriorated. Maintenance or replacement of deteriorated and damaged roof flashings are recommended.

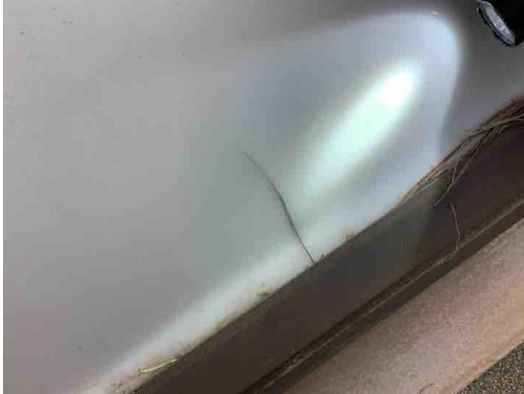
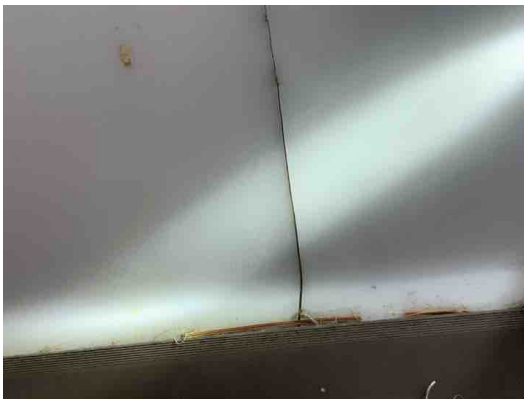
**E&C 61:** Some of the plastic roof skylights are cracked and damaged. Replacement is warranted. Contact a qualified roofer to evaluate and replace damaged skylights.

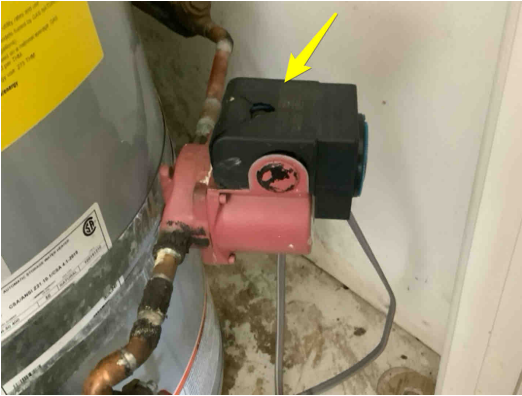
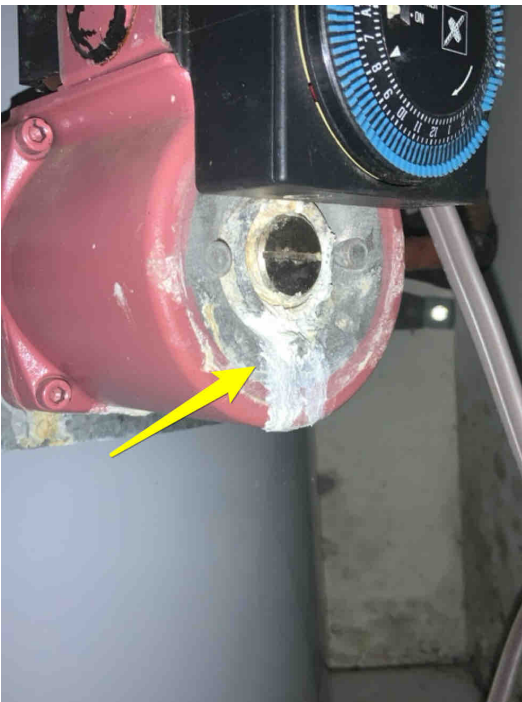
**86:** Water heater circulation pump found damaged and is considered unsafe. Recommend replacement for safety.

Evidence of past leakage

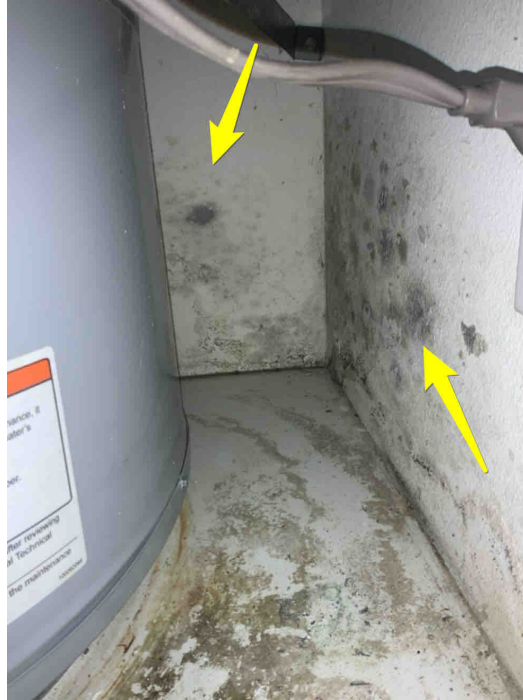
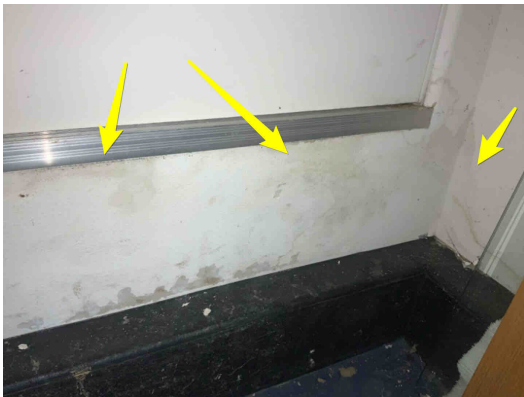
**SC FI 87:** Moisture stains and damage at the drywall areas of the water heater platform and/or enclosure. Some visible mold growth noted on areas of the drywall. Recommend additional review and clean up by a qualified mold remediation professional. Refer to Termite report for additional comments and recommendations.

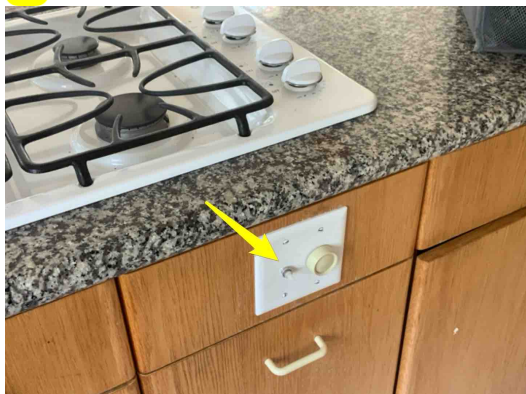
**MR 105:** Missing the knob on the cooktop hood light switch.

Missing knob

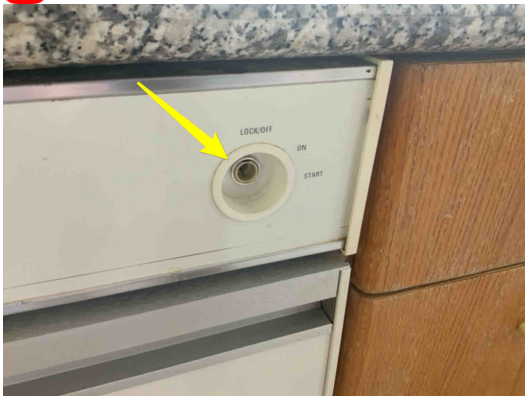
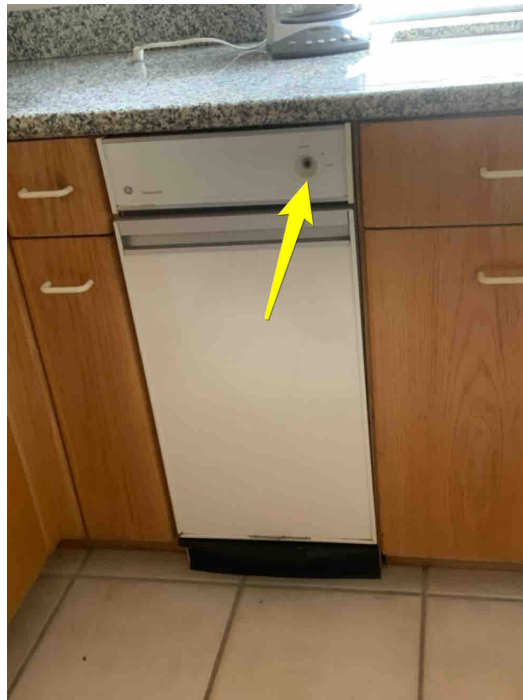
**E&C 109:** Unable to test the kitchen Trash Compactor. Missing the required key.

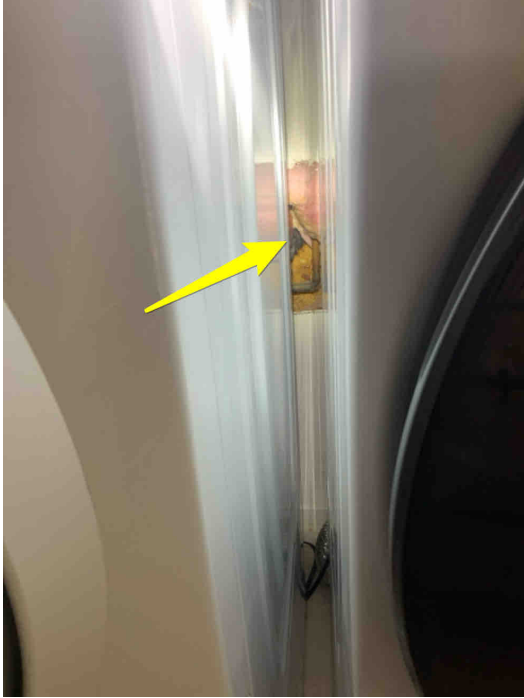
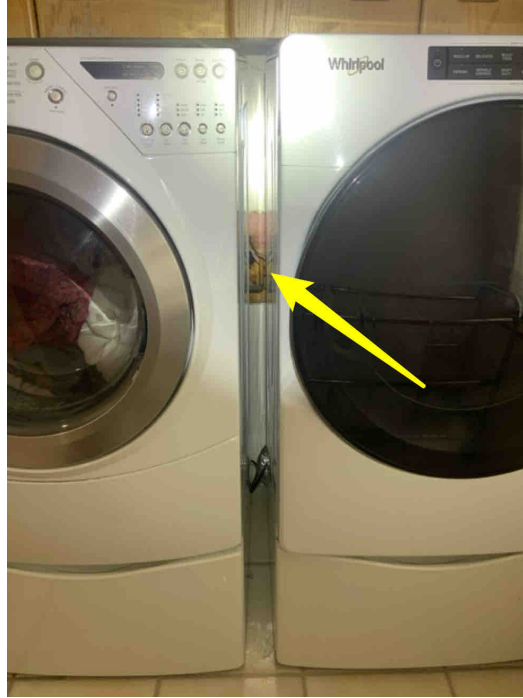
**FI DS 117:** Missing a small section of the drywall below the hot and cold water supply: **AT THE LAUNDRY.** Ask seller for details. Corrections recommended.

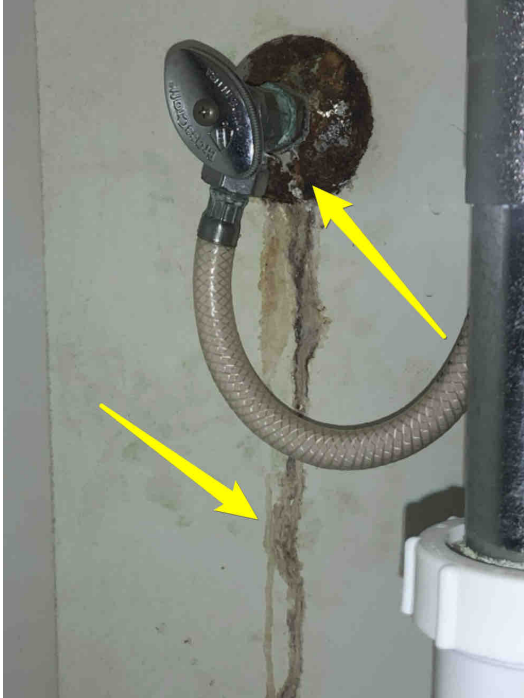
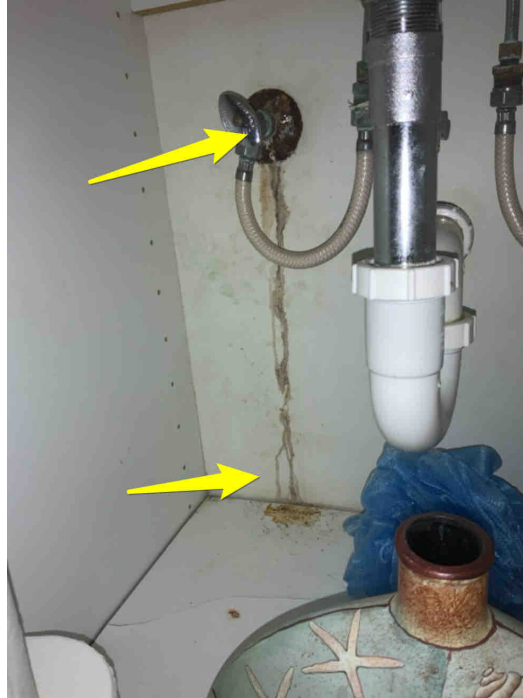
**FI 126:** Some moisture stains and/or damage noted in the cabinetry below the sink in the: UPSTAIRS HALL BATHROOM. Evidence of past moderate to heavy corrosion around the sink hot water shut off valve. Have plumber evaluate and correct any potential past or current leakage. Have appropriate professional clean and correct any water damage.

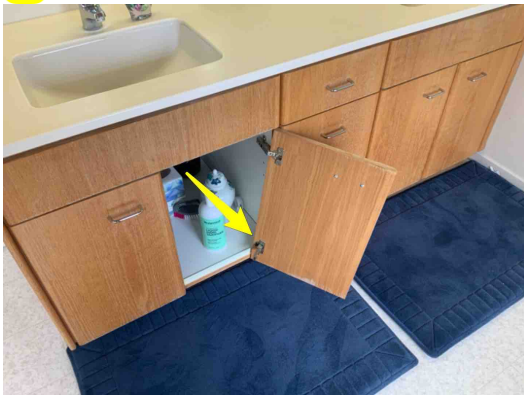
**MR 127:** Some general maintenance recommended at bathroom cabinetry. Some loose hinges, etc.

Example, loose door hinge

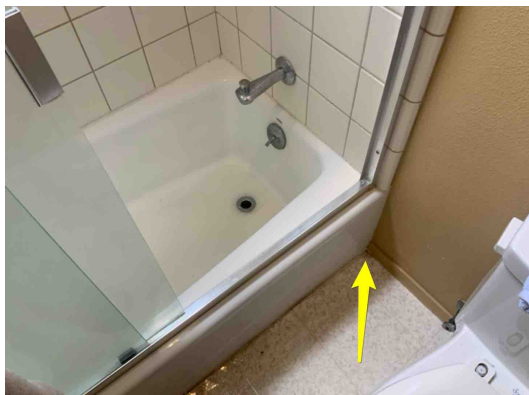
**E&C** **131:** Some Moisture damage or deterioration to the wood subfloor under the vinyl flooring outside tub:  
UPSTAIRS HALL BATHROOM

A Soft spot noted under flooring

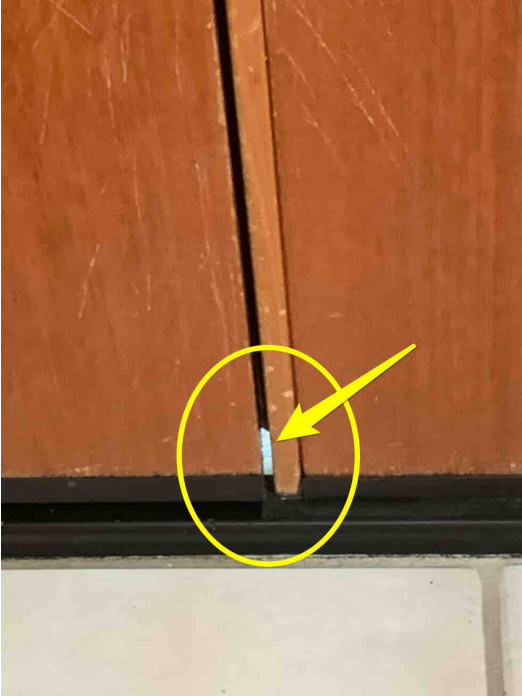
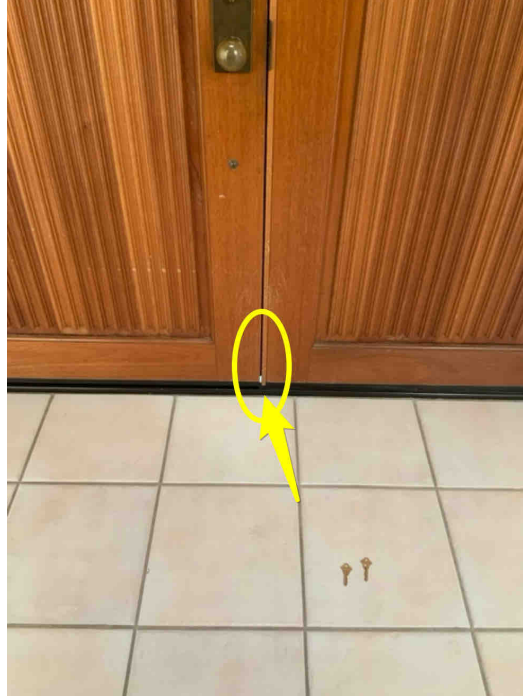
**MR 136:** Some visible daylight noted around the exterior front entry door. Adjustment and/or repair of the weather stripping is recommended to help prevent water and critter intrusion.

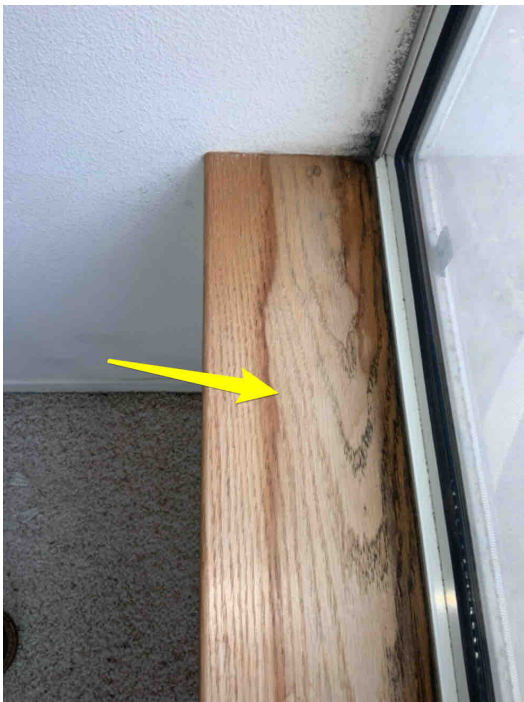
**FI 144:** Moisture stains and/or damage on the inside at some window sills. Some windows may have been left open during the rainy weather. Refer to the termite report for additional comments and recommendations.

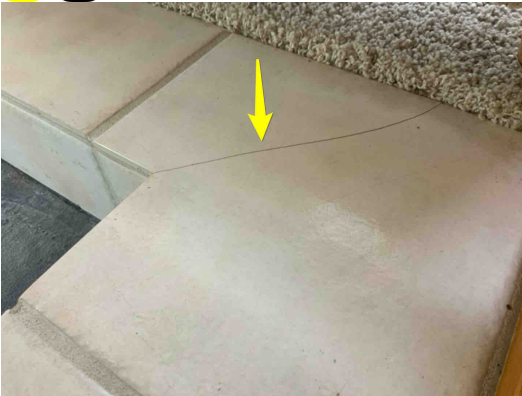
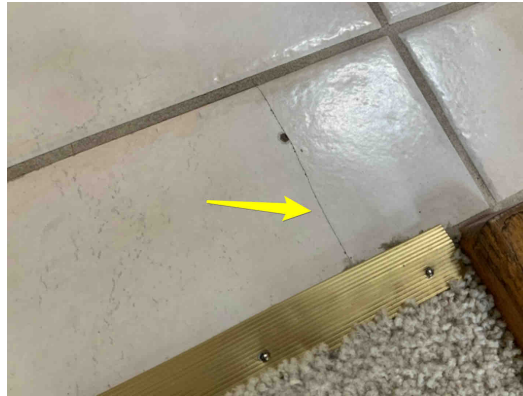
**UPG DS 150:** Disclosure: Some cracked floor tiles noted in areas of the house.

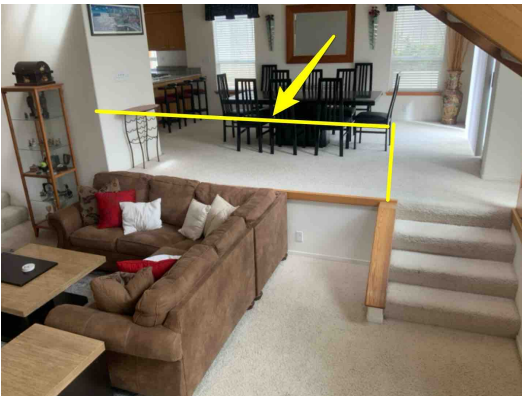
Example location

**151:** Railings are recommended, not required, as an safety upgrade around the SUNKEN LIVING ROOM to prevent a fall.

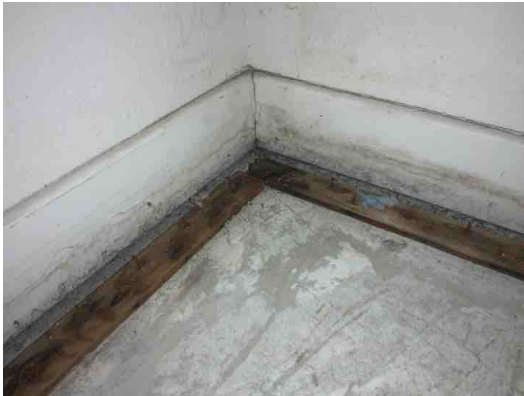
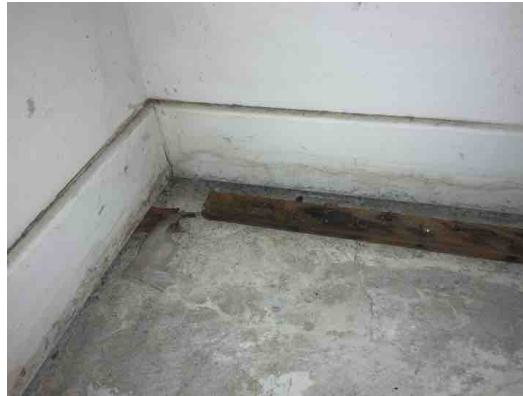
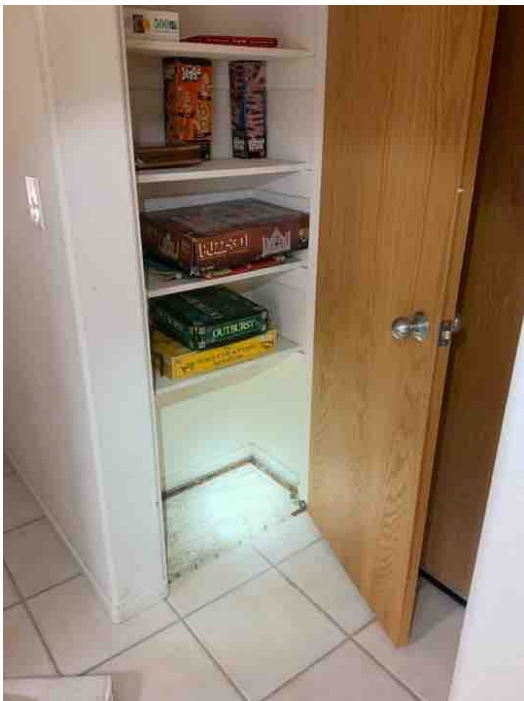
**FI 159:** Evidence of moisture stains and/or damage at the walls INSIDE THE LAUNDRY ROOM LINEN CLOSET. Recommend further review of the water stains to determine the cause, the current condition and if repairs are needed.

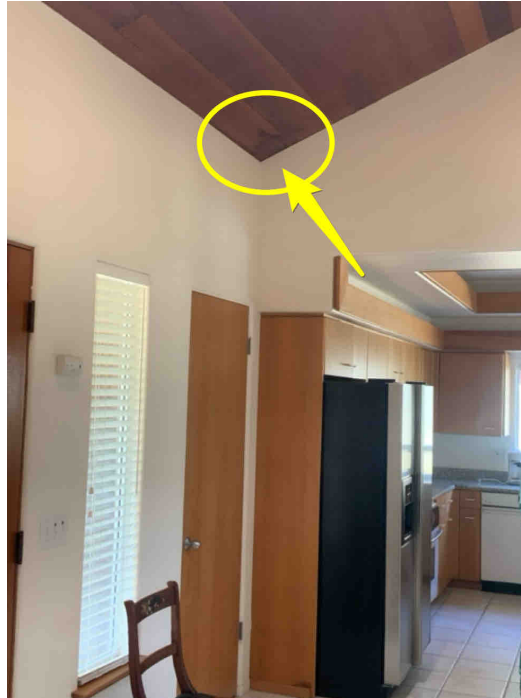
**FI 161:** Evidence of past moisture stains & damage at ceiling area in FRONT ENTRY. Recommend further review of the water stains to determine the cause, the current condition and if repairs are needed.

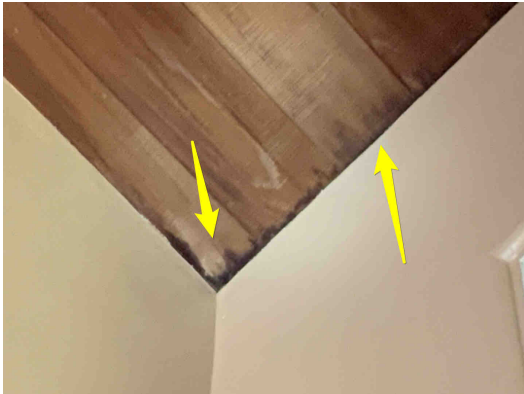
**FI 162:** Evidence of past moisture stains & damage at ceiling area in INSIDE THE UPSTAIRS HALLWAY BATHROOM-ABOVE THE TOILET. Recommend further review of the water stains to determine the cause, the current condition and if repairs are needed.

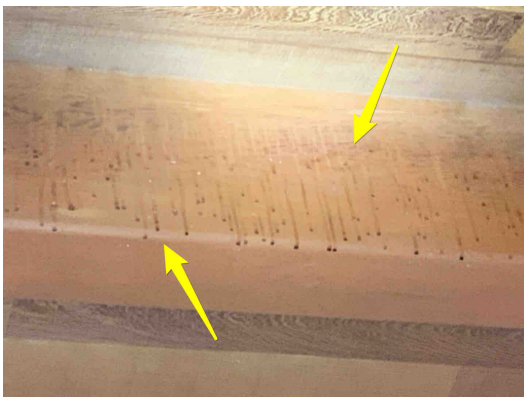
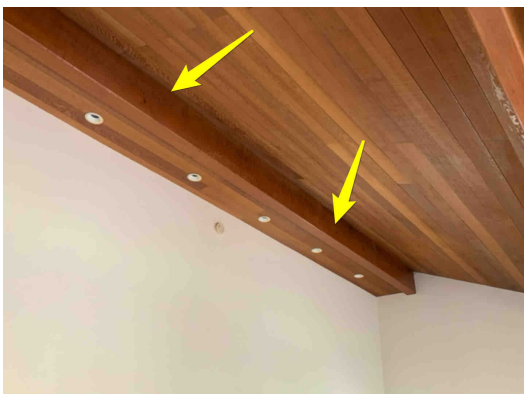
**FI 163:** Evidence of past moisture stains & damage at ceiling area in PRIMARY BEDROOM at the upper wood beam. Suspected condensation buildup due to poor or improper ventilation of the roof system. Recommend further review of the water stains to determine the cause, the current condition and repairs as needed.

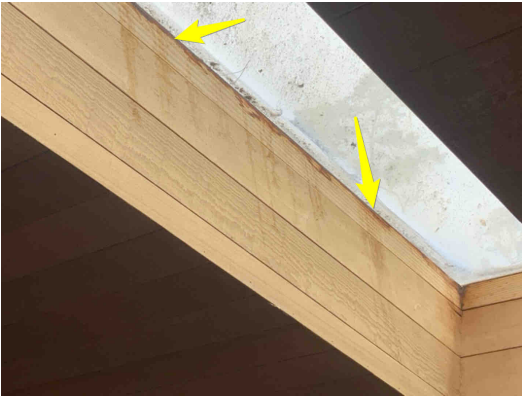
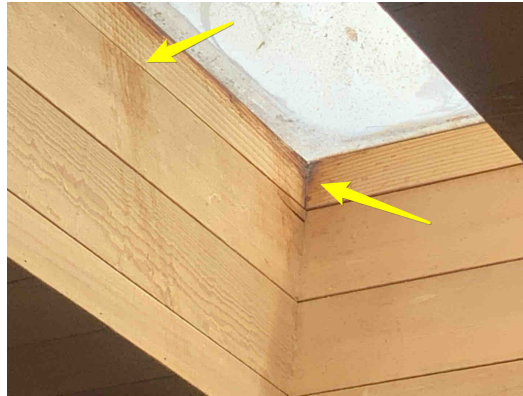
**FI 164:** Evidence of past moisture stains & damage at ceiling area in AROUND THE STAIRWAY AREA SKYLIGHT. Recommend further review of the water stains to determine the cause, the current condition and if repairs are needed.

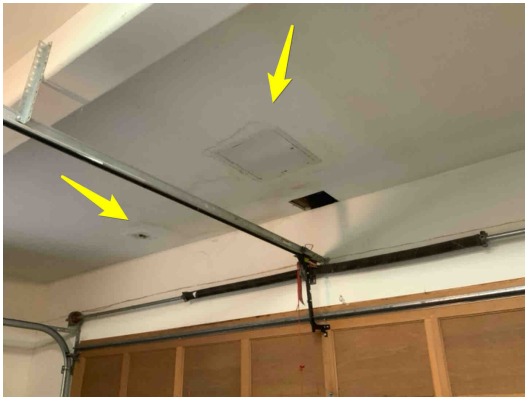
**FI 165:** Evidence of past moisture stains & damage at ceiling and walls in the GARAGE ABOVE THE VEHICLE DOOR (Upstairs bedroom waterproof deck above the stains). Recommend further review of the water stains to determine the cause, the current condition and if repairs are needed.

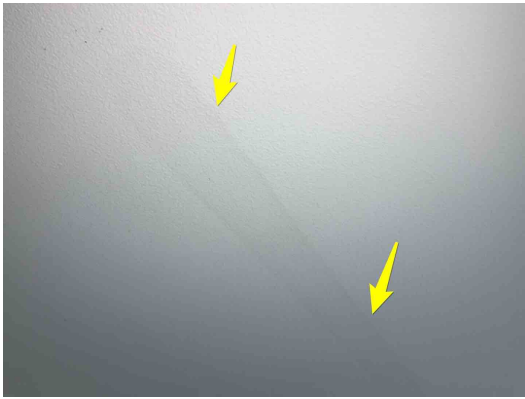
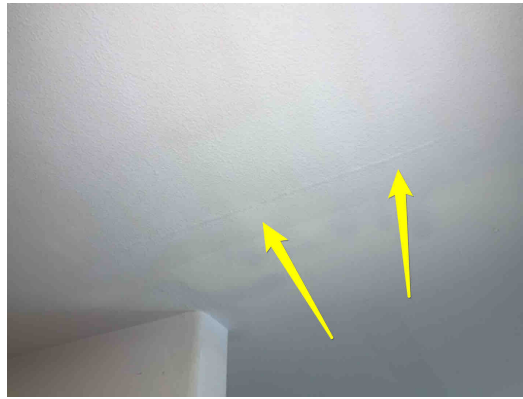
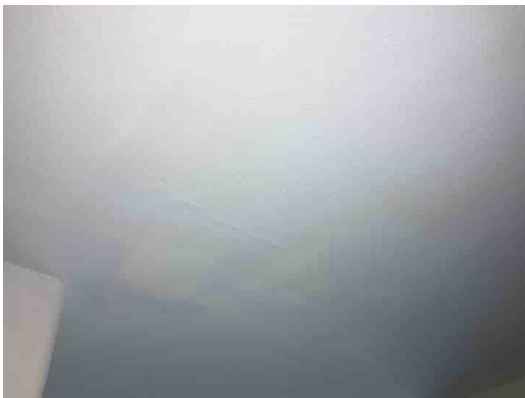
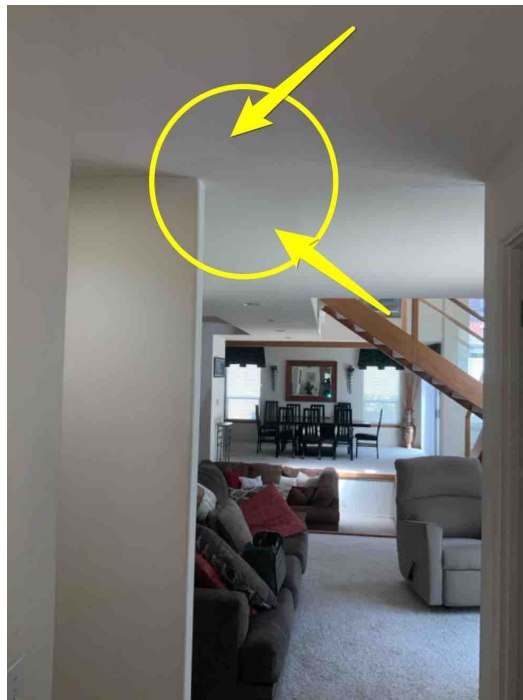
**FI 166:** Evidence of past moisture stains & damage at ceiling area in the downstairs den. Recommend further review of the water stains to determine the cause, the current condition and if repairs are needed.

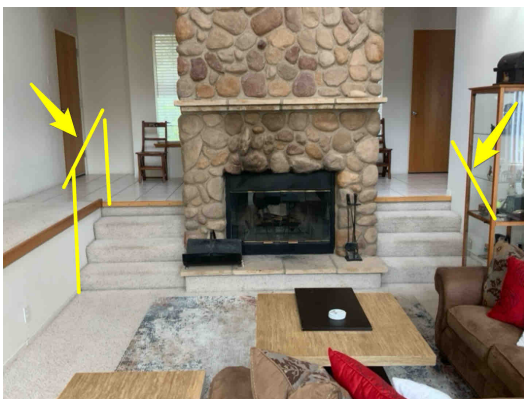
Example location

**SC 168:** Missing a proper gripable handrail and guardrail at some of the interior stairway for safety per standards.

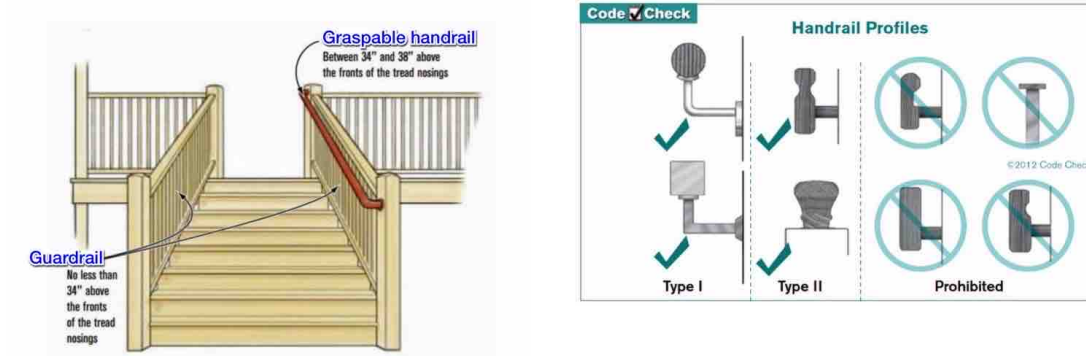
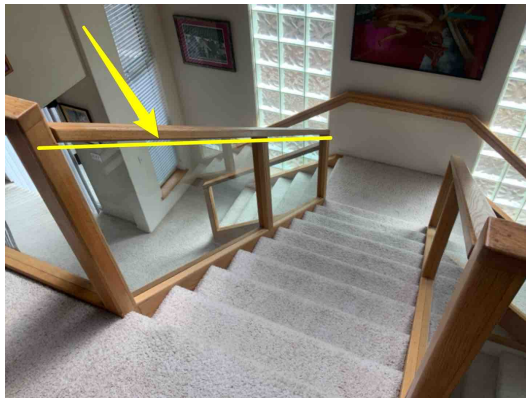
Example location

**SC 171:** Missing a proper gripable handrail at the upper portion of the interior stairway to the UPPER STAIRWAY TO THE SECOND STORY for safety per standards.

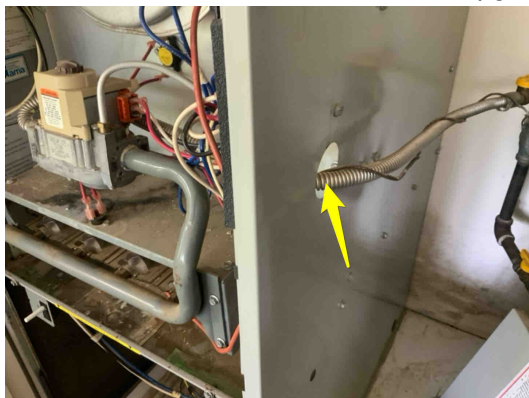
**SU 175: Disclosure:** It is considered an improper installation to have the flex gas connector pass through the metal sidewall of the furnace cabinet. Upgrades recommended.

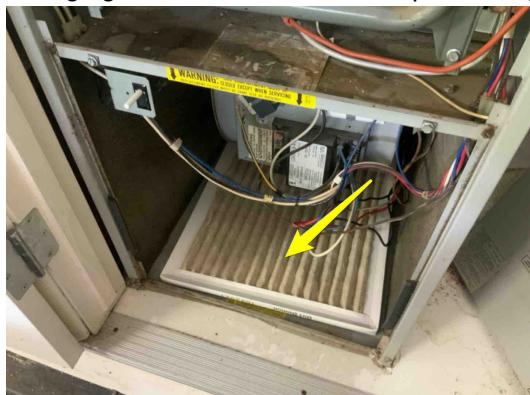
**MR 179:** Dirty Heating air filter found inside the furnace blower box at the furnace. Recommend cleaning or changing the furnace air filters as part of ongoing maintenance.

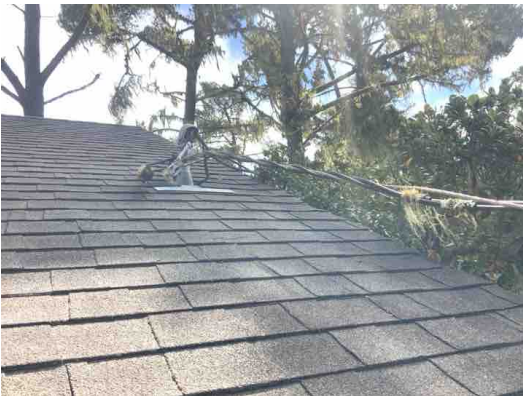
**SC 184:** The overhead electrical service wires found to be improperly installed and are considered unsafe as the wires are hanging too close to the ROOF. A minimum of (18 inches.) needed above a roof for safety per standards. Recommend further review and repair by a qualified and licensed professional familiar with the minimum installation requirements.

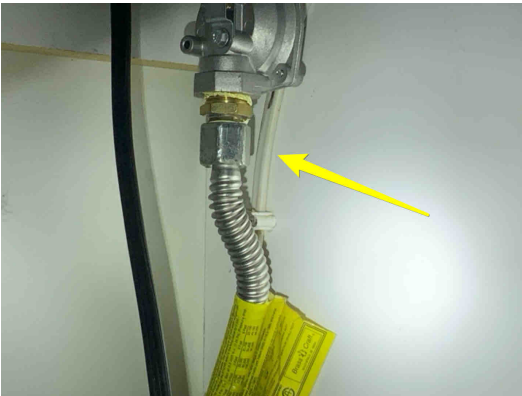
**SC 189:** Improper and unsafe electrical wiring. Exposed electrical wiring, "Romex" improperly installed subject to physical damage, not in a conduit or raceway per standards inside the kitchen cabinet below the cooktop.

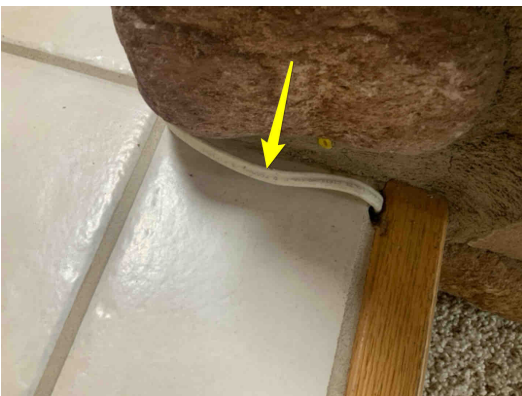
**SC 190:** Improper and unsafe electrical wiring. Exposed electrical wiring, "Romex" improperly installed subject to physical damage, not in a conduit or raceway per standards: AT SOME ADDED ELECTRICAL WIRING AND OUTLET FOR THE FRONT ENTRY GLASS SCULPTURE

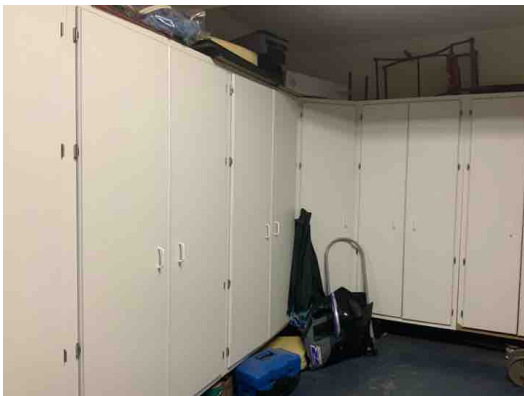
**DS 200:** Due to an excessive amount of stored items and/or cabinetry in the garage, the majority of the garage walls and/or floor, is not accessible, not visible, nor inspected. A re-inspection is recommended once access is made available.

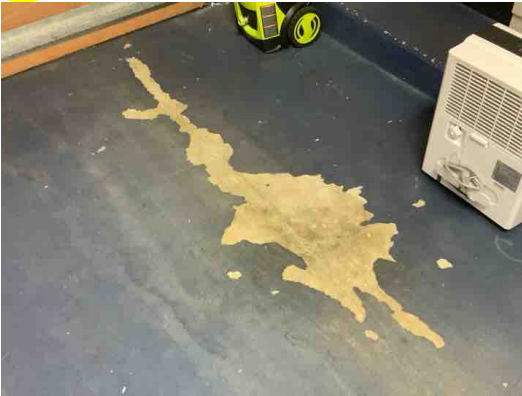
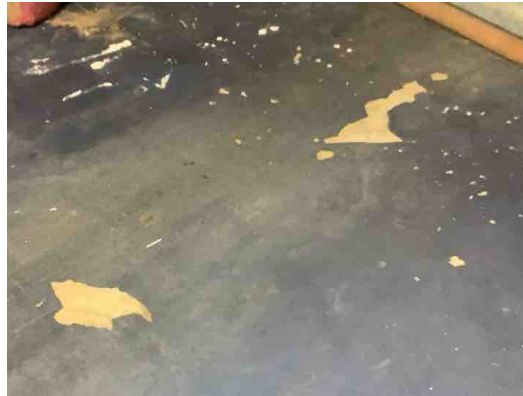
**MR 201: Disclosure:** Some deterioration noted areas of the garage painted floor. Maintenance recommended.

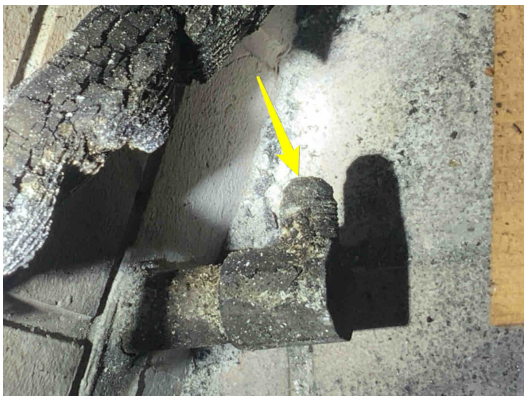
**SC** **214:** Fuel Type: Wood Burning fireplace with Gas, **The unused Gas pipe inside the fireplace is NOT capped for safety.**
