### *Inspection Report*

Address: 1143 16th St Baywood-Los Osos, CA 93402

03/13/2026

Inspector: Taylor Vreeken, CCI

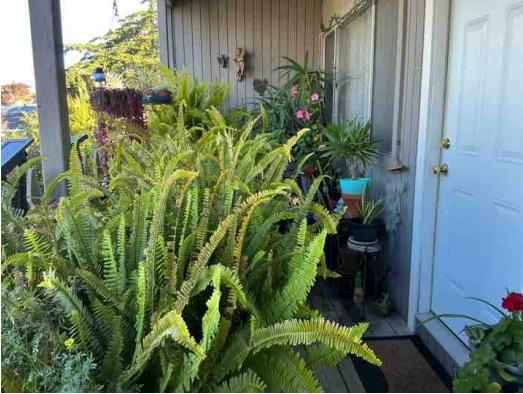
**MR 30:** Areas of the exterior are not fully visible and not inspectable due to overgrown foliage and occupant's belongings. Conditions are behind the blockage are unknown. Client is advised to have the obstructions moved to have the areas reinspected.

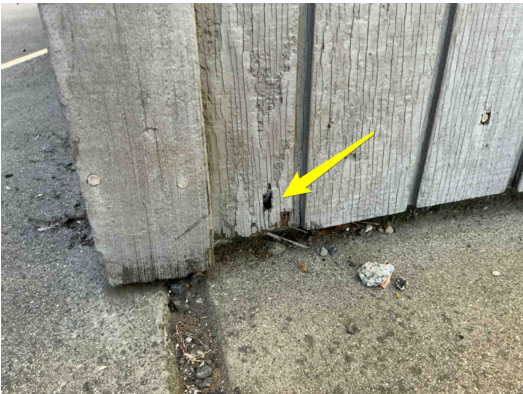
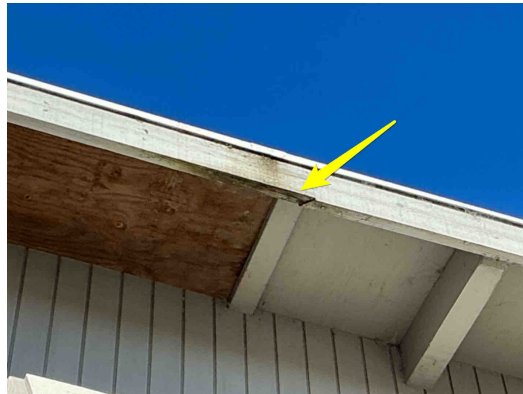
**E&C 31:** Some moisture and/or bug-type damage and deterioration found at areas of the exterior wood siding and/or trim. Refer to the termite report for additional comments, recommendations, locations and extent.

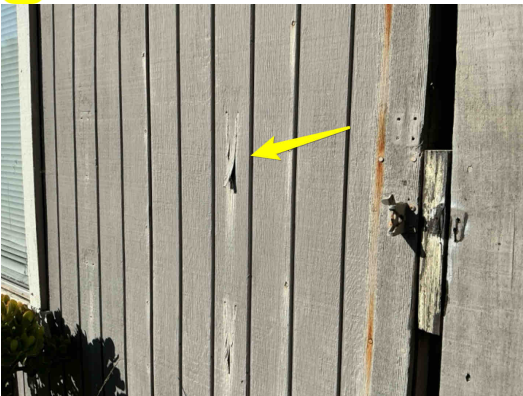
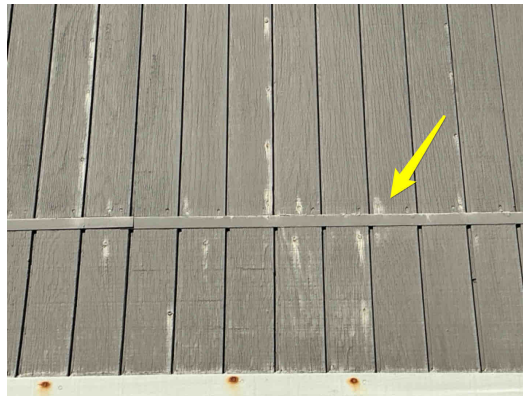
**MR 32:** Deteriorated paint at areas of the exterior.

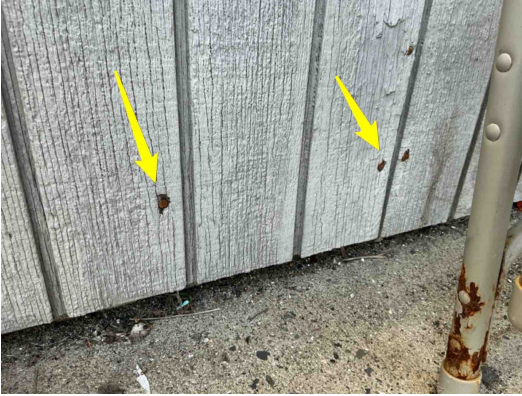
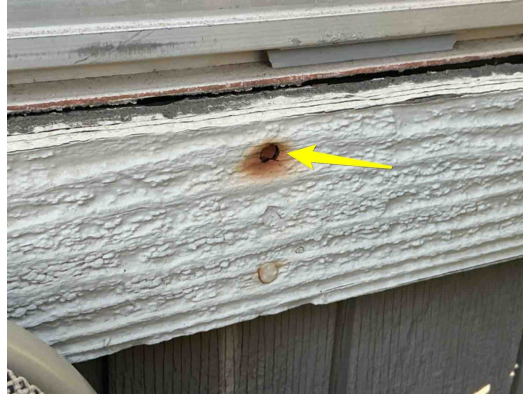
**E&C FI 33:** Several exterior fasteners found rusted and deteriorated.

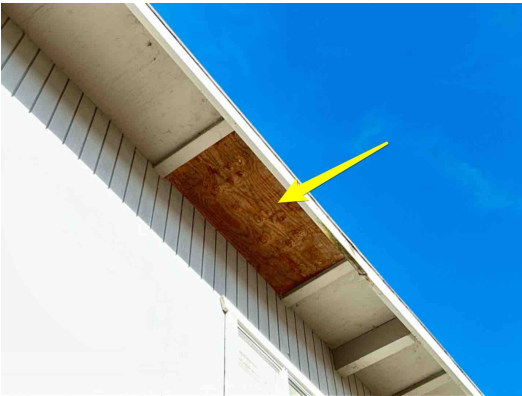
**E&C FI MR 34:** Areas of added or altered exterior wood found unpainted or unfinished. Corrections recommended.

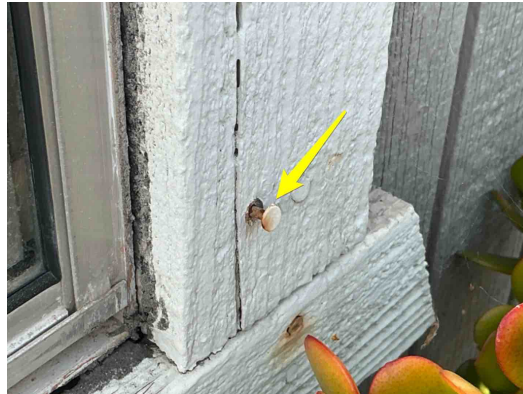
**E&C MR 35:** Multiple loose, unsealed, and/or damaged fasteners noted throughout the exterior. Further evaluation in corrections/ maintenance recommended.

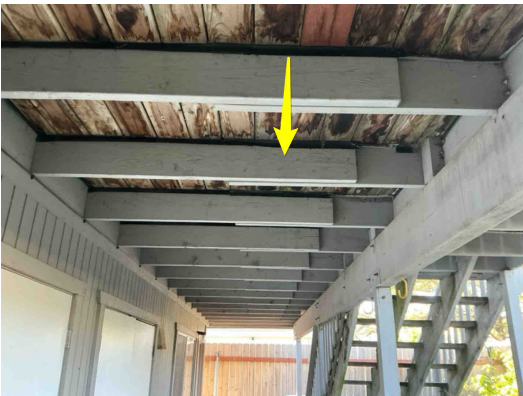
**E&C SC 39:** The UNIT-3 & 4 decks and stairway do not meet minimum construction standards, have heavy moisture damage, and appear to be at the end of serviceable life. **Safety hazard.** Too many individual defects and locations to list. Contact a qualified contractor for evaluation and repairs or replacement.

Split joists

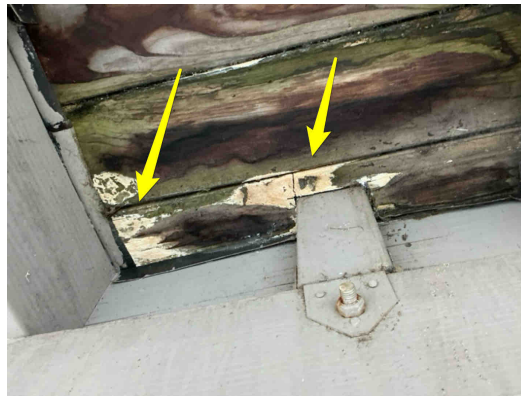
Fungus/ moisture damage

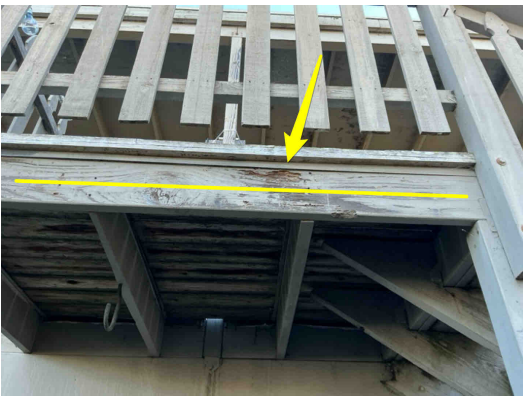
Moisture damage and improper use of a rim joist as a beam

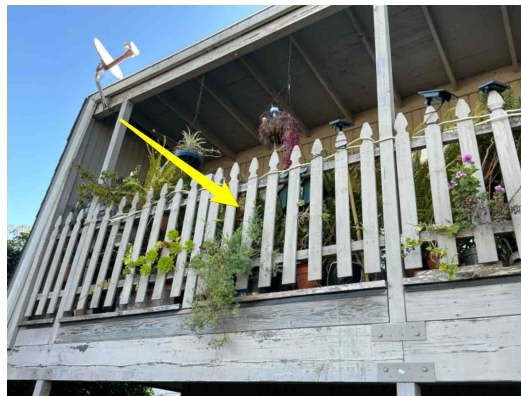
Improper use of fencing pickets as guards

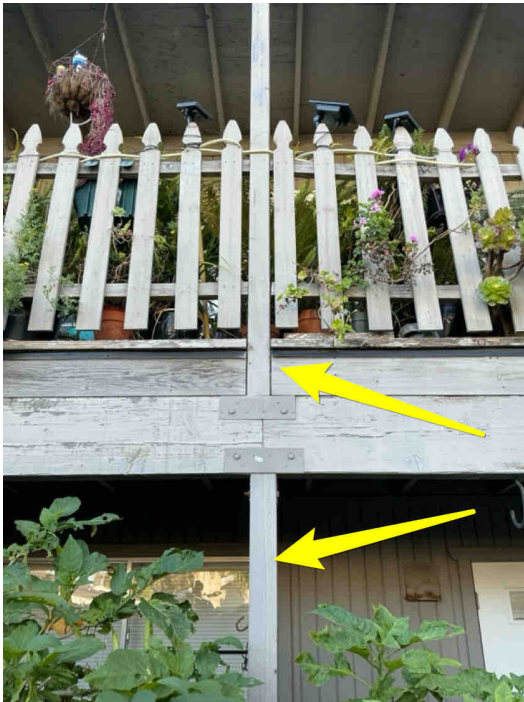
Improper stacked posts

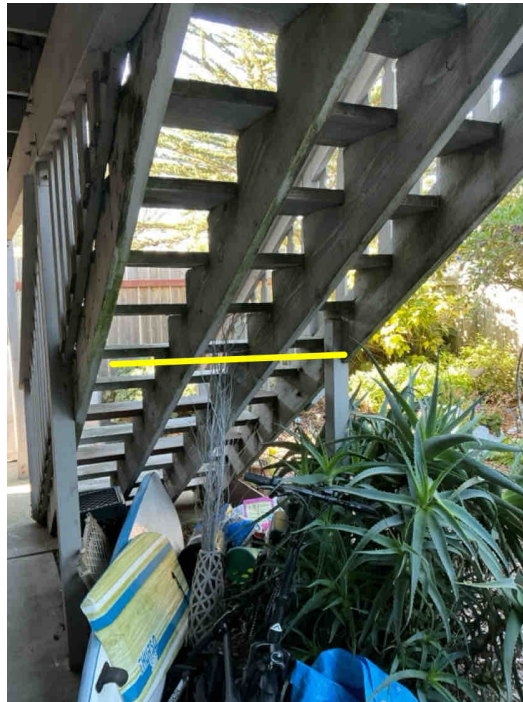
Over-spanned stringers

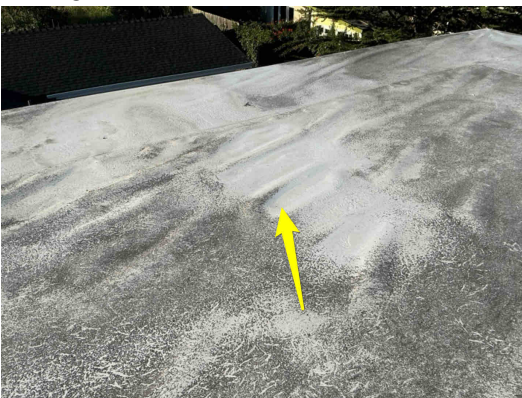
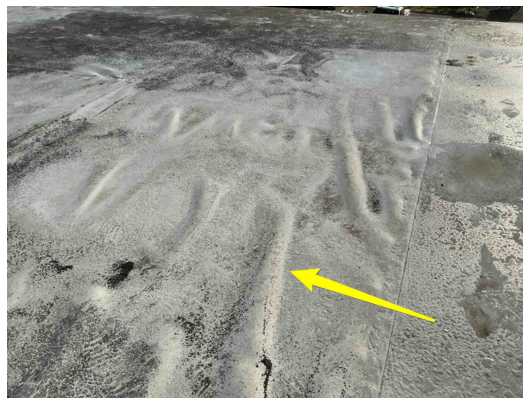
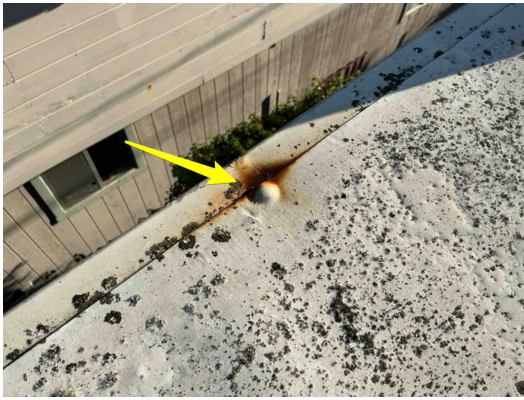
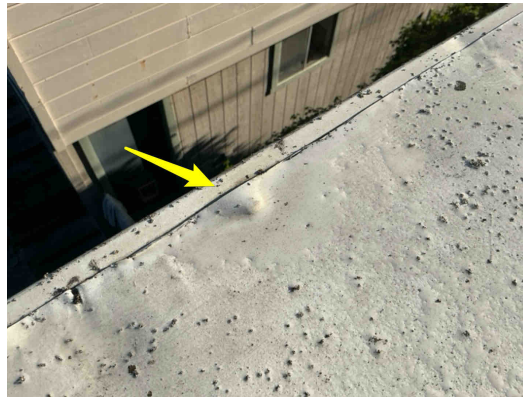
**E&C DS 50:** The TPO roofing membrane exhibited visible buckling and wrinkling across portions of the roof surface. These conditions can occur when the membrane is not properly adhered, fastened, or allowed to relax during installation. While the roof may still be functional at this time, excessive wrinkling can lead to premature wear, water ponding, and increased risk of seam failure. Recommend evaluation and correction by a qualified roofing contractor.

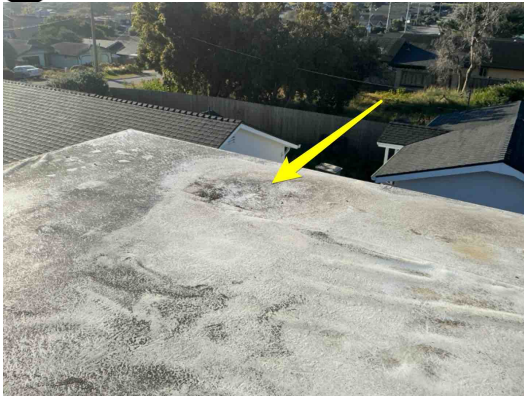
**DS 51:** Disclosure: Small areas of ponding water/ past ponding water on roof noted.

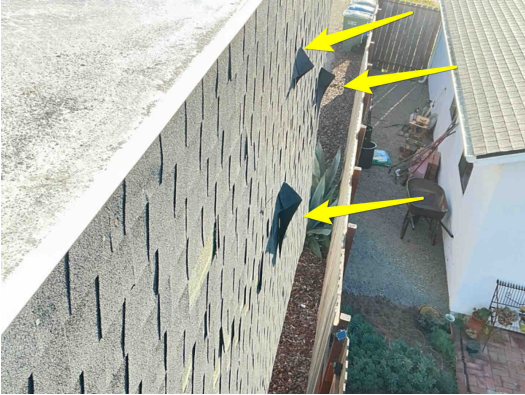
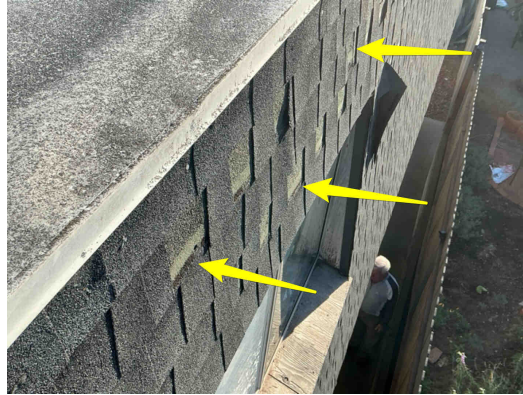
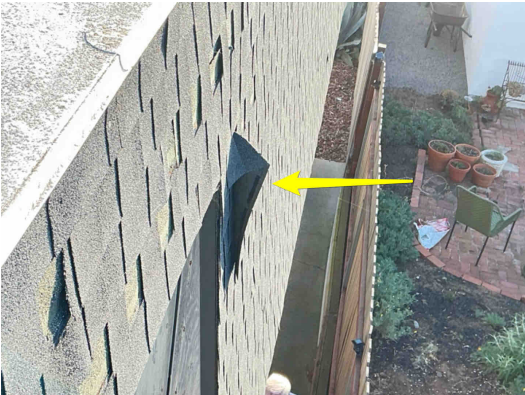
**E&C 55:** Several damaged and missing roof shingles noted at areas of the asphalt composition shingle mansard roof. Corrections are needed. Contact a qualified roofer to evaluate the roof and make the appropriate recommendations and repairs as needed.

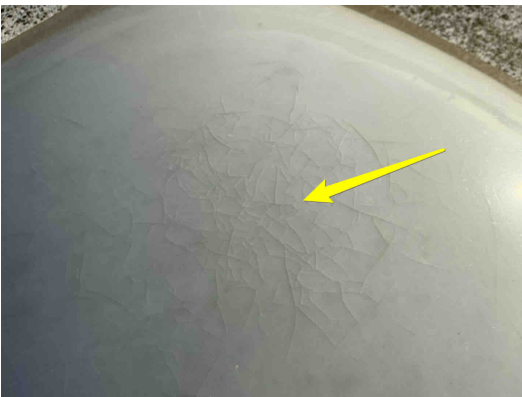
**E&C 57:** BOTH of the plastic roof skylights are cracked and damaged. Replacement is recommended. Contact a qualified roofer to evaluate and replace damaged skylights.

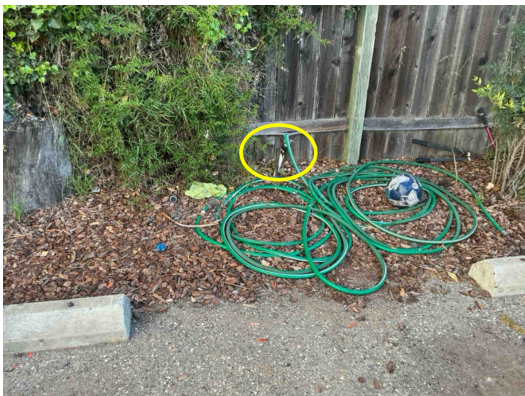
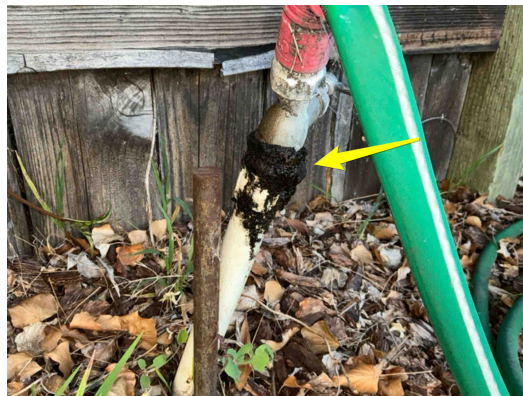
**E&C 66:** Active water leak found at NORTHEAST EXTERIOR (ADDED HOSE BIB). Recommend further evaluation and repairs by qualified plumbing professional.

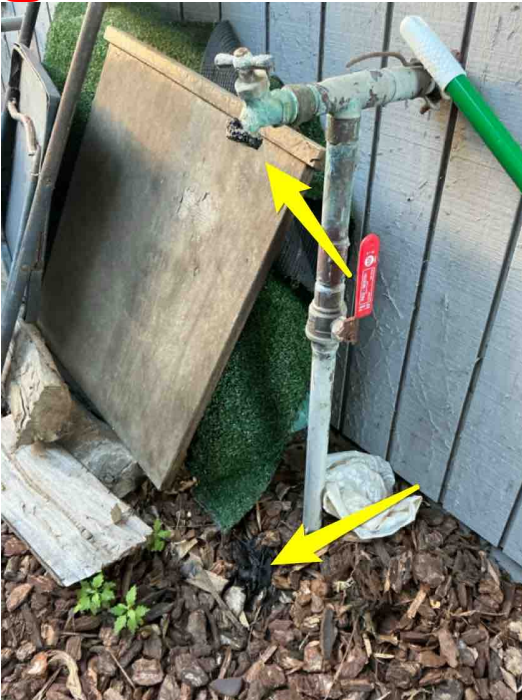
**E&C 68:** The Exterior hose faucet is actively leaking / drips continuously NORTHWEST CORNER OFF MAIN.

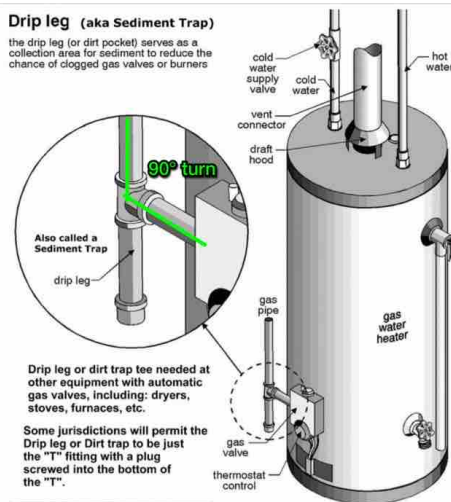
**SU 86:** Recommend the installation of the missing sediment trap / drip leg at the WATER HEATER gas piping at flex connection by a certified or licensed plumbing professional familiar with minimum requirements. [CPC 1212.8]

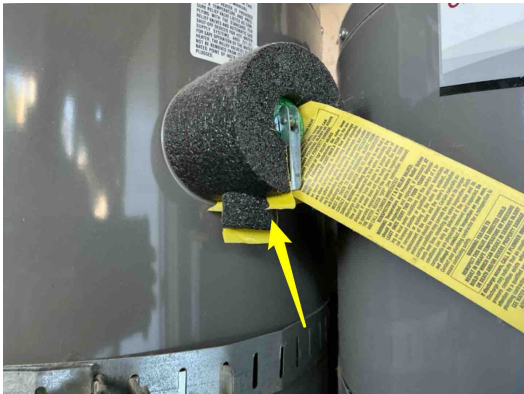
**SC 95:** Water heater TPR (temperature pressure relief) pipe is missing / not installed. The pipe must terminate downward at the exterior or approved location at 6 to 24 inches from the ground.

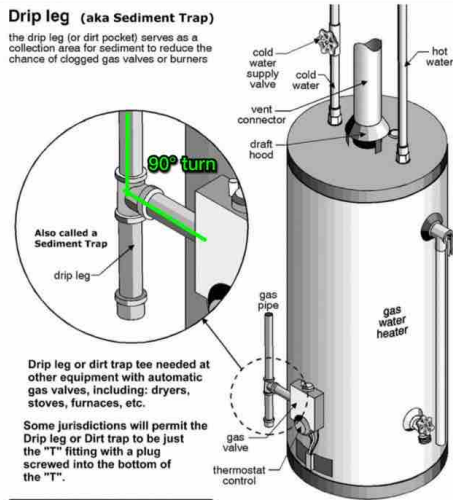
**SU 100:** Recommend the installation of the missing sediment trap / drip leg at the WATER HEATER gas piping at flex connection by a certified or licensed plumbing professional familiar with minimum requirements. [CPC 1212.8]

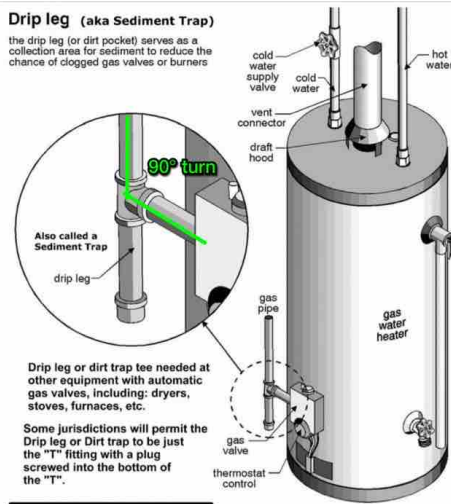
**SU 115:** Recommend the installation of the missing sediment trap / drip leg at the WATER HEATER gas piping at flex connection by a certified or licensed plumbing professional familiar with minimum requirements. [CPC 1212.8]

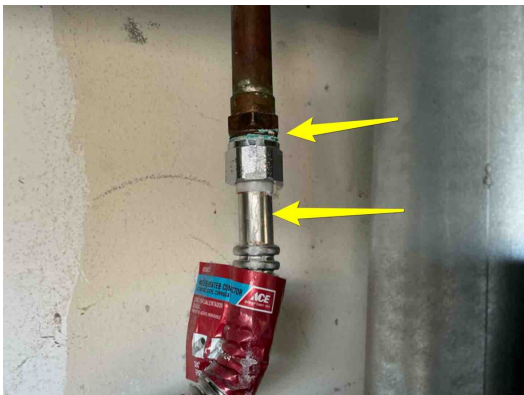
**FI 118:** Evidence of past leaking with corrosion at the HOT water supply piping at the water heater. Contact a qualified plumber to evaluate and correct.

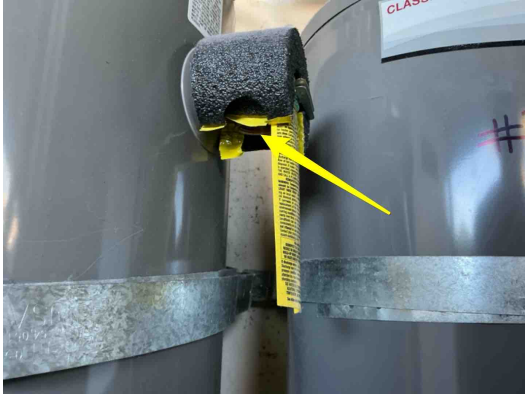
**SC 125:** Water heater TPR (temperature pressure relief) pipe is missing / not installed. The pipe must terminate downward at the exterior or approved location at 6 to 24 inches from the ground.

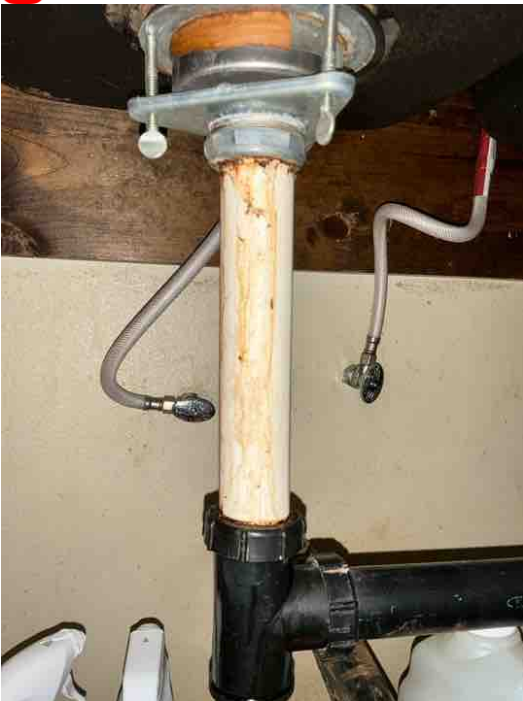
**FI 141:** Some corrosion found at waste pipe connections under the kitchen sinks / evidence of past leaking.

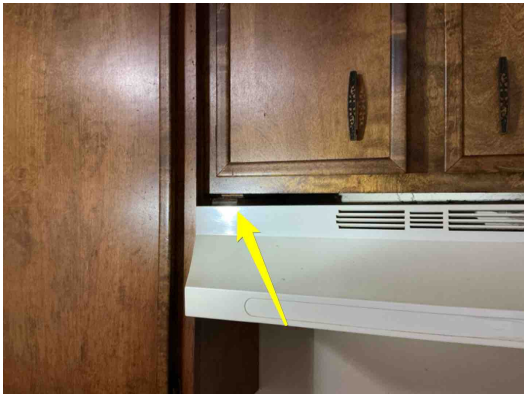
**153:** The kitchen cooktop hood found loose/ improperly connected to the upper cabinetry. Corrections warranted: UNIT-1

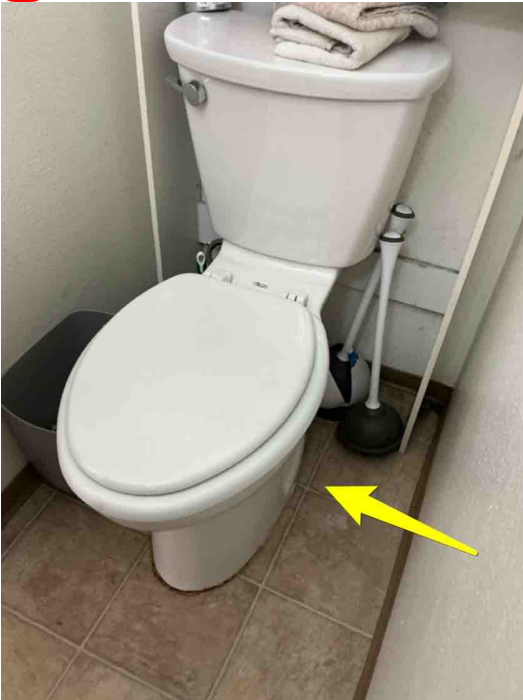
**E&C** 170: Toilet loose at floor: UNIT-1

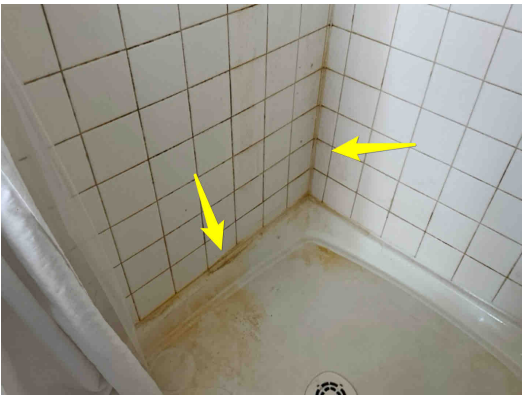
**UPG 180:** Deteriorated/ moldy grout and caulking found in the shower enclosure. Some general maintenance and/or upgrades are recommended: UNIT-1/ UNIT-2/ UNIT-3/ UNIT-4

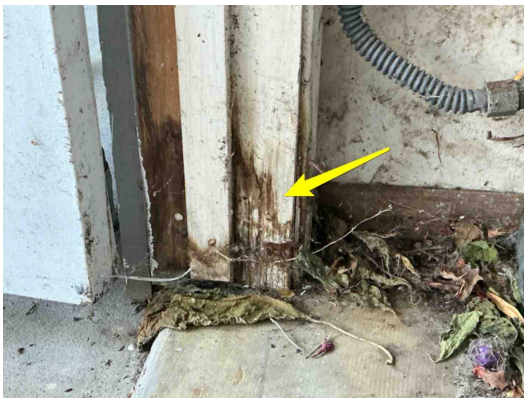
**FI** **189:** Evidence of past water intrusion from around the WEST MECHANICAL ROOM exterior door with stains and/or damage on the interior.

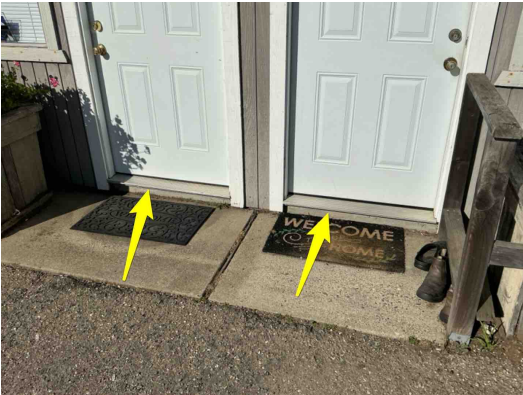
**MR UPG 191:** Loose, unsupported threshold found at multiple exterior doors. This could damage the threshold and/or create a water leak.

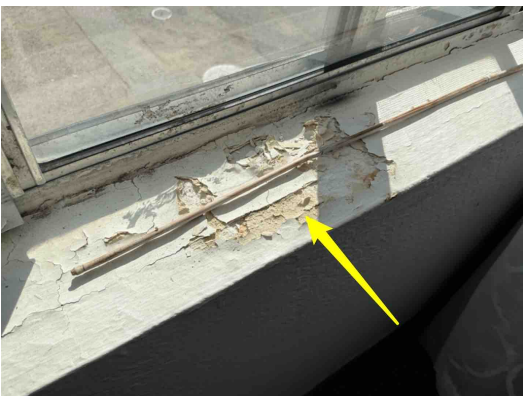
**FI 200:** Moisture stains and/or damage on the inside at some window sills. Refer to the termite report for additional comments and recommendations.

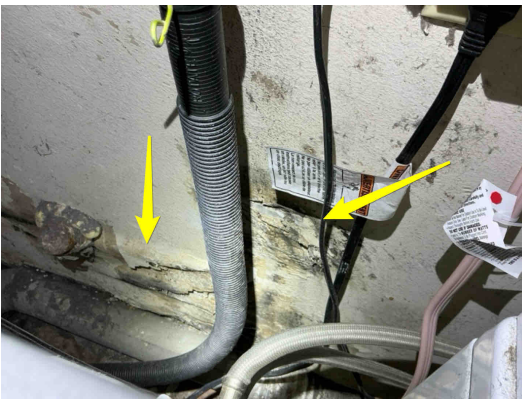
**FI 213:** Evidence of moisture stains and/or damage at the walls BEHIND THE LAUNDRY MACHINES. Recommend further review of the water stains to determine the cause, the current condition and if repairs are needed.

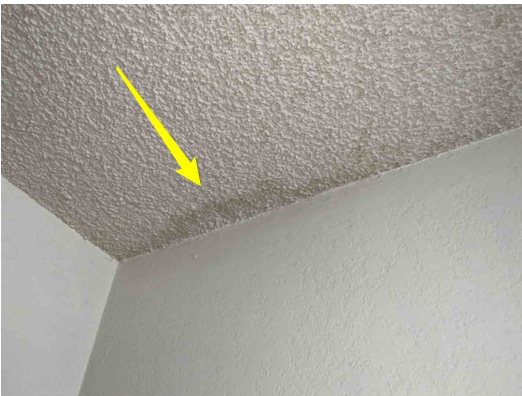
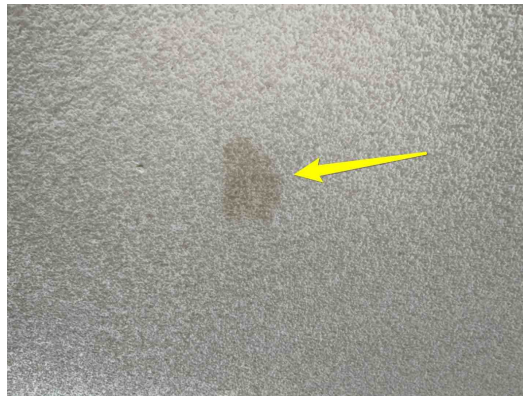
**FI 214:** Evidence of past moisture stains & damage at ceiling area in the UNIT-4 BEDROOM-1 & 2. Recommend further review of the water stains to determine the cause, the current condition and if repairs are needed.

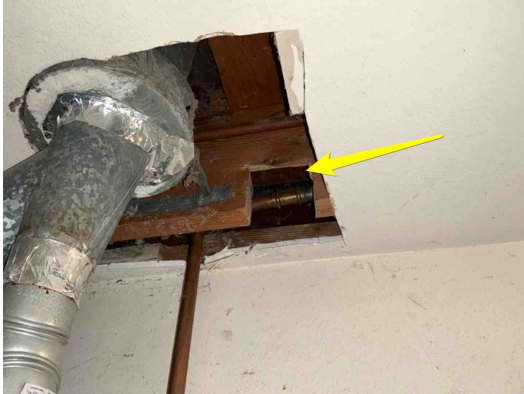
**E&C 216:** Some improper notching of structural framing/ floor joists noted in the: WEST MECHANICAL ROOM ABOVE THE WATER HEATERS

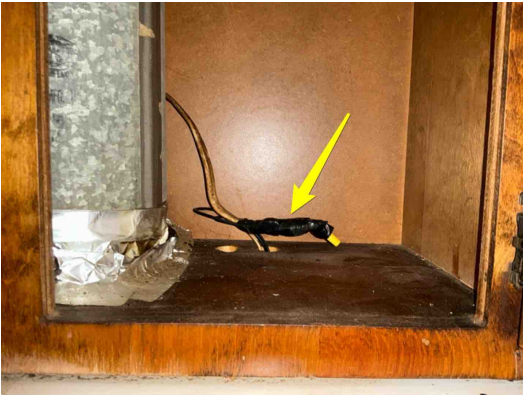
**SC 249:** Improper electrical wiring. Exposed electrical wires and/or splices not protected in a box with a cover: UNIT-4 KITCHEN

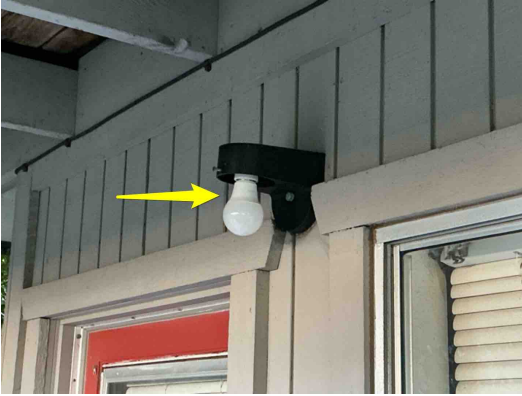
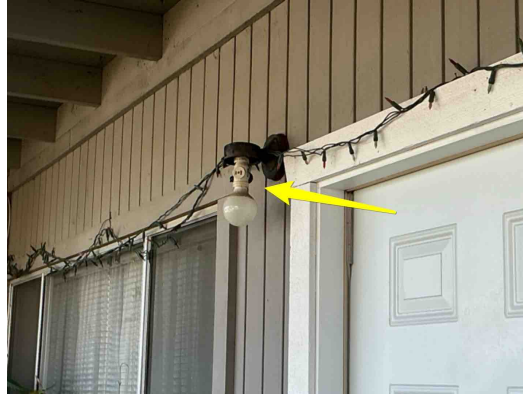
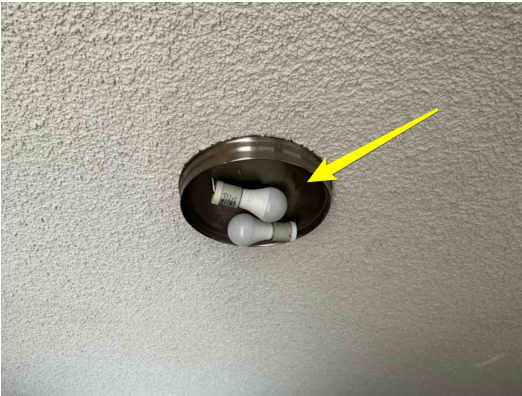
**E&C** 252: Lens at light fixture is missing: MULTIPLE

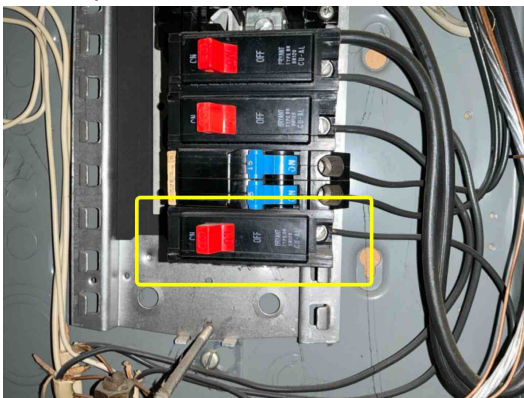
**SC 259:** Electrical panel defect / Over-fusing (breaker found too large for wire), (15-amp wire on a 20-amp breaker) in the ELECTRICAL SUB PANEL.
