## **Property Inspection Report**

***3000 Gold Rush Ln, Paso Robles, CA 93446***

***Date of Inspection: 6/25/2026 Time: 1:30 PM***

***Inspector: Peter Ruiz***

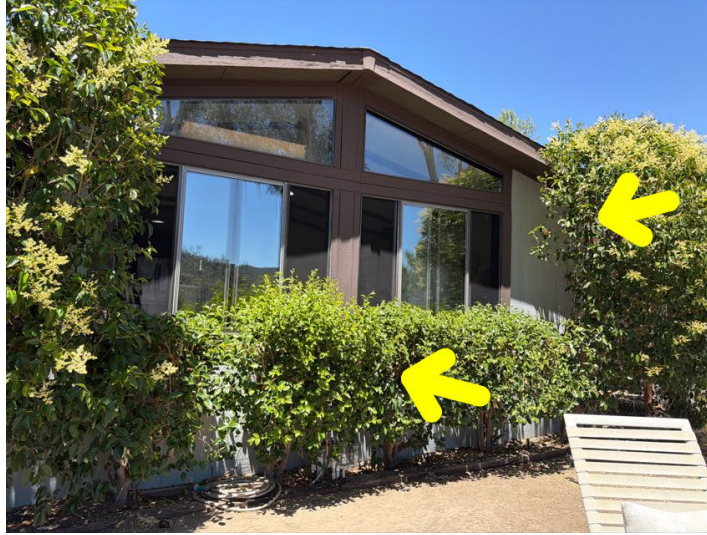
Vines, shrubs or bushes are growing on the house walls and although they are attractive they can introduce pests and rodents and accelerate deterioration. Therefore, you may wish to consider having them removed or cut back to 12 inches (30 cm) away from the home.

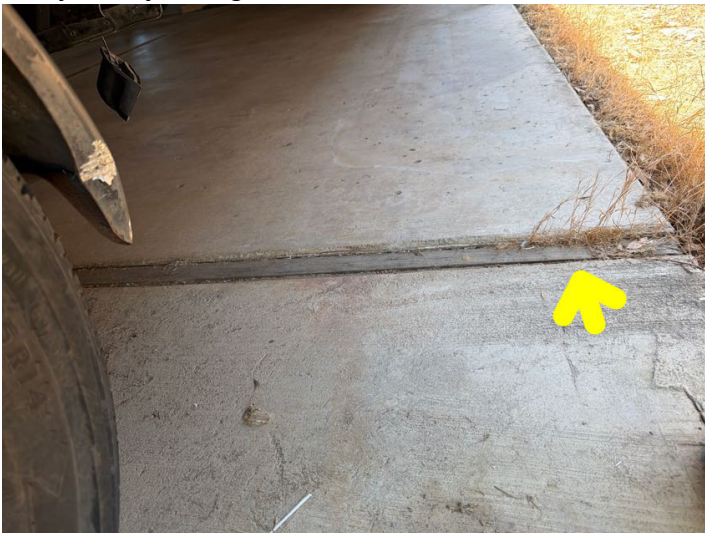
There are one or more offsets in the driveway that could prove to be trip-hazards.

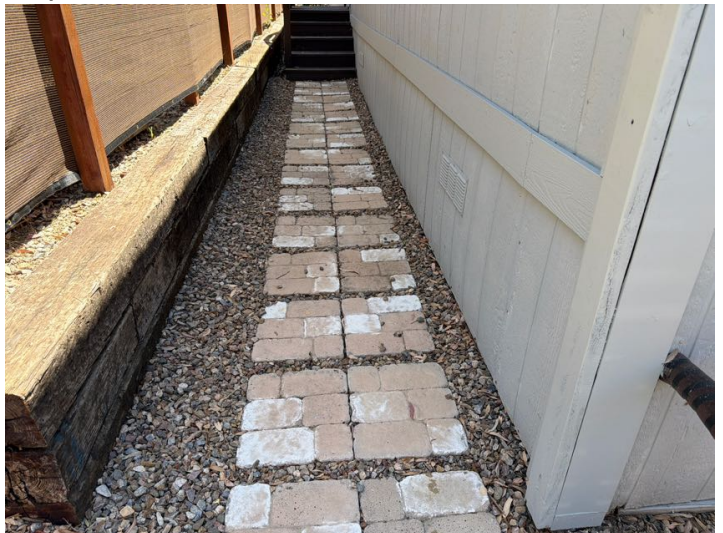
The paver patio or walkway has one or more offsets that may prove to be trip-hazards. This may be by design or due to unsuitable soil below the pavers.

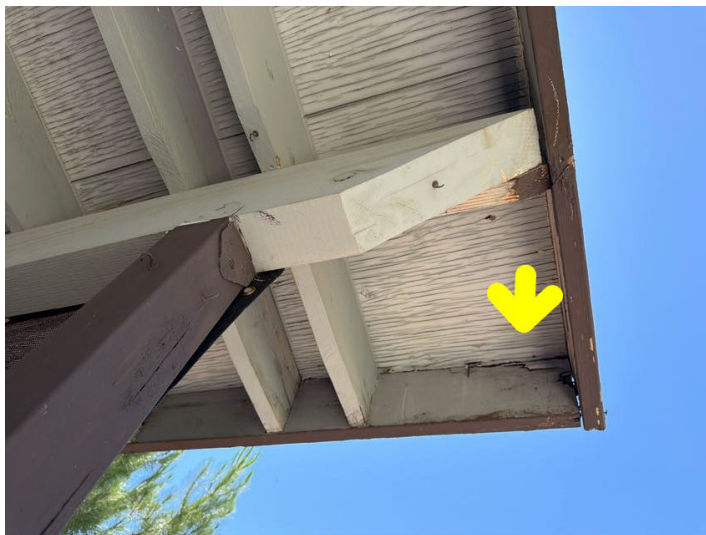
There is damage to the wood trim, fascia, and/or eaves that should be evaluated by a pest inspector.

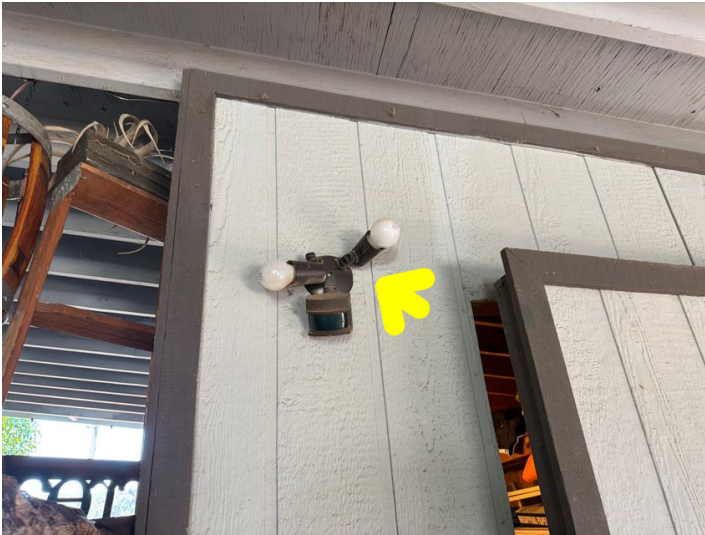
A light is missing its globe or cover and should be serviced.

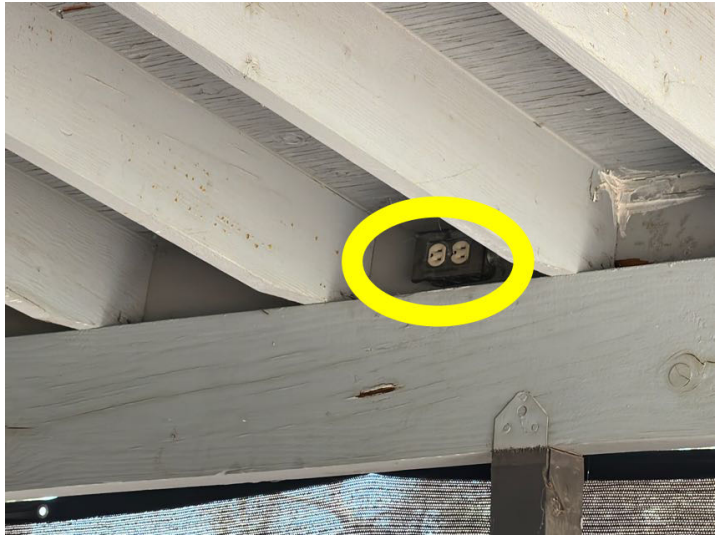
Some of the exterior electrical outlets do not have a weather rated cover or the cover is damaged and should be serviced.

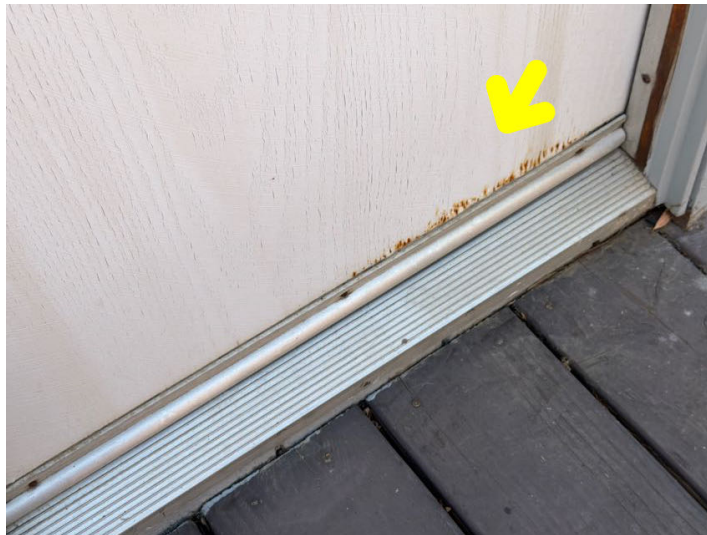
The finish on one or more of the exterior doors is weathered, and you may wish to have them refinished or replaced.

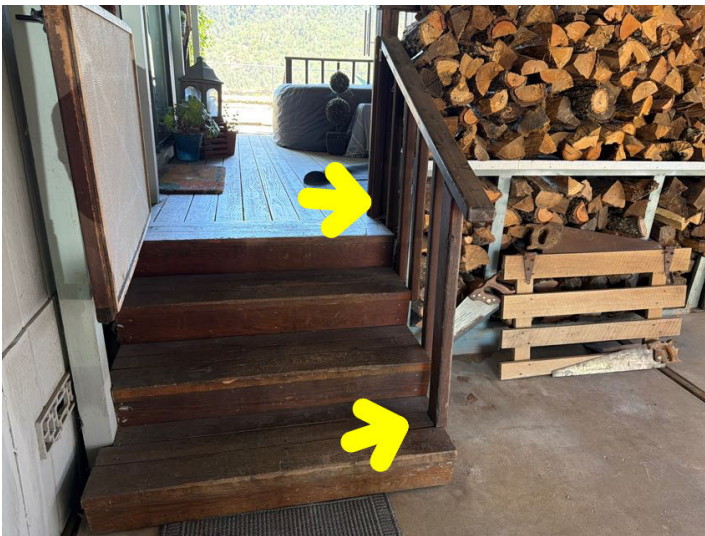
One or more handrails are not secure and should be serviced for optimal safety.

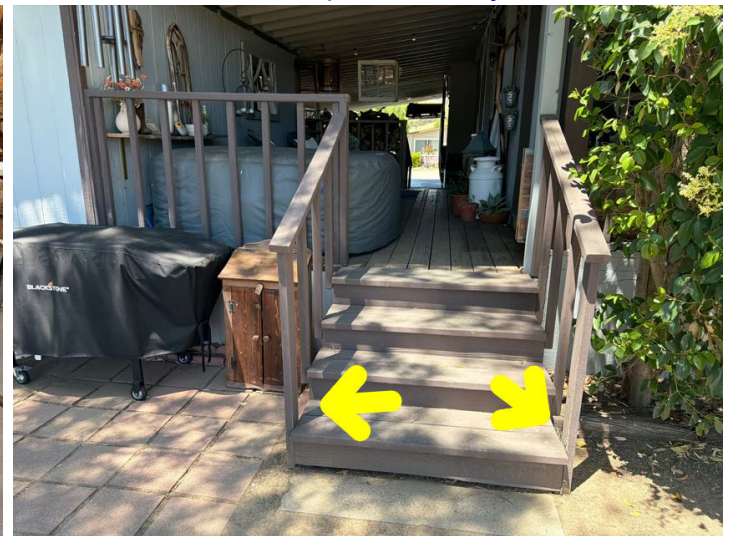
One or more handrails are not secure and should be serviced for optimal safety.

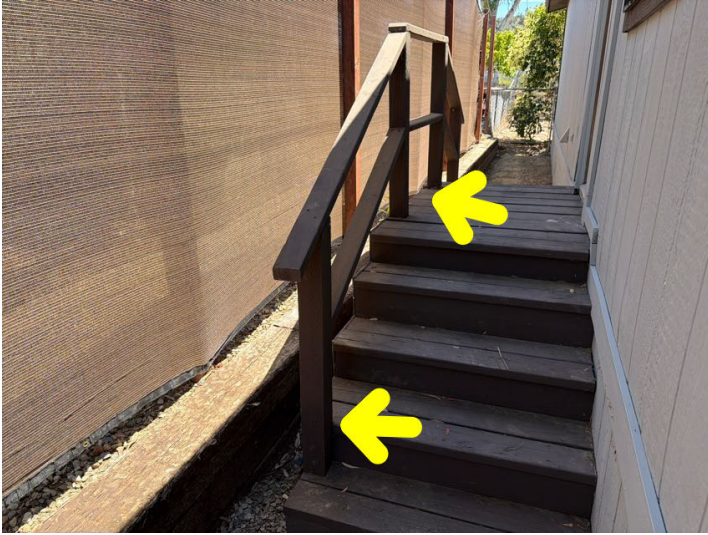
One or more handrails are not secure and should be serviced for optimal safety.

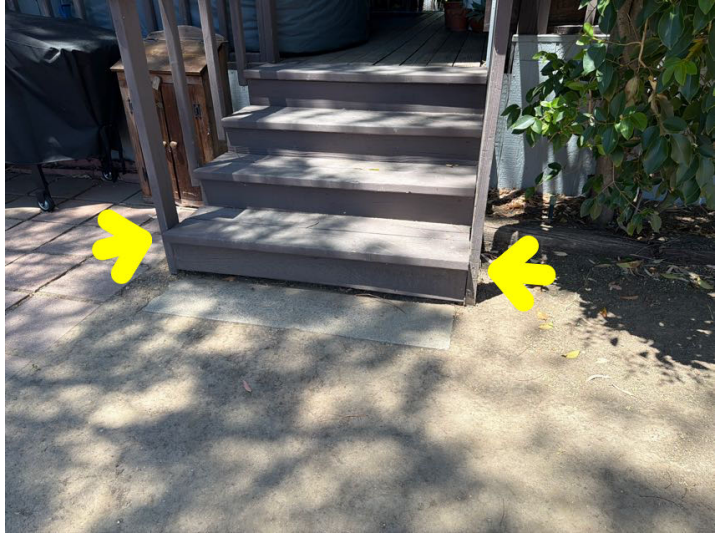
One or more steps have unequal treads or risers. Steps are required to be uniform to prevent trip-hazards. The rise of any step should be no less than four inches and no greater than seven and three-quarter inches, and the run should be no less than eleven inches. Also, the dimensions of the largest step should not exceed that of the smallest by more than three-eighths of an inch.

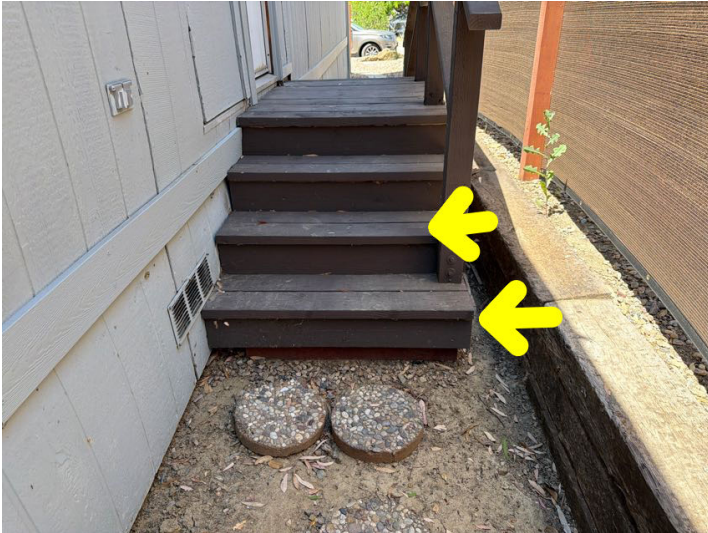
One or more steps have unequal treads or risers. Steps are required to be uniform to prevent trip-hazards. The rise of any step should be no less than four inches and no greater than seven and three-quarter inches, and the run should be no less than eleven inches. Also, the dimensions of the largest step should not exceed that of the smallest by more than three-eighths of an inch.

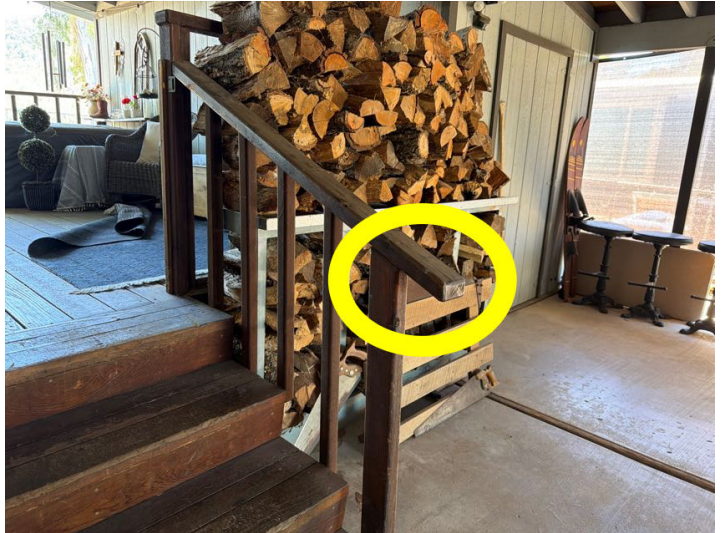
The handrail does not return, which is required at the top and bottom of the stairs by current building standards. This condition could allow a purse or clothing to initiate a fall.

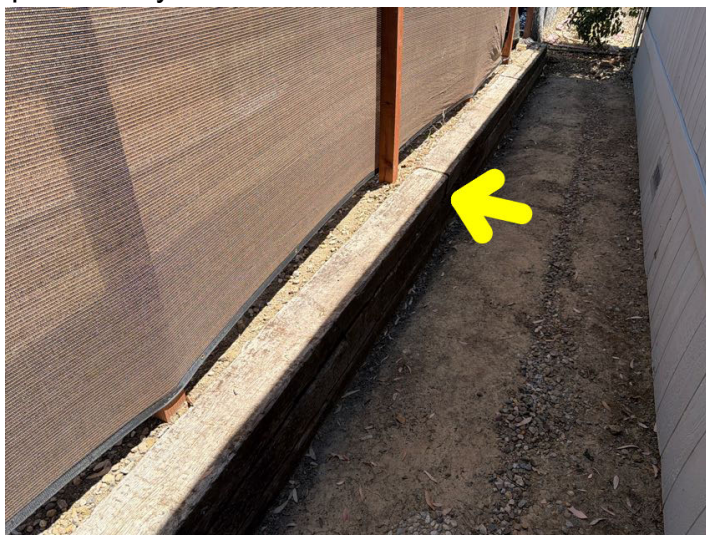
The railroad-tie or wooden yard walls, though functional, have no structural value as retaining walls and will need to be periodically monitored for movement.

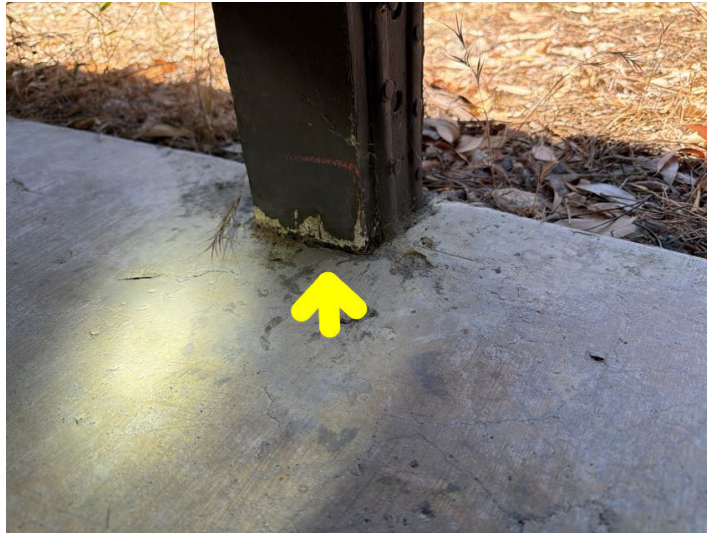
There is damage to the carport that should be evaluated by a pest inspector.

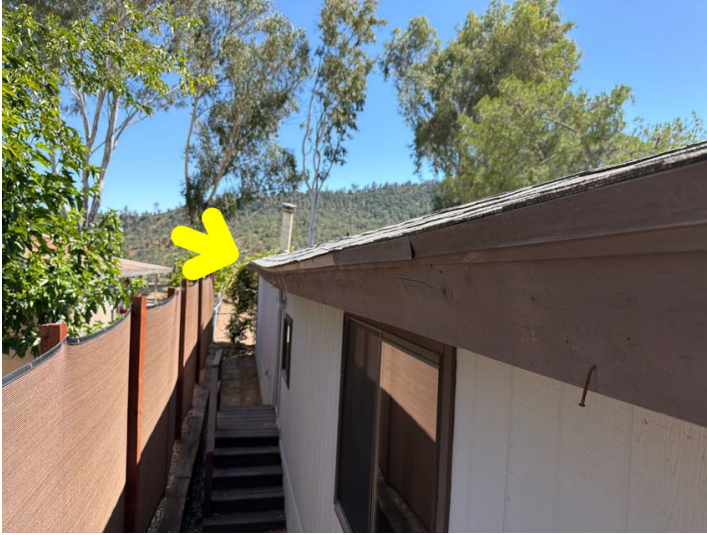
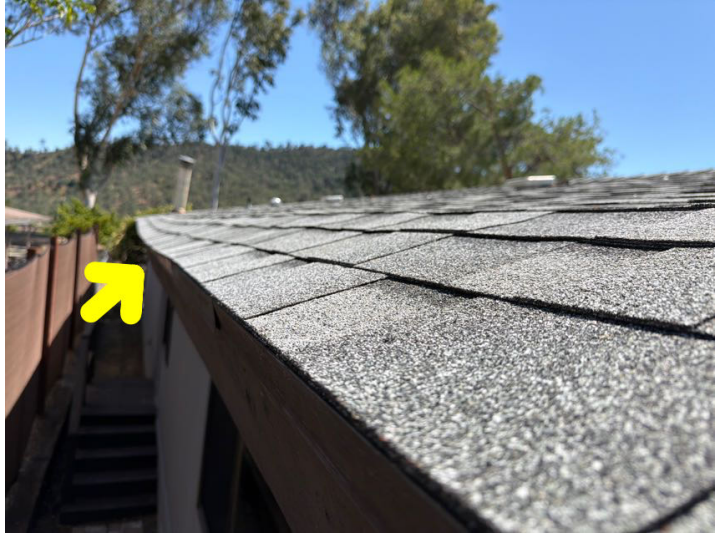
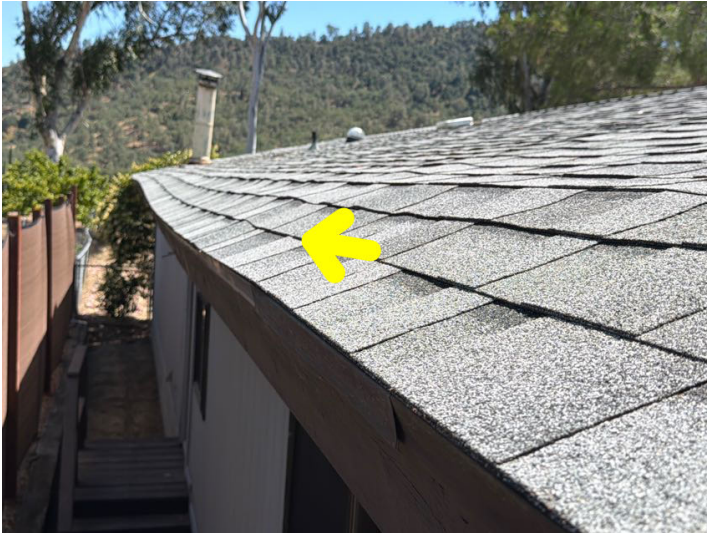
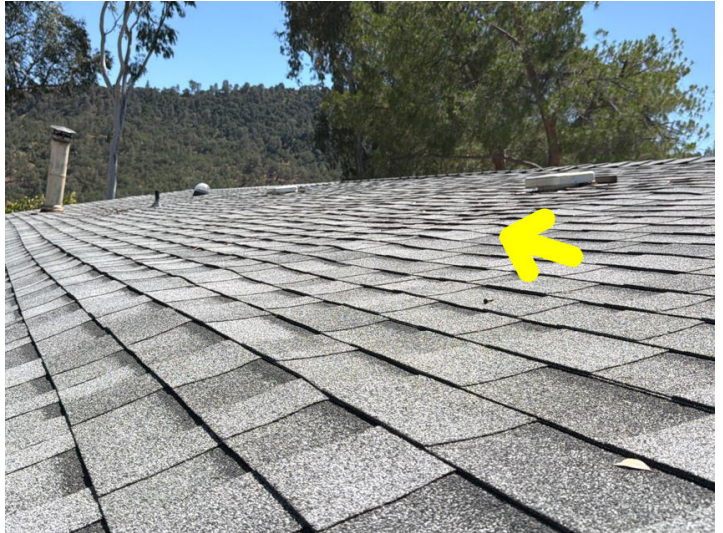
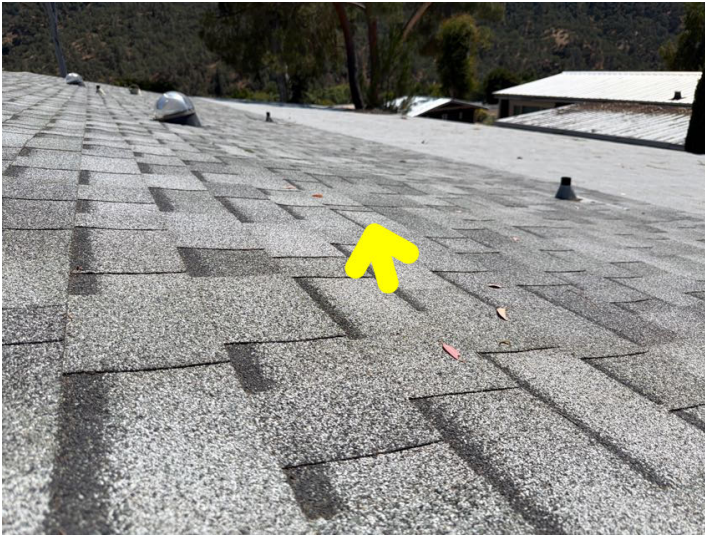
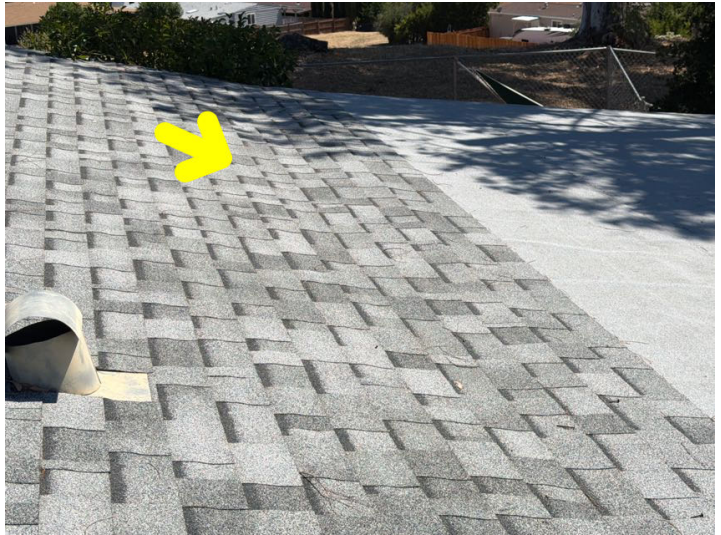
2.9. The ridge or roof-line appears to be wavy in silhouette. We will elaborate on the possible reasons for this, and we recommend an evaluation by a qualified tradesperson.

The ridge or roof-line appears to be wavy in silhouette. We will elaborate on the possible reasons for this, and we recommend an evaluation by a qualified tradesperson.

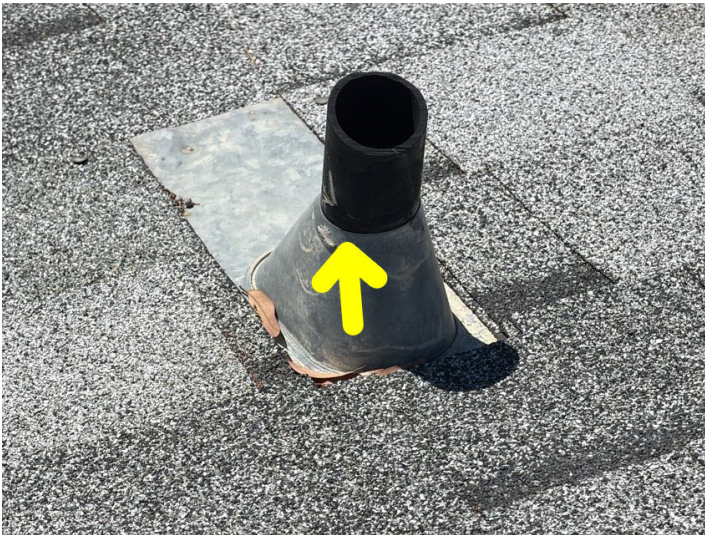
One or more of the roof flashings need to be sealed or serviced. They are comprised of metal that seals valleys, vents, and other roof penetrations, and are the most common point of leaks. This is particularly true of the flashings on a layered roof, which are covered by the roofing material and are even more susceptible to leaks.

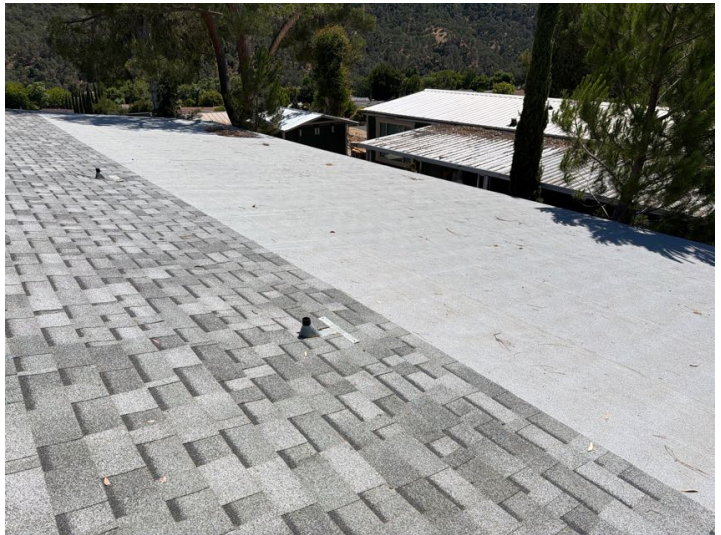
The roof includes a flat-roofed section, and flat roofs can be problematic if they are not kept clean and well maintained. Water ponds on most of them, particularly along the leading edges, and such water will generally only be dispersed by evaporation. Therefore, they must be kept clean and inspected regularly. This is important, as our service does not include any guarantee against leaks.

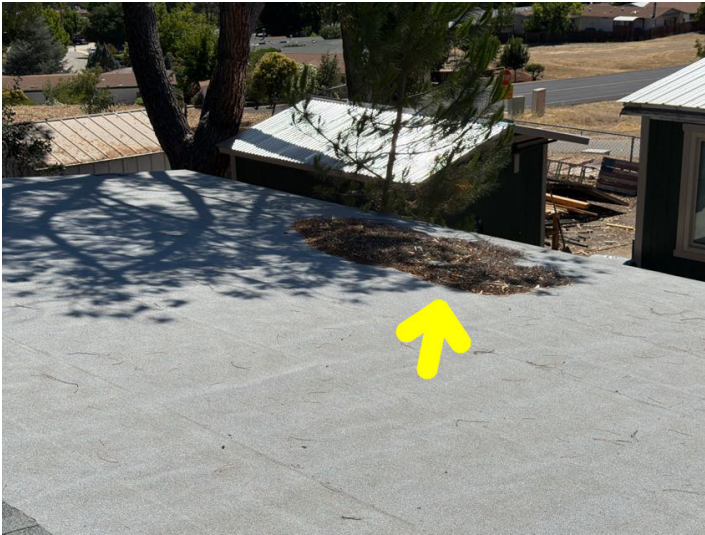
The roof needs to be cleaned and any foliage trimmed away to promote and insure proper drainage.

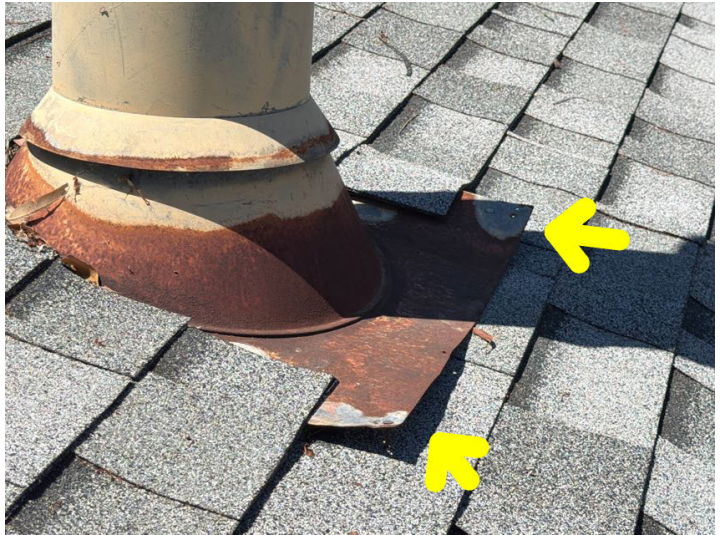
The toe of one or more of the flashings has been lifted, probably by the wind, and should be serviced.

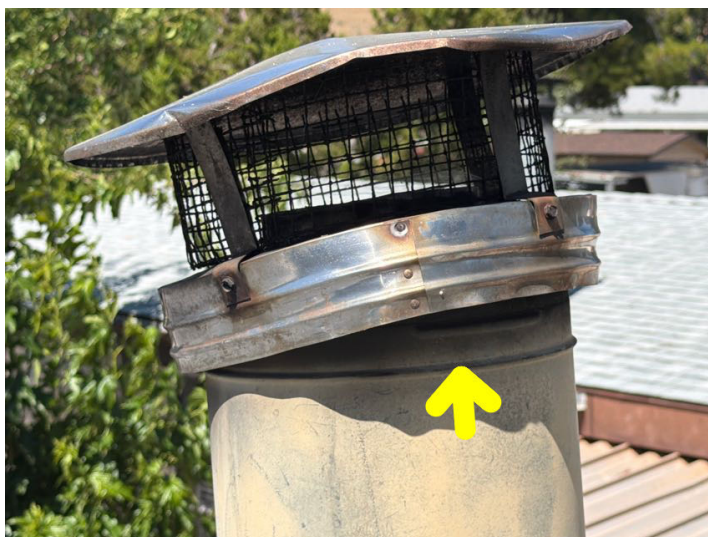
The spark arrestor does not properly attach or fit and should be serviced by a qualified tradesperson.

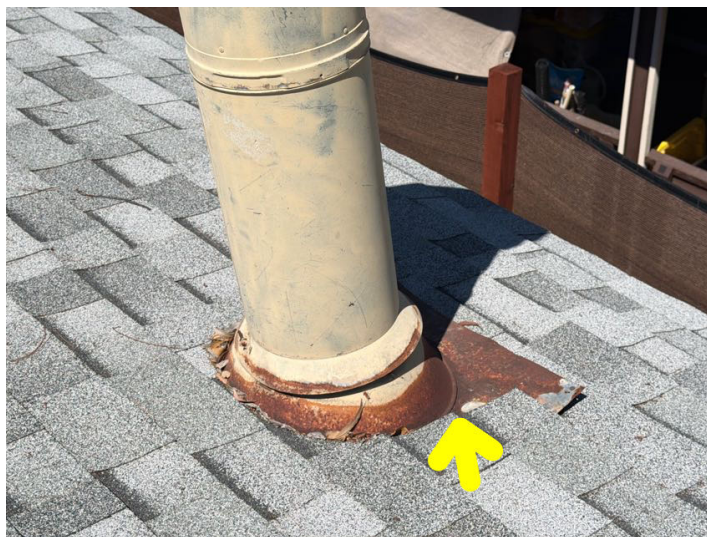
The flashing between the chimney and the roof needs to be serviced by a qualified tradesperson.

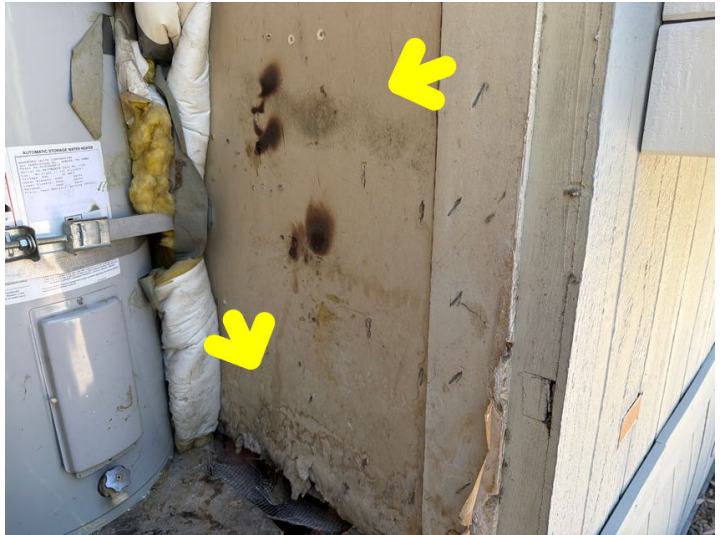
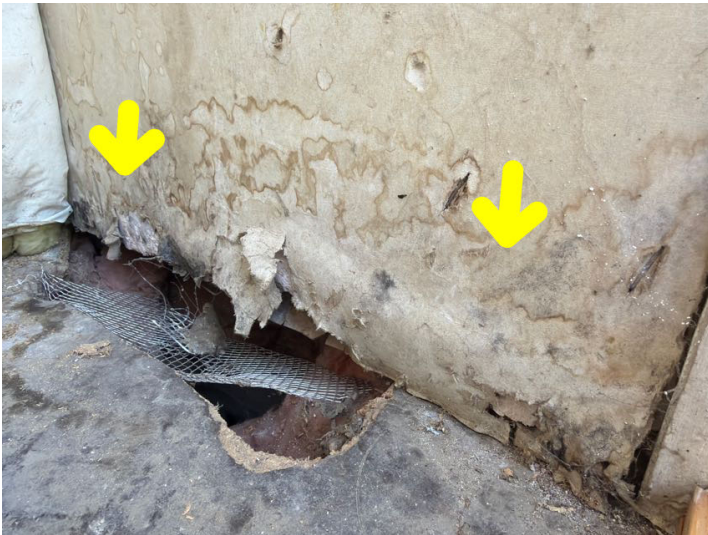
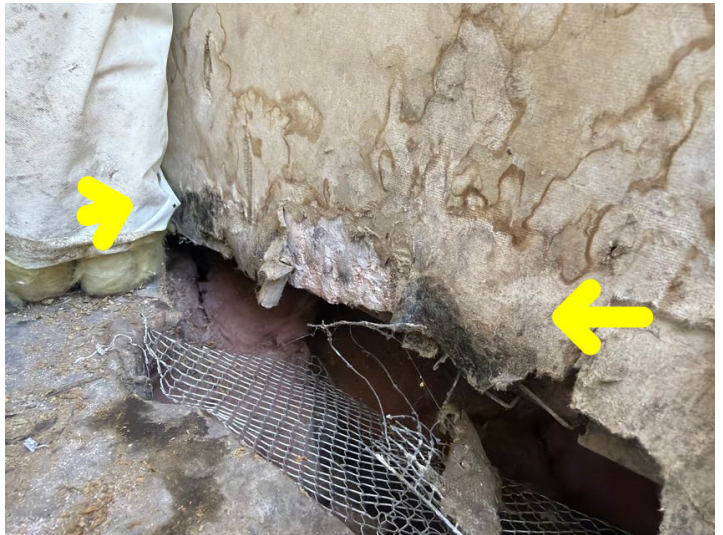
There is a dark staining within the water heater closet that should be evaluated by a qualified specialist and cleaned as necessary.

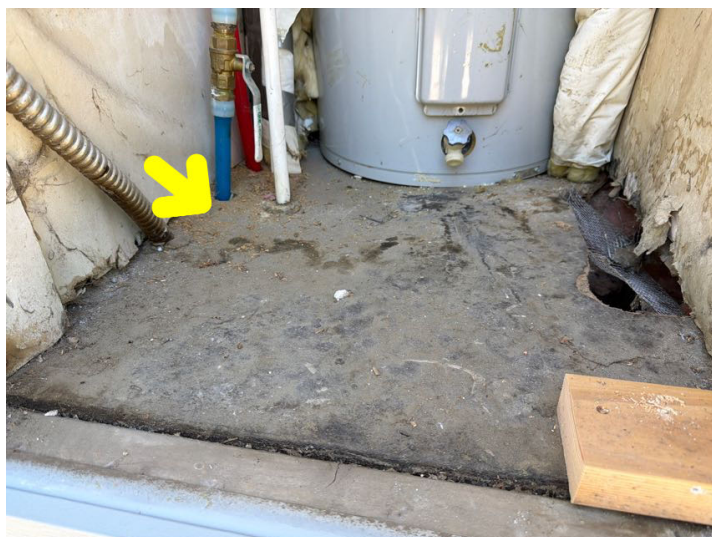
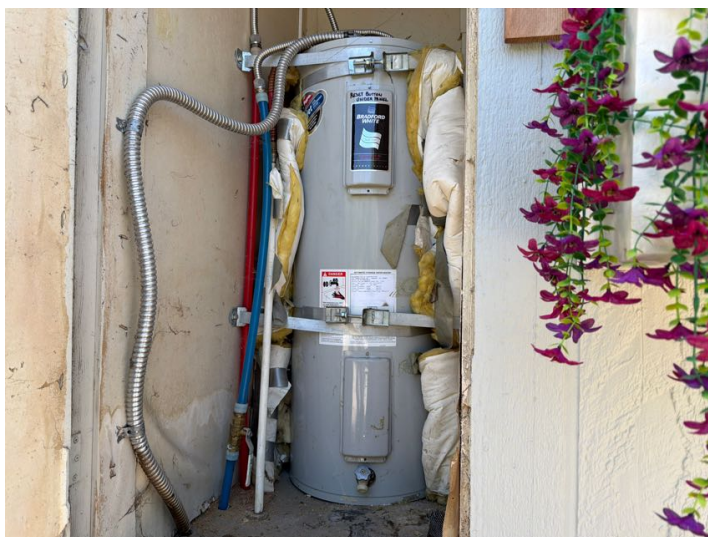
There is a moisture stain on the floor, wall, or ceiling that should be explained or explored further.

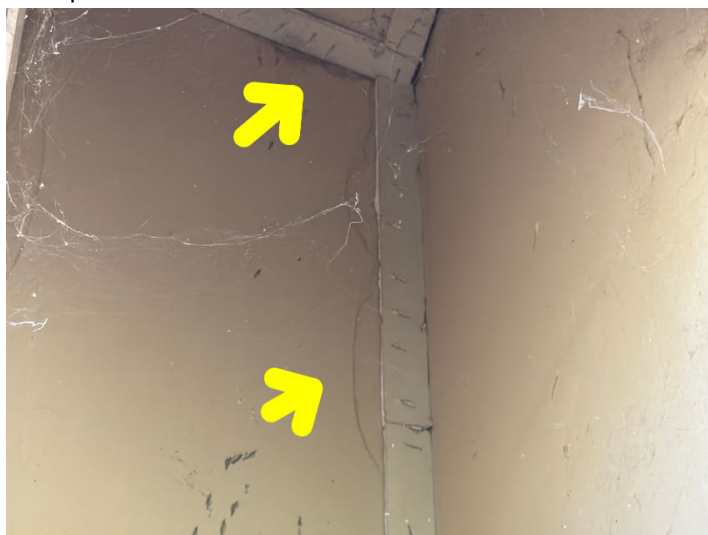
There is a moisture stain on the floor, wall, or ceiling that should be explained or explored further.

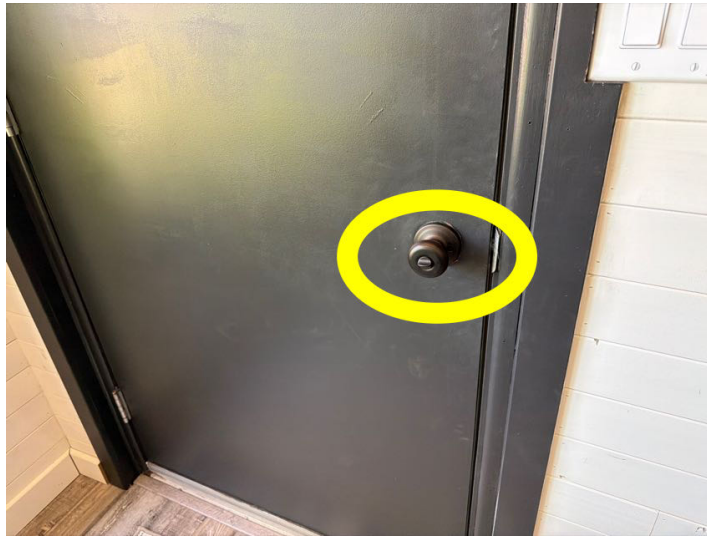
The door handle is loose and needs to be serviced to work smoothly.

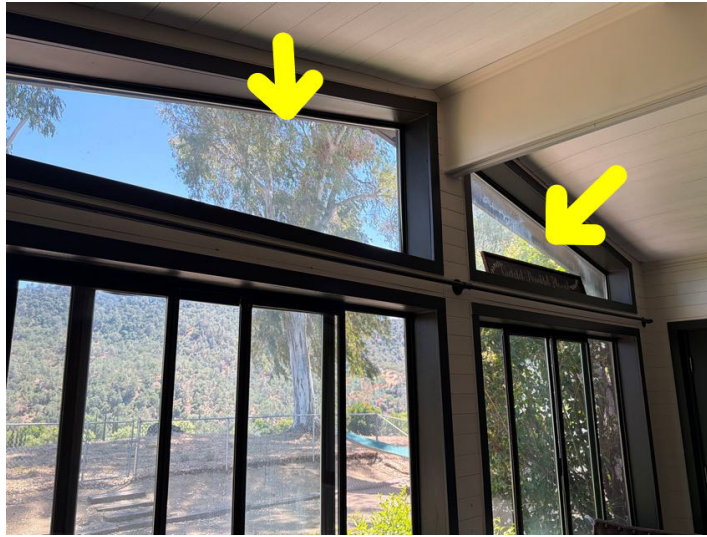
One or more windows may have a broken hermetic seal, which you may wish to have replaced. This is evident from fogging or condensation forming between the panes of glass, which implies that the seal has failed.

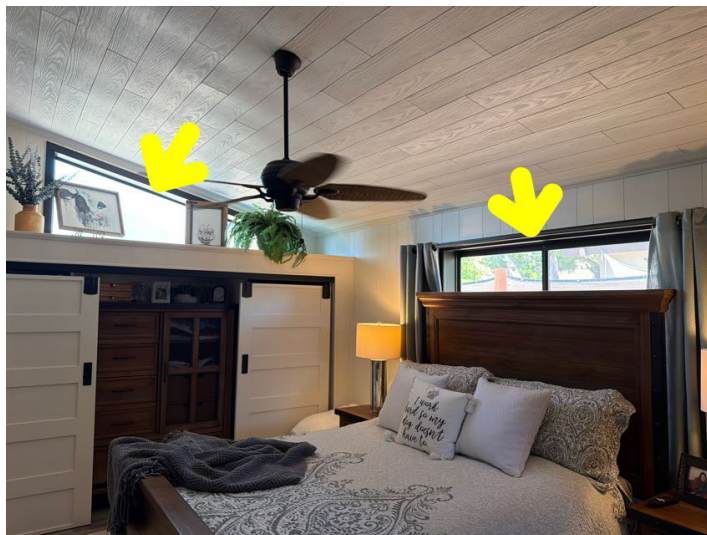
One or more windows may have a broken hermetic seal, which you may wish to have replaced. This is evident from fogging or condensation forming between the panes of glass, which implies that the seal has failed.

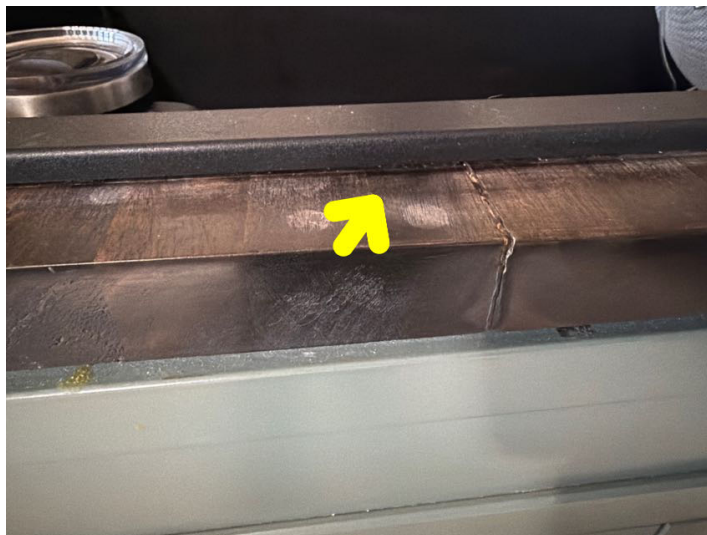
An open seam between the sink and the counter top needs to be caulked or re-grouted to forestall moisture intrusion.

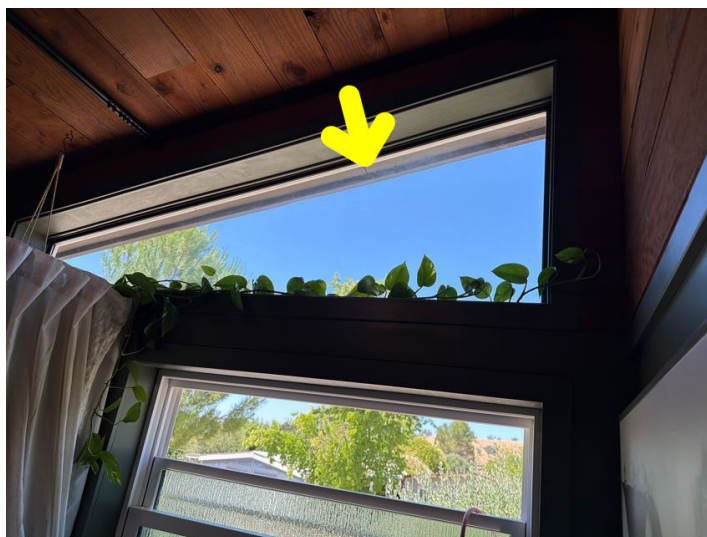
One or more windows may have a broken hermetic seal, which you may wish to have replaced. This is evident from fogging or condensation forming between the panes of glass, which implies that the seal has failed.

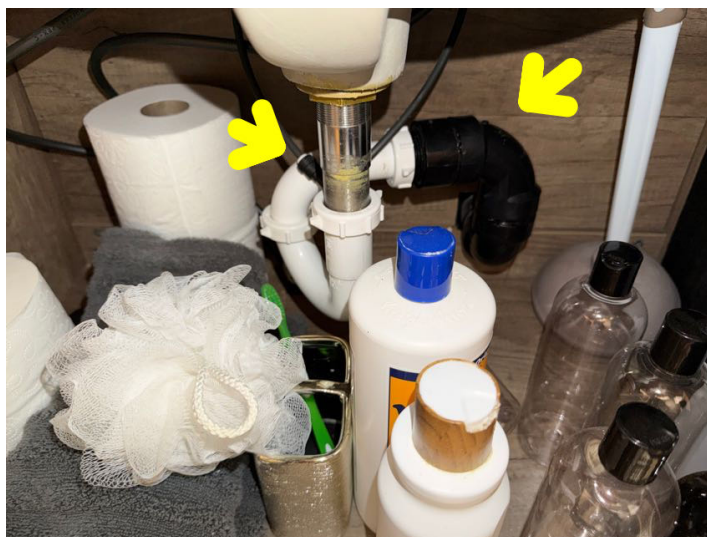
The drain lines below the sink make unnecessary turns, and should be evaluated by a qualified tradesperson.

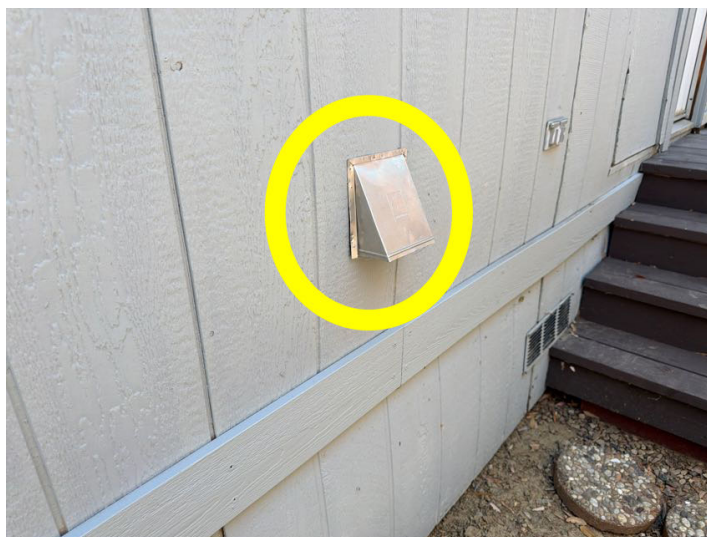
The back-draft on the exterior dryer vent cover is missing, stuck open, or incomplete and should be cleaned, repaired, or replaced.
